# Ibanez FL9 Flanger

# Guitar Pedal Repair

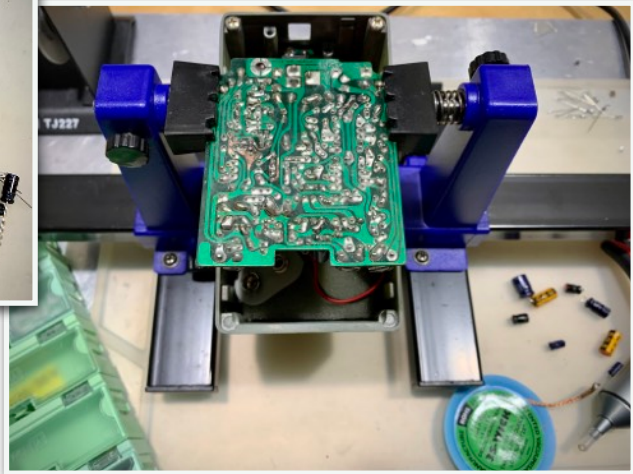
*Repair in-progress.*

One more inspection was conducted after replacing all capacitors and repairing the damaged copper traces. Can't be too careful when getting ready for applying power to test the reconditioned pedal.
