Golden Gate Bridge Inspection Program

Bridge Engineering 101

GGB – Biennial Inspection Schedule

Inspection Form and Report

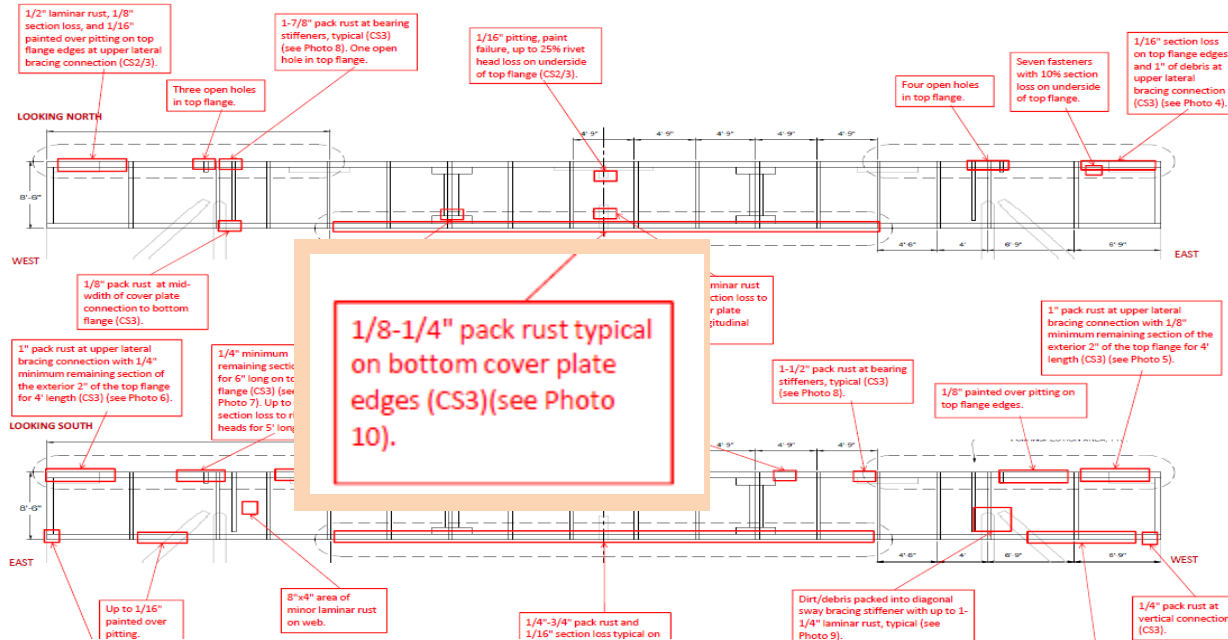
1/8-1/4" pack rust typical on bottom cover plate edges (CS3)(see Photo 10).

1. Clean and paint corroded areas and replace fasteners as needed.
2. Remove dirt/debris from stiffener pockets at sway bracing to connection and install drain holes in the stiffeners to help reduce up/corrosion.
