UNIT 1 Girder Spans: Special Inspections for Steel Girders

Unit 1 Girder Spans

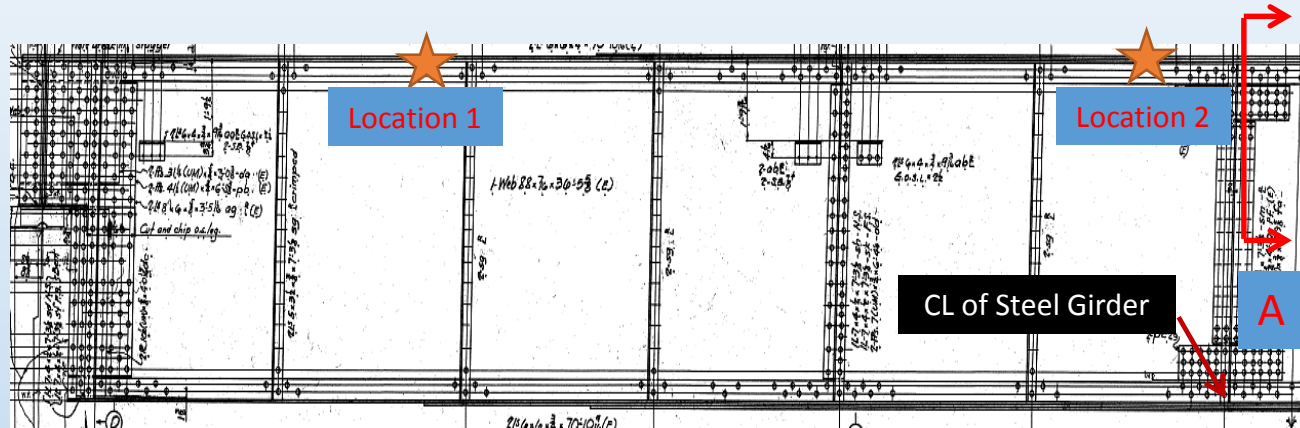
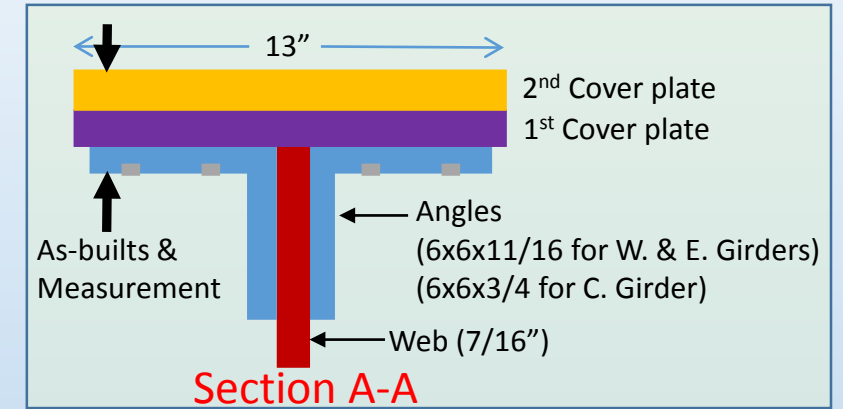
Field Measurements (Top Flange)

Location 1 (1 st cover plate only)			Location 2 (both cover plates)			Fasteners	
	As-built	Measured	Diff. (%)	As-built	Measured	Diff. (%)	Type ⁽²⁾	Condition
West Girder	1.3065"	1.284"	0.02	1.875"	1.85"	0.03	Bolt	Good
Center Girder ⁽¹⁾	1.438"	1.43"	0.01	2.062"	1.99"	0.1	Rivet	Fair/Poor
East Girder	1.3065"	1.3"	0.0	1.93"	1.93"	0.0	Bolt	Good

(1) Center Girder shows moderate to heavy corrosion on rivet heads and steel pitting on top flange

(2) Both W. and E. Girders have bolts, while Center Girder has rivets
