Authorized Field Change

AFC G-06920

Subject: Transmission Clean Power and Ground Rewire

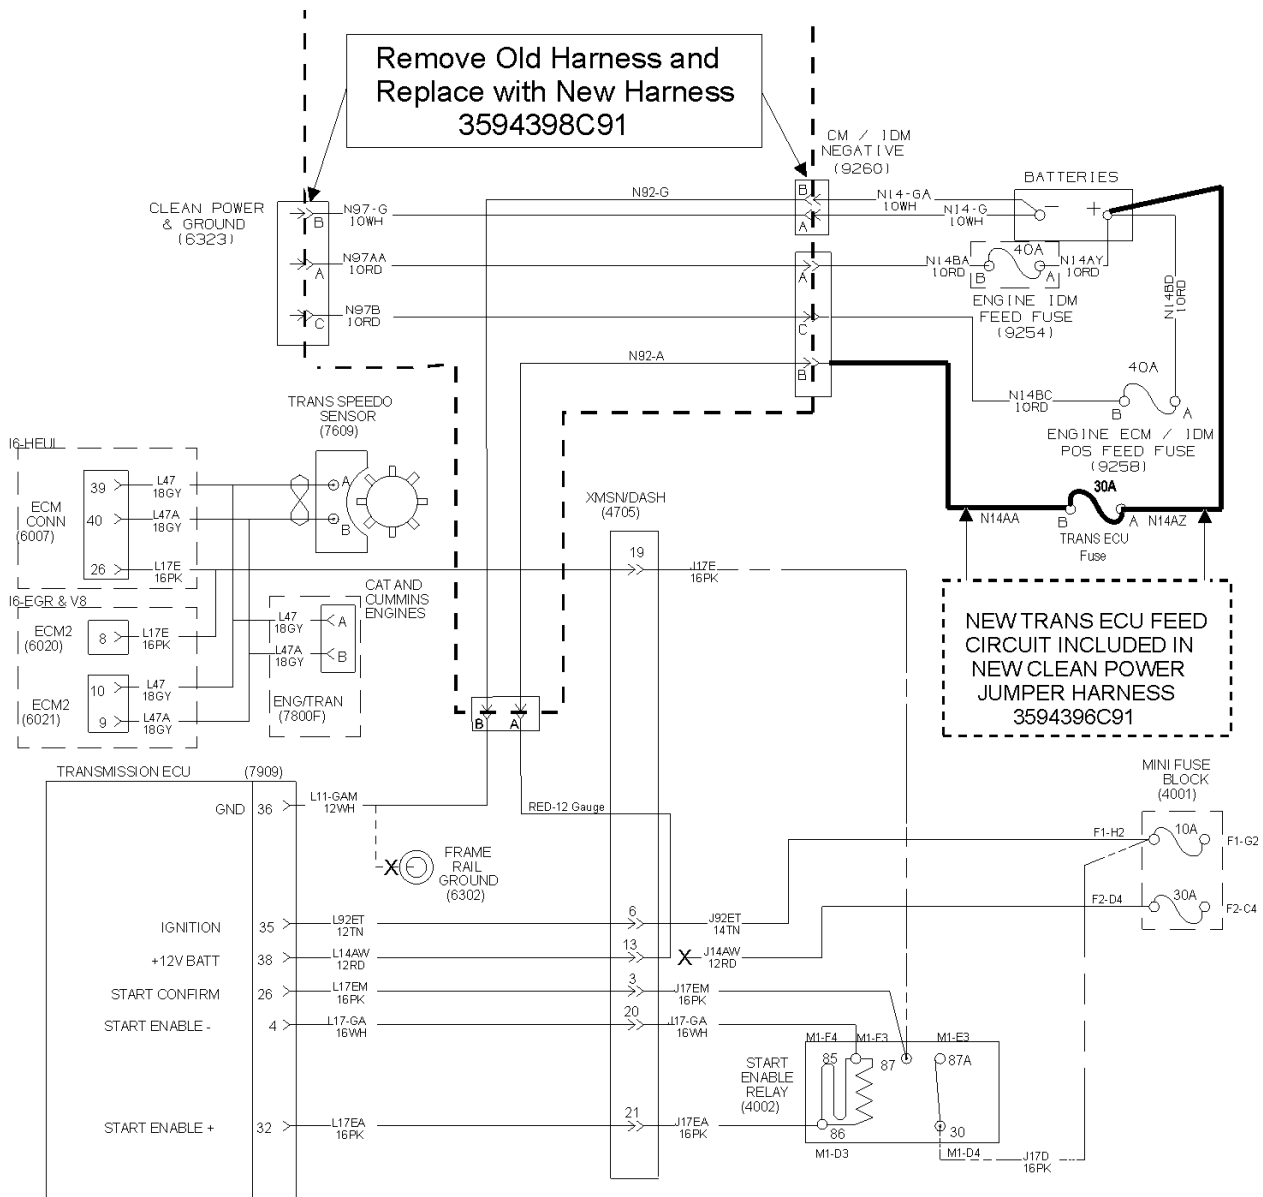
Figure 10

Deterioration of the current power feed to the transmission ECU can experience low voltage that can ultimately cause a No Start condition. Supplying power and ground directly from the batteries to the transmission ECU will eliminate the voltage losses being experienced through the frame rail ground and various chassis connectors. The circuit schematic on the last page illustrates the final wiring after the modifications are completed.
