# VEHICLE RECALL

**G-03513**  
**November 2003**

**SUBJECT: SAFETY RECALL (U.S., EXPORT)**  
**Steering Columns of RE (Rear Engine) and FE**  
**(Front Engine) Busses Built Between 10/28/1993**  
**and 5/21/2003**

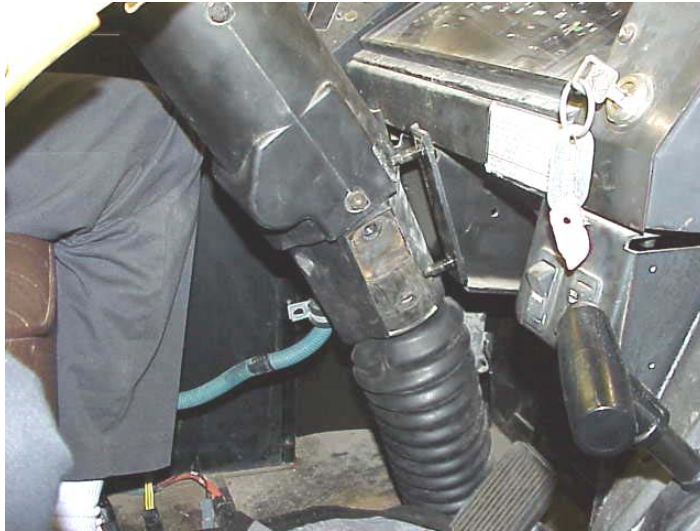
**Figure 5**

***STEERING COLUMN IS NOW ONLY SUPPORTED BY LEFT-HAND UPPER BOLT.***

5. Remove **right-hand** steering column bracket nuts. Remove **right-hand** bracket from column and cowl.
