# Authorized Field Change

AFC G-06904

**Subject:** Engine Air Management System Upgrade for Certain International® 3200 and 4200 Models Built Between November 1, 2001 and December 31, 2002 with International® VT 365 Engines

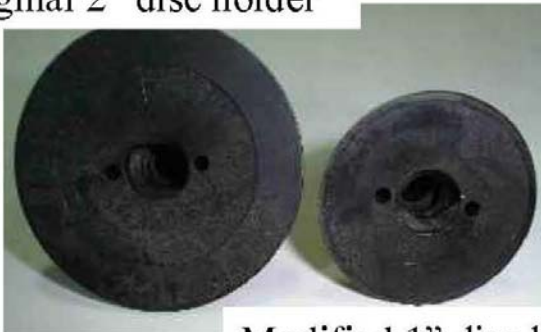
**Figure 13**

Original 2" disc holder

Modified 1" disc holder

15. Prepare the sanding disc holder (Figure 13 and Figure 14):
  - Chuck the disc holder (Figure 13) into a slow speed drill and with the aid of a bench grinder run the drill at slow speed and grind the diameter of the disc holder to approximately 3/4 to 1 inch diameter.
  - Install the desired disc onto the disc holder (Figure 14) and use the same procedure to grind the disc to fit the disc holder.

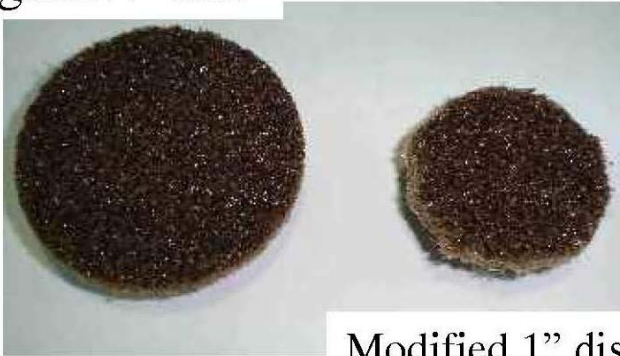
**Figure 14**

Original 2" disc

Modified 1" disc
