41st EU PVSEC 2024, 4AO.8.2, 23.09.2024

# Analysis of Fault Detection and Defect Categorization in Photovoltaic Inverters for Enhanced Reliability and Efficiency in Large-scale Solar Energy Systems

Stephanie Malik<sup>1</sup>, David Daßler<sup>1</sup>, Dharm Patel<sup>1</sup>, Carola Klute<sup>1</sup>, Robert Klengel<sup>1</sup>, Andreas Dietrich<sup>2</sup>, Kai Kaufmann<sup>3</sup>, Carsten Hennig<sup>4</sup>, Danny Wehnert<sup>5</sup>, Matthias Ebert<sup>1</sup>

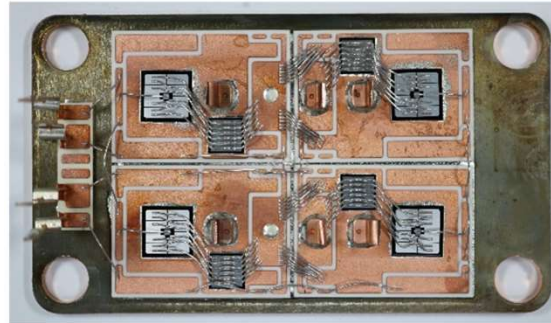
Power module after field ageing

- **a** Impairments in plane of the wire bond connections
- **b** The emitter metallization of the IGBT components is completely degraded and the associated wire bond connections to the DCB substrate are also destroyed.
- **c** Re-melting of the solder connections of the chips and the pins of the connection terminals is visible.

Characterization of the failure mechanisms in inverter components,  
above: Power modules without housing and potting  
bottom: non-destructive scanning acoustic microscopy (SAM) analysis (wire bond level) before removal of housing and potting

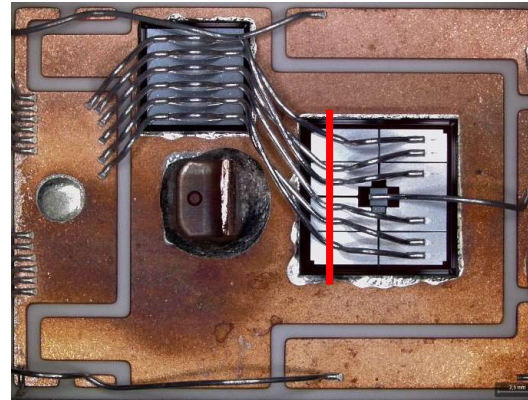
Power module after field ageing

- wire bond contacts are destroyed and not visible
- partially missing chip and solder area up to the DCB substrate
- The module was exposed to enormous heat, causing melting the chip and solder materials locally.

1. all four IGBT components are equally affected
  2. the associated diodes show no damage
  3. the peripheral extent of damage is less drastic overall
- ➔
- a longer lasting overtemperature load has led to degradation of the semiconductors
  - In the end, a breakthrough occurred and the final damage was caused by the short-term release of massive heat.

Cross sectional view of the bonding wires and solder contact using light microscope imaging of the IGBTs

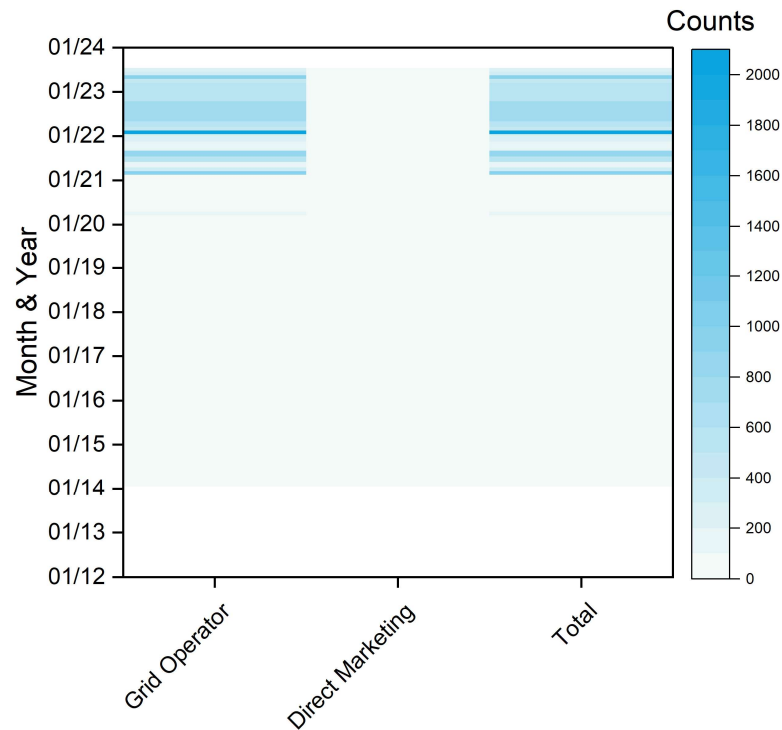
Amount of minutes of curtailment occurrence, aggregated per month and year, split between grid operator and direct marketing
