Investigation Report

Item	Investigation flange cracks and shank defects on items made from U.S. billetcast material trial	November 3, 2016
------	---	------------------

An investigation was launched following flange cracks and shank defects found on bolts made from U.S. billet-cast material.

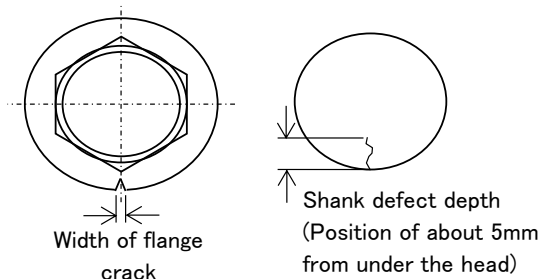
Depth of flange cracks and shank defects on North American billet material

Grade	Item	No.1	No.2	No.3	No.4	No.5	No.6	Unit [mm]
SAE10B23	Flange Crack Width	1.282	1.200	1.035	0.588	0.459	0.494	
	Shank Defect Depth	0.239	0.260	0.228	0.130	0.146	0.135

Original Product Diameter $\phi 12.7\text{mm}$
→ Drawn Diameter $\phi 11.7\text{mm}$
→ Bolt Blank Diameter $\phi 11.05\text{mm}$
(Defect depth unknown at original and drawn diameters.)
