# Solar Panel Inspection Report

Reporting Period: 2025-06-24 23:13:25 to 2025-07-24 23:13:25

Inspection Line: Smart Conveyor Automated System

Total Panels: 4

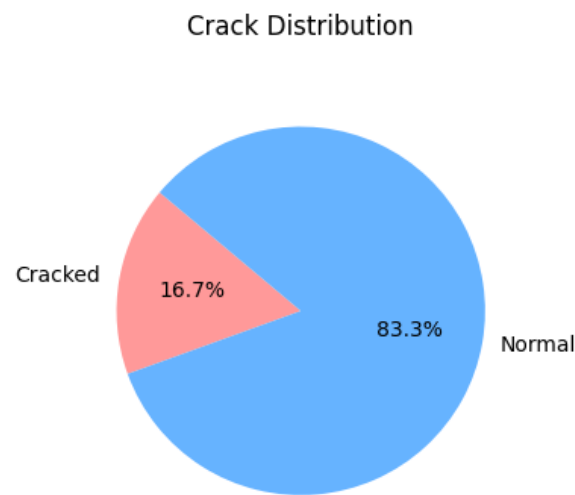
Cracked Count: 1

Crack Rate: 16.67%

\* **Visual Inspection:** A thorough visual inspection of the solar panel is crucial to identify any visible cracks, delamination, or other physical defects. This should be conducted under magnification.

\* **Electroluminescence Imaging (ELI):** ELI will help identify any micro-cracks or faulty cells which might not be visible during visual inspection.

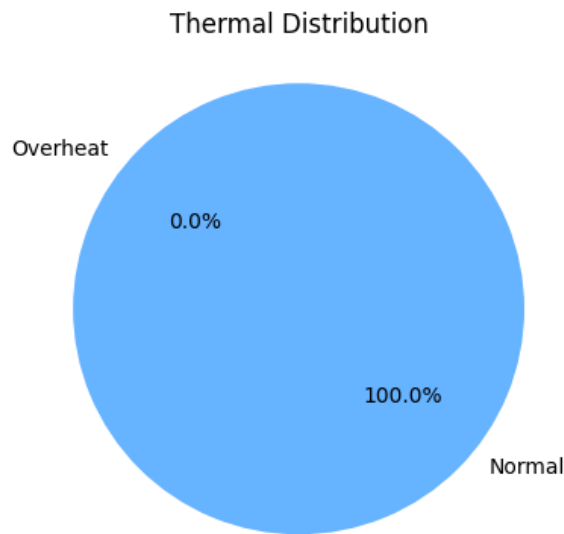
**Thermal Sensor Summary**

Overheated Points (>38°C): 0

Overheat Rate: 0.00%

**\*\*Overall Assessment:\*\*** The thermal data shows localized hotspots in areas 2, 4, and 5, exceeding the expected operating temperature of the cells. Coupled with the YOLOv8 detection showing multiple instances of "solarboard" with varying confidence levels, suggesting potential misalignment or overlapping panels, a comprehensive investigation is needed. This points toward likely manufacturing defects rather than field damage.

\* **Area 4:** Similar to Area 2, with a hotspot reaching 31.35°C. This again points to a possible delamination, poor cell contact, or a localized manufacturing defect. The pattern also suggests potential misalignment of cells during stringing.

\* **Area 5:** Hotspot reaching 31.72°C. This is the most significant hotspot and possibly indicates a combination of issues: delamination, poor cell contact, and potentially a manufacturing defect related to soldering or lamination process.

1. **Lamination Pressure:** The hotspots suggest insufficient pressure in certain areas, leading to incomplete bonding and delamination. This could be due to inconsistent pressure distribution across the lamination press. **Recommendation:** Investigate the lamination press for uneven pressure distribution. Calibrate the pressure sensors and ensure uniform pressure across the entire lamination area.

2. **Lamination Temperature:** While the average temperature is likely within the acceptable range, localized temperature variations during the lamination process might have occurred, resulting in inconsistent bonding. **Recommendation:** Check the uniformity of the lamination temperature profile. Ensure even heat distribution across the entire lamination surface by recalibrating the heating elements.

\* **Infrared Thermography:** A more detailed infrared thermographic scan would provide a higher resolution map of the hotspots, allowing for precise pinpointing of the defective areas.

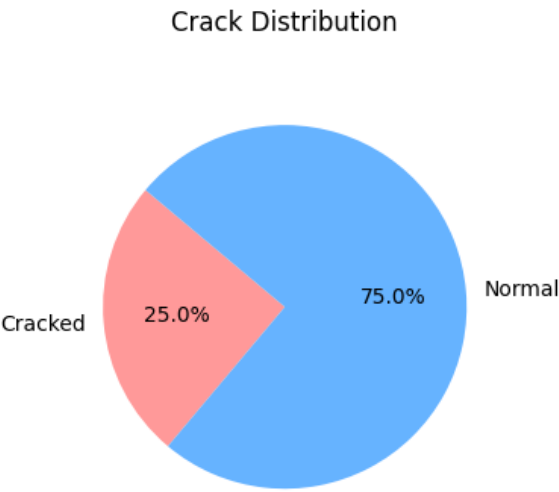
**Vision Scan Summary**

Scan Duration: 2025-06-29T17-17-07 to 2025-07-24T11-04-45  
Total Scans: 8  
Cracked Count: 2  
Crack Rate: 25.00%

\* **\*\*Cooling Rate post-lamination:\*\*** May have exceeded the recommended rate (1-3°C/min), leading to thermal mismatch and stress within the cells. A cooling rate over 5°C/min is suspected in several areas.

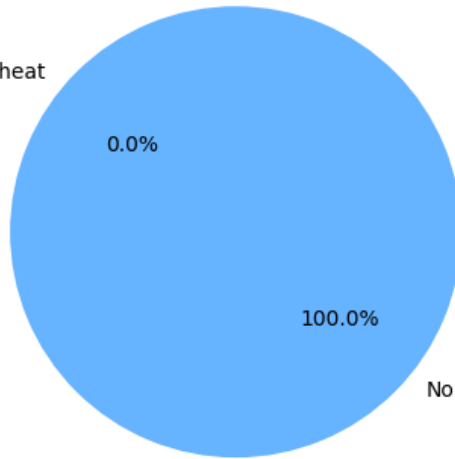
**Thermal Sensor Summary**

Scan Duration: 2025-07-22T16-17-03 to 2025-07-24T11-04-45  
Total Data Points: 1536  
Overheated Points (>38°C): 0  
Overheat Rate: 0.00%
