# Solar Panel Inspection Report

Reporting Period: 2025-06-25 11:29:22 to 2025-07-25 11:29:22

Inspection Line: Smart Conveyor Automated System

Total Panels: 4

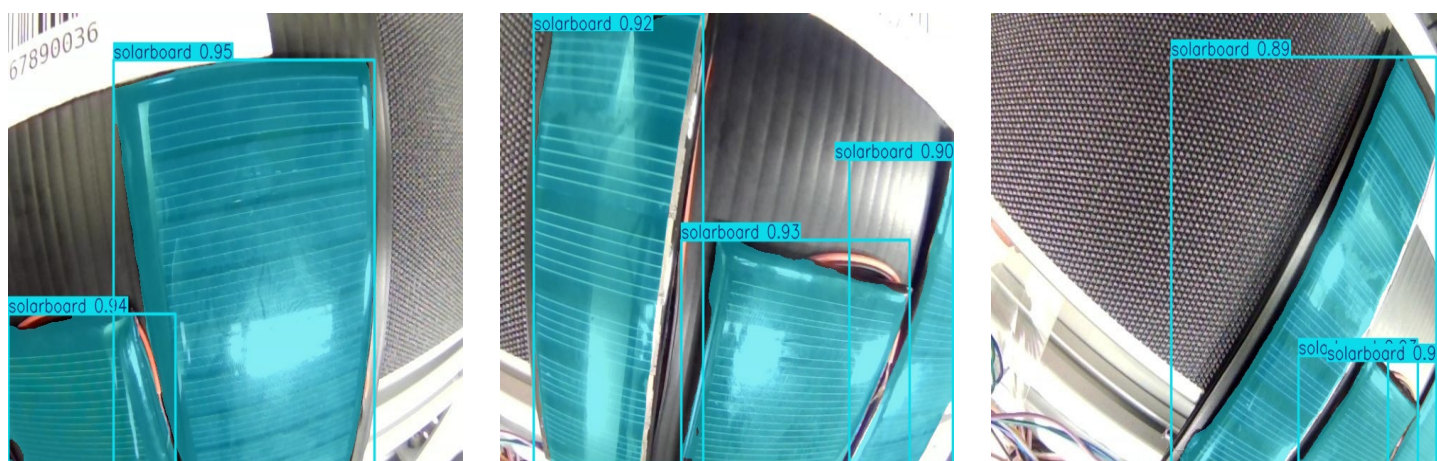
### Panel Images:

**\*\*Summary:\*\*** The analysis of images and thermal data suggests potential localized hotspots and possible minor cracking in areas 4 and 5 of the SolarBoard Min456. The YOLOv8 detections show multiple instances of the solar board in the images, indicating no major physical damage that would be immediately apparent. The thermal data however points towards specific areas requiring closer inspection. The relatively high confidence scores of the YOLOv8 detections also suggest that the detected areas are indeed representative of the solar panel itself.

\* **Area 5:** Although less pronounced than Area 4, Area 5 also displays a localized hotspot reaching 31.77°C, suggesting a similar issue, potentially related to the same root cause. The presence of elevated temperatures in multiple grid points within this area supports this.

\* **Soldering Temperature:** The most likely culprit is a localized soldering issue. The hotspots in areas 4 and 5 may be due to uneven soldering temperature. It's possible that during the soldering process, these areas experienced a momentary spike in temperature exceeding 270°C, resulting in micro-cracks and creating localized high-resistance spots. A brief excursion above 270°C in specific areas could explain the observed thermal pattern without causing widespread damage.

1. **\*\*Visual Inspection:\*\*** Conduct a thorough visual inspection of areas 4 and 5 with a high-resolution camera and magnification, looking for micro-cracks or imperfections in the cell surface or solder joints. Infrared thermography would confirm the hotspots and their precise location.

2. **\*\*Electrical Testing:\*\*** Perform detailed electroluminescence (EL) imaging and I-V curve measurements to identify any cell defects or performance degradation associated with the hotspots. This will help quantify the impact of the localized issues.

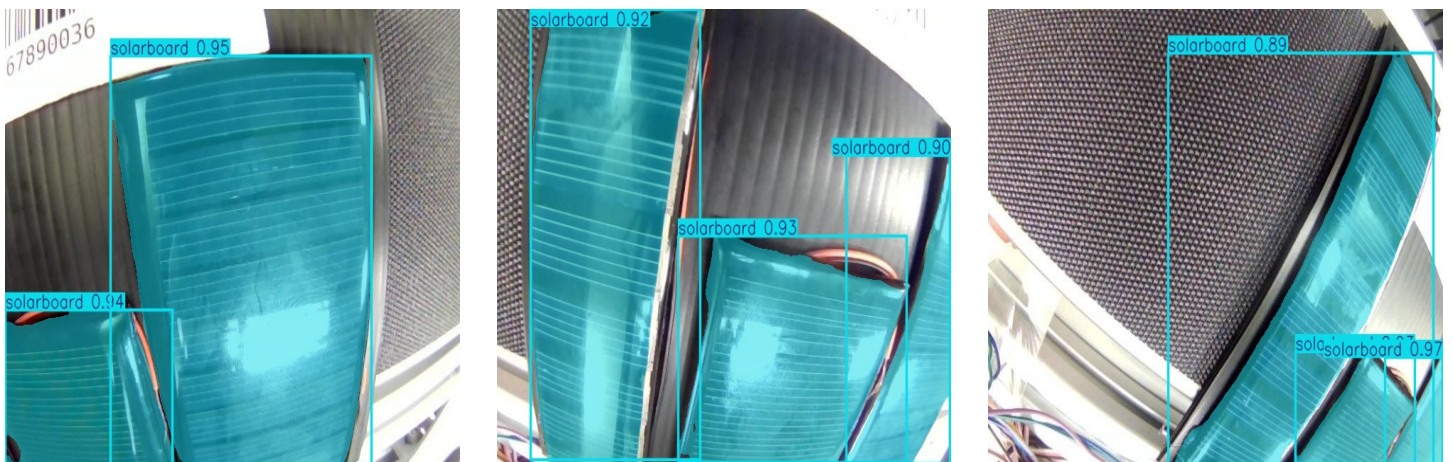
### Panel Images:

Analysis of SolarBoard MIN223 Serial Number 63442000083
