Solar Panel Inspection Report

Generated on: 2025-07-23 16:33:03

Inspection Line: Smart Conveyor Automated System

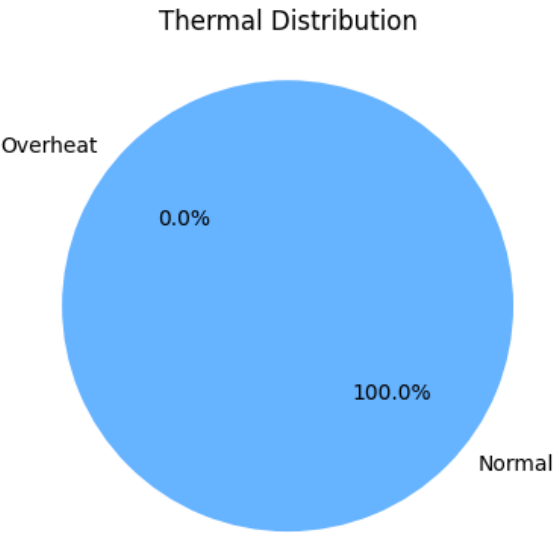
Scan Duration: 2025-06-29T15-20-46 to 2025-07-22T16-47-00
Total Scans: 3
Cracked Count: 1
Crack Rate: 33.33%

Overheated Points (>38°C): 0

Overheat Rate: 0.00%

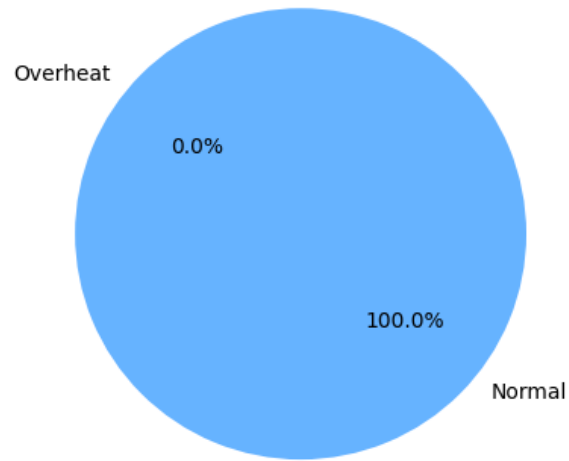
Thermal Distribution

Scan Duration: 2025-07-22T15-22-43 to 2025-07-22T15-22-43
Total Data Points: 256
Overheated Points (>38°C): 0
Overheat Rate: 0.00%
