Solar Panel Inspection Report

Generated on: 2025-07-23 16:08:41

Inspection Line: Smart Conveyor Automated System

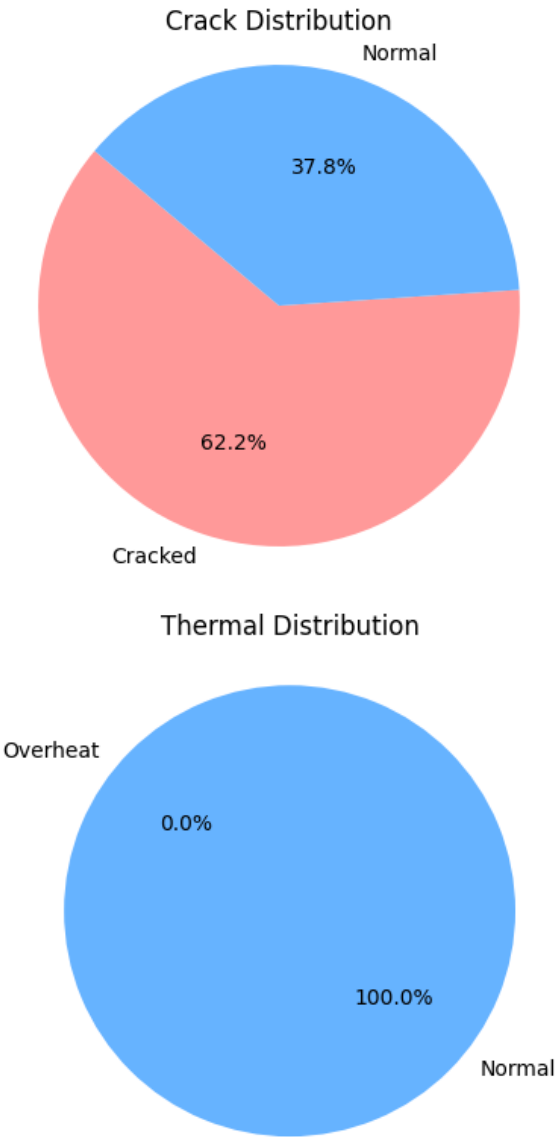
Serial Number: 1234567890012

The YOLOv8 detection reveals a crack (22x14 pixels) detected with a confidence of 0.54 in one of the images. The relatively low confidence suggests the crack might be small or obscured, requiring visual inspection of the original images for confirmation and precise location. The size alone is insufficient to definitively determine the cause. However, we can analyze potential causes based on the available data and production parameters.

1. ****Excessive Lamination Pressure:**** A crack in a relatively small area points towards localized stress. If the lamination pressure exceeded the recommended 100 N/cm² (possibly reaching >120 N/cm²), it could have caused localized stress leading to a crack at a weak point in the cell or the laminate. This is a strong possibility considering the small size of the crack.

2. ****High Handling Force:**** A drop or impact during handling, exceeding the 10N threshold, could result in corner cracking. The location of the crack (reported at x=92, y=445) needs to be correlated to the solar panel's physical layout. If it's near a corner, this becomes a more likely scenario. The image analysis is crucial here.

3. ****Thermal Stress during Lamination or Cooling:**** While a single small crack is less suggestive of widespread thermal damage, excessive lamination temperature (>160°C) or too rapid cooling (>5°C/min) could have contributed. This is less likely than excessive pressure or mishandling, but cannot be entirely ruled out without additional data.

4. ****Defective Cell:**** A pre-existing micro-crack in the solar cell itself could have been aggravated during the lamination process, regardless of the production parameter settings. This possibility highlights the need for rigorous quality control checks on individual cells **before** lamination.

* ****Lamination Pressure:**** Potentially exceeded 100 N/cm², possibly reaching 110-120 N/cm² in the localized area of the crack.

* ****Handling Force:**** If the crack is located at a corner, a handling force exceeding 10N is probable.

1. ****Visual Inspection:**** Manually inspect the original images at high resolution to precisely locate and characterize the crack. Note its location relative to cell boundaries, corners, and other features.

2. ****Review Manufacturing Logs:**** Obtain and thoroughly review production logs for serial number 1234567890012, paying particular attention to the lamination pressure, temperature, cooling rate, and handling procedures. Focus on data from the relevant timestamp (2025-07-22T18-28-55).

3. ****Verify Cell Quality:**** Inspect the quality of the solar cells used in this panel *before* lamination, focusing on potential micro-cracks and other defects.

4. ****Adjust Production Parameters (if needed):**** If the review of logs reveals parameter values outside the recommended ranges, adjust them accordingly to prevent future occurrences. This requires a thorough analysis of the full dataset covering the production batch to which this panel belongs.

5. ****Improve Handling Procedures:**** Re-evaluate and improve handling procedures to minimize risks of damage during transportation and assembly.
6. ****Further Analysis:**** If the crack remains unexplained after reviewing the data, consider more advanced analyses like thermal imaging of the solar panel to detect stress points and material defects.
