# Solar Panel Inspection Report

Generated on: 2025-07-23 17:25:08

Inspection Line: Smart Conveyor Automated System

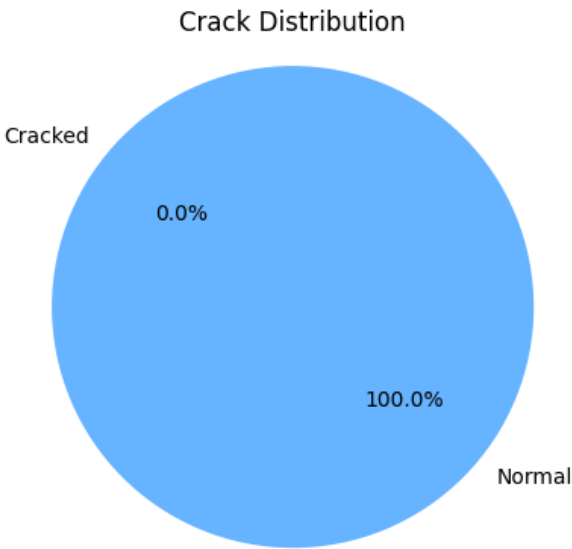
Vision Scan Summary

Scan Duration: 2025-07-23T16-37-16 to 2025-07-23T16-37-16  
Total Scans: 1  
Cracked Count: 0  
Crack Rate: 0.00%

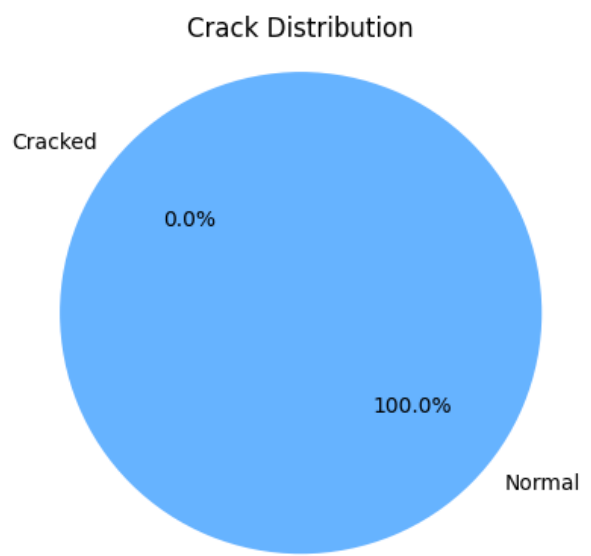
Vision Scan Summary

Scan Duration: 2025-07-23T16-37-16 to 2025-07-23T17-12-37  
Total Scans: 2  
Cracked Count: 0  
Crack Rate: 0.00%
