Solar Panel Inspection Report

Generated on: 2025-07-23 16:35:51

Inspection Line: Smart Conveyor Automated System

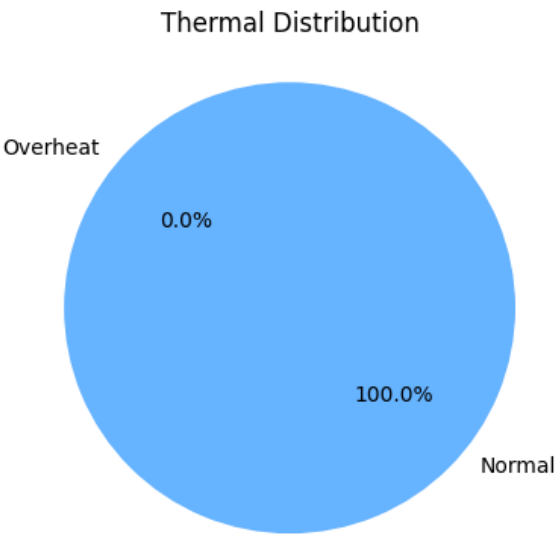
Serial Number: 1234567890005

****Analysis of Solarboard Damage:****

The YOLOv8 detection indicates a crack (confidence 0.64) in the solarboard. The relatively low confidence suggests the crack may be small or difficult to see in the images, warranting a closer visual inspection. The location of the crack (x=447, y=321 in image yolo_1234567890005_2_1753172241.jpg) should be noted and compared to subsequent images for propagation.

Several factors could have contributed to the crack in Solarboard 1234567890005:

****Likely Causes and Estimated Faulty Parameter Values:****

* ****Excessive Lamination Pressure:**** A crack is most frequently caused by the stress induced during the lamination process. A single small crack suggests localized high pressure rather than a global issue. This indicates that the lamination pressure might have exceeded the ideal range of 50-100 N/cm² at a specific point. Without further data, I cannot give an exact faulty value, but I estimate it to have briefly reached or exceeded 120 N/cm² in the region of the crack. This pressure point may have been caused by uneven pressure distribution from the laminator or imperfections in the laminate.

* ****High Soldering Temperature:**** Although less likely to cause a single small crack, it is possible that a localized high soldering temperature (above 270°C) near the crack location might have caused thermal stress leading to a fracture in the cell. This would need to be investigated with further analysis, comparing localized temperatures during soldering against the location of the crack.

* ****Improper Handling:**** The crack's size (9x23 pixels) also suggests that rough handling during manufacturing or transport could be responsible. A force exceeding 10N applied to a corner or edge could create such a fracture. This is possible, but less probable than a lamination issue due to the small size and location of the crack not being at an edge.

* ****Cell Thinness:**** If the cell thickness was closer to or below 150 µm, the fragility of the cell could increase and make it susceptible to cracking from lower forces than otherwise expected. This should be verified by

analyzing manufacturing records for this specific cell and batch.

****Actionable Recommendations:****

1. **Thorough Visual Inspection:** Conduct a detailed visual inspection of the solarboard to confirm the extent and nature of the crack. This will give more evidence for confirming the most likely culprit.

2. **Review Lamination Process Data:** Analyze the lamination pressure data from the specific batch and timeframe of production, looking for spikes or inconsistencies at the suspected point of pressure. Inspect the laminator rollers for damage or unevenness.

4. **Material Analysis:** Consider micro-examination of the cracked area to check for any material defects or micro-fractures present prior to lamination.

5. **Review Handling Procedures:** Evaluate the handling procedures throughout the manufacturing and shipping processes to identify areas where improvement can prevent damage. Ensure that all handling guidelines are being followed.

By addressing these recommendations, you will be able to pinpoint the cause of the crack and implement preventative measures to prevent future occurrences. The focus should be on the analysis of the lamination process data and a careful visual inspection to confirm the type and size of the crack to determine the most likely cause.
