Solar Panel Inspection Report

Generated on: 2025-07-23 17:25:03

Inspection Line: Smart Conveyor Automated System

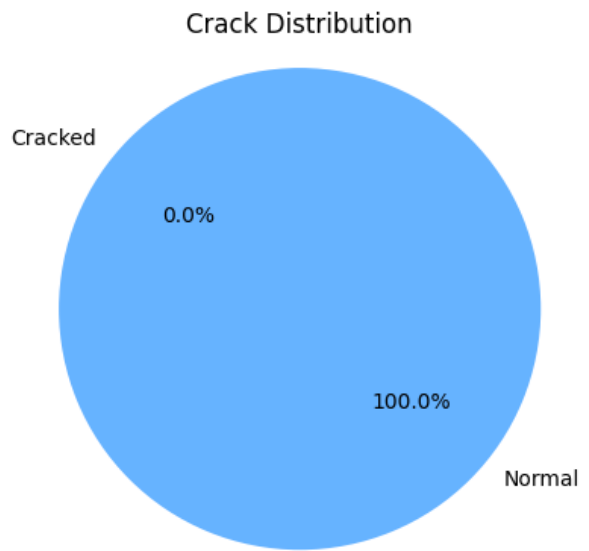
Vision Scan Summary

Scan Duration: 2025-06-28T17-17-07 to 2025-07-23T16-37-16
Total Scans: 6
Cracked Count: 0
Crack Rate: 0.00%
