# Solar Panel Inspection Report

Reporting Period: 2025-06-24 23:31:00 to 2025-07-24 23:31:00

Inspection Line: Smart Conveyor Automated System

## Panel Serial: 1234567890036

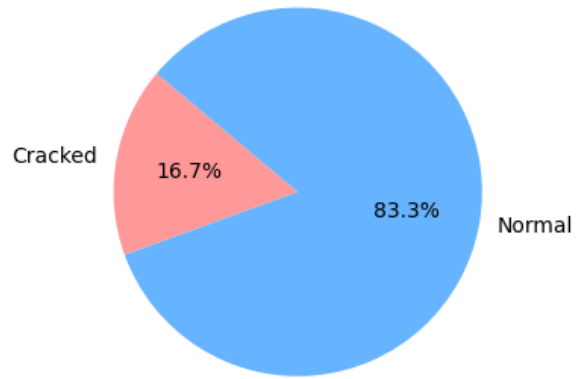
Crack Distribution

Scan Duration: 2025-06-29T15-20-46 to 2025-07-24T11-06-46  
Total Scans: 6  
Cracked Count: 1  
Crack Rate: 16.67%

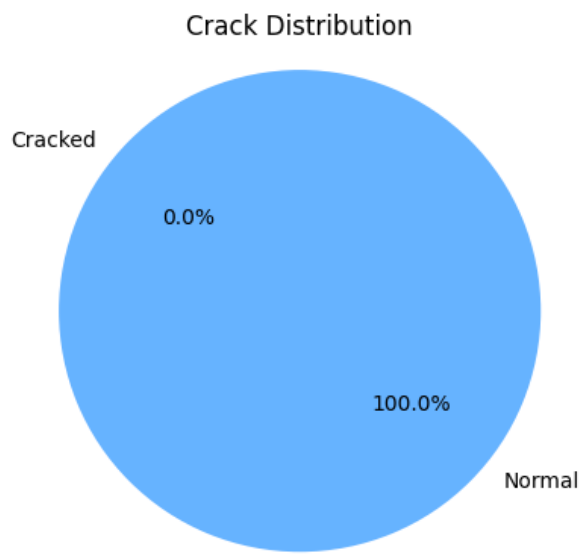
Scan Duration: 2025-06-28T17-17-07 to 2025-07-23T16-37-16  
Total Scans: 6  
Cracked Count: 0  
Crack Rate: 0.00%

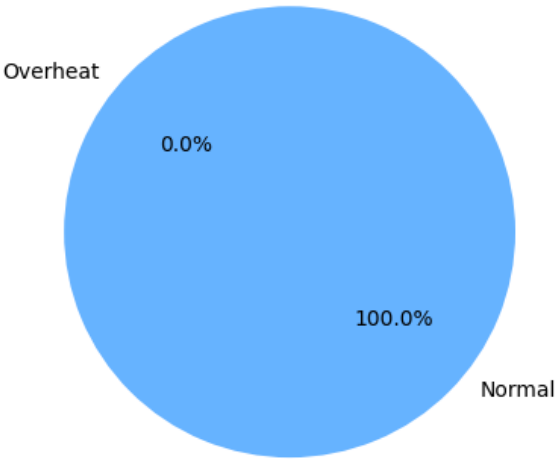
Thermal Distribution

Scan Duration: 2025-07-22T15-22-43 to 2025-07-23T16-37-16  
Total Data Points: 640  
Overheated Points (>38°C): 0  
Overheat Rate: 0.00%

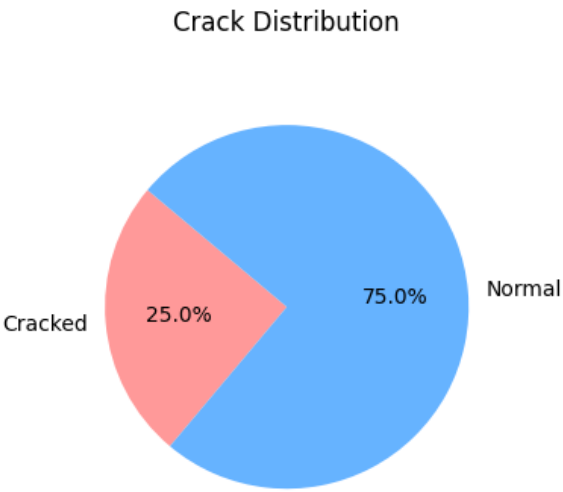
Scan Duration: 2025-06-29T17-17-07 to 2025-07-24T11-04-45  
Total Scans: 8  
Cracked Count: 2  
Crack Rate: 25.00%
