Calibration Report on Brewers #033, #157, #183, #185 at Izaña – Aug. 28-Sept. 6, 2009

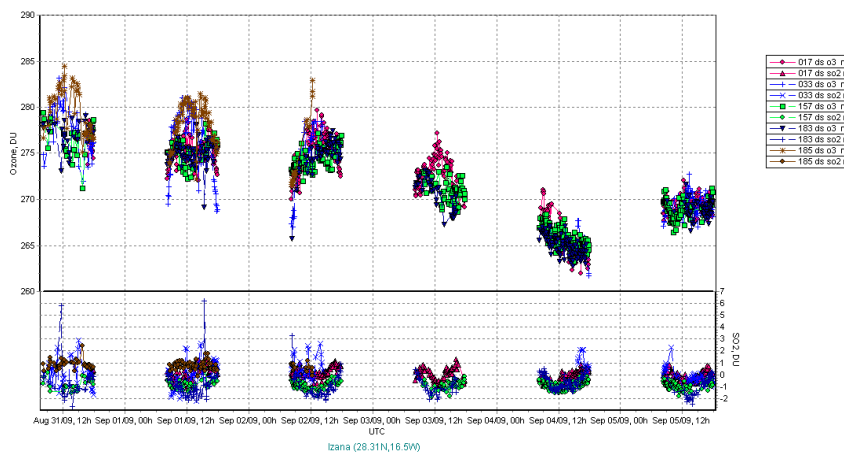
Below are the final ozone results of the ozone comparison data collected, using the recommended constants listed above. For #183 the ETC constants were set to 1768/555 for the first 4 days.
