1996 SEMINAR INFORMATION

"THE BEST FIX IN '96"

AUTOMATIC TRANSMISSION SERVICE GROUP
9200 S. DADELAND BLVD. STE 720
MIAMI, FLORIDA 33156
(305) 670-4161

INTRODUCTION

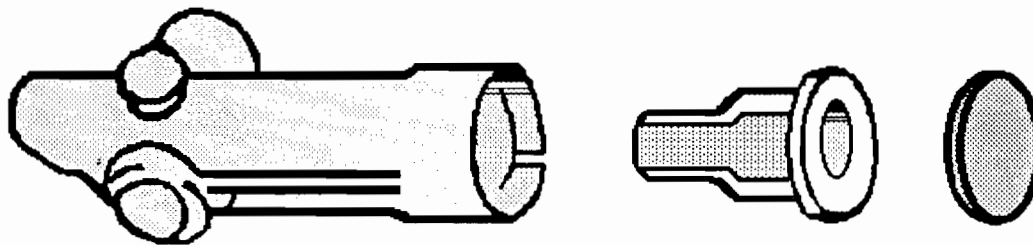
Figure 4

Cause: One cause may be due to a broken air exhaust plug which is pressed into the bottom of the servo bore. This air exhaust plug is an aluminum tube which contains a filter. The filter is held into the tube with a flat metal retainer and the tube is known to break at the groove in which this metal retainer sits. This allows both the broken piece of the tube, the metal retainer and filter to fall into the servo bore. These pieces floating around in the servo bore can cause damage to the piston as well as the bore of the case (See Figure 4).

Correction: If the servo bore has been damaged, the case will have to be replaced. If the case is not damaged, the air exhaust plug can be serviced. Care must be taken when removing the old plug. The best method is to drill into the plug and screw into the hole a dent puller tool and pull the plug out. A new plug assembly can be gently tapped back into the case. The part number for Mitsubishi and Hyundai vehicles are listed below:

Mitsubishi - MD733740

Hyundai - 45245-37000

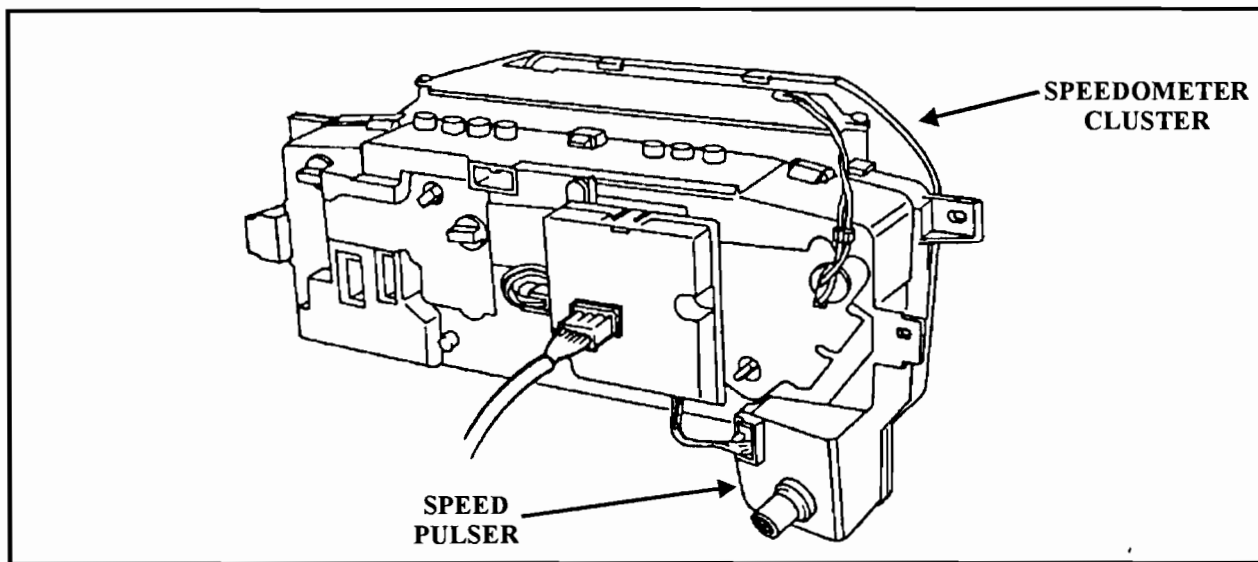
Figure 18

The example shown here is a 1989 Prelude and is the type of vehicle speed sensor located in the speedometer cluster. (Refer to figure 18)

The best way to check this speed sensor is to locate the terminal in the transaxle computer that the speed sensor is wired to and with the multimeter set on DC VOLTS, rotate front wheels by hand, the voltage seen should pulse from 0 to 5 volts.

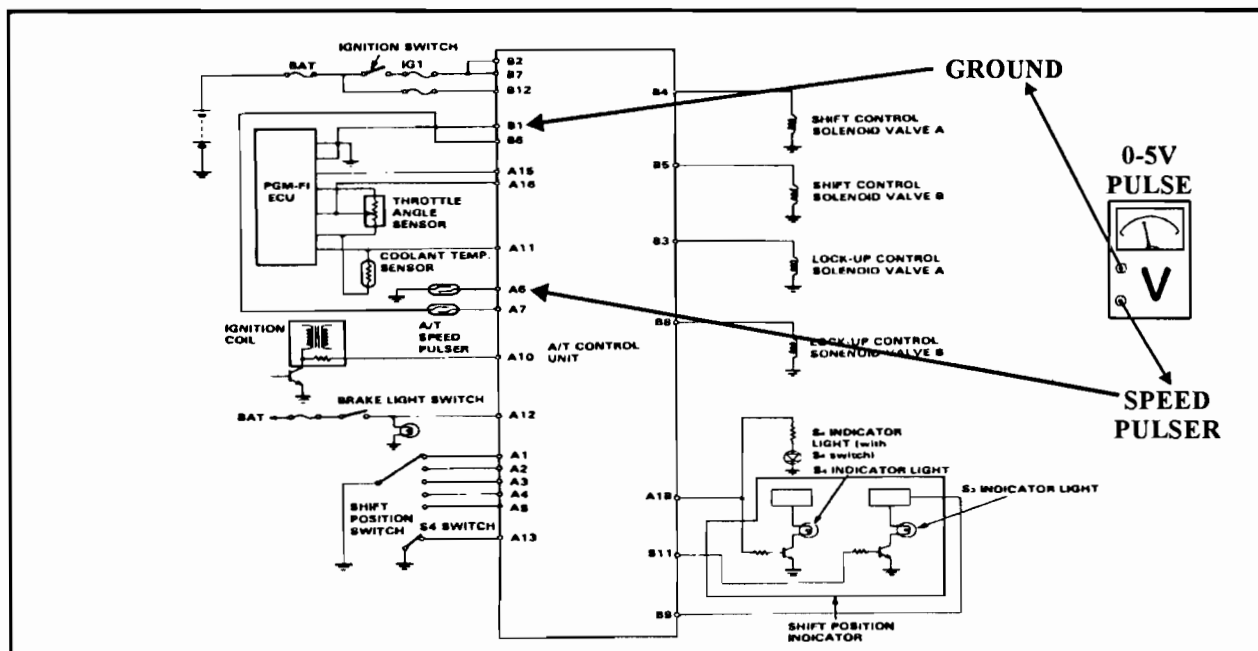
Figure 19

In this example the positive multimeter lead would go to A6 which is the speed pulser wire and the negative lead would go to B1 which is the computer ground. (Refer to figure 19)

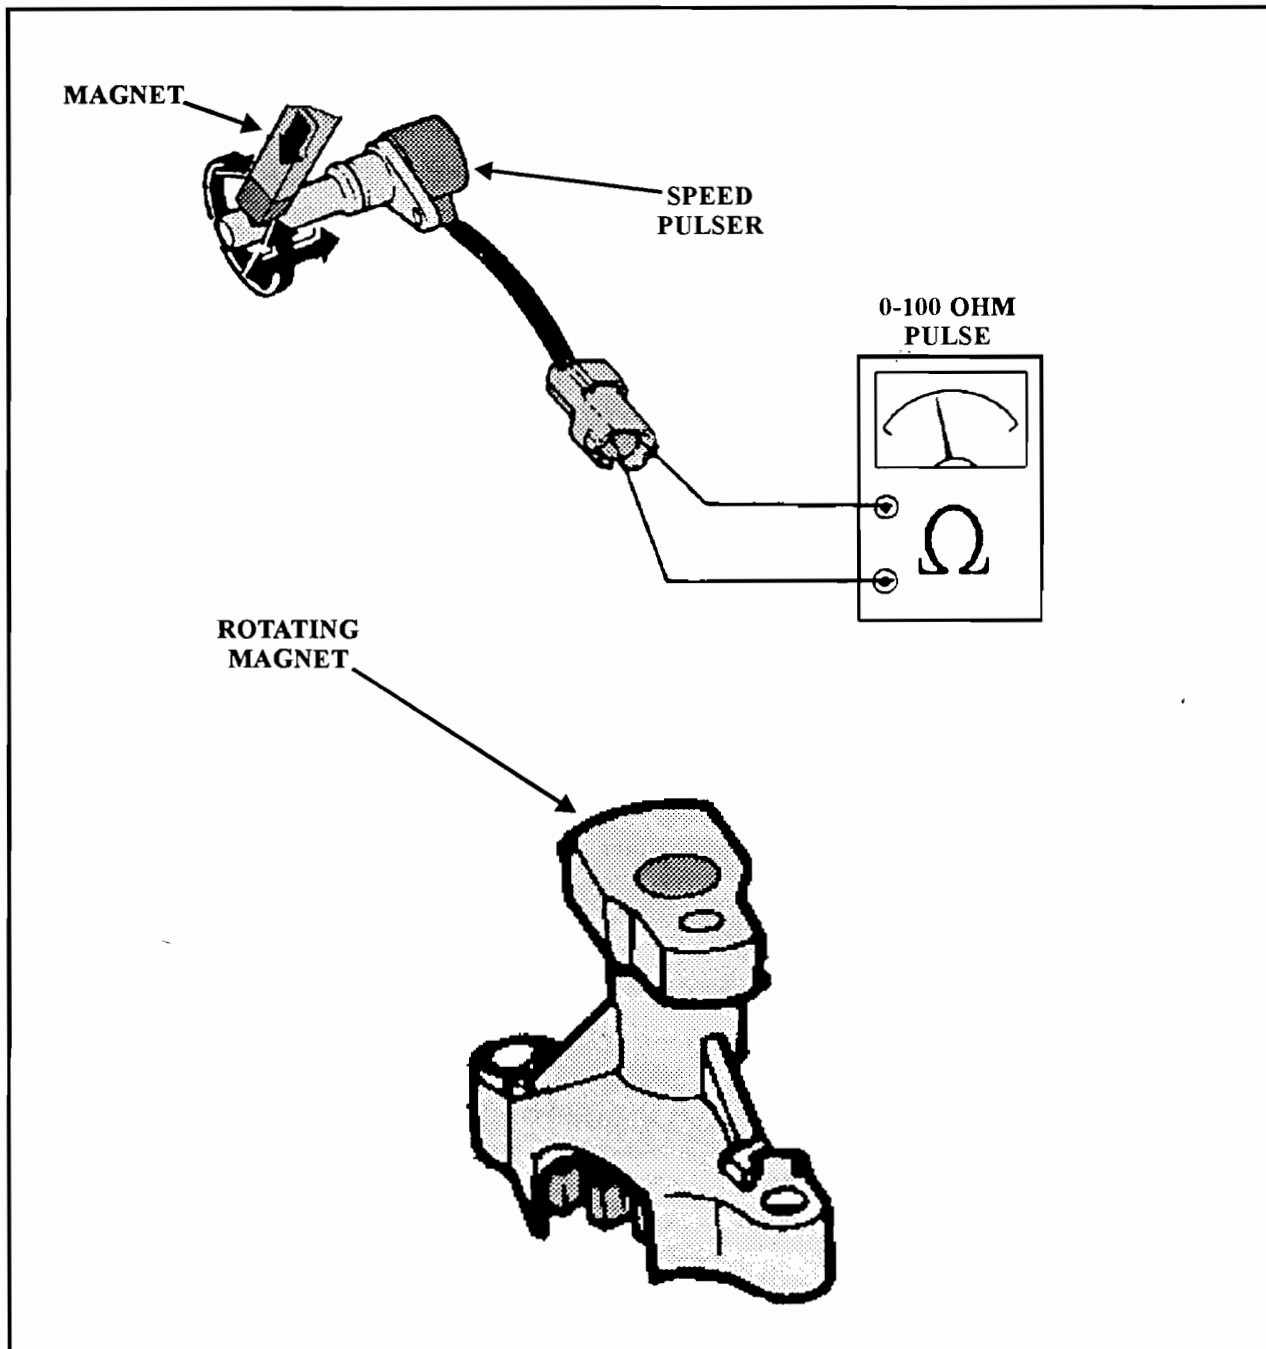
Figure 20

This 2 wire type of speed sensor can be checked with an ohm meter. The meter will pulse whenever the rotating magnet passes the pick-up and the reed switch inside opens and closes. The voltage pulse is 0-5 volts DC. The ohm pulse is INFINITY to 100 ohms. (Refer to figure 20)

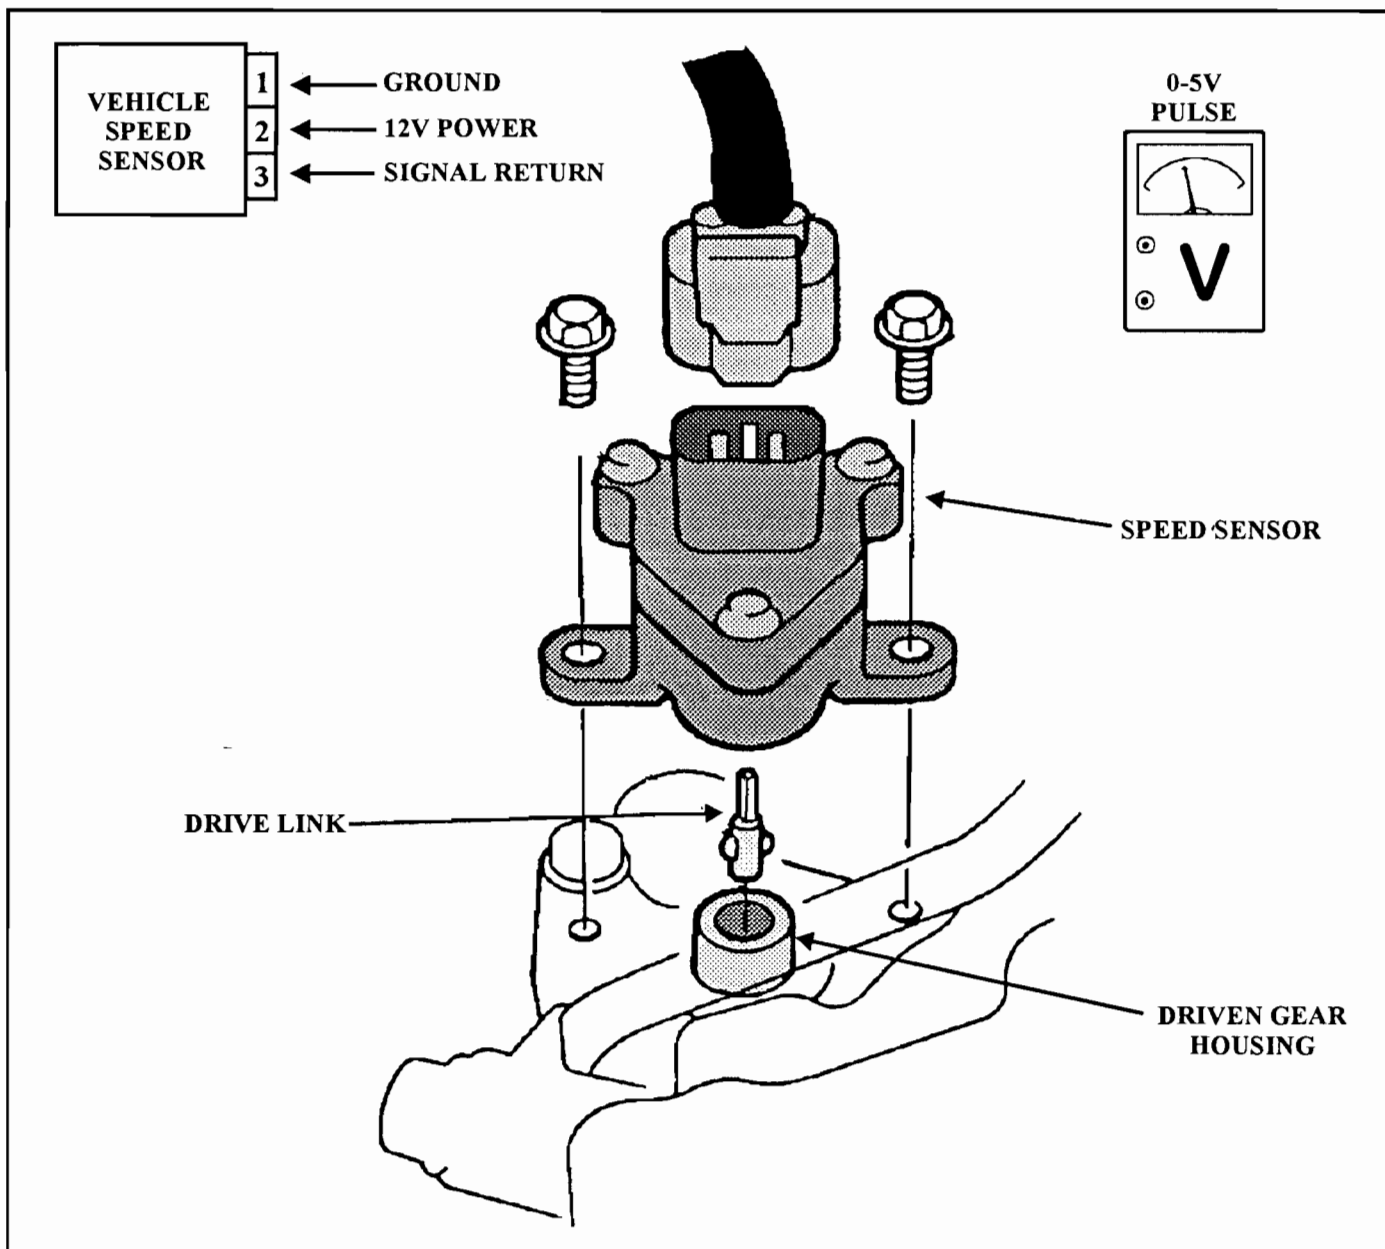
Figure 21

Typically this sensor will have a 12 volt power supply, a signal return and a ground wire.

The volt meter should be connected between the signal return and ground where a 0-5V pulse should be seen. (Refer to figure 21).

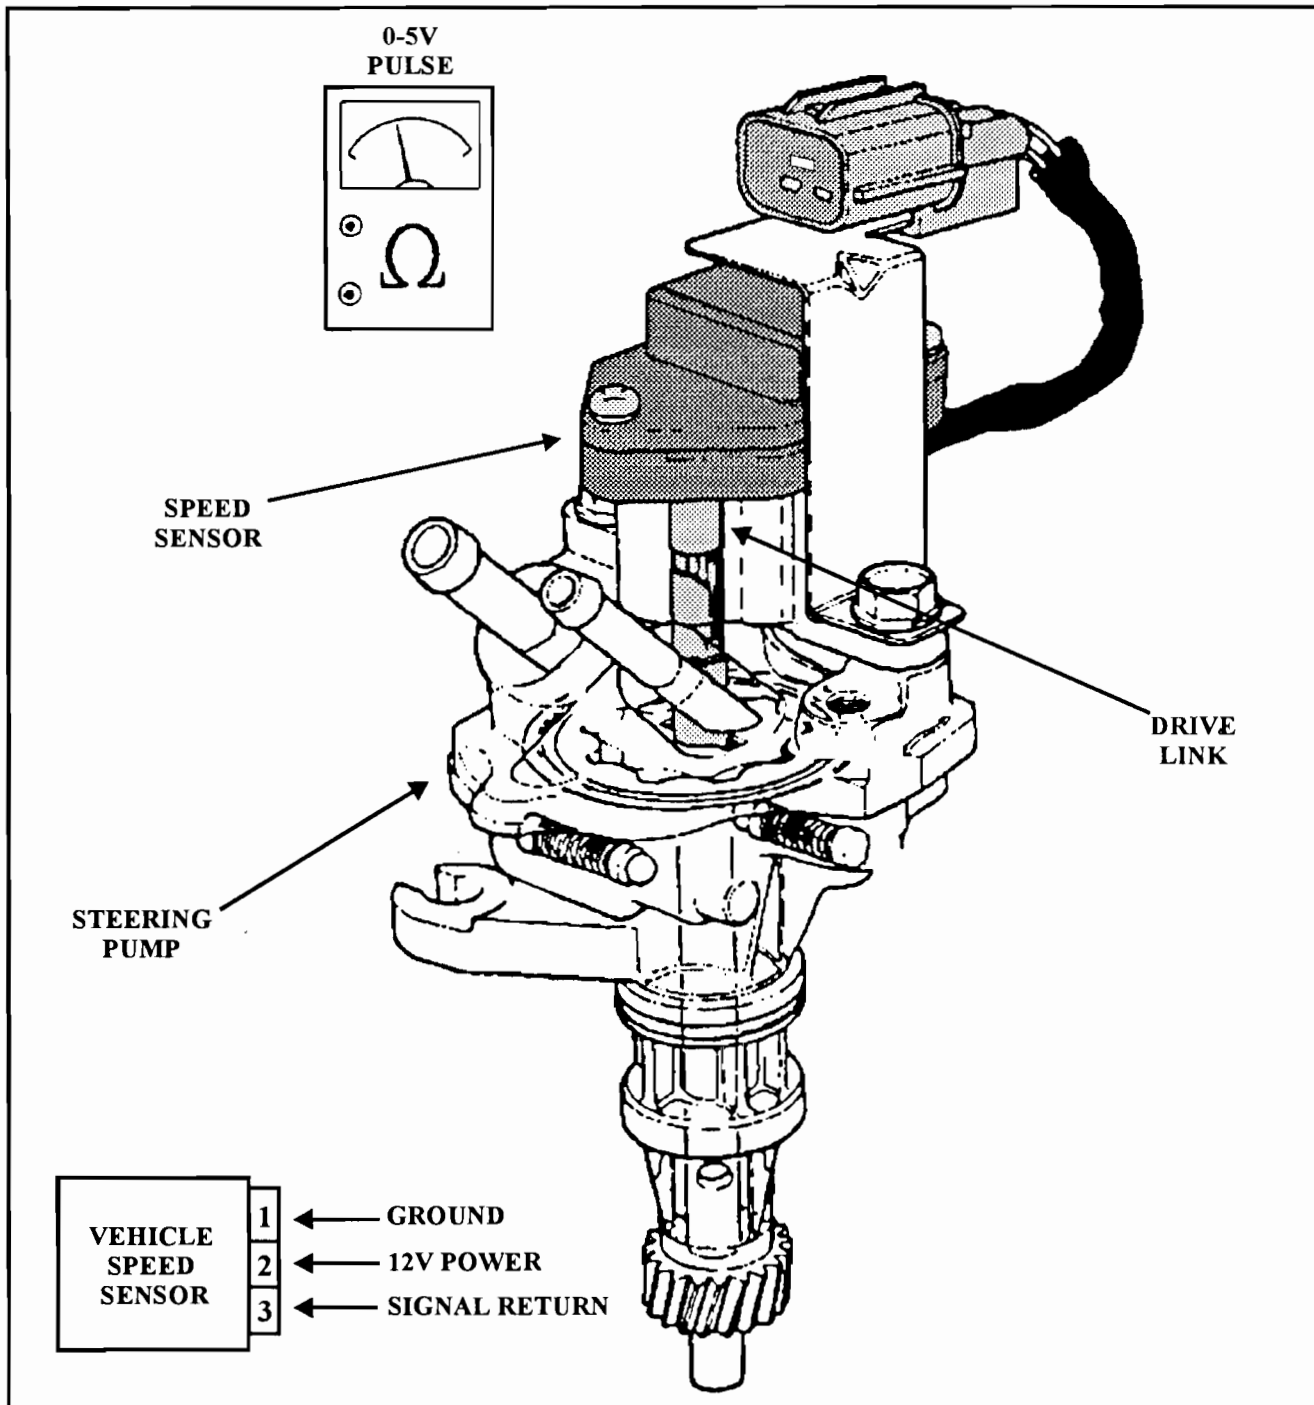
Figure 22

This 3 wire speed sensor is checked the same way as the mechanical speed sensor on the previous page.

The difference is, this speed sensor is used by the power steering pump to control the gain valve in order to control steering effort under varying conditions. (Refer to figure 22)

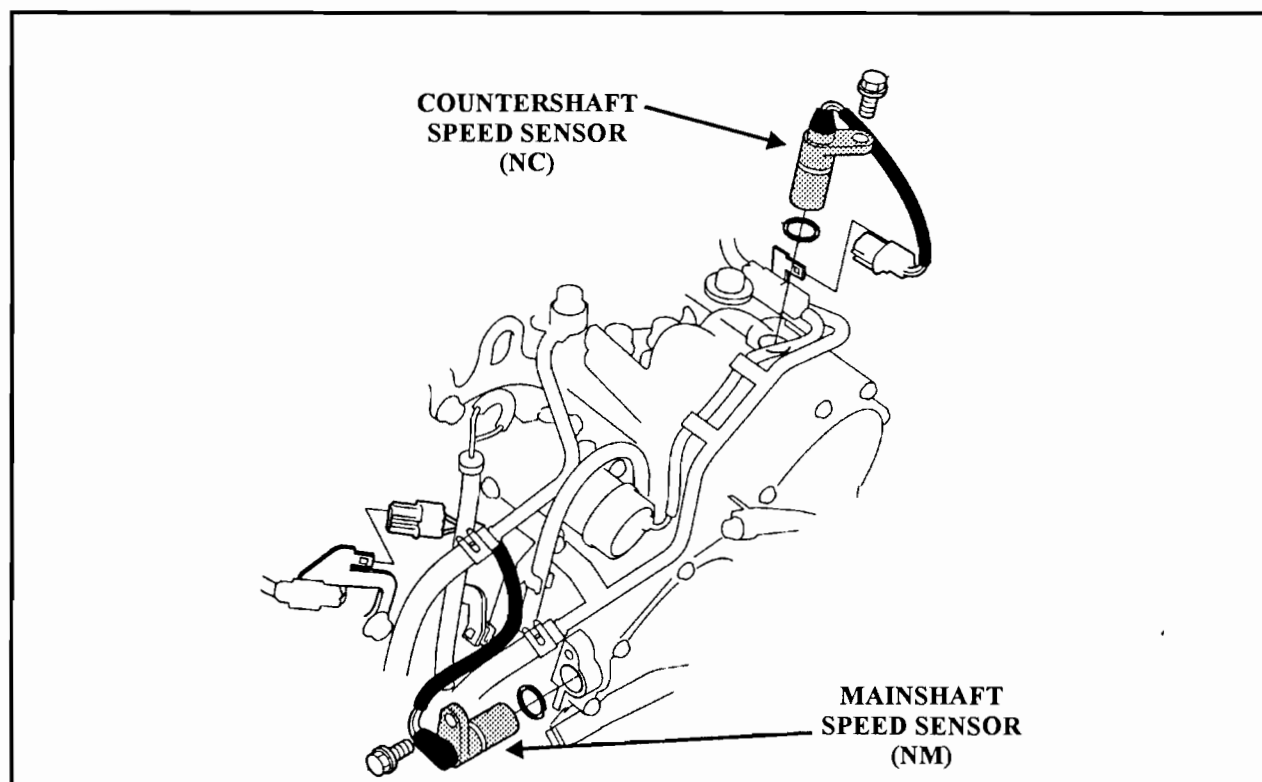
Figure 23

This type of speed sensor generates its own signal when a toothed exciter ring rotates in front of it. This type of speed sensor is checked with a volt meter set on AC volts or with a multi-meter set on HERTZ. (Refer to figure 23)

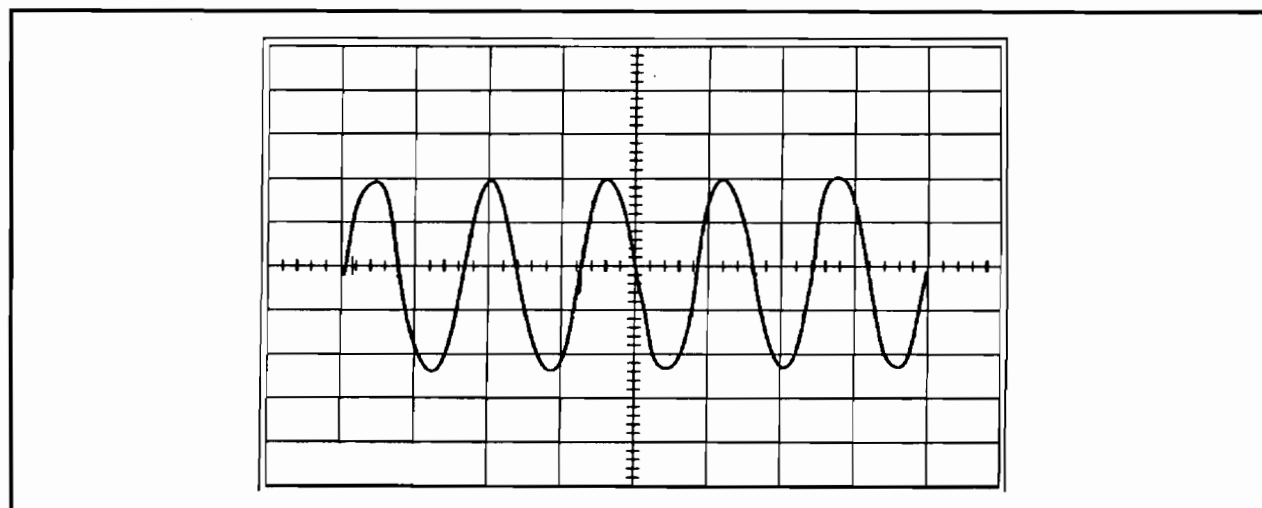
Figure 24

This type of speed sensor can also be checked with an oclloscope, which is the most acurate method of checking AC GENERATORS. (Refer to figure 24)

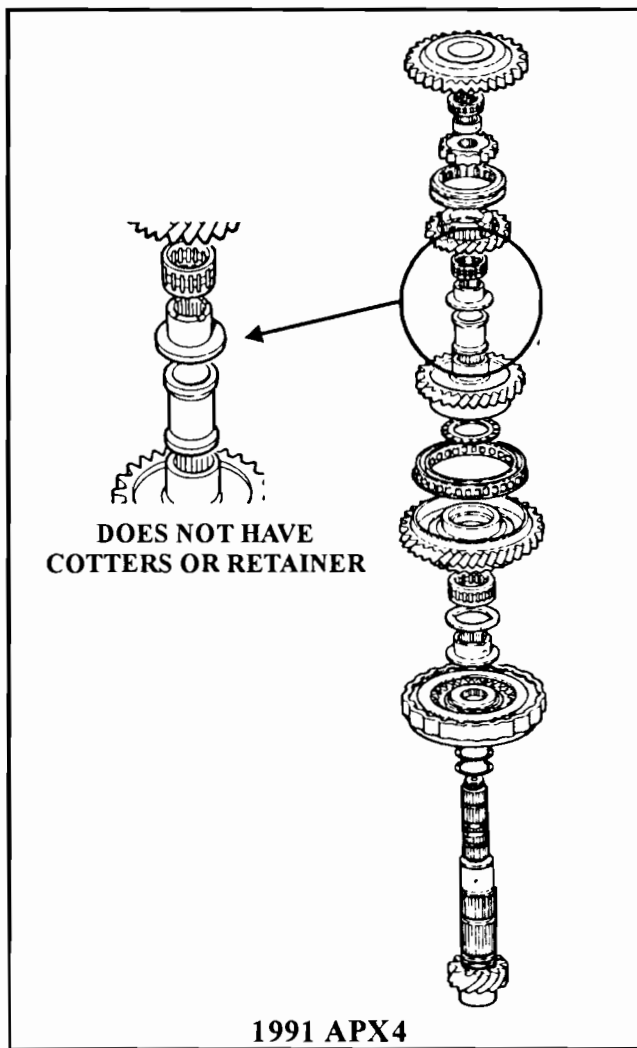
Figure 28

NOTE: This condition cannot occur on a 1991 APX4 because it does not utilize the split cotters or the retainer in this location. (Refer to figure 28)

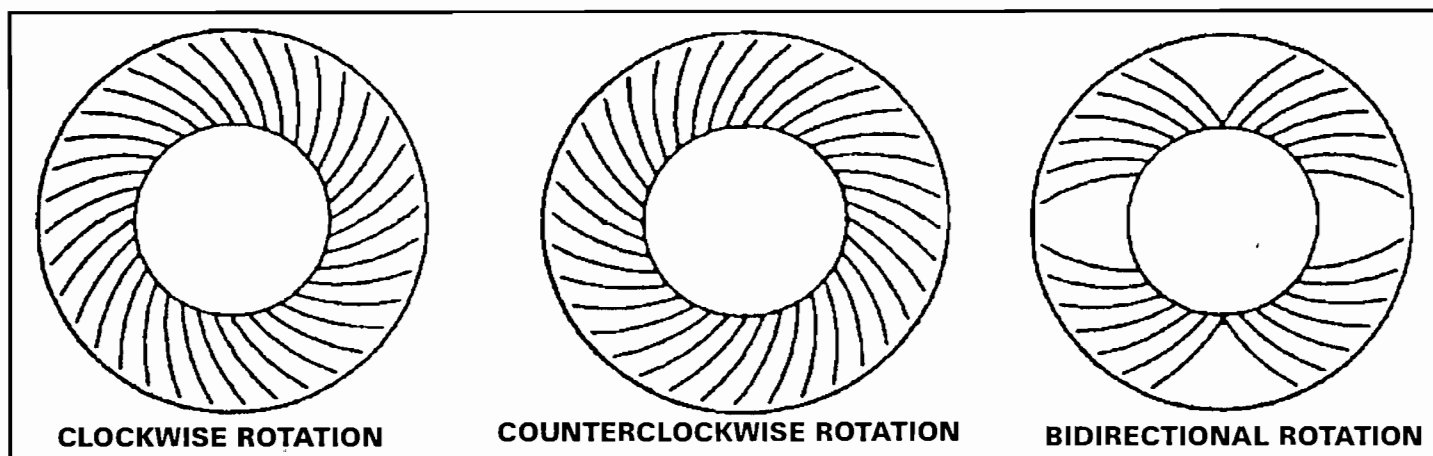
Figure 30

The helix of the seal which are the angled lines on the lip of the seal indicate direction of rotation. (Refer to figure 30)

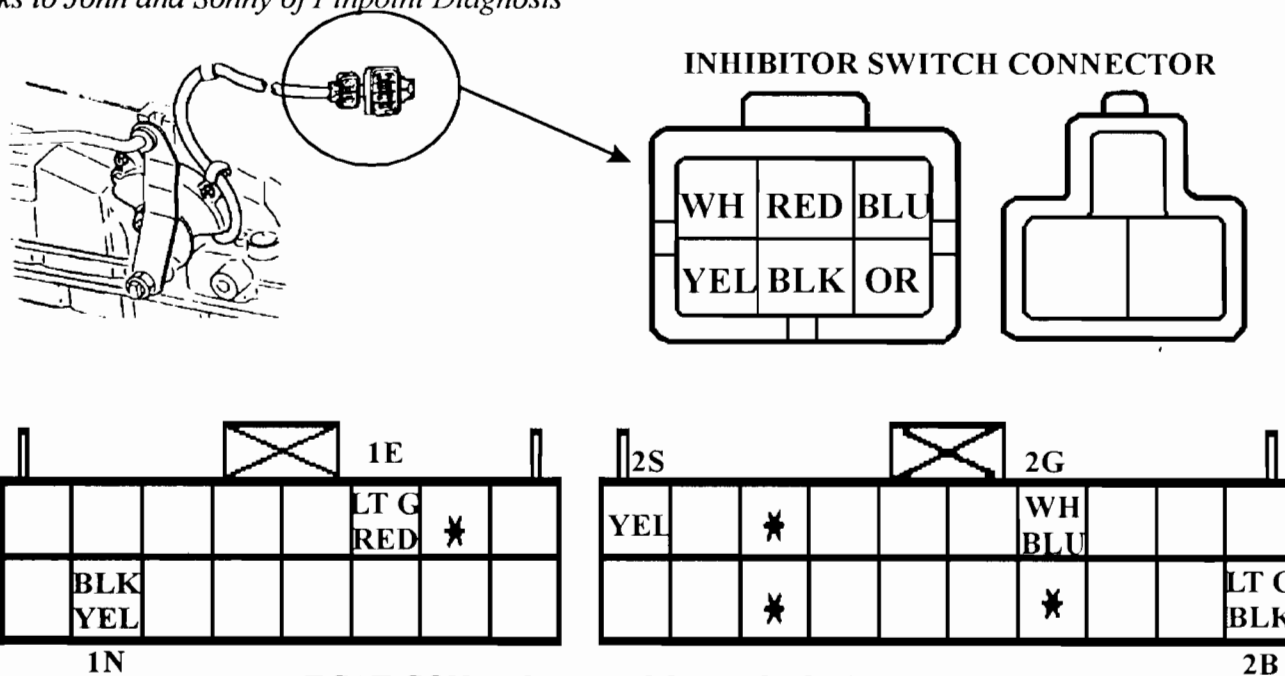
Figure 32

INHIBITOR SWITCH		ECAT CONTROLLER
WHITE	connects to	YELLOW
RED	connects to	LT. GREEN/BLACK
BLUE	connects to	LT. GREEN/RED
YELLOW	connects to	BLANK
BLACK	connects to	BLACK/YELLOW
ORANGE	connects to	WHITE/BLUE

CORRECTION: The wires that are mislocated will have to be removed from the connector and relocated to their correct location. Refer to the illustrations below which show the CORRECT wire location. Make certain the wire color and location in the inhibitor switch connector match the wire color and location in the ECAT control unit as it is shown in the chart below. The inhibitor switch part number is **BV1119444**.

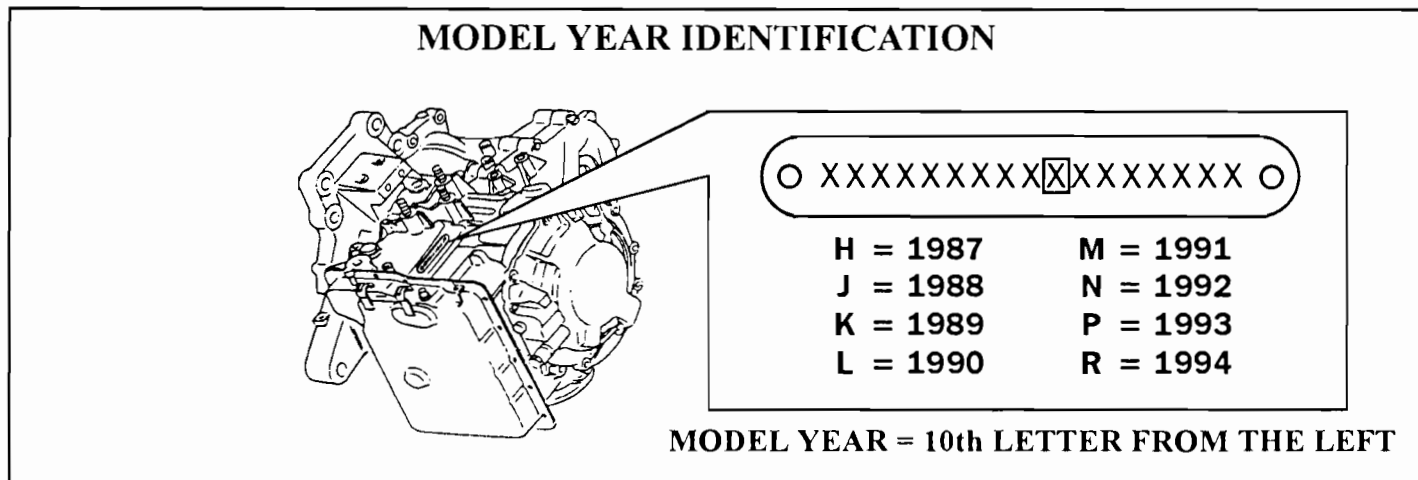
CAUSE: The cause may be, a mismatched 1993 Reverse and Forward drum was installed into as 1987-92 vehicle. **REASON:** 1987-92 Reverse and Forward drums have 12 "Projections." 1993 Reverse and Forward drums have 16 "Projections." These "Projections" are picked up by the "Pulse Generator" converting drum or turbine speed into an A.C. current or frequency that is sent to the ECAT computer. When a 16 "Projection" drum is installed into an 1987-1992 vehicle, drum or turbine speed will automatically be faster and may change shift strategy. (See Figure 34)

CORRECTION: Refer to Figure 35 to identify model year and install the proper drum for your application.

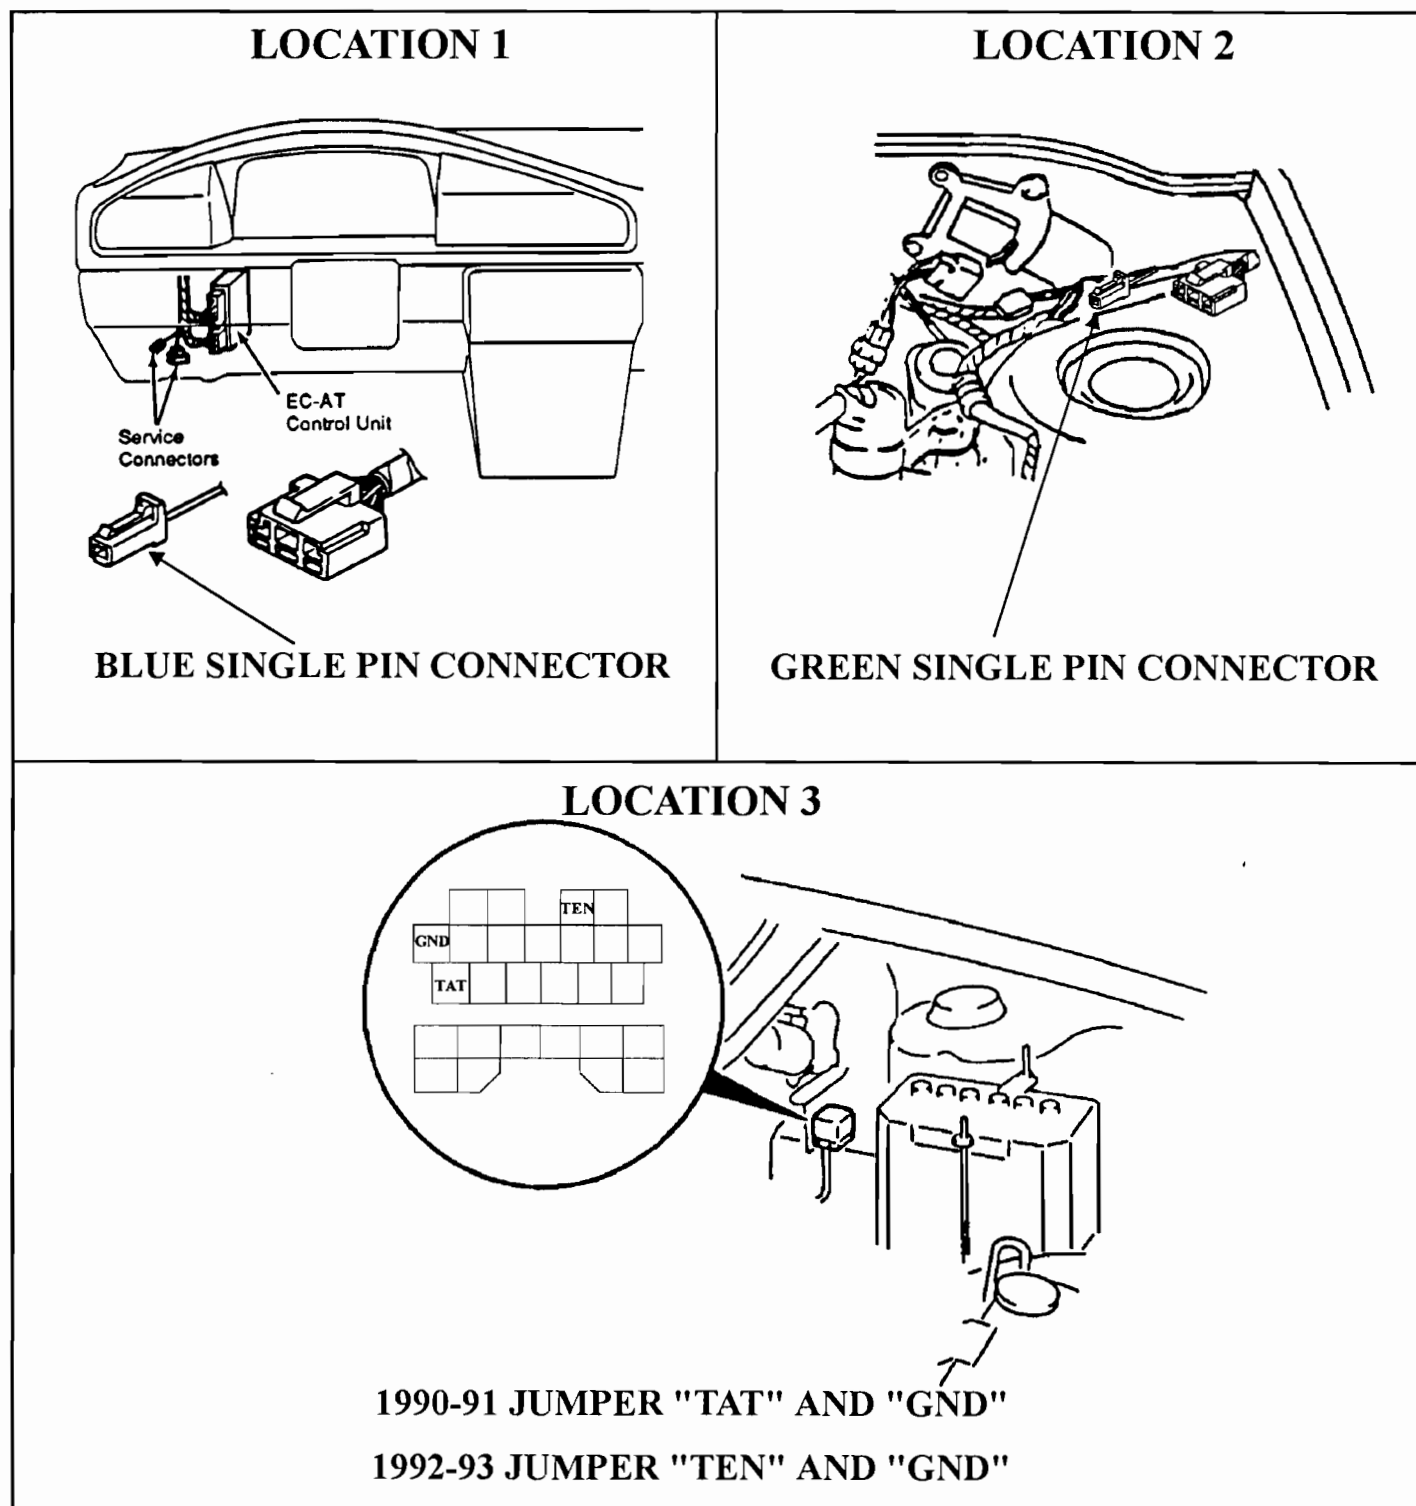
Figure 36

LOCATION: The 6 pin diagnostic connector is located 6-10 inches away from the ECAT main computer connector which is located at the left of the steering column.
(See Location 1 in Figure 36)

LOCATION: The BLUE diagnostic connectors are located 6-10 inches from the ECAT main computer connector which is located at the left of the steering column NOTE: The diagnostic connectors may be taped to the main computer harness and may be difficult to find. (See Location 1 in Figure 36)

1990-92:
LOCATION: The HOLD light will flash if transmission related trouble codes are being stored. The GREEN diagnostic connectors are located in the engine compartment near the windshield wiper motor and the driver side strut tower.
(See Location 2 in Figure 36)

- 1990-91: The HOLD light will flash if transmission related trouble codes are being stored.
- LOCATION: The multiple pin diagnostic connector is located behind the battery below the windshield wiper motor. (See Location 3 in Figure 36)

- 1992-93: The HOLD light will flash if transmission related trouble codes are being stored.
- LOCATION: The multiple pin diagnostic connector is located behind the battery below the windshield wiper motor. (See Location 3 in Figure 36)

- ALL MODELS: The HOLD light will flash if transmission related codes are being stored.
- LOCATION: The BLUE diagnostic connectors are located 6-10 inches from the ECAT main computer connector which is located at the left of the steering column. (See Location 1 in Figure 36)

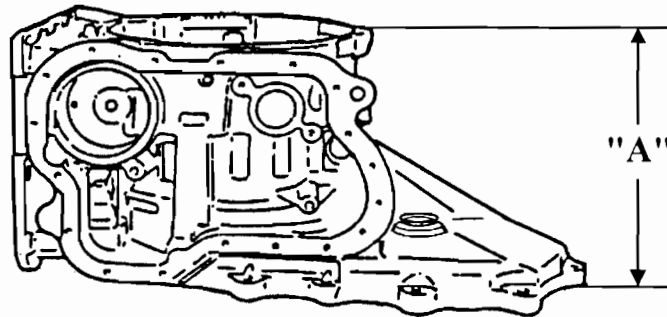
DIMENSION "A"= 8 INCHES ON 2.2 "NON-TURBO" MODELS

DIMENSION "A"= 8.250 INCHES ON 2.2 "TURBO" AND 3.0L MODELS

CORRECTION: Refer to Figure 44 to correctly identify and match 2.2 Turbo, 3.0L, and 2.2 Non-Turbo "Manual Valve" and rear "Case" dimensions. Install the proper "Manual Valve" for your application.

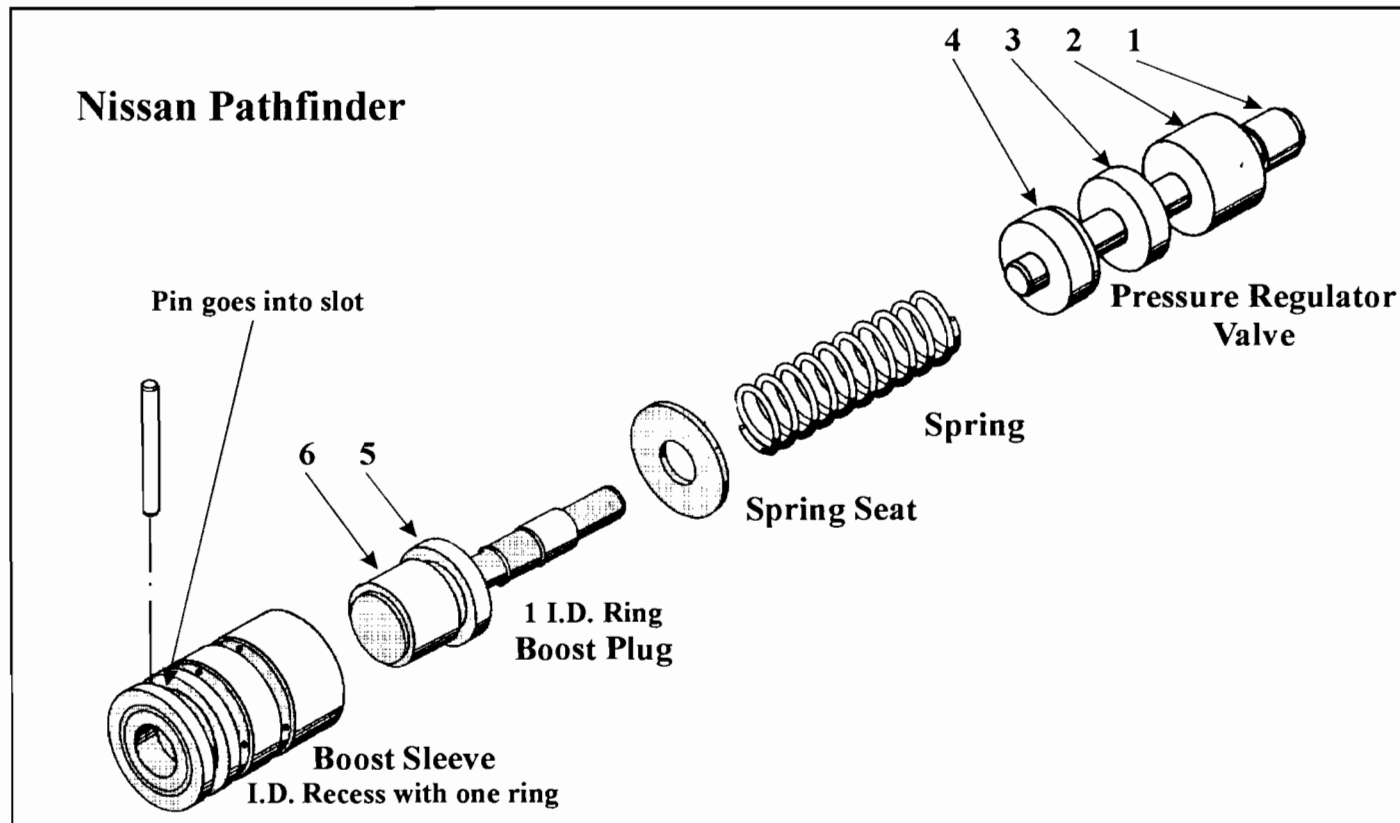
<p>Pressure Regulator Valve Overall Length of Valve 2.090"</p> <p>Land Diameter and Length</p> <p>1. Dia. .318" Length .305" 2. Dia. .589" Length .435" 3. Dia. .589" Length .177" 4. Dia. .589" Length .220"</p> <p>Land "1" goes into valve body first. Non machined flat around diameter of land "4".</p>	<p>Boost Sleeve Overall Length 1.201" Inside Dia. .655" Outside Dia. .787" I.D. Recess with one ring.</p> <p>Spring Free Length 1.675" Inside Dia. .434" Outside Dia. .548" Wire Dia. .057"</p> <p>No. of Coils 10</p>	<p>Boost Plug Overall Length of Plug 1.575"</p> <p>Land Diameter and Length</p> <p>5. Dia. .654" Length .118" 6. Dia. .599" Length .374"</p> <p>Spring seat goes over the stem. One I.D. ring next to land "5" in back of the machined area on the stem shown in Figure 54 below.</p>
--	--	---

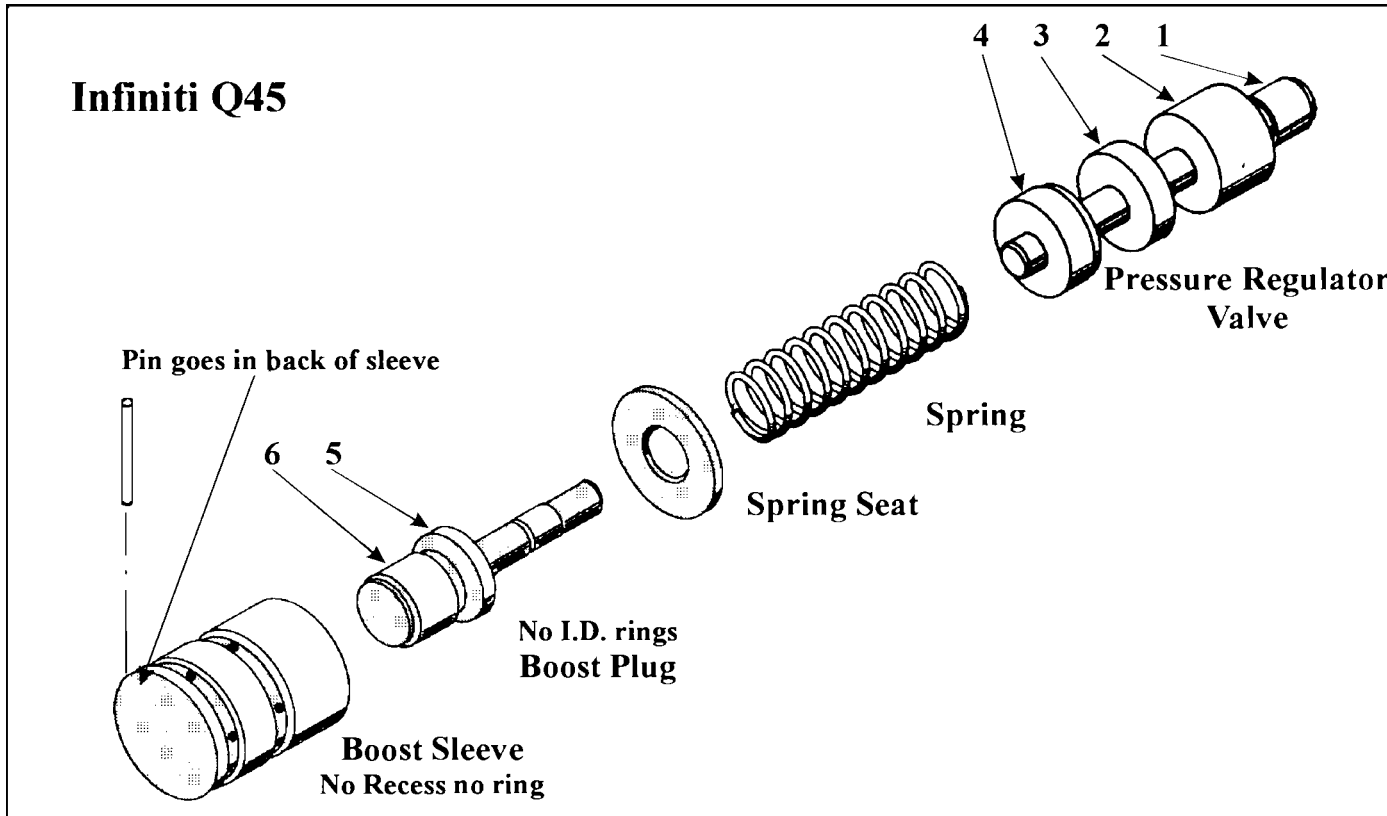
<p>Pressure Regulator Valve Overall Length of Valve 2.090"</p> <p>Land Diameter and Length</p> <p>1. Dia. .318" Length .288" 2. Dia. .589" Length .437" 3. Dia. .589" Length .177" 4. Dia. .589" Length .280"</p> <p>Land "1" goes into valve body first. Non machine flat around diameter of land "4".</p>	<p>Boost Sleeve Overall Length .959" Inside Dia. .598" Outside Dia. .781" I.D. No recess no ring</p> <p>Spring Free Length 1.651" Inside Dia. .435" Outside Dia. .549" Wire Dia. .057"</p> <p>No. of coils 10</p>	<p>Boost Plug Overall Length of Plug 1.575"</p> <p>Land Diameter and Length</p> <p>5. Dia. .597" Length .118" 6. Dia. .518" Length .374"</p> <p>Spring seat goes over the stem. No I.D. rings on the boost plug (See Figure 55 below).</p>
---	---	--

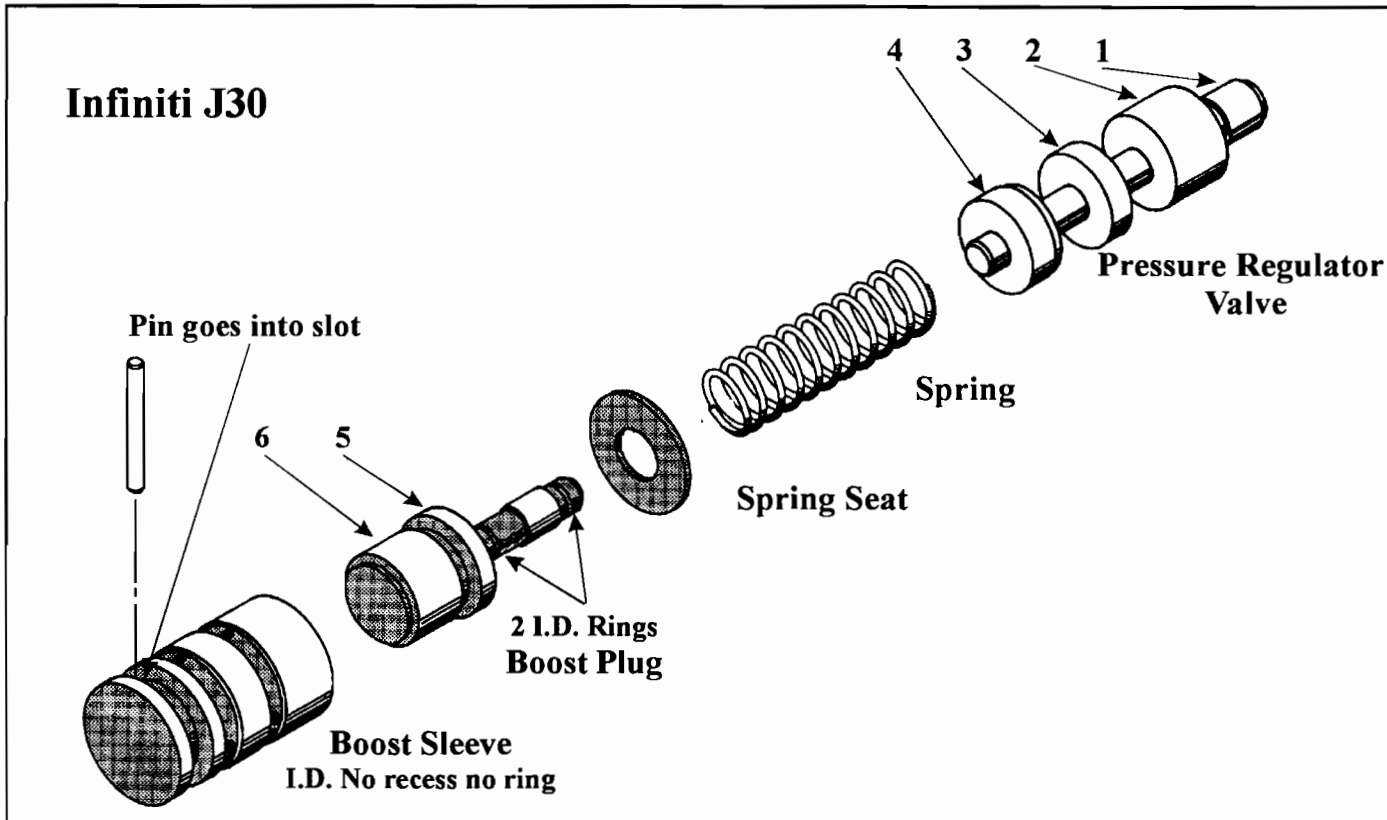
<p>Pressure Regulator Valve Overall Length of Valve 2.090"</p> <p>Land Diameter and Length</p> <p>1. Dia. .318" Length .288" 2. Dia. .589" Length .437" 3. Dia. .589" Length .177" 4. Dia. .589" Length .280"</p> <p>Land "1" goes into valve body first. Non machined flat around diameter on land "4".</p>	<p>Boost Sleeve Overall Length 1.201" Inside Dia. .661" Outside Dia. .787" I.D. No recess no ring.</p> <p>Spring Free Length 1.669" Inside Dia. .405" Outside Dia. .519" Wire Dia. .057"</p> <p>No. of Coils 11.</p>	<p>Boost Plug Overall Length of Plug 1.575"</p> <p>Land Diameter and Length</p> <p>5. Dia. .660" Length .120" 6. Dia. .648" Length .374"</p> <p>Spring seat goes over the stem. Two I.D. rings one next to land "5" in back of machined area. One near the end of the stem in front of machined area shown in Figure 56 below.</p>
--	--	--

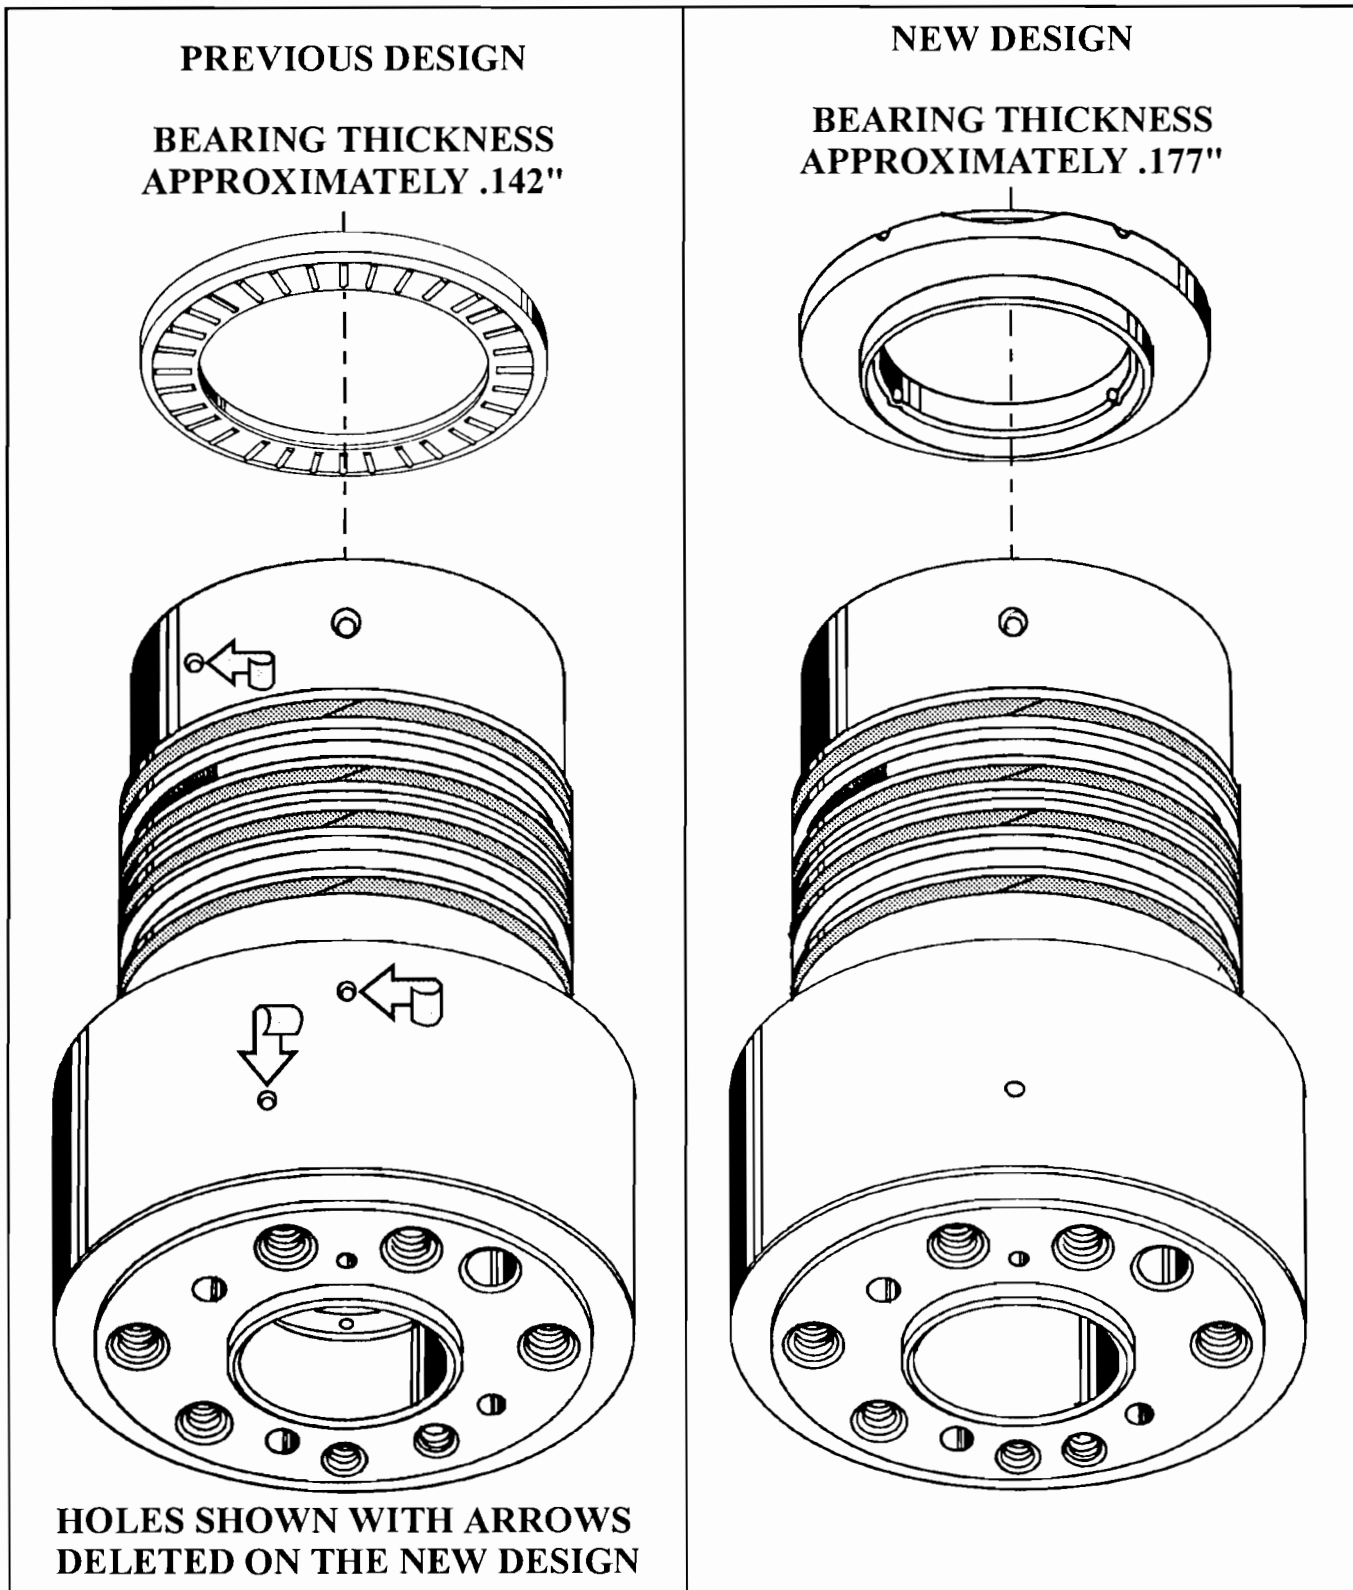
Figure 57

CHANGE: The Low Sprag Inner Race (Rear Support) was reduced in overall height by approximately .035" on all RE4R01A A transmissions, to accommodate a new design three piece needle bearing (See Figure 57).

- (1) **LOW SPRAG INNER RACE (REAR SUPPORT)** - Reduced in overall height by .035", to accommodate the new design (Thicker) three piece needle bearing (See Figure 57). The new design inner race also has revised lubrication holes. There are currently two lube holes in the new design race, one feeding lube to the sprag, and one feeding lube to the forward clutch drum bushing (See Figure 57). The new design Low Sprag Inner Race (Rear Support) can be identified by the lube hole differences mentioned above (See Figure 57), and/or by measuring the overall height, as shown in Figure 58.
- (2) **NEEDLE BEARING** - The previous two piece needle bearing located between the overrun clutch hub and the low sprag race, was replaced with the three piece design (See Figure 57).

The previous design and new design parts CANNOT be mismatched, or it WILL result in premature bearing failure, and/or end play concerns.

Low Sprag Inner Race (New Design)	31472-41X01
Three Piece Bearing (New Design).....	31407-41X11
