1996 SEMINAR INFORMATION

"THE BEST FIX IN '96"

AUTOMATIC TRANSMISSION SERVICE GROUP
9200 S. DADELAND BLVD. STE 720
MIAMI, FLORIDA 33156
(305) 670-4161

INTRODUCTION

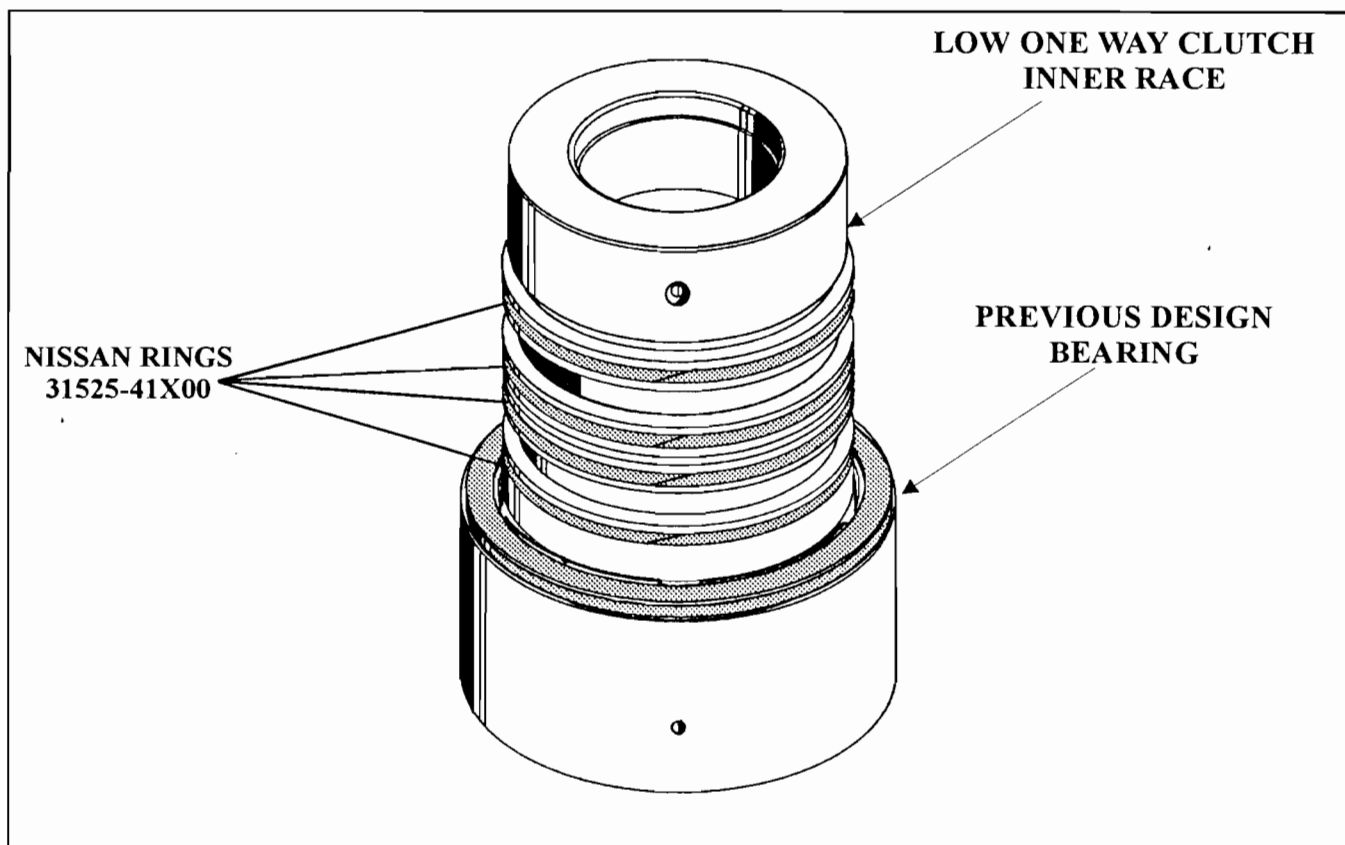
Figure 59

CHANGE: The three piece needle bearing located at the rear of the low one way clutch inner race in RE4R01A transmissions has changed (See Figure 59).

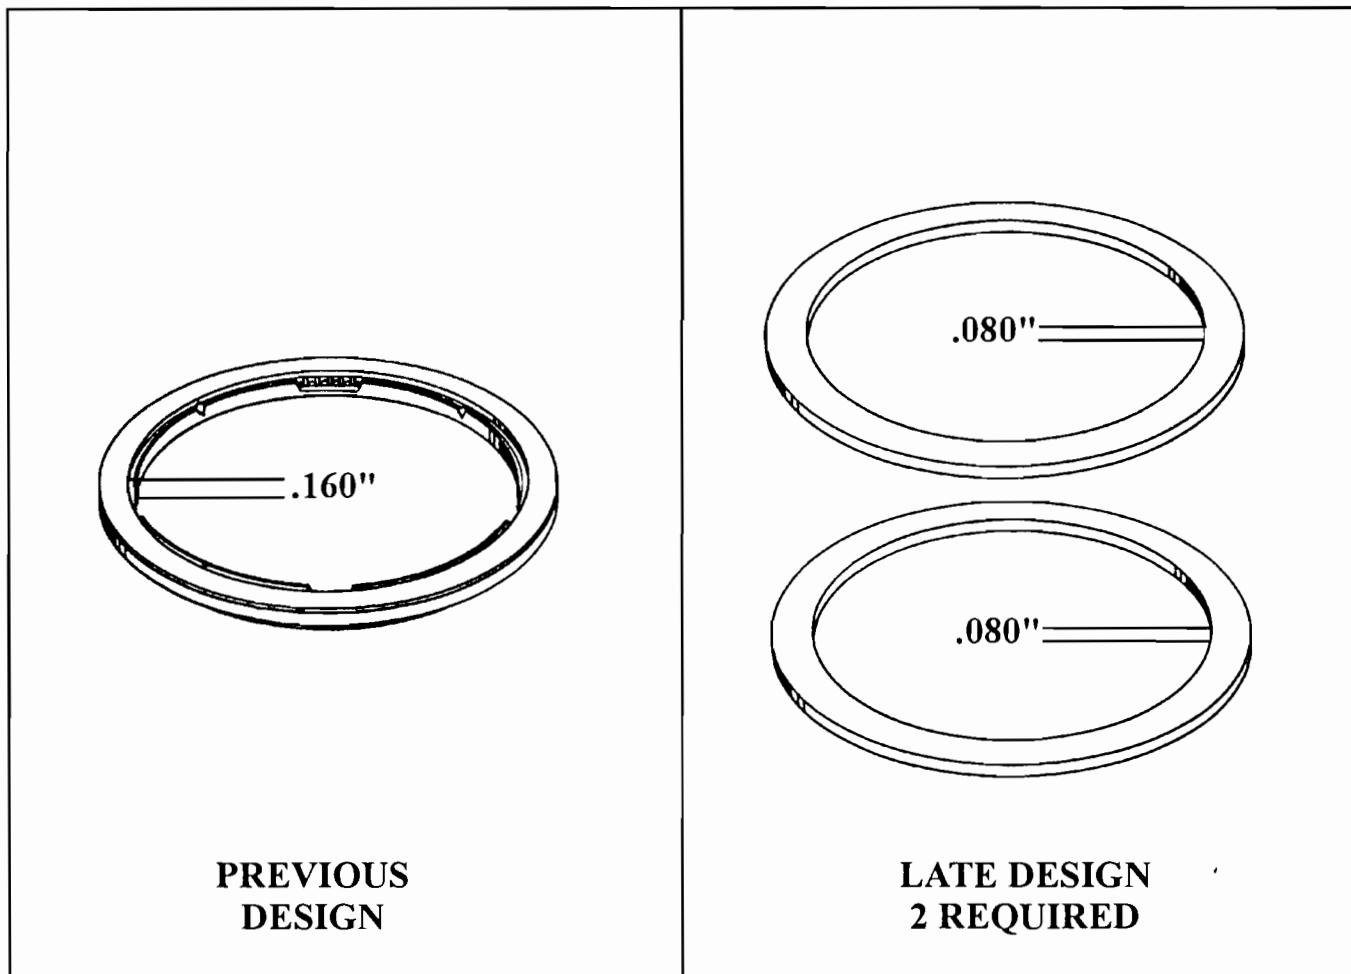
Figure 60

The previous design 3 piece bearing has been replaced by 2 thrust washers (See Figure 60).

The 2 new design thrust washers will retrofit backwards. These thrust washers must be used in a pair. If not, premature bearing failure, lubrication and or end play problems will arise.

THRUST WASHER (NEW DESIGN - 2 REQUIRED).....	31508-41X01
NEW LOW EXPANSION RINGS.....	31525-41X00

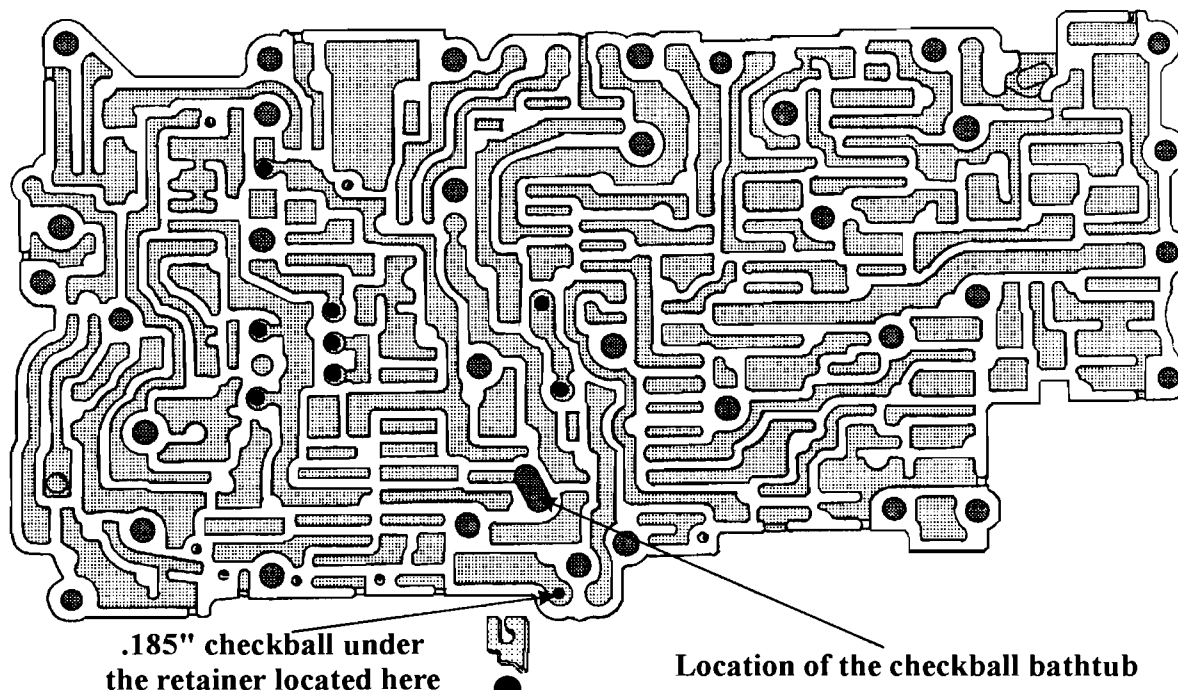
Figure 62
Automatic Transmission Service Group

Cause: One cause may be a checkball installed into a bathtub that does not require a checkball. (See Figure below for the location of the checkball in question). In order for this location to require a checkball, there must be two holes in the separator plate above the bathtub (See Figure). When a checkball is mistakenly installed in this location, the checkball will act as a one way valve and trap oil going to the face side of the 2 - 3 shift valve keeping the valve in against spring tension. This prevents a 2 - 3 upshift from taking place and a shift from 2 - 1 will occur.

Correction: Look at the diagram of the separator plate in Figure to determine if the valvebody requires a checkball or not. One hole in the separator plate will not require a checkball. Two holes in the separator plate will require a checkball. A picture of the hydraulic circuit is also provided in Figure on the next page.

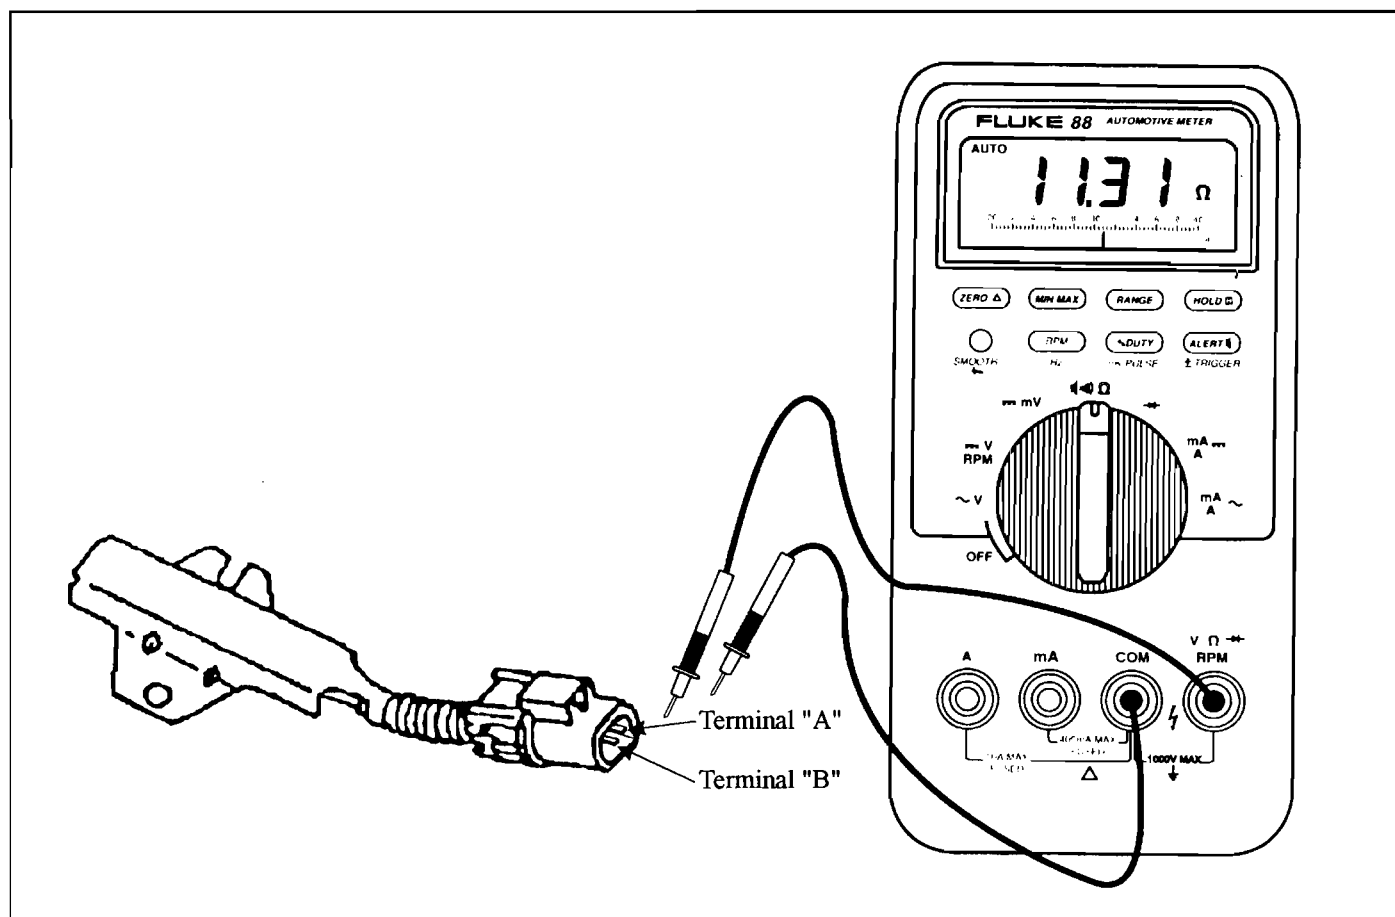
Figure 66

Cause: One cause may be a faulty dropping resistor. A dropping resistor is an inline resistor that receives computer variable voltage and reduces or "Drops" the voltage down to an acceptable range that the pressure control solenoid can handle.

Correction: Check the dropping resistor circuit or replace the dropping resistor. To properly check the dropping resistor and to locate the resistor on various models, see accompanying text and Figures 65 and 66. To begin checking the dropping resistor place the leads of a DVOM across terminals "A" and "B" with the connector disconnected, as shown in Figure 65. The resistance should be between 11.2 and 12.8 ohms. Voltage can be checked coming from the computer to the dropping resistor, as well as the voltage being sent to the pressure control solenoid. To check the voltage being sent from the computer, start the engine and warm it up to operating temperature, and then shut it off. With the connector plugged into the harness, use a voltmeter and with the positive lead of the meter, carefully backprobe terminal "A" of the connector (This is the receiving terminal coming from the transmission computer) place the negative lead of the meter to the negative terminal of the battery, or a good known ground. Set the meter on DC volts. Turn the ignition to the ON position (Do not start) and note the voltage that is shown on the meter screen. Depending on engine temperature, the reading should be between 7.0 and 13.0 volts with the throttle closed. As soon as the throttle is opened, the voltage will begin to drop. With a 30% throttle opening approximately 4.0 volts should be present (**It may be noticed that the voltage does not drop smoothly, this is normal operation. The voltage drop will seem erratic, unlike TPS voltage which should be smooth.**) When 50% throttle is reached, there should be approximately 0.5 volts. This voltage should remain at approximately 0.5 volts all the way to wide open throttle. Next place the positive lead of the meter to terminal "B" of the connector at the dropping resistor. Keep the negative lead on a good known ground. At a closed throttle the voltage should be between 2.0 and 3.5 volts. (**This voltage drop will also be erratic.**) The voltage should drop slowly until approximately 50% throttle is reached. The voltage should then drop to approximately 0.5 volts and remain at 0.5 volts all the way to wide open throttle. All voltage readings should fluctuate with engine temperature. If the voltage at terminal "A" is correct, and voltage at terminal "B" is incorrect, the dropping resistor is bad causing no line pressure rise. If the voltage at terminal "A" is incorrect, a malfunctioning TPS or a bad computer may be the cause of the problem. If voltage at terminal "B" is at 0.00 volts at all throttle ranges, and voltage at terminal "A" is at 5.00 volts at all throttle ranges, a shorted wire or an open in the circuit will be the cause of this problem. This fault will not cause a no pressure rise, but rather a constant high line pressure regardless of throttle opening.

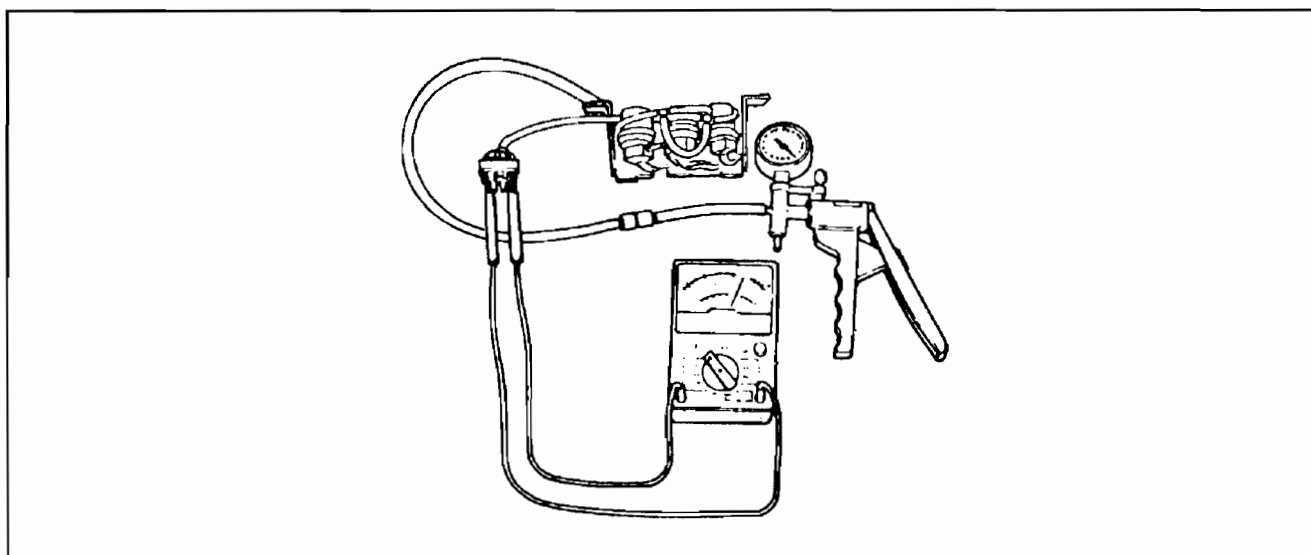
Figure 67

CAUSE: One cause may be a faulty vacuum switch assembly.

CORRECTION: All Sprint vehicles are equipped with a vacuum switch assembly which signals to the computer throttle position information based on manifold vacuum (See Figure 67). This vacuum switch assembly is located on the passenger side of the firewall behind the air cleaner. A plastic box is used as a cover for protection. To check the switch assembly, remove both the cover and vacuum switch assembly from the firewall and perform the following test using a vacuum pump and ohm meter:

1. Place a vacuum pump onto the main vacuum supply hose to the switches. With an OHM meter set to continuity, place the negative lead to the black wire for the entire test routine. Place the positive lead onto the blue wire. The meter should read continuity (0 ohms). When 2.5 to 3.5 inches of vacuum is pumped up, the meter should go to infinite (No reading).
2. Lock the vacuum pump to hold the 2.5 to 3.5 inches of vacuum and move the positive lead of the meter to the green wire. The meter should show continuity and go to infinity when the vacuum pump is brought up to 6.5 to 7.5 inches.
3. Lock the vacuum pump at 6.5 to 7.5 inches and place the positive meter lead to the brown wire. The meter should show continuity and go to infinite when the vacuum pump is brought up to 11.5 to 12.5 inches of vacuum.

Replace the vacuum switch assembly if the above test procedure has failed.

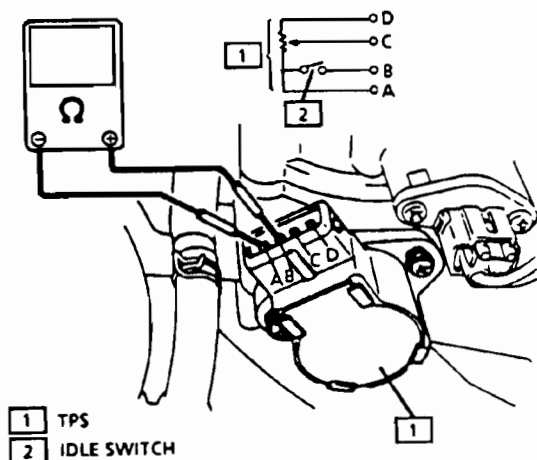
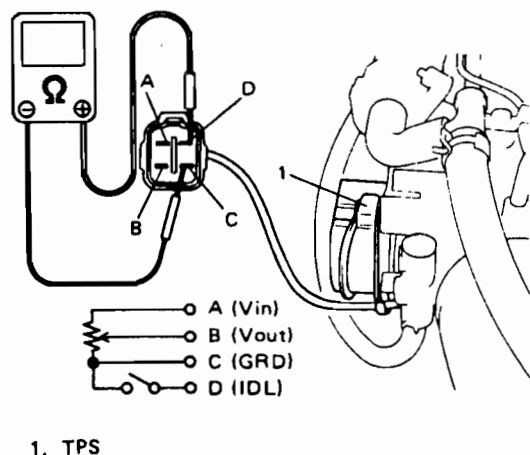
Figure 68

CAUSE: One cause may be a bad TPS. Another cause may be a bad engine computer.

CORRECTION: Check the TPS for proper operation (See Figure 68). The TPS sends a typical varying voltage to the engine computer. The Engine computer then send a separate signal to the transaxle controller. If the TPS checks bad, replace it. If the TPS checks good, go to the transaxle controller and check the signal being sent to the controller by the engine computer (See Figure 69). If the signal is incorrect, replace the Engine computer.

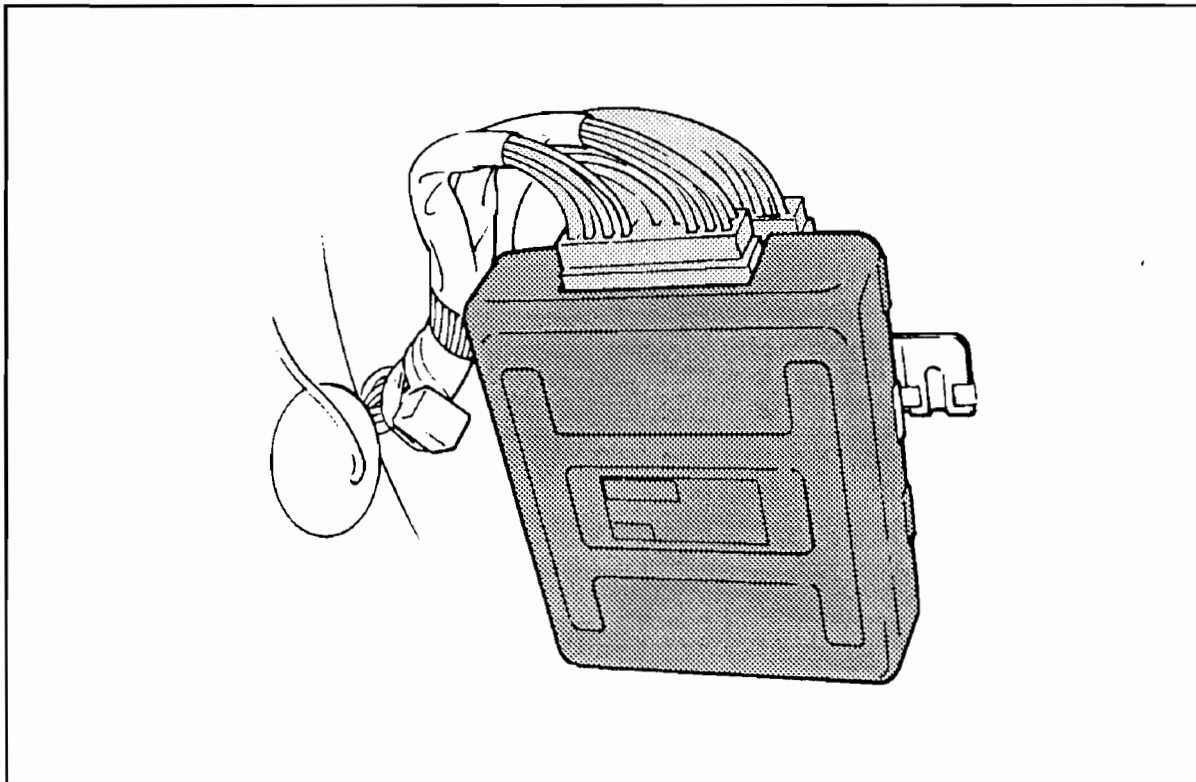
Figure 70

COMPLAINT: Before overhaul, the vehicle experienced a no reverse condition with all forward ranges working correctly. When the transaxle was overhauled, no evidence as to why a no reverse condition existed.

CAUSE: One cause may be a bad controller which energizes the 2nd brake solenoid in the reverse range. This blocks Low/Reverse apply oil at the 1-2 shift valve.

CORRECTION: Replace the controller. There are 3 different controllers available. To order the correct controller, you must acquire code numbers off a label on the controller. A quick test to verify that the controller is defective, unplug the solenoid wire connector. If a reverse gear is achieved, the controller is defective.

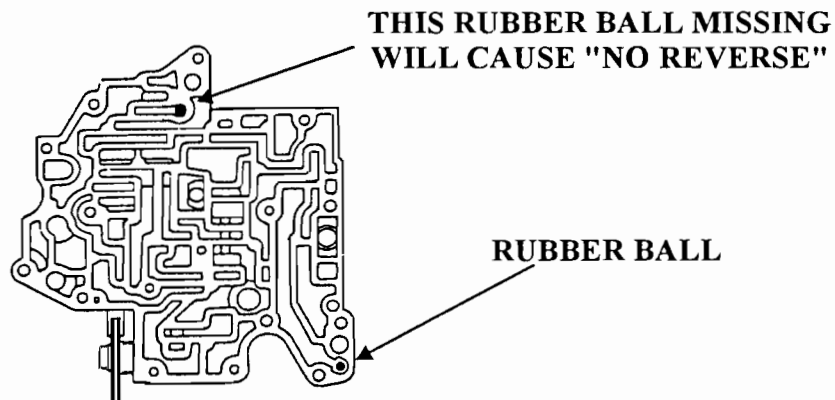
Figure 72

1. A rubber check ball was missing or was left out of the Upper valve body.
2. The "CO" or "Overdrive Direct" clutch drum, accumulator or apply gaskets, located in the Overdrive Case, were misassembled.

1. Install missing check ball in the Upper valve body as shown in Figure 72.
- 2. Renew "Overdrive Direct" clutch drum piston seals.
 - "Bore" fit sealing rings into the Overdrive Direct drum and ensure a snug fit.
 - Check Overdrive Direct clutch accumulator "O-ring" and ensure a snug fit when installed into its bore. (See Figure 73)
 - Ensure that the Overdrive brake and Overdrive Direct clutch apply gaskets or plugs are installed between the main and Overdrive case. (See Figure 73).
 - NOTE: When air checking the Overdrive Direct clutch, through the Overdrive case, ensure that the accumulator strokes against its cover and the Overdrive Direct clutch plates apply. (See Figure 74)

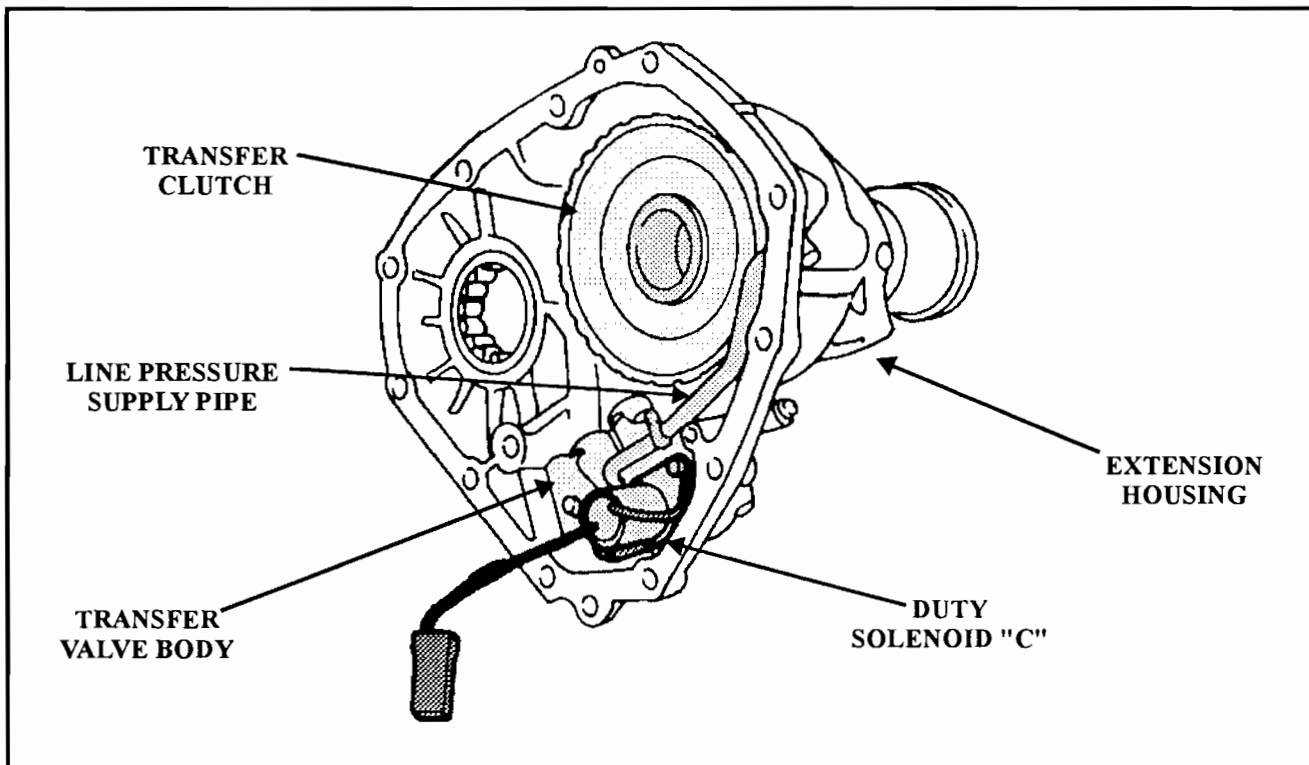
Figure 75

CAUSE: This experience is commonly referred to as "Tight Corner Braking" and is caused by a malfunction in the ALL WHEEL DRIVE electronically controlled transfer clutch system.

Hydraulically, the transfer clutch, located in the extension housing, (Refer to figure 75) is a stand alone system requiring only a line pressure supply from the transmission control system. The transfer clutch has its own valve body and a normally open pressure control solenoid. The valve body contains a pilot valve which sets the supplied line pressure to a fixed level. It is this pilot oil pressure that the pressure control solenoid "C" is regulating, in relation to duty cycle controlled by the TCM, and sending to the transfer control valve which will control the apply of the transfer clutch so that torque distribution will match vehicle driving conditions (Refer to figure 76).

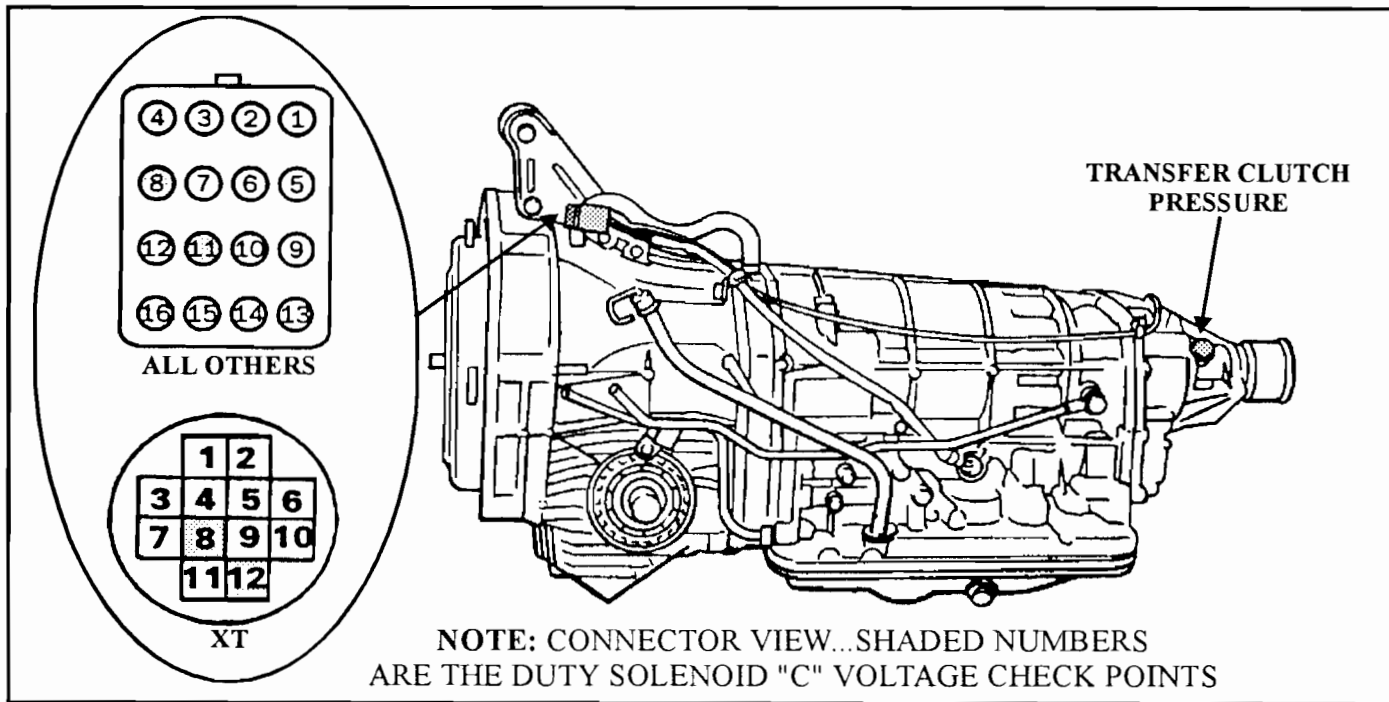
Figure 80

- STEP 3:** If voltage and pressure respond to throttle opening as per the chart in figure 80, the transfer clutch may be stuck on due to severe clutch damage.

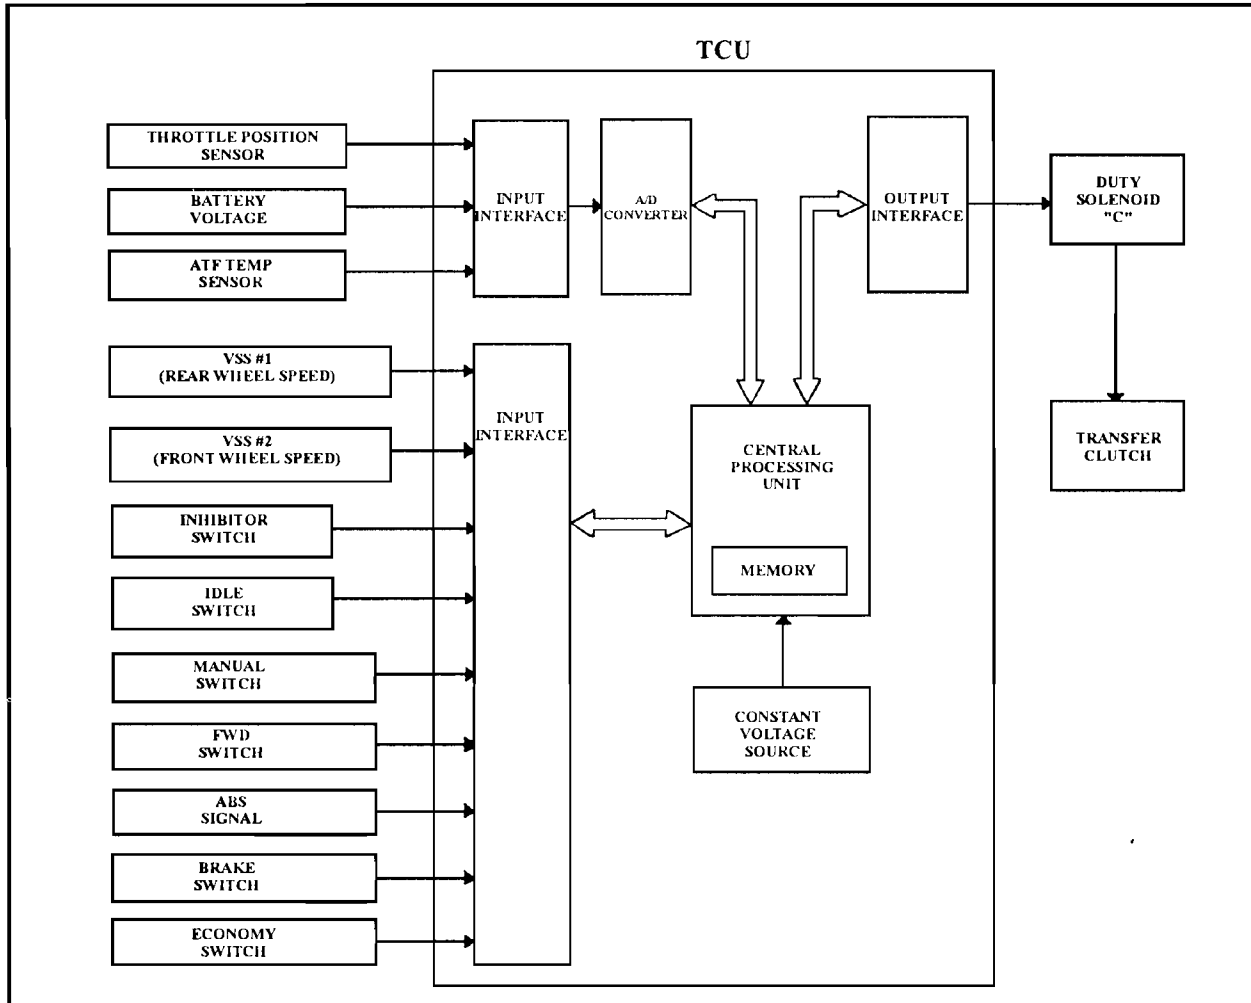
Figure 82

- STEP 4:** If voltage responds but pressure does not, the problem could be the "C" solenoid is faulty or the transfer control valve is stuck closed.
- STEP 5:** If voltage does not respond to throttle opening, the problem could be a faulty TPS, VSS #1 or #2, or any of the sensors shown in figure 82 or a faulty TCU.

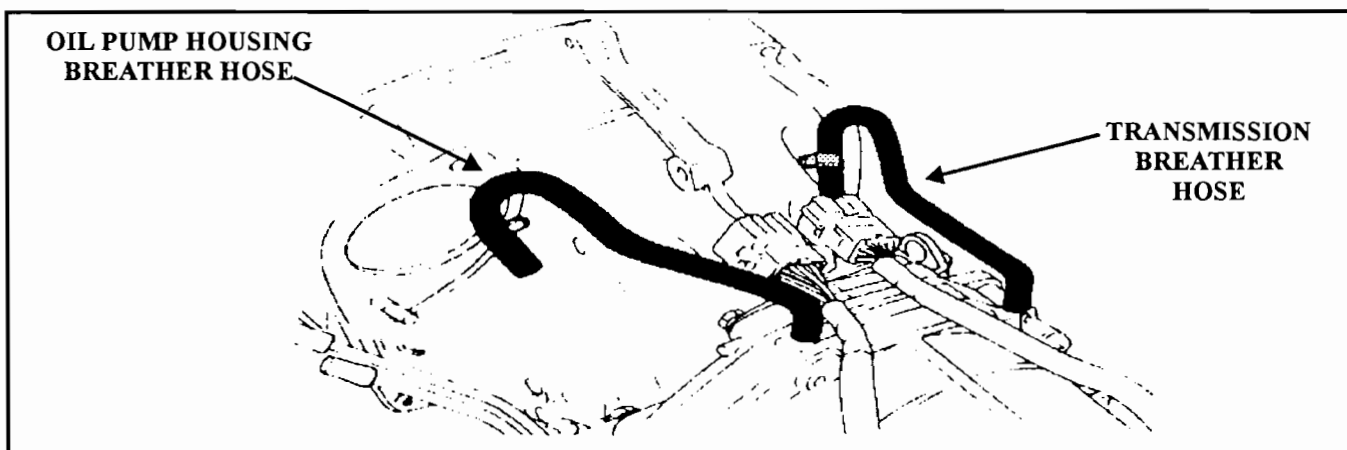
Figure 84

CAUSE: If the rubber seal that goes between the differential housing and the oil pump cover (Refer to figure 83) is NOT installed or is mispositioned, automatic transmission fluid will leak from the transmission into the differential area. This will delete the ATF level in the transmission causing it to slip and can also result in fluid leakage out the oil pump housing breather hose. (Refer to figure 84).

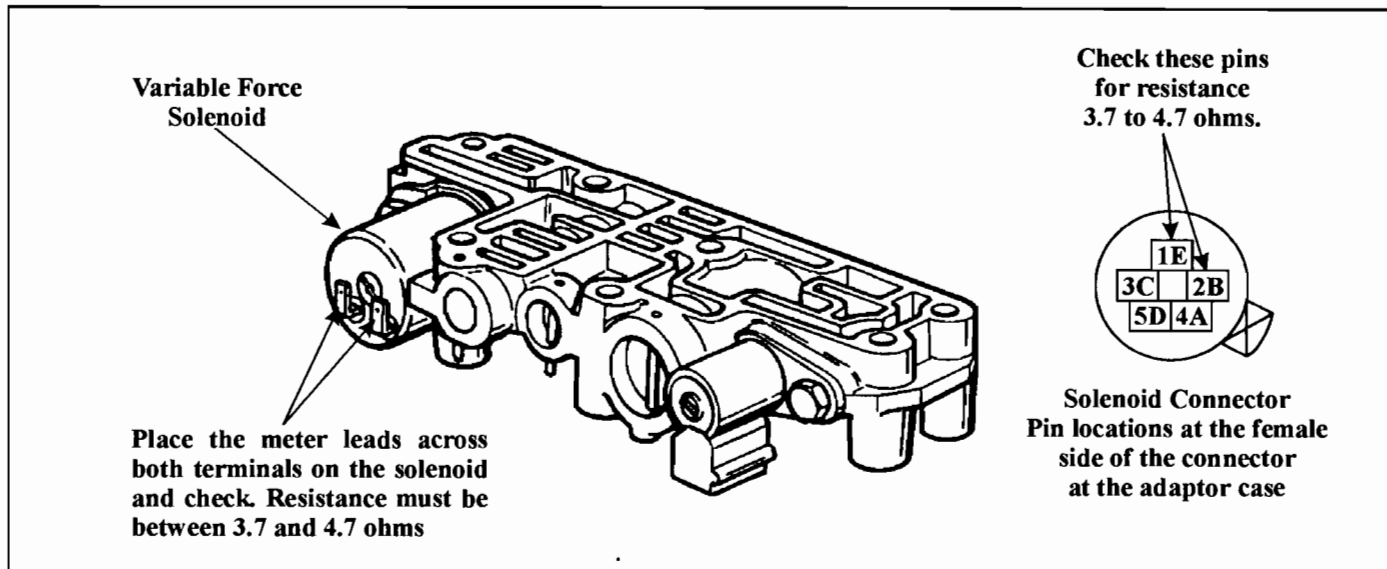
Figure 86

- STEP 6:** With the solenoid harness still disconnected at the transmission, use an ohmmeter and check the resistance between pins 2B and 1E at the female side of the transmission case connector (See Figure 86). The resistance should be between 3.7 and 4.7 ohms. **(If the resistance is correct go to step 7).** If the resistance is not correct remove the oil pan on the adaptor housing and disconnect the wires from the solenoid (See Figure 86). Using a meter place the leads across both terminals and check for resistance. Resistance should be between 3.7 and 4.7 ohms. If resistance is not correct replace the solenoid, clear the code and recheck.

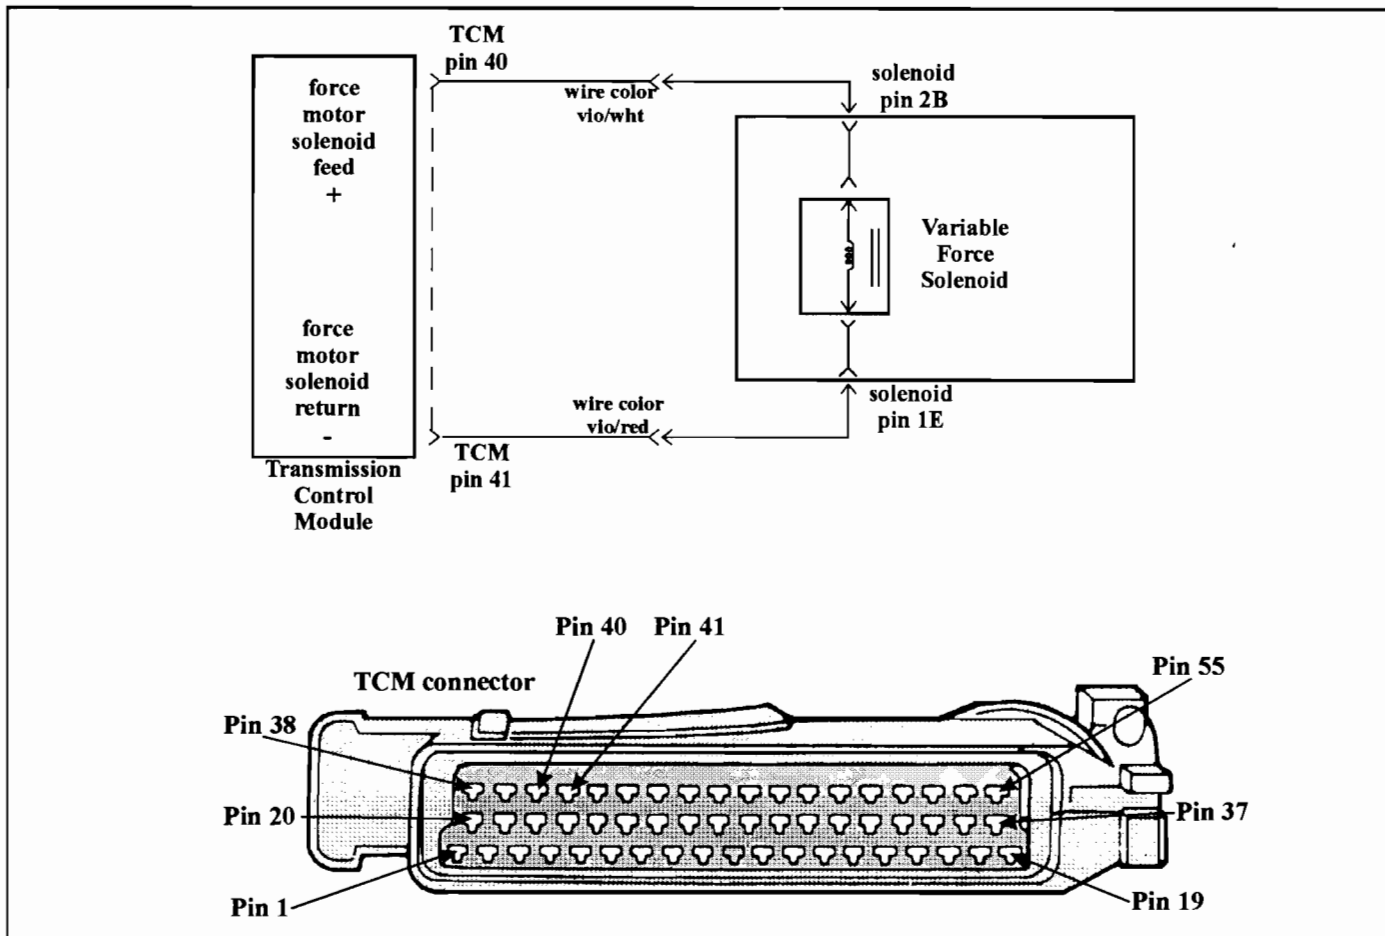
Figure 87

STEP 3: Turn the vehicle ignition switch to "OFF". Go to the TCM and disconnect the harness connector. Using an ohmmeter place the leads of the meter across pins 40 and 41 of the TCM harness connector going to the transmission (See Figure 87). Resistance should be between 3.7 and 4.7 ohms. **(If resistance is correct, proceed with this step. If resistance is incorrect go to step 4).** If the resistance is correct, check for a faulty TCM connector. If the TCM connector is "OK", replace the TCM clear the code and recheck.

STEP 4: If the resistance between pins 40 and 41 of the TCM connector is not between 3.7 and 4.7 ohms, place the meter leads between pin 40 of the TCM connector and a good ground. No continuity should exist. Next place the meter leads between pin 41 of the TCM connector and a good ground. No continuity should exist. **(If no continuity exists on either wire, proceed to step 5).** If continuity exists between pin 40 and ground, there is a short to power on the wire between the TCM and the variable force solenoid. If continuity exists between pin 41 and ground, there is a short to power on the wire between the TCM and the variable force solenoid. Fix the short to power on the proper wire or run a new wire, clear the code and recheck.

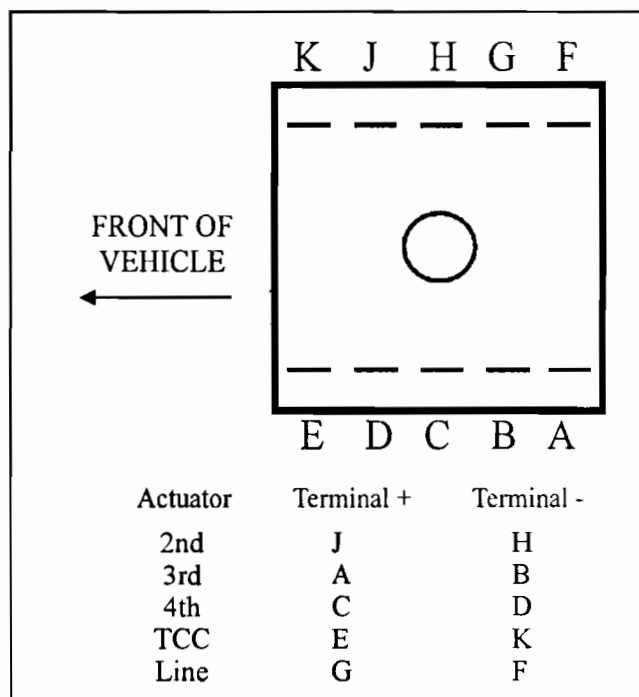
Complaint: After the replacement of new actuators, the vehicle experiences erratic shifts. Codes for the actuators may or may not be set.

Cause: The wrong design actuators were installed. All 1991 and 1992 actuators measure approximately 2.5 to 4.5 ohms while all 1993 and up actuators measure 4.0 to 6.0 ohms. These actuators will not interchange.

Correction: Install the correct design actuators. Verify actuator resistances through the connector using a DVOM set to ohms. Figure 3 provides a view of the actuator connector with each terminal identified. Each actuator has its own positive and negative terminals as shown in Figure 3. When checking each actuator, refer to the chart in Figure 4 for the resistance values.

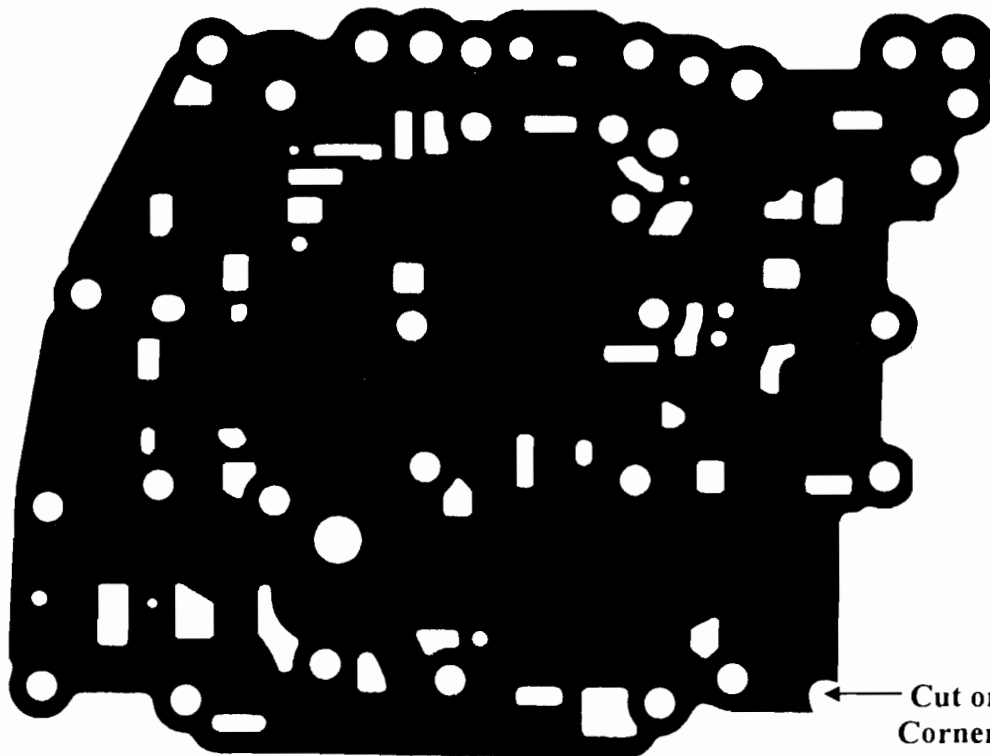
Figure 9

The spacer plate and spacer plate gaskets are redesigned to accommodate the new valvebody. The 1992 2nd design parts will contain an identification mark as shown in Figure 9.

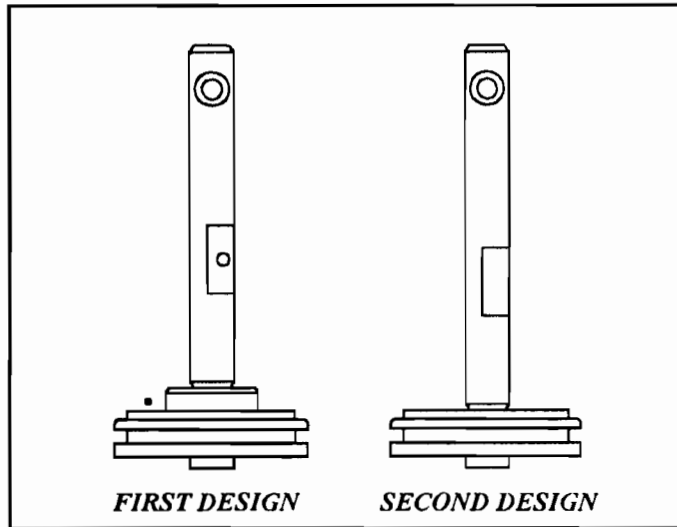
Figure 10

In addition to the servo valve previously described, the forward/reverse servo piston and spring have been redesigned. The main difference in the new piston is that the step and a hole in the shaft have been eliminated. Also, the spring in the new design is longer. Figures 9 and 10 show the differences.

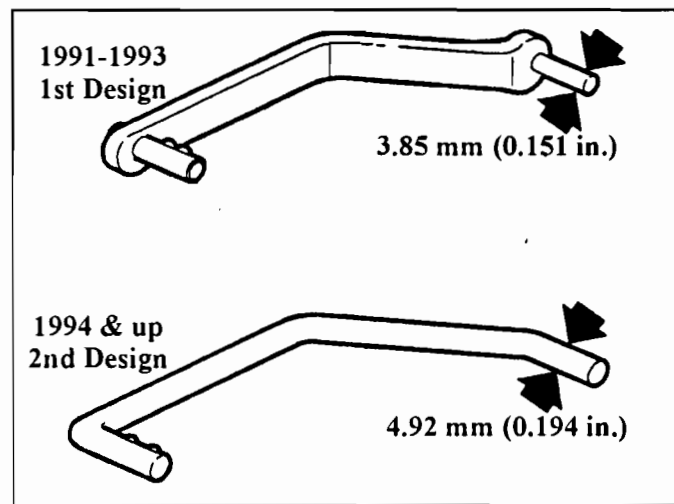
Figure 13

Due to the elimination of the step in the forward/reverse servo piston, the case has been redesigned to accommodate the removal of this step (See Figures 13 and 14).

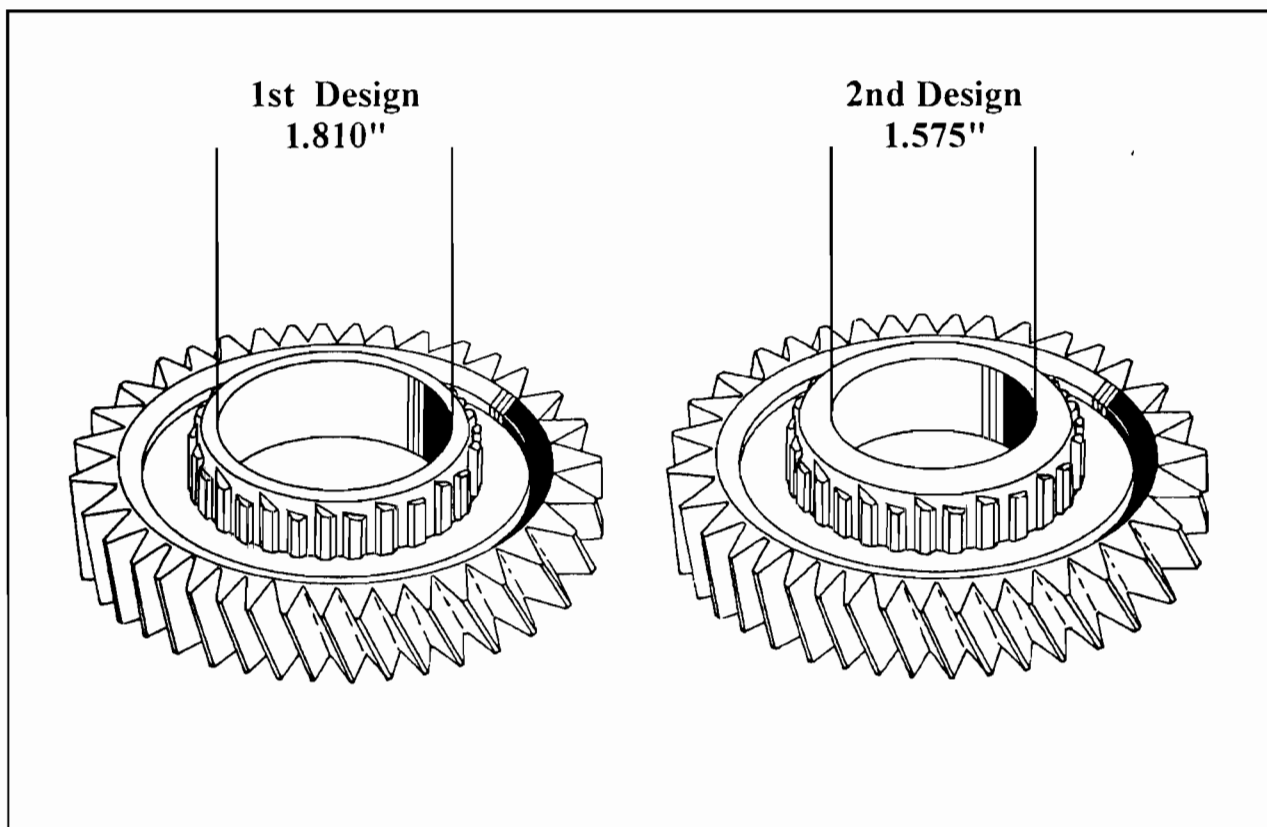
Figure 17

CHANGE: 1991 and 1992 SL1 and SL2 Sedans and SC Coupes with MP6 and MP7 automatic transaxles built after and including VIN number NZ174649, had eliminated the caged needle bearing for the counter shaft driven 2nd gear (See Figure 17).

The inner diameter of the 2nd driven counter shaft gear was reduced in diameter for a direct gear to race fit. The gear will now run on the inner race that the needle bearing used to run on (See Figure 17).

The new design 2nd driven gear with the reduced inner diameter will be the only gear available for service. This gear will retro fit back to earlier models by simply removing the caged needle bearing (See Figure 17).

MP7 2nd Driven Gear.....	21002606
MP6 2nd Driven Gear.....	21002605

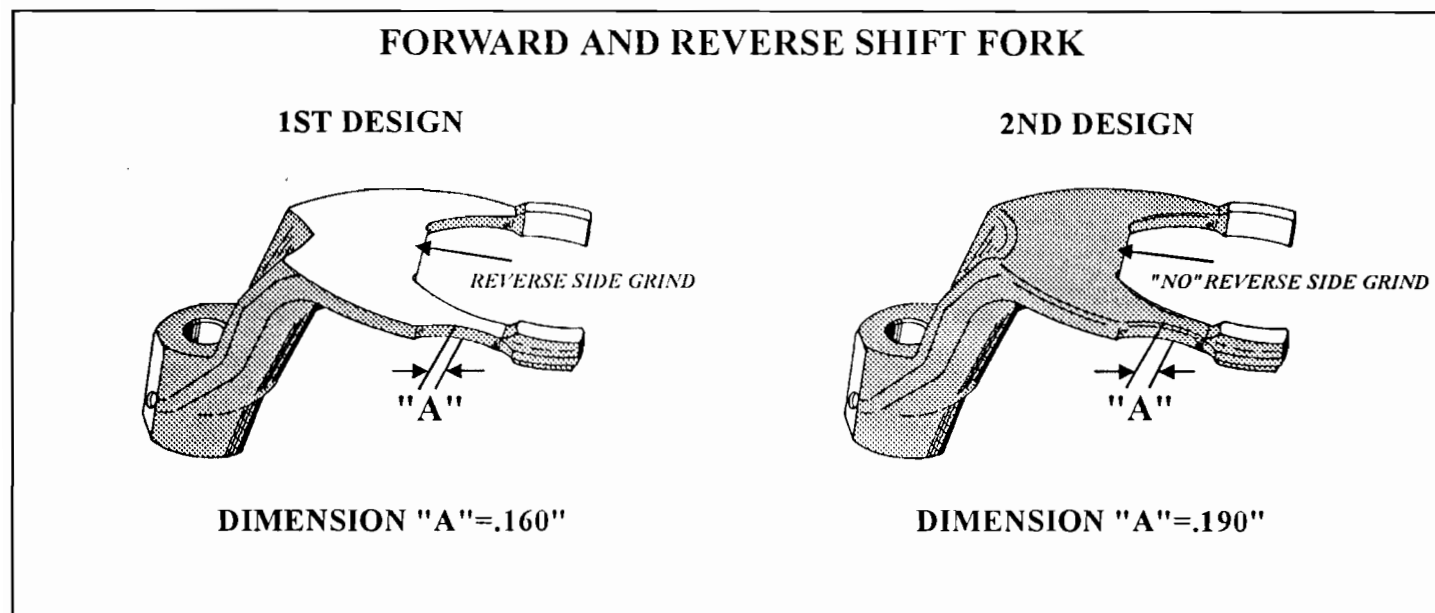
Figure 17a

NOTE: 1st design Fork is no longer serviced. (See Figure 17a)

Forward and Reverse Shift Fork and Reverse Driven Gear Kit.....21005969

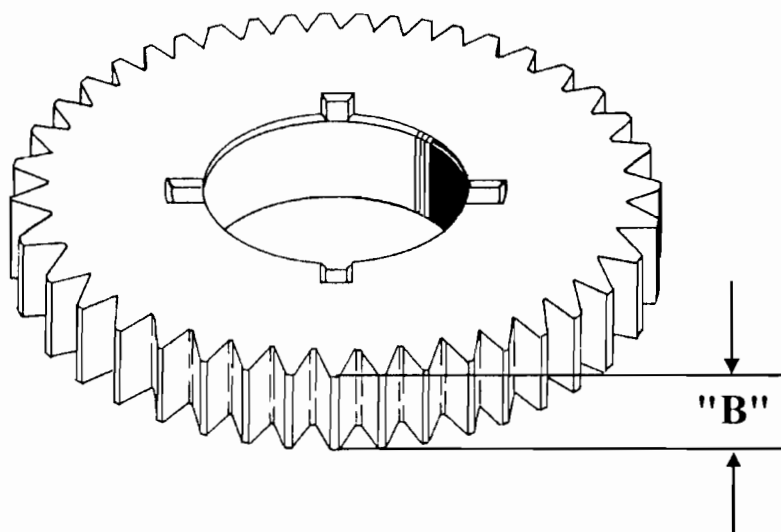
Figure 17b

NOTE: 1st design Reverse gear is no longer serviced. (See Figure 17b)

2nd Design (93) - the thickness of the gear is approximately .449". The increase in the Fork thickness made it necessary to reduce the thickness of Reverse gear. (See Figure 17b)

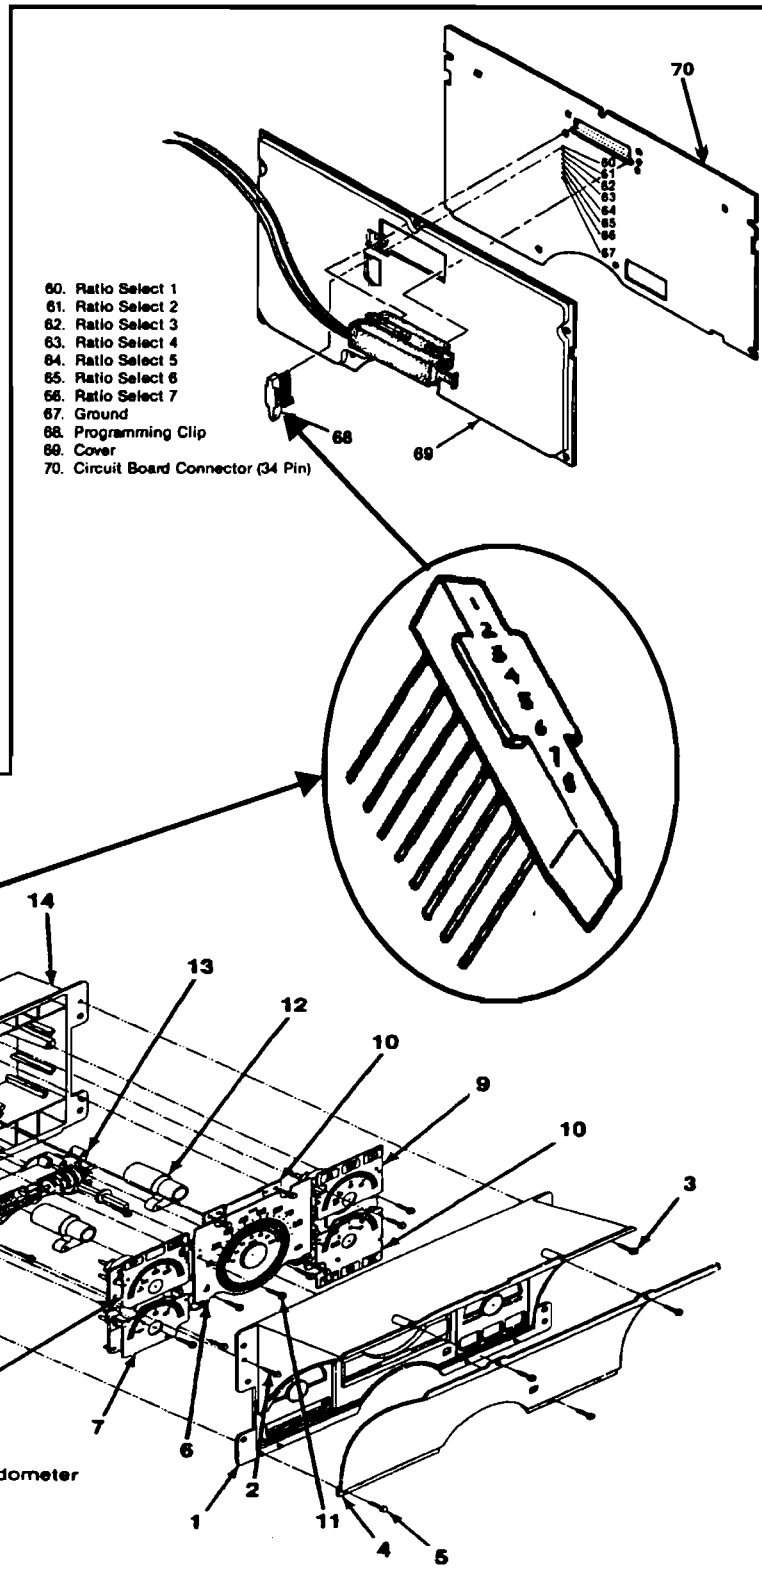
Figure 22

4L80E DRAC LOCATION AND DIAGNOSIS

1992-95 "C & K" SERIES PICKUP & SUBURBAN
