1996 SEMINAR INFORMATION

"THE BEST FIX IN '96"

AUTOMATIC TRANSMISSION SERVICE GROUP
9200 S. DADELAND BLVD. STE 720
MIAMI, FLORIDA 33156
(305) 670-4161

INTRODUCTION

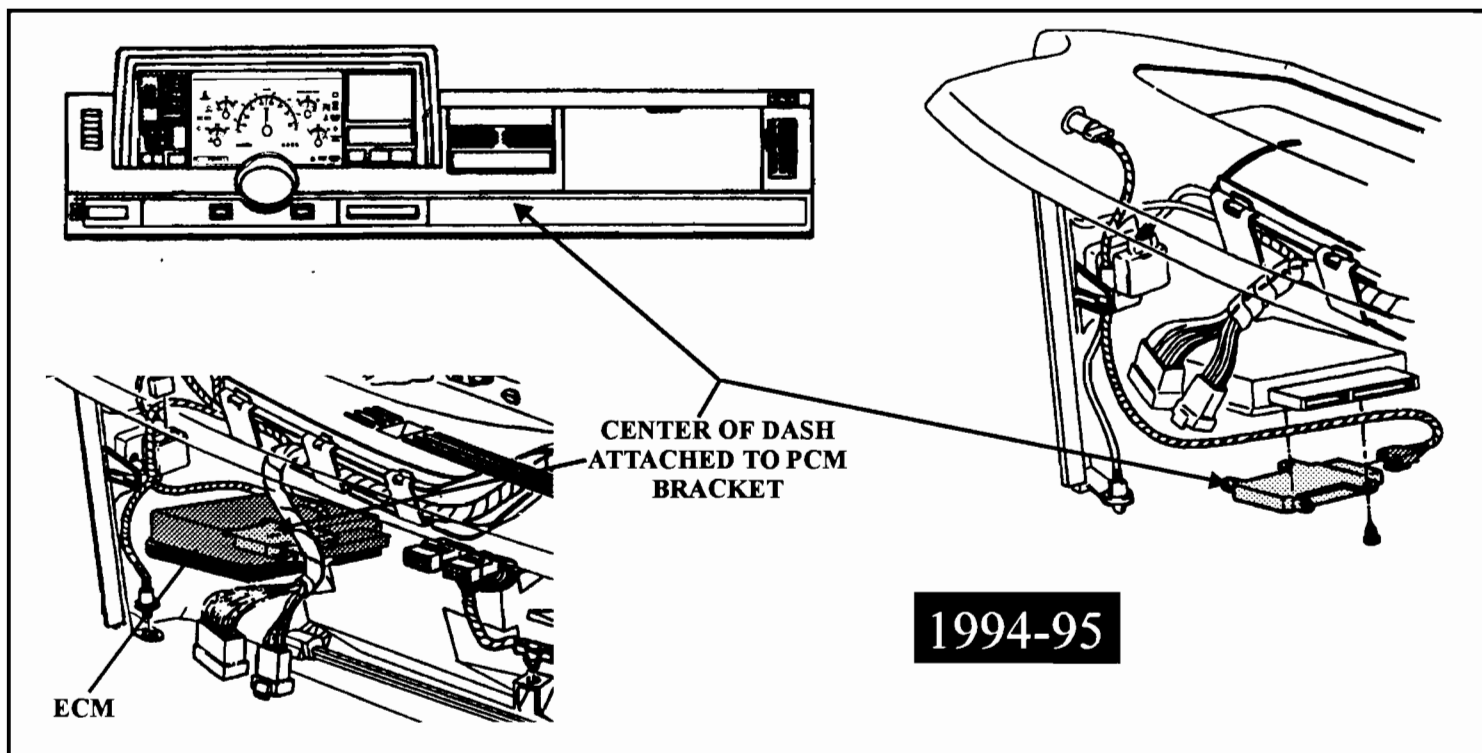
Figure 24

4L80E DRAC LOCATION AND DIAGNOSIS
1991-95 "G" SERIES VAN

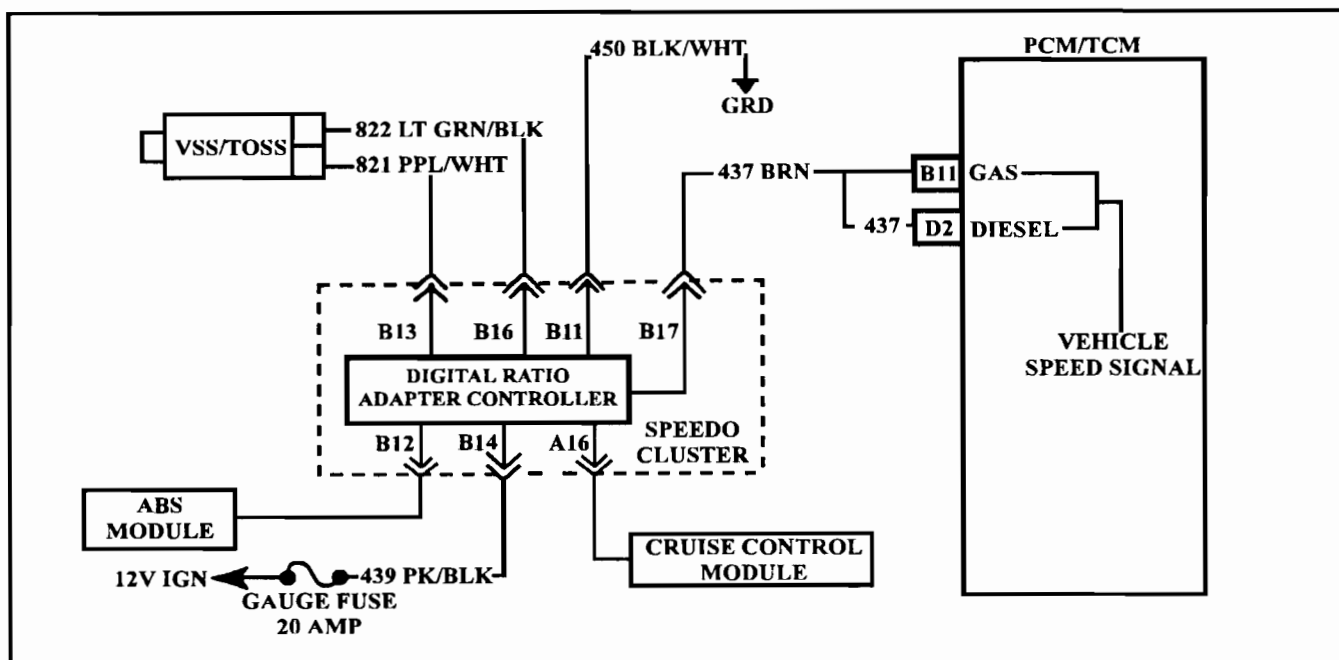
Figure 30

DTC 24, STUCK IN LOW GEAR, SPEEDOMETER INOPERATIVE

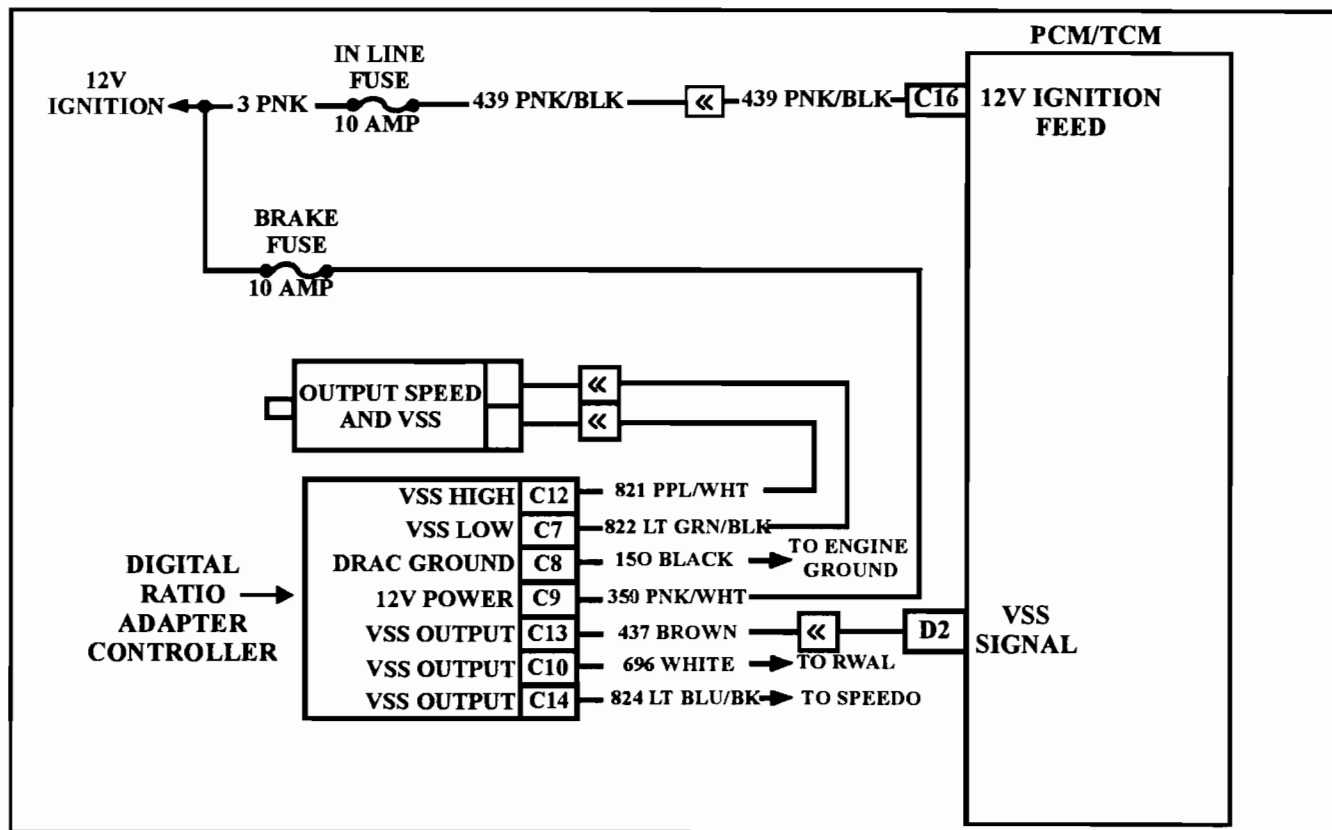
Figure 31

1991-93 2WD TRUCKS WITH EXTERNAL DRAC

DTC 24, STUCK IN LOW GEAR, SPEEDOMETER INOPERATIVE

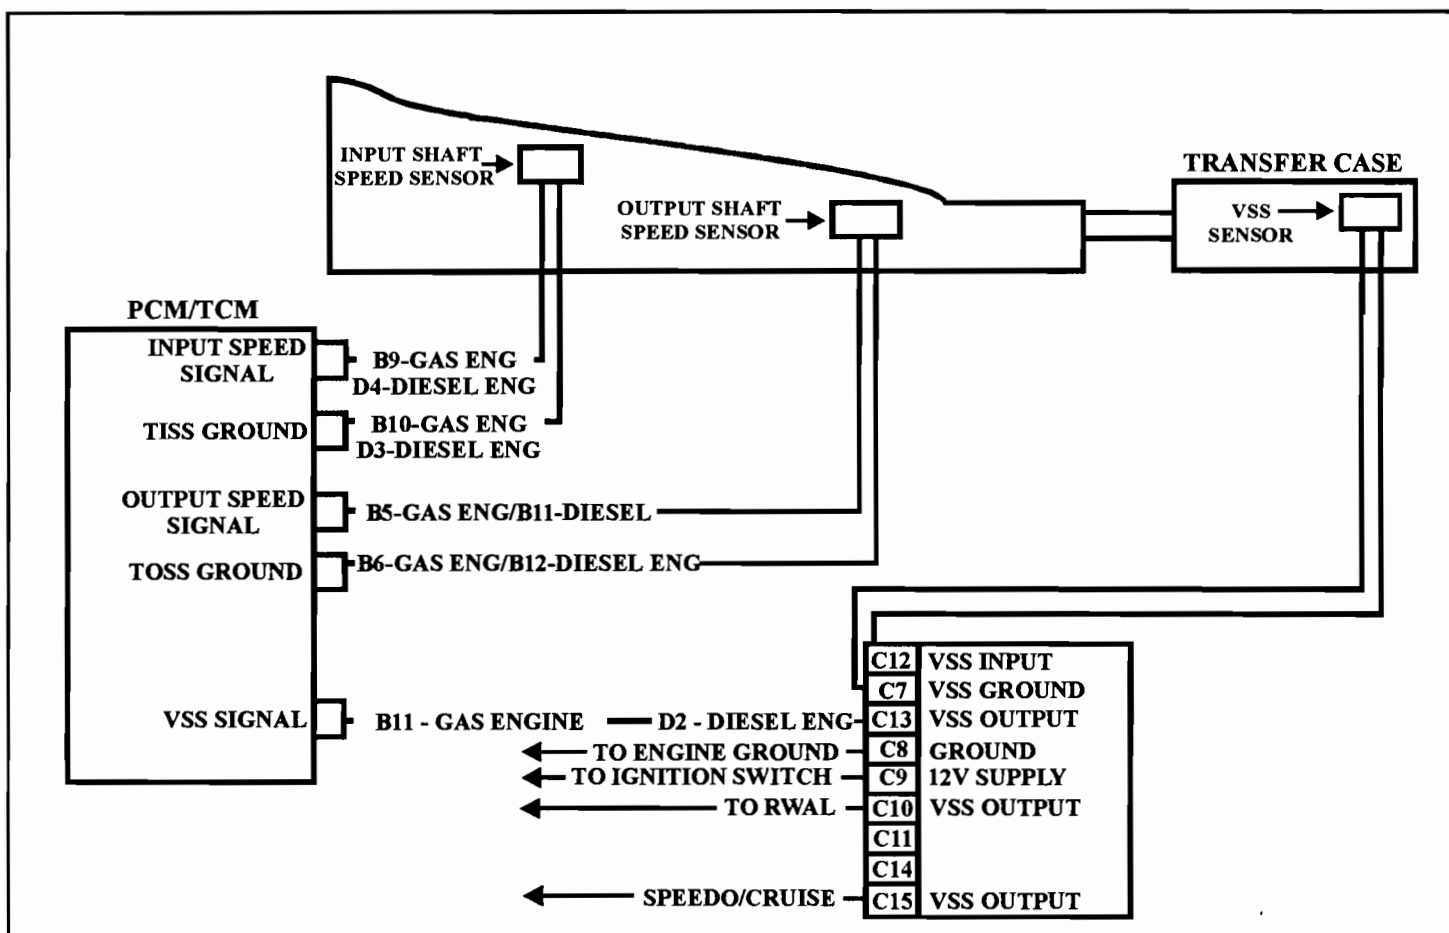
Figure 32

1991-93 4WD TRUCKS WITH EXTERNAL DRAC

DTC 24, STUCK IN LOW GEAR, SPEEDOMETER INOPERATIVE

DTC 24, STUCK IN 2ND GEAR, SPEEDOMETER OK
