"2008" SEMINAR INFORMATION

AUTOMATIC TRANSMISSION SERVICE GROUP

"Shiftin' Great in 2008" ***Seminar Information***

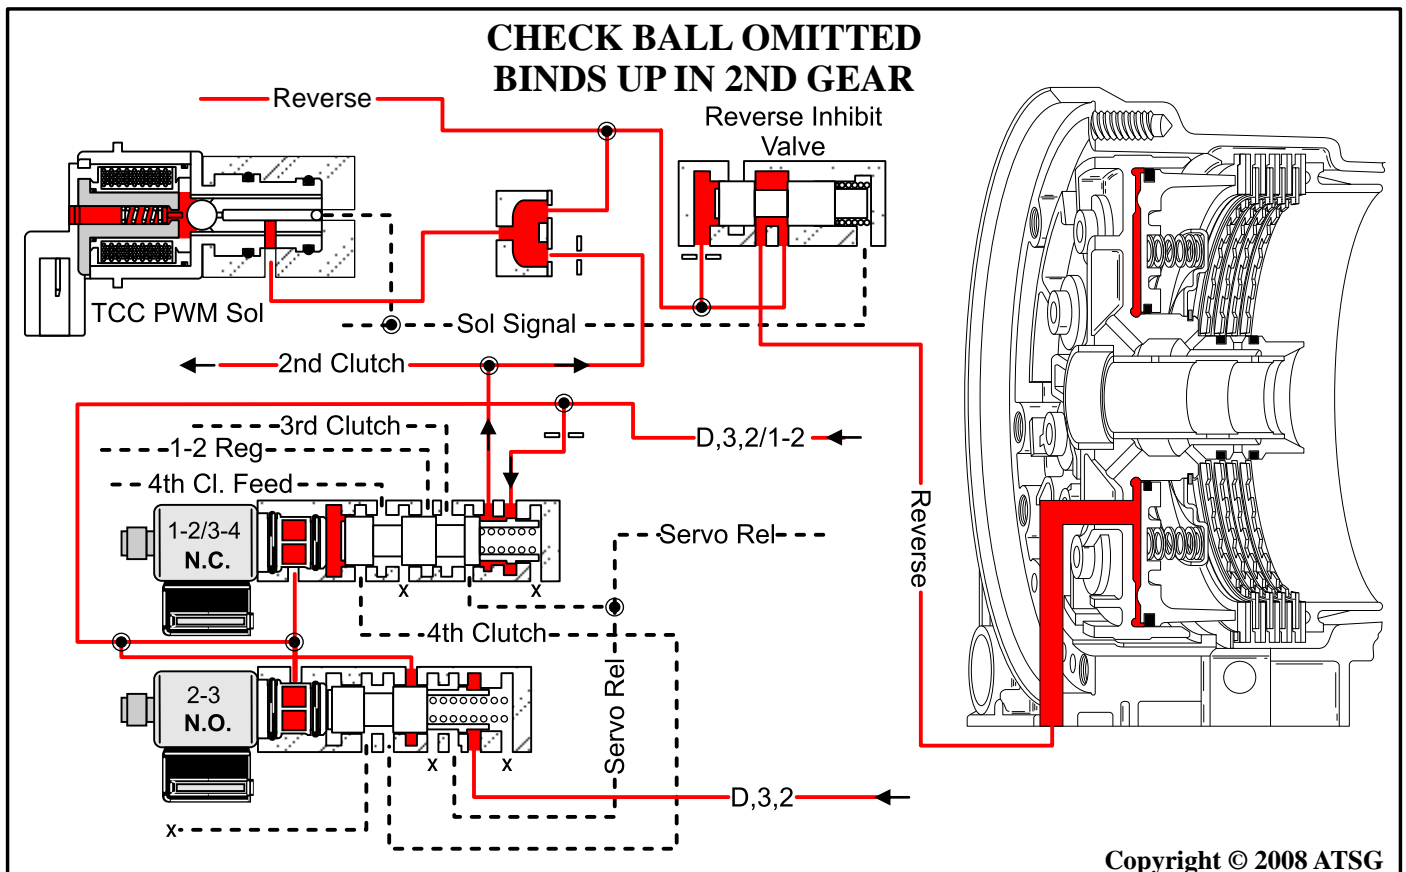
Figure 6 shows the ball missing. Oil pressure is allowed to enter the reverse clutch circuit causing the reverse clutch and 2nd clutch to apply together which causes the bind up condition on the shift.

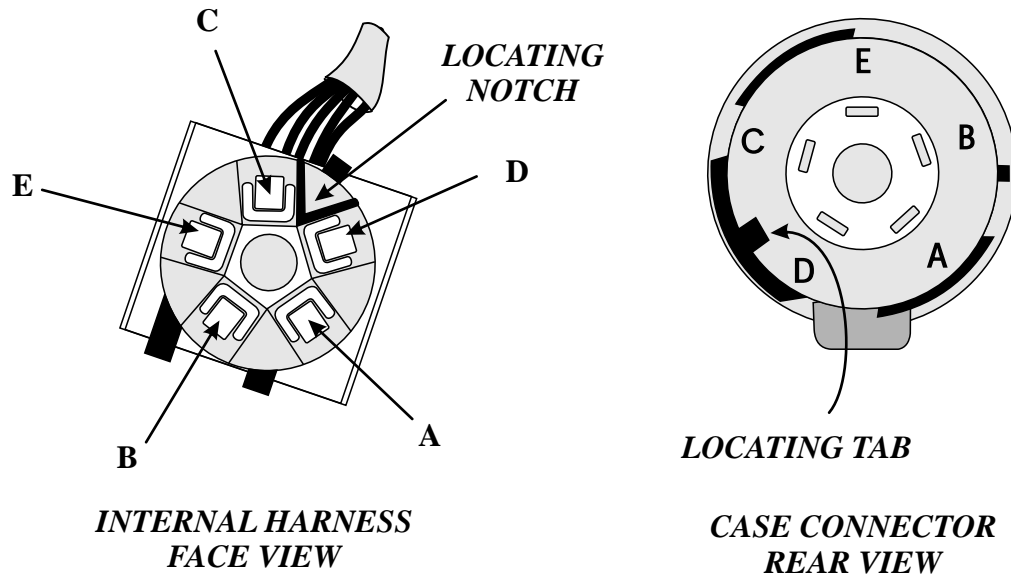
Figure 3

CAUSE: Case configurations changed depending on year of manufacture and make of vehicle. 1990 to 1999 Isuzu vehicles equipped with the 4L30E used the round case connector in the overdrive housing in the front and the square case connector in the main case in the rear. The same locations were used for the Honda Passport starting with the 1994 model year. In 1997 when the Cadillac Catera was introduced, these case connectors reversed positions. Now, the square case connector was up front in the overdrive housing and the round case connector was located in the main case in the rear of the unit. Isuzu and Honda adopted this same arrangement beginning with the 2000 model year. This can lead to cross connect situations which will result in the setting of the solenoid codes, (Refer to Figures 1 and 2). Another problem area that can cause the above mentioned complaints has to do with the case connector locating tabs. These tabs become brittle over a period of time and break off. When this happens the case connectors can be plugged into the vehicle wire harness plug incorrectly, (Refer to Figure 3).

CORRECTION: Replace the internal wire harness if the locating tabs are broken and insure that the correct case connector/internal harness assembly is in the correct location.

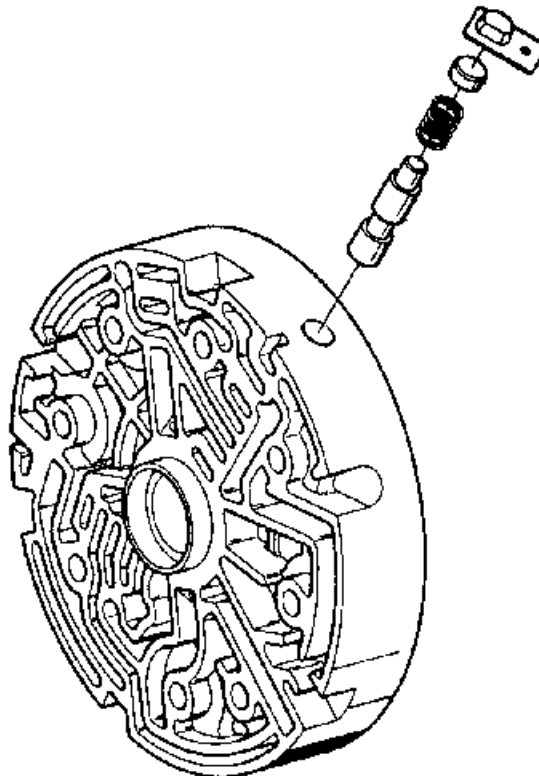
Figure 4

When the reverse lockout valve was added to the center support, (See Figure 4), another problem was produced. If the TCC and Pressure Control Solenoids are cross connected, the Pressure Control Solenoid signal will activate the TCC solenoid which in turn will stroke the reverse lockout valve, and a no reverse condition will exist. Refer to the hydraulic schematics in Figure 5 for TCC and reverse lockout valve operation.

4L30E CENTER SUPPORT WITH REVERSE LOCKOUT VALVE

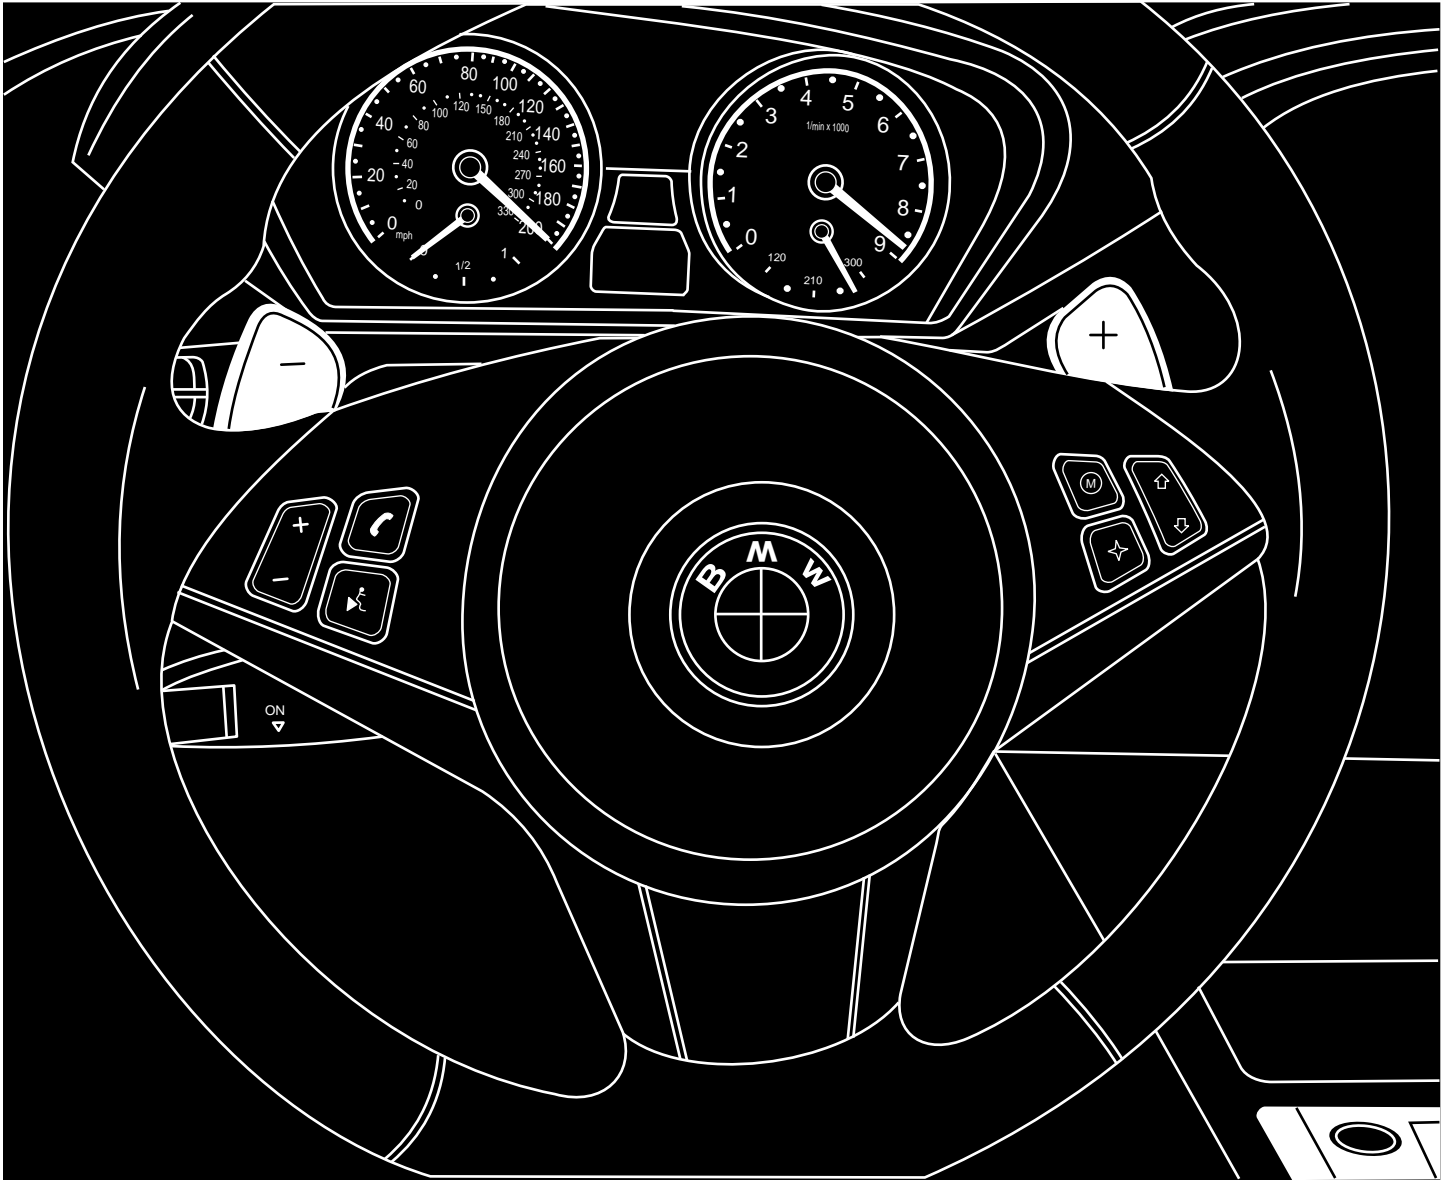
Figure 6

Some vehicles will have the selector lever as well as steering wheel mounted paddles as seen in Figure 6.

STEERING WHEEL MOUNTED PADDLES

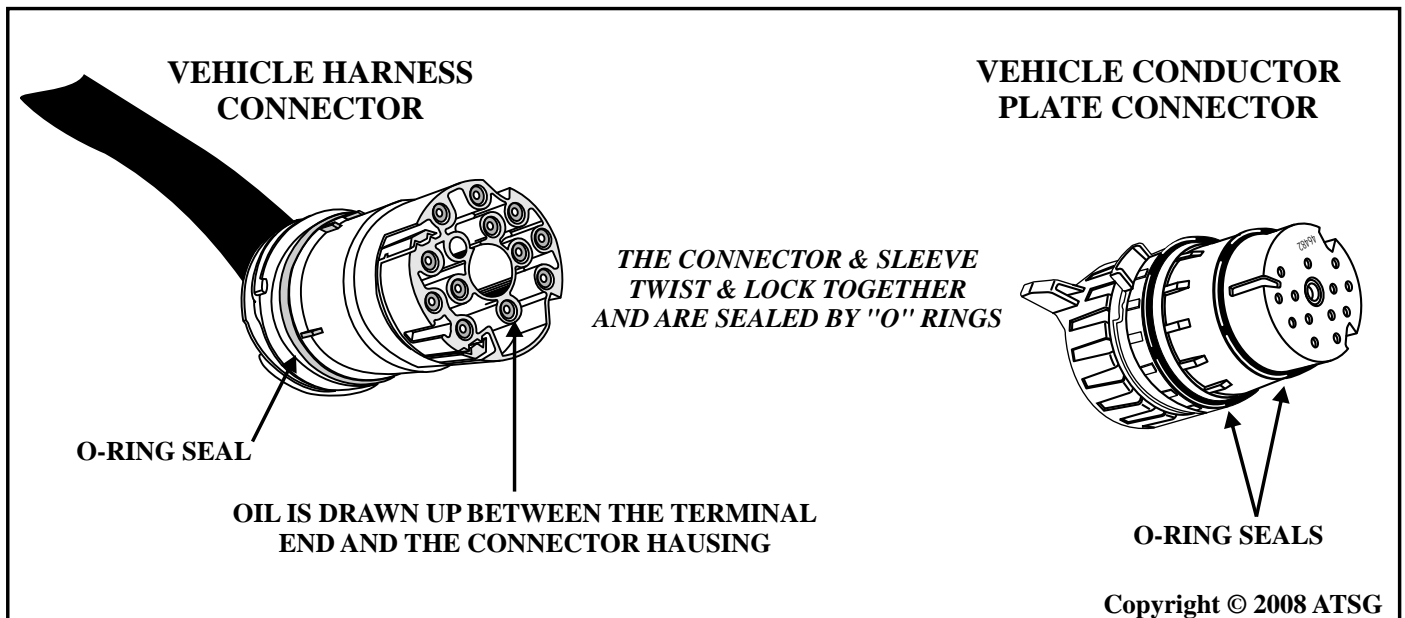
Figure 3

COMPLAINT: The vehicle may experience intermittent speed sensor or solenoid codes with reoccurring limp mode. When the technician locates the TCM, (Refer to Figure 1), to do some electrical checks, the TCM is found to be full of transmission fluid.

TCM FLUID CONTAMINATION

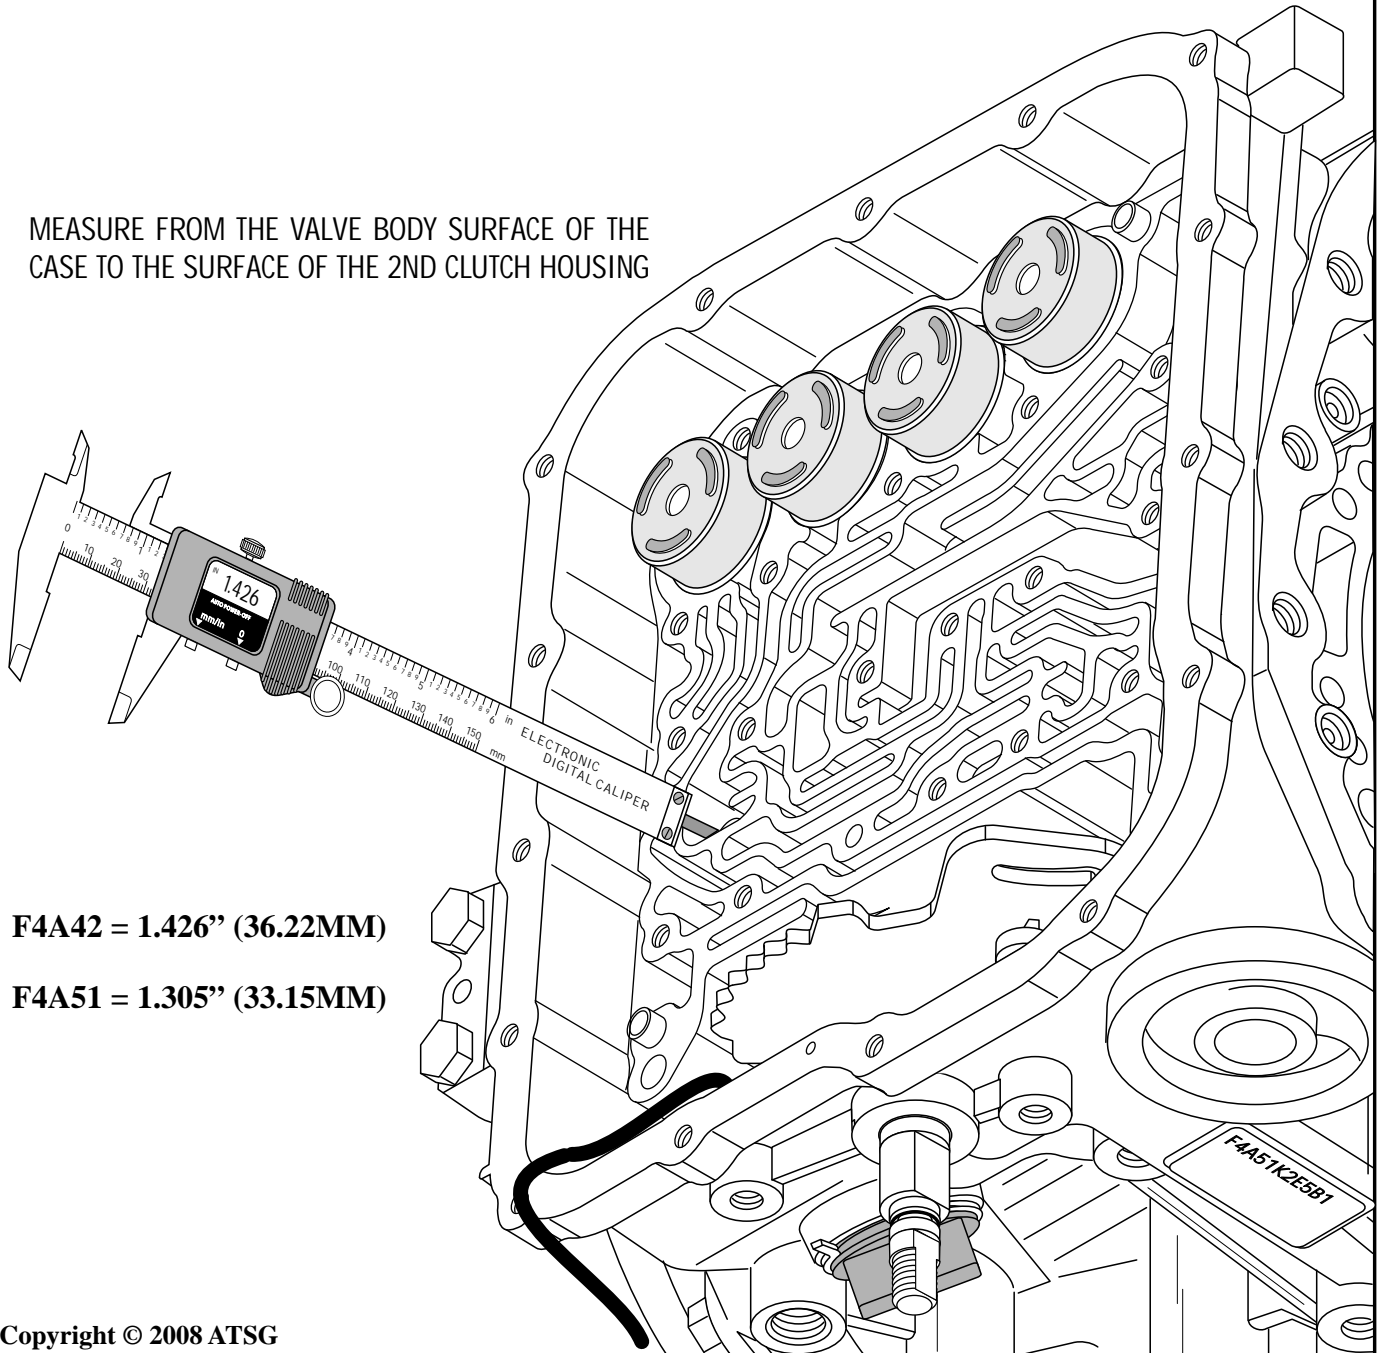
Figure 3

MEASUREMENT FOR CORRECT 2ND CLUTCH HOUSING SEAL USAGE

MEASURE FROM THE VALVE BODY SURFACE OF THE
CASE TO THE SURFACE OF THE 2ND CLUTCH HOUSING

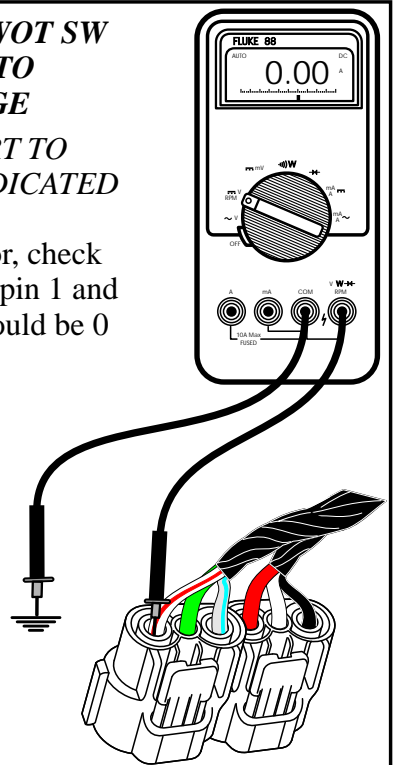
Figure 5

This step checks for a short to power on the WOT Switch wire. Disconnect the connector from the WOT/IDLE Switch. Leave the red lead of your meter connected to Pin 1 of the connector. Leave the black lead of your meter on the battery negative terminal. You should see a reading of 0 volts. Any voltage on this wire would be an indication that the wire is shorted to a power. If the wire is shorted to a power, either locate the short in the harness, or cut the wire at the computer and the WOT/IDLE switch and run a new wire. For reference, refer to Figure 5.

NO SHORT TO VOLTAGE INDICATED

Unplug connector, check voltage between pin 1 and ground, there should be 0 volts DC.

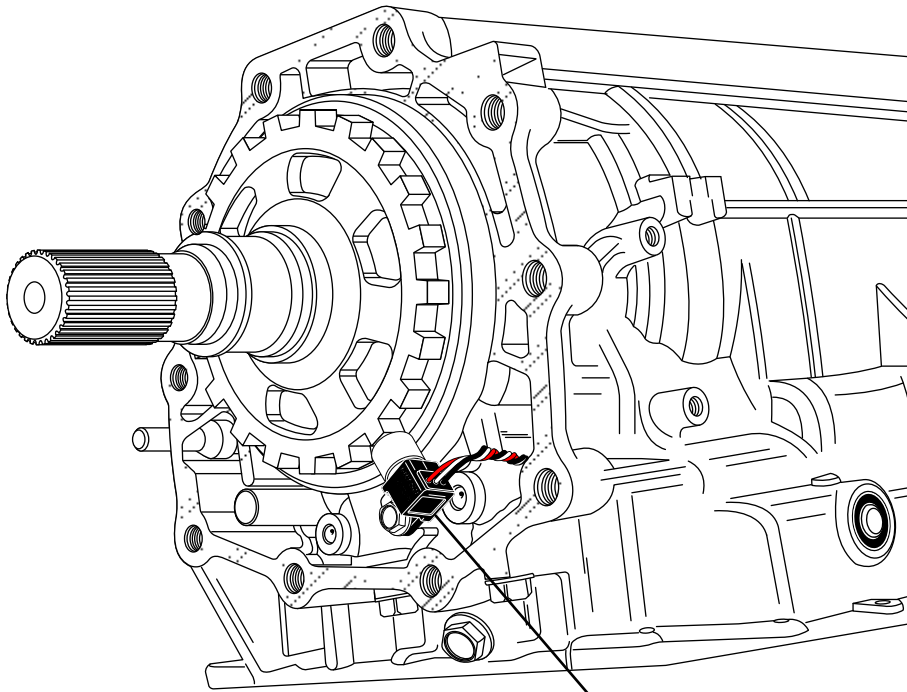
CAUSE: One cause may be a faulty Vehicle Speed Sensor A/T (*Revolution/Output Sensor*). The Revolution/Output Sensor is a Hall Effect Sensor type located in the rear housing of the transmission and obtains its reading off the park gear. The Revolution/Output Sensor is used by the Transmission Control Module (TCM) to assist in determining shift scheduling.

DTC P0720 is set when the TCM doesn't receive a proper voltage signal from the sensor while driving. This code can also be set when the ignition switch is turned "ON", and an improper signal is received from the Vehicle Speed Sensor MTR before the vehicle begins moving.

CORRECTION: Check and/or replace the Revolution/Output Sensor as necessary.

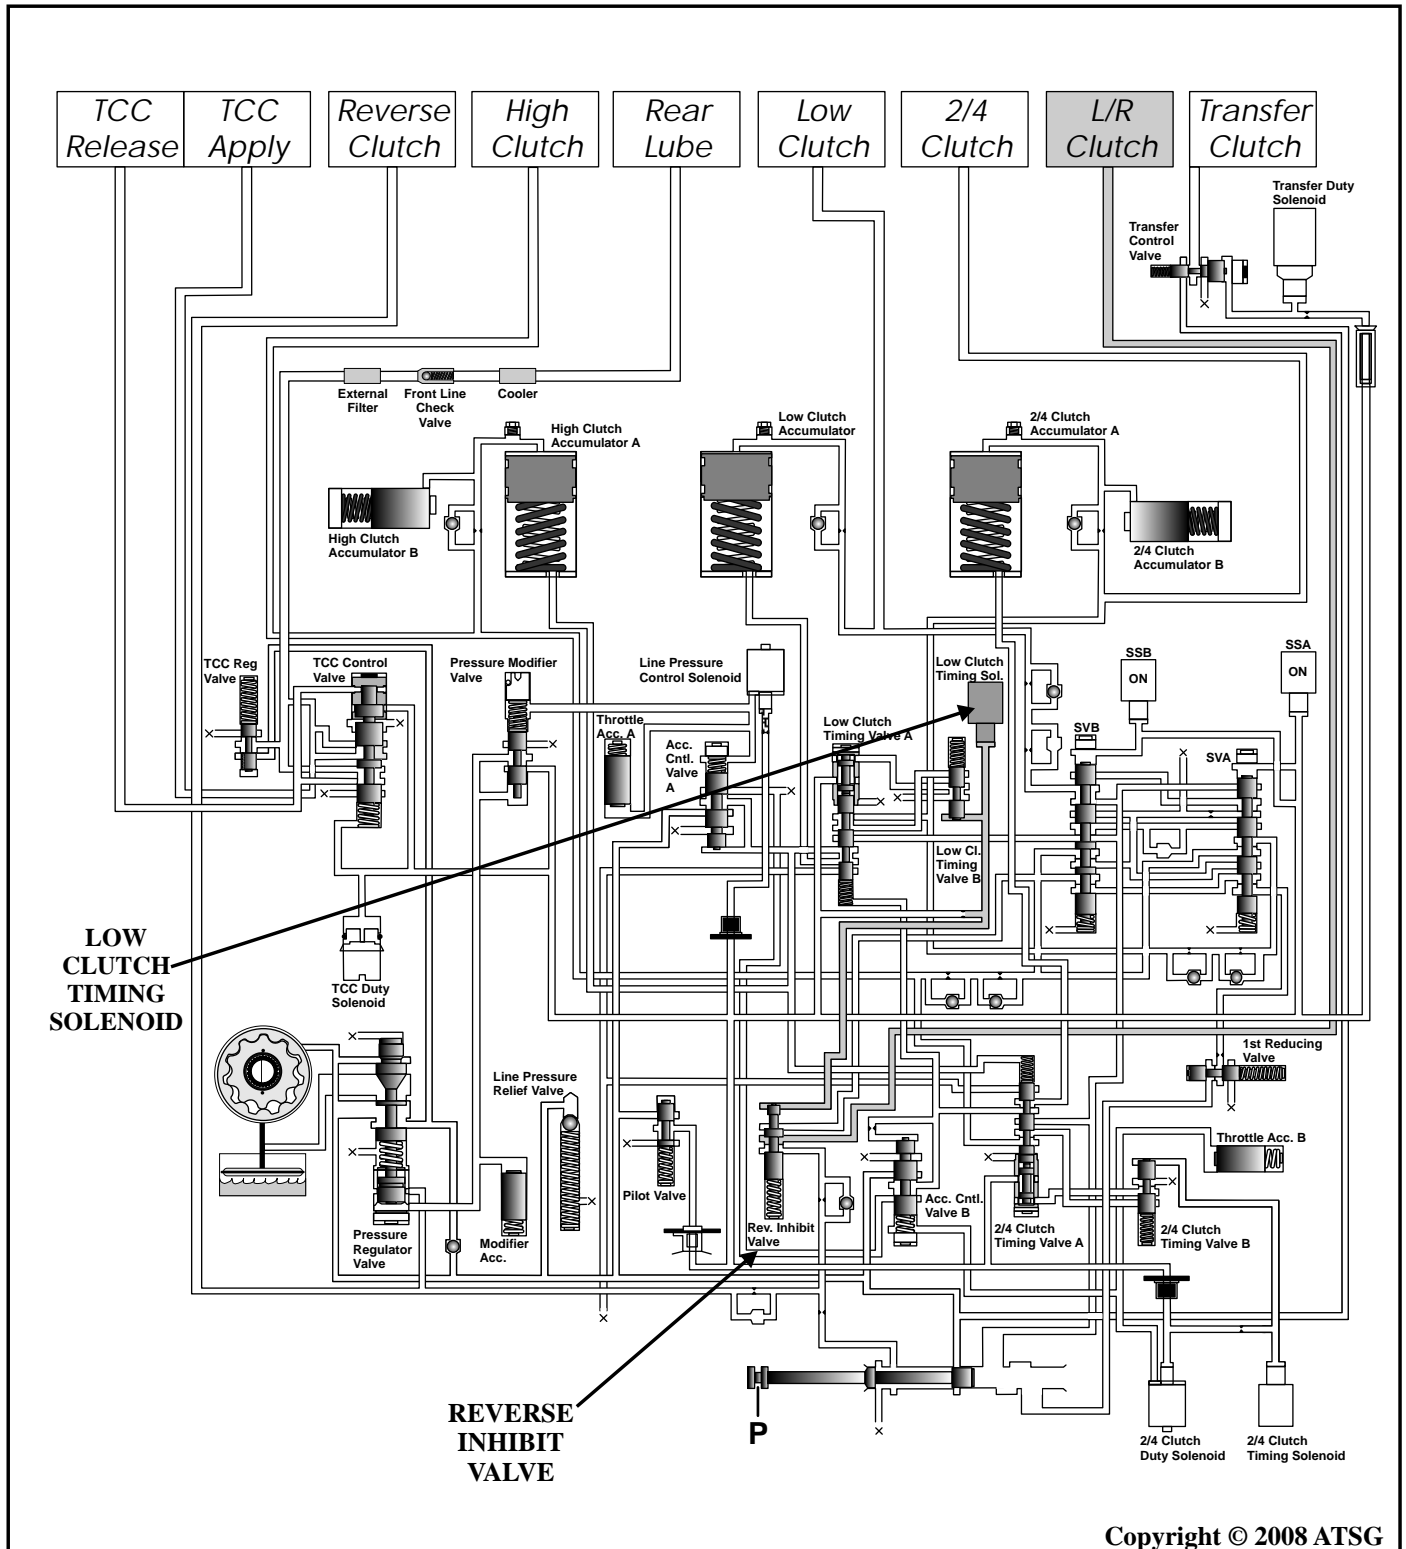
Figure 2

The no reverse condition is a result of the Low Clutch Timing Solenoid running all the time due to the Pressure control Solenoid connector that is plugged into it. This causes oil to stroke the Reverse Inhibit Valve as seen in the hydraulic schematic in Figure 2.

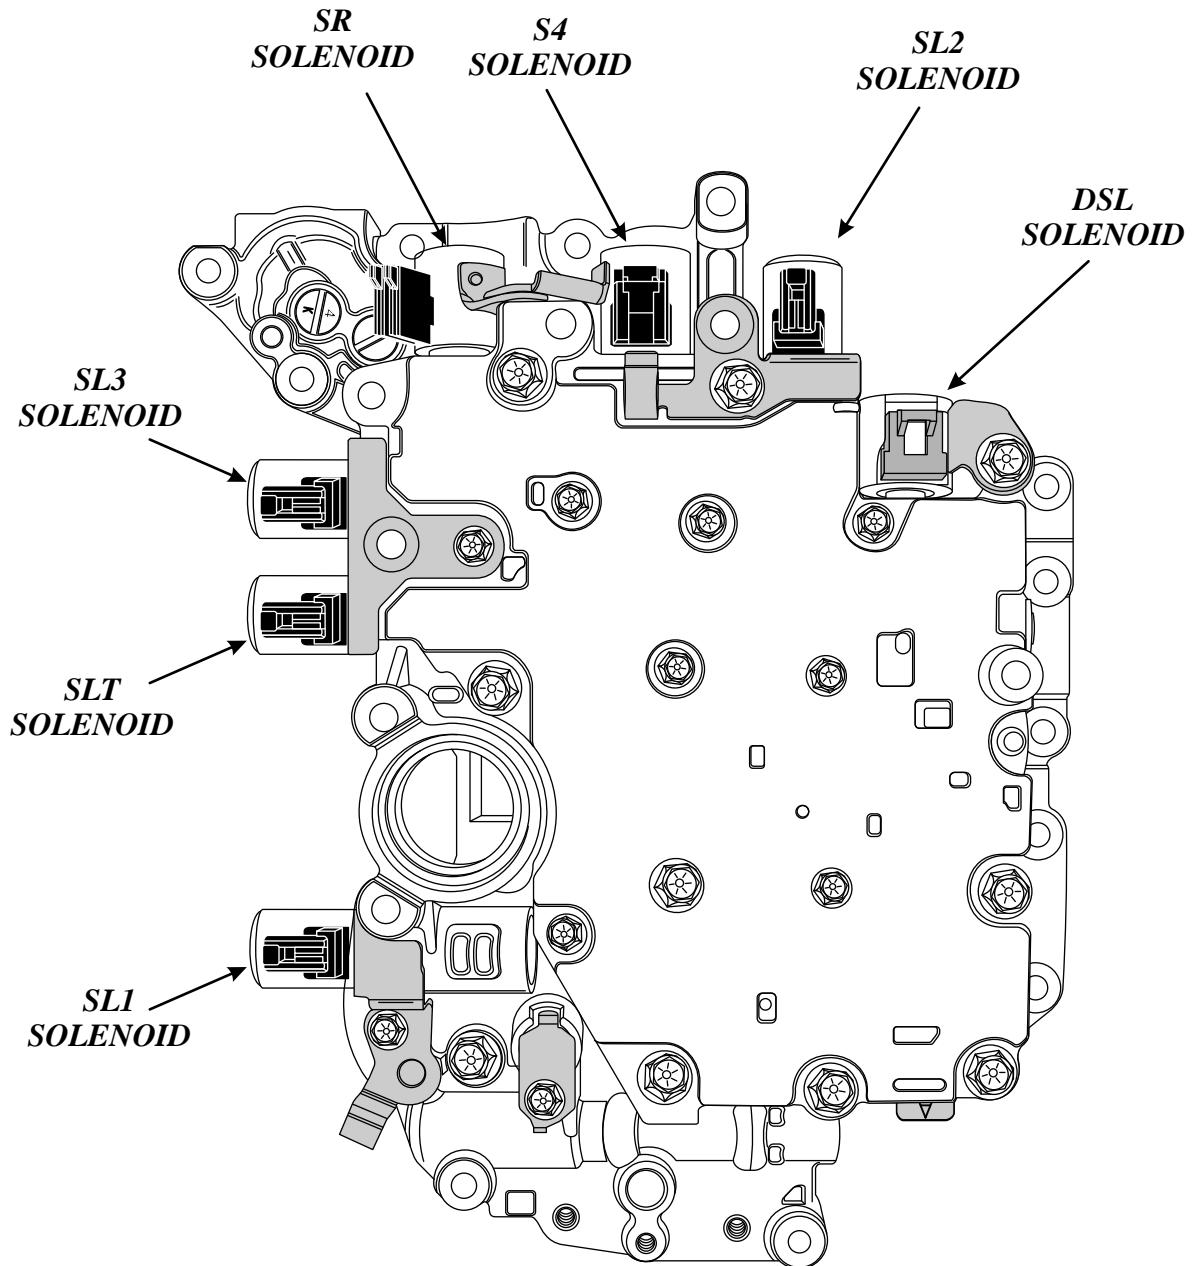
Figure 1

CAUSE: The cause may be, a faulty Pressure Control Solenoid which is referred to as the SLT (Figure 1), or a worn out Solenoid Modulating Valve Bore in the upper valvebody (Figure 2). Reason: The SLT solenoid controls line pressure, if it is faulty slipping shifts will occur. The Solenoid Modulating Valve Controls solenoid feed to all of the solenoids except the SR and S4 solenoids, which are fed line pressure thru a .046" orifice. Low solenoid feed will cause low feed to the linear solenoids which are controlling shift overlap, which means premature trans failure.

CORRECTION: To correct this condition, attach a line pressure gage on the Line pressure port located on the front of the case where the accumulator outline is. Line pressure is approximately 60 psi. in Drive and 150 at stall. Evaluate line rise as the vehicle is driven, an erratic or bouncy needle can indicate SLT failure, replace as necessary. If Pressure is good, disassemble the Upper Valvebody as shown in Figure 2 and check the solenoid modulating valve bore for wear. Note: at the time of this printing there are no repairs for this valve, a good used or new valvebody will have to be purchased.

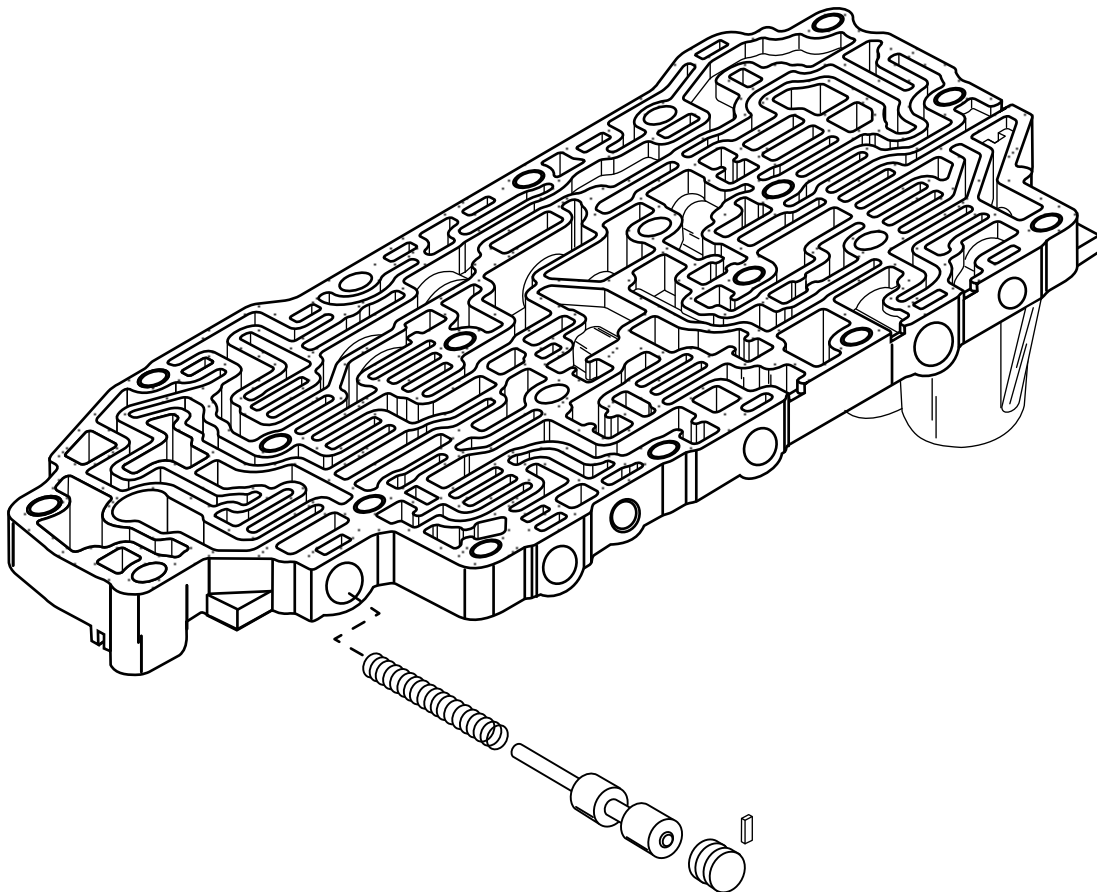
UPPER VALVE BODY

Note: Bore wear in the Solenoid Modulating Valve may cause low Solenoid Feed Pressure causing poor shift quality and premature Transmission Failure.

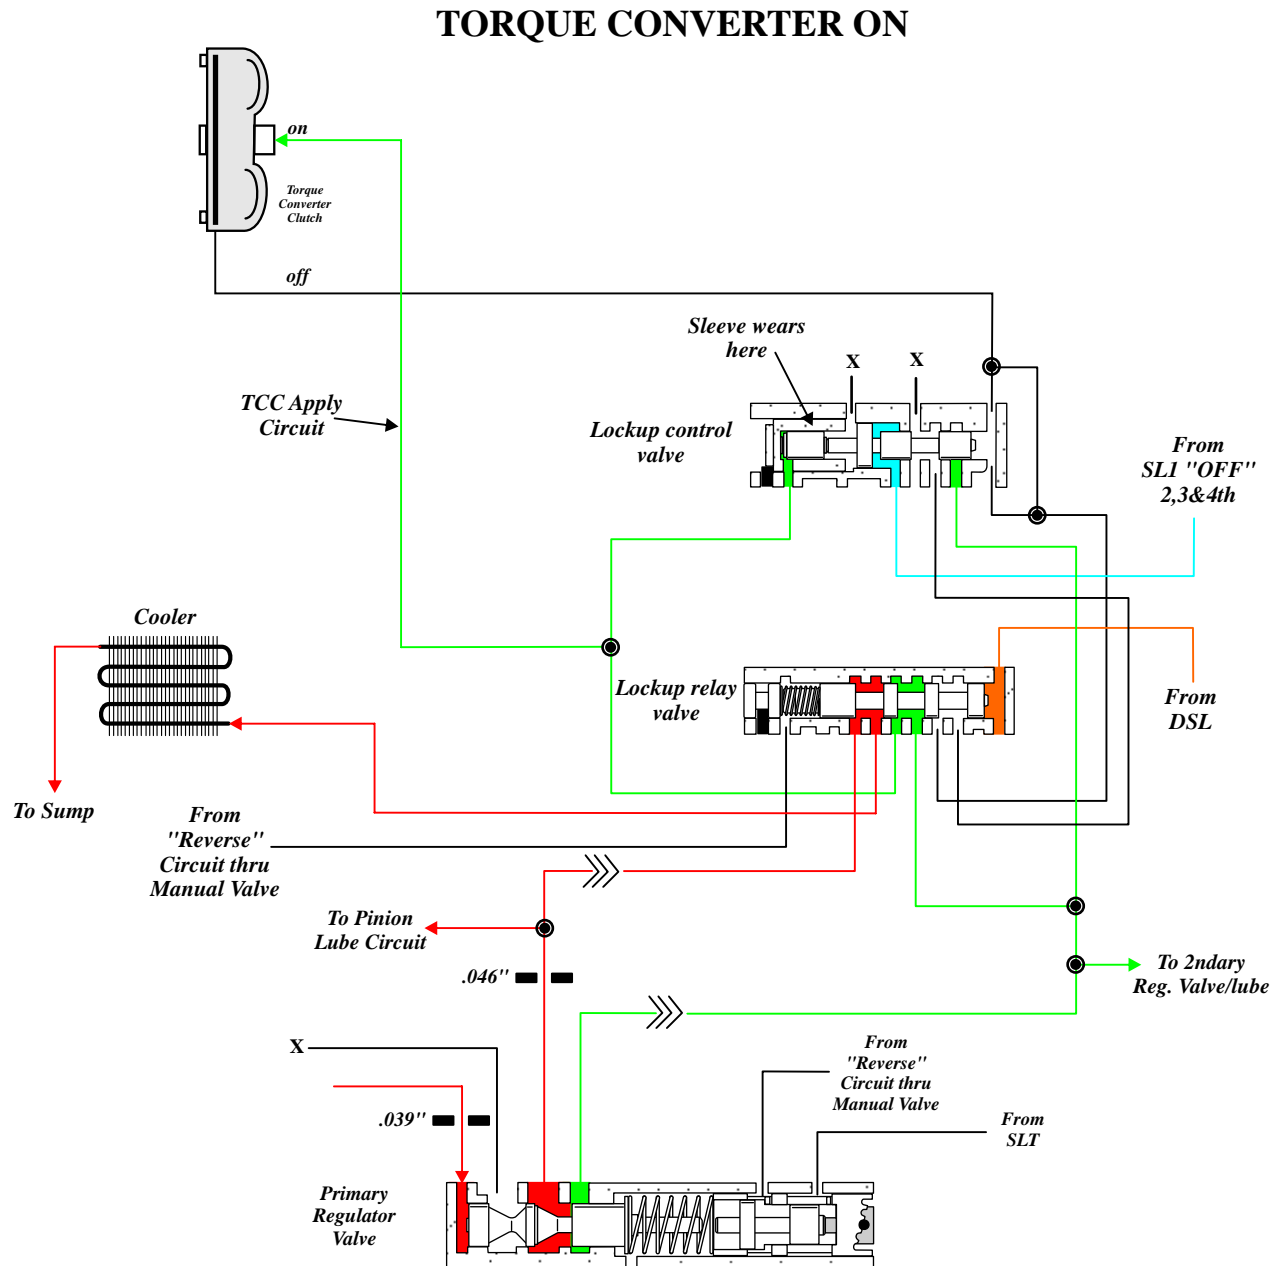
Figure 4

Summary: When the Torque Converter is ON, the Lockup relay valve is stroked to the left and orificed line pressure is fed to the cooler circuit. Note: when the Lockup control valve sleeve wears, the TCC Apply circuit can leak past the valve and sleeve, to an exhaust, and cause a pressure loss in the TCC Apply Circuit.

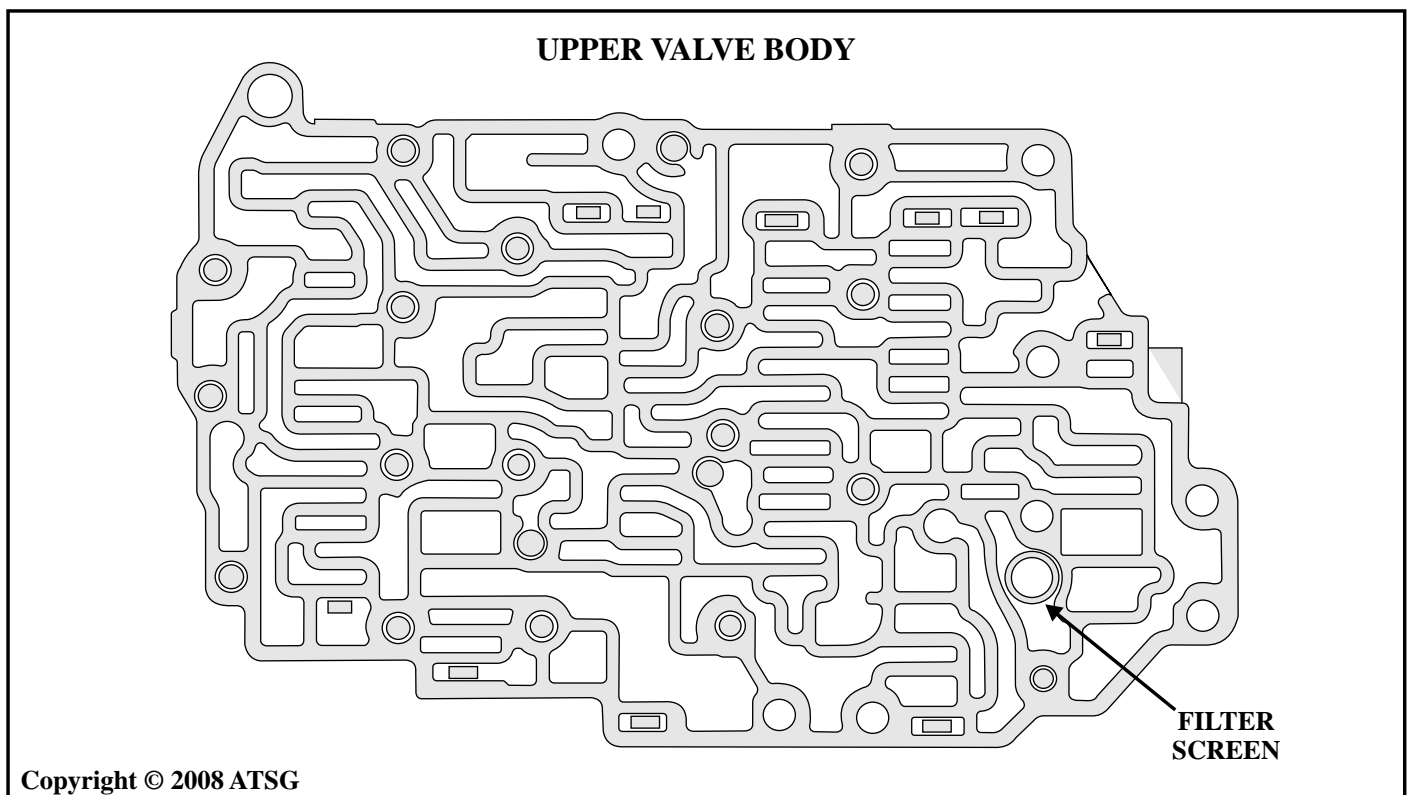
Figure 2

CAUSE: The next step was to check the valve body, at first nothing looked out of place. But when the oil passages were followed from the direct and reverse clutch circuit, they led to the filter screen in the upper valve body shown in Figure 2.

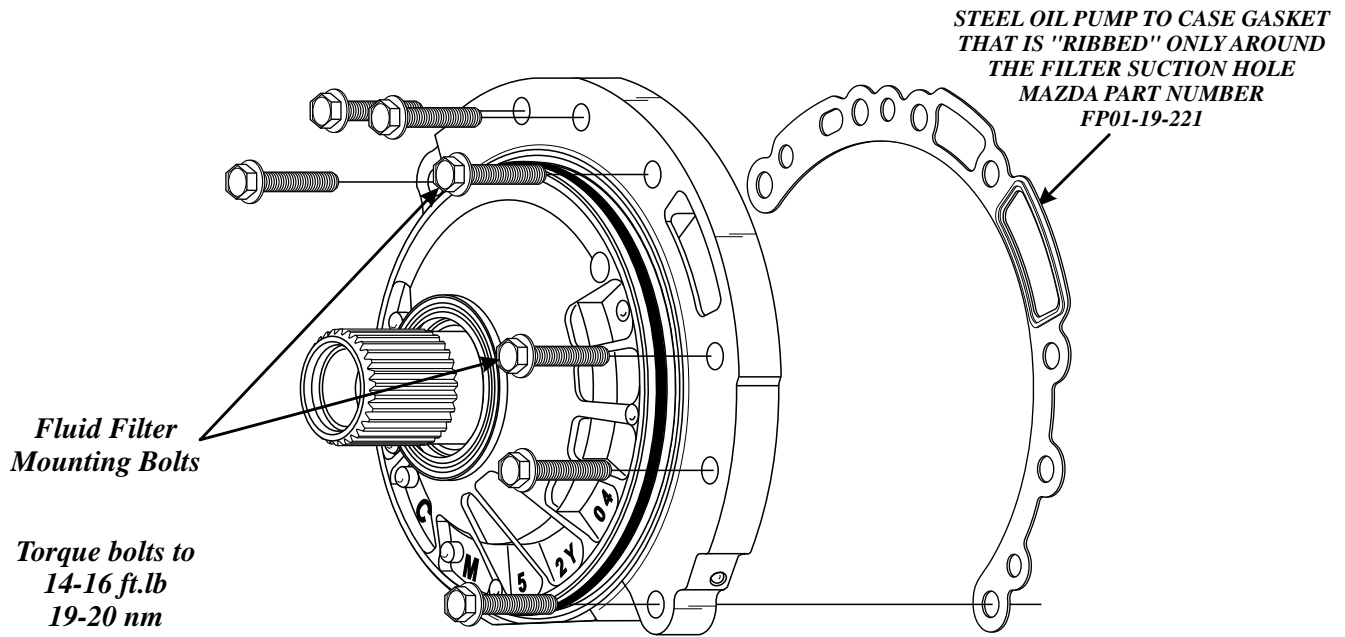
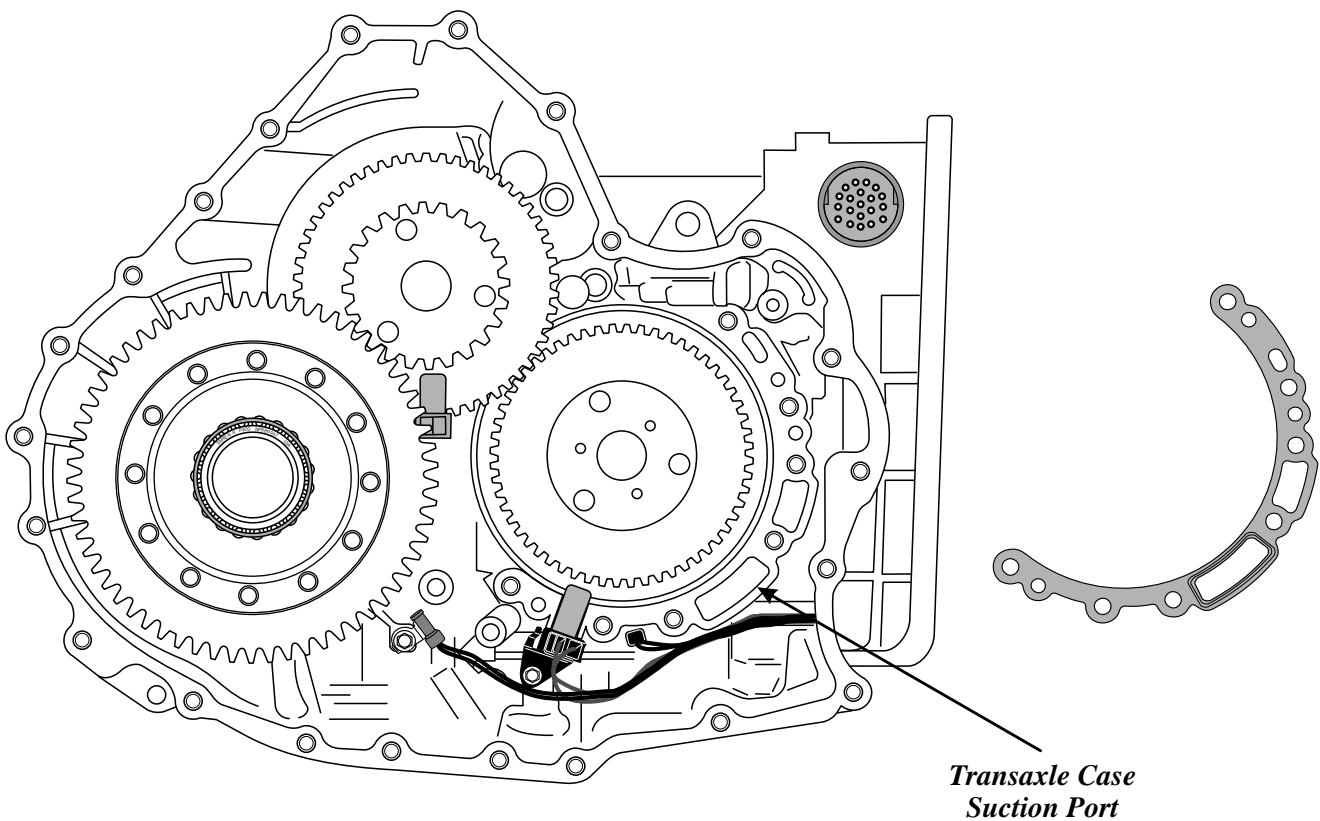
Figure 1

CAUSE: The cause may be, a less than desirable oil pump to case gasket. The oil pump to case gasket is a stamped steel gasket, with a dark rubber coating that at a close look is actually machined. This type of gasket would normally be "Ribbed" around all oil passage holes, however the gasket is "Ribbed" only around the pump suction port, as shown in Figure 1.

OIL PUMP GASKET CONCERNS

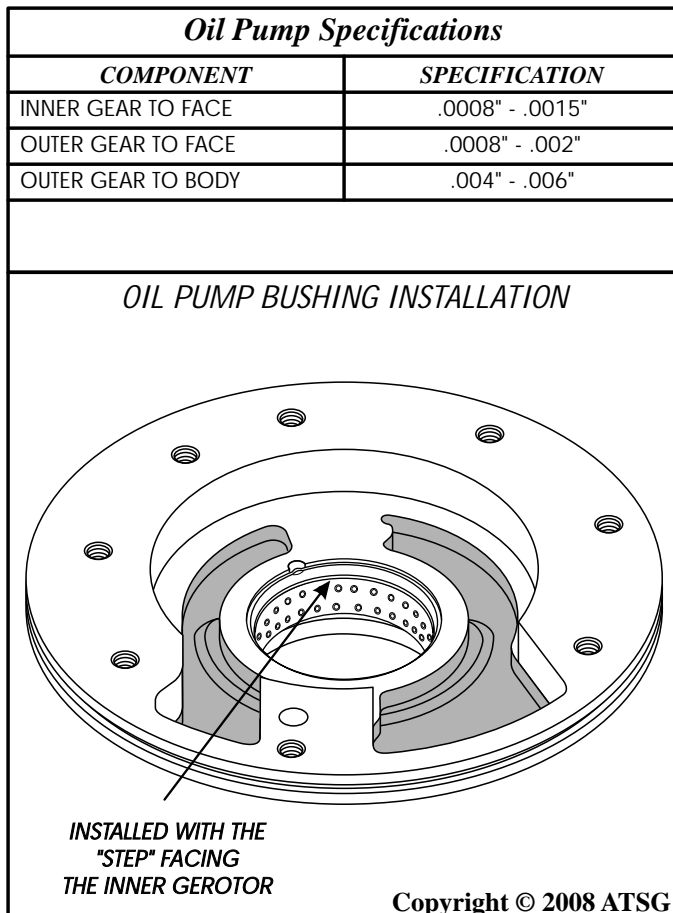
Figure 2

The Oil Pump Assembly has the Gerotor style pump gears, without a pump crescent, as shown in Figure 3. The converter hub bushing in the oil pump also has a step in it, that gets installed facing the pump gears, as shown in Figure 2. Oil Pump specifications are also shown in Figure 2.

Torque cover to body bolts to 62-70 in.lb (7-8 nm)

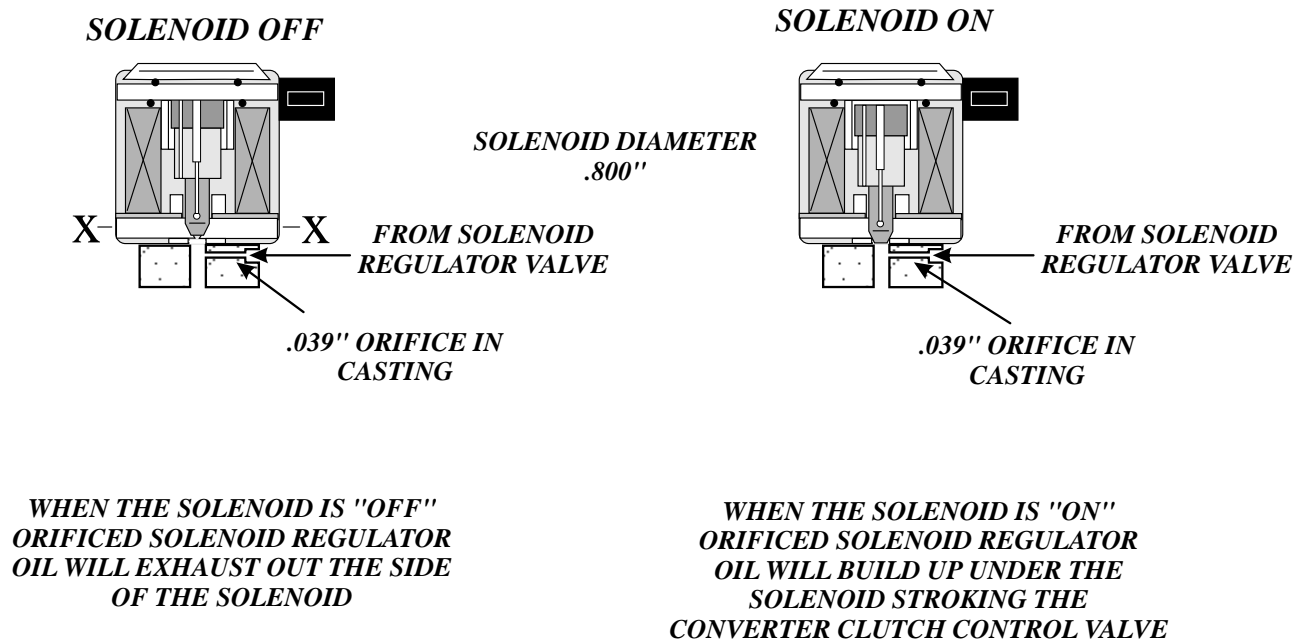
CAUSE: One cause may be, a mechanically stuck closed EV4 solenoid. This solenoid is Normally Open and must drain the regulated solenoid pressure thru the exhaust port located on the side of the solenoid as shown in Figure 1. Another cause may be, the Converter Clutch Control Valve and Sleeve as well as the Converter Clutch Apply Valve, as shown in Figures 3 and 4, may also cause the same complaint, because of bore wear in the valvebody casting, or the valve and sleeve below EV4 may be worn out. . Refer to Figure 2 for a partial hydraulic schematic of EV4 and how when it is partially stuck closed it will stroke the TCC Control Valve and cause the Converter Clutch to be partially or fully applied.

EV4 (N91) SOLENOID CHECK AND OPERATION

CORRECTION: Replace EV4 solenoid, and check the TCC Control valve as well as the small valve and sleeve for wear, repair or replace as necessary. **Note: Valve bore repair and replacements are available from Sonnax.**

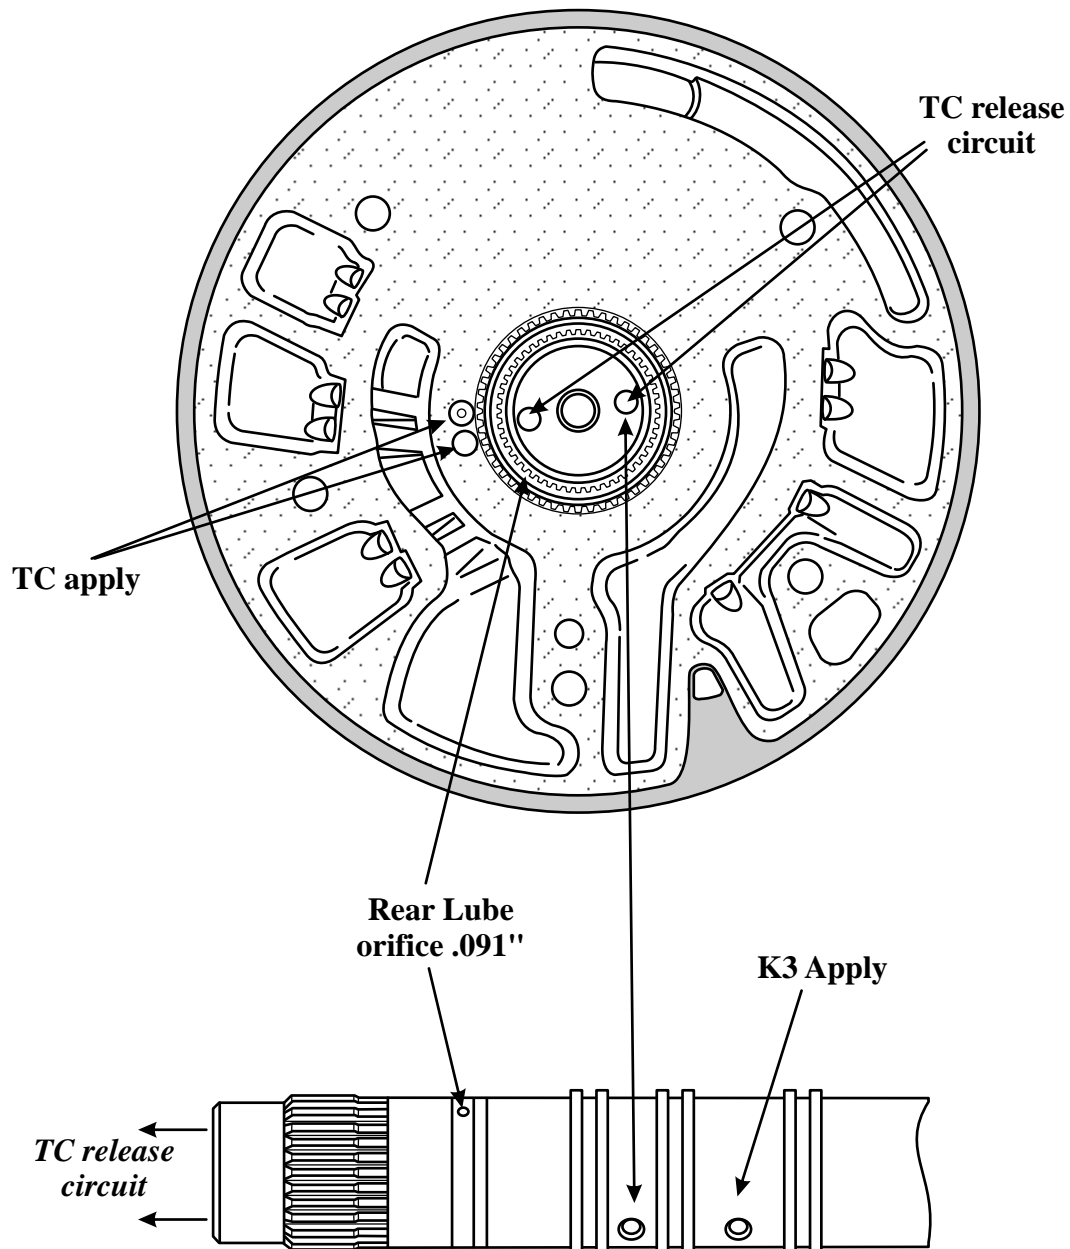
PUMP PASSAGE I.D.

CAUSE: The cause may be, during pump assembly, the inner pump gear was installed backwards causing a restriction in the TCC apply circuit, which may cause the Torque Converter Clutch apply to be delayed for a split second, producing the slip code. Refer to Figure 1 for the identification of the TCC release circuits and the TCC apply circuit. Refer to Figure 2 for a view of the inner pump gear installed on the stator and how TCC apply pressure is fed to the two open lugs that the Torque Converter drive lugs are not possessing. Refer to Figure 3 for a cross-sectional view of the stator and the inner pump gear showing it's correct installation.

The rear lube orifice is fed from the area in-between the Stator and the Turbine shaft.

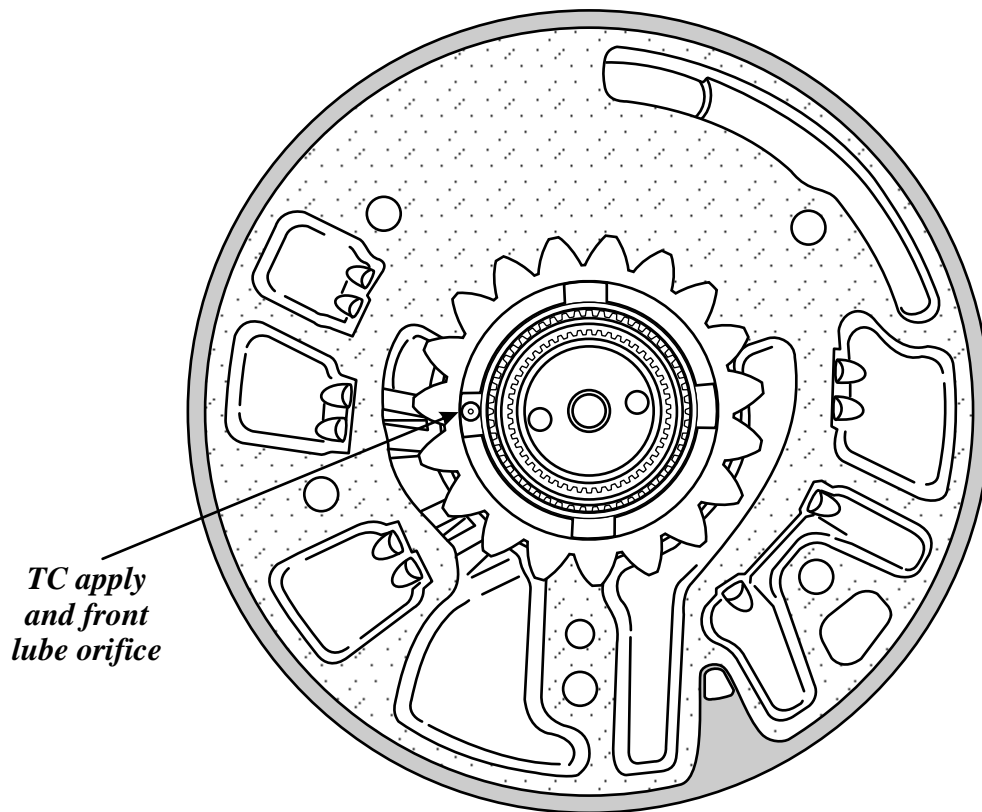
PUMP PASSAGE I.D.

The Torque Converter Apply Circuit is fed thru the two open holes in the pump gear that the drive lugs of the Torque Converter hub are not possessing.
