"2008" SEMINAR INFORMATION

AUTOMATIC TRANSMISSION SERVICE GROUP

"Shiftin' Great in 2008" ***Seminar Information***

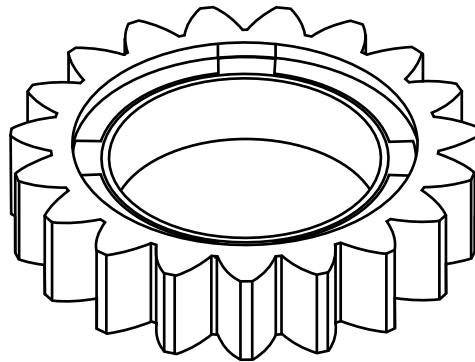
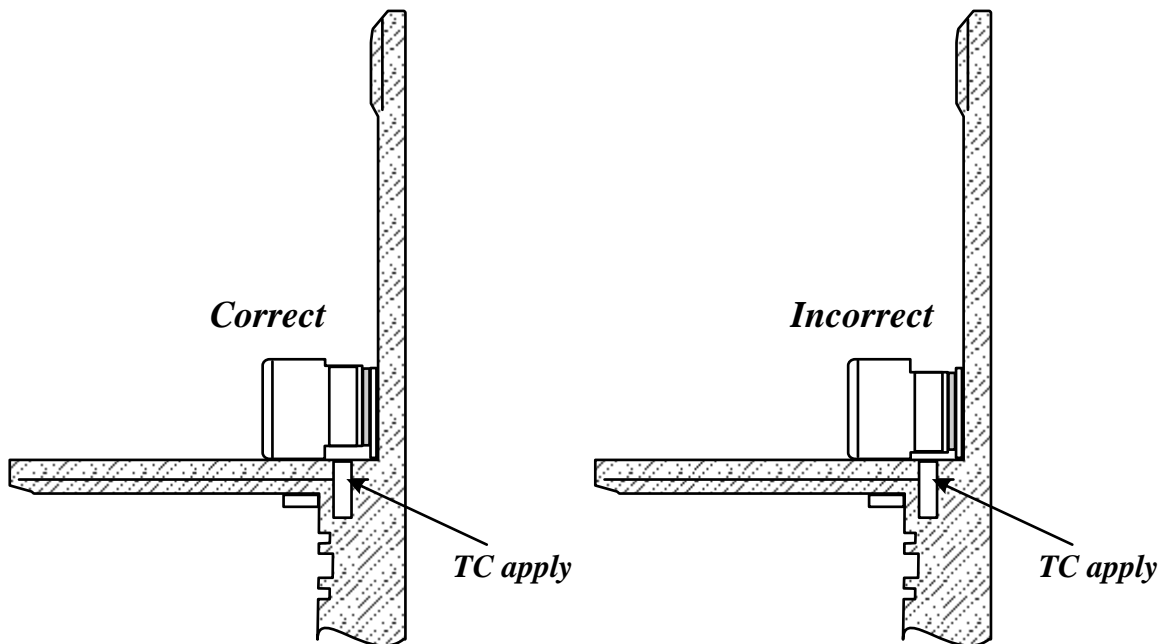
INNER PUMP GEAR

CAUSE: The cause may be, during pump assembly, the inner pump gear was installed backwards causing a restriction in the TCC apply circuit, which may cause the Torque Converter Clutch apply to be delayed for a split second, producing the slip code. Refer to Figure 1 for the identification of the TCC release circuits and the TCC apply circuit. Refer to Figure 2 for a view of the inner pump gear installed on the stator and how TCC apply pressure is fed to the two open lugs that the Torque Converter drive lugs are not possessing. Refer to Figure 3 for a cross-sectional view of the stator and the inner pump gear showing it's correct installation.

The Pump drive gear is cut deeper on the stator side to allow a larger volume of Apply Pressure to enter the Torque Converter.

CORRECTION: To correct this condition, refer to Figure 3 and install the inner pump gear with the deeper cut towards the pump stator.

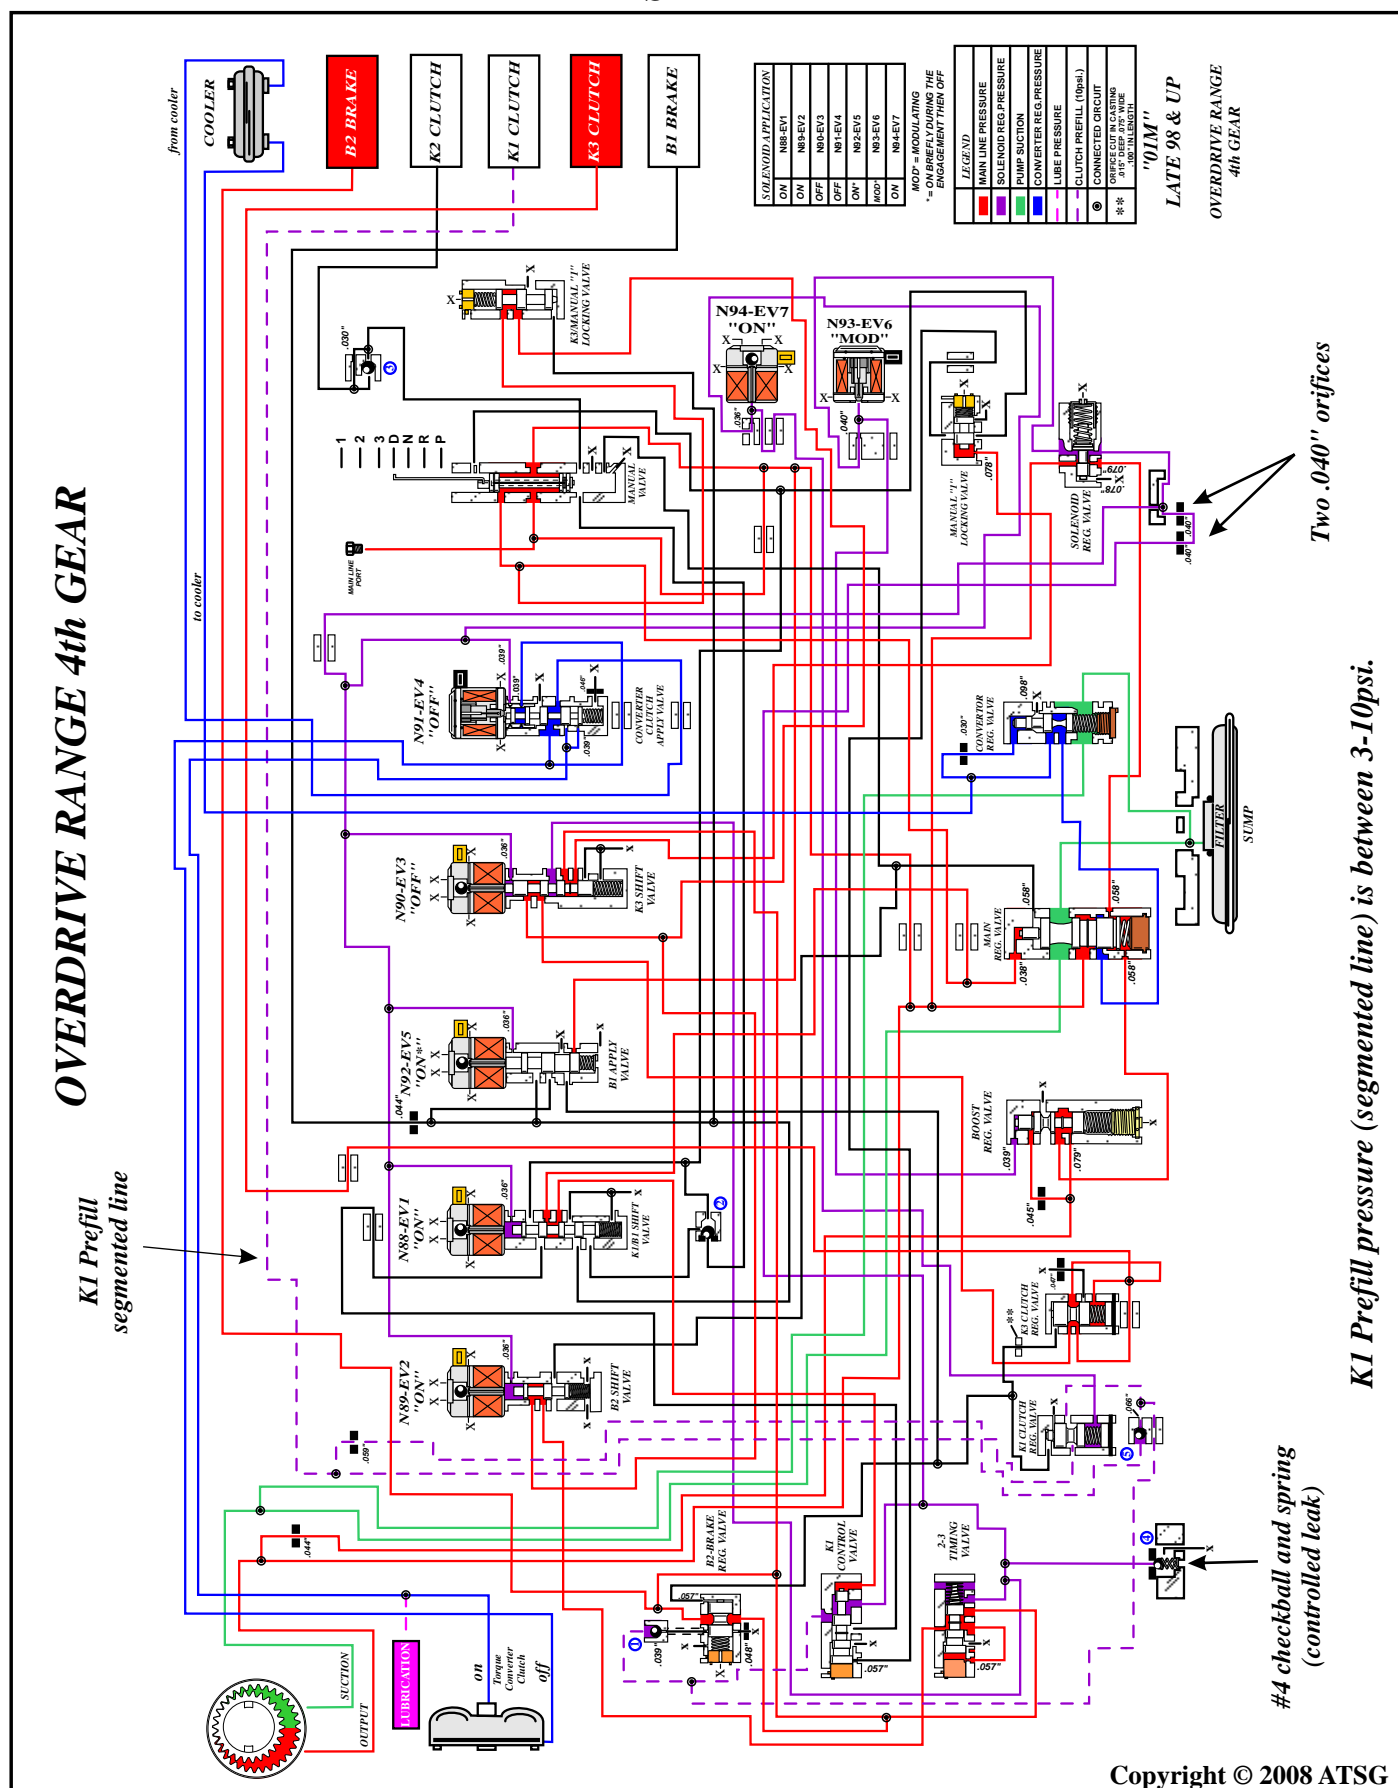
CAUSE: The cause may be, low solenoid feed pressure, a worn Solenoid Regulator Valve bore, or a missing spring for checkball number 4. This can cause a flair on the 3-4 upshift because of the lack of pre-fill on the K1 clutch. This pre-fill pressure ranges from 3-10 psi. and begins at the solenoid regulator valve, is fed thru two .040" orifices and is finally regulated by the number 4 checkball and spring. The lack of pre-fill can cause the K1 clutch to release too quick during the 3-4 upshift transition. See the partial circuit diagram shown in Figure 1.

SOLENOID REGULATOR VALVE

Check the bore of the Solenoid Regulator Valve for wear. Pressure bleeding past the valve lands will be exhausted at the plug shown above

CORRECTION: To correct this condition, ensure that the solenoid casings are sealed against the valve body casting, by using gaskets, as shown in Figure 3 and 4. Check the bore of the solenoid regulator valve and repair bore if necessary. See Figure 2 for a cross-sectional view and Figure 4 for the valve location. Verify that the spring under checkball number 4, as shown in Figure 6, is in the correct location.

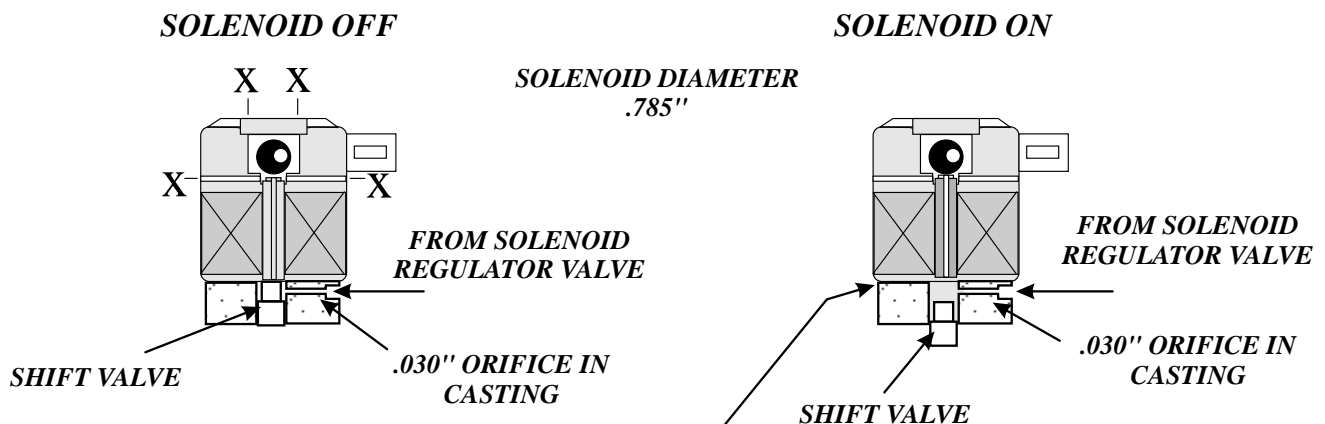
Figure 3

EV1 (N88), EV2 (N89), EV3 (N90), EV5 (N92) AND EV7 (N94) SOLENOID CHECK AND OPERATION

Use a gasket in-between the Solenoid casing and the Valvebody Casting

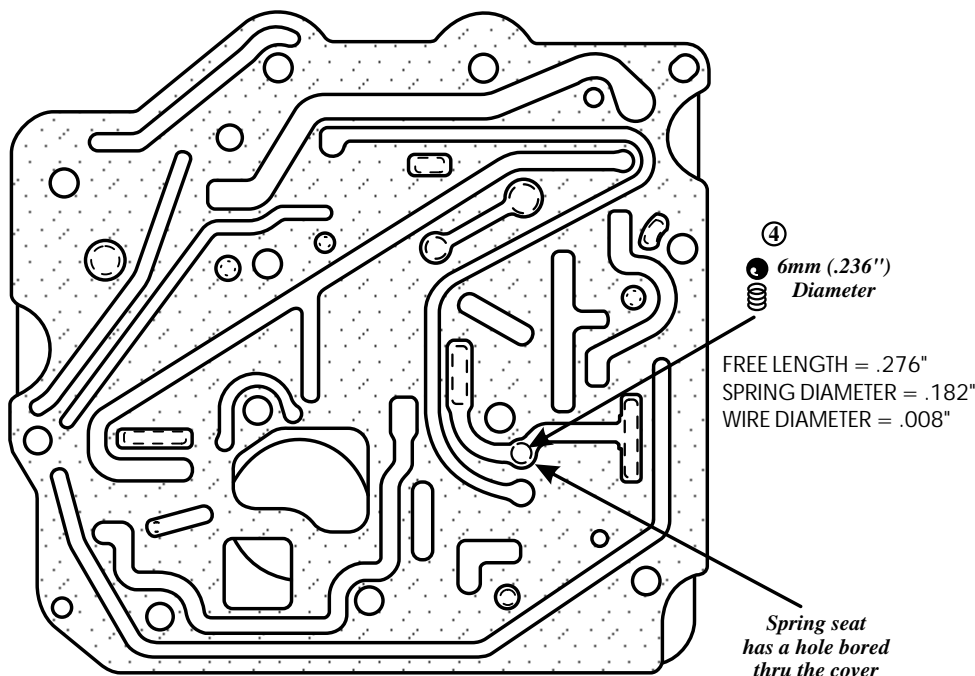
Figure 6
Automatic Transmission Service Group

CHANNEL PLATE CHECKBALL AND SPRING LOCATION

Solenoid gaskets are available in some aftermarket overhaul kits. Valve repair and a replacement spring, for the number 4 checkball are available from Sonnax.
