TRANSMISSION SEMINAR 1992

1992 SEMINAR INFORMATION

THM 4L80-E COMPONENT LOCATIONS AND CONNECTIONS

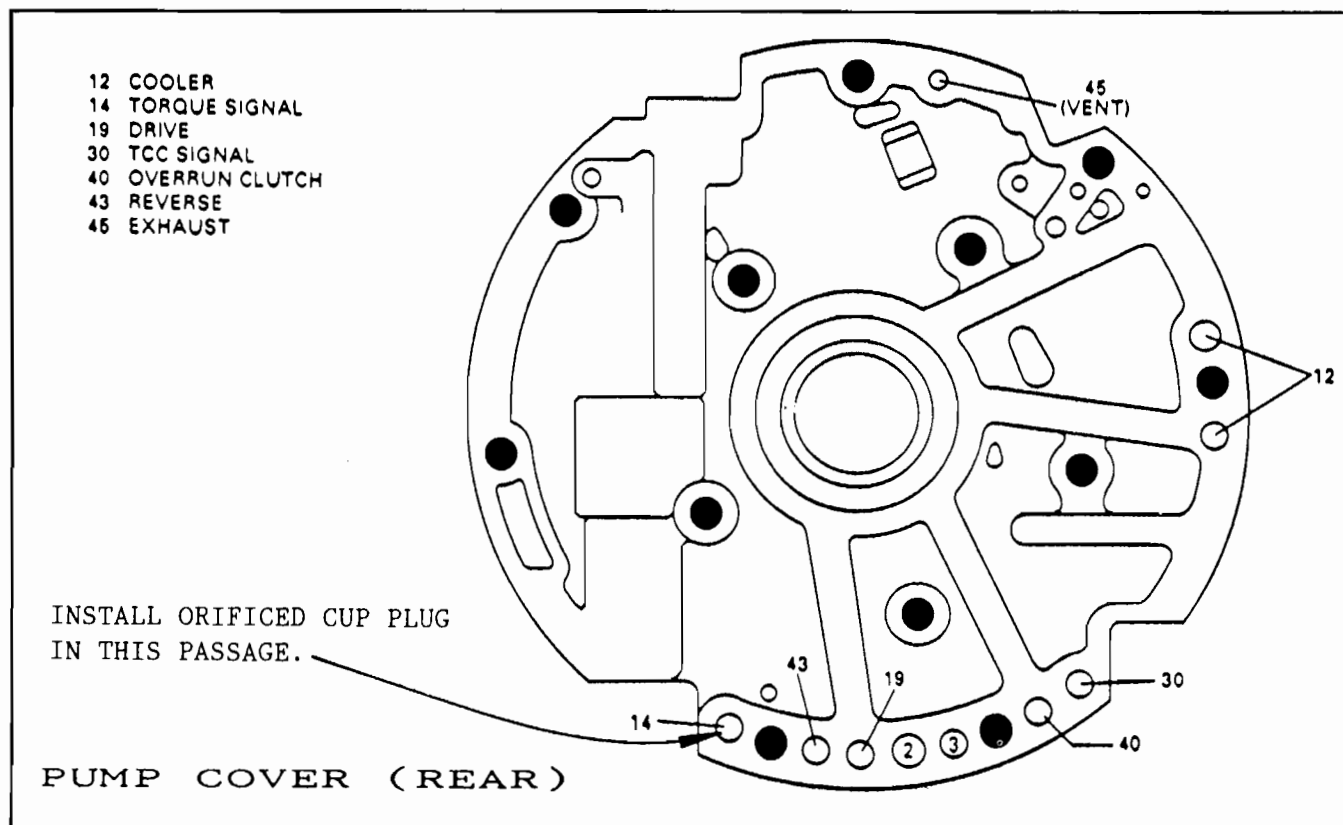
Figure 29

CAUSE: The cause may be, line pressure instability in the pressure regulator valve line-up located in the pump cover.

STEP 2. Install a 9/32" diameter cup plug, with a .075" orifice hole drilled in the center of the cup plug, into the torque signal passage of the pump cover (See Figure 29).

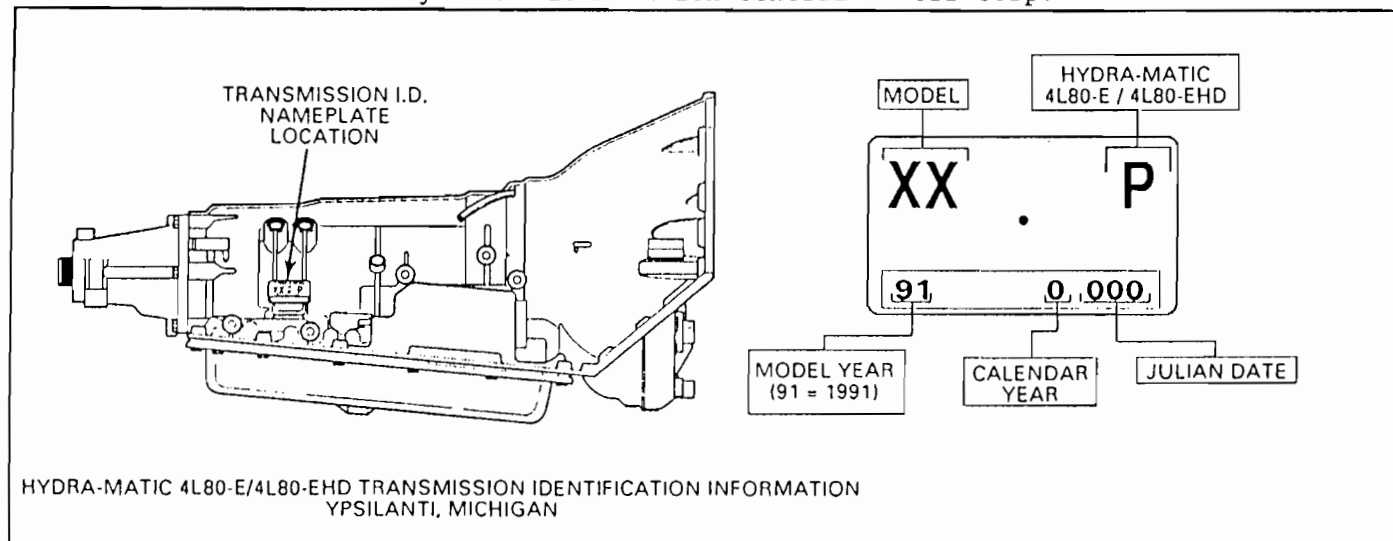
CAUSE: This condition may be caused by the Powertrain Control Module (PCM) on gasoline models, or the Transmission Control Module (TCM) on diesel engine models, selecting the output speed sensor located on transfer case instead of the output speed sensor from transmission.

Beginning on January 15, 1991 (Julian Date 015) all ACP, BJP, CKP, and DLP transmission model applications were built with the new PROM. Use Figure 1 for Julian Date location, to determine if your vehicle needs the new PROM installed.

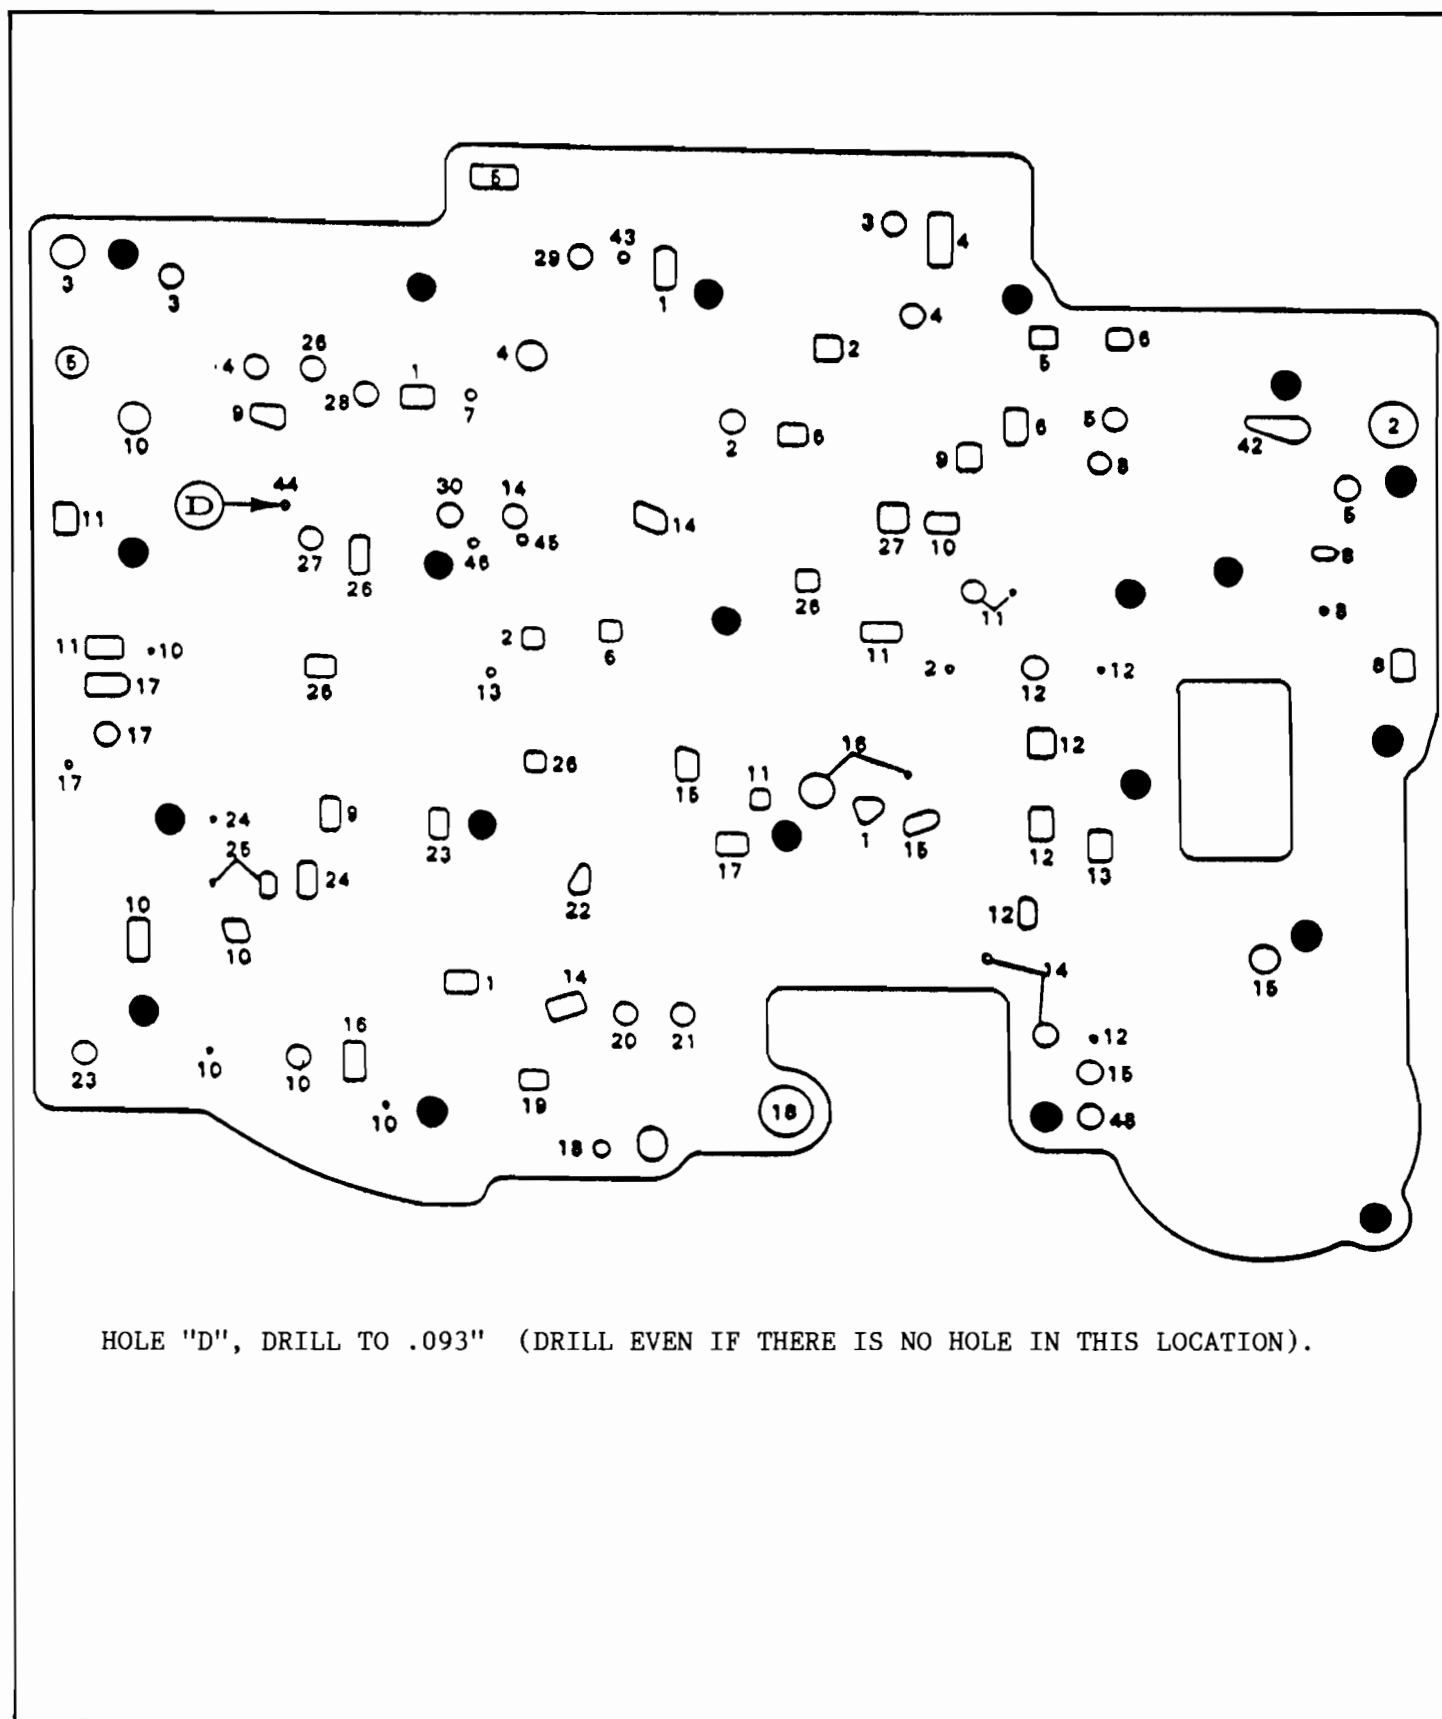
Figure 2

COMPLAINT: Premature 3-4 clutch failure on 1988 to 1992 model 700-R4 transmissions, and can occur as early as 200 miles on the unit.

CAUSE: The cause may be too much spring pressure for available 3-4 clutch oil pressure to overcome.

CORRECTION: Remove and discard the 3-4 Load Release Spring Assemblies, on ALL vehicles so equipped (See Figure 1).
Drill hole marked "D" in the spacer plate out to .093", as shown in Figure 2. This hole was eliminated on 1988 and later 5.7L models. If your spacer plate does not have this hole, use the gasket as a template and drill it to .093" (See Figure 2).
Set the 3-4 clutch clearance to .050"-.060".

This will help prevent the 3-4 clutches from burning. This hole was eliminated on the 1988 and later 5.7L models. If your spacer plate does not have this hole, use the gasket as a template and drill it to .093".

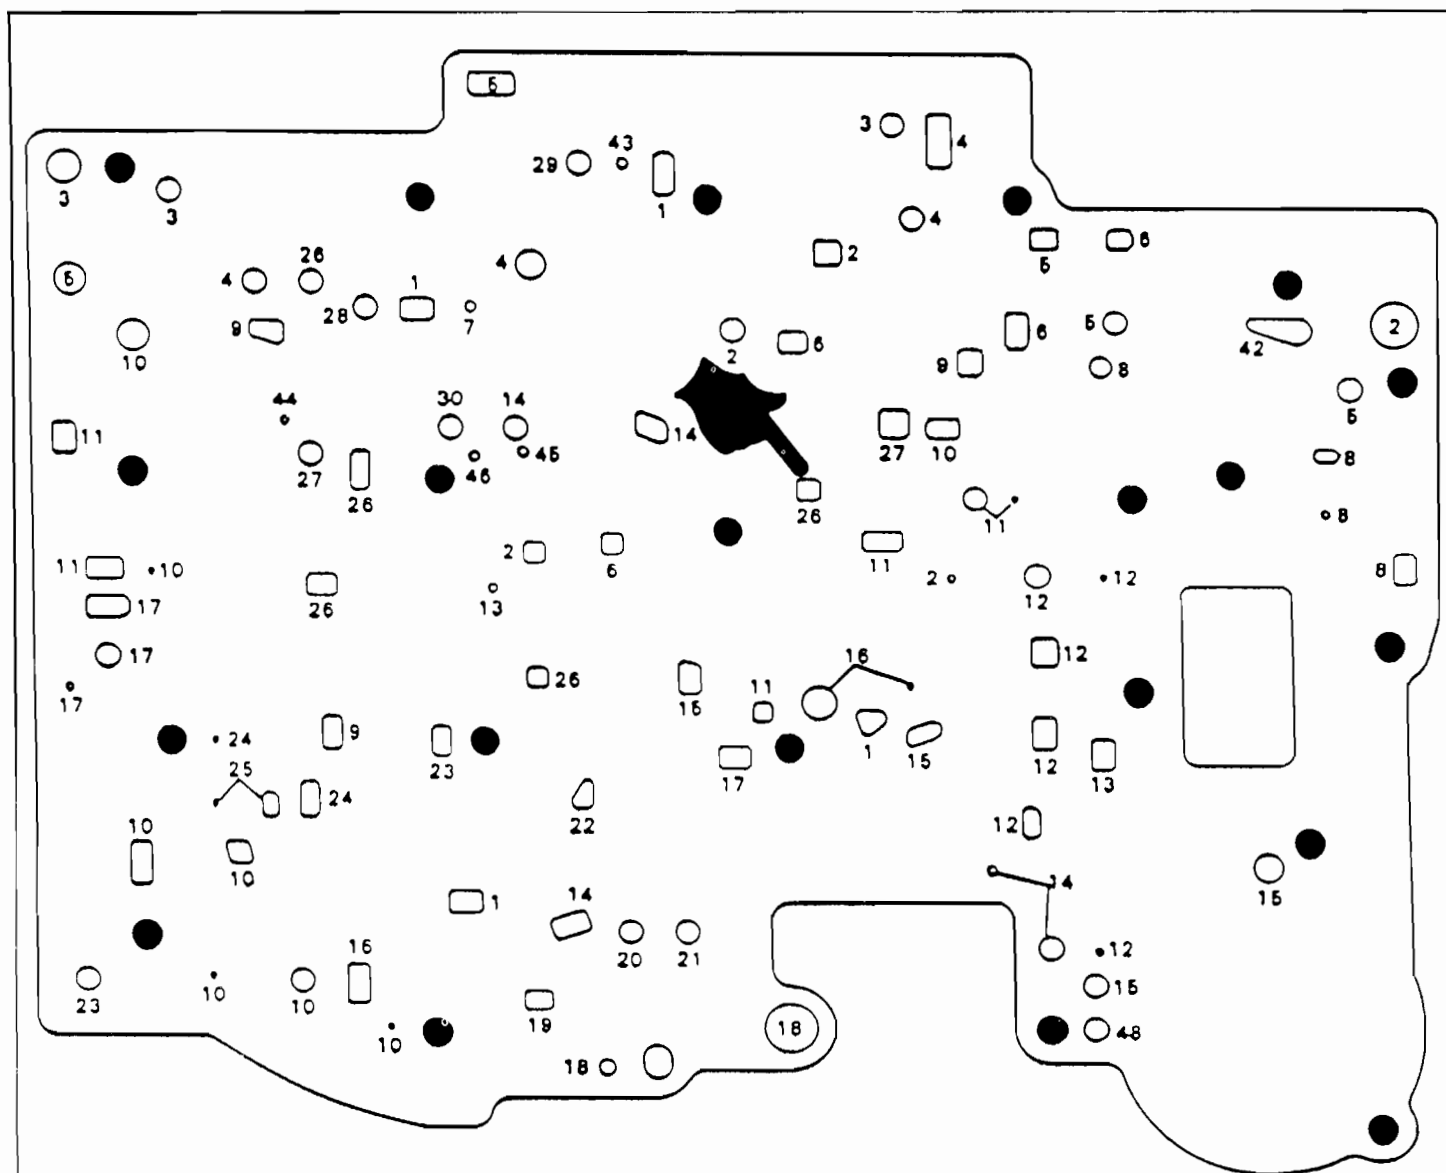
Figure 5

CAUSE: The cause may be a mis-matched line bias valve, and spacer plate. Beginning in 1987, a 2nd design line bias valve was introduced that has a "Flat" on the small land (See Figure 4). This change required that the detent hole in the spacer plate be eliminated (See Figure 5). If the 2nd design line bias valve (With Flat) is installed with the 1st design spacer plate (With Detent Hole), all T.V. oil will be exhausted at 3/4 to full throttle positions.

CORRECTION: Install matching line bias valve and spacer plate.
Line bias valve WITHOUT flat, requires spacer plate WITH detent hole. (Refer to Figures 4 and 5).
Line bias valve WITH flat, requires spacer plate WITHOUT detent hole. (Refer to Figures 4 and 5).

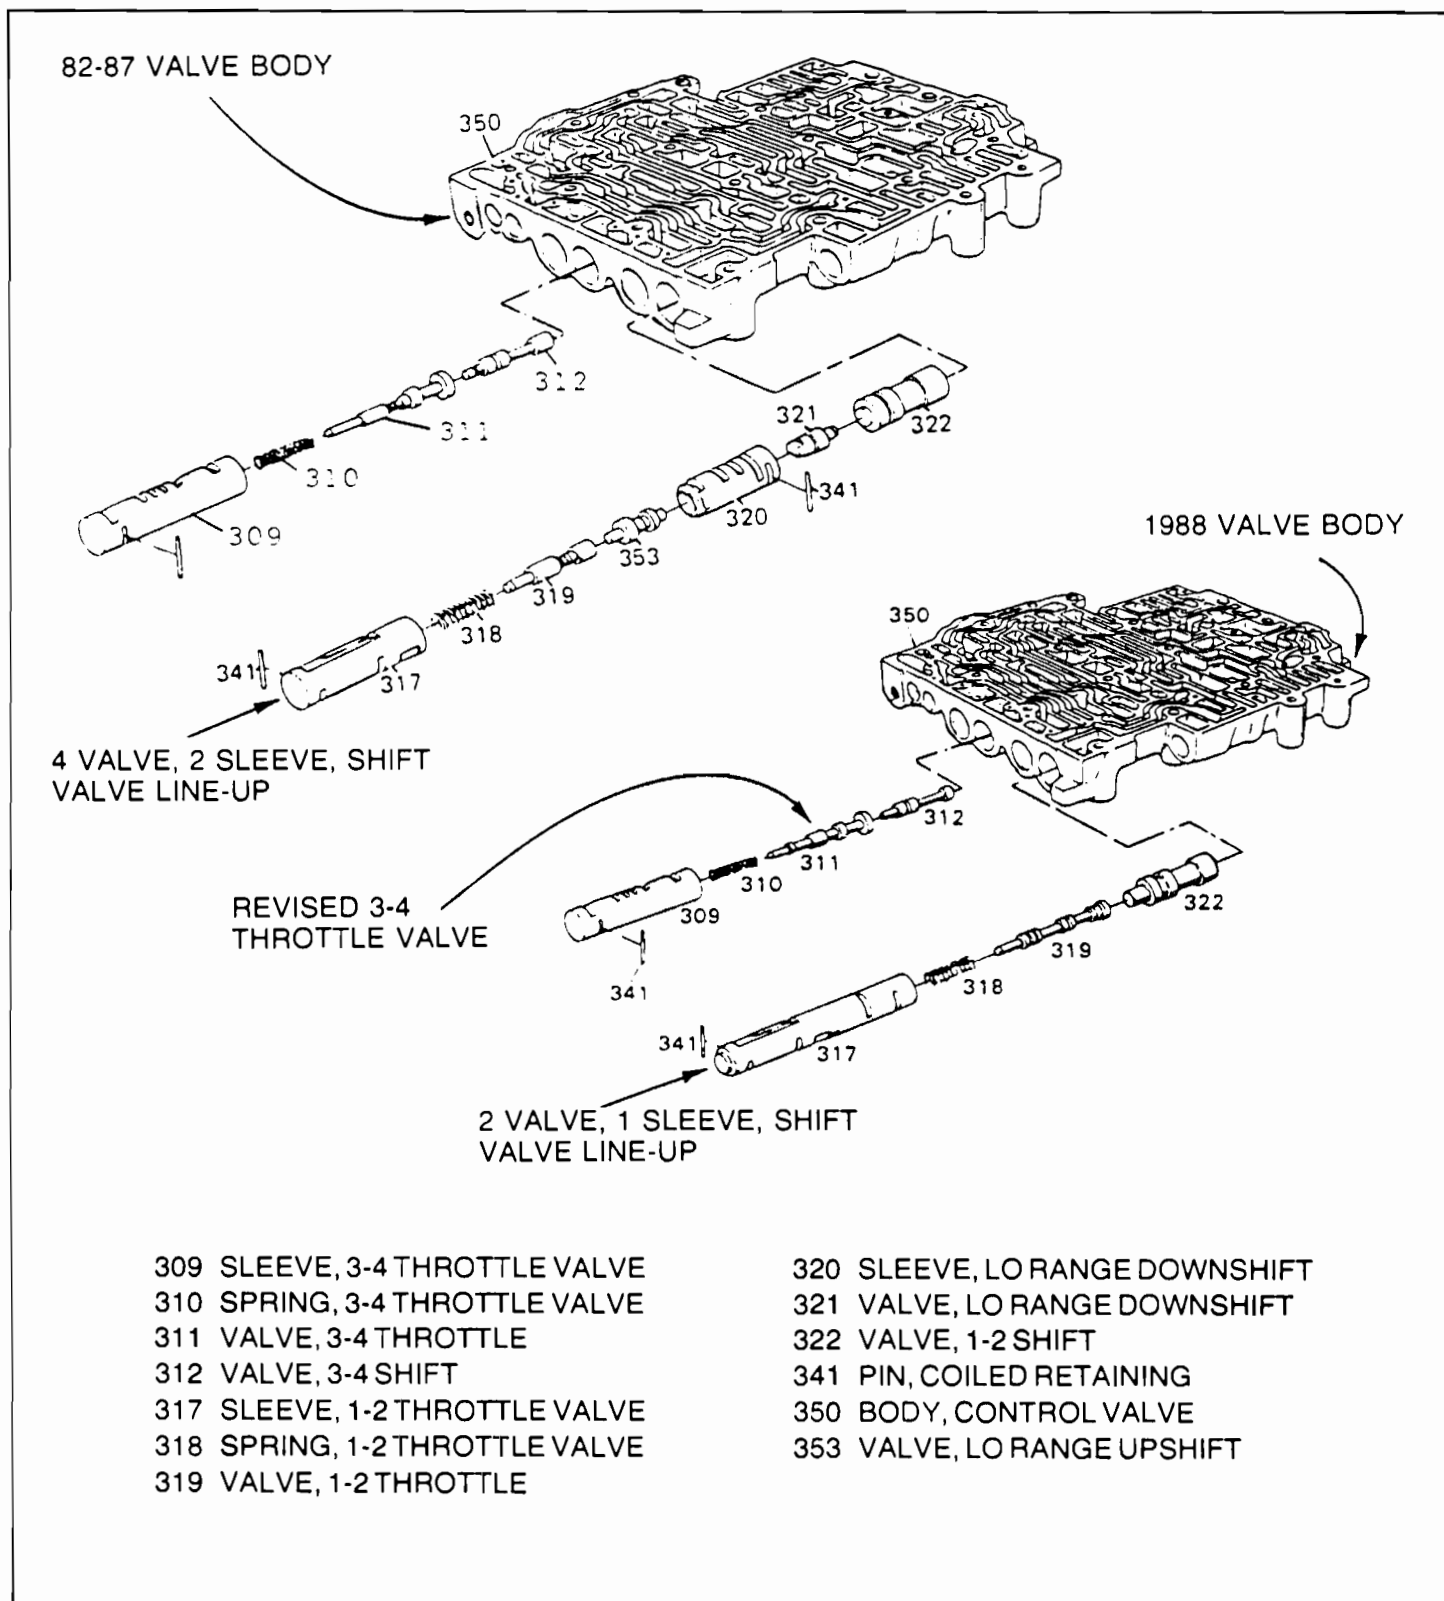
Figure 6

CHANGE: Revised 1-2 shift valve line-up in the main valve body, and a revised 3-4 throttle valve and sleeve (See Figure 6).

REASON: This change reduced internal leakage, thus improving consistency for the 1-2 and 3-4 shifts, and allows engine braking at a higher speed during a manual 2-1 downshift.

- (1) 1-2 SHIFT VALVE LINE-UP - The 1-2 shift valve line-up changes from 4 valves and 2 sleeves, to 2 valves and 1 sleeve. The Lo-Range Downshift Valve(321), Lo-Range Control Sleeve(320), and the 1-2 Lo-Range Upshift Valve(353) have been eliminated from 1988 and later models (Figure 6).

- (2) 3-4 THROTTLE VALVE - The 3-4 throttle valve and sleeve have been revised. (See Figure 6).
- (3) MAIN VALVE BODY CASTING - One roll pin hole eliminated and machining changes will not allow you to interchange the 1-2 shift valve line-ups. (See Figure 7).
- (4) SPACER PLATE - Spacer plate has been revised to accommodate the new valve body. There is now a "Two" letter code on all 87 and later spacer plates. Refer to pages 9 thru 14 for spacer plate charts.
- (5) NUMBER 9 CHECKBALL - The number 9 checkball, located in the bathtub in the case next to the manual shaft, has been ELIMINATED on all 1988 and later models.

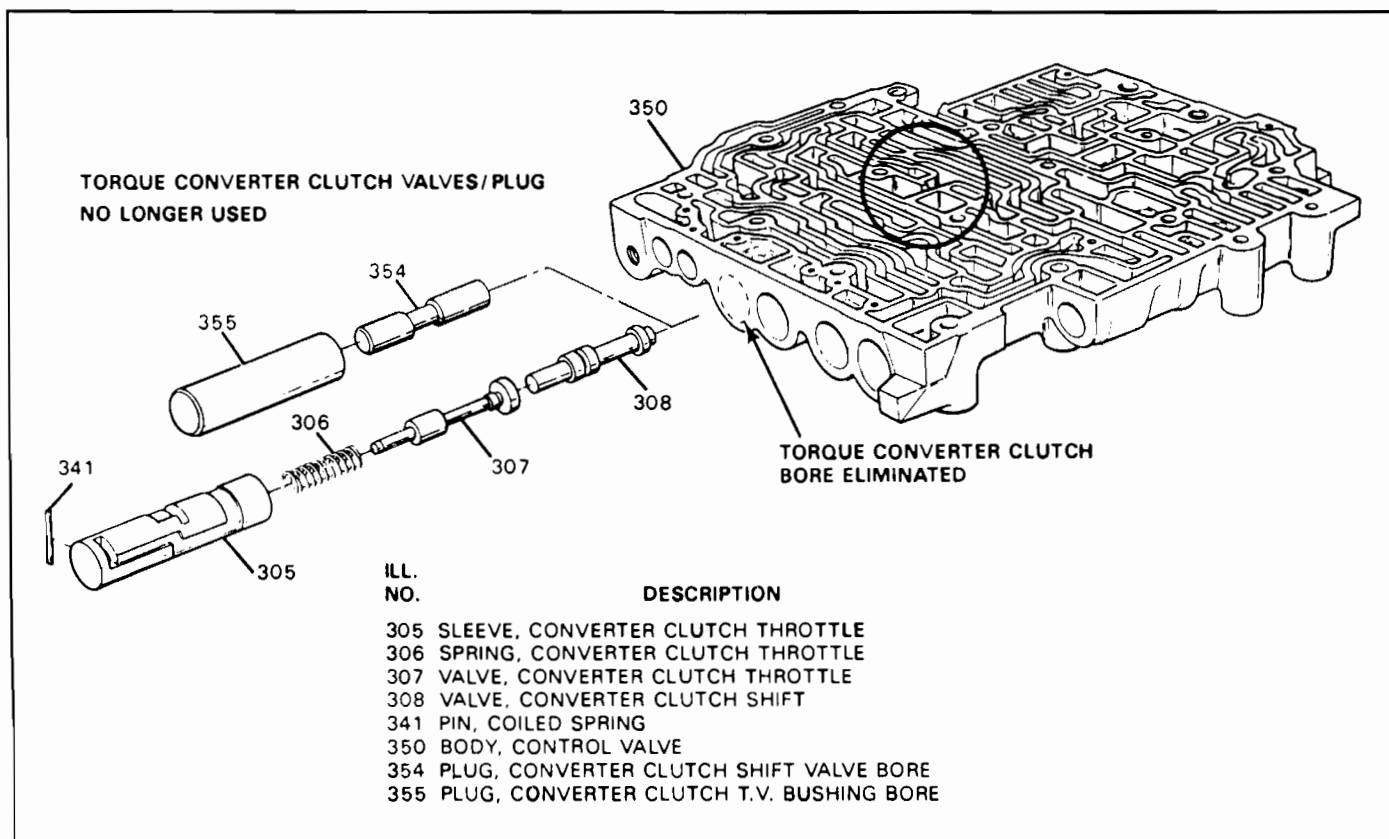
Figure 8

- (1) **VALVE BODY CASTING** - The new valve body casting will no longer have the TCC bore, and now contains a "Notch" in the worm track area allowing 2nd clutch oil into the TCC Signal circuit (See Figure 8).

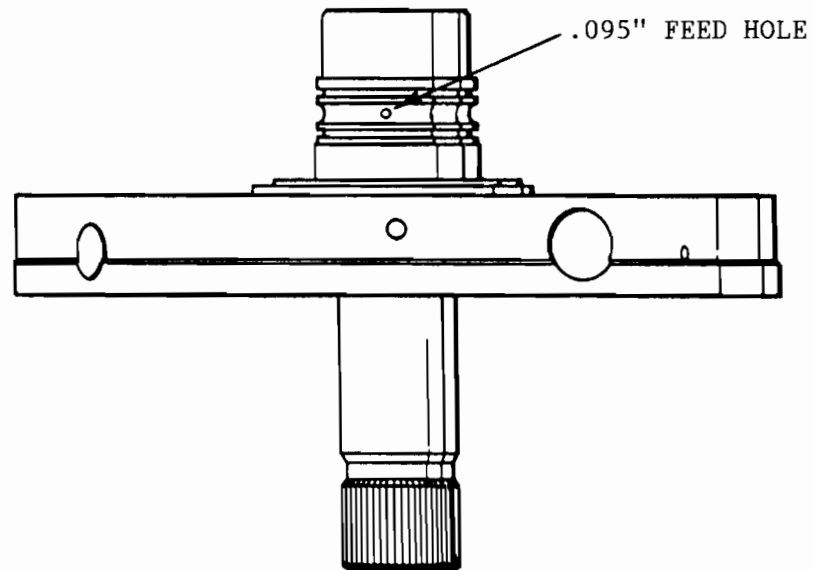
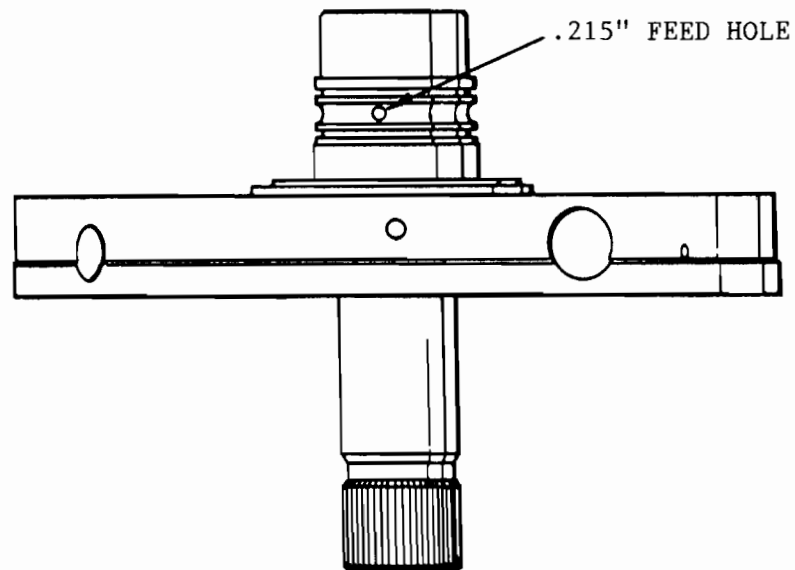
Figure 9

Basically the orifice for the reverse input clutch was moved from the stator shaft (.095" Feed Hole), to the new reverse input housing (See Figures 9 & 10). This now provides two different stators, both made for the forward clutch oil pipe, that WILL NOT interchange.

- (1) EARLY STATOR (.095" Feed Hole) - CANNOT be used with the new reverse input housing, which is the one with the aluminum piston. You will have installed "Two" orifices for the reverse input clutch, and the result will be delay to reverse (Refer to Figures 9 & 10).
- (2) LATE STATOR (.215" Feed Hole) - Can POSSIBLY be used on all previous models. This combination may create a harsh reverse as we now have no orifice for the reverse input clutch (Refer to Figures 9 & 10).
When used with 82-86 models you MUST install a cup plug in the feed hole for the forward clutch oil pipe (See Figure 11).

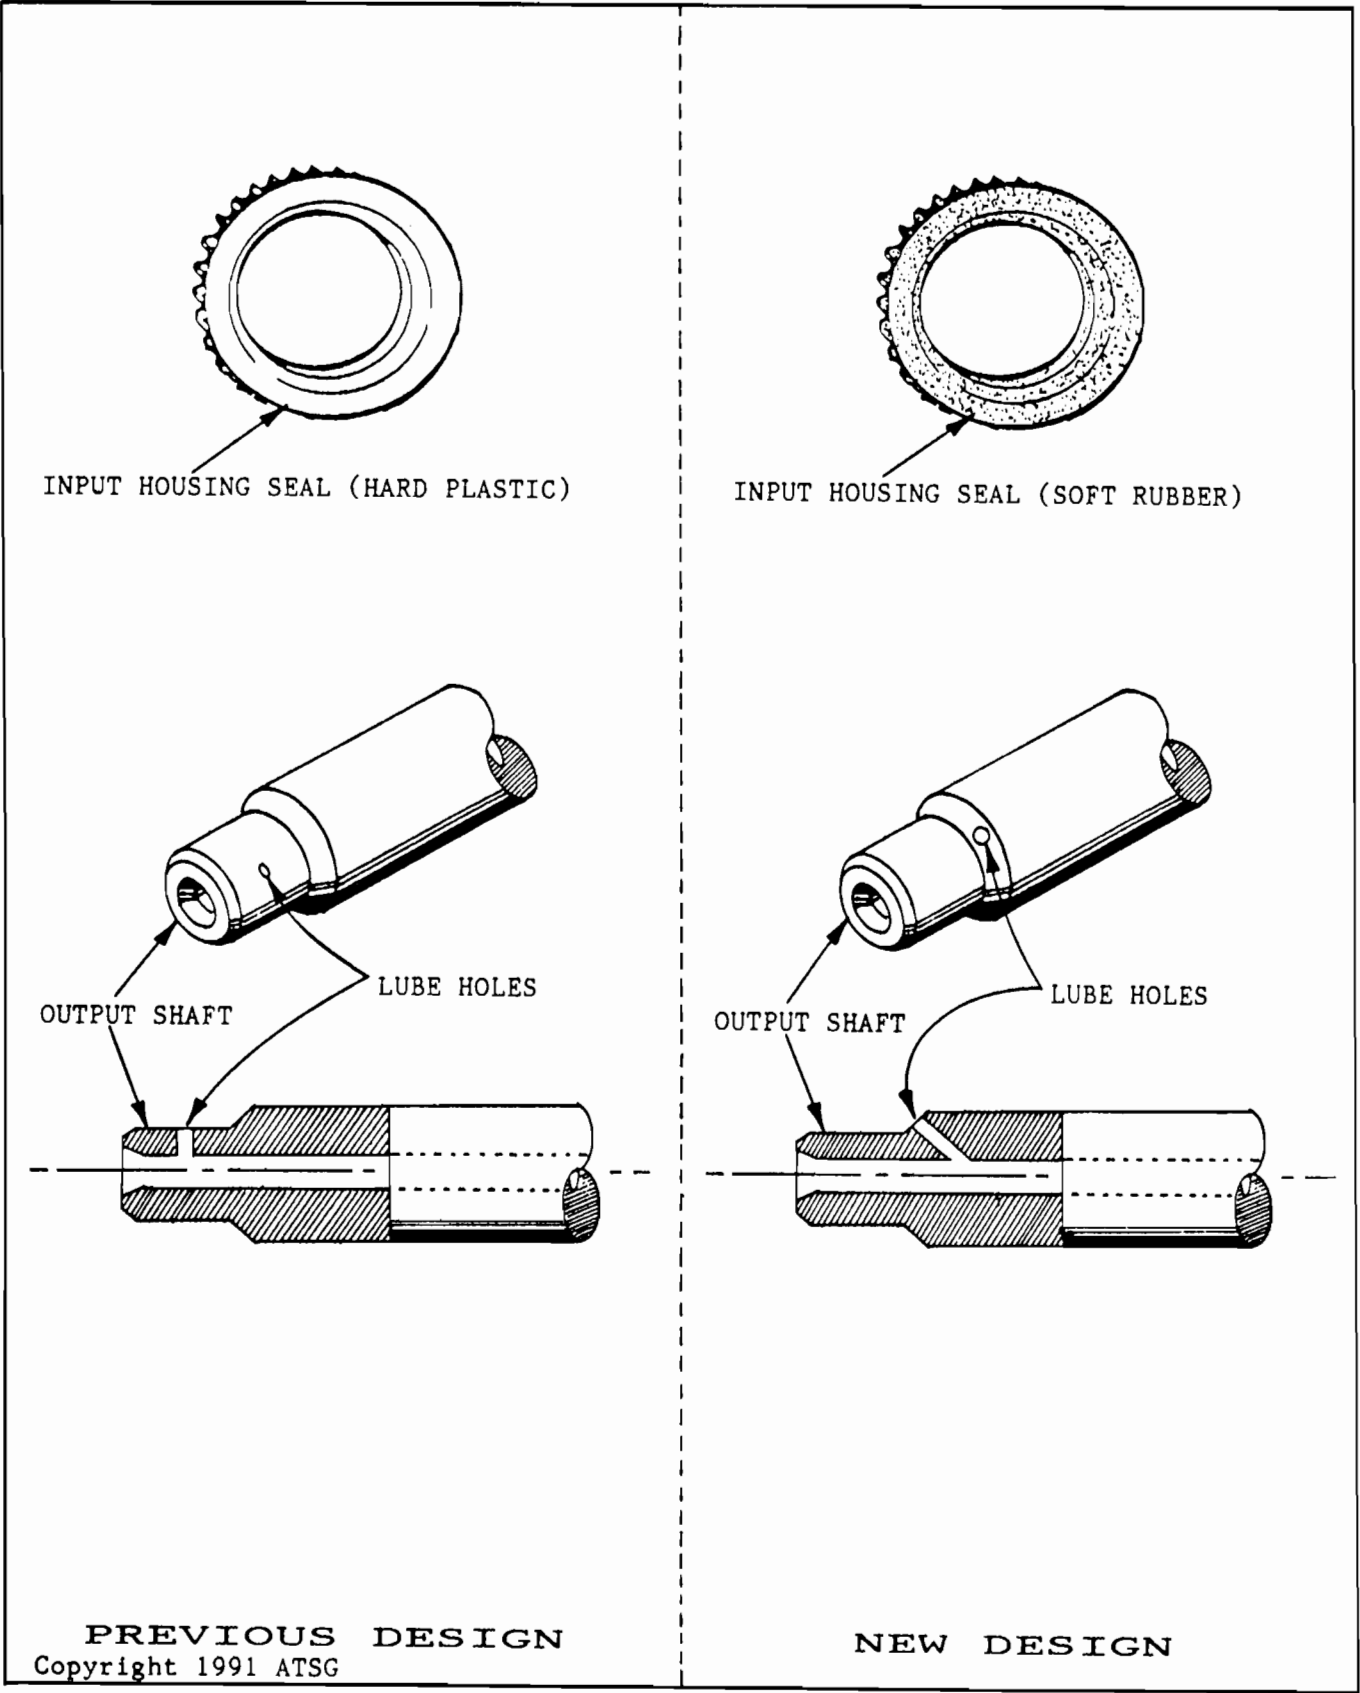
Figure 13

REASON: Increased lube oil flow to the Input Housing/Input Sun Gear Bearing.
(See Figure 12).

- (1) INPUT HOUSING LUBE SEAL - Now made of a soft rubber material instead of the previous hard plastic, is Red Oxide in color, and helps retain lube oil even in mis-alignment conditions because of soft material.
(Refer to Figures 12 and 13).
- (2) OUTPUT SHAFT - Revised lube hole location. New design can be identified by lube hole in the chamfer at the front of the output shaft. Previous design has the lube hole located on the pilot at the front of output shaft (See Figure 13). The new design output shaft now aims lube oil directly at the Input Housing/Sun Gear Bearing, greatly increasing the durability of the bearing (See Figure 12).

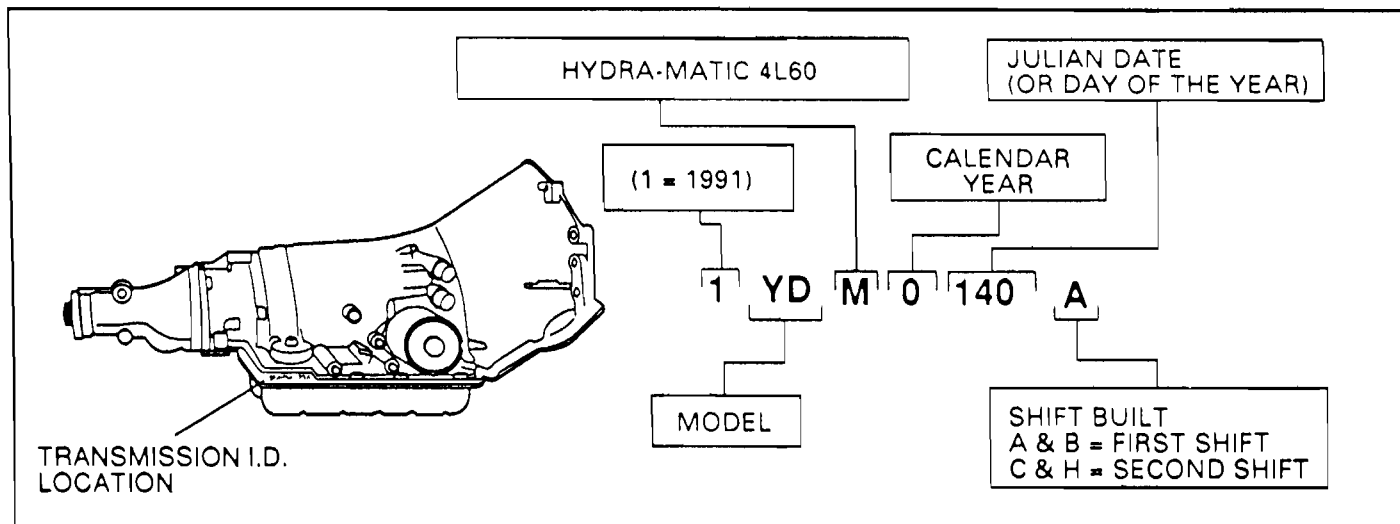
NOTE: Beginning May 20, 1991 (Julian Date 140), all 1YHM models were built using the new servo cushion assist spring and spacer plate. Use the Figure below to determine if the modification is necessary in your transmission.

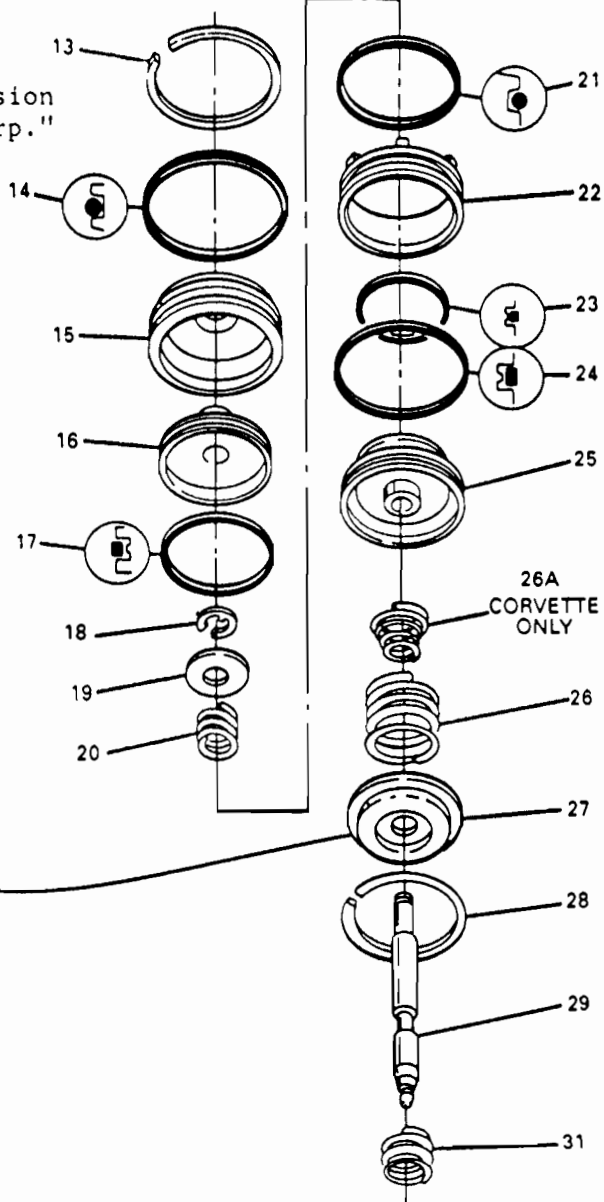
Figure 14
AUTOMATIC TRANSMISSION SERVICE GROUP

CAUSE: The cause may be, timing of the release of the 3-4 clutch and re-apply of the 2-4 band. A new conical 2-4 servo cushion assist spring has been released to alleviate this condition, along with enlarging the 3rd clutch exhaust hole in the spacer plate.

CORRECTION: (1) Install the new conical 2-4 servo cushion assist spring, OEM part number 8681195, inside of the current servo cushion spring with the small end towards the retainer, as shown in Figure 14.
(2) Enlarge the 3rd clutch exhaust hole in the spacer plate to .093", as shown in Figure 15.

INSTALL CONICAL SPRING 8681195 WITH SMALL DIAMETER TOWARD THE RETAINER AS SHOWN.

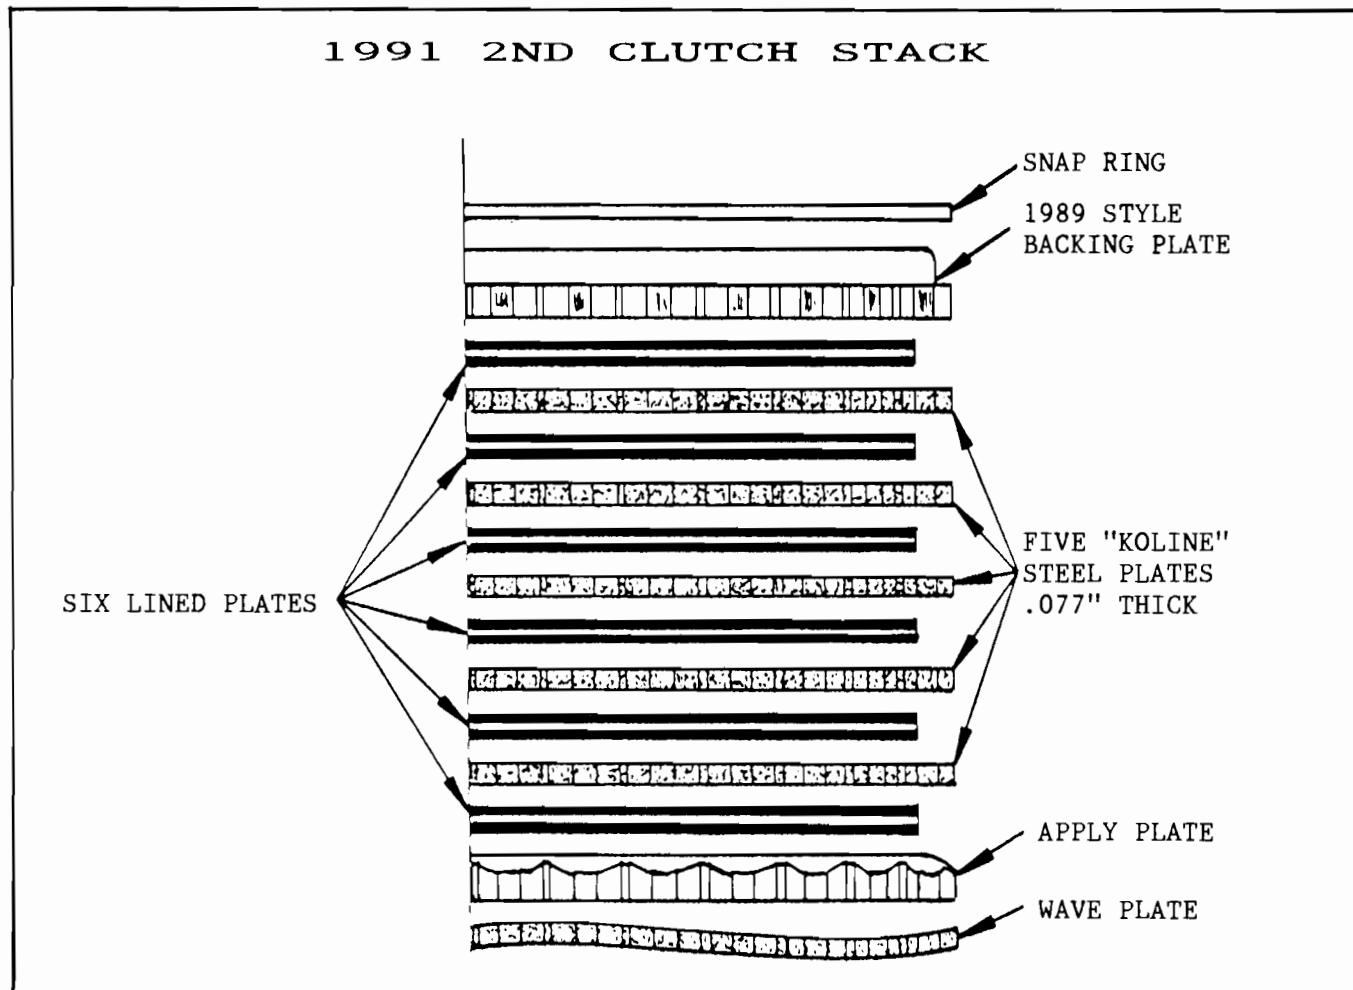
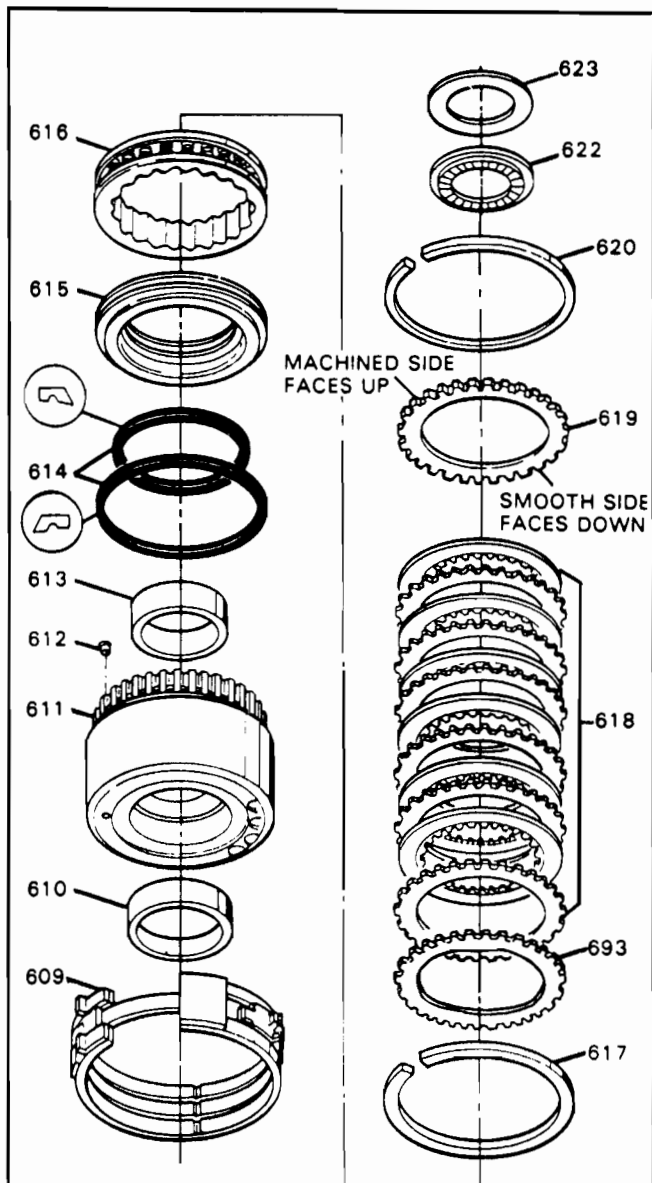
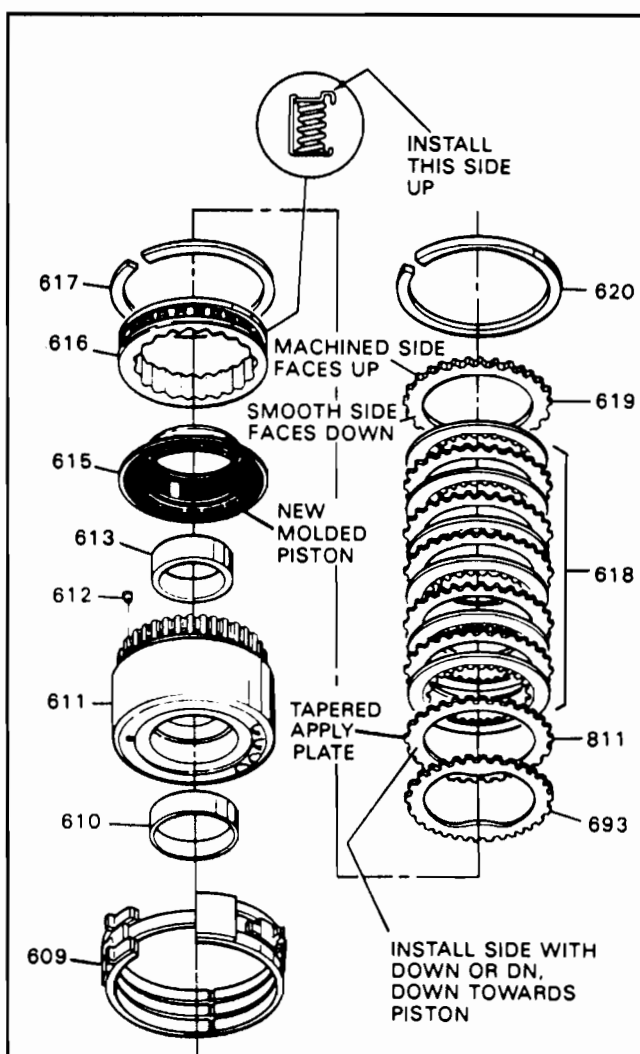
Figure 17

COMPLAINT: Premature failure of the second clutch pack.

CAUSE: The cause may be, lack of clamping force of the 2nd clutch. The 1991 molded 2nd clutch piston, and new 2nd clutch drum, have a larger area for 2nd clutch oil pressure to work against.

CORRECTION: Install the 1991 2nd clutch drum, 1991 molded 2nd clutch piston, the 1991 apply ring & return spring assembly, and the 1991 2nd clutch apply plate. Use Figures 17 & 18 for proper assembly procedure.

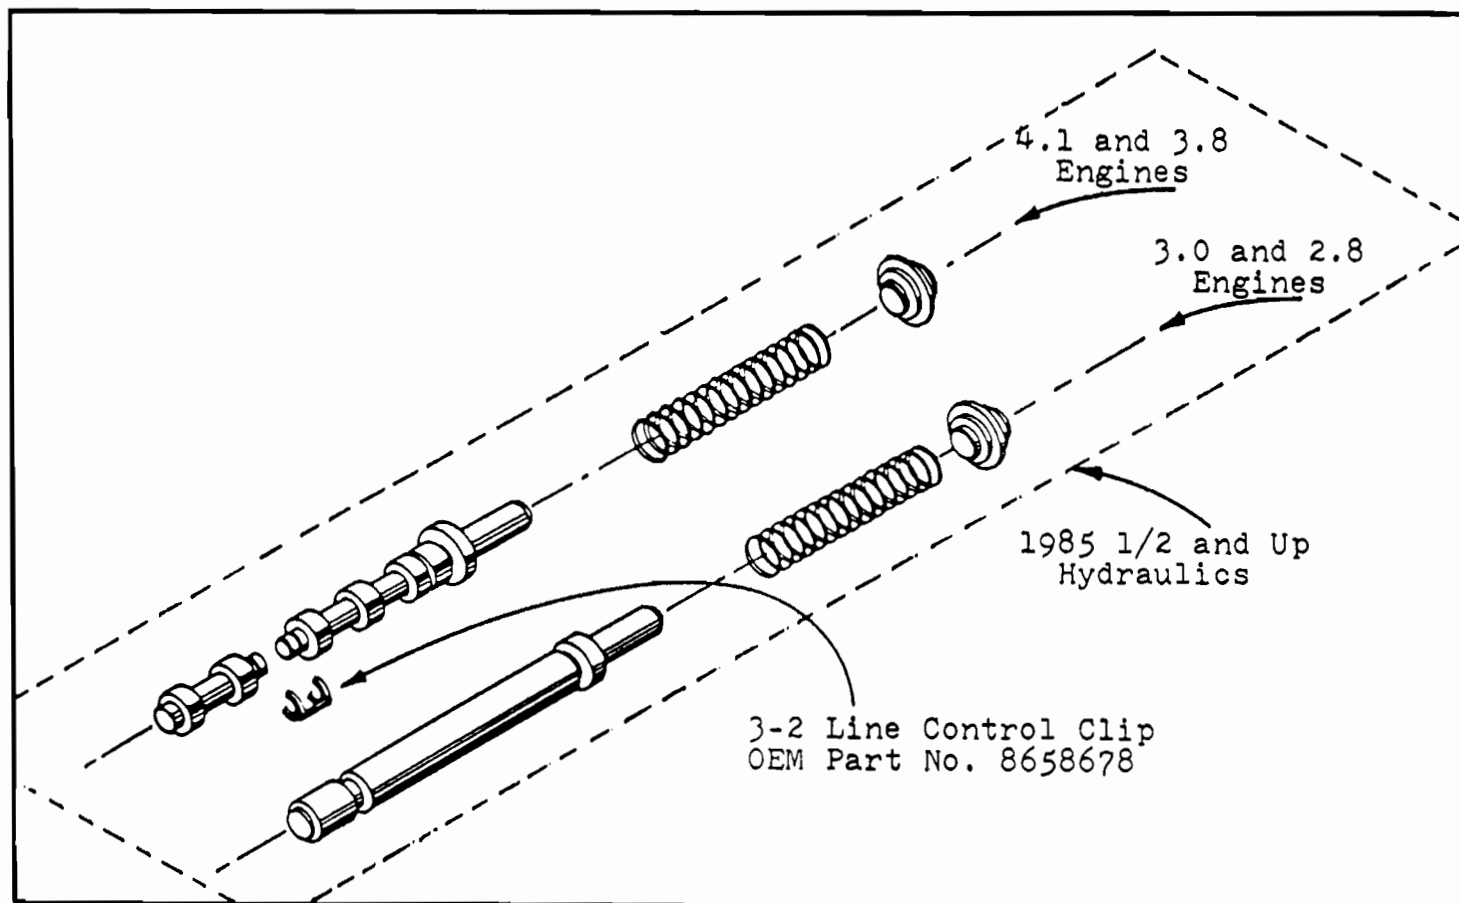
Figure 19

Proper spacer plate identification and selection is a MUST on the THM 440-T4. There are 2 different line-ups for the 3-2 line control valve, located in the channel plate, on all 1985 1/2 and later hydraulics. The 2 piece 3-2 line control valve is used on 4.1L and 4.5L Cadillac, and 3.8L Buick engines (See Figure 19). The "Plug" that is also shown (Figure 19), is used on 3.0L Buick, and 2.8L Chevrolet engines.

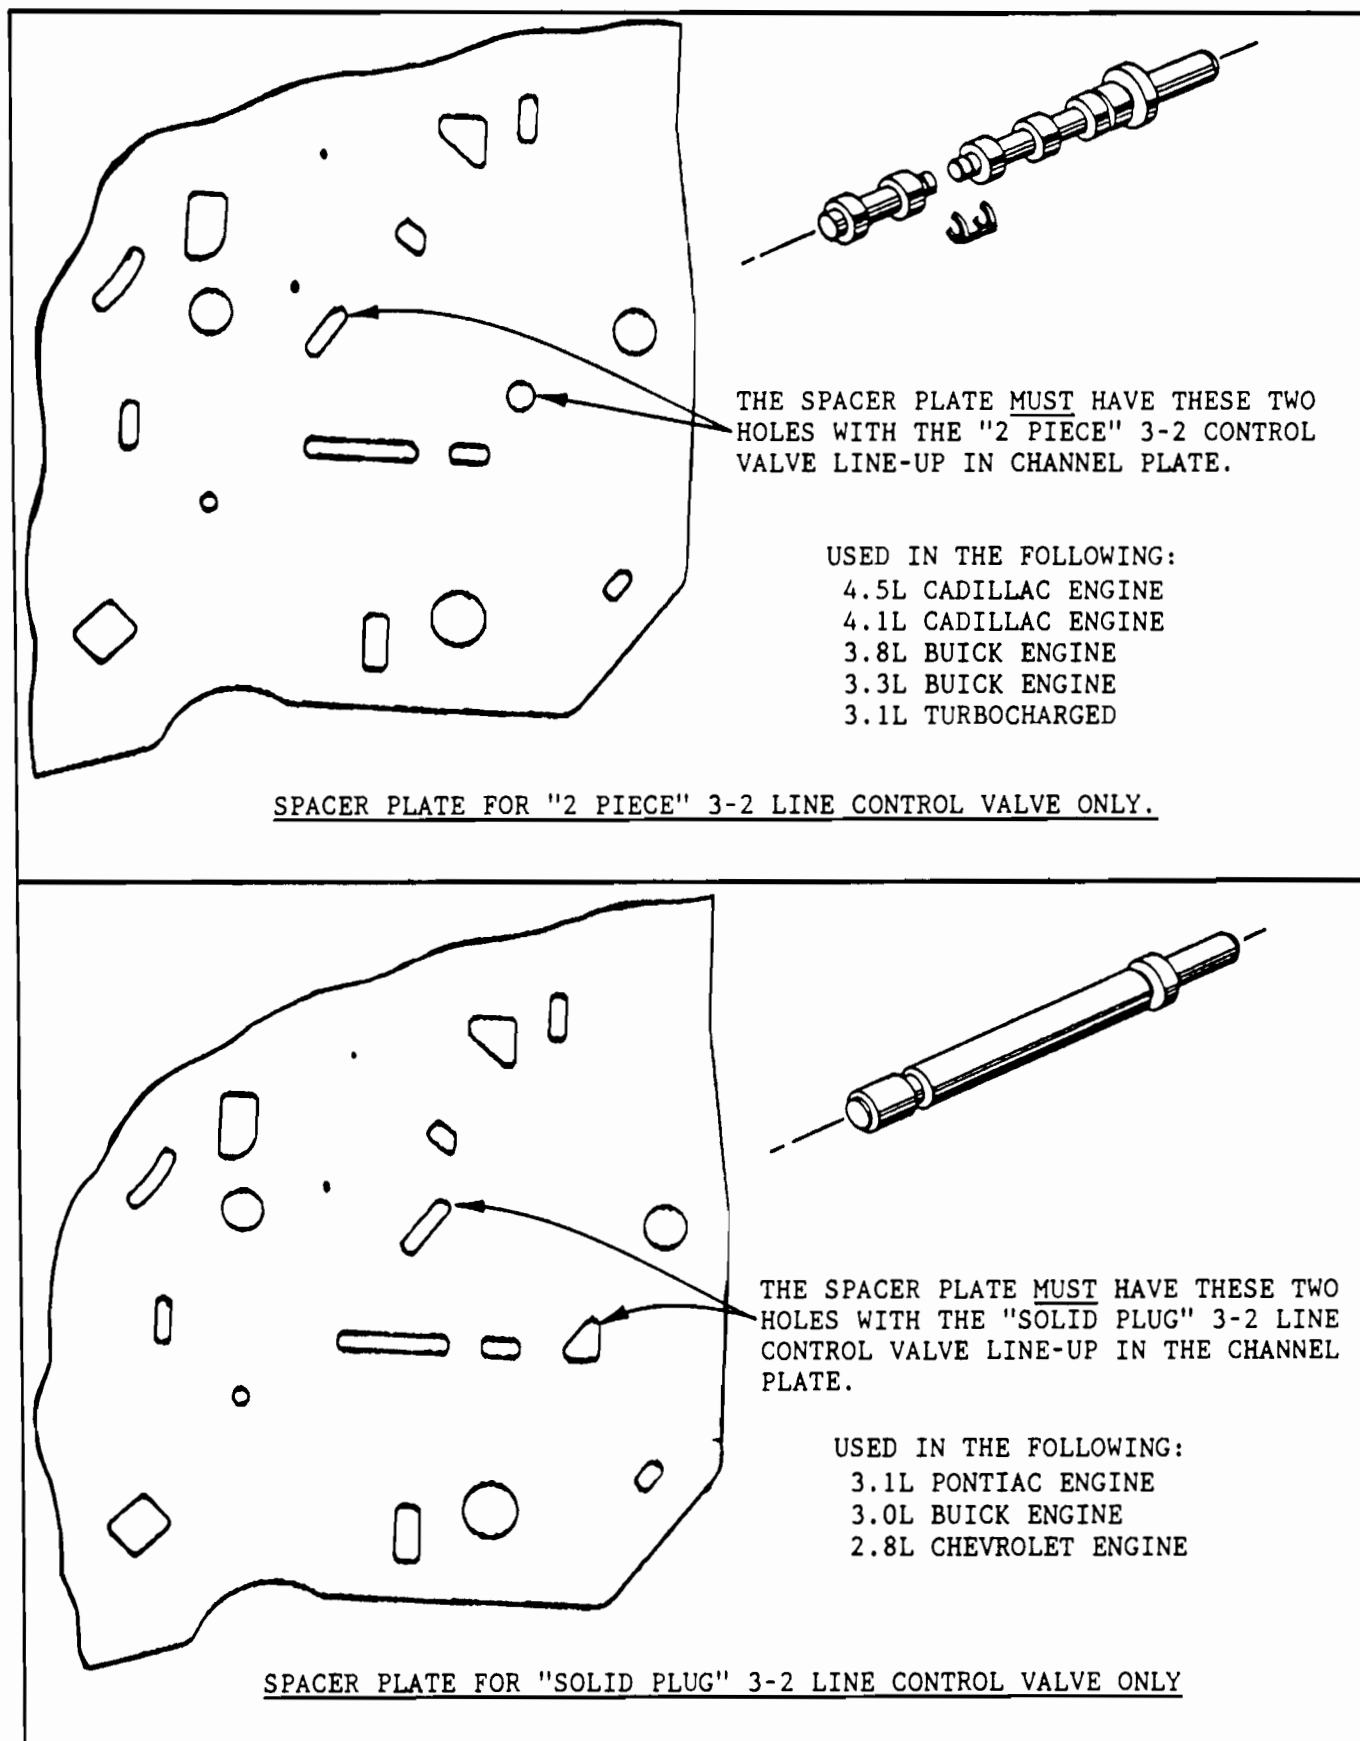
Refer to Figure 20 for the specific holes in the spacer plate to identify which valve line-up the spacer plate is compatible with.

THESE SPACER PLATES WILL NOT INTERCHANGE.
