TRANSMISSION SEMINAR 1992

1992 SEMINAR INFORMATION

THM 4L80-E COMPONENT LOCATIONS AND CONNECTIONS

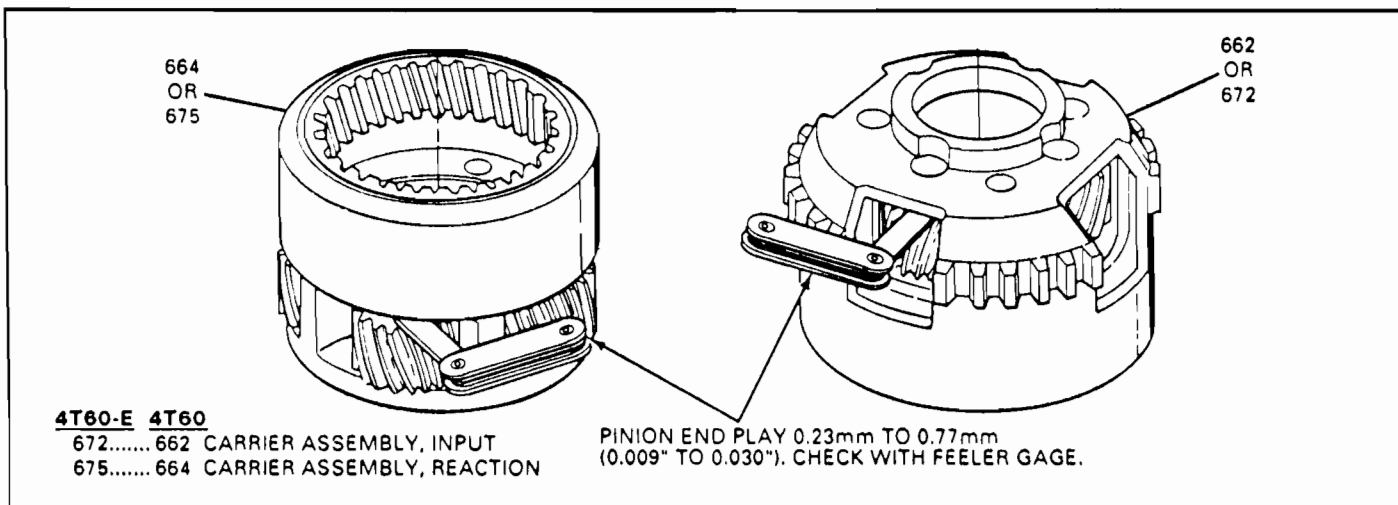
Figure 25

The reaction carrier and input carrier pinion gear end play specifications have been changed for service. The previous specification was .009" to .024" and the new specification is .009" to .030", and can be checked with a feeler gage as shown in Figure 25.

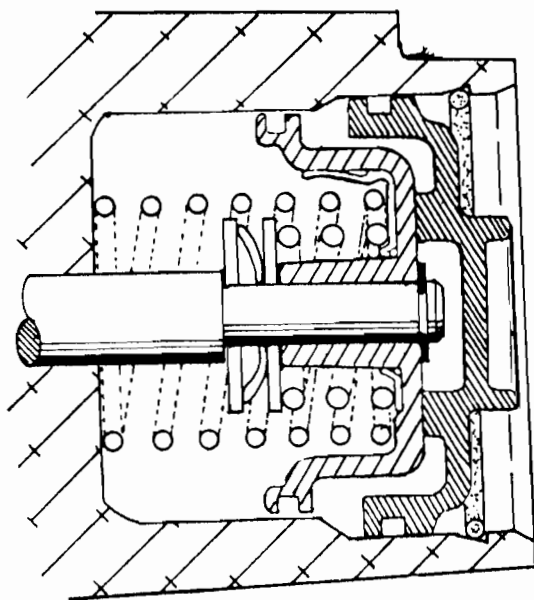
Figure 27

CAUSE: A band must be applied on either of these shifts, so the cause may be too much piston travel, or band clearance.

PUSH IN ON SERVO COVER AND MEASURE THIS
DISTANCE BETWEEN SERVO COVER AND SNAP RING.

1/8" MINIMUM TO 3/16" MAXIMUM

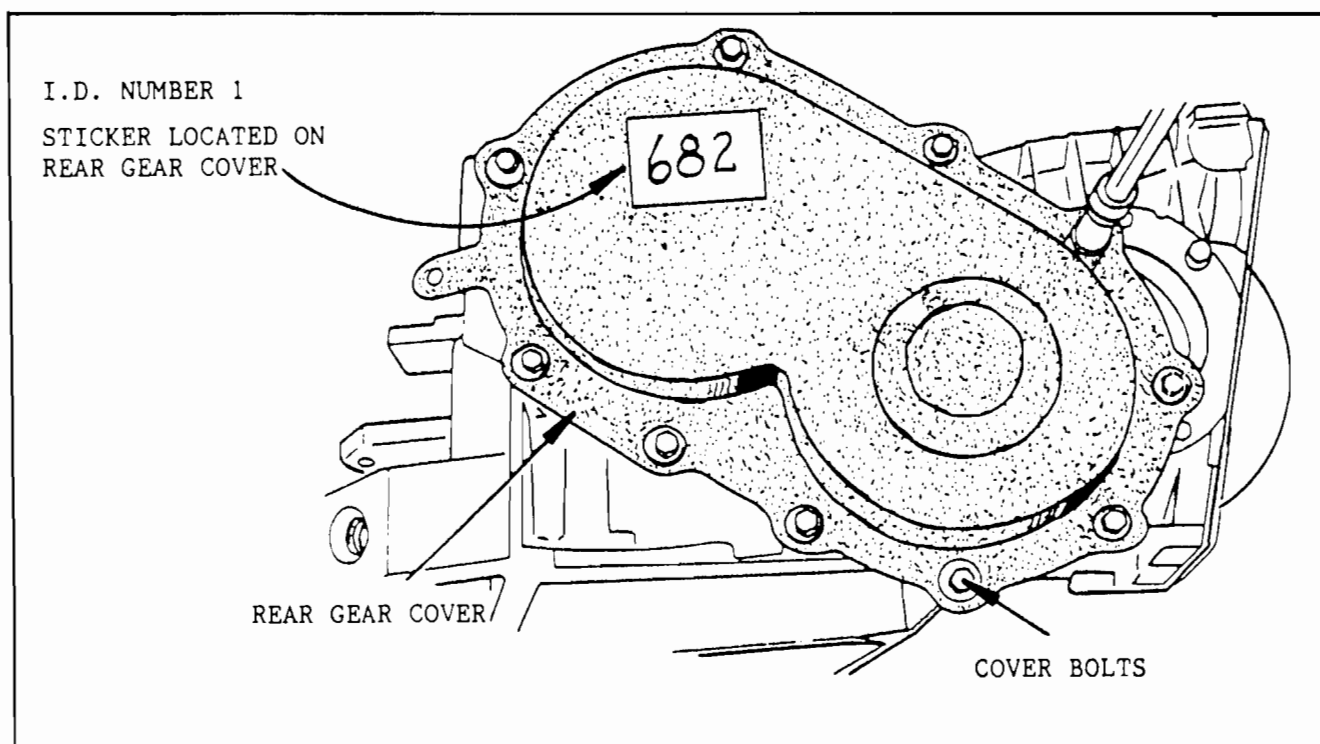
Figure 33

It will be imperative that you identify the transaxle properly. The transaxle is identified by the "Last 3 Digits" of the OEM part number, and is found on a sticker located on the rear gear cover (See Figure 33). Then refer to the chart in Figure 36 for proper applications.

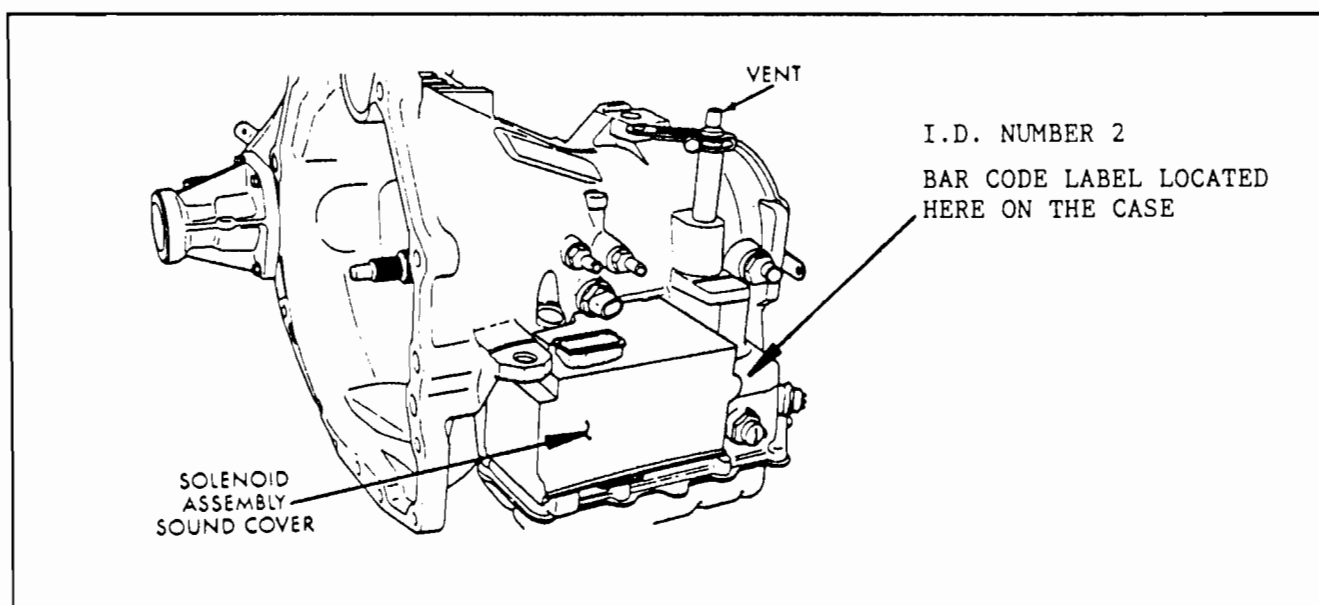
Figure 34

If the gear cover sticker is missing, or painted over, there is also a bar code label located on the case directly above the PRNODL and neutral safety switches, or sometimes on the bell housing (See Figure 34). Then refer to the chart in Figure 36 for proper applications.

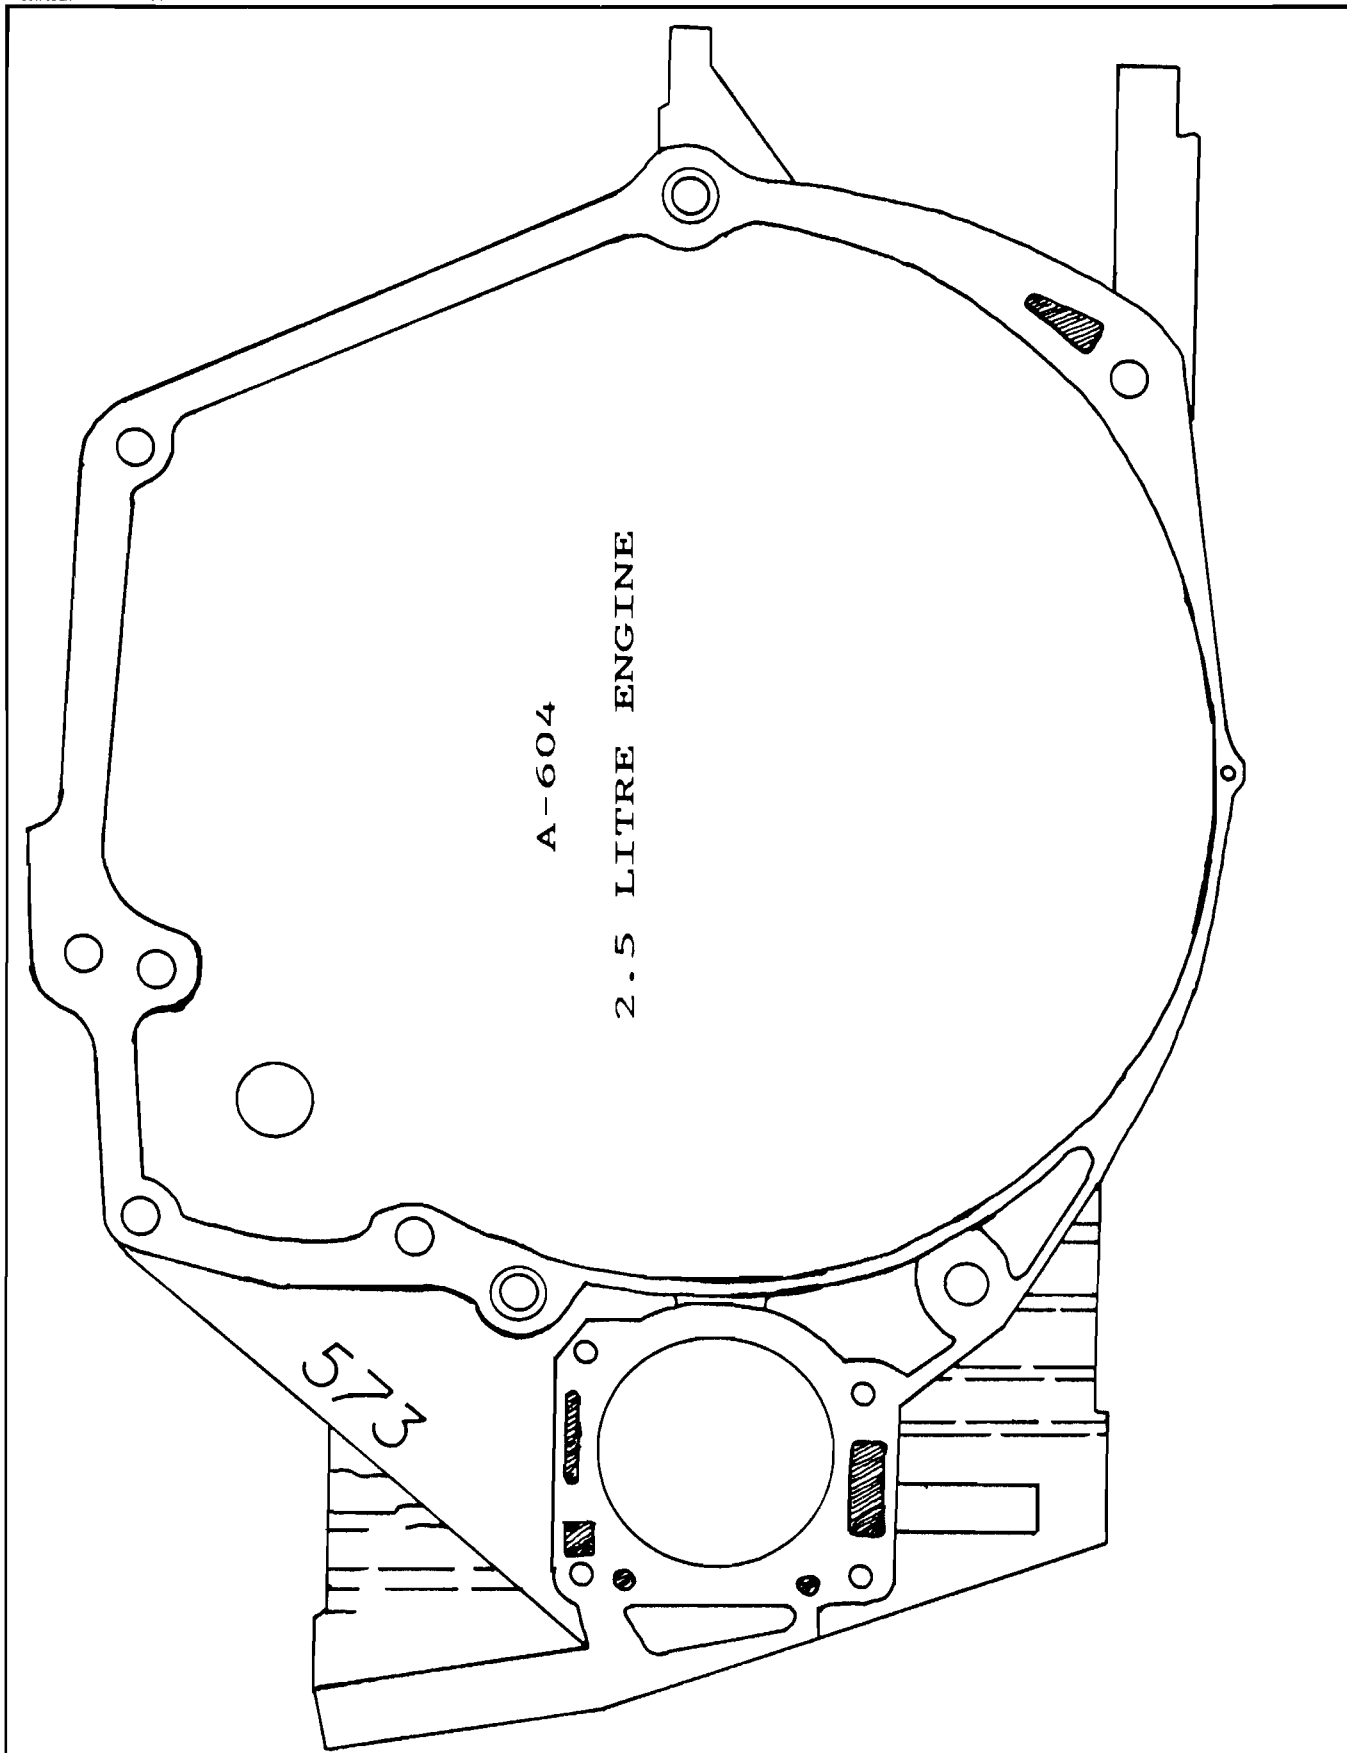
Figure 38
AUTOMATIC TRANSMISSION SERVICE GROUP

This transaxle is also found behind 3 different engine applications, 2.5 Litre, 3.0 Litre, and 3.3 Litre engines. They all have different bolt patterns. Refer to Figures 38, 39, and 40 for the bell housing patterns.

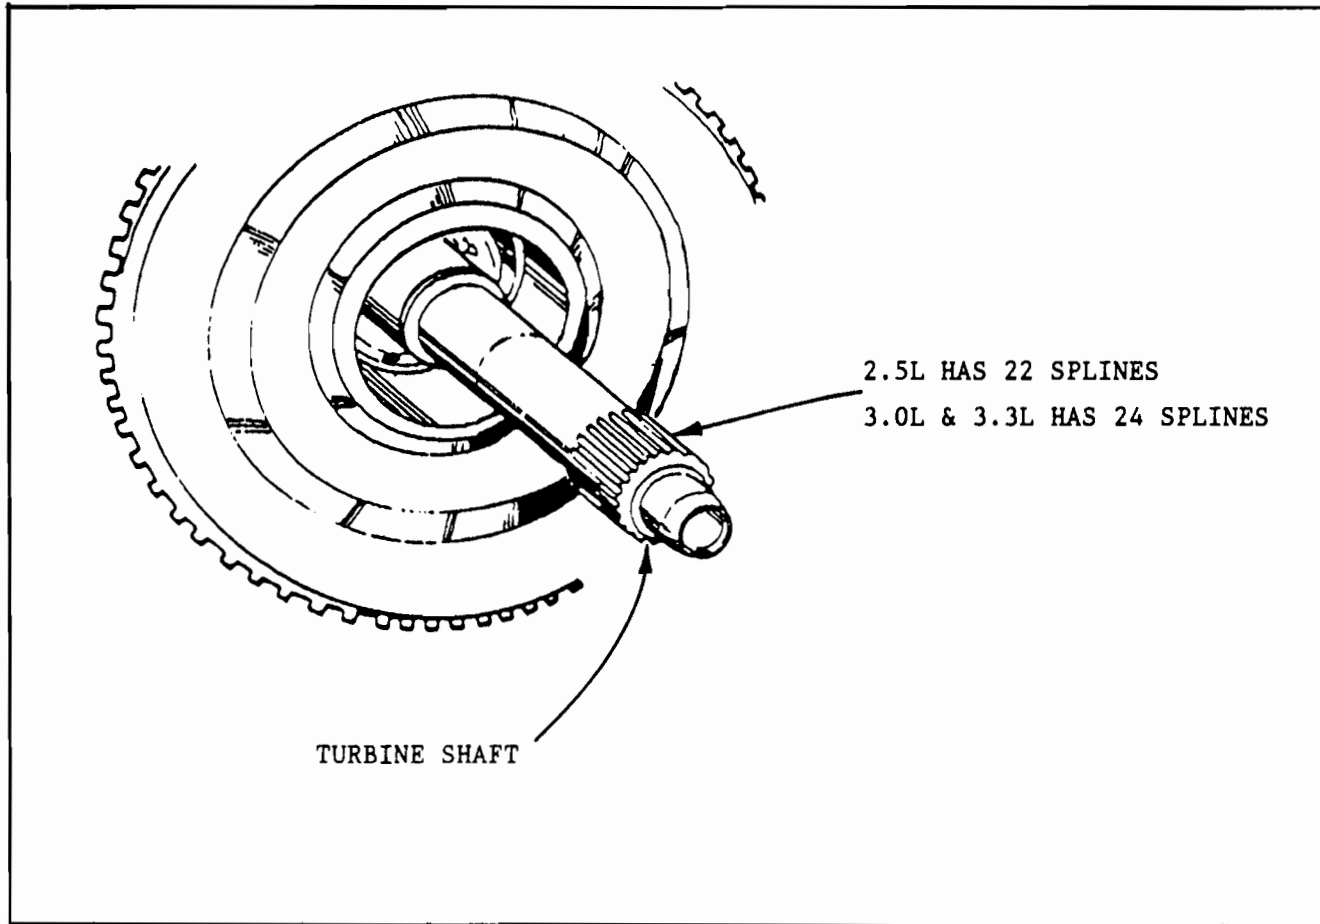
Figure 41

The 2.5 Litre engine uses a turbine shaft and torque converter that has only 22 splines. The 3.0 Litre and 3.3 Litre engines both use a turbine shaft and torque converter that has 24 splines. Refer to Figure 41, and be carefull.

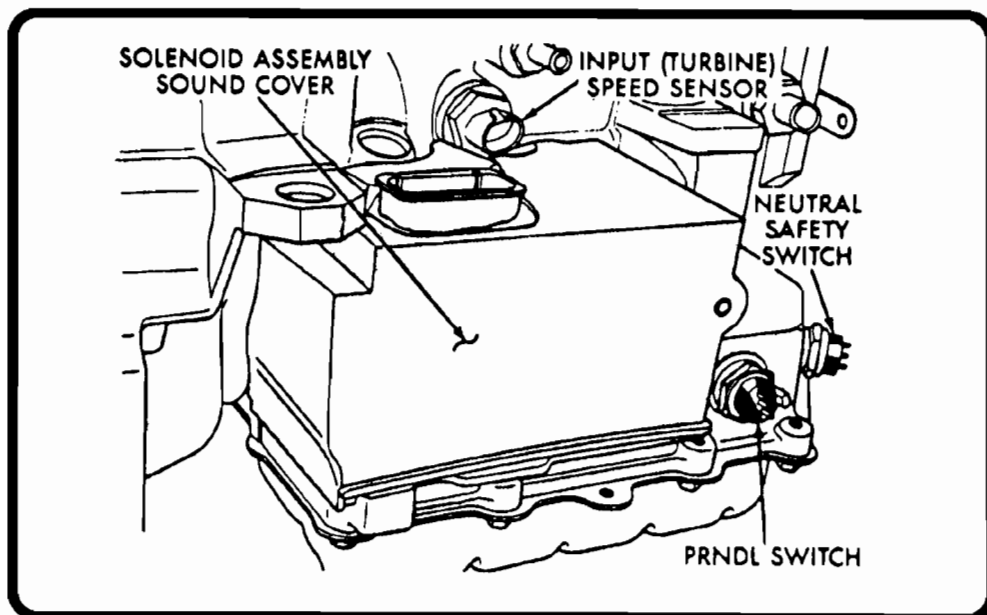
CHANGE: PRNODL Switch and Neutral Safety Switch have been changed for the 1990 model year, as well as the vehicle wiring harness connectors. Refer to Figure 42 for location of switches on the transaxle.

REASON: Positive locking mechanism, with a weathertight seal, to prevent the connection from becoming loose.

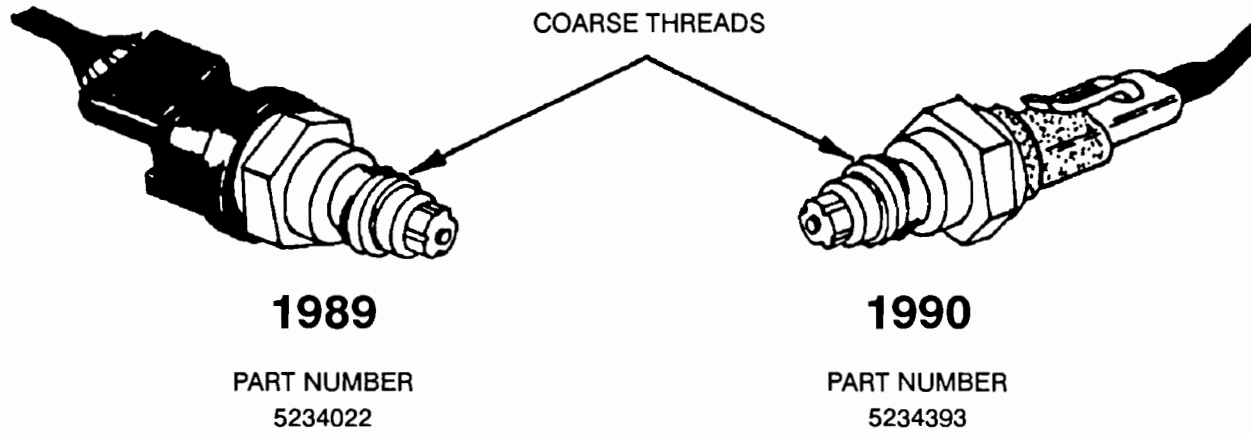
- (1) **PRNODL SWITCH AND CONNECTOR** - The PRNODL Switch and its wiring harness connector have changed for 1990, and can be identified visually (See Figure 43). These PRNODL Switches WILL NOT interchange with one another.
- (2) **NEUTRAL SAFETY SWITCH AND CONNECTORS** - The Neutral safety Switch and its wiring harness connector have changed for 1990, and can be identified visually (See Figure 44). These Neutral Safety Switches WILL NOT interchange with one another.

NOTE: Each of the new for 1990 switches may look similar at first glance, but the PRNODL switch features a "Coarse" thread, while the Neutral Safety Switch is black and features "Fine" threads. (See Figure 43 - 44).

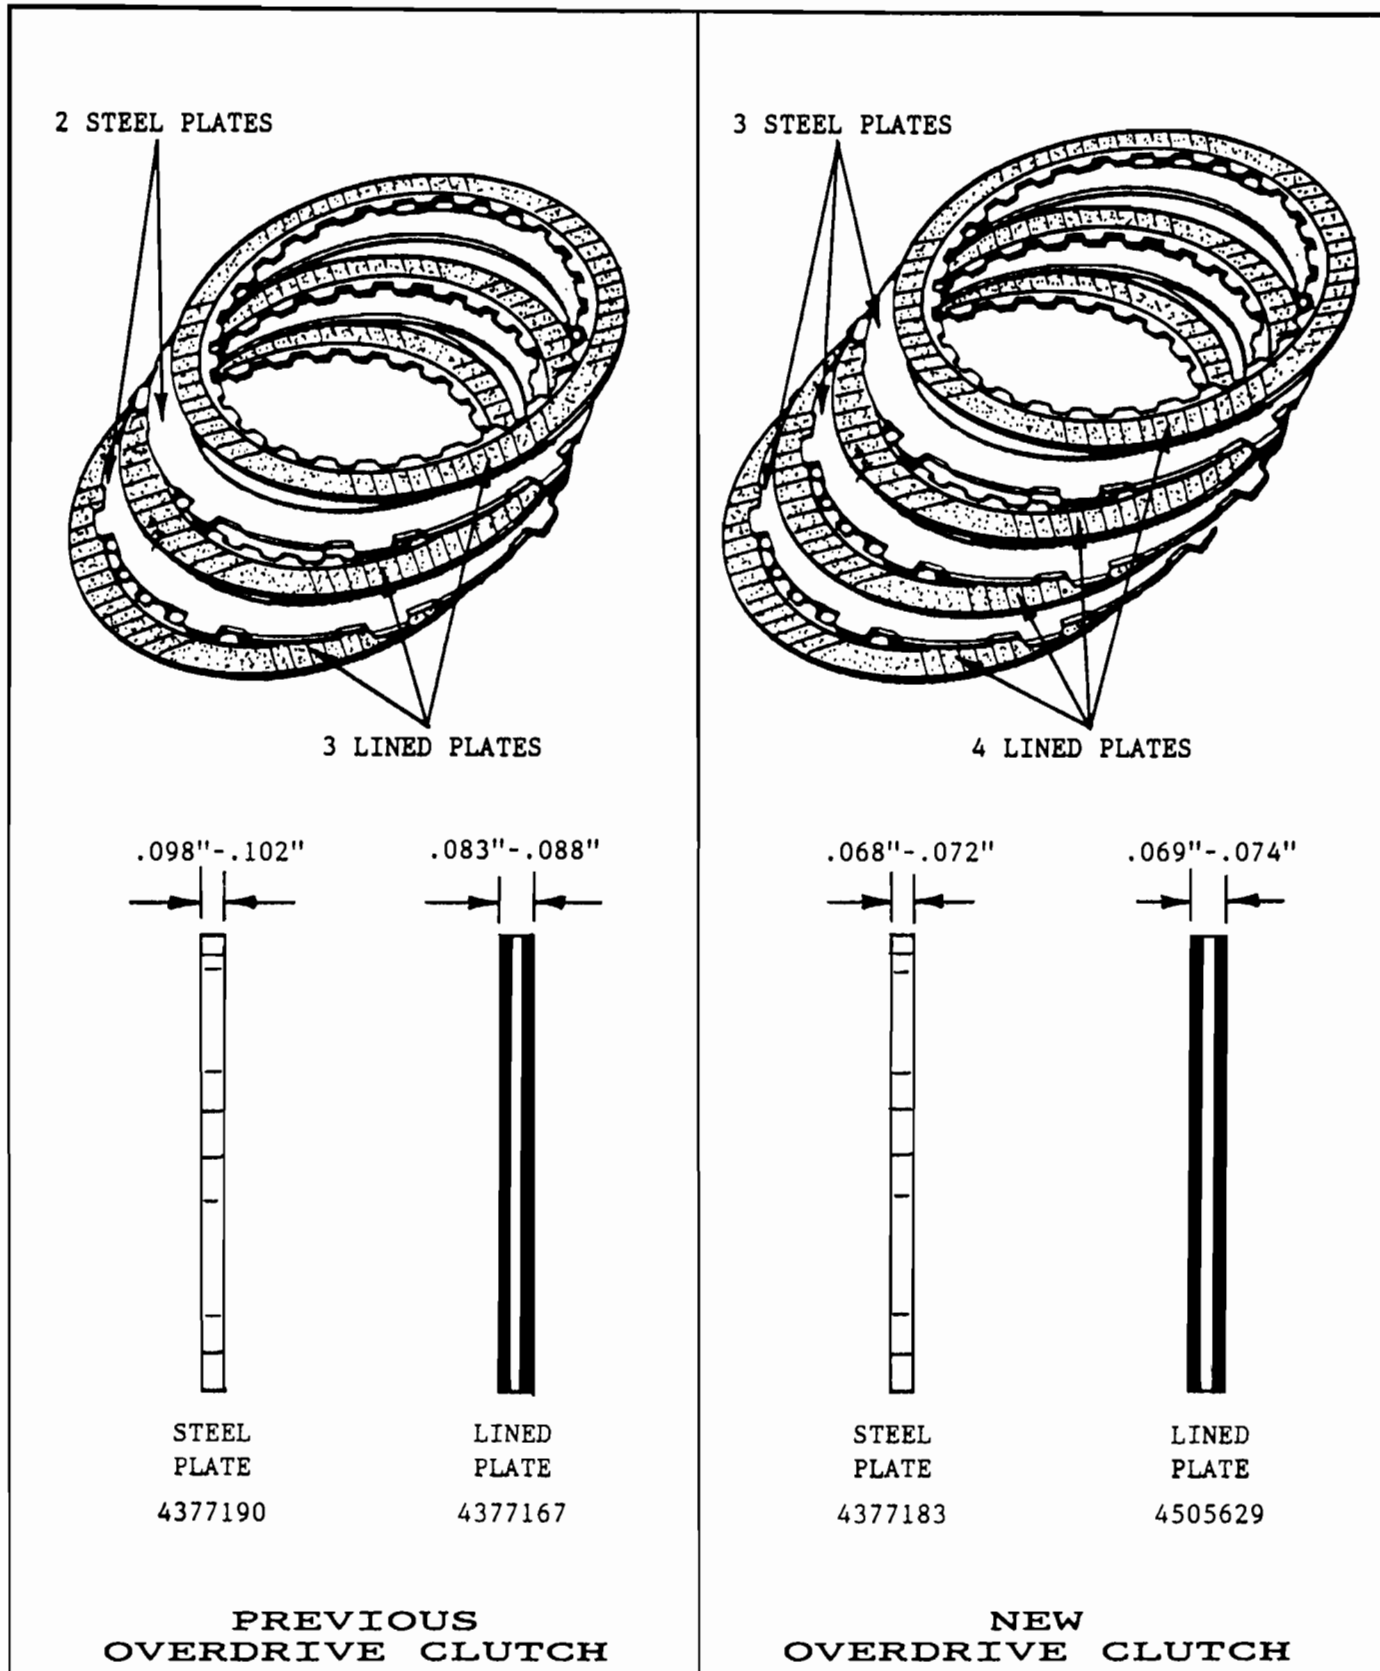
Figure 45

CHANGE: A running change for 1990 model A604 transaxles was the introduction of a four (4) disc Overdrive Clutch Assembly, to replace the previous three (3) disc assembly (See Figure 45).

None of the parts listed above will interchange with one another between 1989 and 1990 model years. It is imperative that you "Positively" I.D. each part to insure that you are assembling with compatible parts.

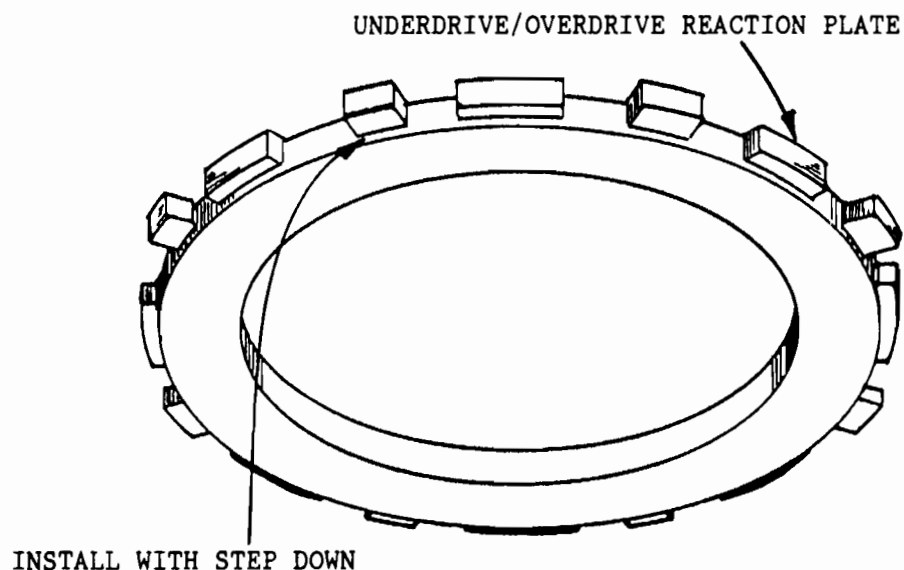
Figure 46
AUTOMATIC TRANSMISSION SERVICE GROUP

FOR 1990, EACH REACTION PLATE WAS REDUCED IN THICKNESS BY .040", TO ACCOMMODATE THE EXTRA OVERDRIVE PLATES.

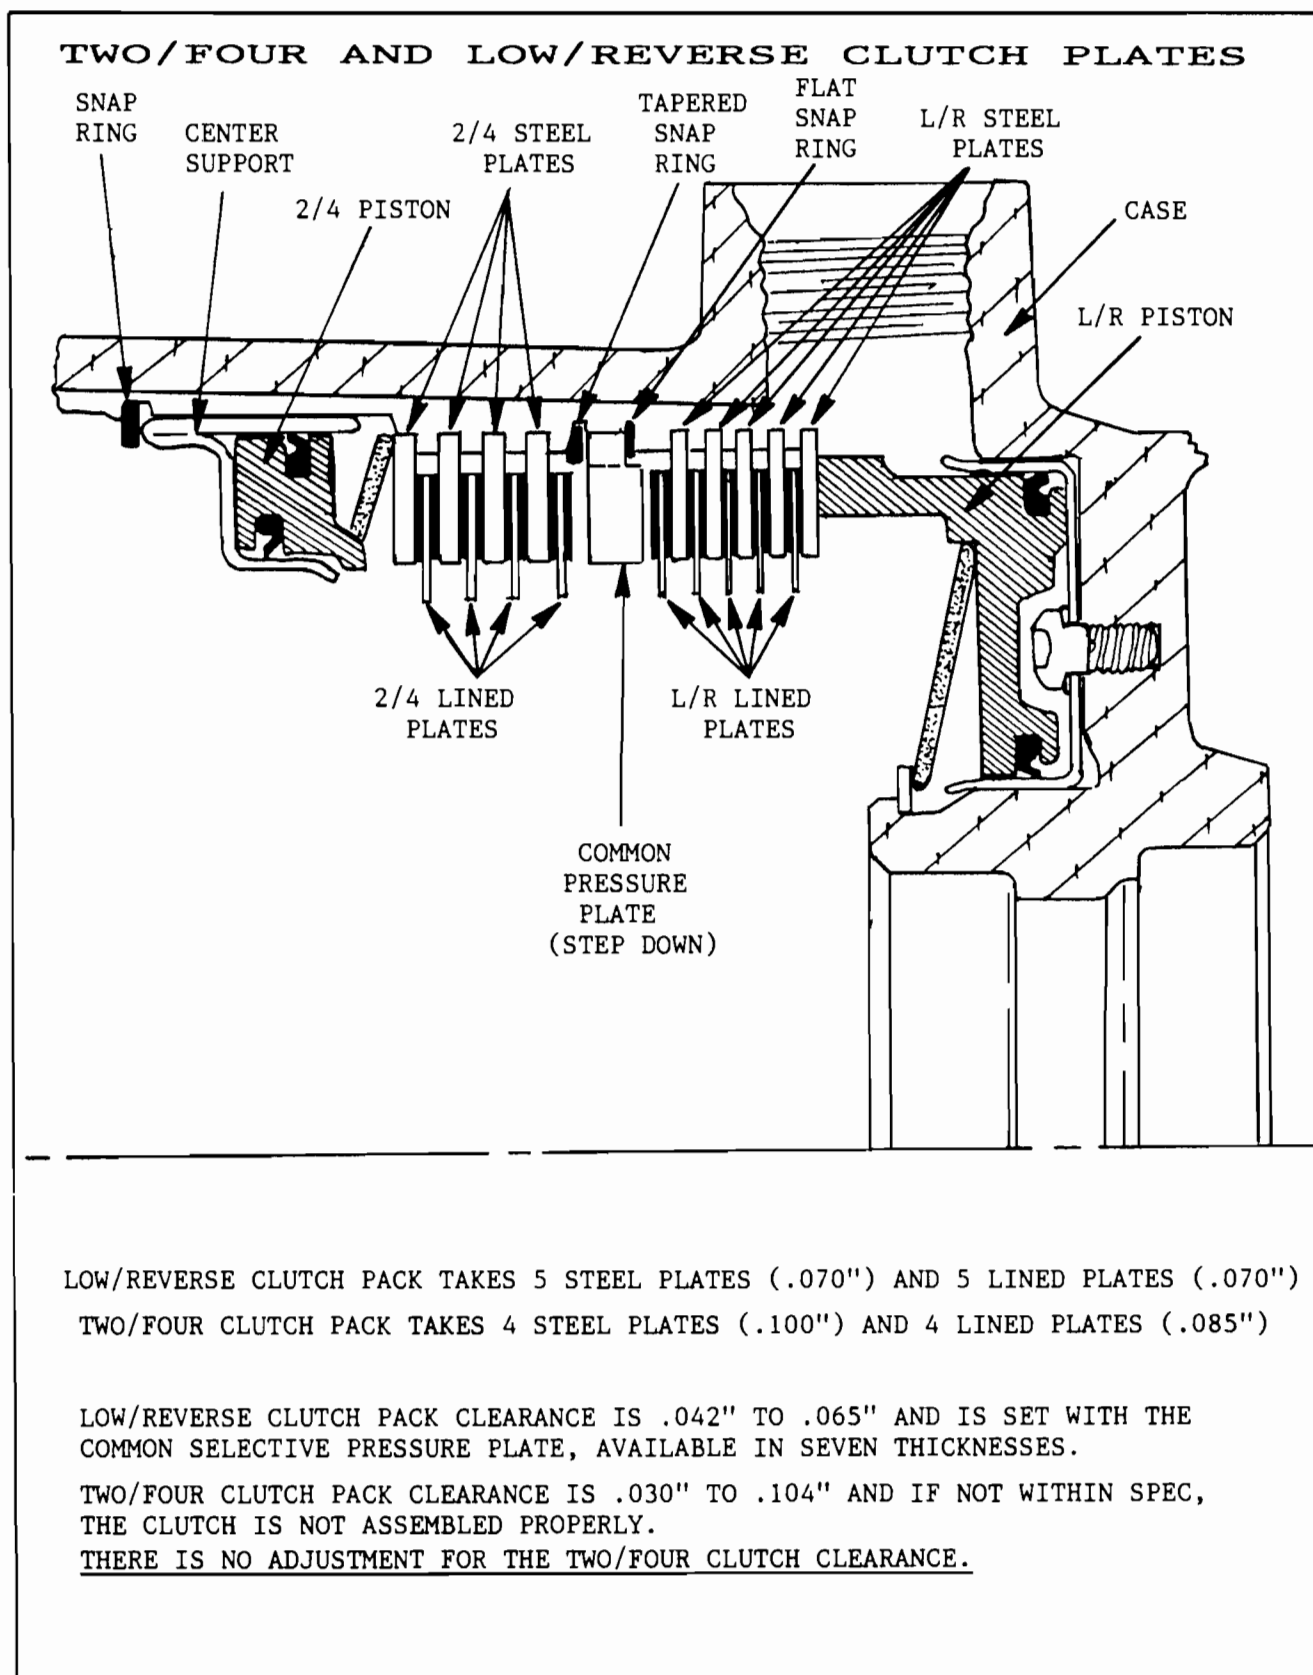
Figure 50
AUTOMATIC TRANSMISSION SERVICE GROUP

We have provided you with proper clutch stack up for these clutch packs, to assist you with proper assembly for the 2/4 and L/R clutch packs. Refer to Figure 50 for proper assembly procedures.

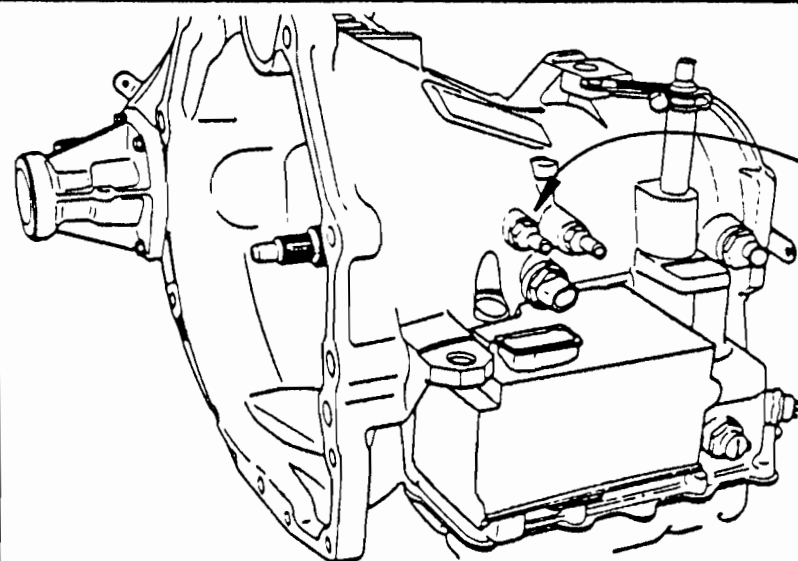
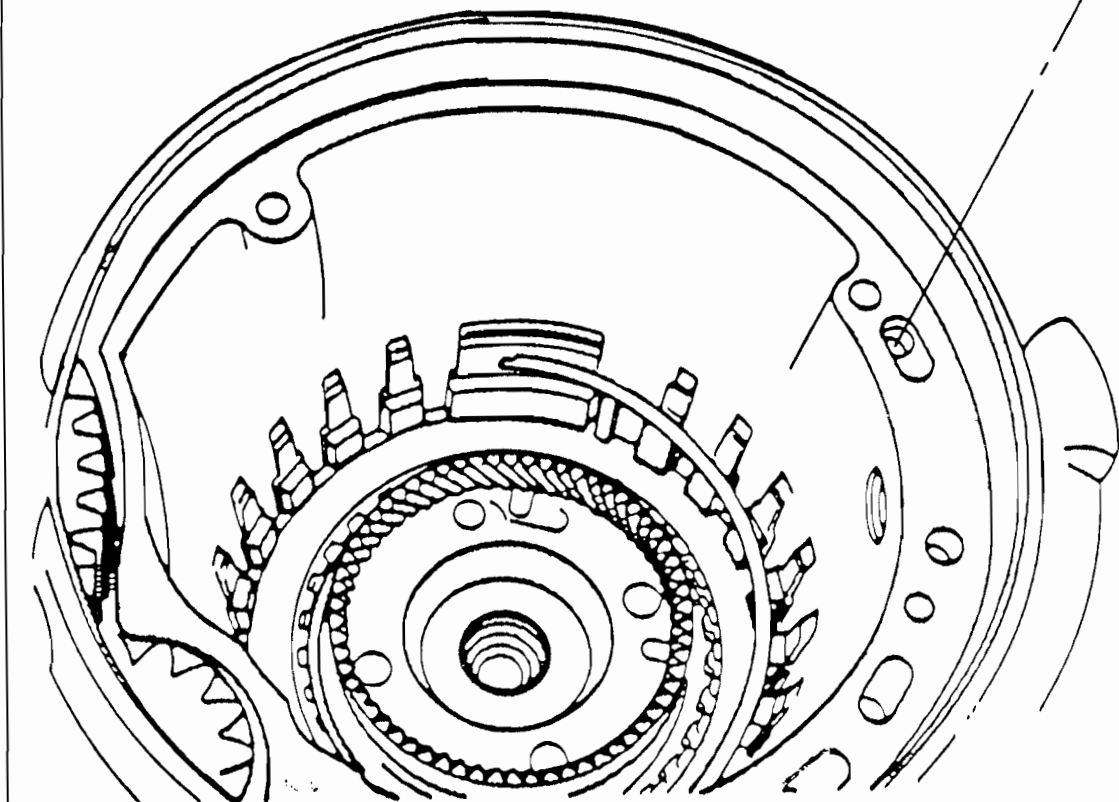
Figure 52
AUTOMATIC TRANSMISSION SERVICE GROUP

- (1) **COOLER BYPASS CHECK VALVE** - Added into the case cooler passage behind the oil pump (See Figure 52). If cooler oil flow is restricted, or blocked, the new check valve will open, and allow cooler feed oil direct into the lube circuit to prevent transaxle damage. Normal operation is resumed after oil temperature is again warm enough to flow through the cooler (See Figure 51).
NOTE: Customers should be advised to let the vehicle warm-up thoroughly before attempting to drive the vehicle, especially in the colder climates.
- (2) **TRANSAXLE CASE** - The new case has added material between the two cooler line fittings, to accomodate the machining process needed for the new cooler bypass check valve assembly (See Figure 52).
- (3) **VALVE BODY SPACER PLATE** - Lube feed hole in spacer plate has been enlarged to .112", as shown in Figure 53.

THE NEW CASE HAS ADDED MATERIAL BETWEEN COOLER LINE FITTINGS TO ACCOMMODATE MACHINING PROCESS FOR NEW COOLER BYPASS CHECK VALVE.

INSTALLS IN THE 1991 CASE PASSAGE, UNDER OIL PUMP IN THE DIRECTION SHOWN.

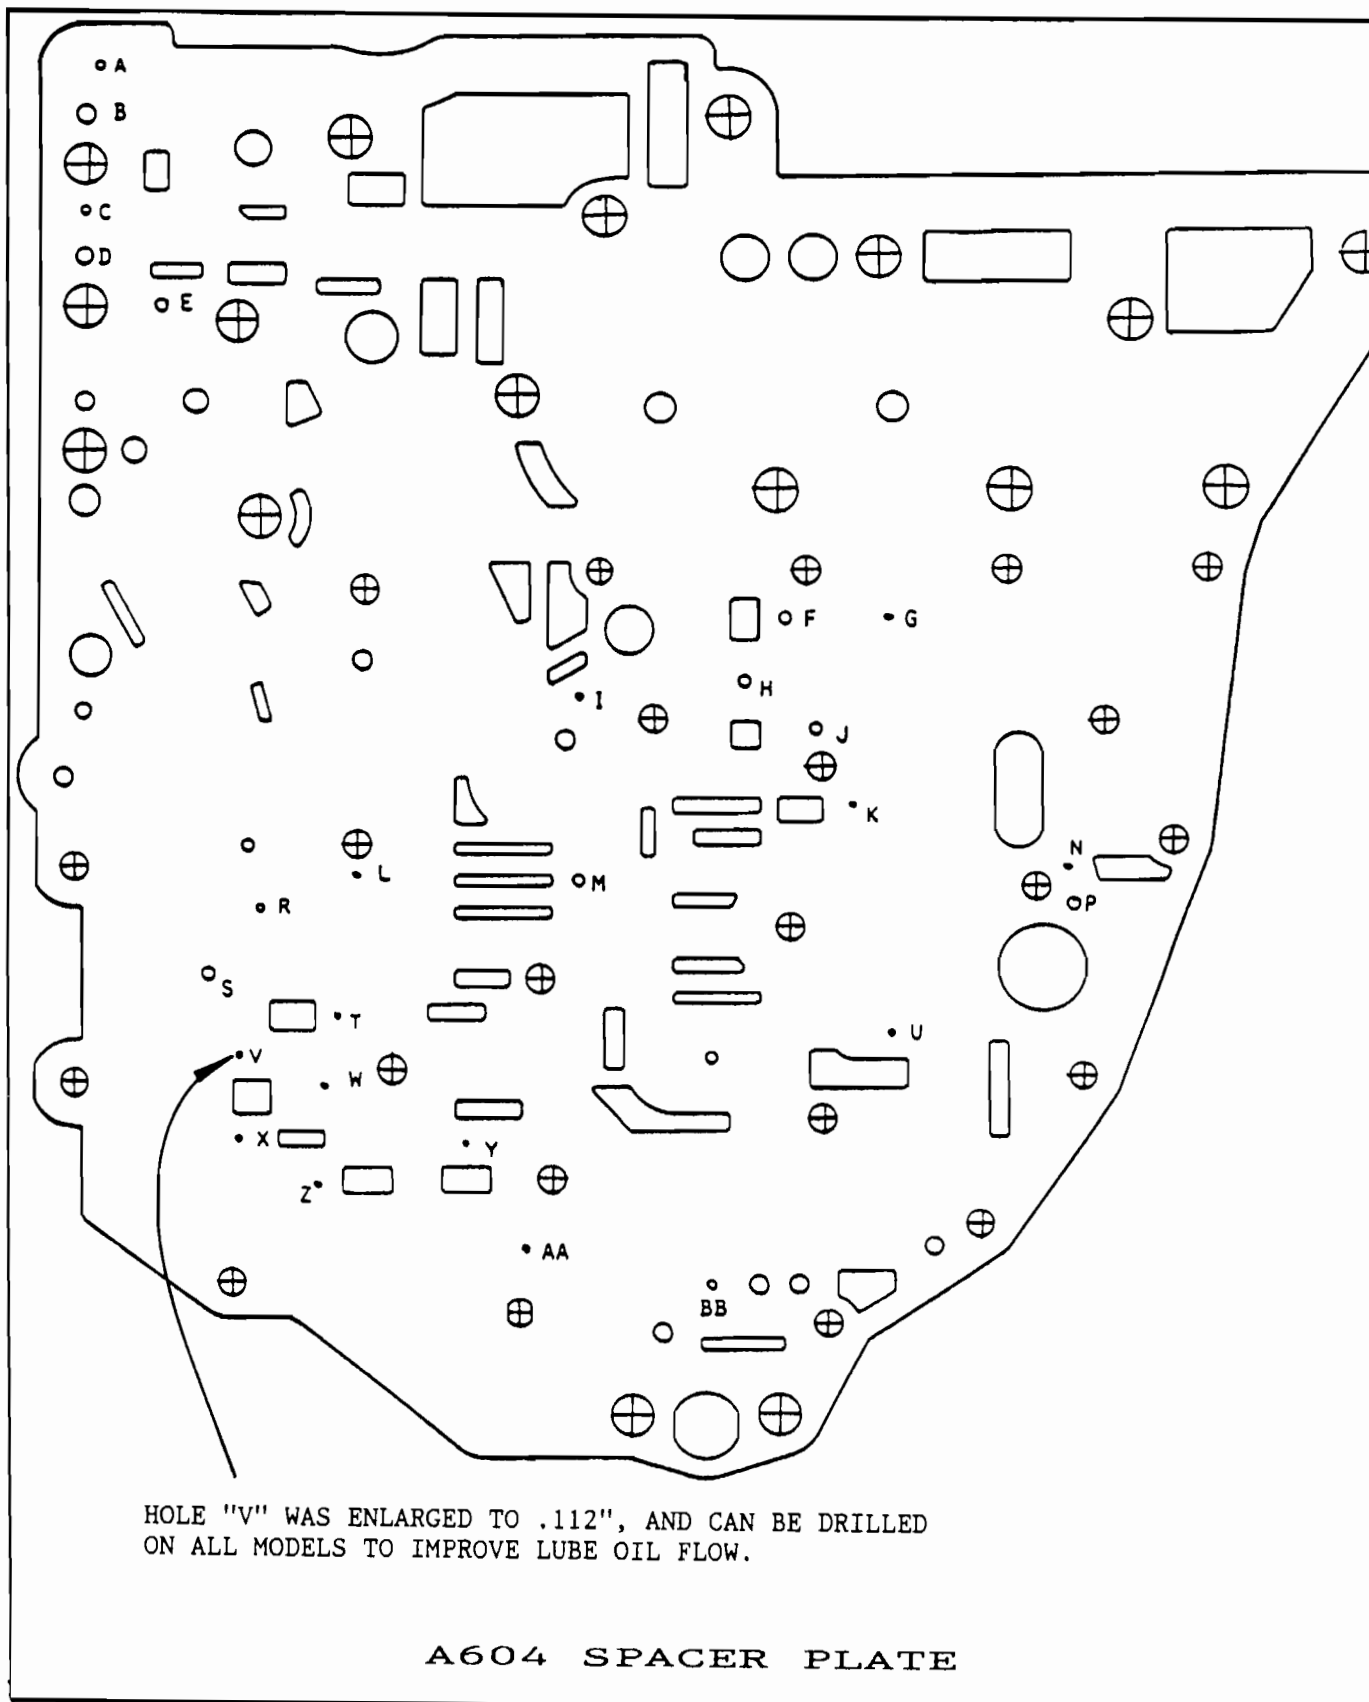
Figure 53
AUTOMATIC TRANSMISSION SERVICE GROUP

COMPLAINT: On 1989 and 1990 Chrysler models, equipped with the A604 transaxle, under extremely cold ambient operating temperatures (0° F or Below), transmission fluid may get cold enough to resist flow through the transmission oil cooler. The transaxle may fail prematurely due to lack of lubrication

CAUSE: Not enough lube flow to the transaxle because of restriction.

The lube feed hole in the spacer plate can be drilled to .112" on all models to improve oil flow (See Figure 53).

- (1) Install a pressure actuated bypass cooler valve assembly, now available from OEM under the part number 5252836, that will bypass the transmission oil cooler if it becomes restricted (See Figure 54).
- (2) Drill the hole marked "V" in the spacer plate to .112" as shown in Figure 53. This can be done on all models regardless of bypass valve installation, to improve lube flow to the transaxle.
- (3) Refer to the appropriate instruction sheet, included in the manual, as installation procedures vary depending on vehicle model.

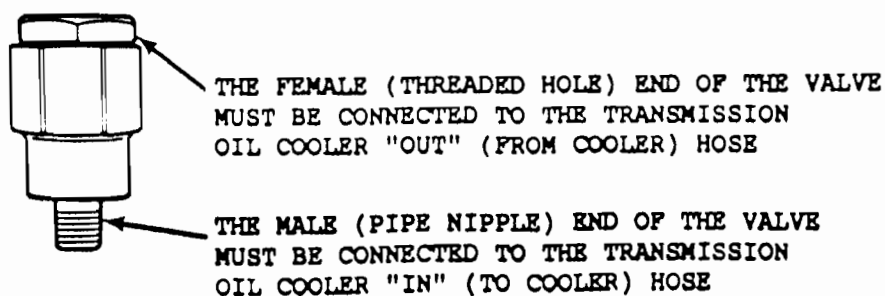
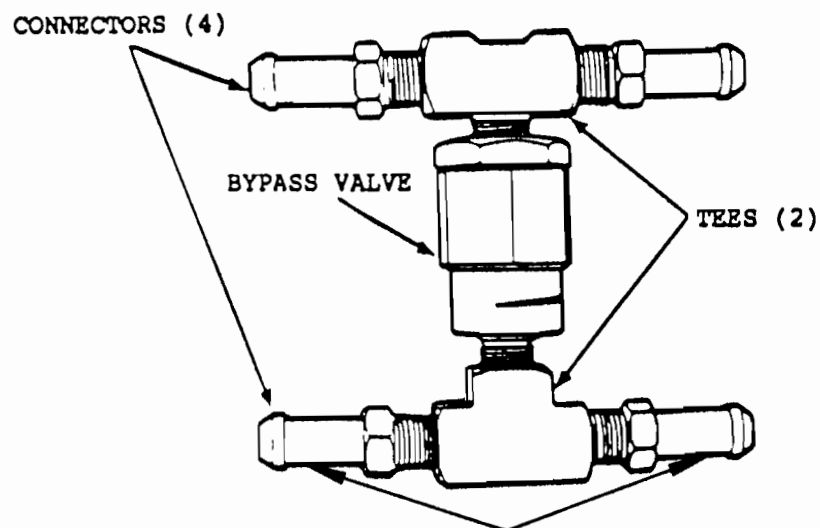
Figure 54
AUTOMATIC TRANSMISSION SERVICE GROUP

THIS SIDE OF THE BYPASS VALVE ASSEMBLY "MUST" BE CONNECTED
TO THE TRANSMISSION OIL COOLER "IN" (TO COOLER) HOSE.

NOTE: THE BYPASS VALVE IS DIRECTIONAL. IF IT IS NOT CONNECTED
TO THE TRANSAXLE OIL COOLER HOSES IN THE CORRECT OIL FLOW
DIRECTION, - THE BYPASS VALVE WILL NOT FUNCTION.

NOTE: THE BYPASS VALVE (5252836) IS DIRECTIONAL. IF IT IS NOT CONNECTED TO THE TRANSAXLE OIL COOLER HOSES IN THE CORRECT OIL FLOW DIRECTION, THE BYPASS VALVE WILL NOT FUNCTION (SEE FIGURE 54).

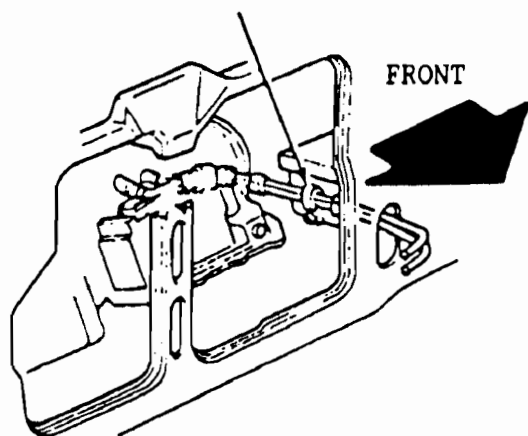
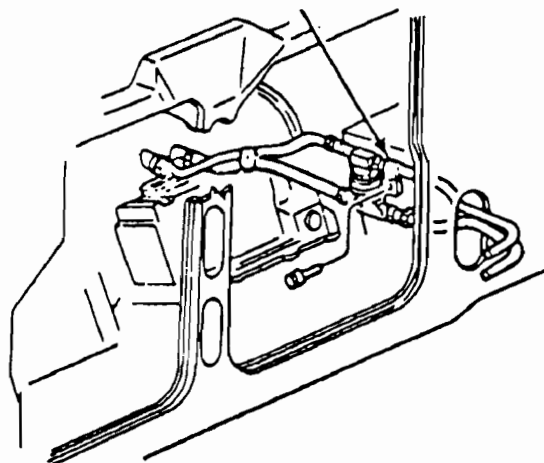
Figure 58

EXISTING COOLER LINE CLIP AT THE
ABS CONTROL MODULE

SUPPORT THE VALVE/HOSE ASSEMBLY
WITH EXISTING CLIP HOLDING THE TOP OF
HOSE AS SHOWN

1. The existing cooler hoses are retained by a clip at the ABS Module, as shown in Figure 58. Drilling of a hole is not required on this model.
2. Mark the hoses at the rear edge of the clip at the ABS Module, and then remove the retaining clip.

7. Re-install the retaining clip to support the bypass valve assembly, as shown in Figure 58, and tighten all hose clamps and retaining clips.
8. The bypass valve assembly must be positioned vertically (See Figure 58).
