"2001" SEMINAR INFORMATION "PRACTICAL TECH"

AUTOMATIC TRANSMISSION SERVICE GROUP

INTRODUCTION

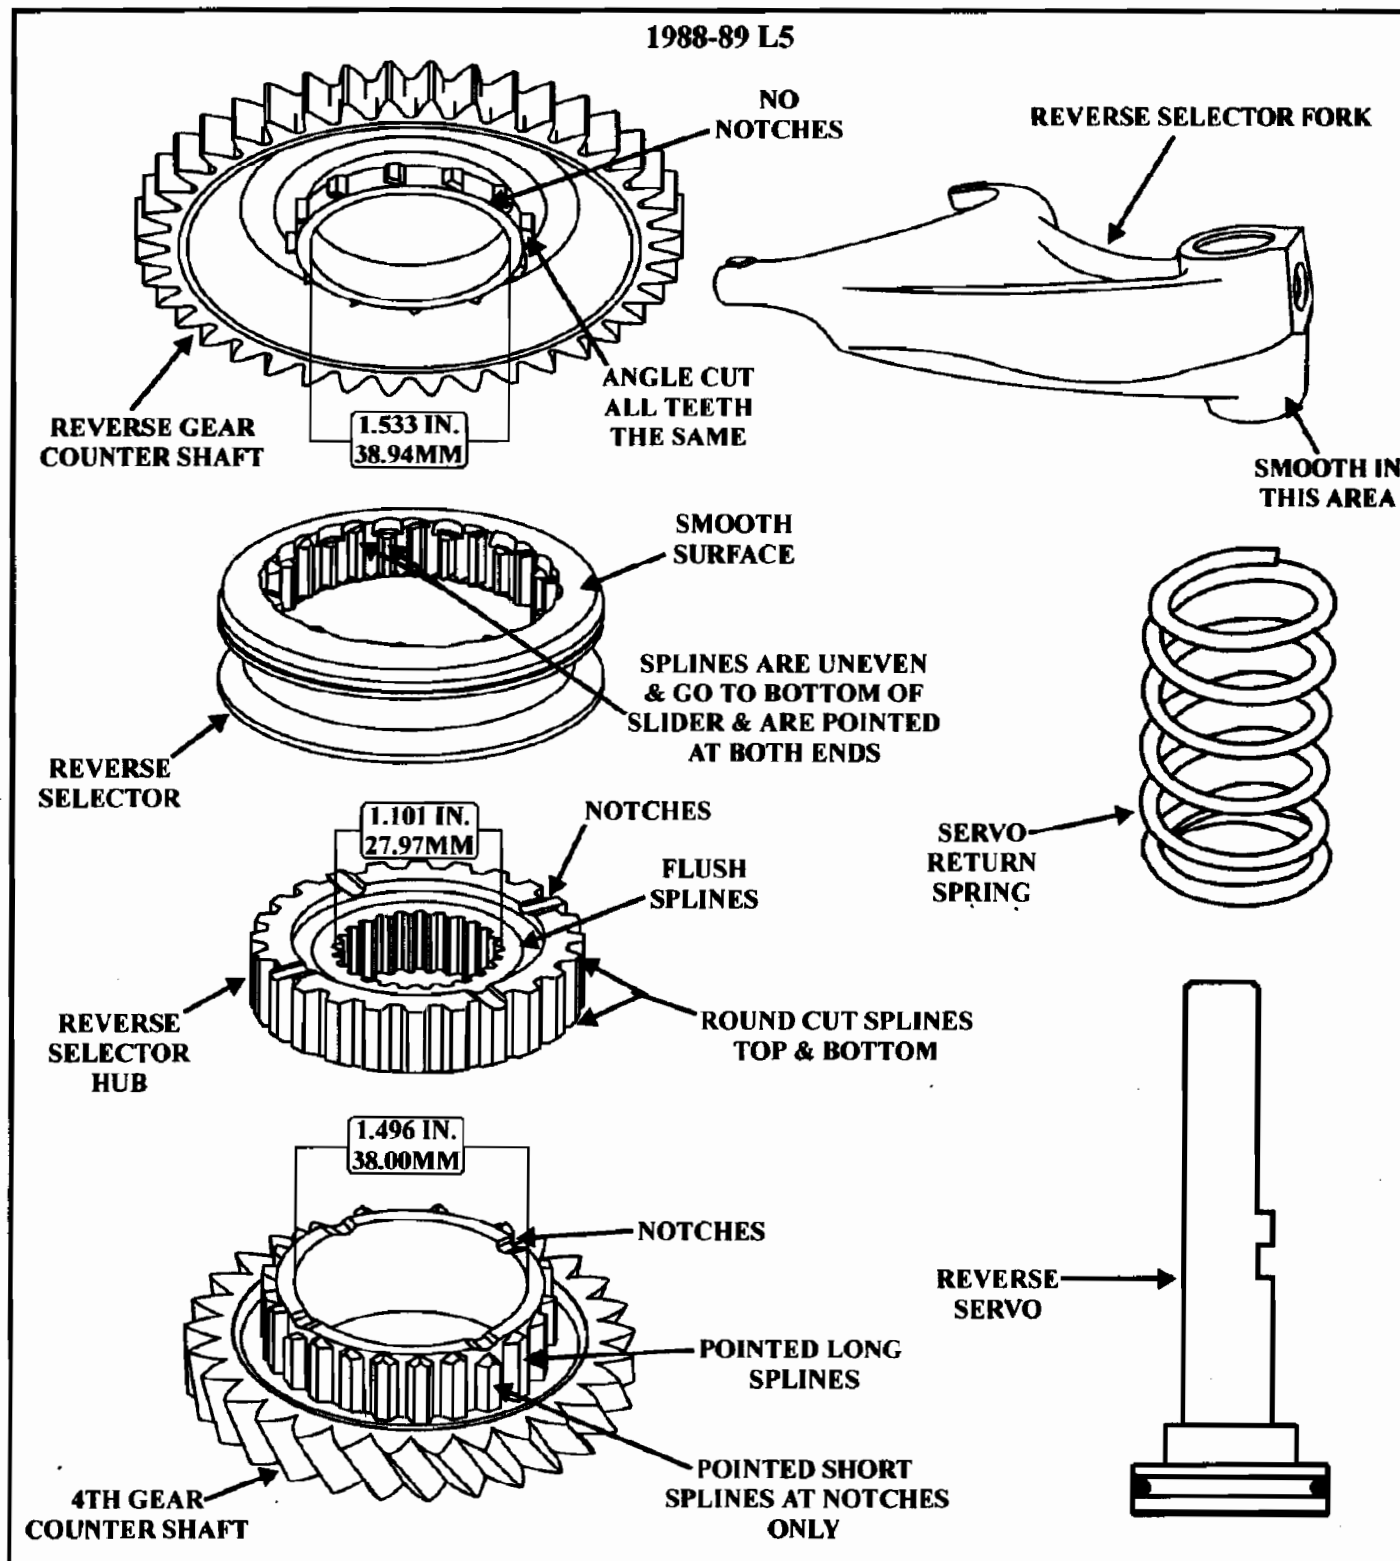
Figure 2

ACURA LEGEND WITH G4, L5 & PL5X TRANSAXLES

GRINDING OR BIND-UP IN REVERSE

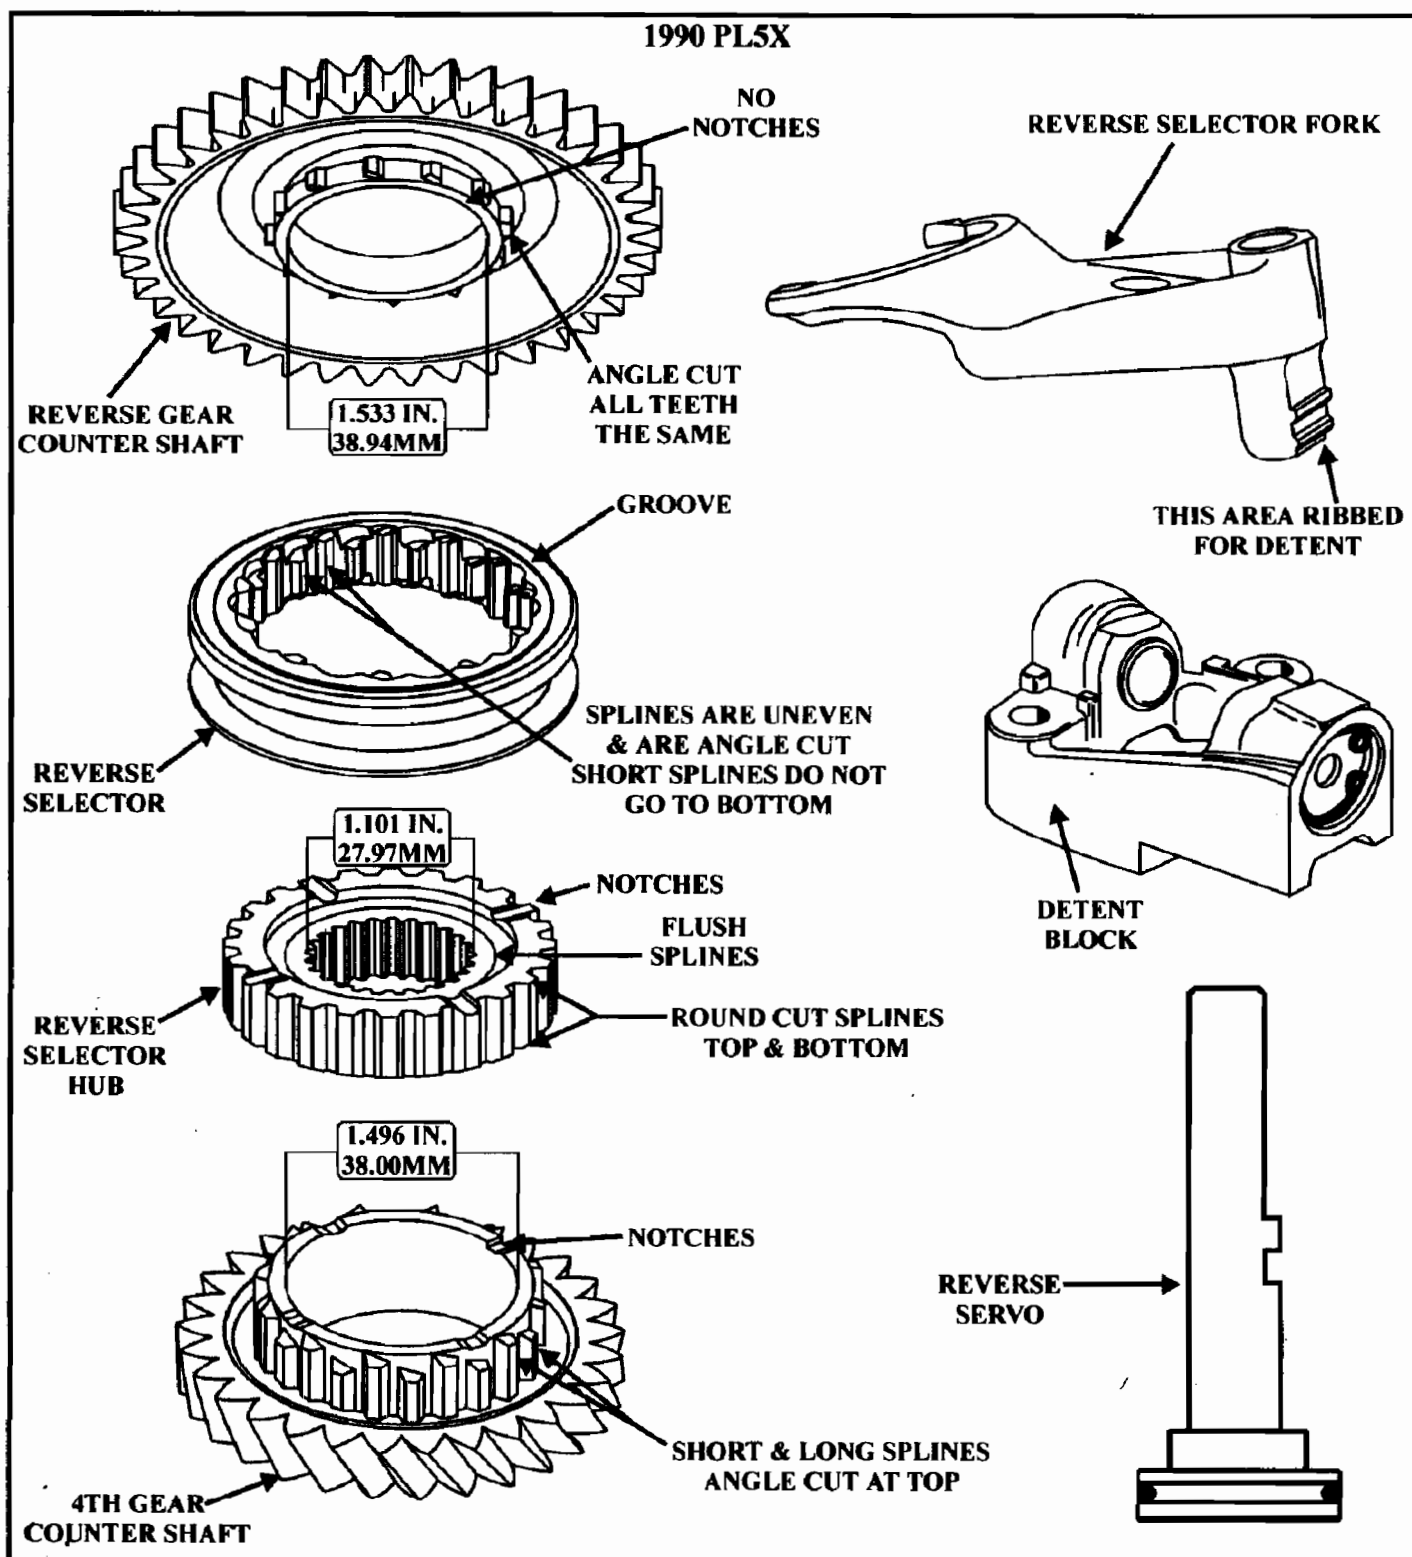
Figure 3

ACURA LEGEND WITH G4, L5 & PL5X TRANSAXLES

GRINDING OR BIND-UP IN REVERSE

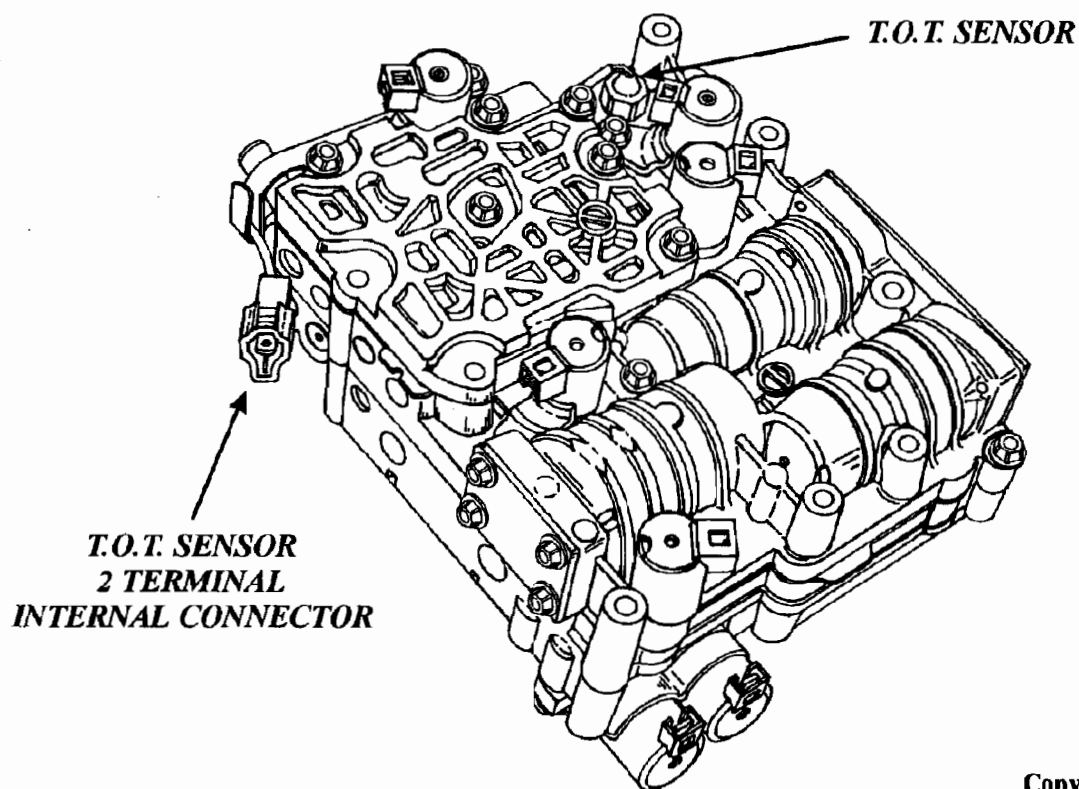
CAUSE: The cause may be, a faulty Transmission Temperature Sensor. **WHY:** Vehicles equipped with GF4A-EL transmissions have a computer strategy that *commands* line pressure to be maximum when fluid temperature is at or below 10°F. Therefore if the temperature sensor is faulty it may indicate that temperature is at or below 10°F at all times.

GF4A-EL TRANSMISSION OIL TEMPERATURE SENSOR LOCATION

CORRECTION: Refer to Figure 1 for the location of the Transmission Oil Temperature Sensor. Refer to Figure 2 for the Ohm value and testing procedure to check the sensor. Refer to Figure 3 for the testing procedure of the sensor at the 10 pin connector. Repair or replace temperature sensor as necessary.

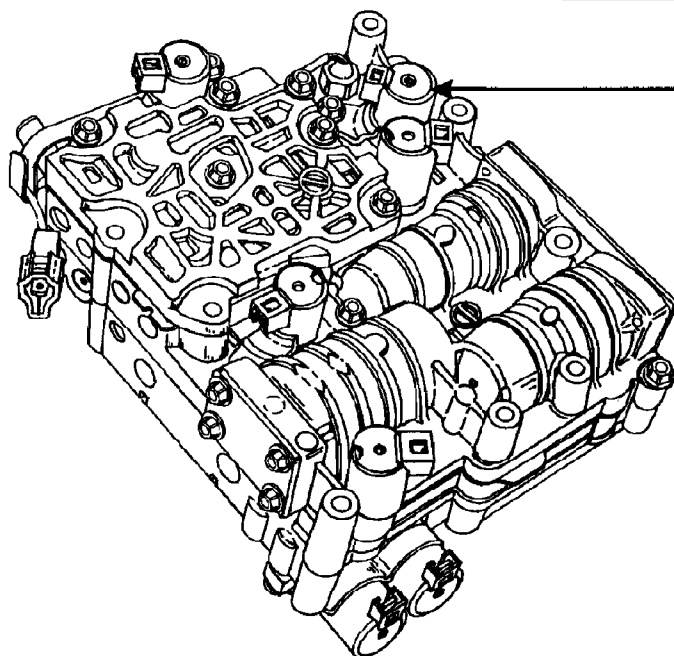
PRESSURE CONTROL SOLENOID

CAUSE: The cause may be, a faulty Pressure Control Solenoid, a worn Boost Valve and Sleeve and/or a worn Pressure Regulator Valve bore which is part of the Rear Control Valve Body.

CORRECTION: Replace the Pressure Control Solenoid as shown in Figure 1, with Ford part number F32Z-7G136-AA or Mazda part number FU9A-21-1G1A. Inspect the Pressure Regulator Valve and the Pressure Regulator Valve bore for wear or scoring as shown in Figure 2. If the bore has "shiny" spots where the Valve rides a "New" Rear Control Valve Body can be purchased from Mazda. Inspect the Boost Valve and Boost Valve Sleeve for wear or scoring, and replace as needed with Sonnax boost valve and sleeve as shown in Figure 2.

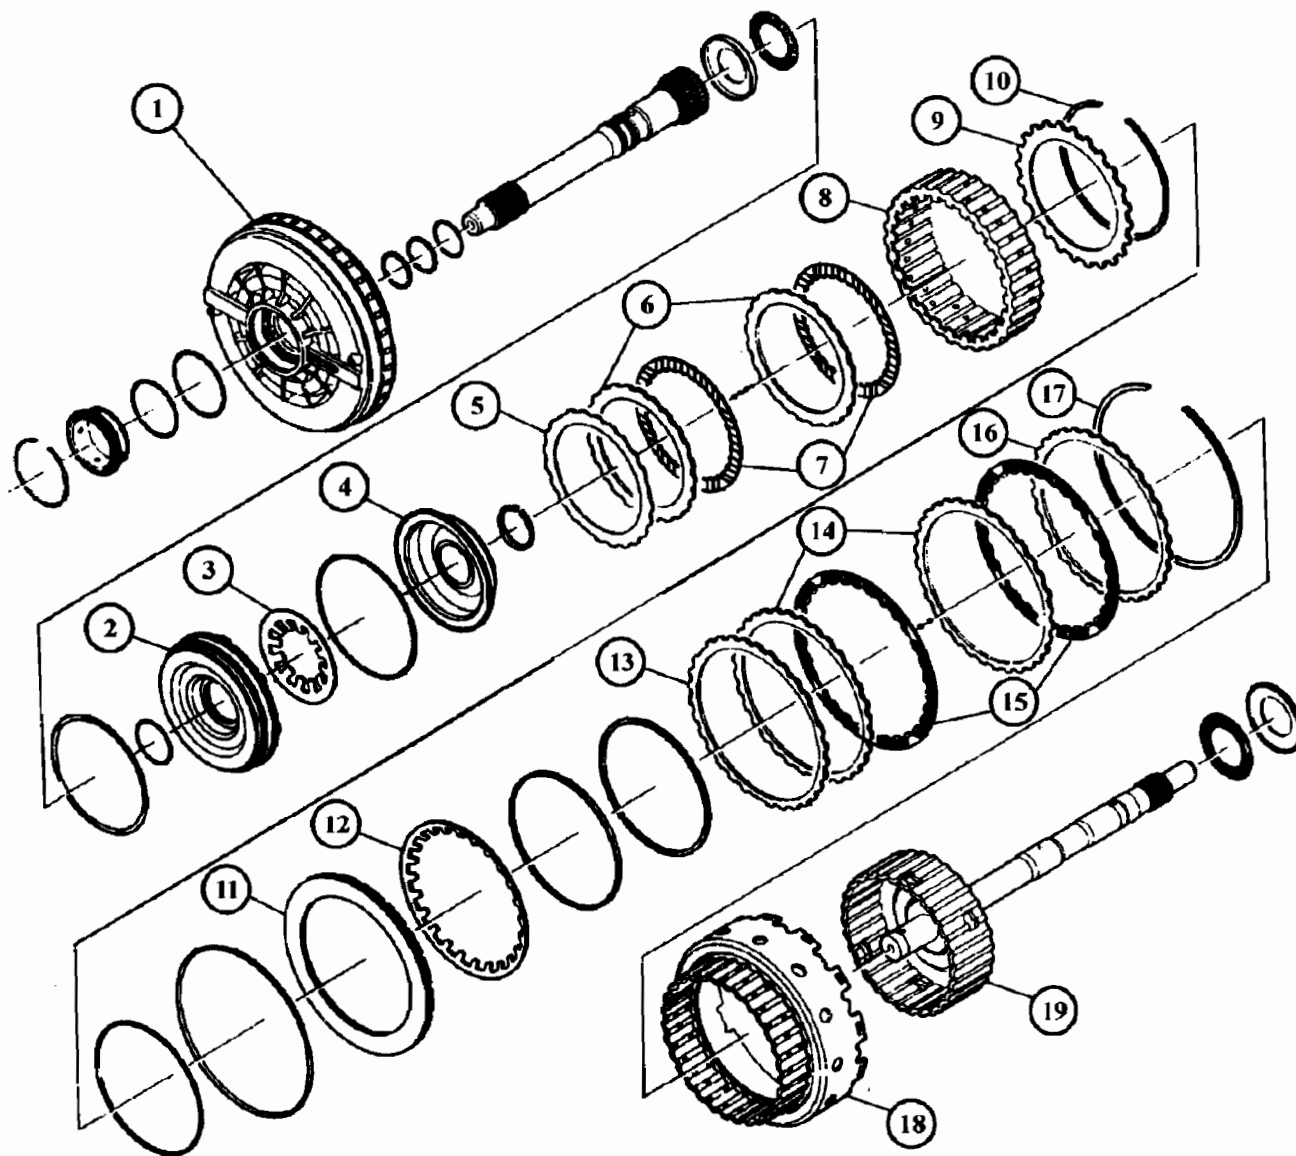
"A"/"C" CLUTCH HOUSING COMPONENTS

COMPLAINT: 1991 and later BMW vehicles equipped with the ZF5HP30 transmission may exhibit a no reverse condition, when selector lever is placed in the reverse position. This condition usually occurs after overhaul.

CAUSE: This condition can be caused by the incorrect assembly of the "A"/"C" Clutch Housing. If the clutch housing has been severely damaged, aluminum material will be evidenced in the bottom pan upon inspection.
When the unit is removed and the "A"/"C" Clutch Housing is dis-assembled, it is not uncommon for the unit to set for over a week waiting on parts. When re-assembling it is very easy to *mis-assemble* the "B" Clutch Hub (Figure 1, Item 8) on top of the retaining snap ring for the "A" Clutch pack (Figure 1, Item 10). This mis-assembly will create a neutralizing on the 3-4 upshift, and the Trans light will begin flashing.

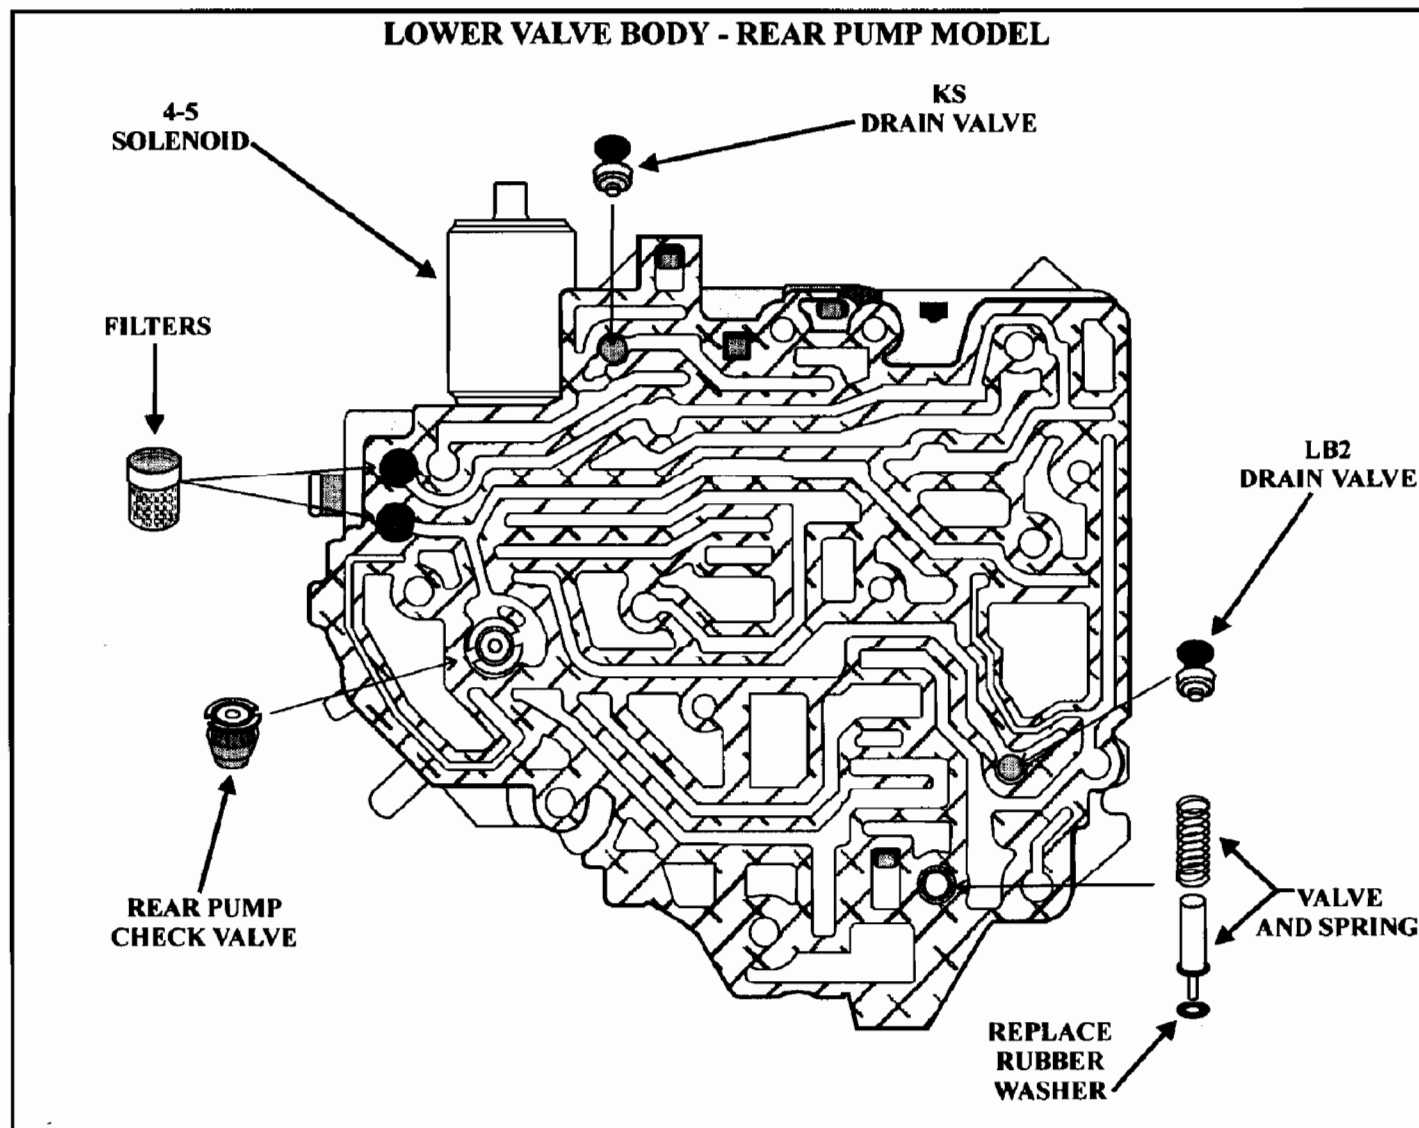
Figure 1

In figure 1 there is a rubber washer that is often lost and goes unnoticed, this rubber washer is located at the bottom of the valve and spring seen in the illustration below.

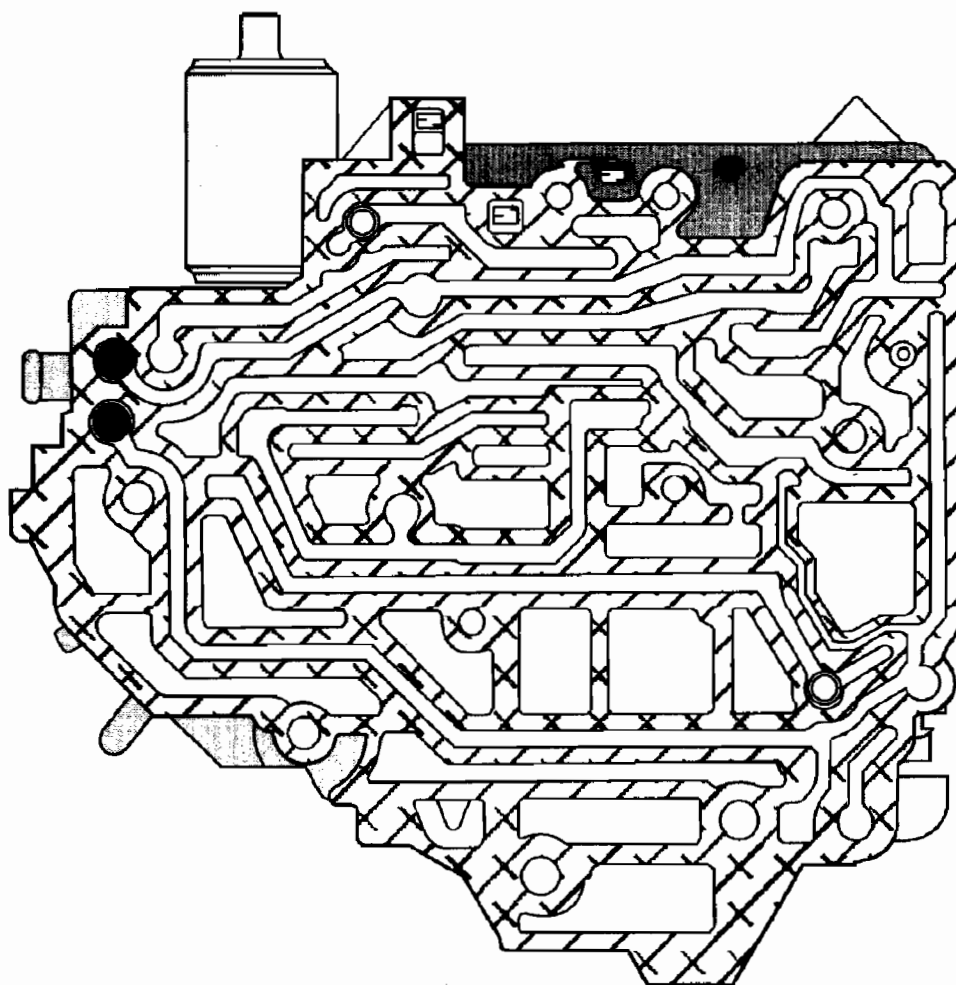
Figure 2

CAUSE: The lower cover section of the valve body still contains the Secondary Pump Shift Valve, See Figure 2. When this valve strokes, it allows B2 apply oil to exhaust, which causes the transmission slip on take-off. This directly affects the application of the B2 band which is necessary for forward movement.

CORRECTION: Install the aluminum plug seen in figure 2, in place of the secondary pump shift valve train, using only the retainer and the aluminum plug.

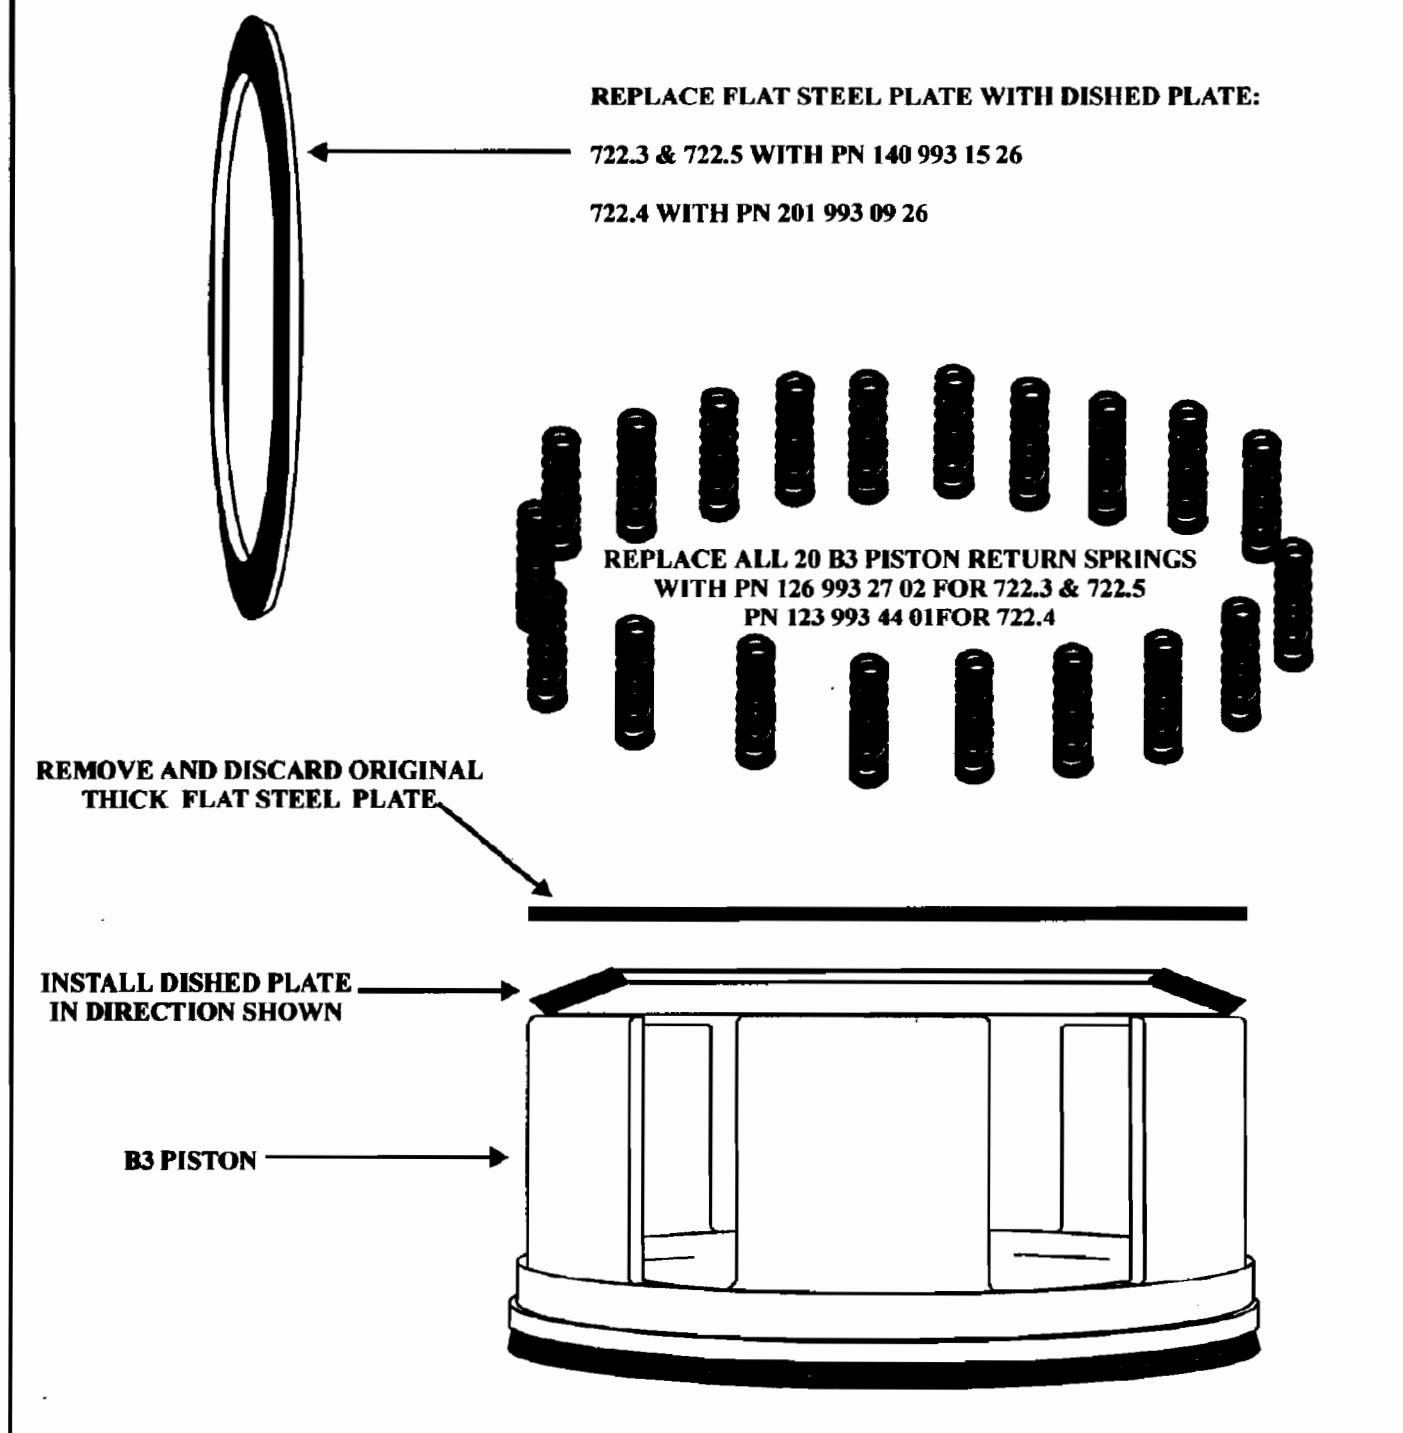
Figure 1

- (1) The harsh reverse engagement is a result of the flat steel plate not providing enough of a cushioning effect for the application of the B3 clutch. In addition, the B3 piston return springs are too weak. (Refer to Figure 1)
- (2) & (3) Delayed reverse engagement caused by pressure leaking between the valve body separator plate and the KS Drain Valve in the transmission case. The orifice feed in the separator plate shown in figures 2 and 3 were made too large (4MM) by the factory.
Delayed reverse engagement caused by the checkball in the valve body, shown in figure 4, not seating properly resulting in a loss of B3 apply oil.

MERCEDES BENZ 722.3, 722.4 & 722.5**REVERSE CONCERNS****722.3, 722.4 & 722.5 HARSH REVERSE ENGAGEMENT**

- (1) On 722.3, 722.4 and 722.5 replace the thick flat steel plate that is normally positioned on top of the B3 piston with the dished plate in the direction indicated in figure 1. The twenty B3 piston return springs, also shown in figure 1, should also be replaced at this time.

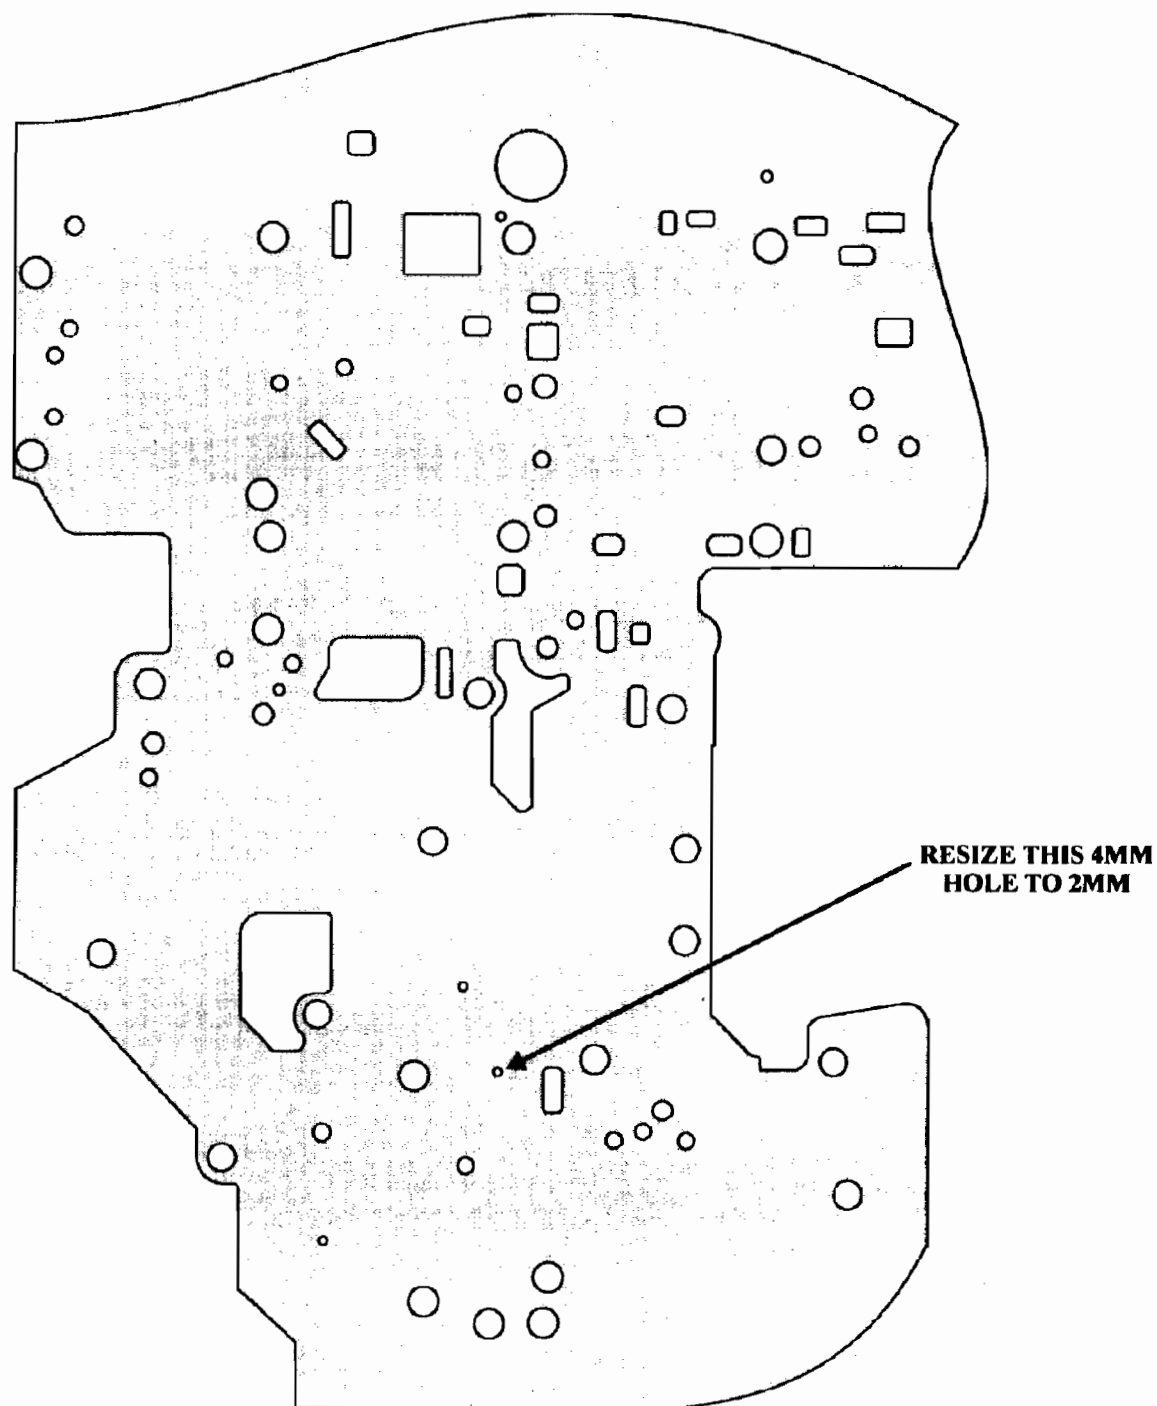
**Figure 2**

MERCEDES BENZ 722.3, 722.4 & 722.5**REVERSE CONCERNS****722.5 WITH REAR PUMP ONLY - DELAY IN REVERSE**

- (2) On 722.5 with rear pump reduce the 4MM (.157") hole in the separator plate shown in figure 2 to 2MM (.787").
- (3) On 722.5 without rear pump and 722.3 reduce the 4MM hole in the separator plate shown in figure 3 to 2MM. If your separator plate has the large hole shown in figure 3, replace the separator plate.
If the vehicle is a 1992 or later, this problem has been corrected by the factory.
On 722.3 and 722.5, discard the checkball shown in figure 4 and enlarge the hole in the bottom of the checkball pocket to .159" (4.4MM). Then tap the hole for a 10-32 machine screw thread and screw a 10-32 machine screw into the threaded hole as shown in figure 5.

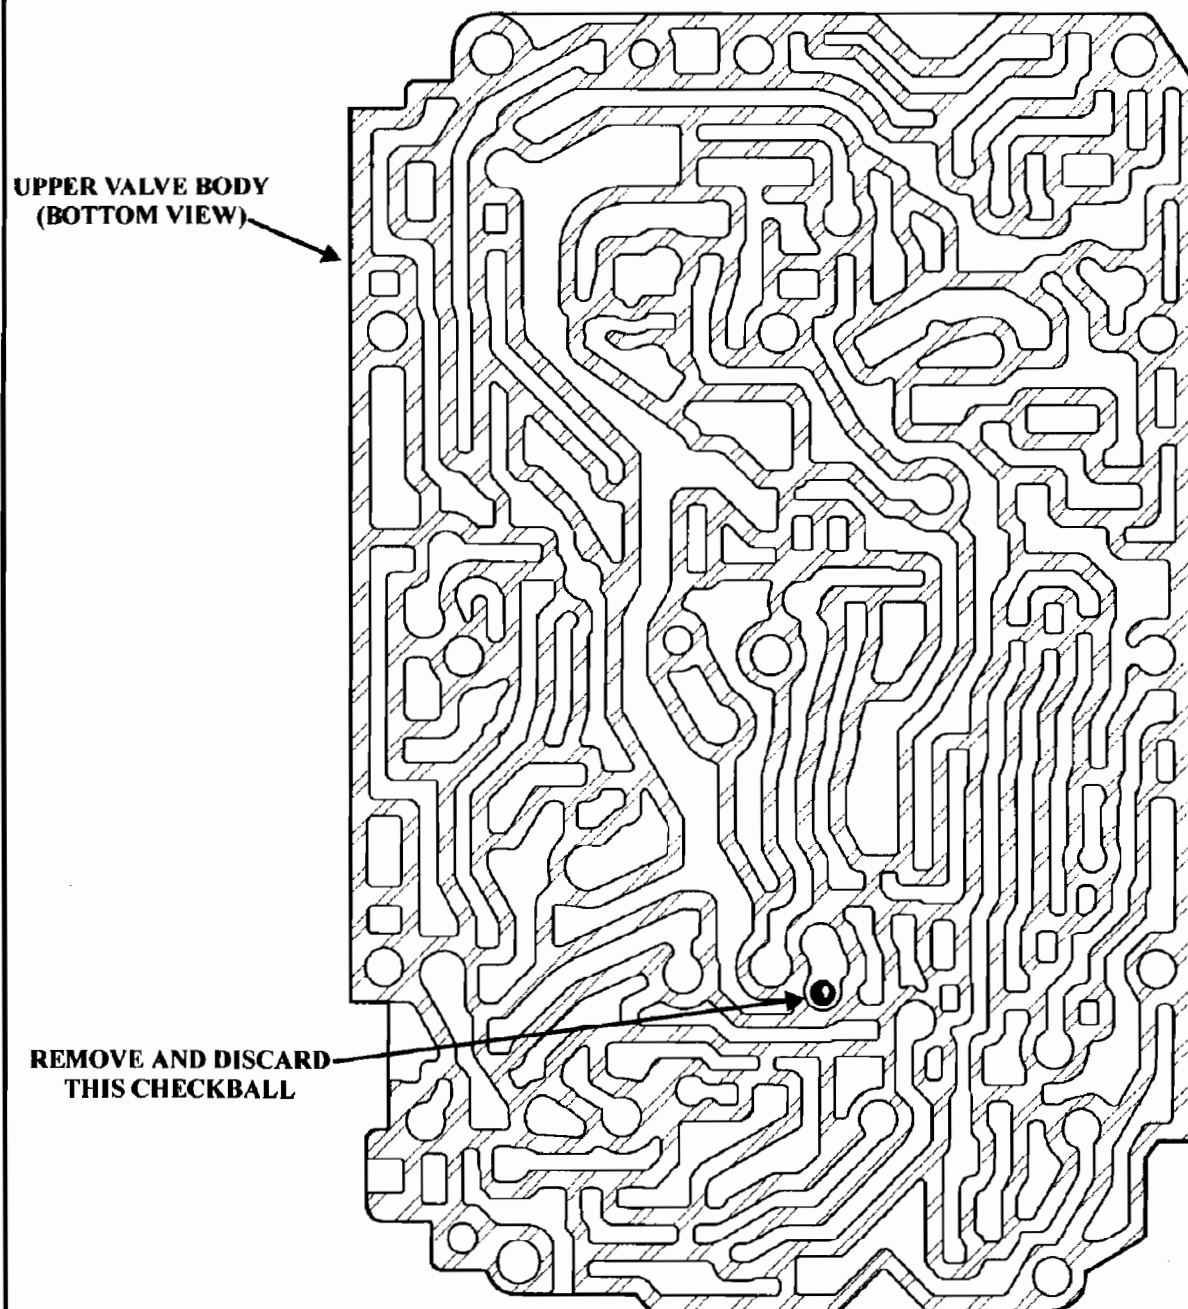
**Figure 4**

MERCEDES BENZ 722.3, 722.4 & 722.5**REVERSE CONCERNS****722.3 & 722.5 DELAYED REVERSE ENGAGEMENT**

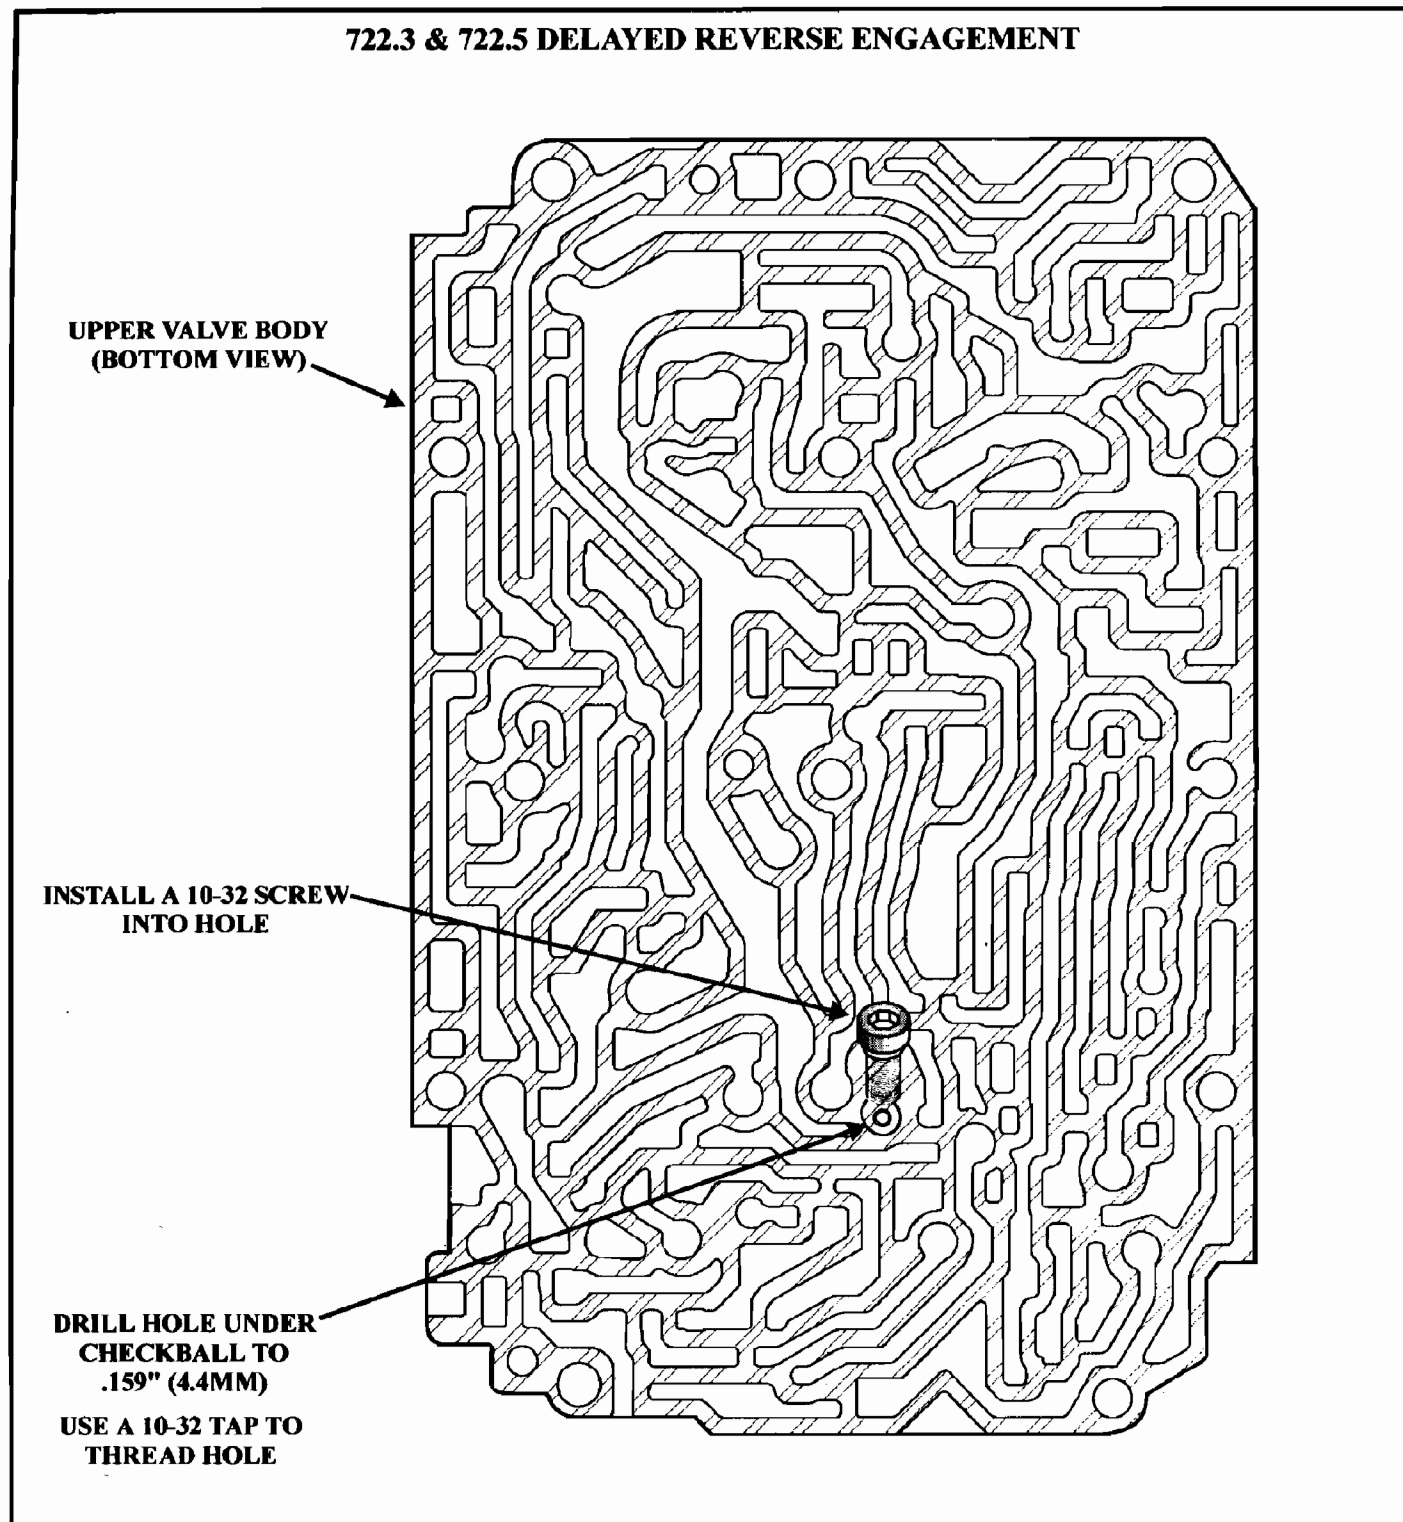
Figure 5

MERCEDES BENZ 722.3, 722.4 & 722.5**REVERSE CONCERNS****722.3 & 722.5 DELAYED REVERSE ENGAGEMENT**

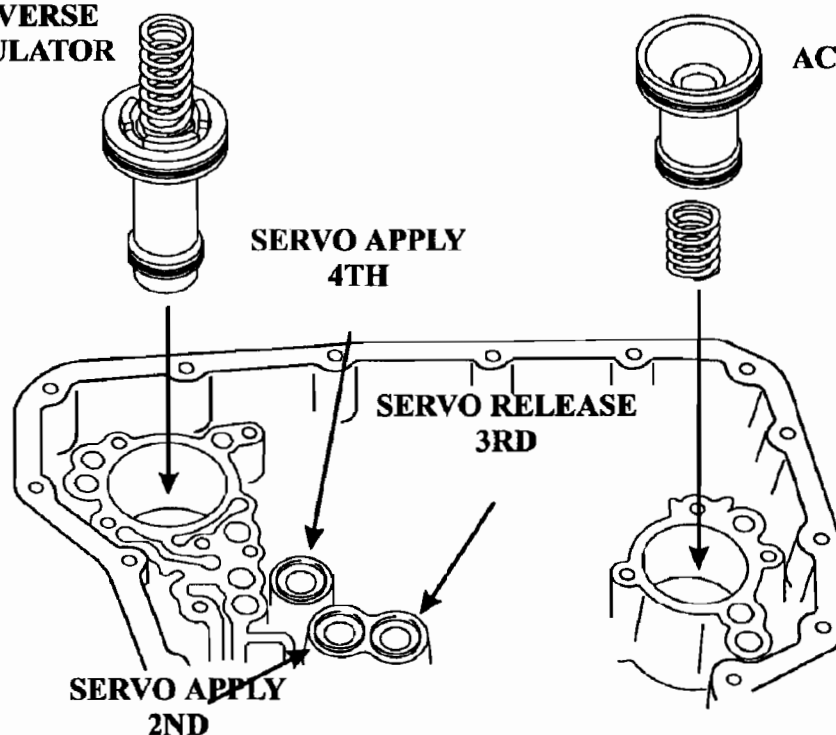
CAUSE NO. 2: Another cause may be the 2/4 servo return spring switched with the N/D accumulator spring. If the N/D accumulator spring is installed in the location for the 2/4 servo return spring, the N/D accumulator spring will coil bind before the 2/4 servo gets a chance to fully apply the band resulting in a no second gear condition. Refer to Figure 5 for spring specifications and proper placement of the 2-4 servo return spring and the N-D accumulator spring.

CORRECTION NO. 2: Refer to Figure 5 for spring specifications and place the 2-4 servo return spring and the N-D accumulator spring in their proper locations.

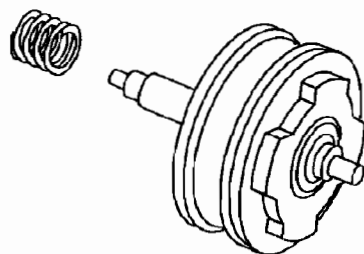
**THE N/D ACCUMULATOR
SPRING IS APPROX. 1.7" TO 1.9"**

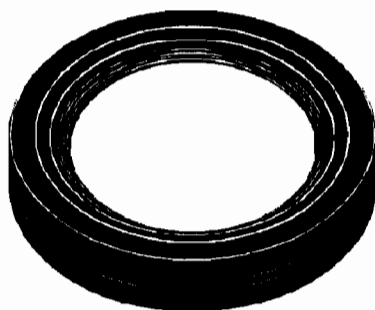
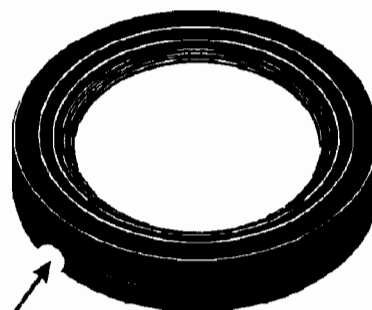
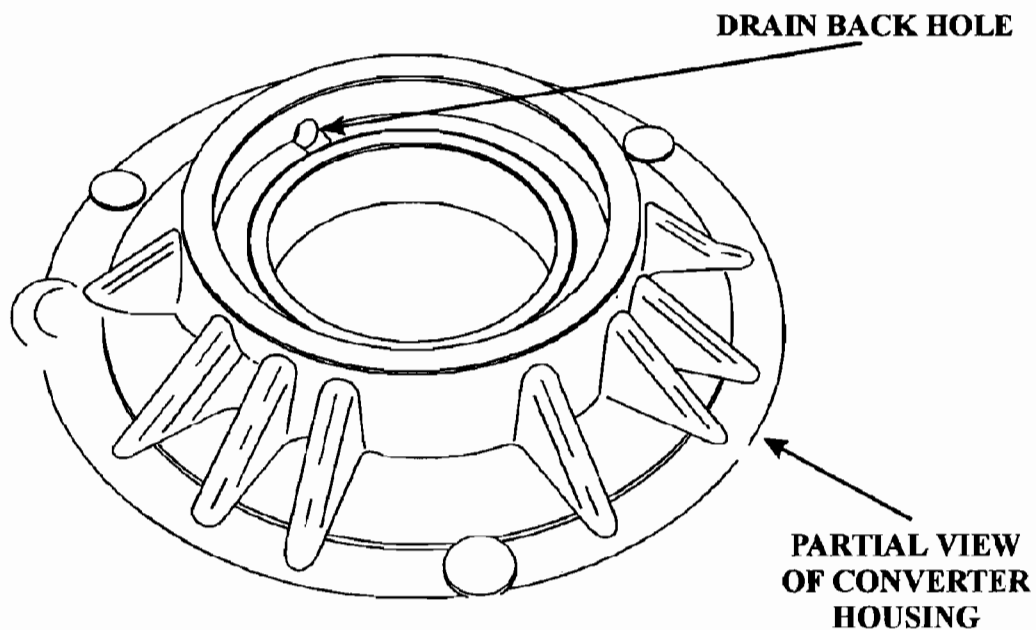
CAUSE: One cause may be that during the rebuild procedure the front pump seal was installed too deeply into the converter housing. When this happens, the seal will block off approximately half of the drain back hole in the pump causing an increase of oil pressure behind the seal. Due to the increased pressure, the front seal may either pop out of the converter housing, or oil may blow past the seal between the seal lip and the converter hub.

INSTALLING A NEW SEAL TOO DEEPLY INTO THE CONVERTER HOUSING WILL BLOCK ABOUT HALF OF THE DRAIN BACK HOLE IN THE SEAL AREA, WHICH COULD CREATE EXCESS PRESSURE BEHIND THE SEAL CAUSING THE SEAL TO WALK OUT OF THE PUMP.

CORRECTION: To correct the problem use a die grinder and cut a round notch into the seal approximately the same size as the drain back hole, then index the seal into the converter housing lining up the notch that you just cut, with the drain back hole. Refer to Figure 1 for location of the drain back hole in the converter housing and location of round notch in seal. It has been ATSG's experience that OEM seals have a better retention rate than some of the aftermarket seals.

USE A DIE GRINDER AND CUT A NOTCH INTO THE SEAL AS SHOWN ABOVE. NEXT INDEX THE NOTCHED CUT OUT OVER THE DRAIN BACK HOLE IN THE CONVERTER HOUSING WHEN INSTALLING THE SEAL.

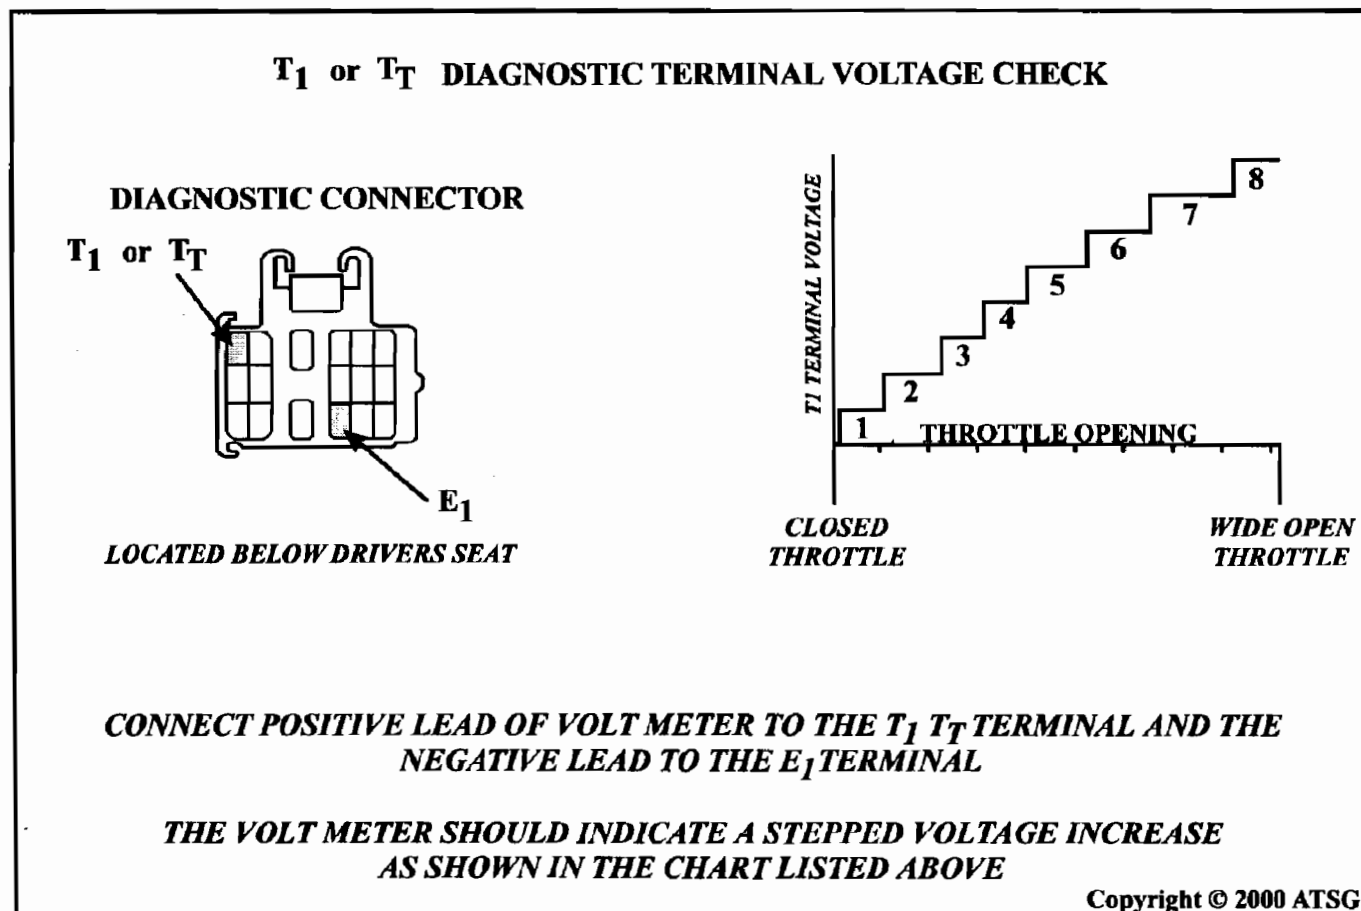
CAUSE: The cause may be, a broken wiring harness at the Throttle Position Sensor Connector or a break in the harness from the Throttle Position Sensor where it enters a protective cover as shown in Figure 2, or a faulty Throttle Position Sensor.

CORRECTION: Refer to Figure 1 to test the Throttle Position Sensor Diagnostic Voltage output at the Diagnostic connector as shown in Figure 1. Locate the break in the harness as shown in Figure 2. If the wires are broken where the harness enters the protective cover, add some length, with some new wire, to the harness and reconnect the harness. If the wires are broken at the connector, where they can not be repaired, replace the connector with a TPS connector with 7 or 8 inches of the harness from a 1.8 L Tercel engine from a salvage yard or a new upper wire harness for the whole upper engine can be purchased from Toyota. If the wire harness is good test the Throttle Position Sensor as shown in Figure 3 and replace as necessary.
