"2001" SEMINAR INFORMATION "PRACTICAL TECH"

AUTOMATIC TRANSMISSION SERVICE GROUP

INTRODUCTION

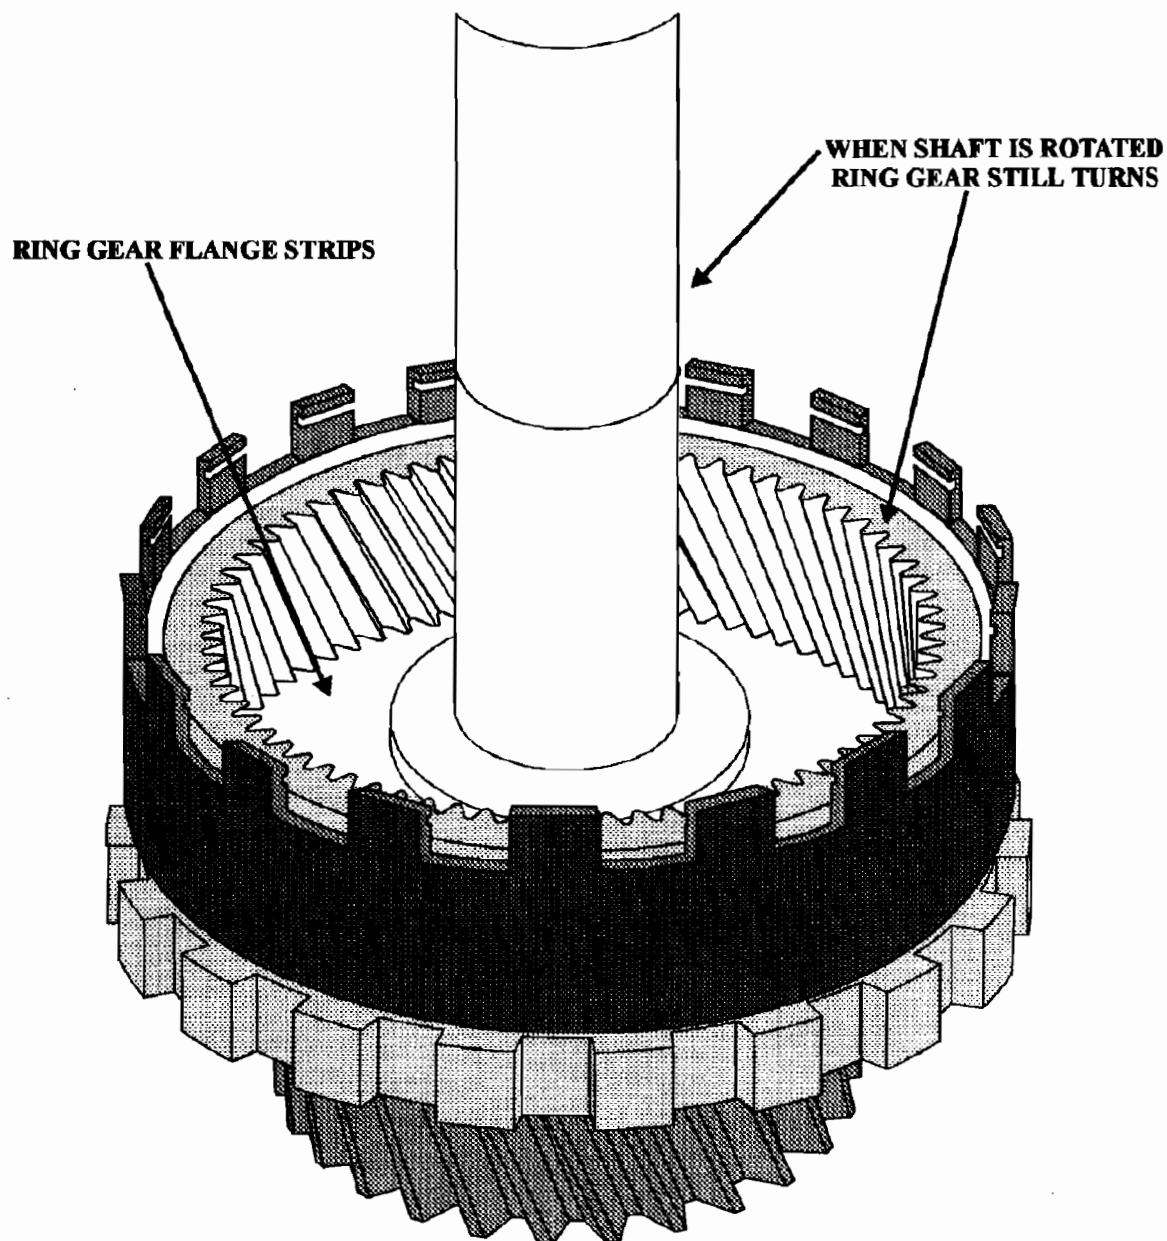
Figure 1

CAUSE: The component that was overlooked that caused the "no move" condition is the counter shaft/ring gear assembly shown in figure 1. The actual cause of the "no move" condition is the stripped teeth of the counter shaft ring gear flange. With these teeth stripped, the mechanical connection between the counter shaft and the final drive is lost, resulting in the "no move" condition. (Refer to Figure 2)

The reason for overlooking this damage is two fold. First, this component is usually not disassembled because the technician may not want to loose the preload on the counter shaft bearings which would save time by not having to set up the counter shaft bearing preload due to the fact that preload is set via a crush collar.

CORRECTION: If a vehicle equipped with a 240 series transaxle is towed in with a "no move" condition, be sure the counter shaft/ring gear assembly is disassembled and inspected.

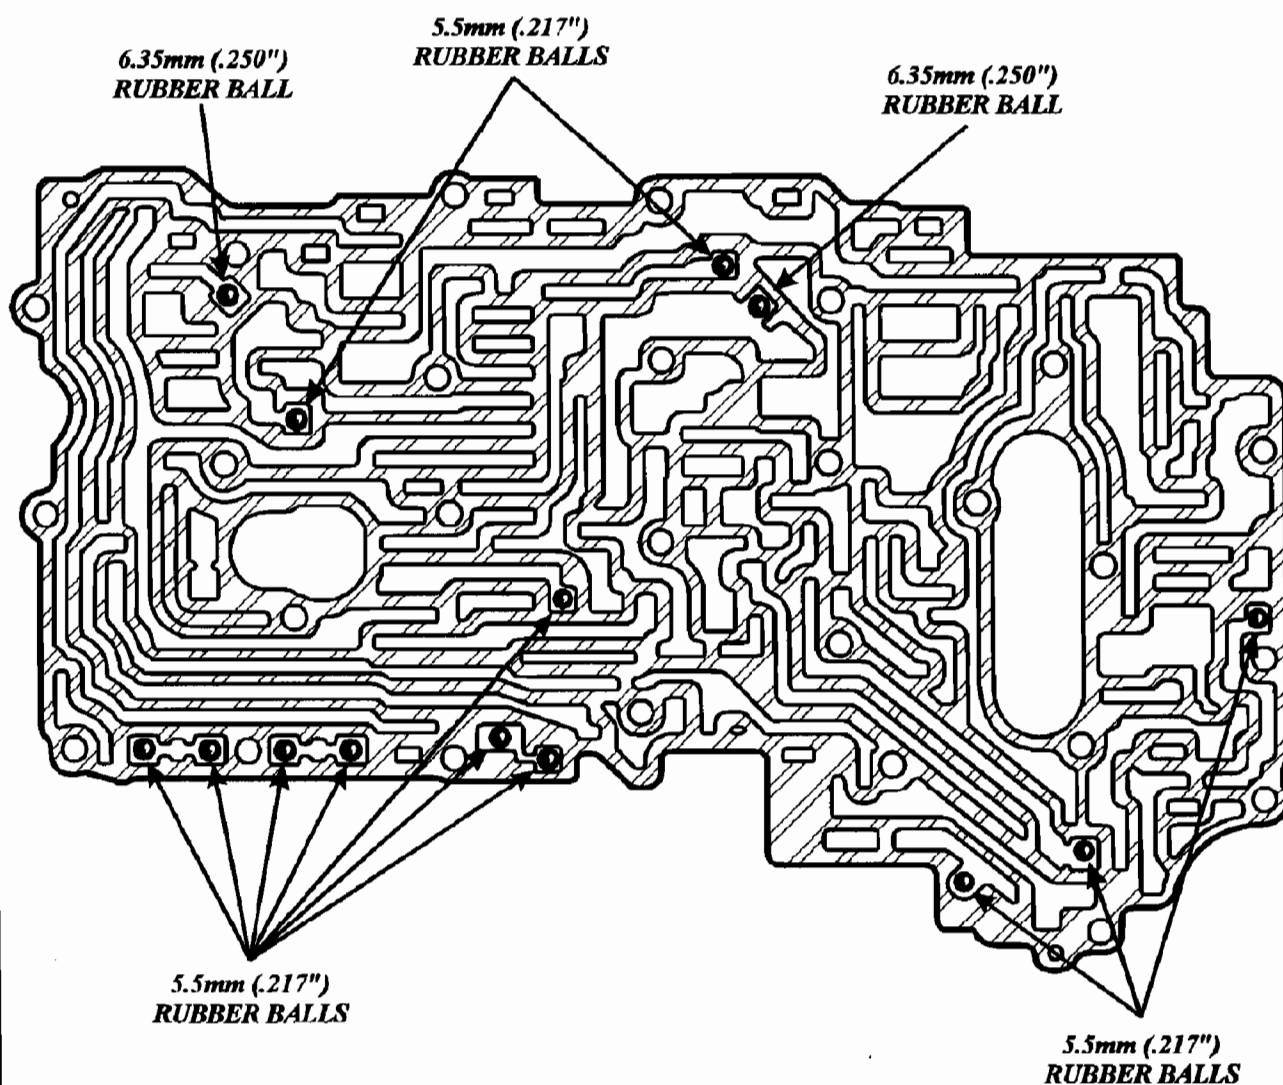
CAUSE: The cause may be, a check ball was added to the Upper Valve Body for the 93 and up checkball locations as shown in Figure 2. When this happens, the C2 or Direct clutch can apply at a faster rate, because the passage to the C2 or Direct accumulator piston is restricted by the ball.

CORRECTION: Refer to Figure 1 for the correct checkball location for 1991-92 model applications and Figure 2 for 1993 and later models.

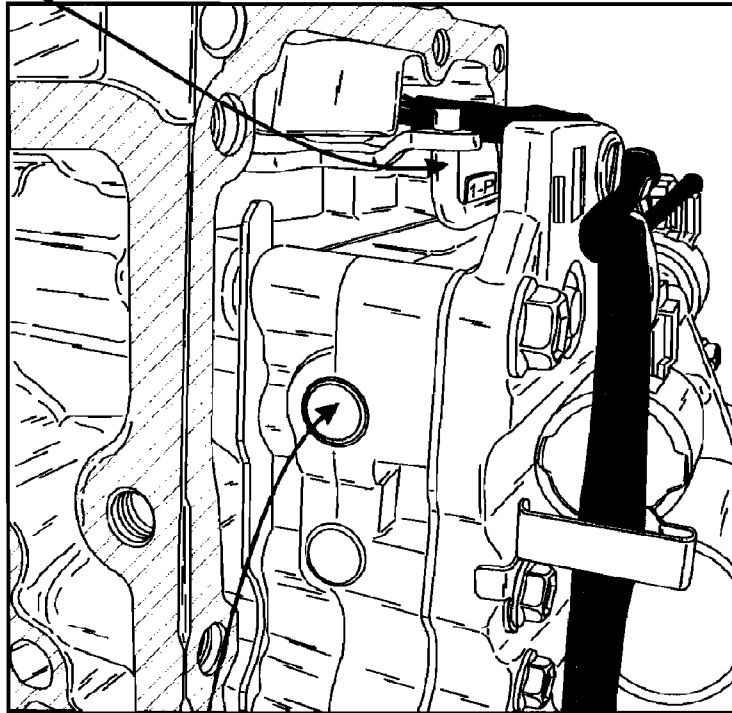
Figure 1

- (1) Misadjustment of the manual valve due to a linkage problem or the manual valve link that connects the internal linkage to the manual valve as seen in figure 1.
- (2) The installation of flat friction plates instead of the OE style **WAVED** friction plates in the C2 (DIRECT) clutch pack as shown in figure 2.
- (3) Wearing of the center ring land in the C1 (FORWARD)/C2 (DIRECT) drum in the rear cover as illustrated in figure 3.

- (1) With the shift lever in the "Park" position, the end of the manual valve should be **FLUSH** with the valve body casting as shown in figure 1 and replace worn parts as necessary.
- (2) Make certain when replacing the C2 (DIRECT) friction plates, that they are **WAVED** as seen in figure 2.
- (3) Be sure to check the center ring land for wear (Refer to Figure 3) and to replace the rear cover if the ring land wear is excessive, preferably using a rear cover with the **STEEL** support. Also be sure to use the correct rings for the type of material the support is made with as follows:
Aluminum Support.....Metal Rings
Steel Support.....Teflon® Rings
- (4) Check the condition of the upper torque arm as seen in figure 4 and replace as needed.

**THE END OF THE MANUAL VALVE IS
FLUSH WITH THE END OF THE VALVE
BODY CASTING, WHEN THE SELECTOR
IS IN THE "PARK POSITION"**

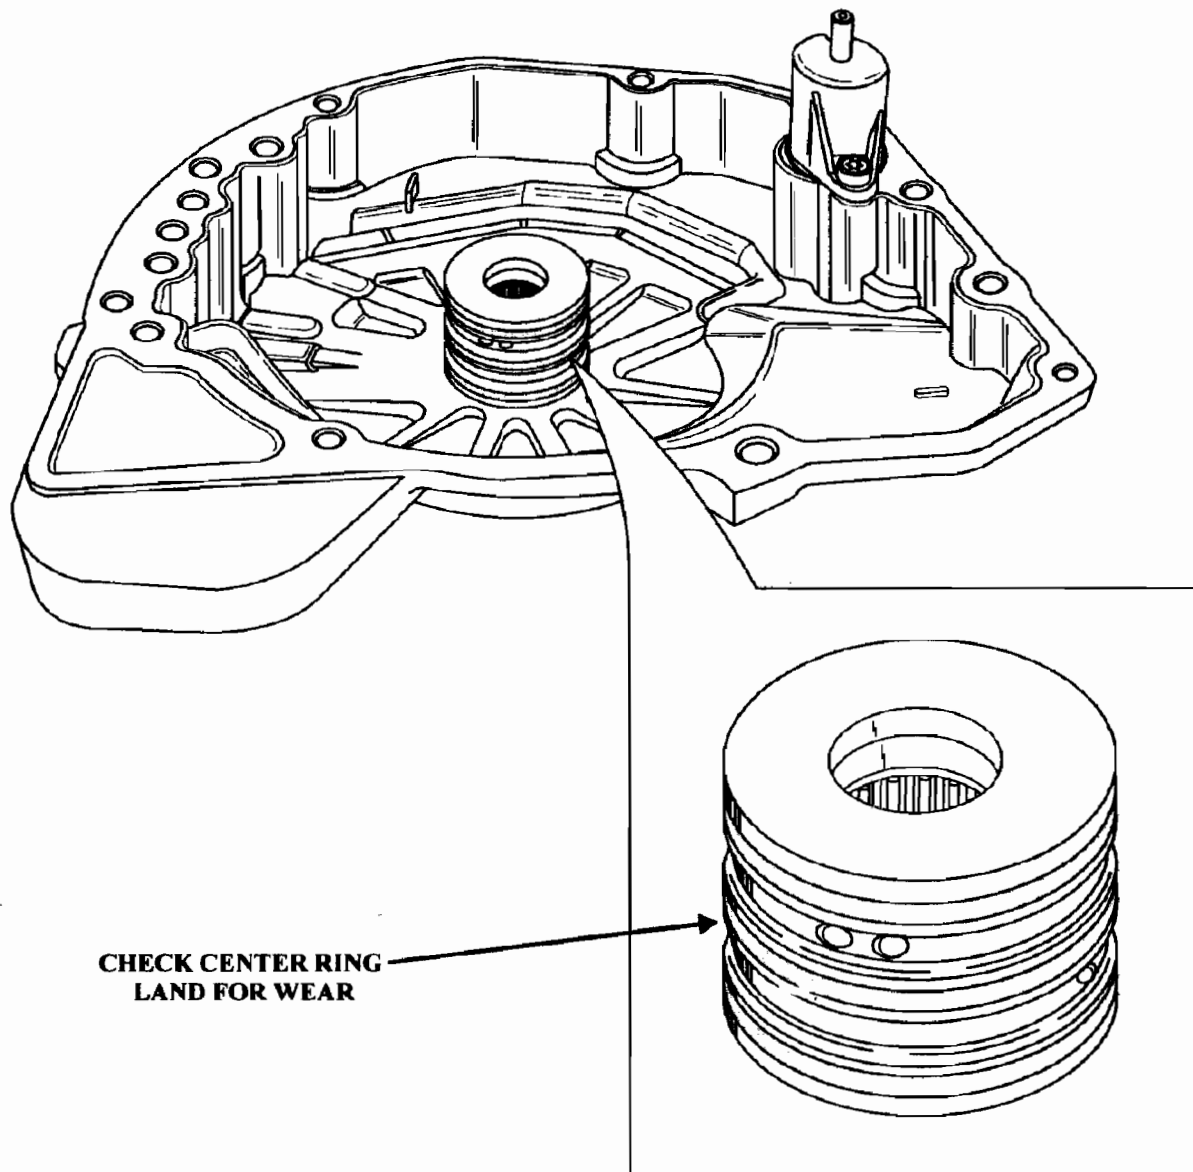
Figure 3

ALUMINUM SUPPORT MUST USE METAL RINGS
STEEL SUPPORT USES TEFLON® RINGS

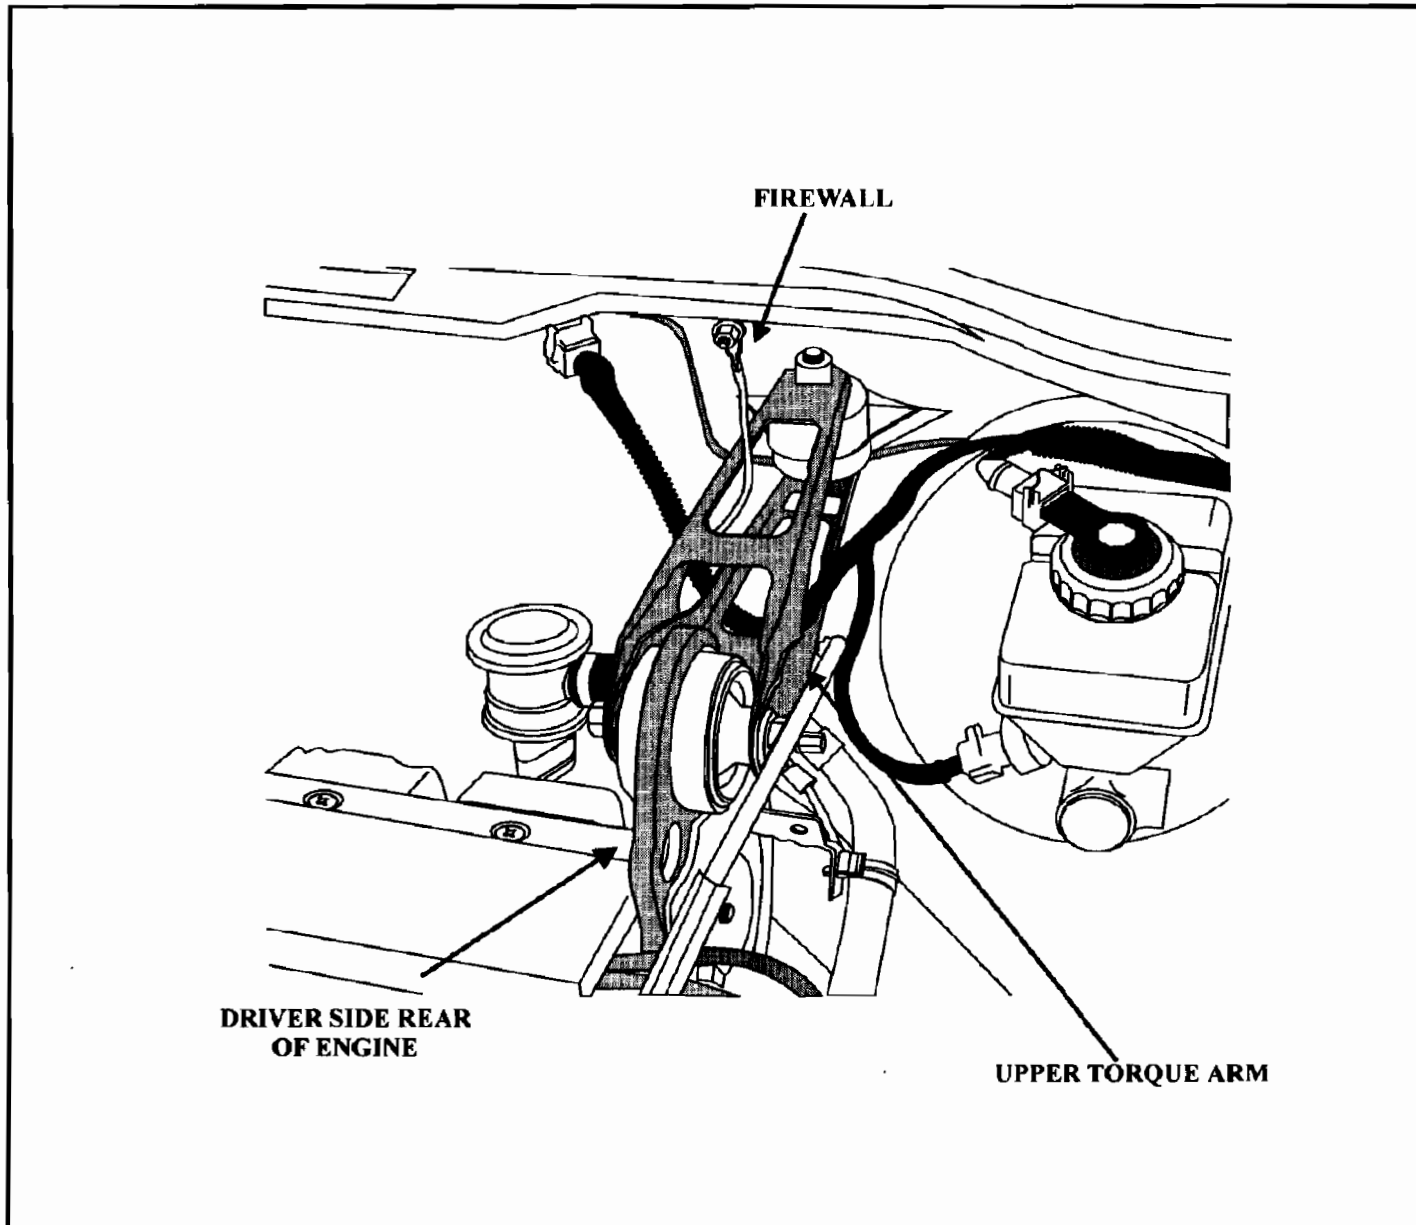
Figure 4

- (4) A worn upper torque arm which cushions engine movement when selecting reverse (Refer to Figure 4).
