## **"2007" SEMINAR INFORMATION INDEX**

# ***"Tech is Rev'n in 2007"***

## ***Seminar Information***

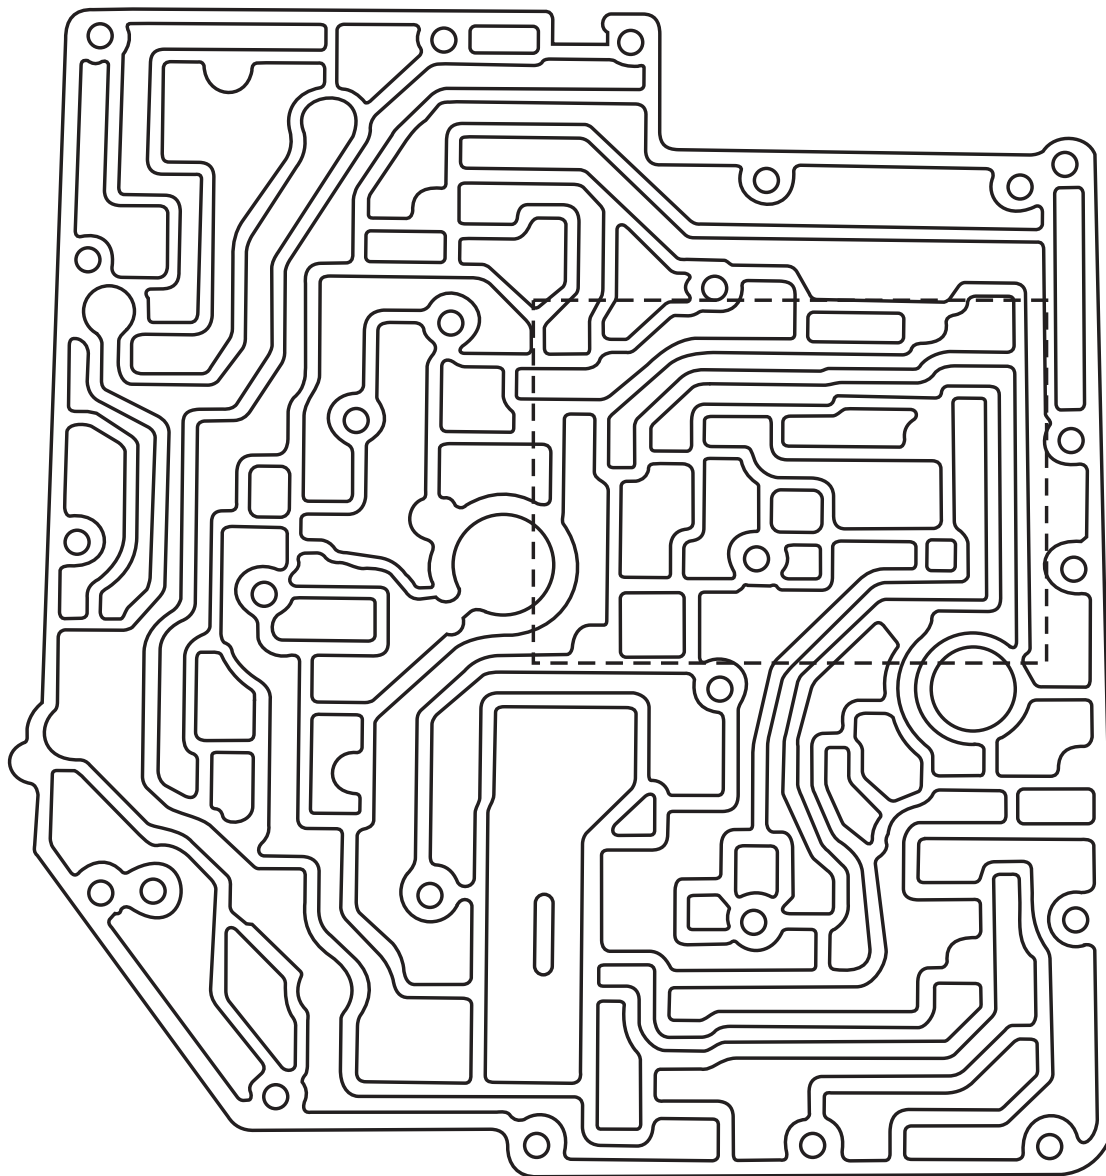
Figure 1

**COMPLAINT:** A 2004 and up Ford Motor Company vehicle equipped with the 4F50N Transaxle may exhibit a no move condition in both forward and reverse ranges.

**CAUSE:** One possible cause for this condition may be that during overhaul, or Valve Body exchange, a Valve body for a 2001-2003 4F50N was installed on the 2004 unit.

**2000-2003 Case Cover Passages**

**Case Cover Casting Number RF-YF1P**

**CORRECTION:** Use the illustrations in figures 1-8 to identify the proper castings for 2000-2003 and 2004-up. The Rough Forge Numbers will be added with each illustration to aid in proper Case cover, Valve Body, and Oil Pump assembly and checkball identification.

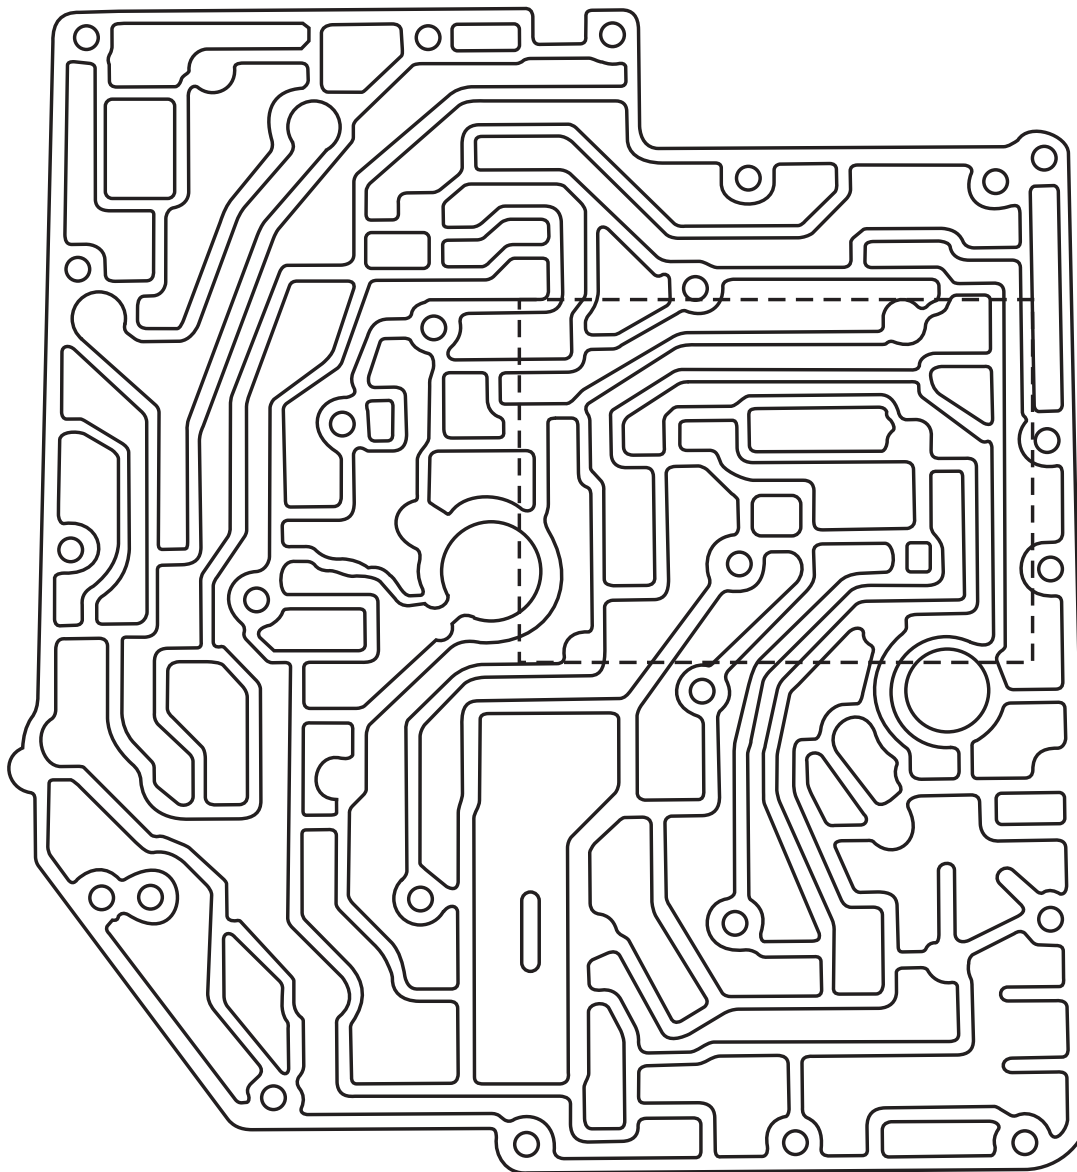
Figure 2

**2004-Up Case Cover Passages**

**Case Cover Casting Number RF-4F1P**

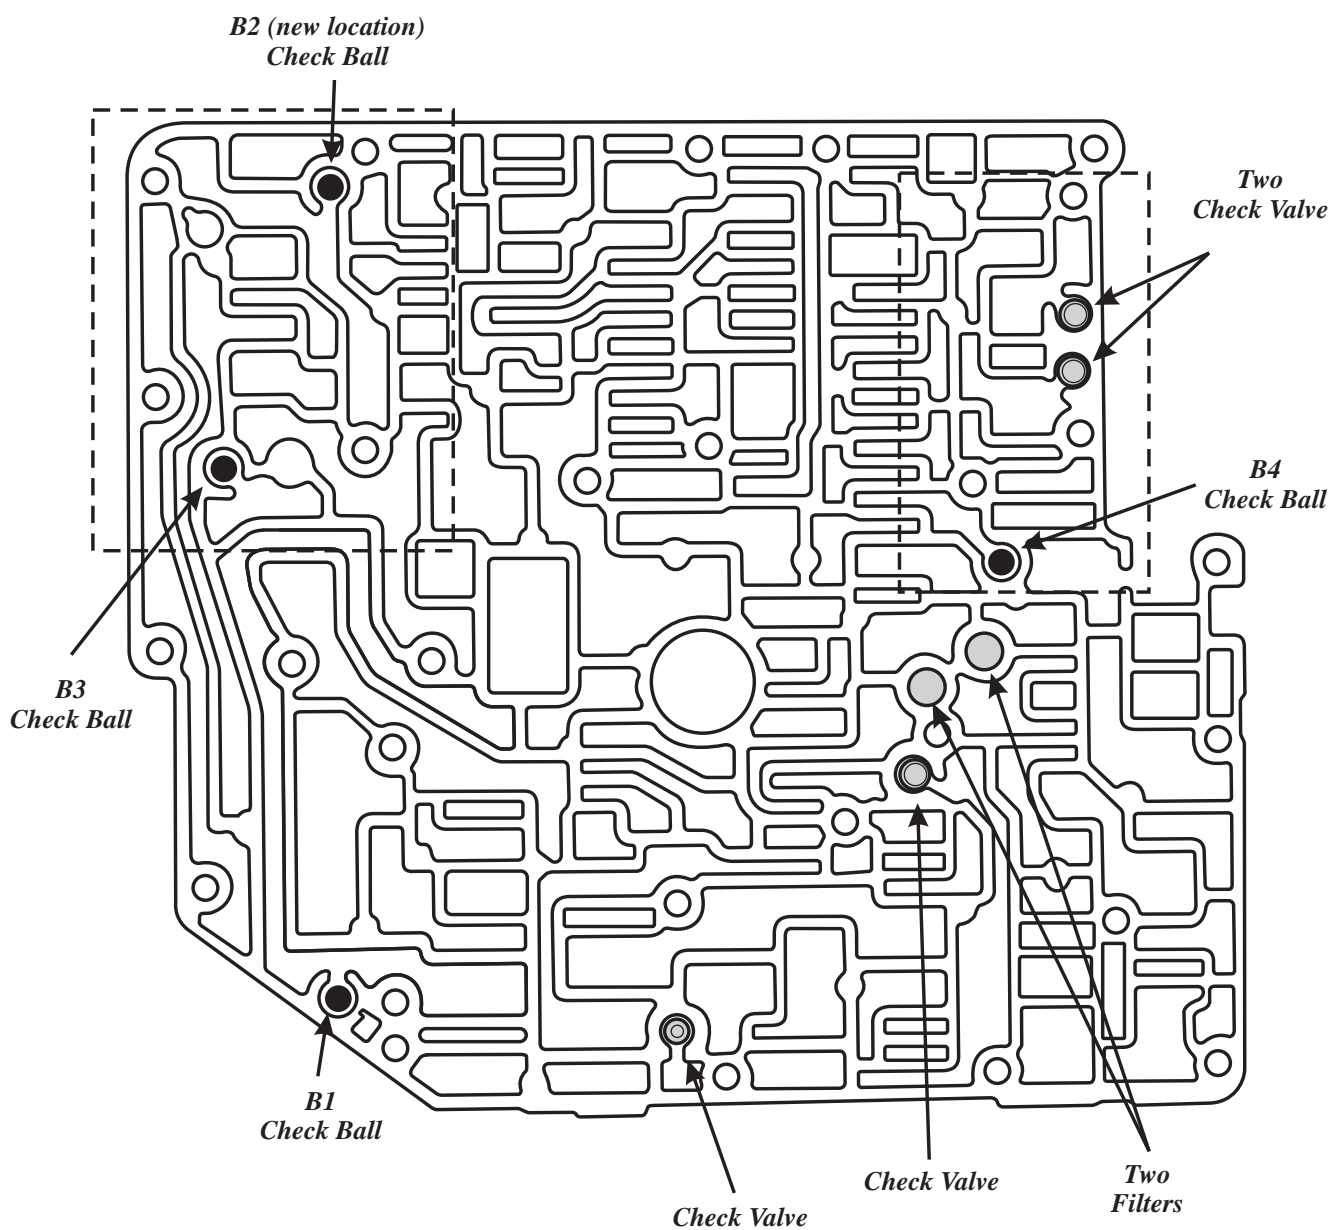
Figure 4

**2004-Up Valve Body-Case Cover Side**

**Valve Body Casting Number RF-4F1P**

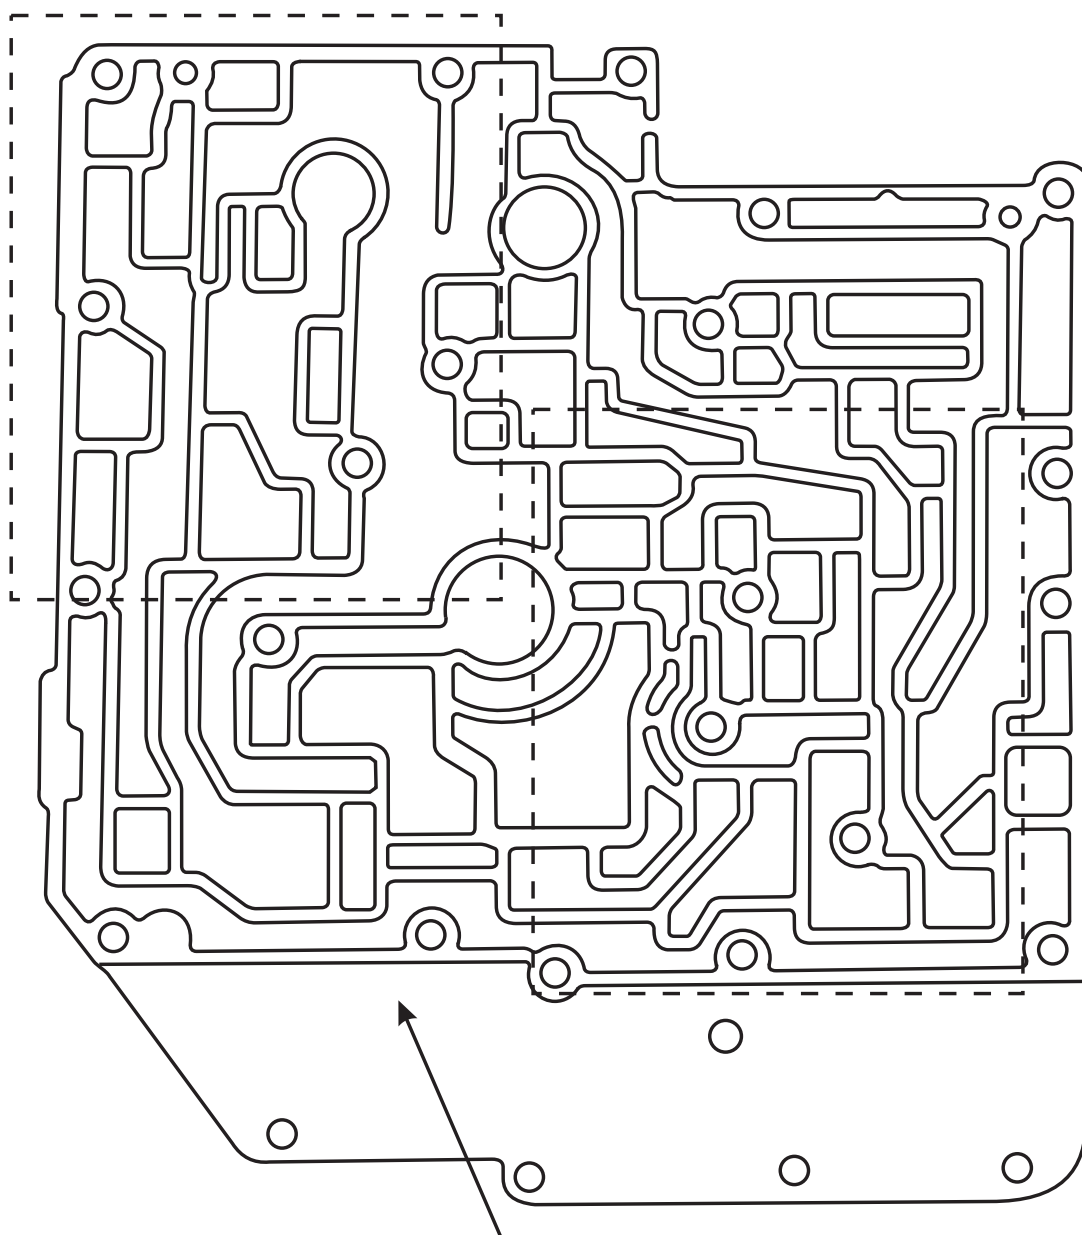
Figure 6

**2004-Up Valve Body-Oil Pump Side**

**Valve Body Casting Number RF-4F1P**

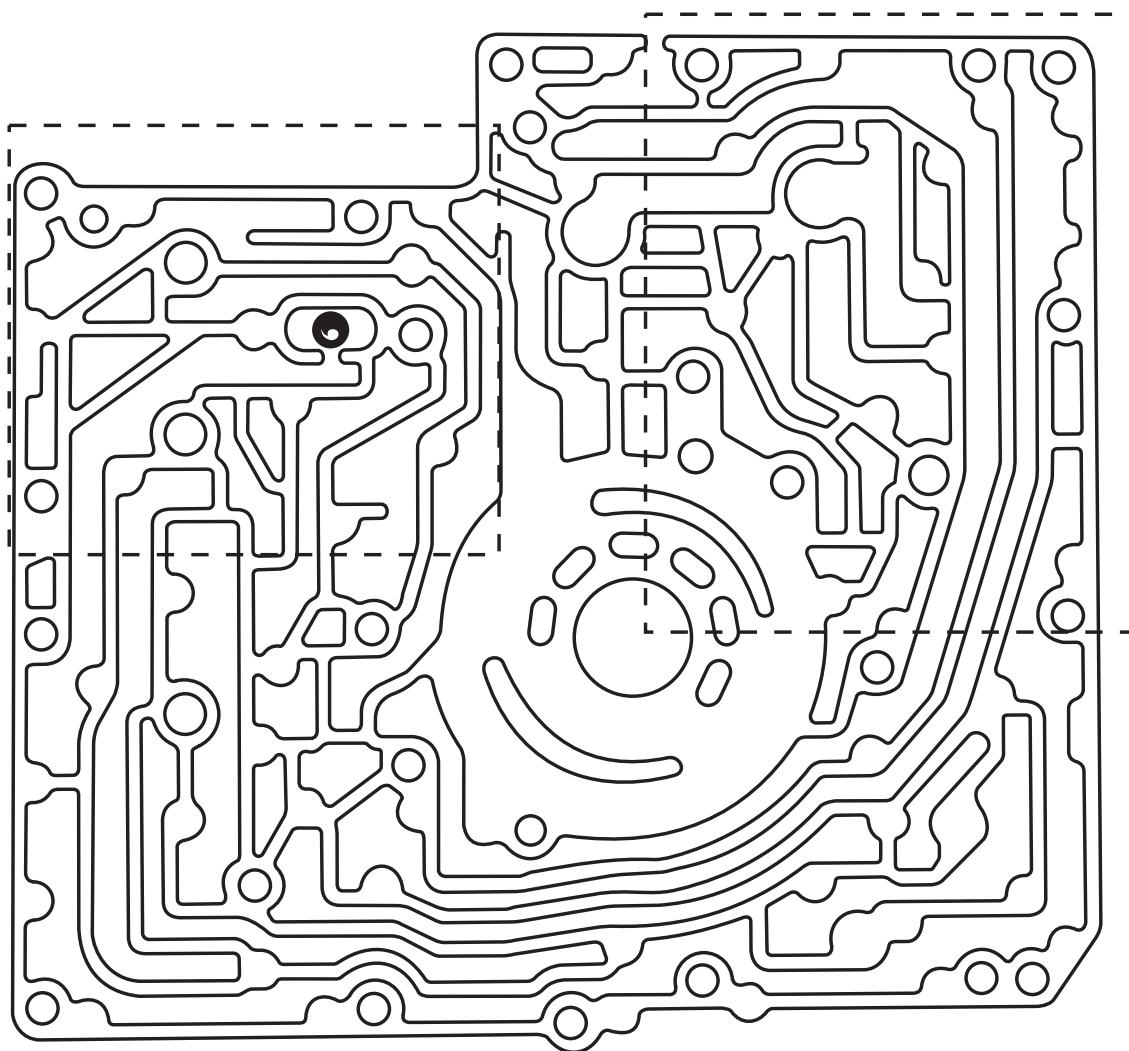
Figure 7

**2000-2003 Oil Pump**

**Oil Pump Casting Number RF-XF1P**

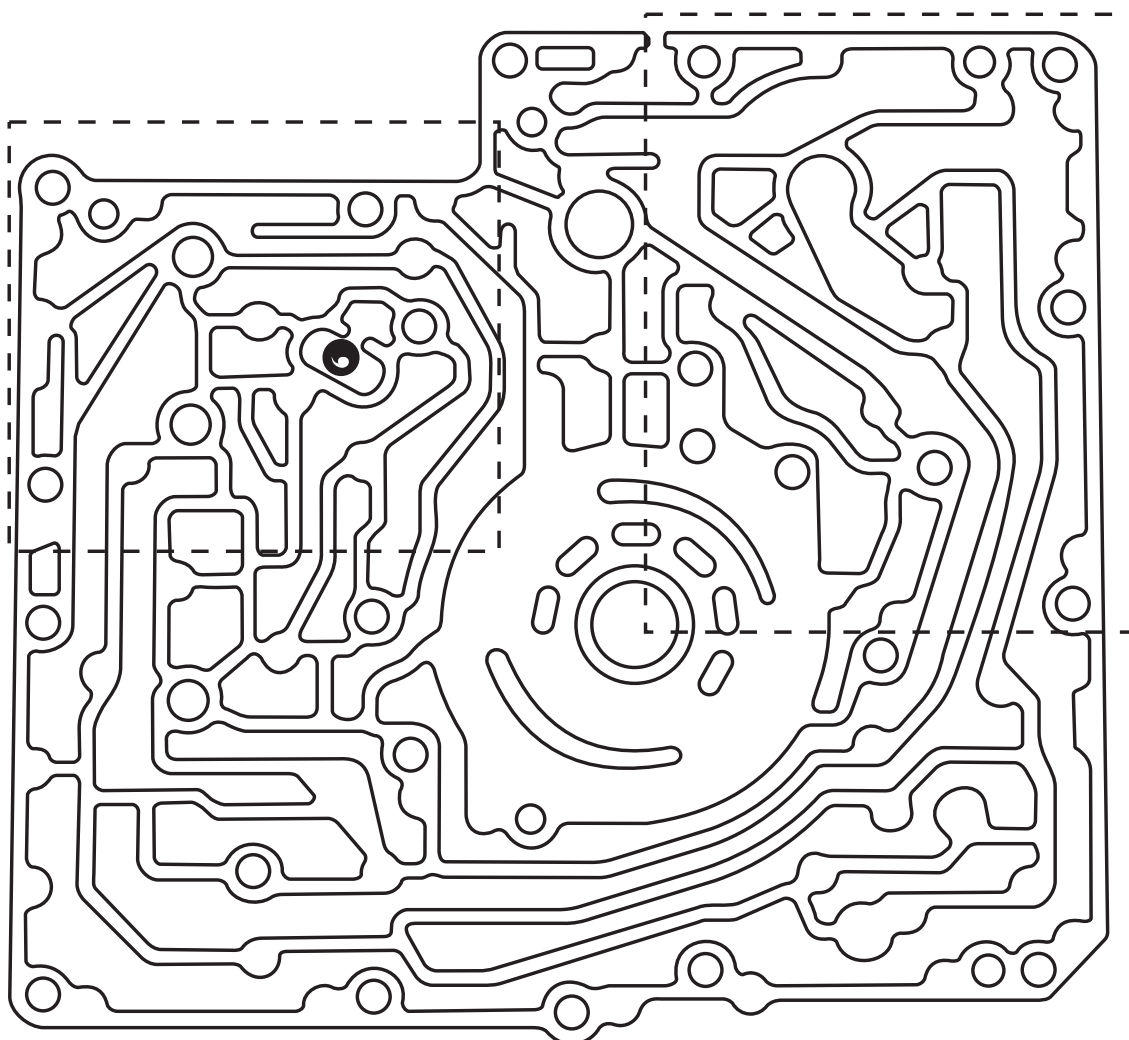
Figure 8

**2004-Up Oil Pump**

**Oil Pump Casting Number RF-4F1P**

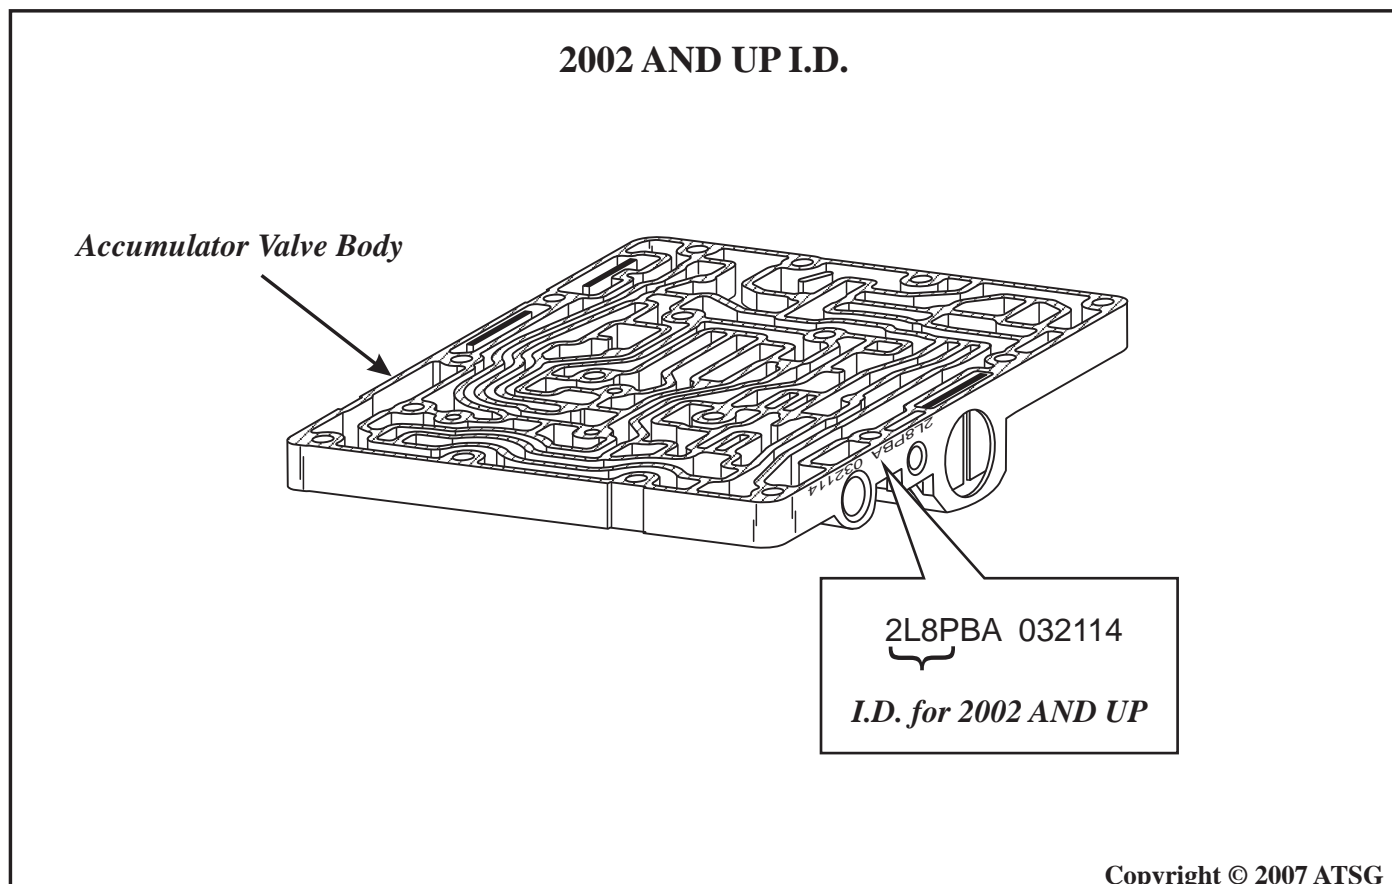
**3-2 TIMING VALVE AND SPRING:** The 3-2 Timing valve was redesigned as shown in Figure 2 and is now installed into the valve body with the spring first, opposite the previous design. Refer to Figure 1 to see how to identify the Accumulator section of the Valve Body on 2002 and UP. The ink stamp of 2L8P designates 2002 and UP.

**3-2 TIMING VALVE LOCATION**

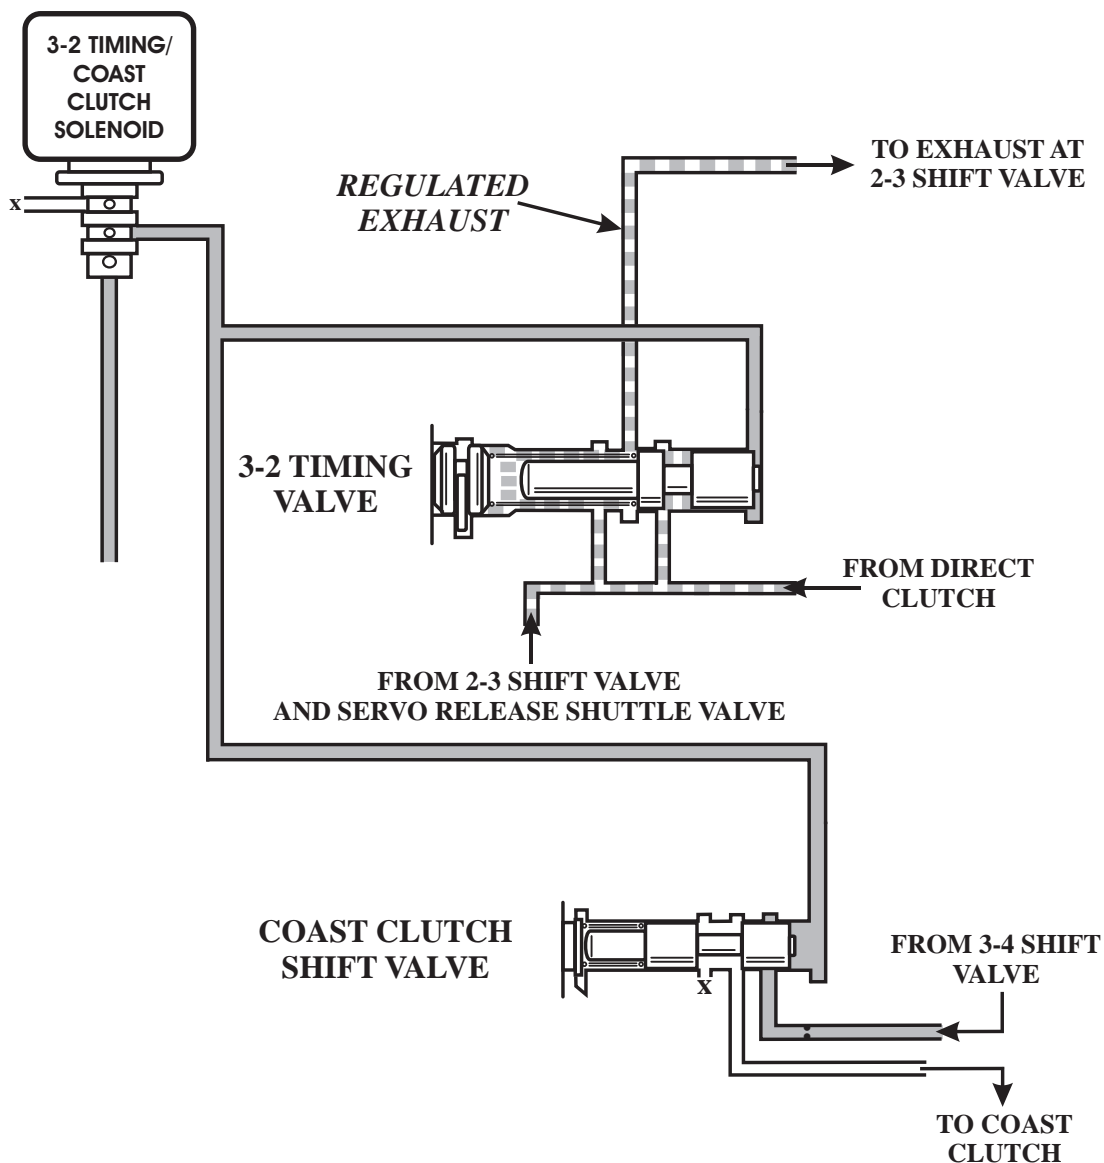
**REASON:** For quicker release of the Direct Clutch during a 3-2 downshift. Figure 3 shows the previous design 3-2 Timing Valve on a 3-2 downshift, notice that the 3-2/CCS Solenoid is at a lower duty cycle providing a regulated exhaust of the Direct Clutch. Figure 4 shows a 3-2 downshift at a higher duty cycle of the 3-2/CCS Solenoid, which will create a quicker "unregulated" exhaust of the Direct Clutch. Figure 5 shows the 2002 and Up Hydraulics, notice that the 3-2 Timing Valve is now held to the left by it's spring, which will create a quicker "unregulated" exhaust of the Direct Clutch regardless of 3-2/CCS duty cycle.

*Summary: The 3-2 Timing Valve is forced to the right by its spring tension and Low duty cycle of the 3-2 Timing solenoid to create a regulated exhaust of direct clutch pressure on a 3-2 downshift.*

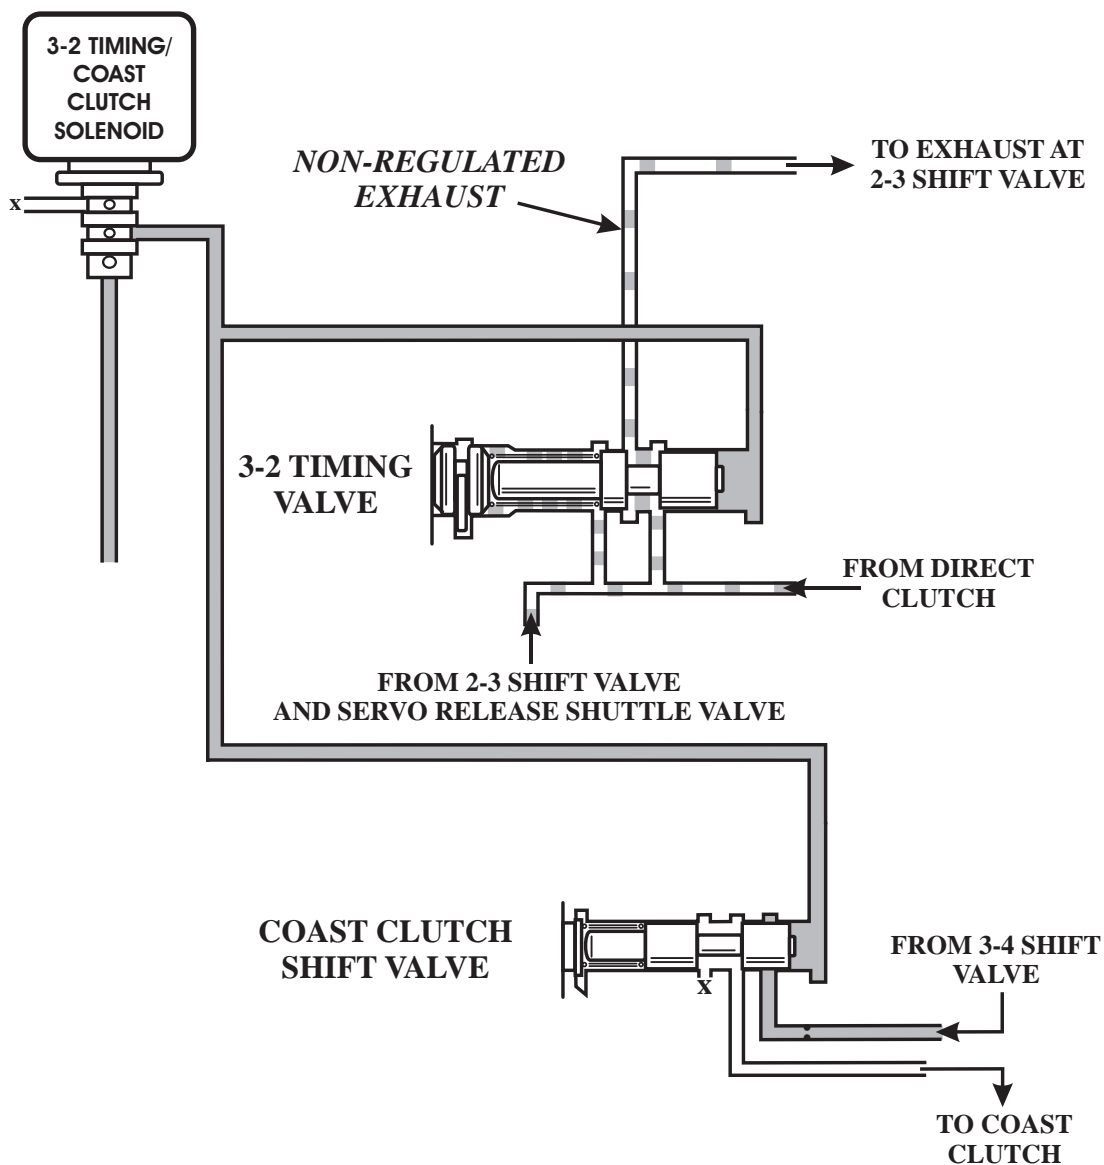
Figure 4

*Summary: The 3-2 Timing Valve is moved to the left by high duty cycle of the 3-2 Timing solenoid to create a quick and un-regulated exhaust of direct clutch pressure on a 3-2 downshift.*

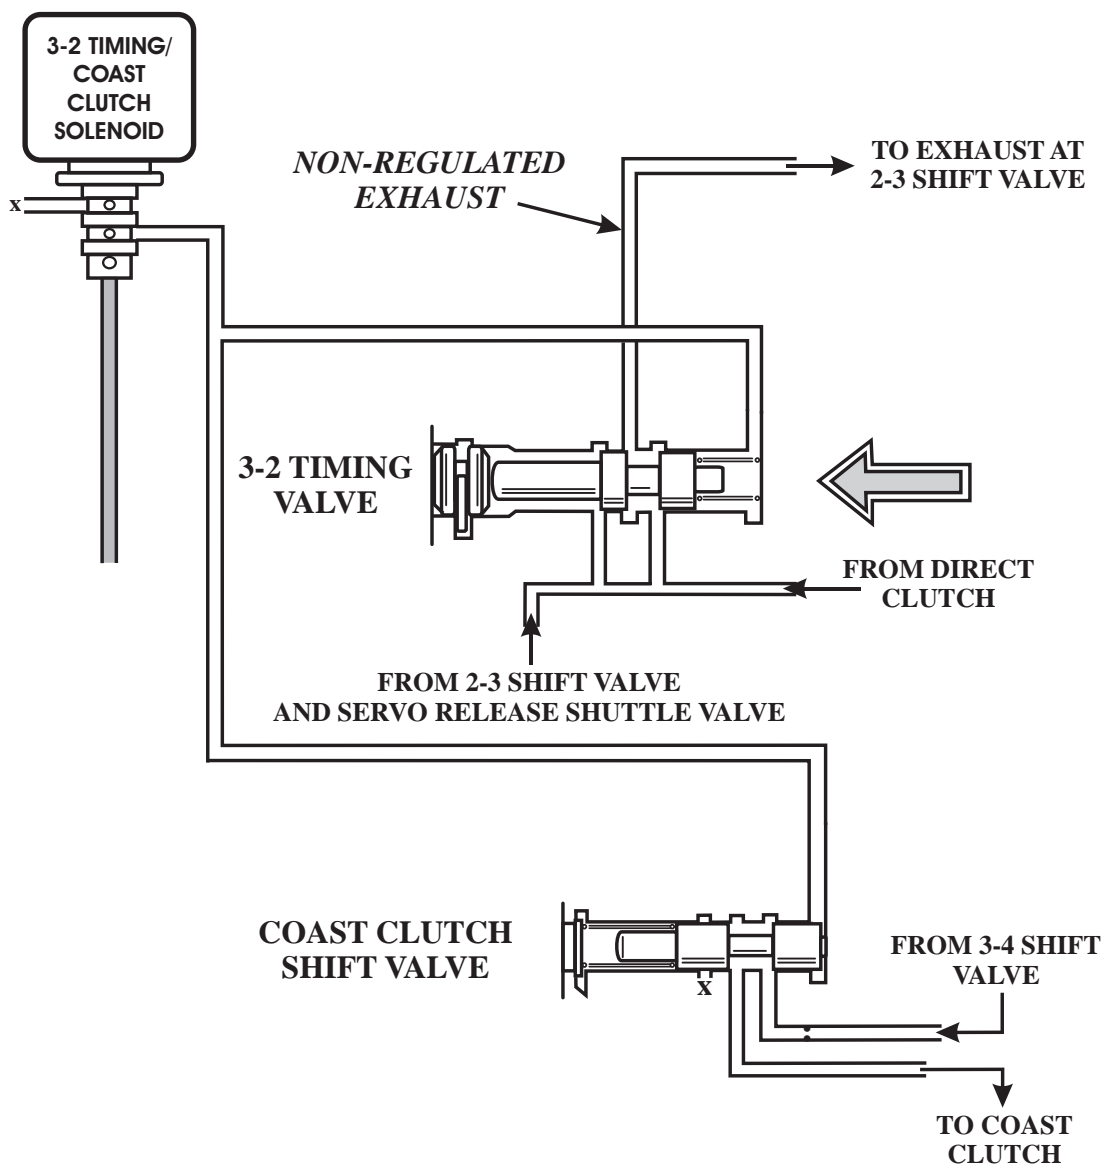
Figure 5

*Summary: The 3-2 Timing Valve is now moved to the left by the spring allowing a quick exhaust of direct clutch pressure regardless of the duty cycle of the 3-2 Timing Solenoid on a 3-2 downshift, creating a more consistent 3-2 downshift.*

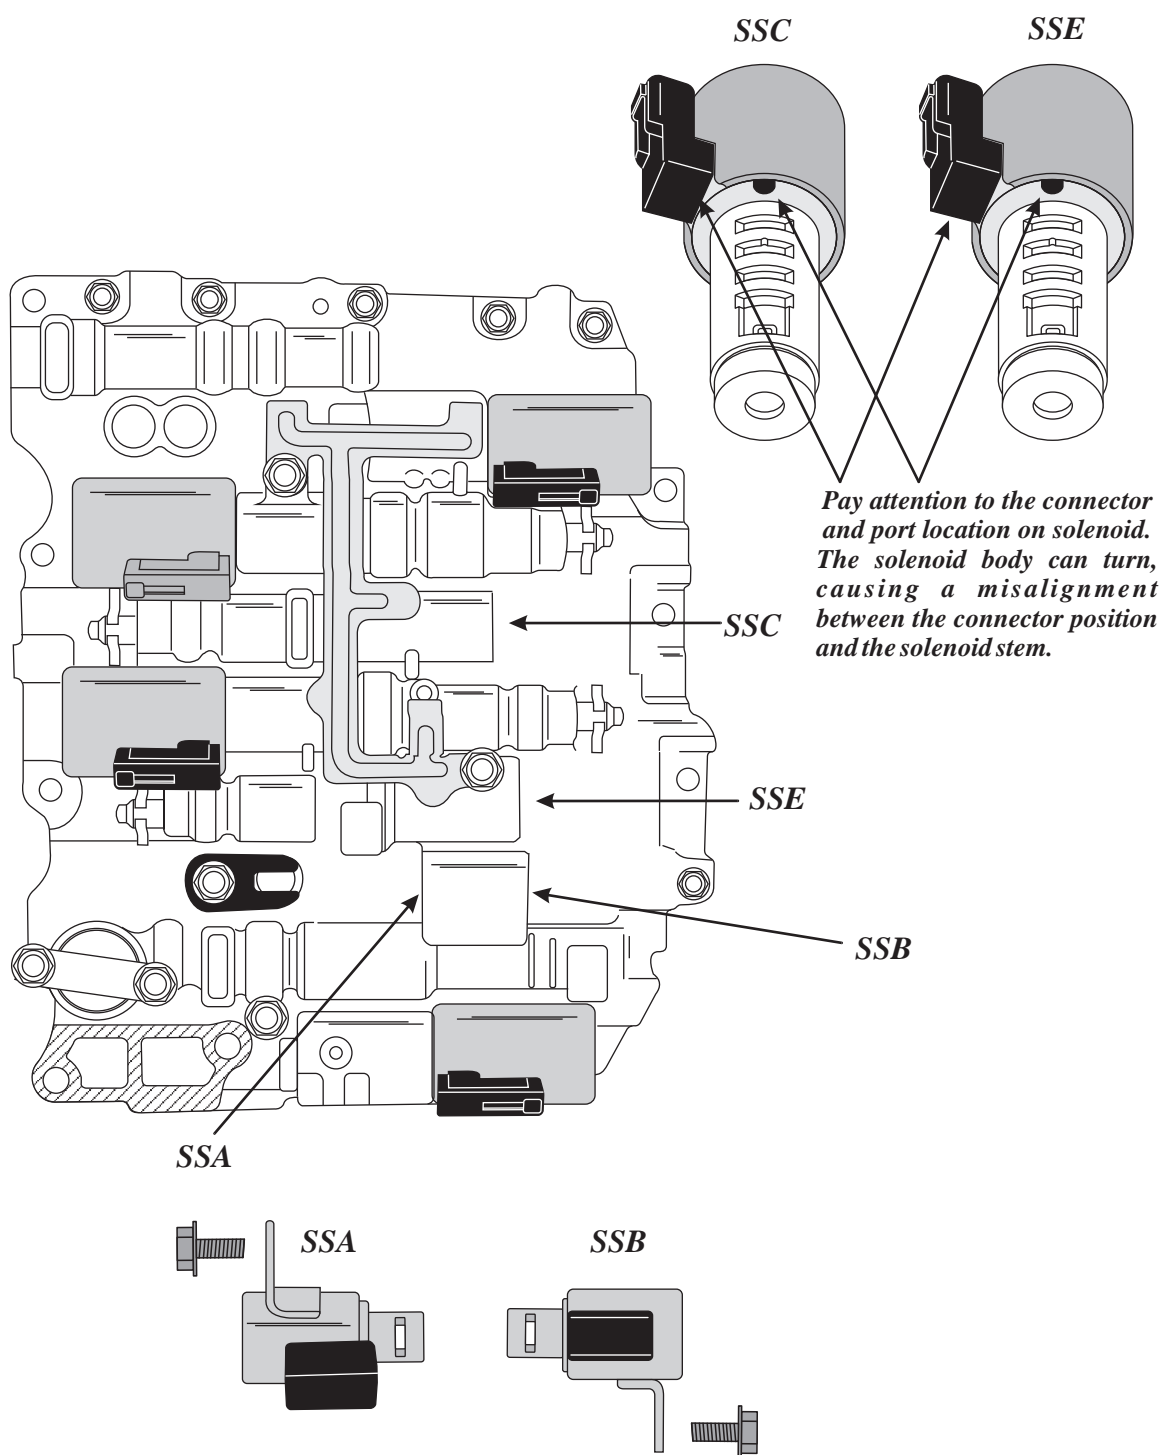
Figure 12  
Automatic Transmission Service Group

**Note:** Make sure to verify that the solenoids are in the right locations by the positioning of the connectors and the ports. The Solenoids are retained into the Valve Body by roll pins, If a Solenoid is put into the wrong location the feed ports may be blocked, making it inoperable.

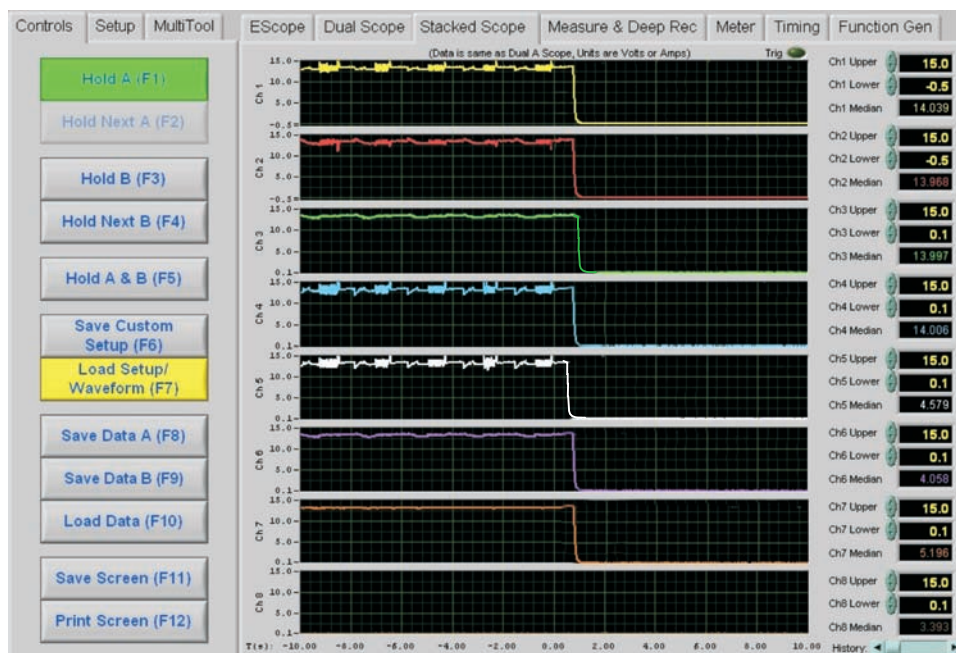
Figure 11

## LR Solenoid & LR Pressure Switch Comparison

**Channel 1** = LR Pressure Switch Signal during TCC Command  
**Channel 4** = LR Solenoid Duty Cycle during TCC Command

As the computer was commanding the TCC to be applied the pressure switch was toggled to ground indicating that the solenoid switch valve was latched in the LR position. The computer went to failsafe cutting all power to the transmission.

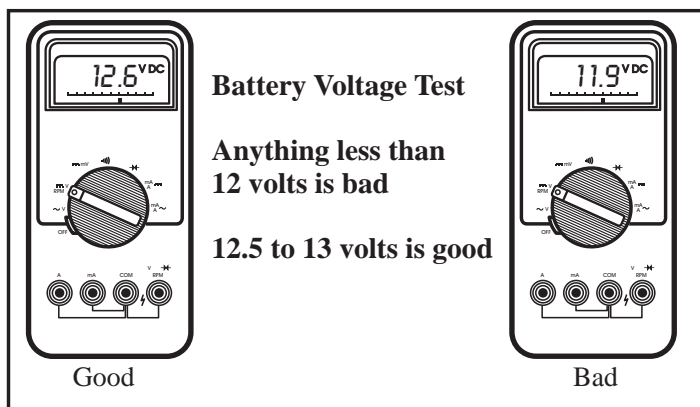
Figure 1

Low battery voltage indicates a battery that has, or is about to fail. This makes the alternator work harder and possibly create noise or cause the alternator to fail.

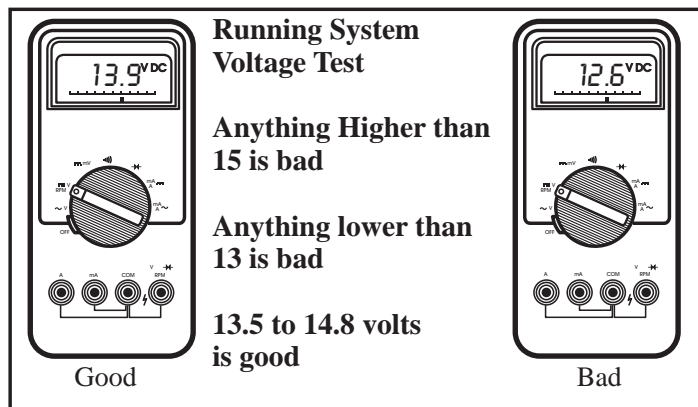
Figure 2

System running voltage is an indicator of alternator health. Low or high voltage, as well as noise, can cause a variety of problems.

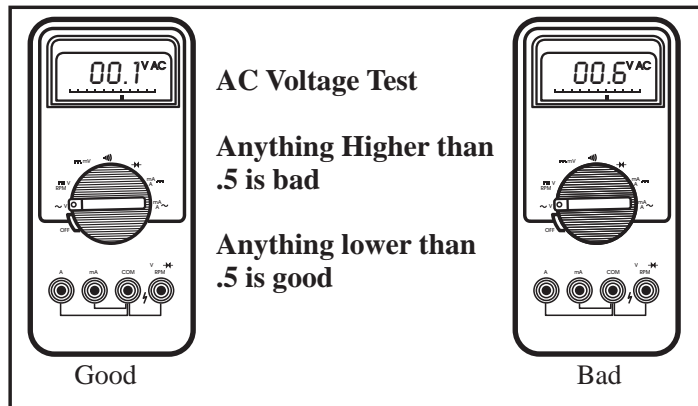
Figure 4

Excessive AC voltage is an indicator of power system noise which is almost always an indication of alternator problems.

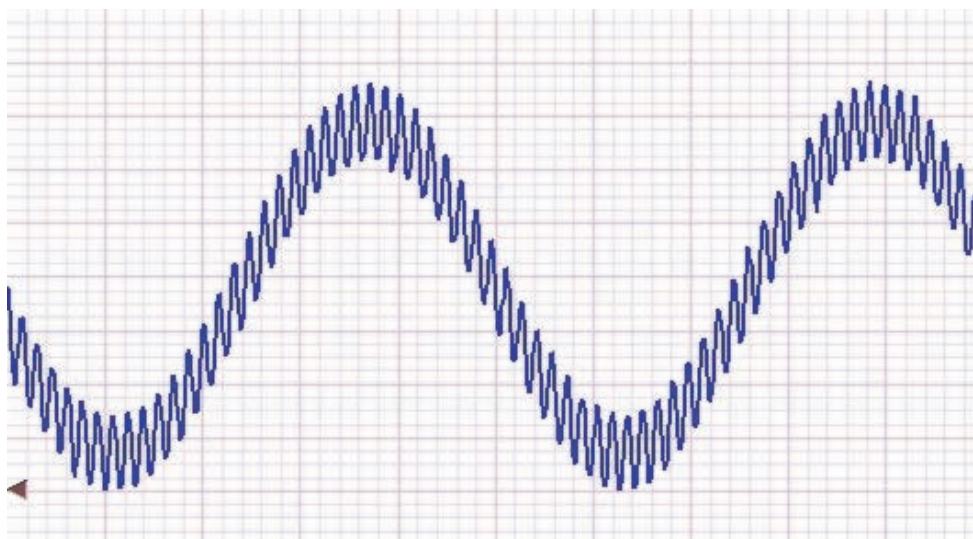
Figure 7

**Noisy AC Pulse Generator Waveform**

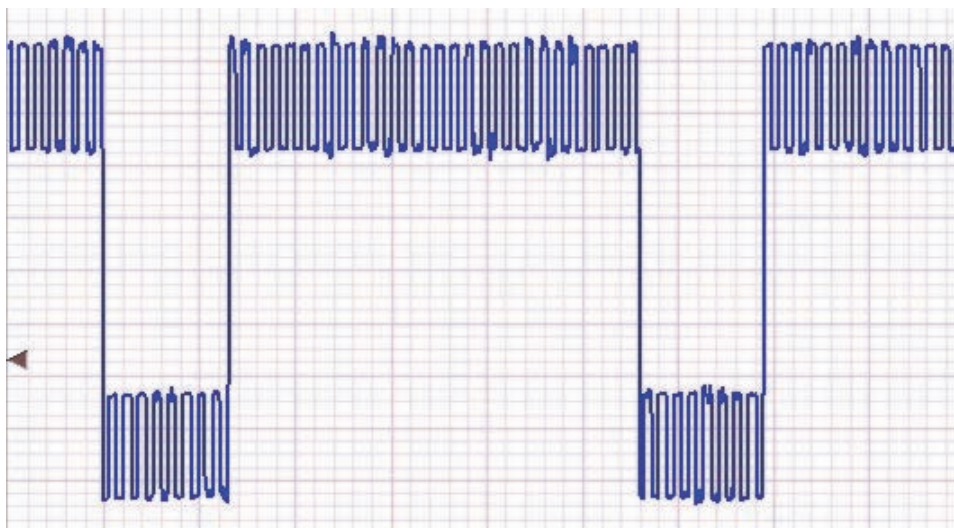
Figure 9

**Noisy Digital Pulse Waveform**

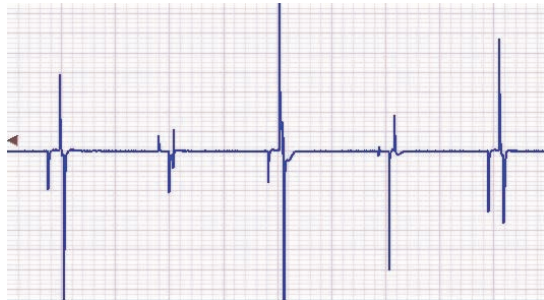
Figure 10

**Wiring too close to plug wire**

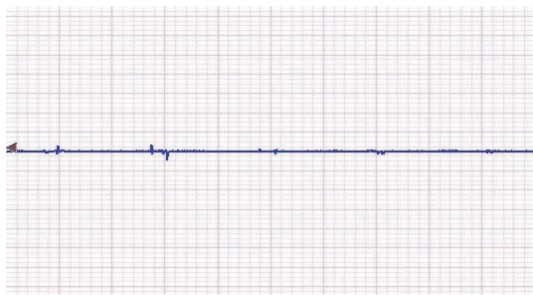
Figure 13

**Ungrounded Shield**

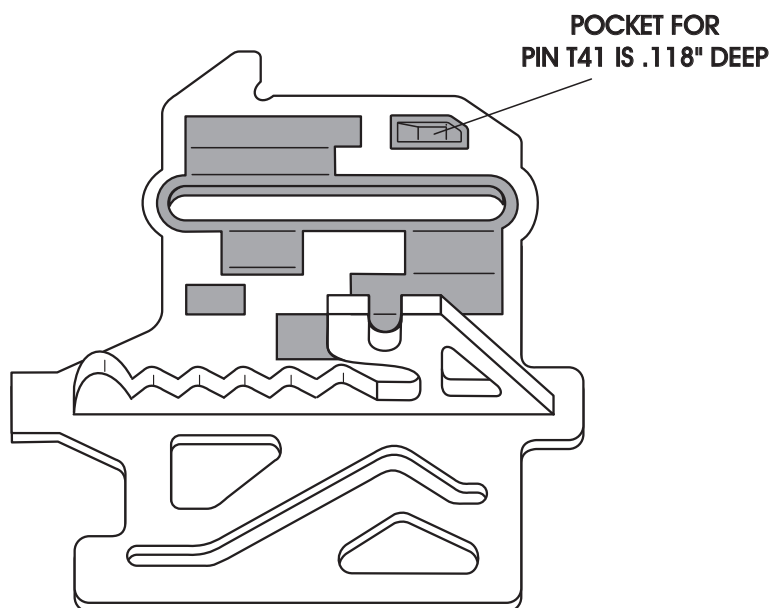
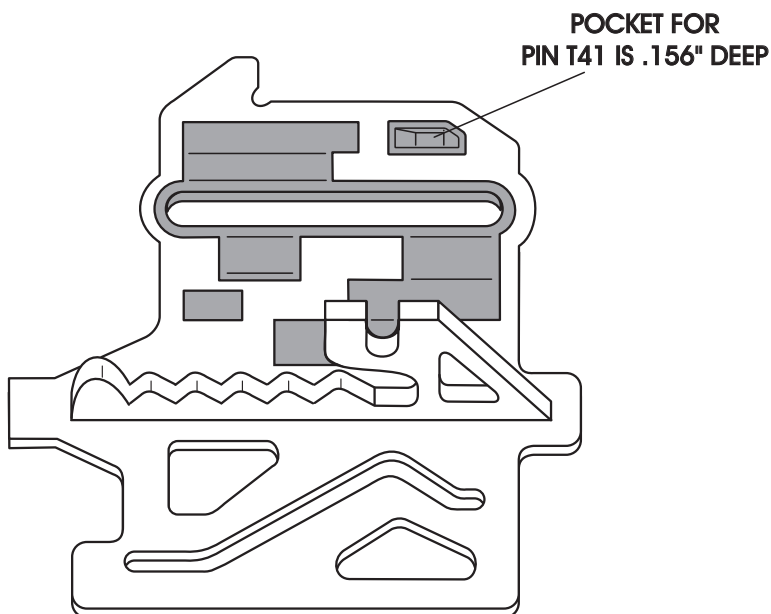
- (1) SOLENOID PACK - Totally re-designed casting with changes in the worm track area as shown in Figure 1.
- (2) SOLENOID BODY SCREEN AND GASKET ASSEMBLY - Changed to accommodate the changes in the Solenoid Pack and is illustrated in Figure 2.
- (3) TRS/ AND 23 WAY CONNECTOR - Changed to accommodate internal solenoids. See Figures 3 and 4 for early design and Figures 5 and 6 for updated design.
- (4) RANGE SENSOR SELECTOR PLATE - The pocket for the T41 pin was made deeper and is illustrated in Figure 7.

*Special Note: The 1999 - 2003 range sensor plate can be modified and used with the updated Solenoid Pack. by making the T41 pocket .040" deeper (Figure 7).*

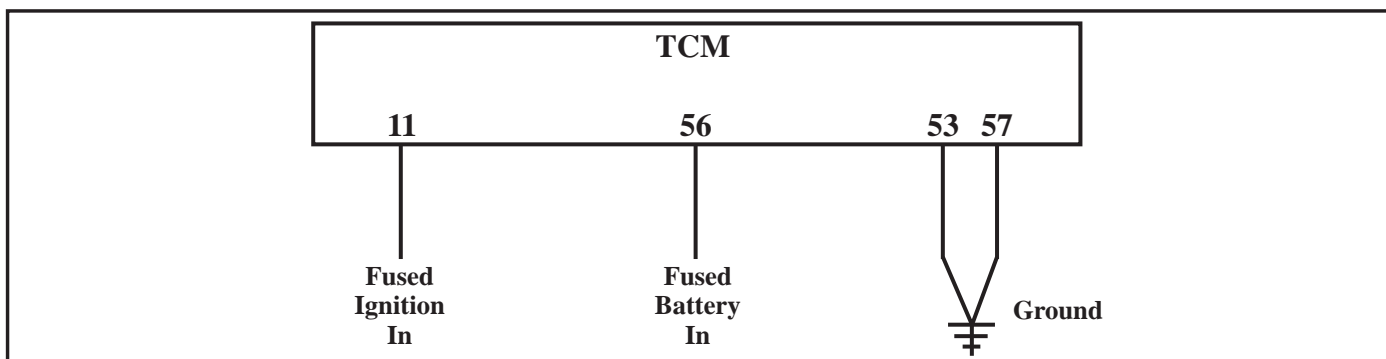
Figure 1

**CAUSE:** The cause is a faulty TCM possibly induced by system voltage irregularities.

**CORRECTION:** Check for any system voltage concerns such as a weak battery or a defective alternator that may cause a low charge or an over charge condition and repair or replace as necessary. Clean all battery cable connections including main ground cable at engine or transaxle and body ground.

With a volt meter, check for battery voltage always present at TCM pin 56, key off or on. With the key on and/or the engine running, there must be battery voltage at pin 11. Verify good grounds for any wires located at TCM pins 53 and/or 57. See wire diagram in figure 1. With key off and battery disconnected, clean TCM connector and check pin terminals 11, 53, 56 and 57 for loose fit on TCM pins. For TCM connector terminal ID refer to figure 2. Replace the TCM and reconnect the battery.

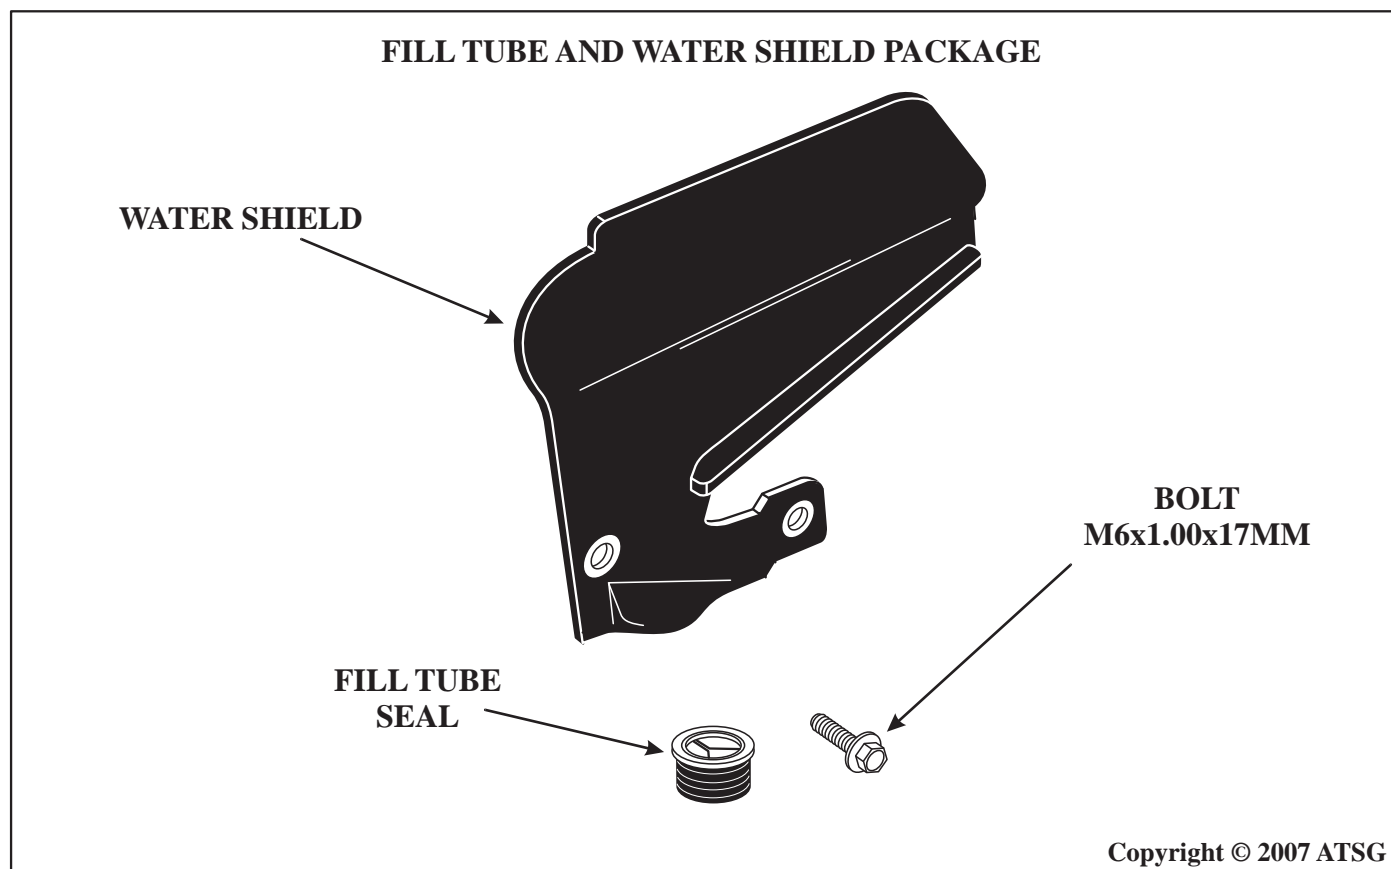
Figure 1

### FILL TUBE SEAL INSTALLATION

*Replace fill tube seal  
using a C clamp for an  
installation tool. Lightly  
coat the two sealing surfaces  
with silicone sealant*

FILL TUBE AND WATER SHIELD PACKAGE (Chrysler part number).....CBL0E131

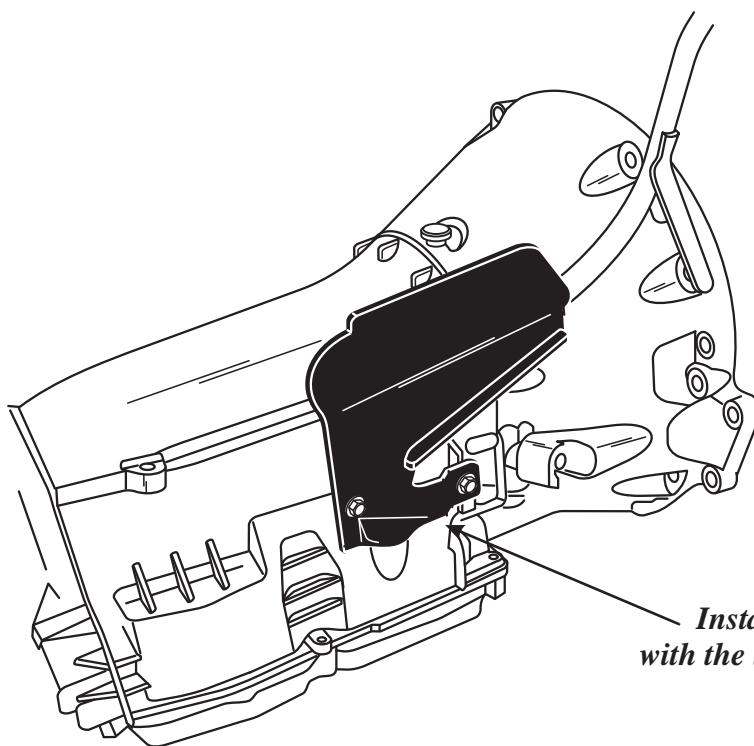
Figure 2

### WATER SHIELD INSTALLATION

*Install Water Shield  
with the longer bolt supplied*

**CORRECTION:** To correct this condition, repair internal components as water intrusion will destroy rubber seals and create friction disintegration, not only inside of the transmission but in the Torque Converter as well. Ensure that all of the models listed above have the Water Shield in place. The kit consists of a new Fill tube seal, longer bolt and a Water Shield, as shown in Figure 1. If this repair is being attempted in the vehicle as per TSB number 21-011-05 Revision A, use a C-clamp to install the Fill Tube Seal, after using a small bit of silicone sealant onto its sealing surfaces inside and out, as shown in Figure 2. **Caution: It is going to be very difficult to flush out all of the water in this trans.** Refer to Figure 3 for the installation of the Water Shield, on the transmission.
