## **"2007" SEMINAR INFORMATION INDEX**

# ***"Tech is Rev'n in 2007"***

## ***Seminar Information***

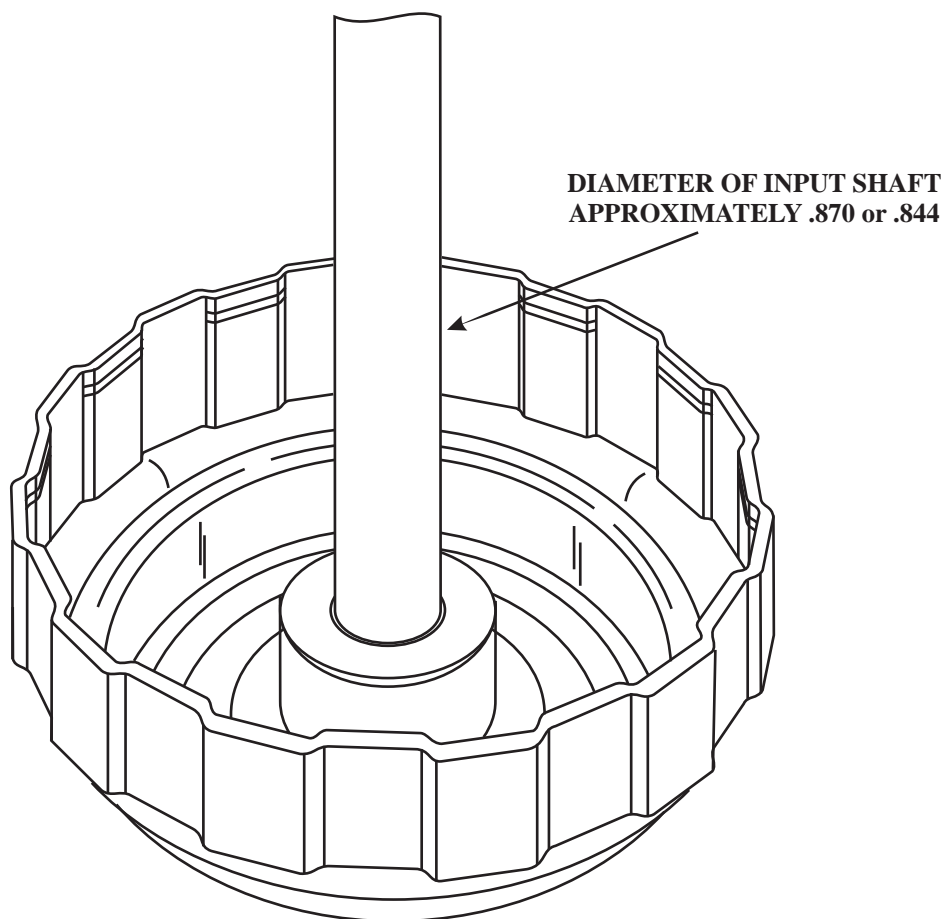
Figure 1

**CAUSE:** Incorrect Forward/Direct clutch housing input shaft diameter used. The outside diameter of the different shafts are 0.844 and 0.870 (See Figure 1). If the smaller shaft was installed in place of the larger shaft, there will be a loss of lockup apply oil between the input shaft bushing journal and the undersized bushings in the pump stator shown in Figure 2.

### FORWARD (C1)/DIRECT (C2) CLUTCH HOUSING

**CORRECTION:** Replace the drum with the correct diameter forward drum input shaft.

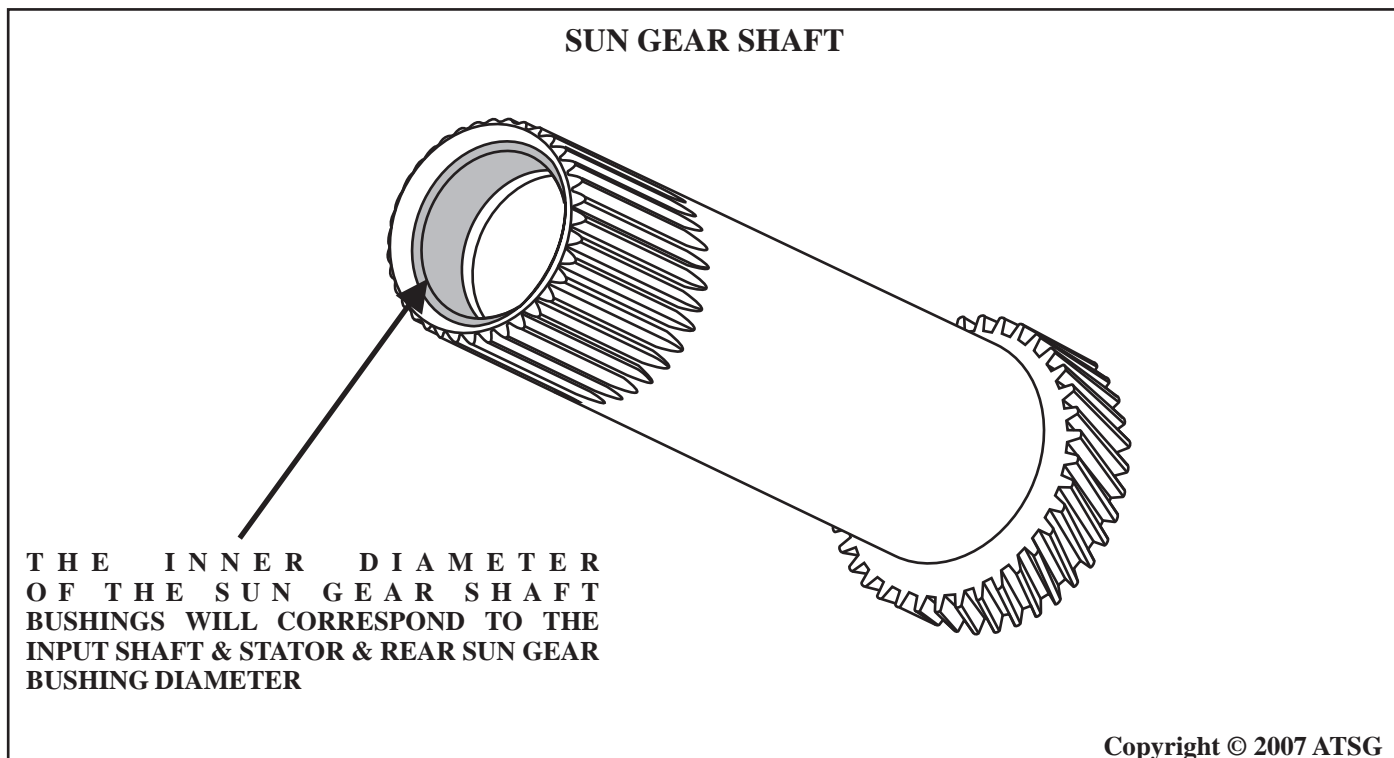
Figure 3

The inner diameter stator bushings will correspond to the outside diameter of the forward drum shaft, along with the inside diameter of both the front and rear sun gears as seen in figures 3 and 4. The larger shaft Forward/Direct drum is designed for Turbo and/or All Wheel Drive vehicles with larger engines, and will retro fit as a complete assembly.

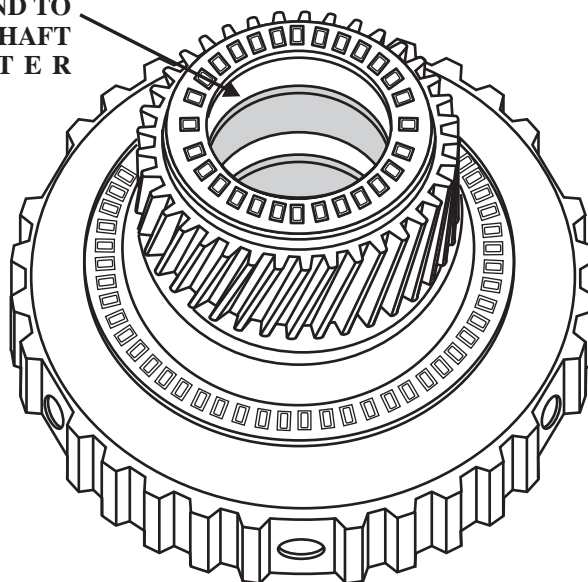
Figure 4

THE INNER DIAMETER  
OF THE REAR SUN GEAR  
BUSHINGS WILL CORRESPOND TO  
INPUT SHAFT & SUN GEAR SHAFT  
BUSHING DIAMETER

REAR SUN GEAR

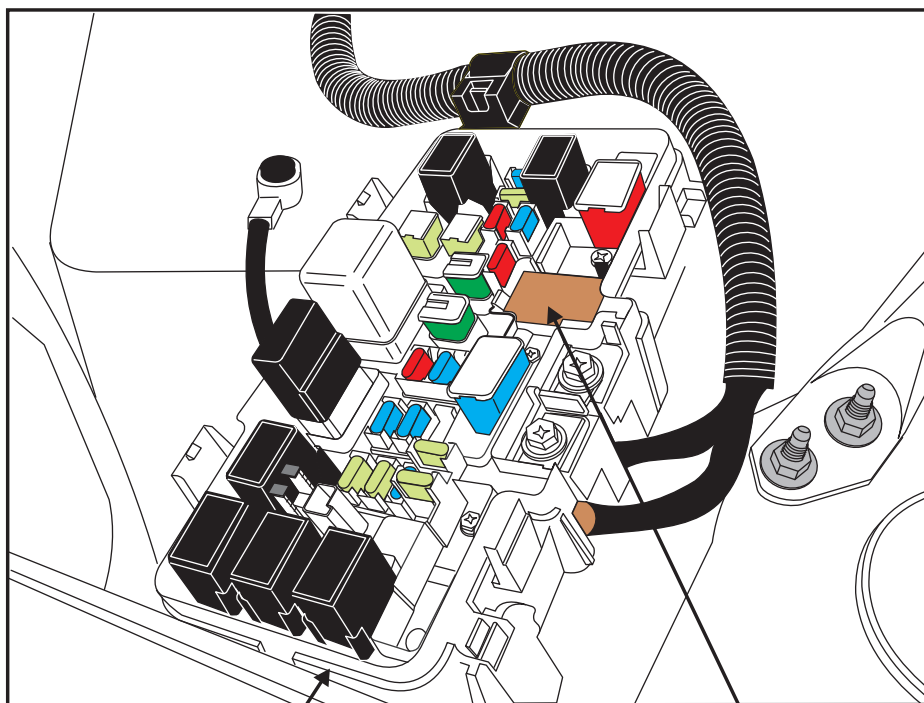
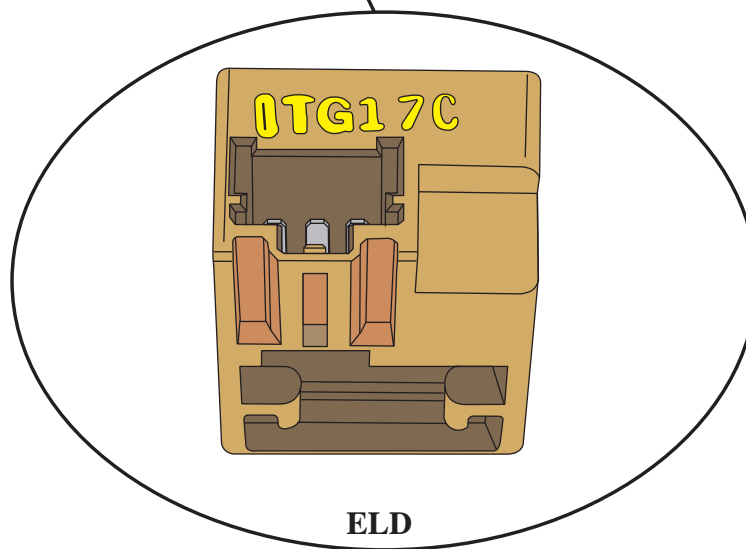
Figure 1

**CAUSE:** The Electronic Load Detector (ELD), located in the under hood fuse box (Refer to Figure 1), has failed allowing the alternator to overcharge which causes high system voltage which results in *causing solenoid codes to be stored falsely.*

**ELECTRONIC LOAD DETECTOR (ELD) LOCATION**

**UNDERHOOD  
FUSE BOX**

**ELD**

**THE ELD IS ACCESSED FROM THE UNDERSIDE OF FUSE BOX**

The ELD can be bought separately on some models, while on others the entire underhood fuse box must be bought, check with your local Honda dealer.

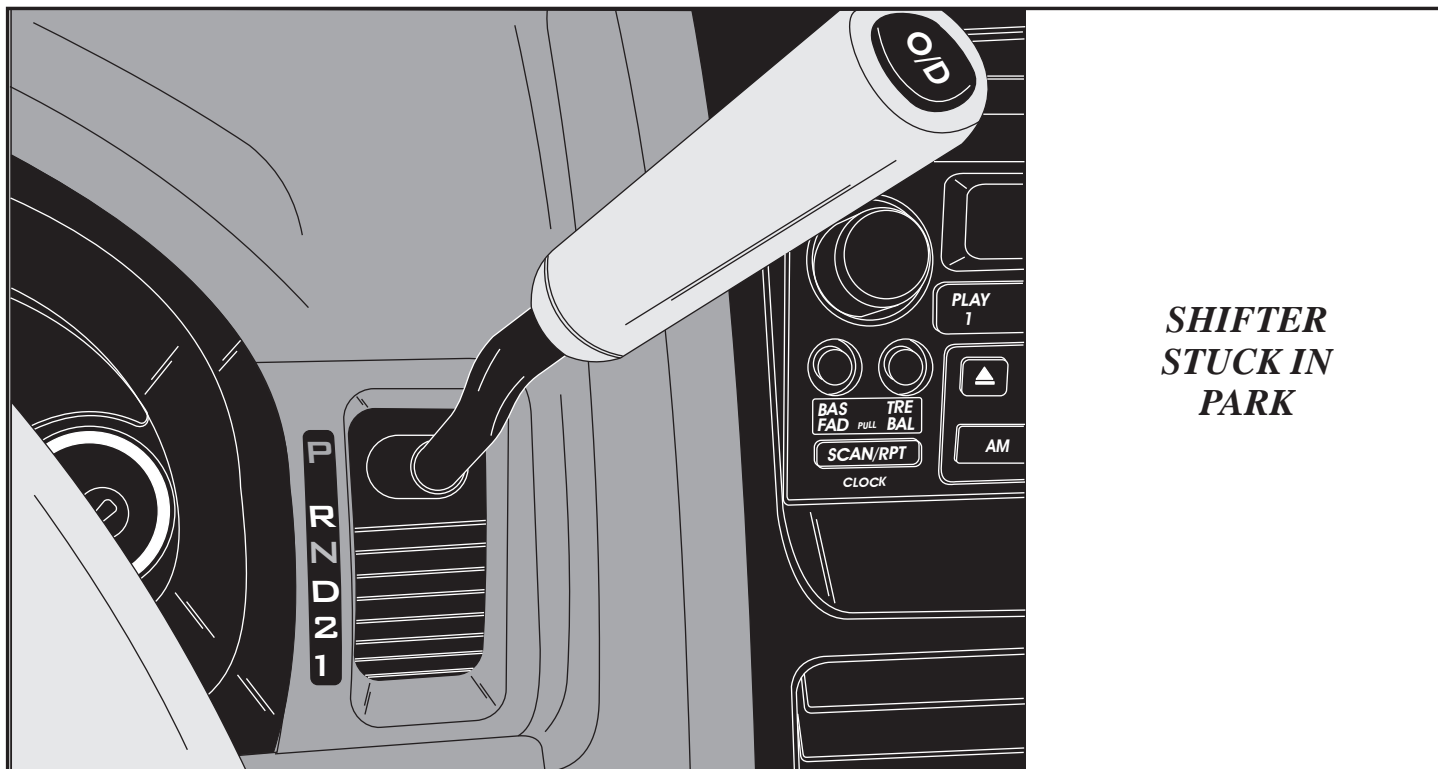
Figure 1

**CAUSE:** Whenever the throttle body is replaced on the above mentioned vehicles, the PCM needs to relearn the relative throttle position.

- (1) Make certain all electrical items are off.
- (2) Start the engine and hold the idle at 3,000 rpm, in park, or until engine temperature reaches 194° F (90° C).
- (3) Let the engine idle for about 5 minutes with the throttle fully closed.
- (4) Move the shifter out of Park to confirm relearn was successful.

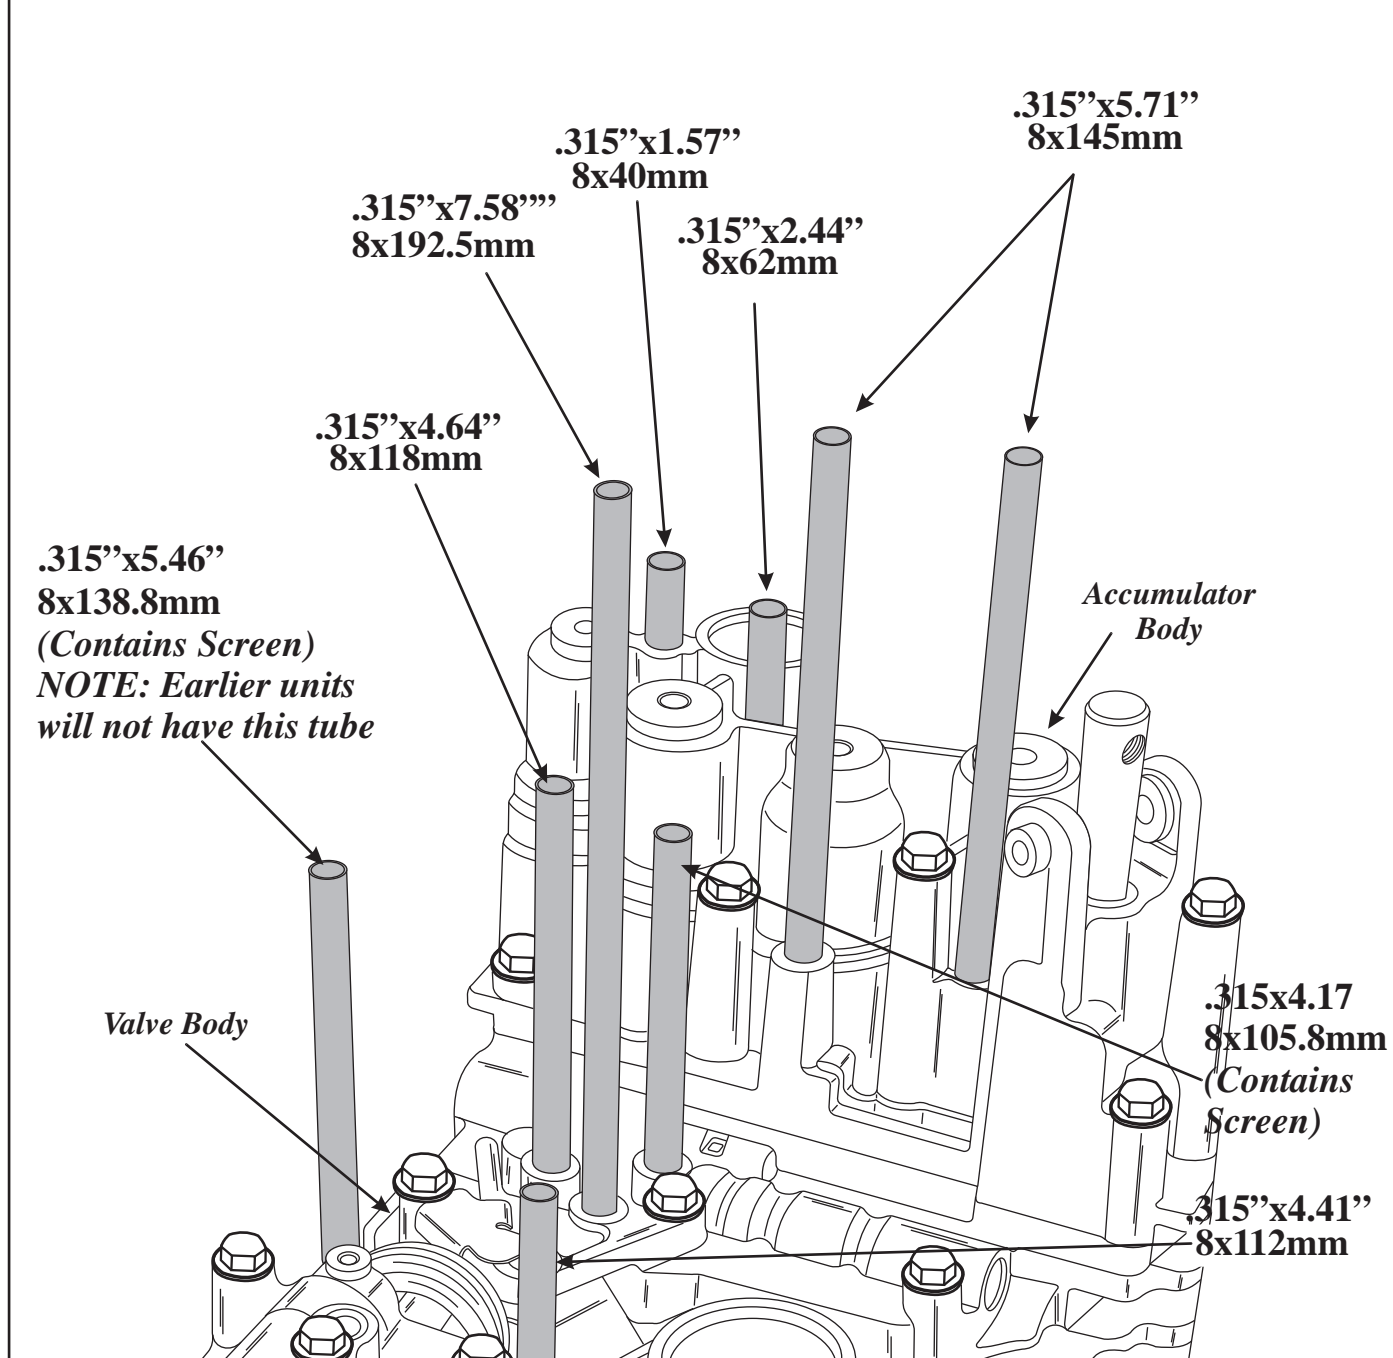
**HONDA CIVIC  
B4RA-M4RA-BMXA FAMILY  
FEED TUBE LOCATIONS**

**CORRECTION:** To correct this condition, refer to Figure 1 and measure the feed tube lengths to ensure that they are going into the correct locations on the accumulator body and valve body.
