*1995 SEMINAR INFORMATION*  
**"HOW TO SURVIVE IN 95"**

# "HOW TO SURVIVE IN '95"

## INTRODUCTION

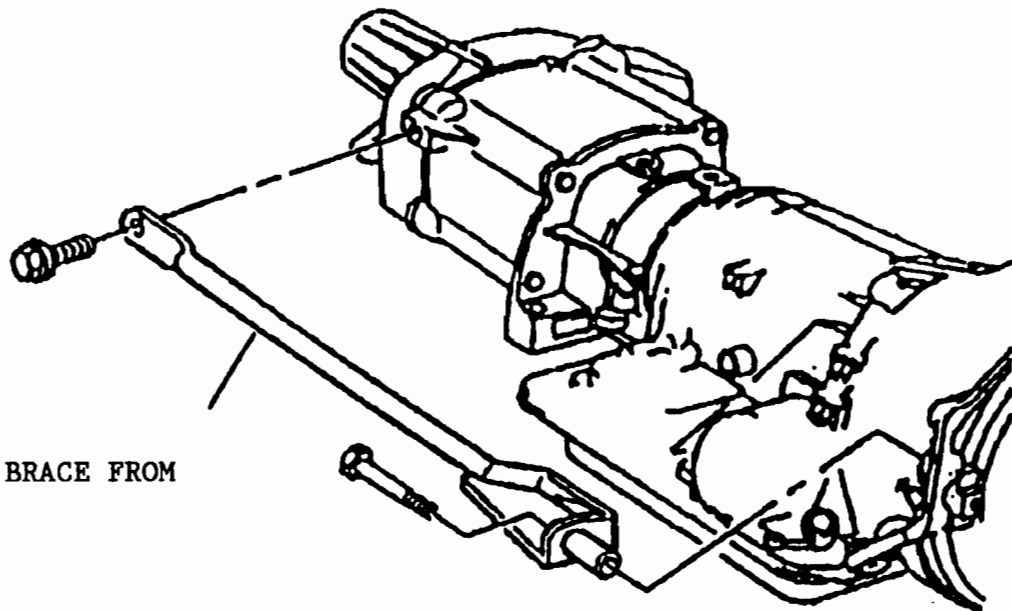
Figure 28

STEP 3: IF YOU HAVE A "T" TRUCK, which is the small "S" type truck with 4 wheel drive, REMOVE AND DISCARD THE BRACE FROM TRANSMISSION TO TRANSFER CASE, as shown in figure 28

REMOVE AND DISCARD THIS BRACE FROM  
ALL 4WD "T" TRUCKS.

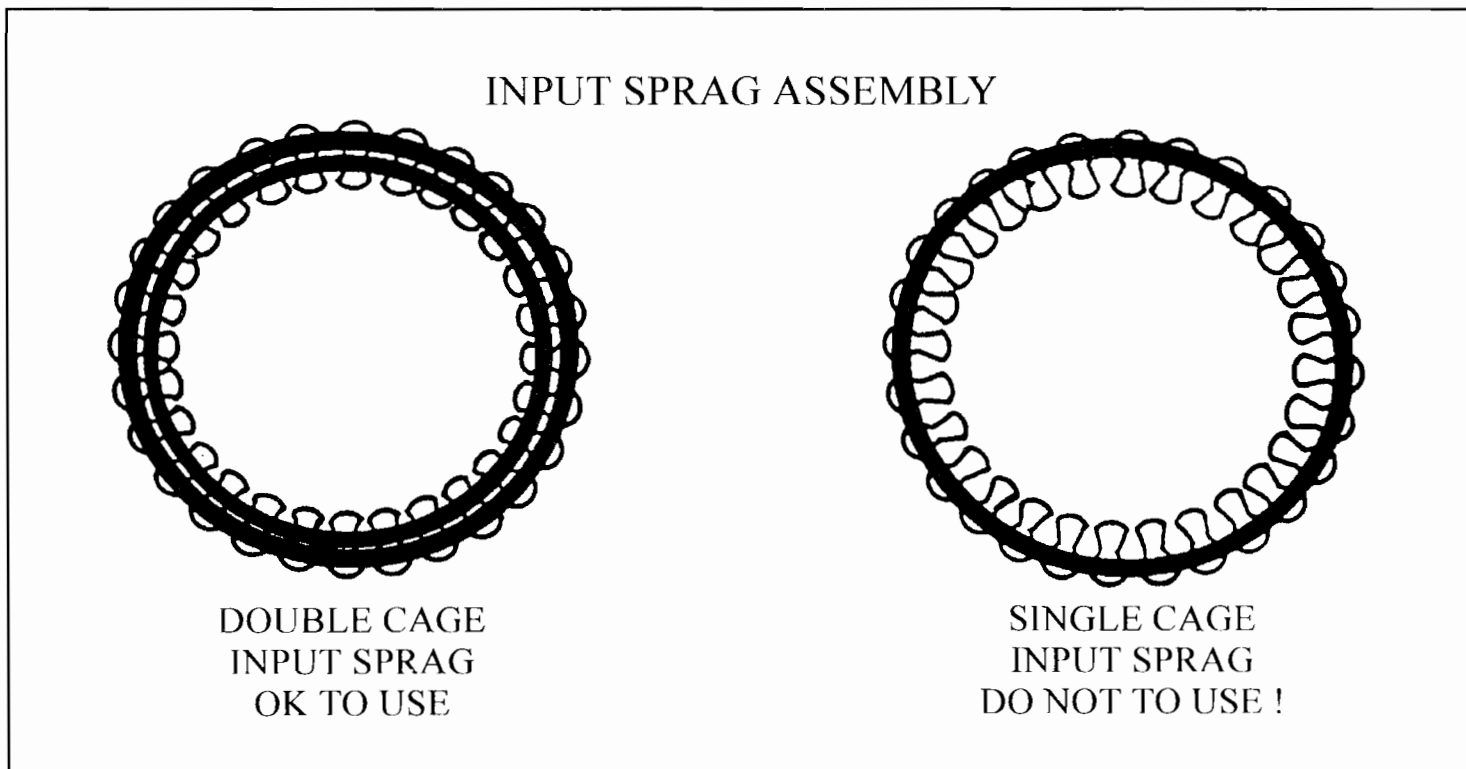
Figure 31

- COMPLAINT:** Complaints will vary depending on the failure mode of the input sprag. If the sprag failure results in "Not Holding", the complaint will be;  
"No Movement in the D4 Range!"  
If the sprag failure results "Not Freewheeling" the complaint will be;  
"Tie-up When Shifting Into 4th Gear"!
- CAUSE:** The cause may be the type of input sprag being used. The manufacturer is currently using an input sprag manufactured by SKF.
- CORRECTION:** Install an input sprag manufactured by BORG-WARNER. The sprags are easy to identify, as the SKF sprag Does Not use an inner cage and the BORG-WARNER sprag Does use an inner cage, as shown in Figure 31.

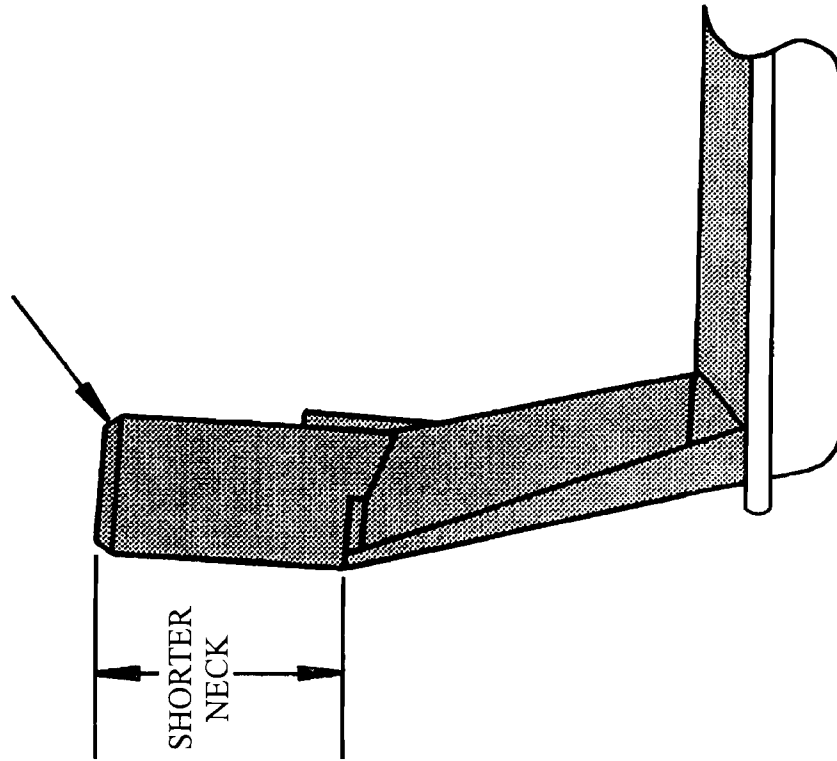
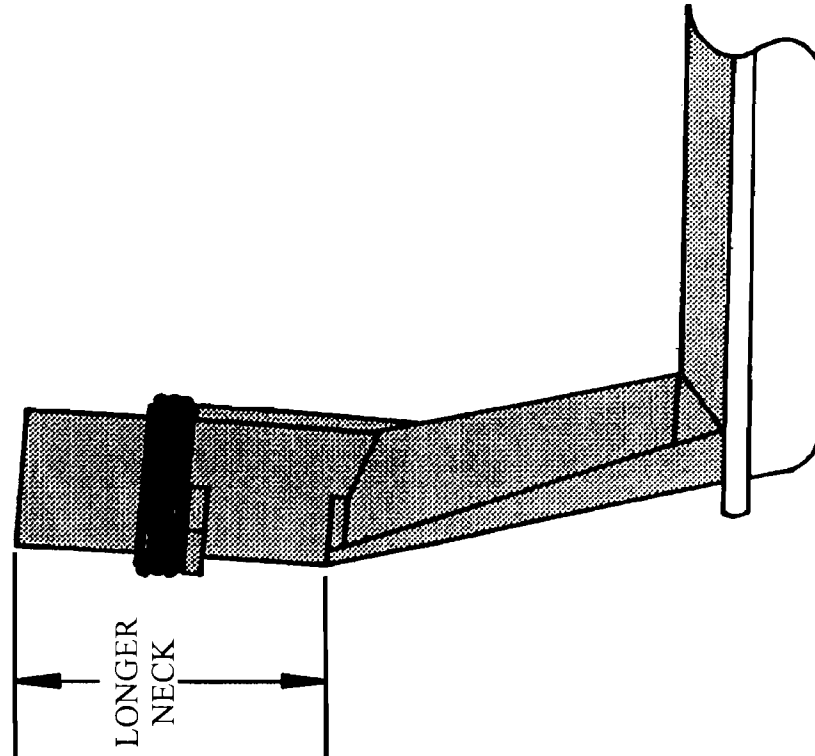
Figure 34A

- (2) BOTTOM PAN FILTER - The new design filter neck is approximately .360" SHORTER than the previous design filter neck, and the filter stops on neck are in different locations to accommodate the new design filter seal (See Figure 34A). Filter neck is also chamfered to prevent damage to the seal during installation.

NEW DESIGN FILTER SEAL  
IS PRESSED INTO PUMP

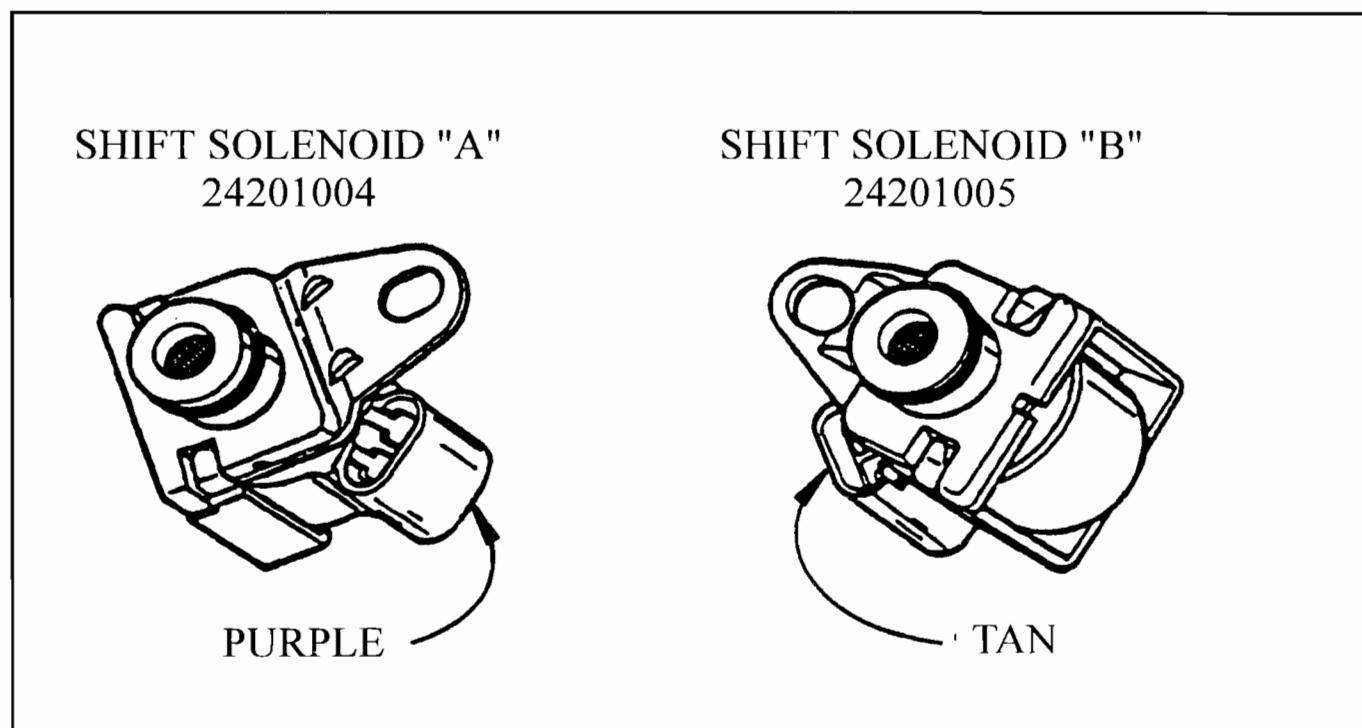
Figure 36

- (1) SHIFT SOLENOID "A" - Revised internal seal material, and is now PURPLE in color, instead of the previous Gray (See Figure 36).
- (2) SHIFT SOLENOID "B" - Revised internal seal material, and is now TAN in color, instead of the previous Green (See Figure 36).

Shift Solenoid "A" (PURPLE) .....	24201004
Shift Solenoid "B" (TAN) .....	24201005

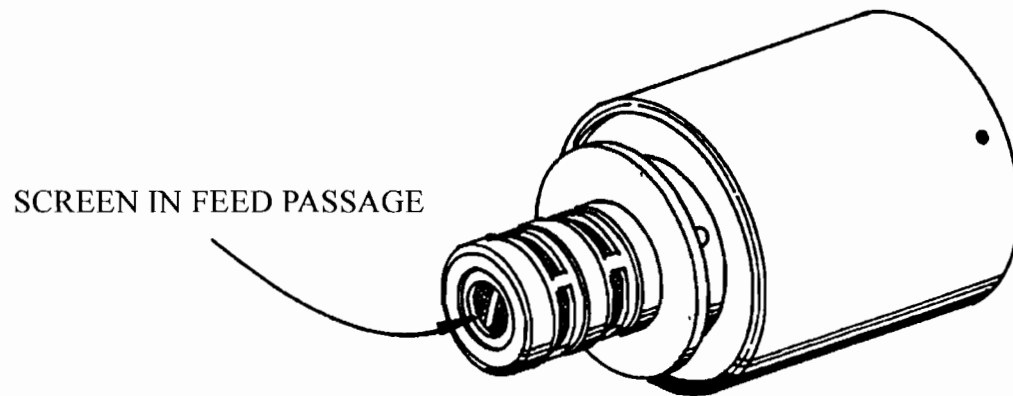
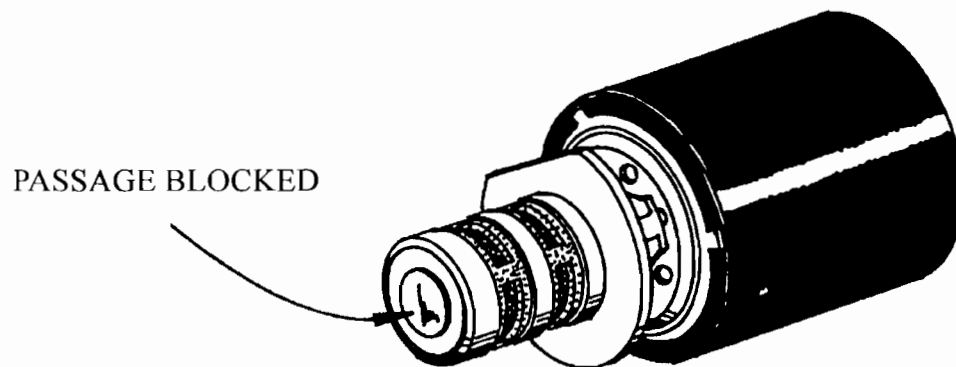
Figure 38

- (1) FORCE MOTOR - New design that does not require torque signal oil be sent back to the end of the enclosed spool valve, so the feed passage and the screen in the end of it were eliminated, as shown in Figure 38. The armature housing is also smaller in diameter than the previous force motor, and is now Black in color (See Figure 38).
- (2) SPACER PLATE - The orificed feed hole for torque signal oil in the spacer plate, marked "A" in Figure 39, has been eliminated to accommodate the new design force motor (See Figure 39).
- (3) TORQUE SIGNAL COMPENSATOR VALVE - Eliminated because it is no longer needed to absorb torque signal pulses created by the previous model PCM. The torque signal feed passage is no longer drilled in the accumulator housing on 1994 models (See Figures 40 and 41)

Force Motor, 91-93 Models .....8677314  
Force Motor, 94-Up Models .....8684216

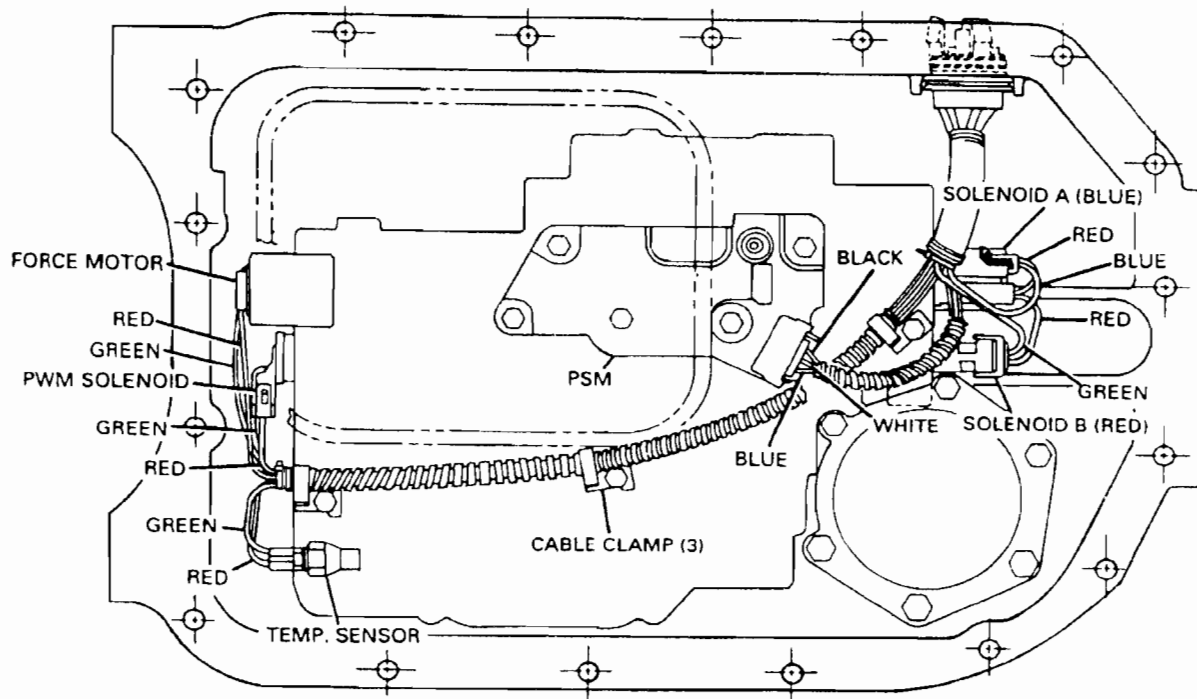
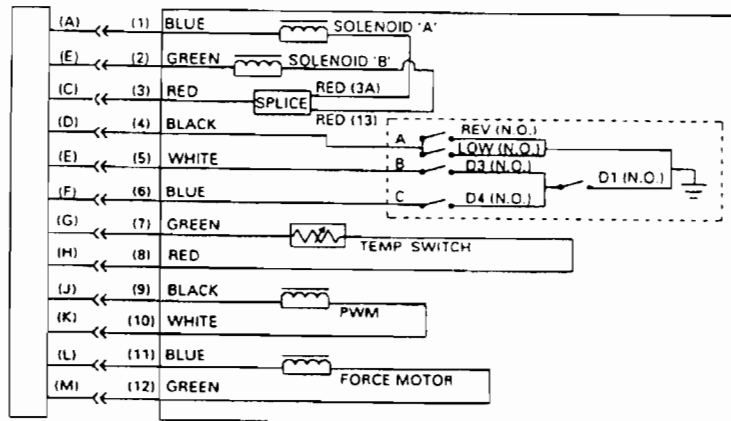
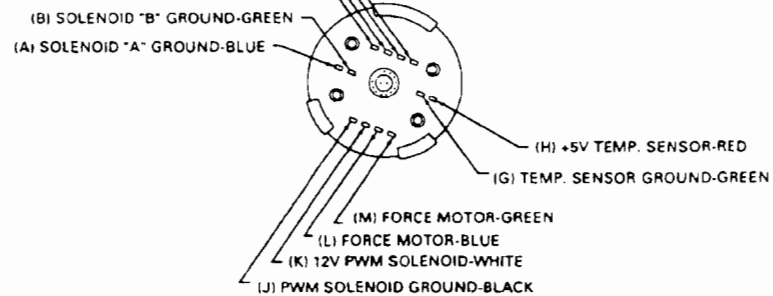
Figure 43

PREVIOUS CASE CONNECTOR

UPDATE SERVICE PACKAGE (Includes the following) .....24200161

1. New Design Transmission Case Connector, and Internal Wiring Harness Assembly.
2. New Design External Vehicle Harness Connector.

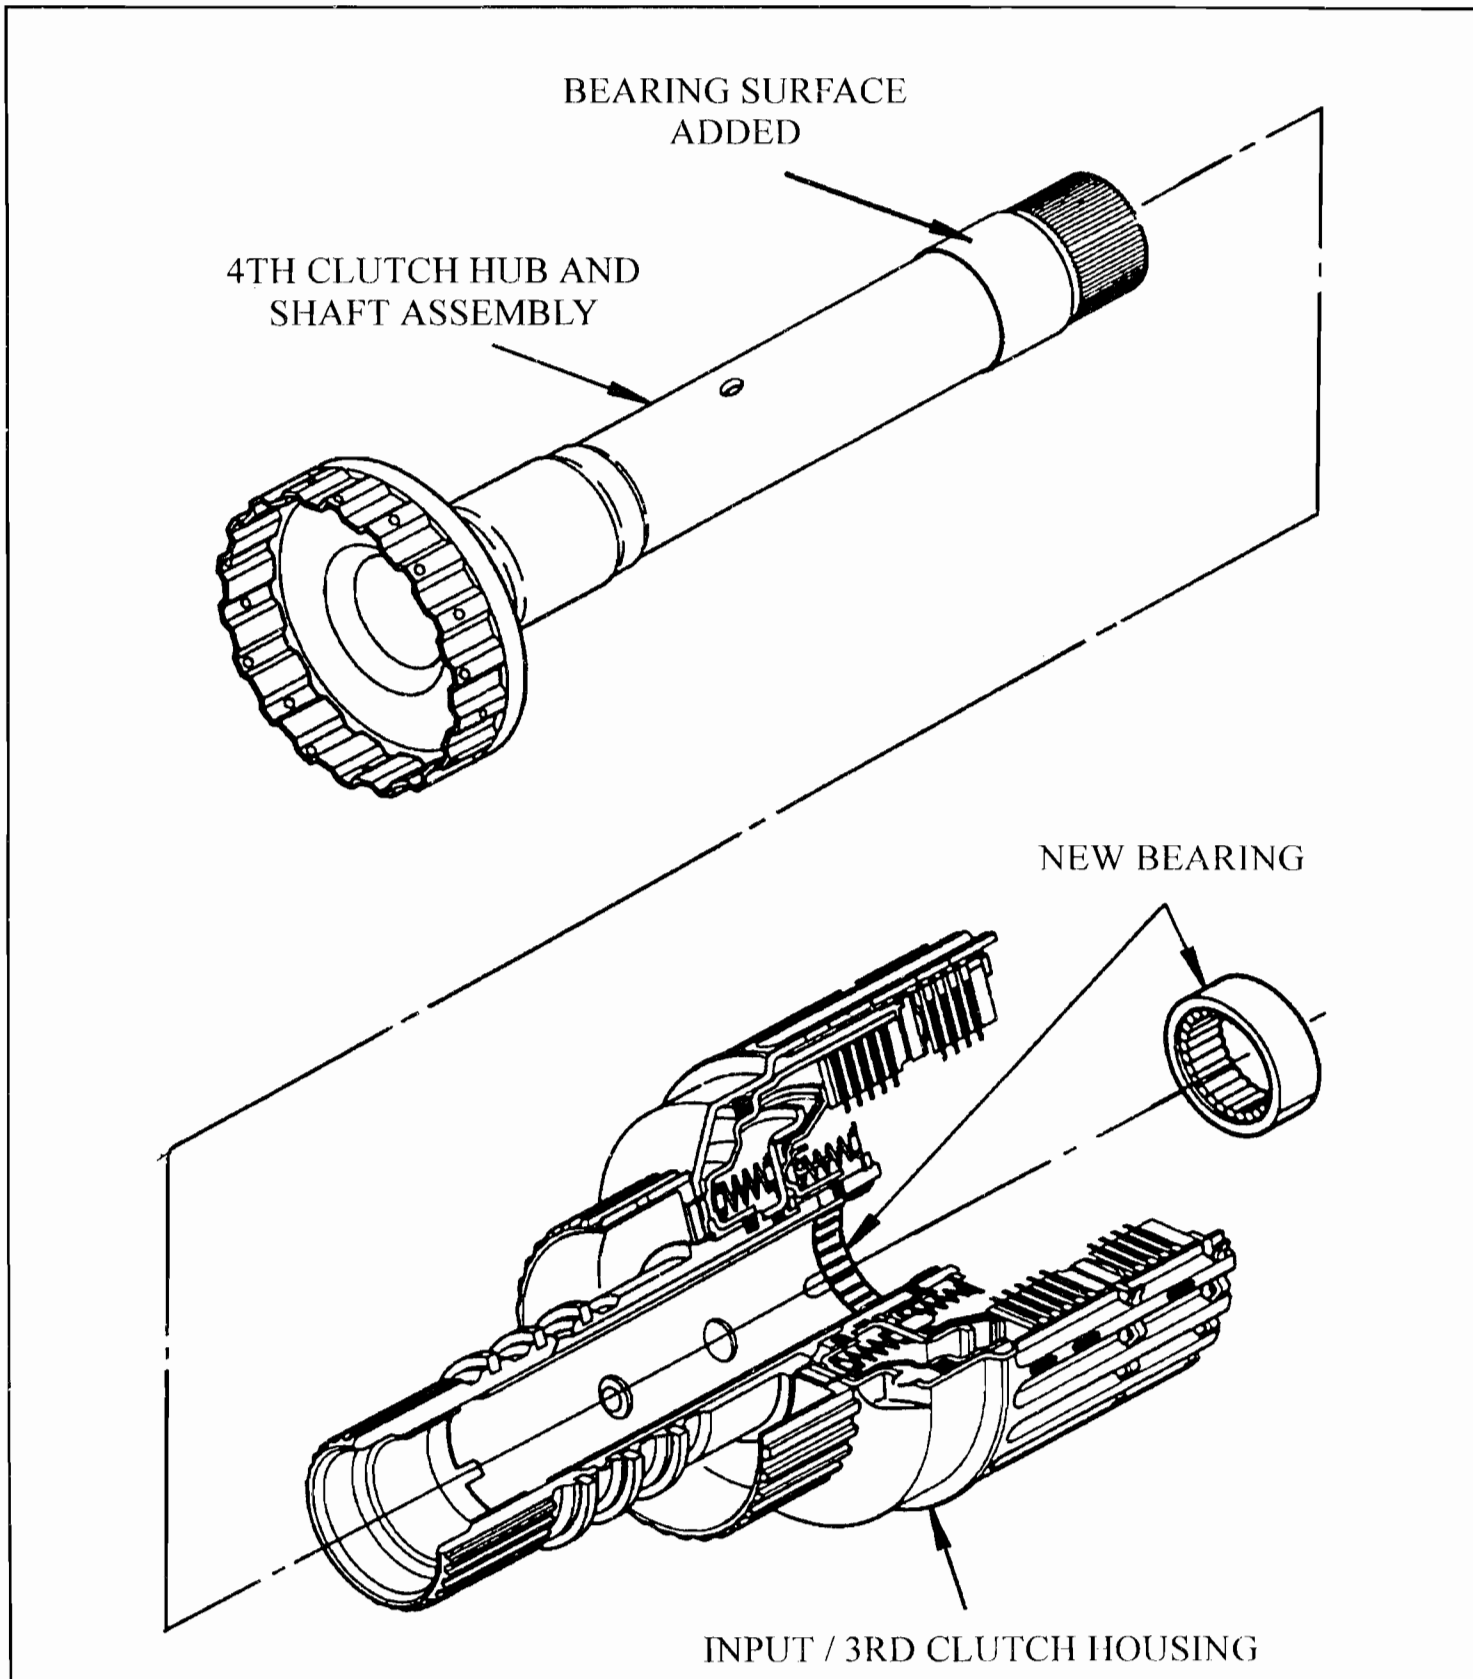
Figure 48

- (1) OUTPUT SHAFT - Caged needle bearing located in the center of the output shaft has been eliminated, as shown in Figure 47.
- (2) INPUT/3RD CLUTCH HOUSING ASSEMBLY - Caged needle bearing **ADDED** to the input housing assembly, and located on the inside diameter of the input shaft, as shown in Figure 48.
- (3) 4TH CLUTCH HUB AND SHAFT - Hardened sleeve added to the shaft next to the splines that is 1.310" in diameter, and rides in the added bearing in the input/3rd clutch housing, as shown in Figure 48.
- (4) INPUT SUN GEAR - Since the sun gear no longer rides on a bearing, it was not necessary to machine the surface finish on the inside diameter. The inside diameter has been reduced preventing it from being installed into transaxle with a bearing on the output shaft.

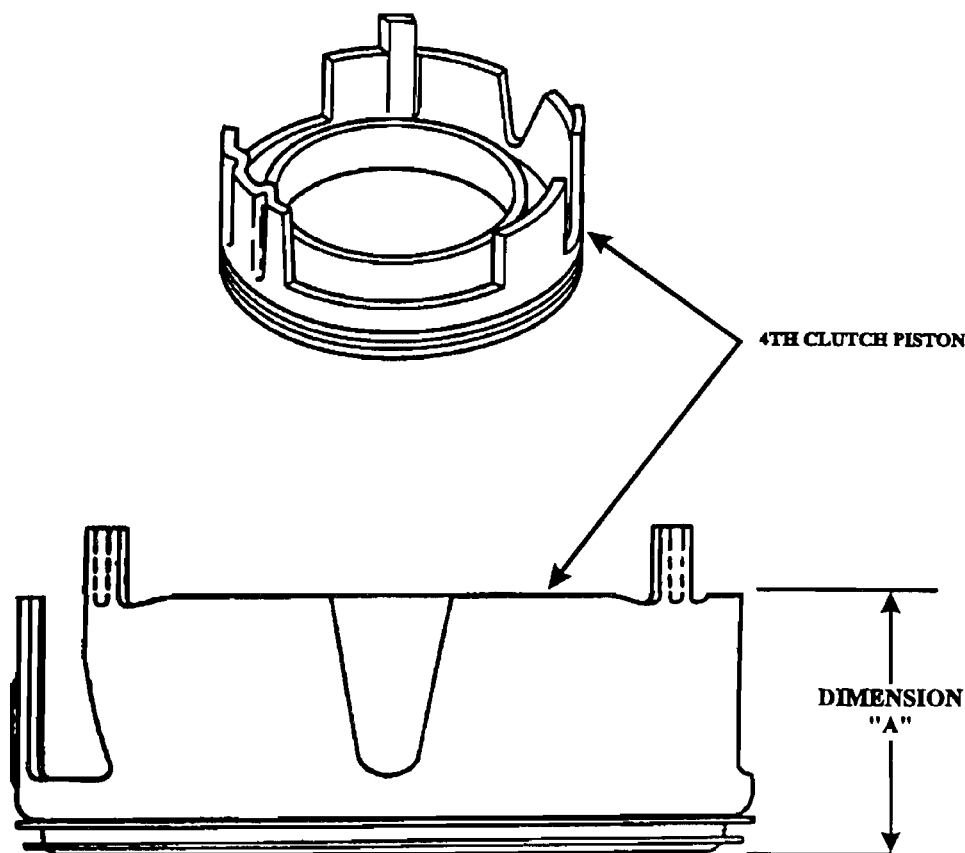
Figure 50

- (1) 4TH CLUTCH PISTON - Height of the piston apply legs, as measured in Figure 50, has changed slightly on both minimum and maximum tolerances.
- (2) 4TH CLUTCH APPLY PLATE - Changed to a "Flat" plate instead of the previous "Tapered" plate, and the thickness changed to .133" instead of the previous .163", as shown in Figure 51. There are now two of these .133" thick plates used in the 4th clutch stack-up, as shown in Figure 51.

91-92 PISTON, DIMENTION "A" = 1.992" - 2.007"

91-92 PISTON, DIMENTION "A" = 1.980" - 1.996"

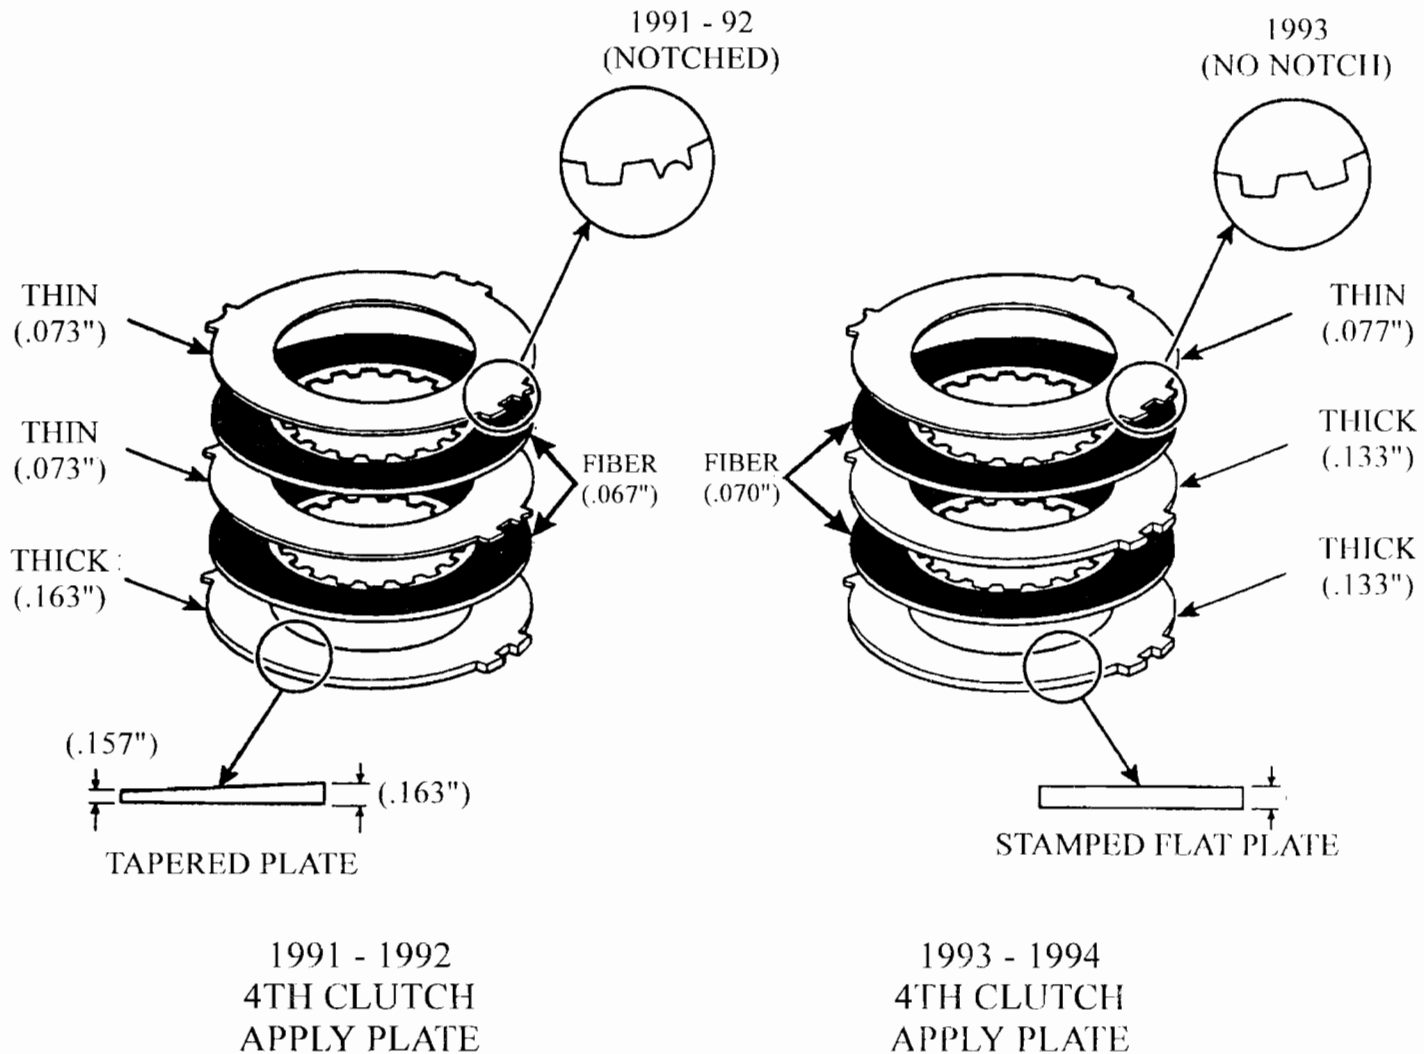
Figure 51

- (3) 4TH CLUTCH STEEL PLATES - Thickness was increased to .077" instead of the previous .073", and the "Notch" was removed from the tab for I.D. as shown in Figure 51. The new 4th clutch stack now uses only one of these plates and is the same thickness and part number as the early 440-T4 steel plate (See Figure 51).

- (4) 4TH CLUTCH FIBER PLATES - Very minimal thickness change as shown in Figure 51.
- (5) CHANNEL PLATE - The depth in the 4th clutch area, as measured from the gasket surface to the 4th clutch surface, was increased to .792" instead of the previous .772" to accommodate the revised 4th clutch stack-up (See Figure 52). This distance MUST be measured with a depth micrometer for accuracy. 91-92 Channel Plate Casting Number = "Varies" 93-94 Channel Plate Casting Number = 8682217

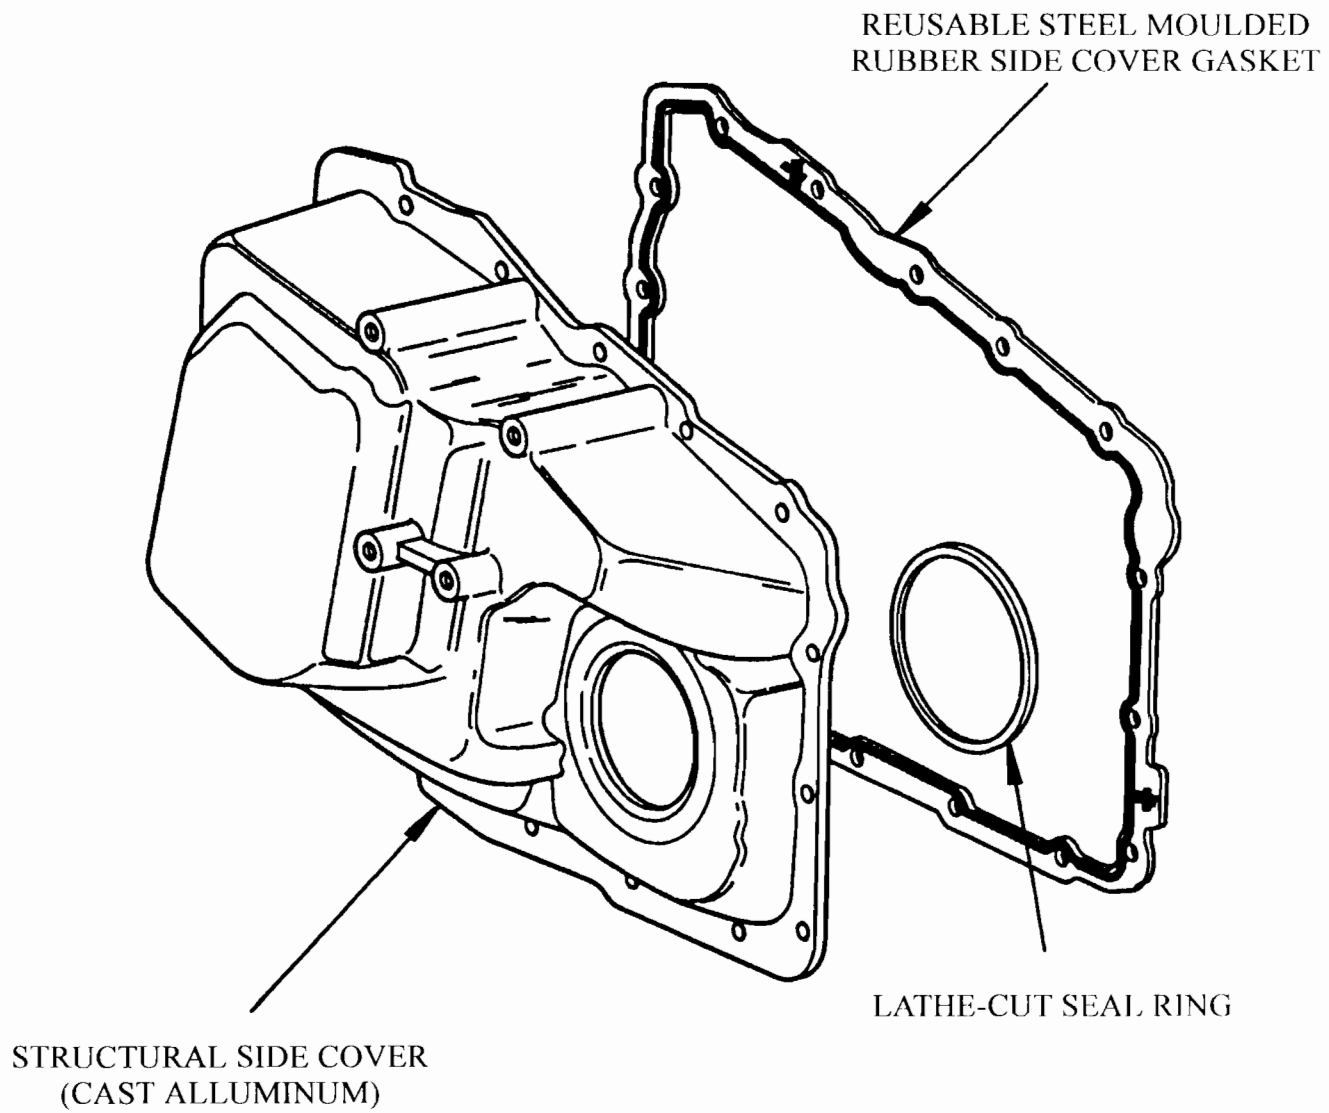
Figure 54

- (1) STRUCTURAL SIDE COVER - Now made of cast aluminum with drilled and tapped bosses for mounting into the vehicle (See Figure 54). There are currently two different structural side covers used in different car bodies, one with four cast bosses (See Figure 56), and one with six cast bosses (See Figure 57).

- (2) SIDE COVER GASKET - Now has rubber bead molded onto thin steel gasket, and is reusable as long as the rubber bead is not broken. Also uses a lathe-cut rubber seal that fits into a groove inside the structural side cover, and replaces the previous doughnut gasket (See Figure 54).

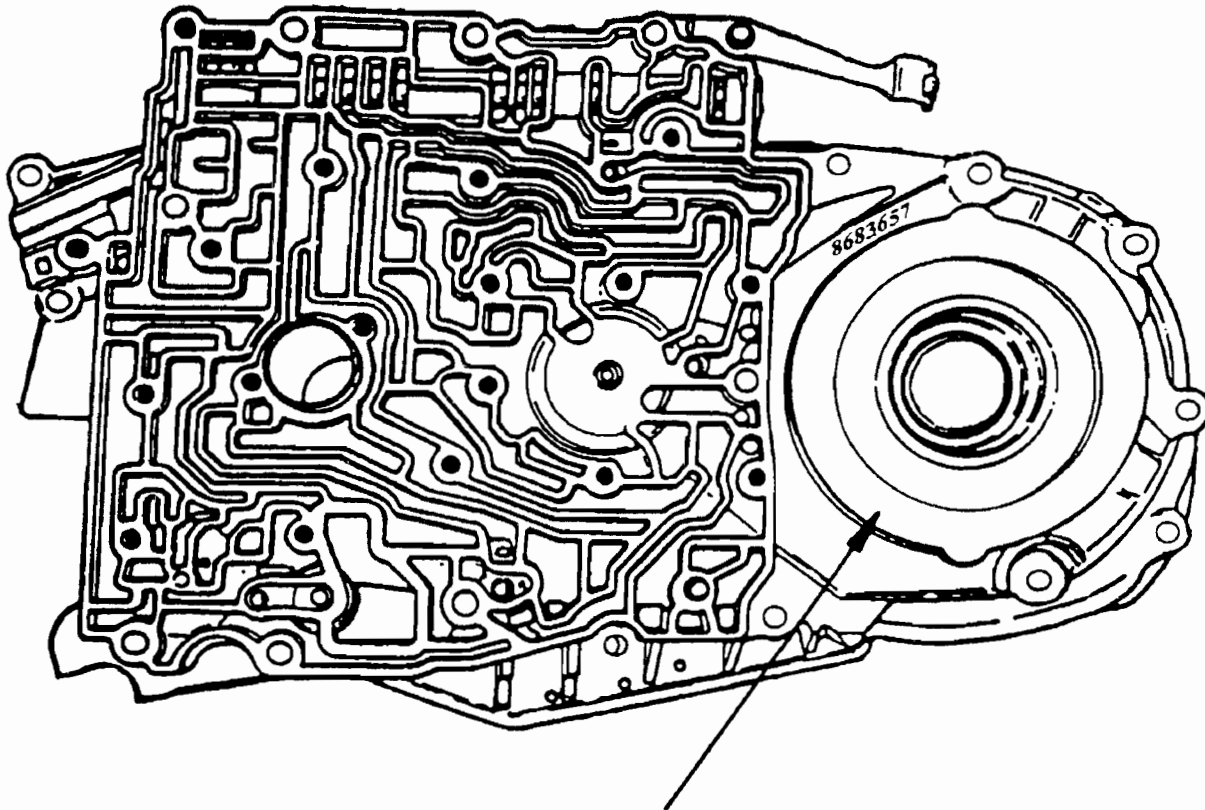
Figure 55

- (3) CHANNEL PLATE - The six studs that come through the channel plate in the doughnut gasket area have been eliminated, and the sealing surface made wider to accommodate the new lathe-cut seal ring (See Figure 55)

CHANGED AREA OF CHANNEL PLATE

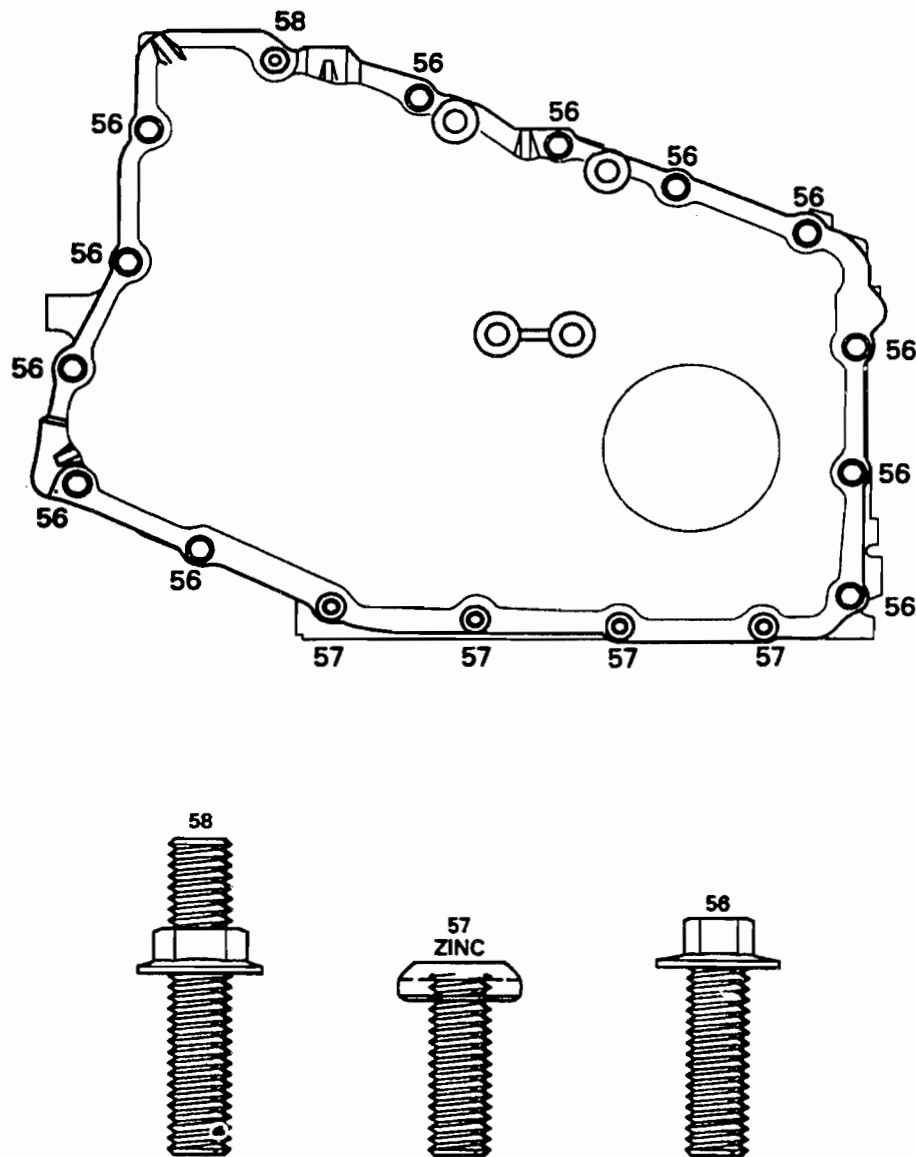
Figure 56

- (4) SIDE COVER RETAINING BOLTS - Have all been changed to accommodate the new structural side cover. There are currently three~different types of the retaining bolts used per vehicle, and are shown in Figures 56 and 57, along with their proper locations. Refer to Figures 56 and 57, depending on the model you are working on. Refer to Figure 58 for the stamped steel cover.

"4 BOSS" STRUCTURAL SIDE COVER  
AND PROPER BOLT LOCATIONS  
FITS ONLY THE FOLLOWING "W" BODIES  
1994 CHEVROLET LUMINA  
1994 BUICK REGAL  
1994 OLDS CUTLAS SUPREME  
1994 PONTIAC GRAND PRIX

The Structural Side Covers MUST be used on the 1994 models that are shown in Figures 56 and 57.

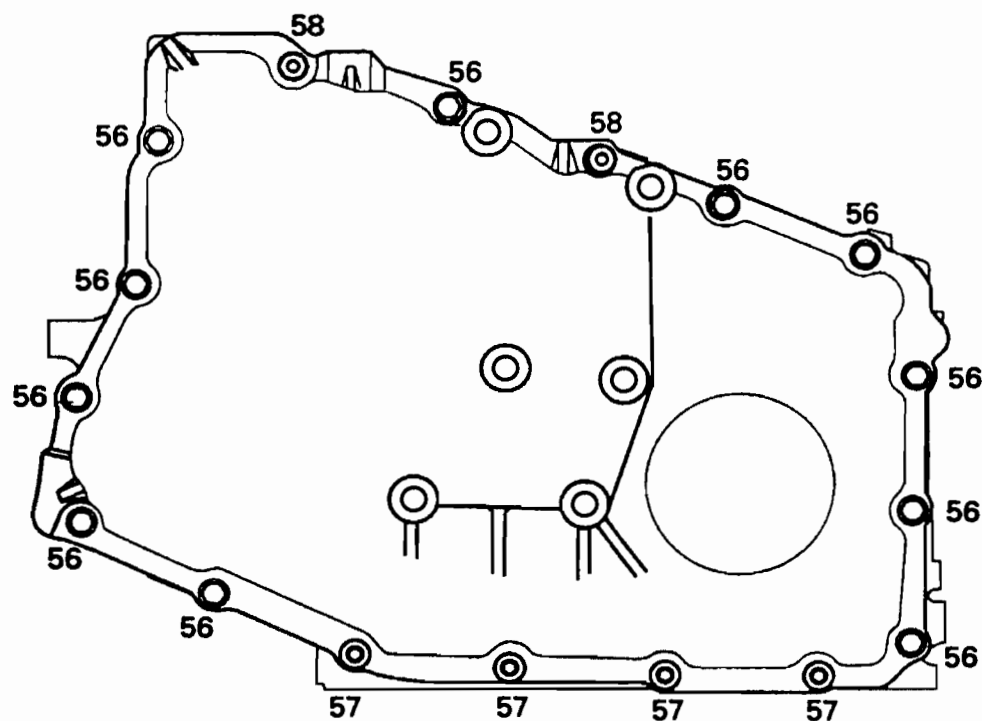
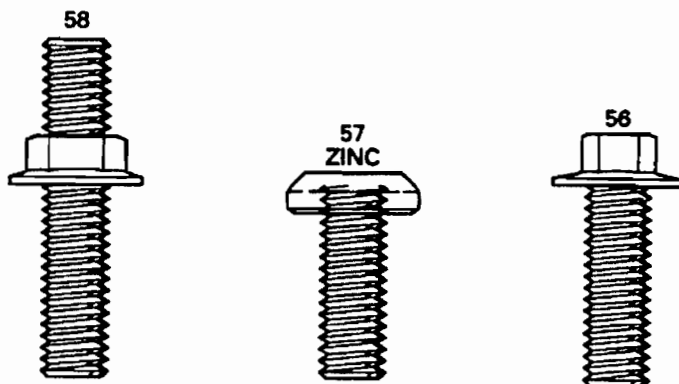
Figure 57

"6 BOSS" STRUCTURAL SIDE COVER  
AND PROPER BOLT LOCATIONS  
FITS ONLY THE FOLLOWING "L" AND "N" BODIES

1994 CHEVROLET BERETTA (L)  
1994 CHEVROLET CORSICA (L)  
1994 BUICK SKYLARK (N)  
1994 OLDSMOBILE ACHIEVA (N)  
1994 PONTIAC GRAND AM (N)

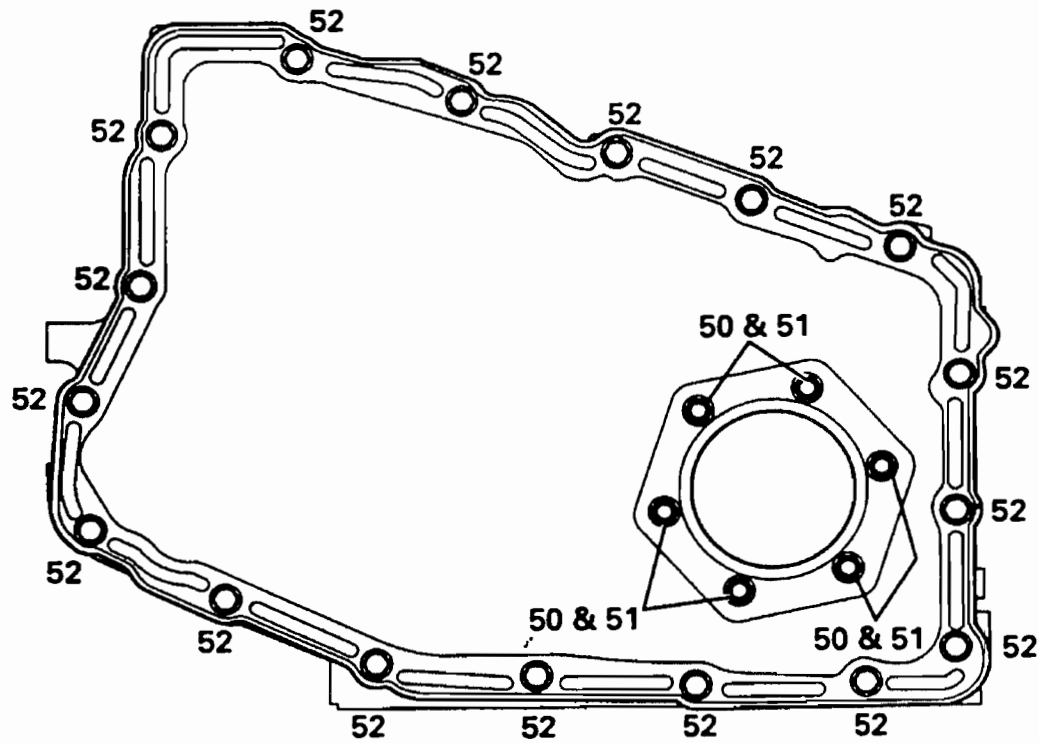
Figure 58

STAMPED STEEL SIDE COVER  
FITS ALL OTHER 1994 MODEL

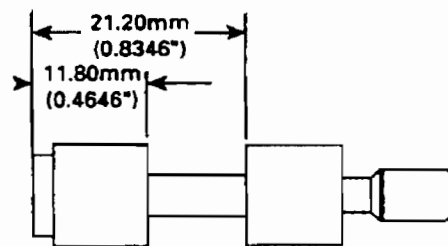
Figure 60

1991 - 1992 3/2 MANUAL  
DOWNSHIFT VALVE

1993 3/2 MANUAL  
DOWNSHIFT VALVE

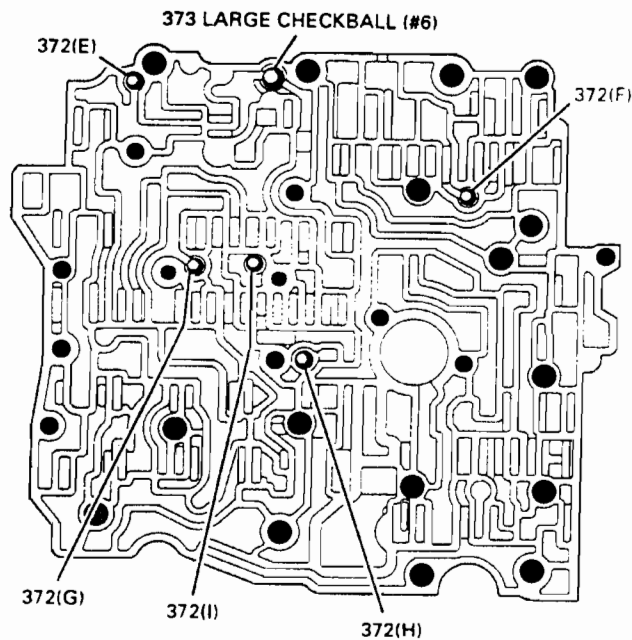
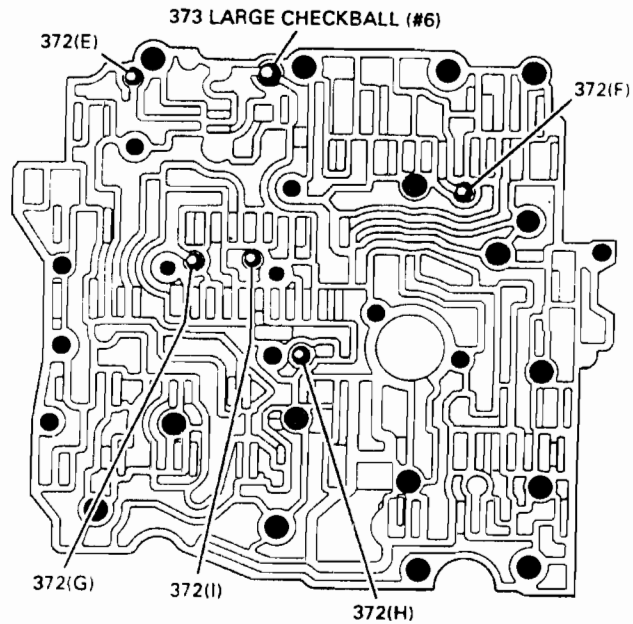
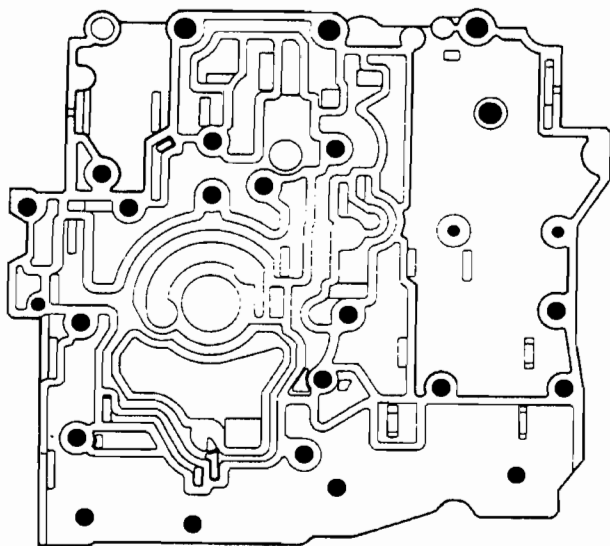
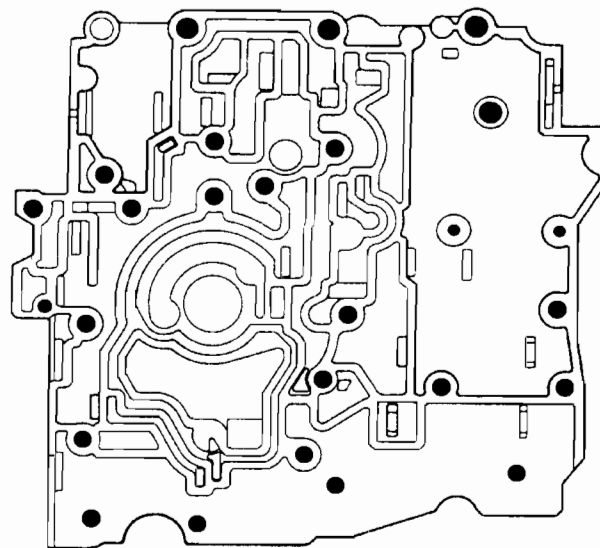
Figure 61

- (1) VALVE BODY CASTING - The aluminum plug and retainer clip for converter clutch regulator valve were eliminated, and replaced with a new bushing and new style retainer, as shown in Figure 59.  
The 1-2 accumulator valve bushings (Both Primary and Secondary), the 2-3 accumulator valve bushing, and the 3-4 accumulator valve bushing were revised to accommodate new design retainers with more holding capacity as shown in Figure 59. The 2-3 Shift Valve and the 3-2 Manual Downshift Valve received some dimensional changes, as shown in Figure 60.  
These changes required changes in the Valve Body Casting, in the worm track areas of both sides, and the differences are shown in Figure 61. Note that there are not any check ball location changes.

1991 - 92 VALVE BODY  
(CHANNEL PLATE SIDE)

1993 - 94 VALVE BODY  
(CHANNEL PLATE SIDE)

1991 - 92 VALVE BODY  
(PUMP SIDE)

1993 - 94 VALVE BODY  
(PUMP SIDE)

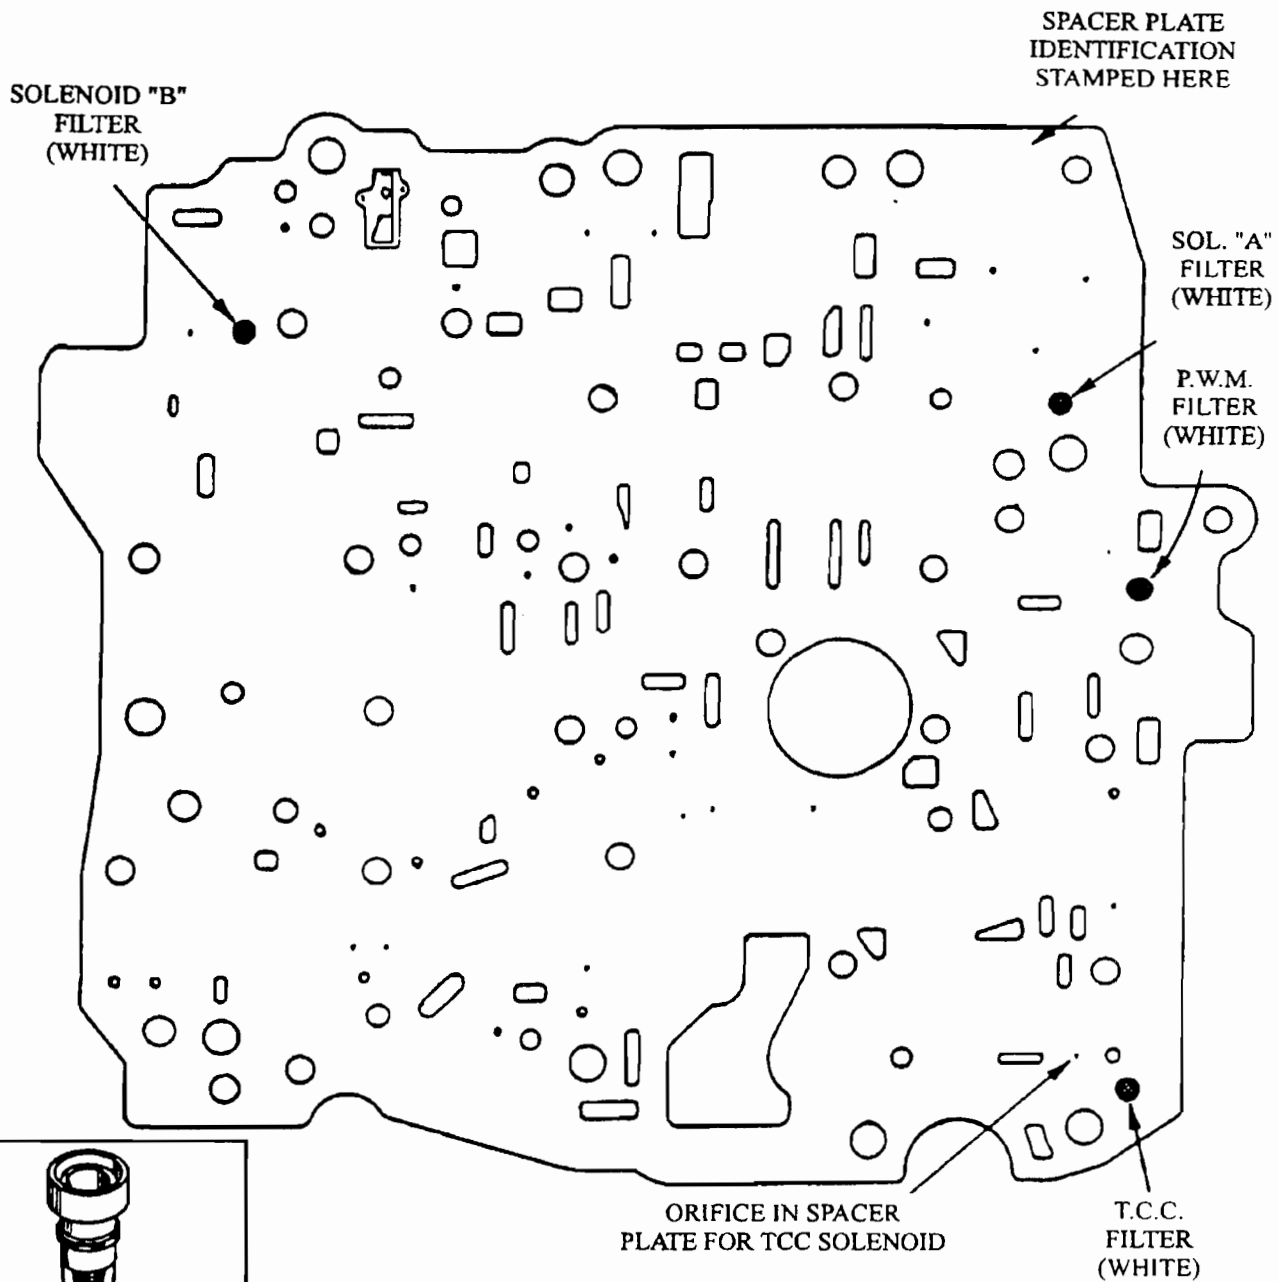
Figure 62

- (2) VALVE BODY SPACER PLATE - Different hole spacing to accommodate the valve body and channel plate casting changes. Also the 91-92 hydraulics spacer plate has the TCC solenoid orifice in the spacer plate, and the 93-94 hydraulics requires the same screen and orifice assembly, with "O" ring, that is currently used in the THM 440-T4 transaxle and is shown Figures 62 and 63.

91 -92 HYDRAULICS SPACER PLATE

WHITE SCREEN  
8651658
