*1995 SEMINAR INFORMATION*  
**"HOW TO SURVIVE IN 95"**

# "HOW TO SURVIVE IN '95"

## INTRODUCTION

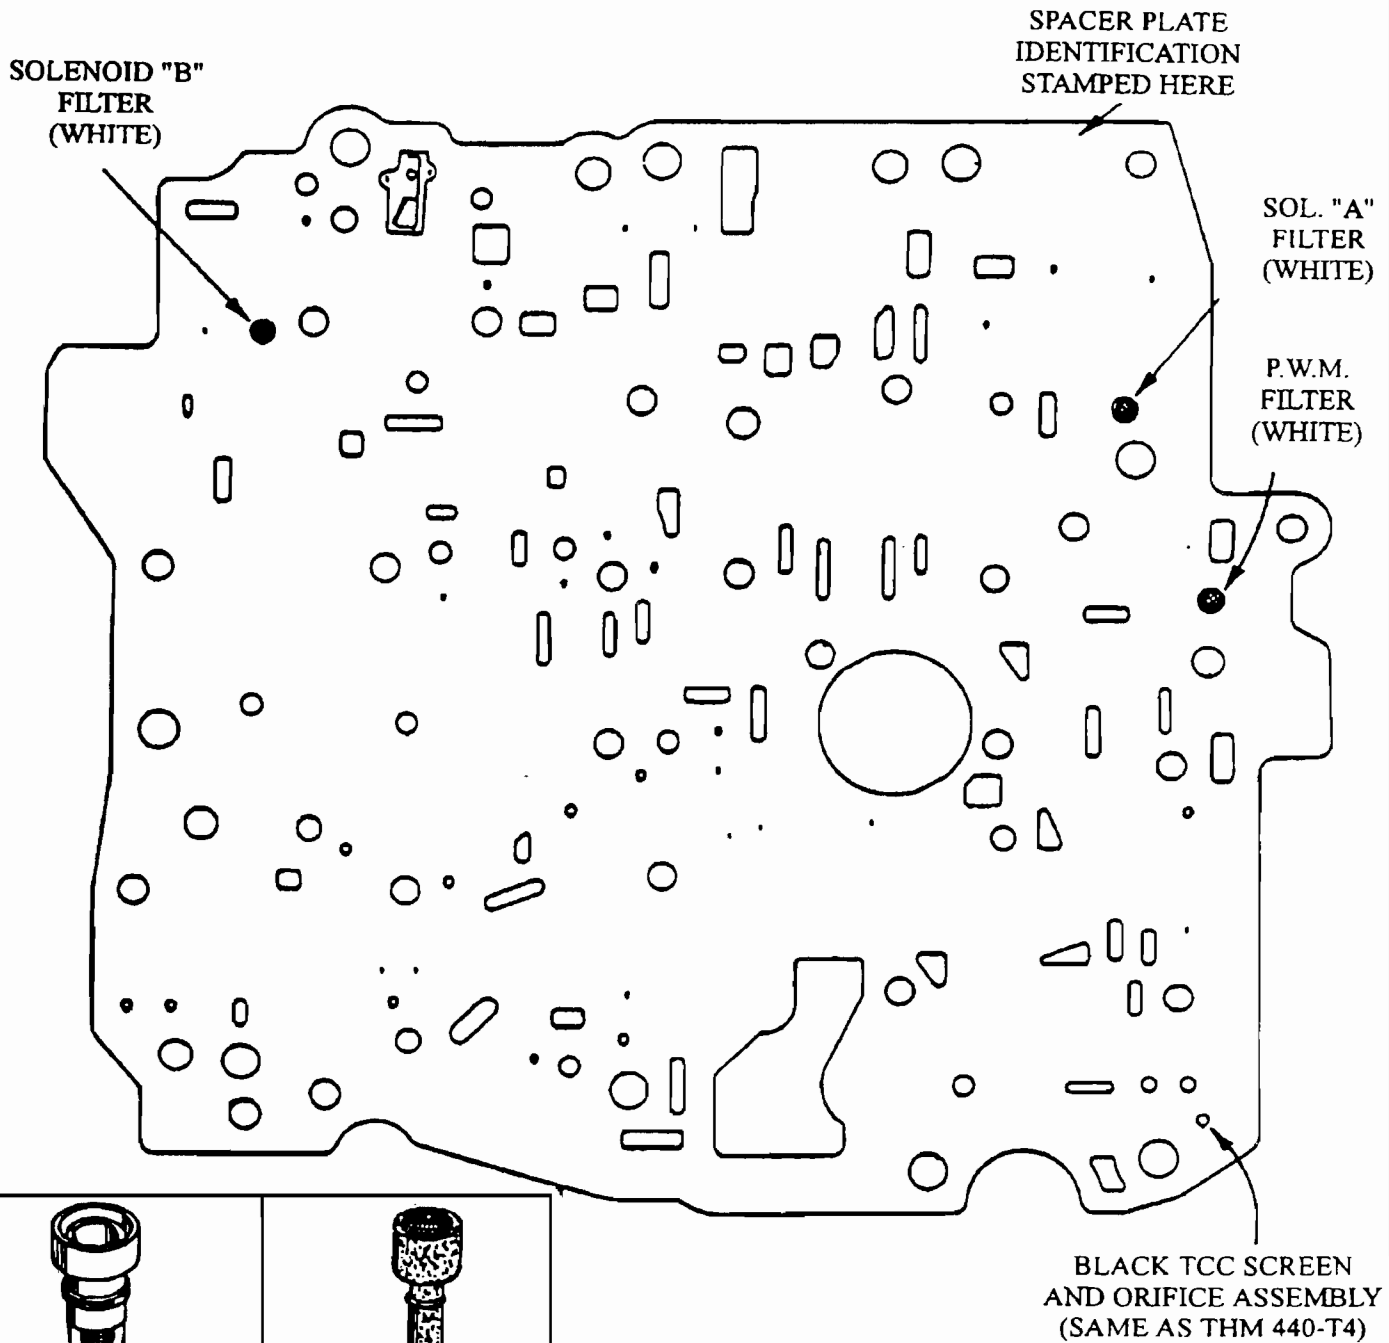
Figure 63

- (2) VALVE BODY SPACER PLATE - Different hole spacing to accommodate the valve body and channel plate casting changes. Also the 91-92 hydraulics spacer plate has the TCC solenoid orifice in the spacer plate, and the 93-94 hydraulics requires the same screen and orifice assembly, with "O" ring, that is currently used in the THM 440-T4 transaxle and is shown Figures 62 and 63.

93 - 94 HYDRAULICS SPACER PLATE

WHITE SCREEN  
8651658

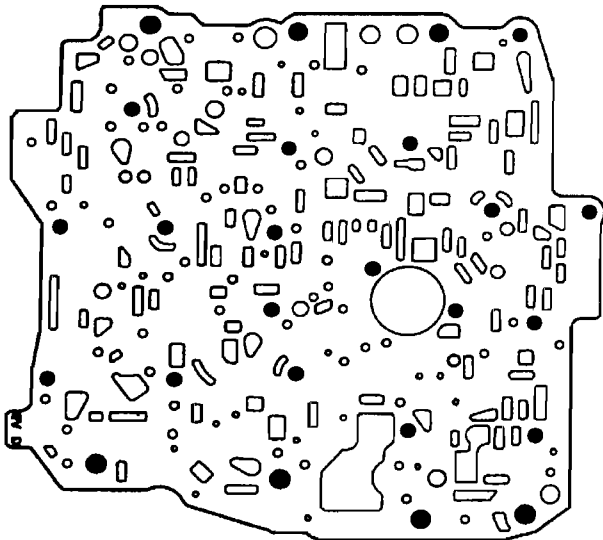
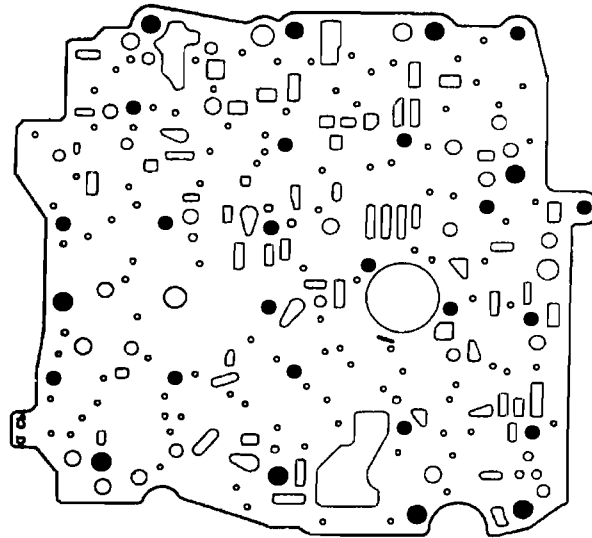
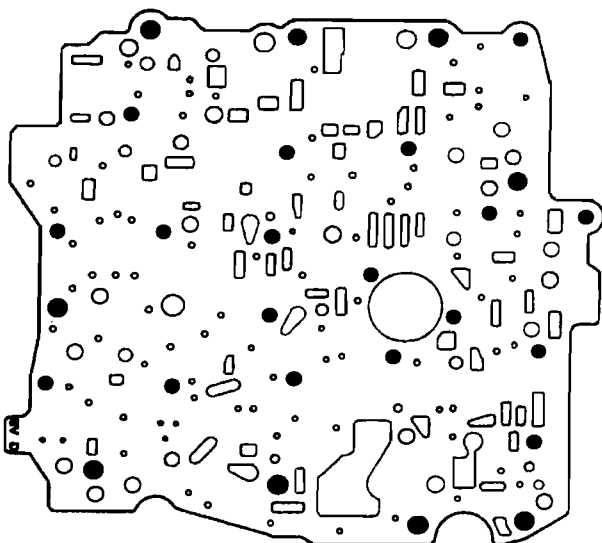
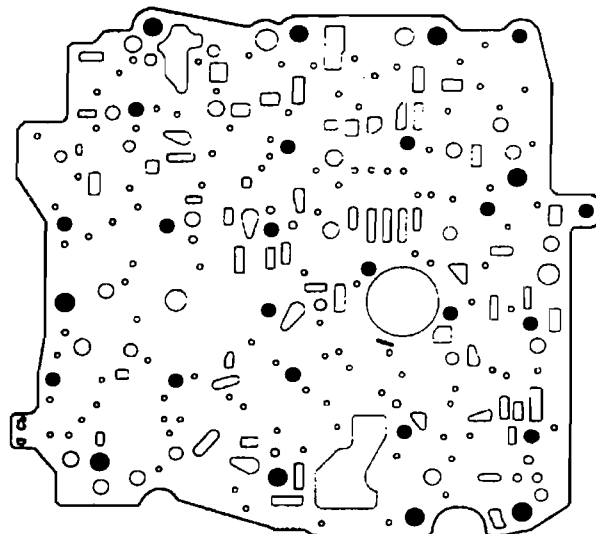
- (3) VALVE BODY GASKETS - Both the valve body to spacer plate, and spacer plate to channel plate gaskets change to accommodate the revised hydraulics. They are easily identified by the OEM part number ink stamped on each gasket. Refer to Figure 64 for proper identification.

1991 - 92 GASKET  
(VALVE BODY TO SPACER PLATE)  
INK STAMPED 8678762

1991 - 92 GASKET  
(SPACER PLATE TO CHANNEL PLATE)  
INK STAMPED 8678761

1993 - 94 GASKET  
(VALVE BODY TO SPACER PLATE)  
INK STAMPED 8682281

1993 - 94 GASKET  
(SPACER PLATE TO CHANNEL PLATE)  
INK STAMPED 8682280

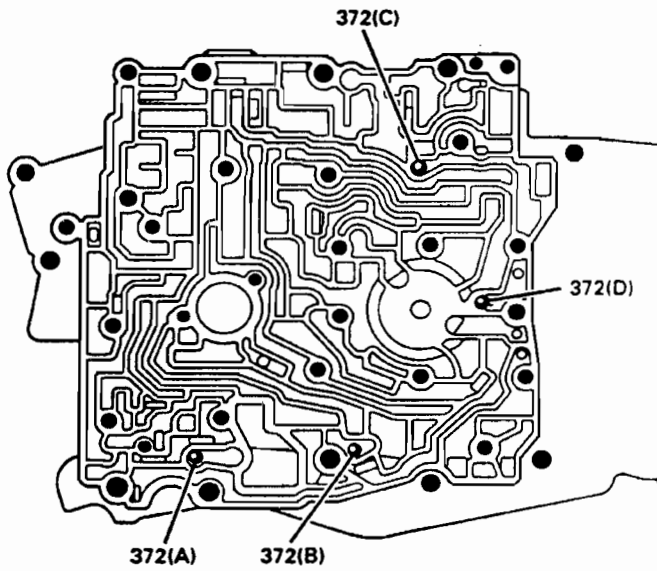
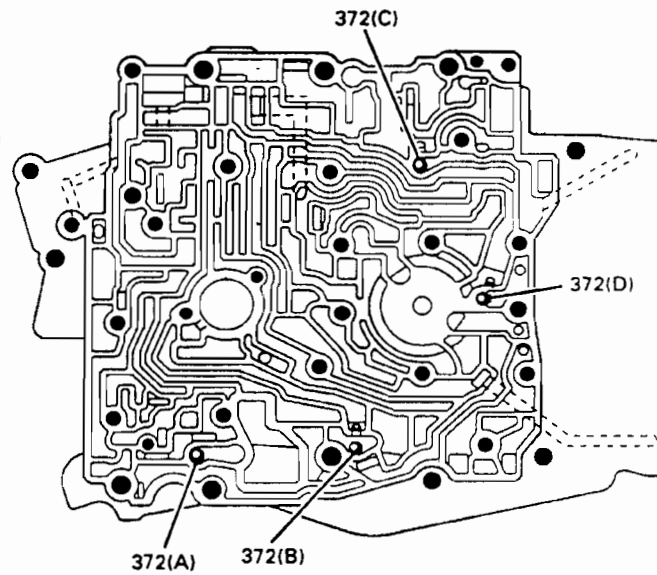
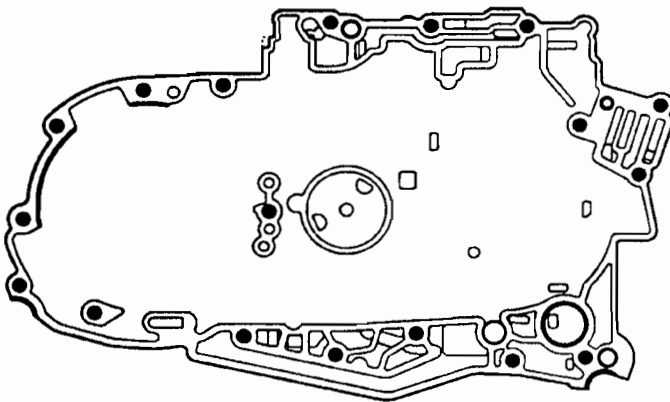
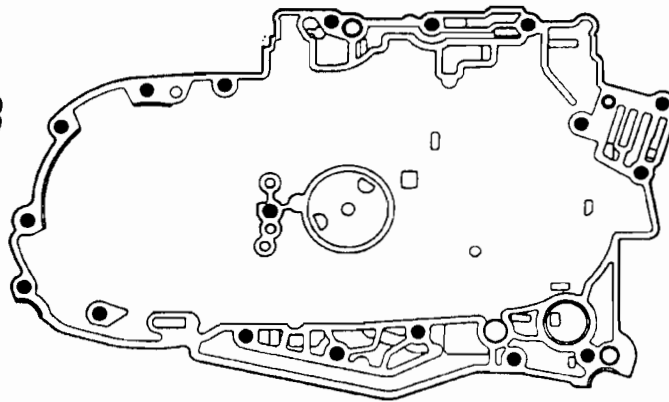
Figure 65

- (4) CHANNEL PLATE ASSEMBLY - There are casting changes in the worm track area to accommodate the valve body changes, as shown in Figure 65. The Channel Plate can be easily identified by the casting number. Refer to Figure 66 for casting number location. The casting number for the 91-92 hydraulics is 8667284, and casting number for the 93-94 hydraulics is 8682217, and is shown in Figure 66.  
There was also a change in the Lo Blow Off Valve and Seat, which is also located in the channel plate. These changes are shown in Figure 67.

1991 - 92 CHANNEL PLATE  
(VALVE BODY SIDE)

1993 - 94 CHANNEL PLATE  
(VALVE BODY SIDE)

1991 - 92 CHANNEL PLATE  
(CASE SIDE)

1993 - 94 CHANNEL PLATE  
(CASE SIDE)

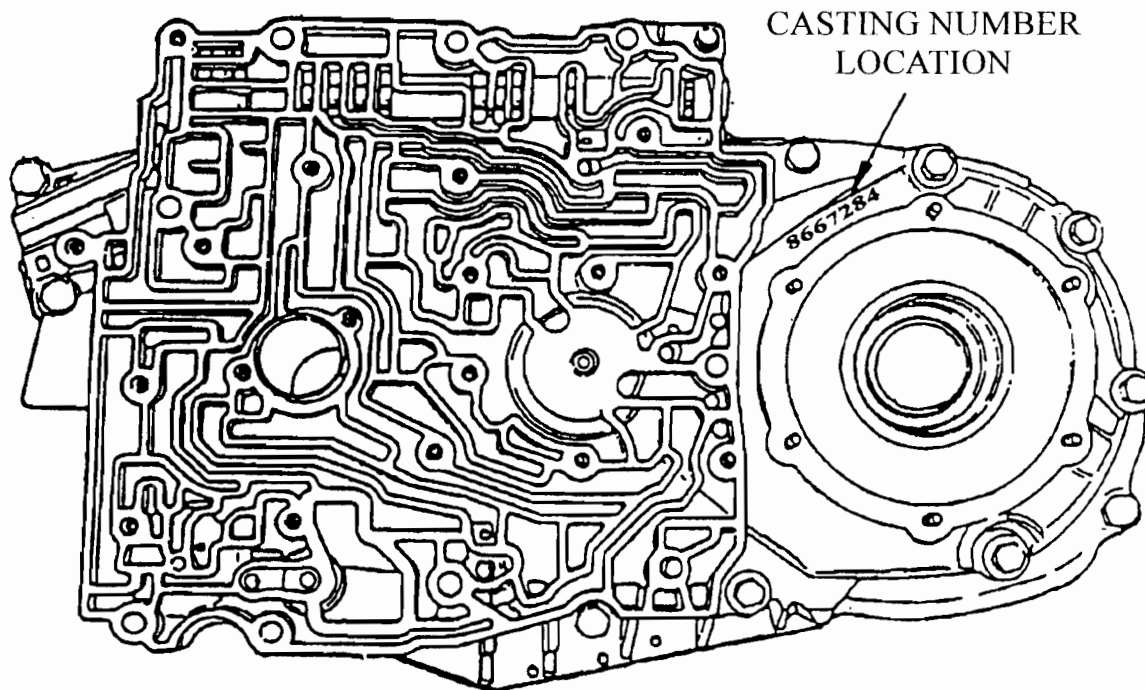
Figure 66

91 - 92 HYDRAULICS = 8667284  
93 - 94 HYDRAULICS = 8682217

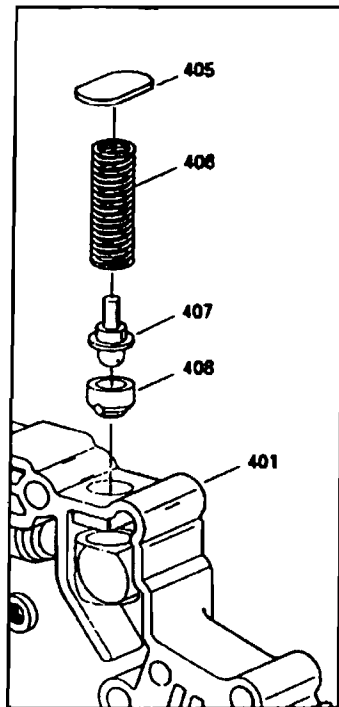
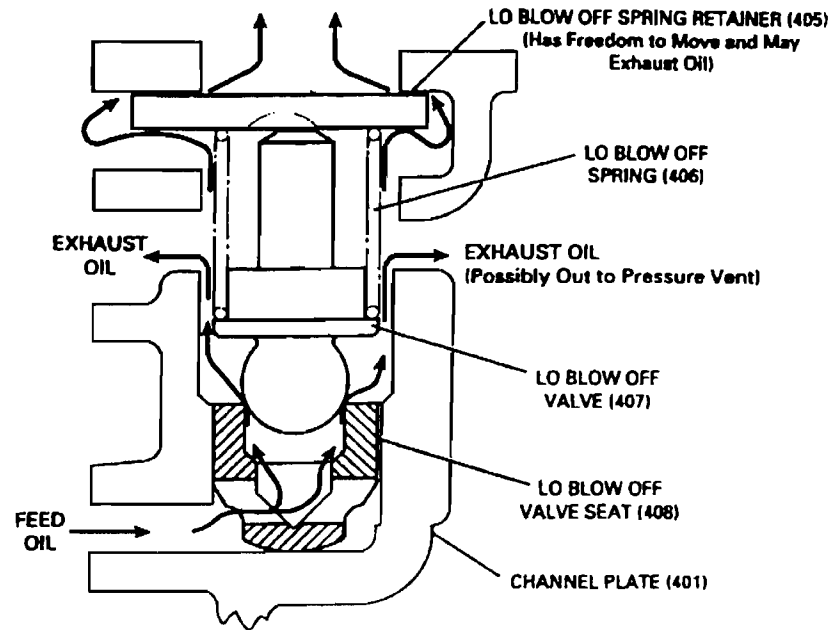
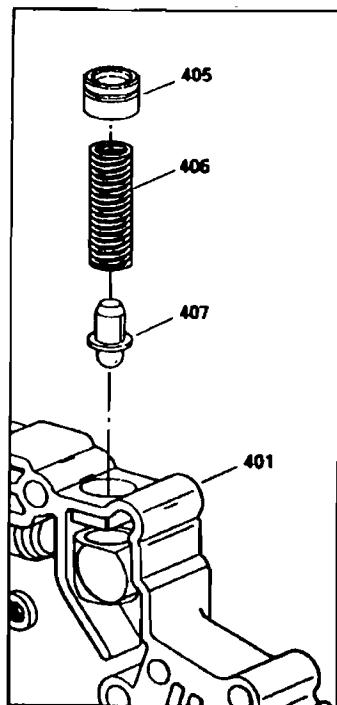
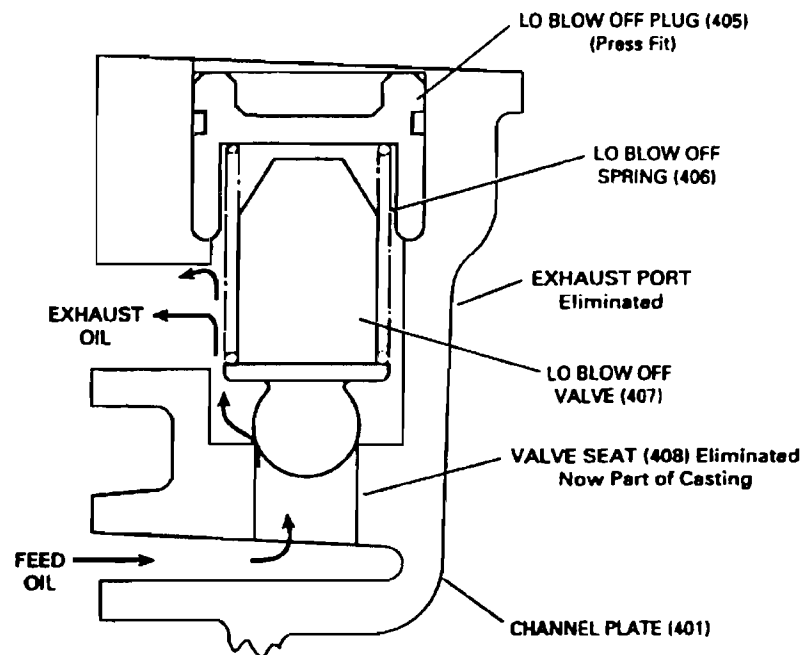
Figure 67

91 - 92 LO BLOW OFF VALVE AND SEAT

93 - 94 LO BLOW OFF VALVE AND SEAT

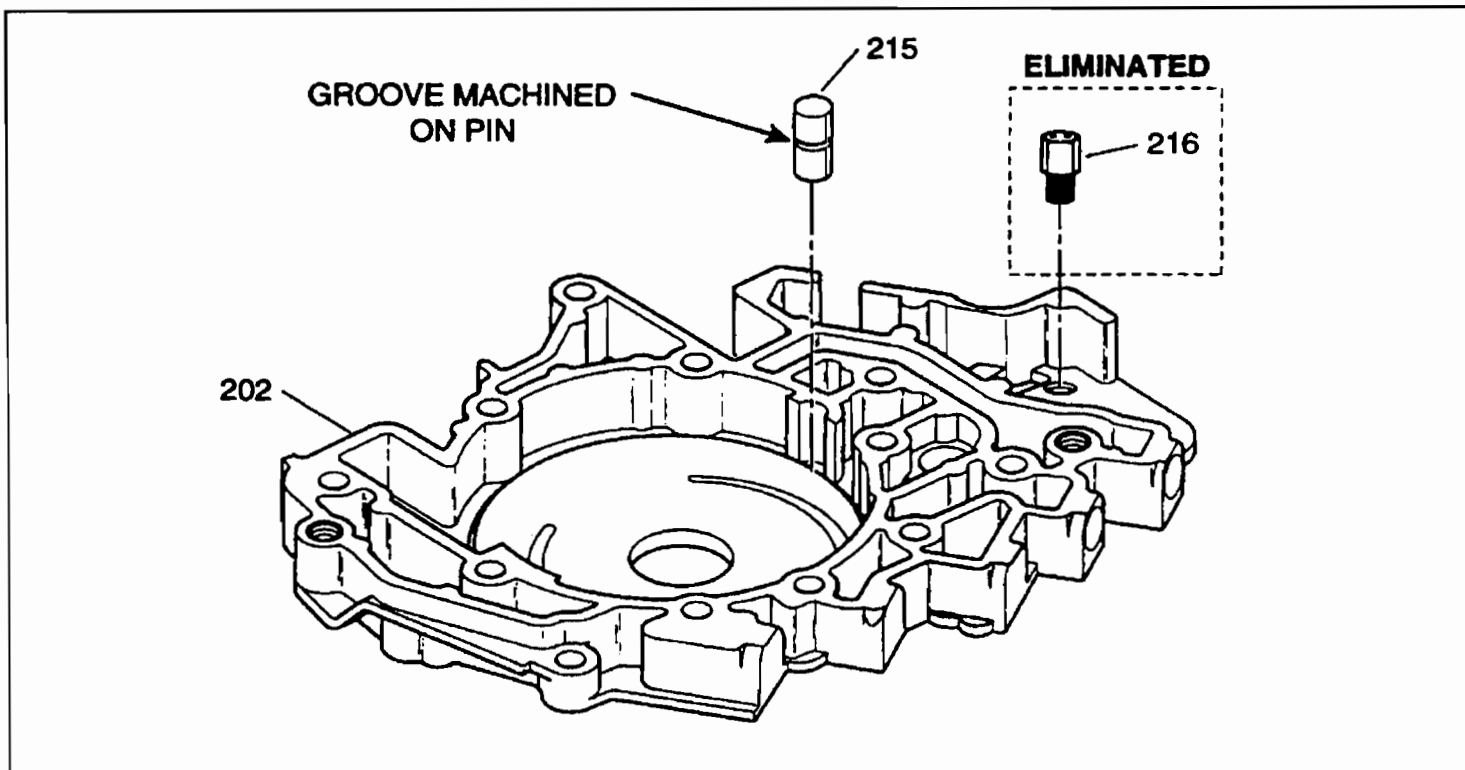
Figure 68

- (1) OIL PUMP PIVOT PIN - Now has a groove machined around the diameter of the pivot pin to establish the air bleed in the decrease oil circuit, as shown in Figure 68.
- (2) PUMP CASTING - The threaded brass air bleed plug that screwed into the pump casting has been eliminated, as shown in Figure 68. This hole is now cast shut.

- (1) When servicing models WITH the brass air bleed plug, the SOLID pivot pin MUST be used.
- (2) When servicing models WITHOUT the brass air bleed plug, the GROOVED pivot pin MUST be used (See Figure 68).

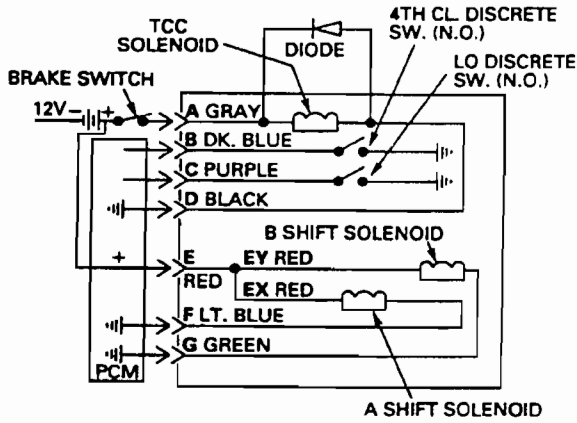
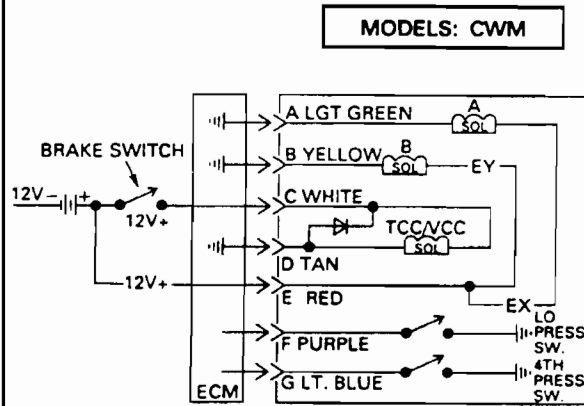
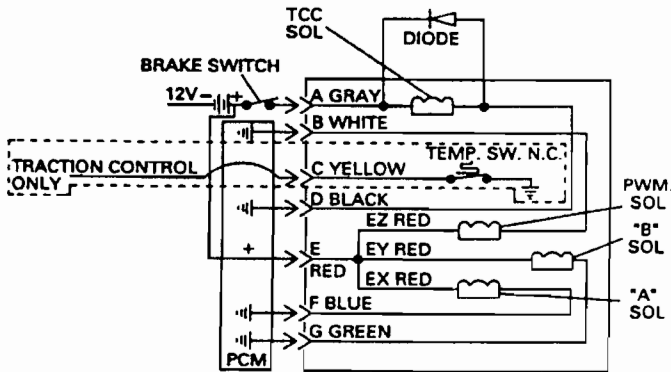
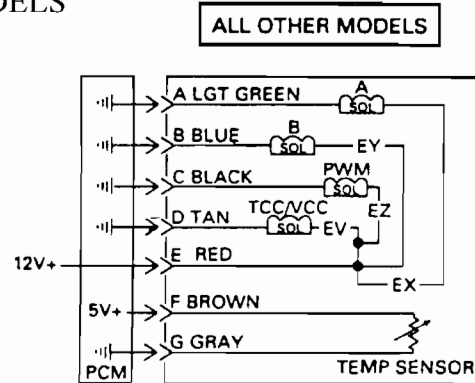
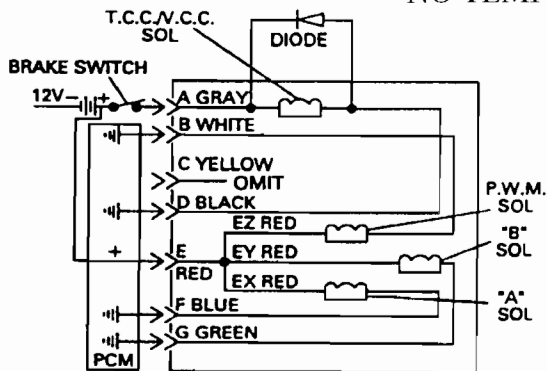
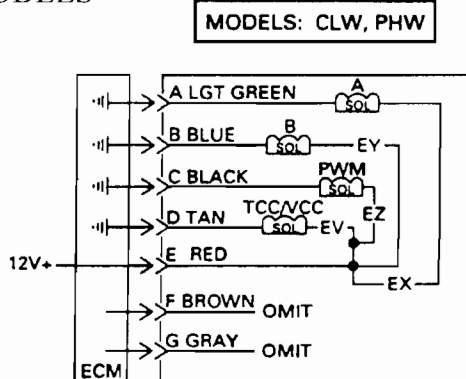
Figure 69

- (1) **VEHICLE WIRING HARNESS** - Cavity function changes to accommodate the new design wiring, as shown in Figure 69, which includes both previous and the new design electrical schematics.

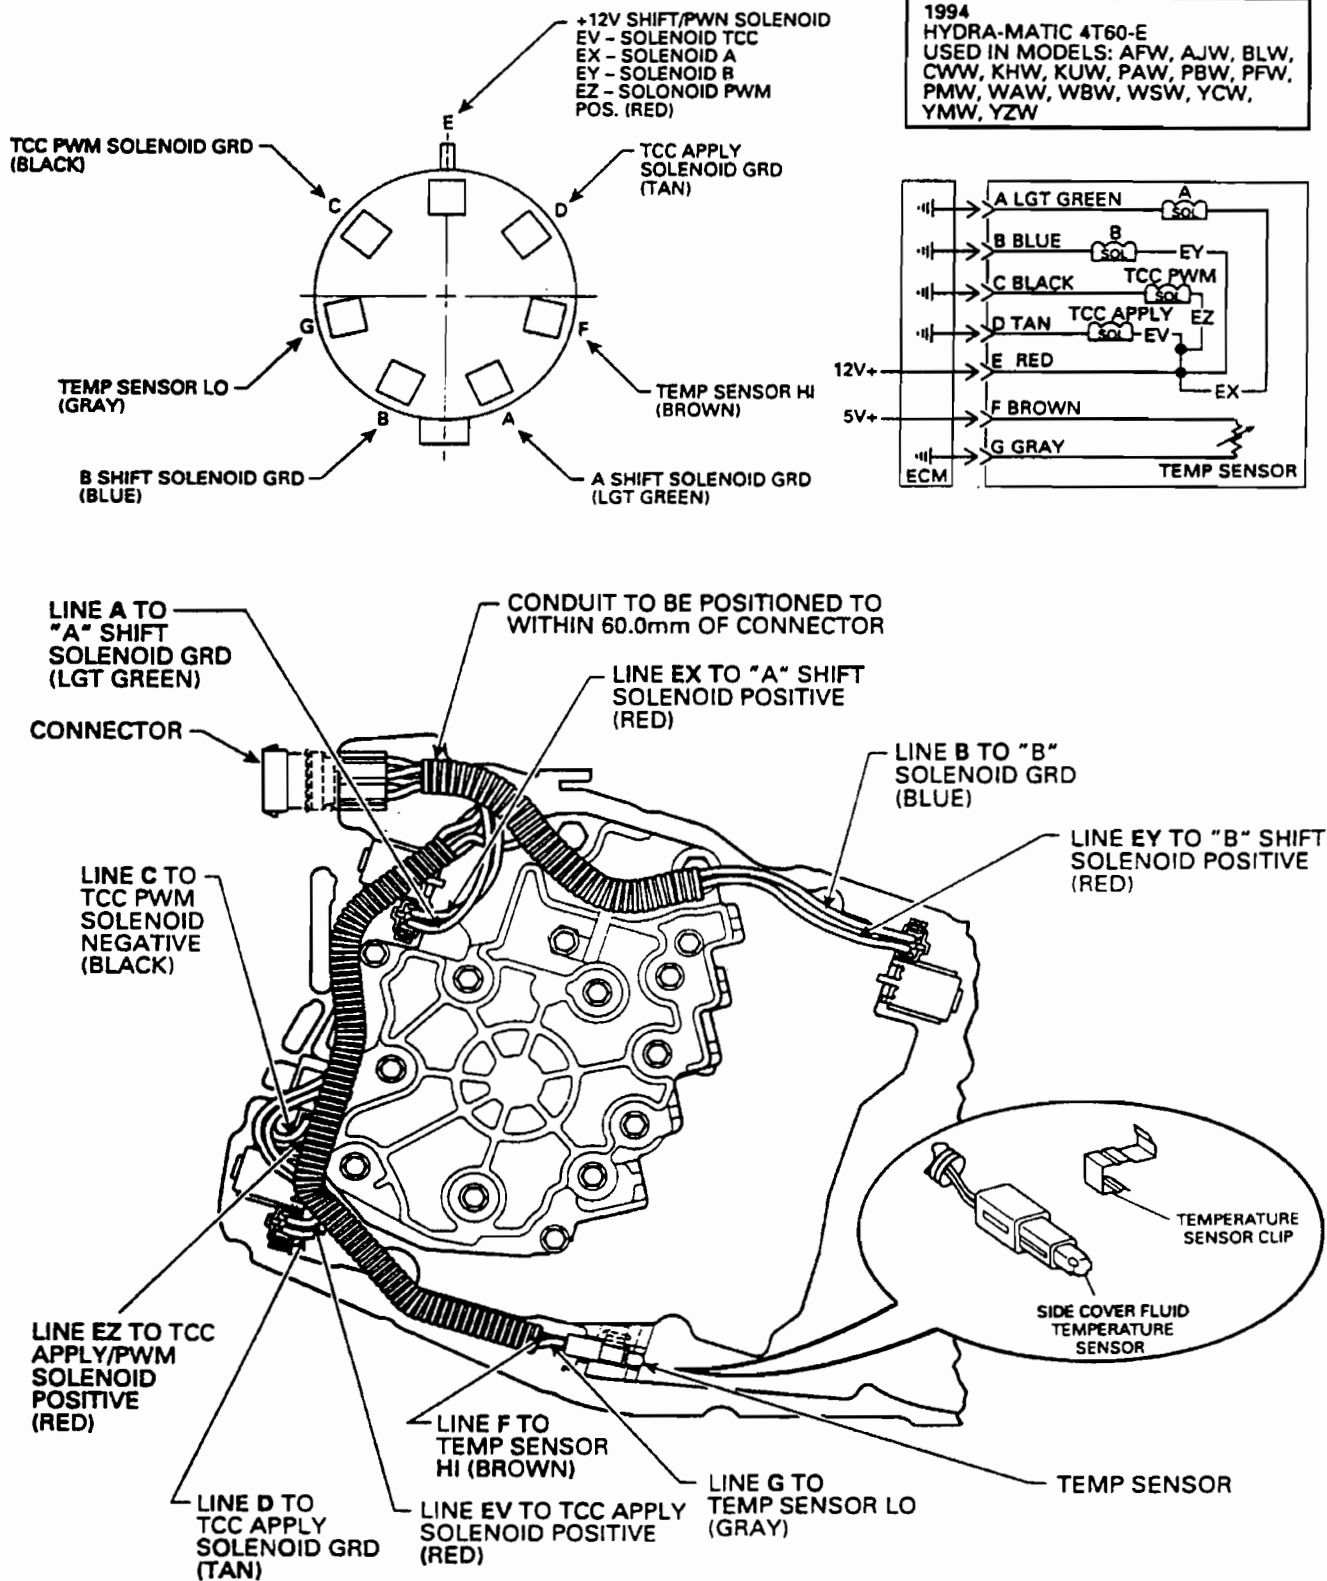
Figure 70

- (2) **INTERNAL TRANSAXLE WIRING HARNESS** - Cavity function changes to accommodate the re-designed wiring. Refer to Figures 70, 71, 72, and 73, which will depend on the model you are working on.

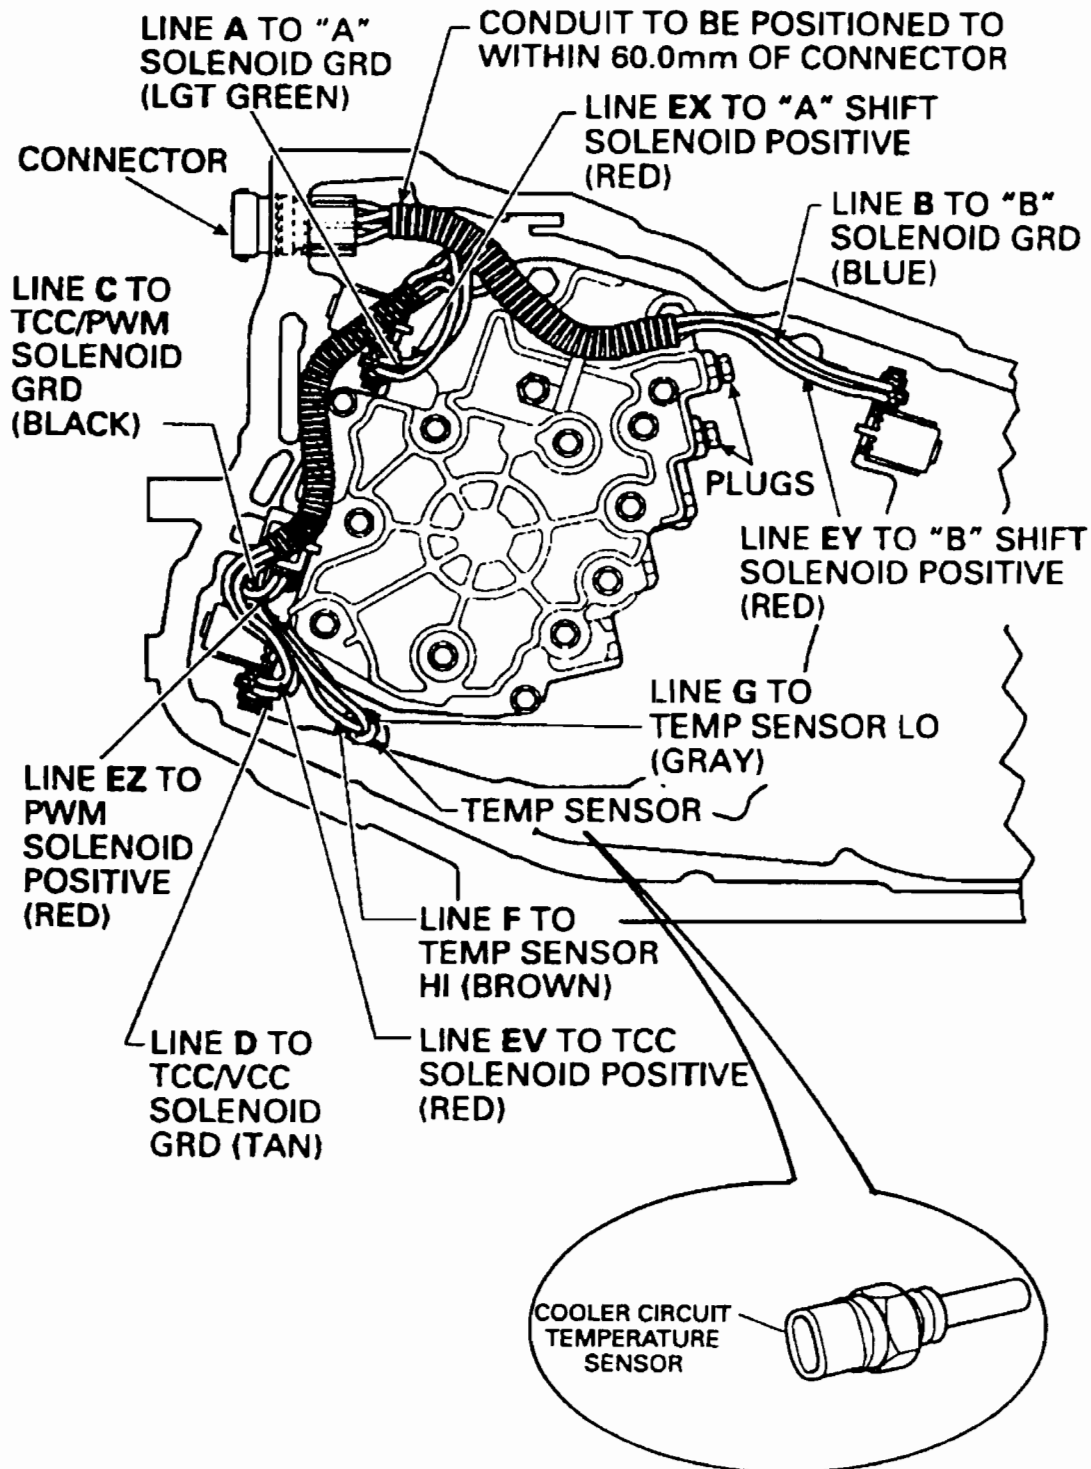
- (3) **TEMPERATURE SENSOR** - Added internally to the transaxle to give the PCM transaxle temperature information. There are 2 different types of the temperature sensor. One sensor is screwed into the channel plate near the TCC accumulator bore and monitors cooler fluid temperature. Refer to Figure 73 for this sensor. The other type sensor is incorporated into the wiring harness and clips to the valve body spacer plate, as shown in Figure 70. Regardless of which type temperature sensor you have, the wires will go through terminals "F" & "G" in the new case connector.

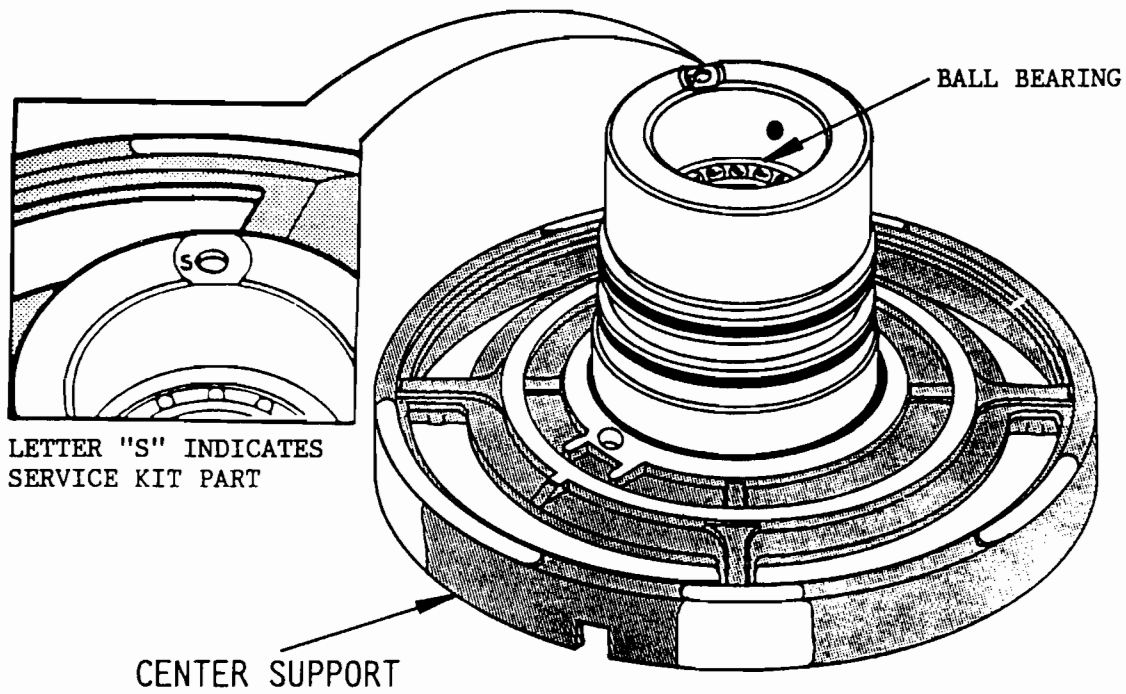
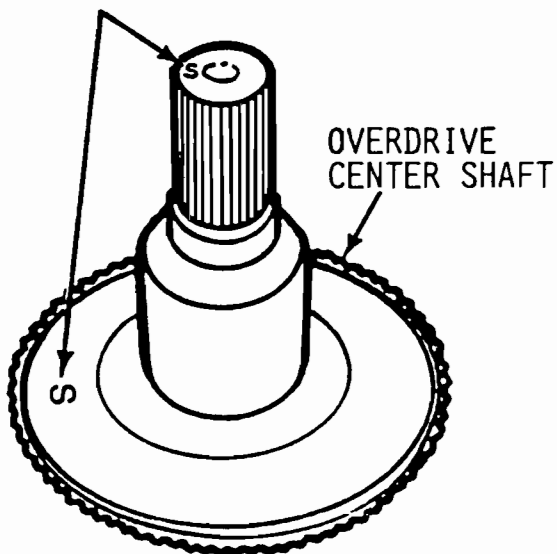
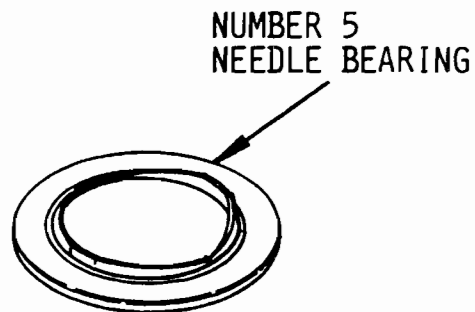
Figure 1

THE LETTER "S" COULD BE IN EITHER LOCATION. THE "S" INDICATES SERVICE KIT PART

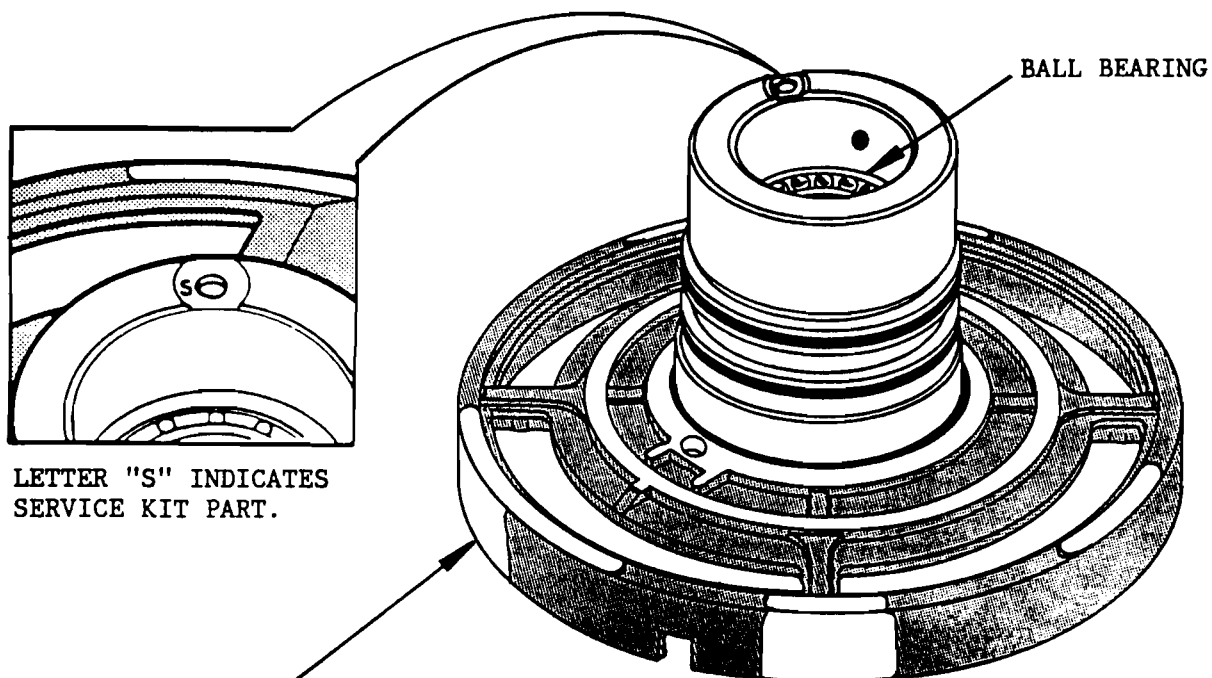
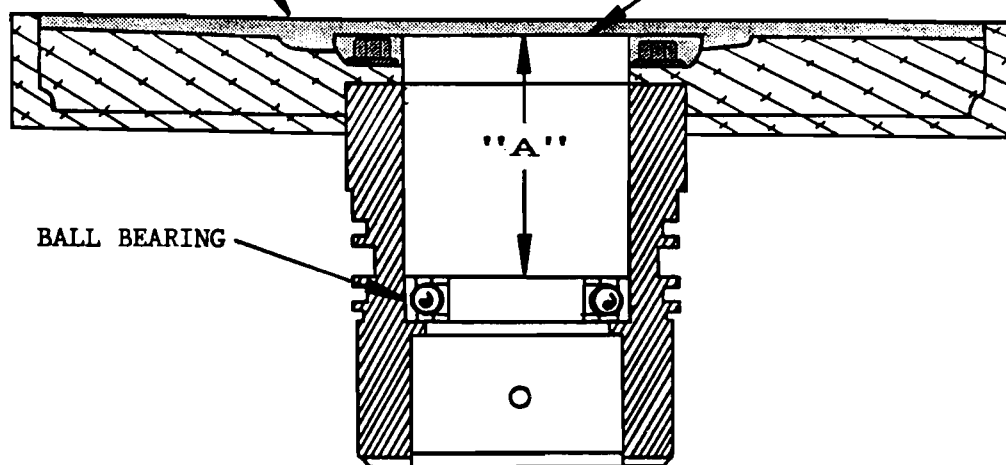
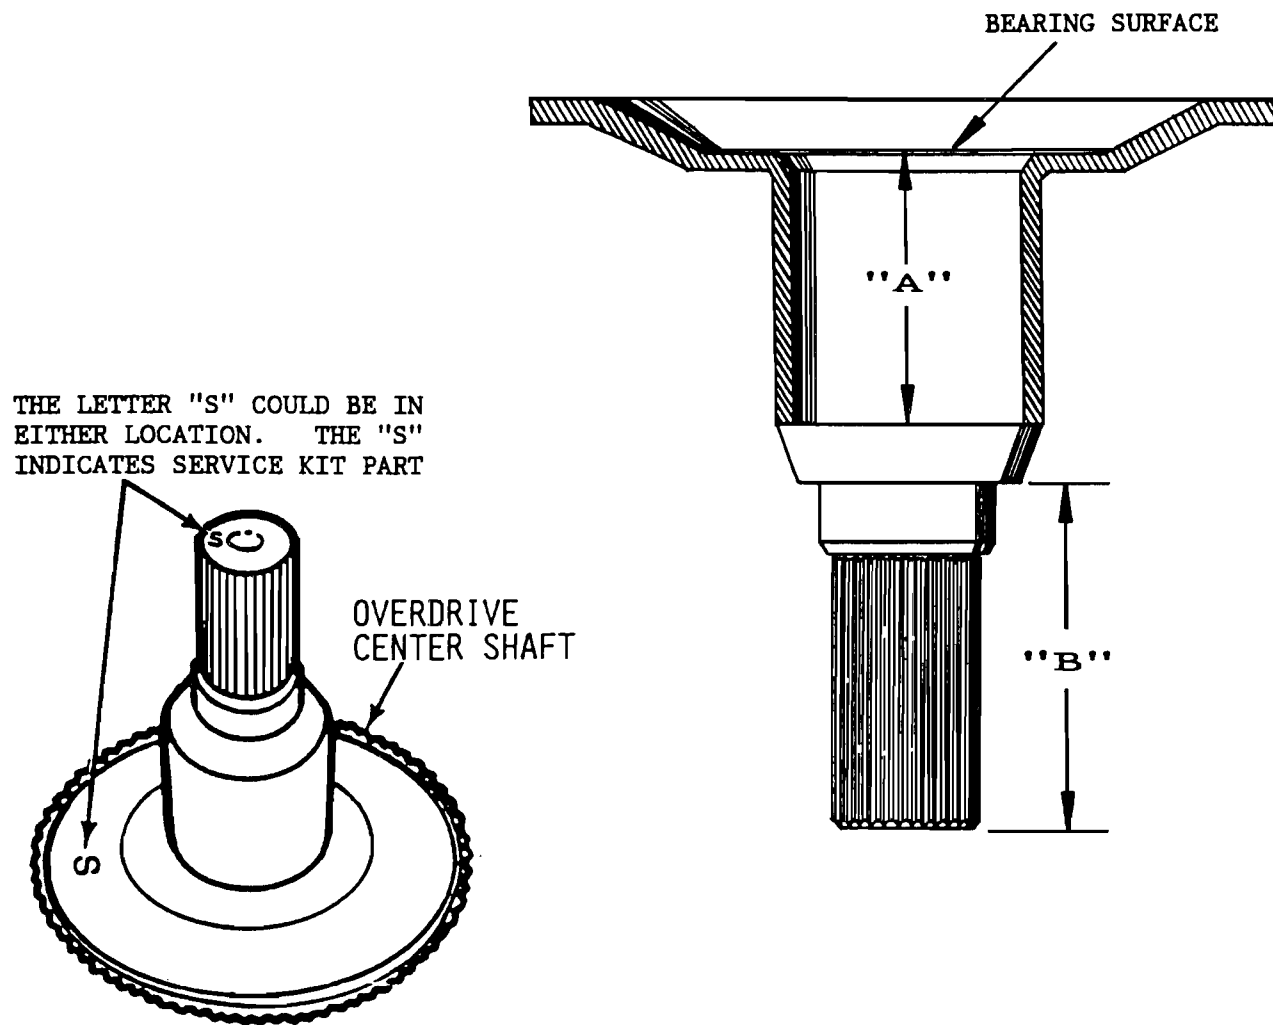
Figure 3

**(2) Overdrive Center Shaft**-Different machining dimensions on the center shaft to accommodate the added ball bearing, and the pilot on the center shaft has been removed. The new design Overdrive Center Shaft can be identified as a "Service Part", by the letter "S" stamped on the shaft in one of two places, as shown in Figure 3. The Service Kit Overdrive Center Shaft has different dimensions than the 1995 model year production overdrive center shaft, as shown in Figure 3.

SERVICE KIT PART = 2.062"  
1995 PRODUCTION = 1.838"

SERVICE KIT PART = 2.368"  
1995 PRODUCTION = 2.592"

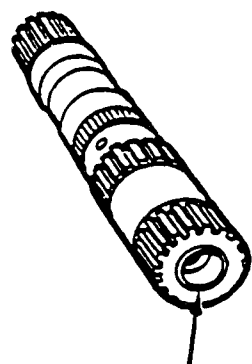
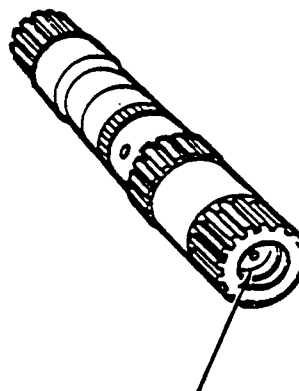
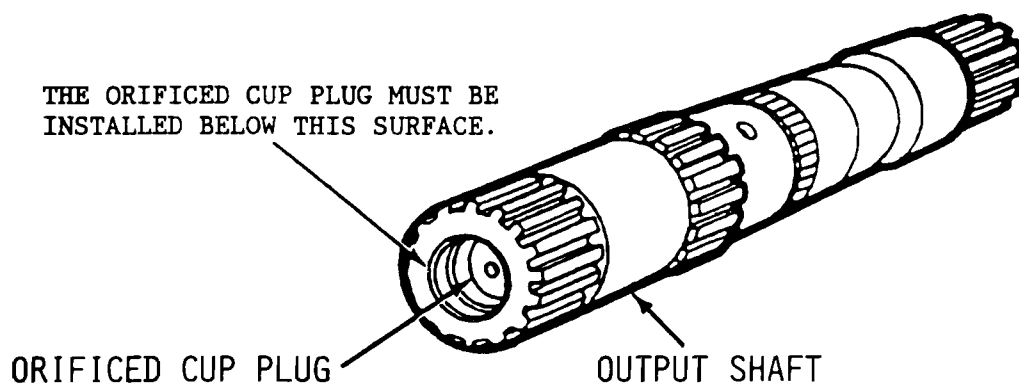
NOTE: THE ORIFICED CUP PLUG IN THIS SERVICE KIT IS DIFFERENT  
DIMENSIONS THAN 1995 PRODUCTION MODELS, AND WILL FIT  
ONLY AN OUTPUT SHAFT WITH A BUSHING.

**(3) Output Shaft**-Small bushing **MUST** be removed and the orifice cup plug included in the service kit **MUST** be installed, to accommodate the removal of the pilot from the overdrive center shaft. This will now ensure that lube oil will be directed to the proper areas. Refer to Figure 4 for the bushing removal and orifice cup plug installation.

REMOVE BUSHING

INSTALL ORIFICED CUP PLUG  
FROM SERVICE KIT

THE ORIFICED CUP PLUG MUST BE  
INSTALLED BELOW THIS SURFACE.

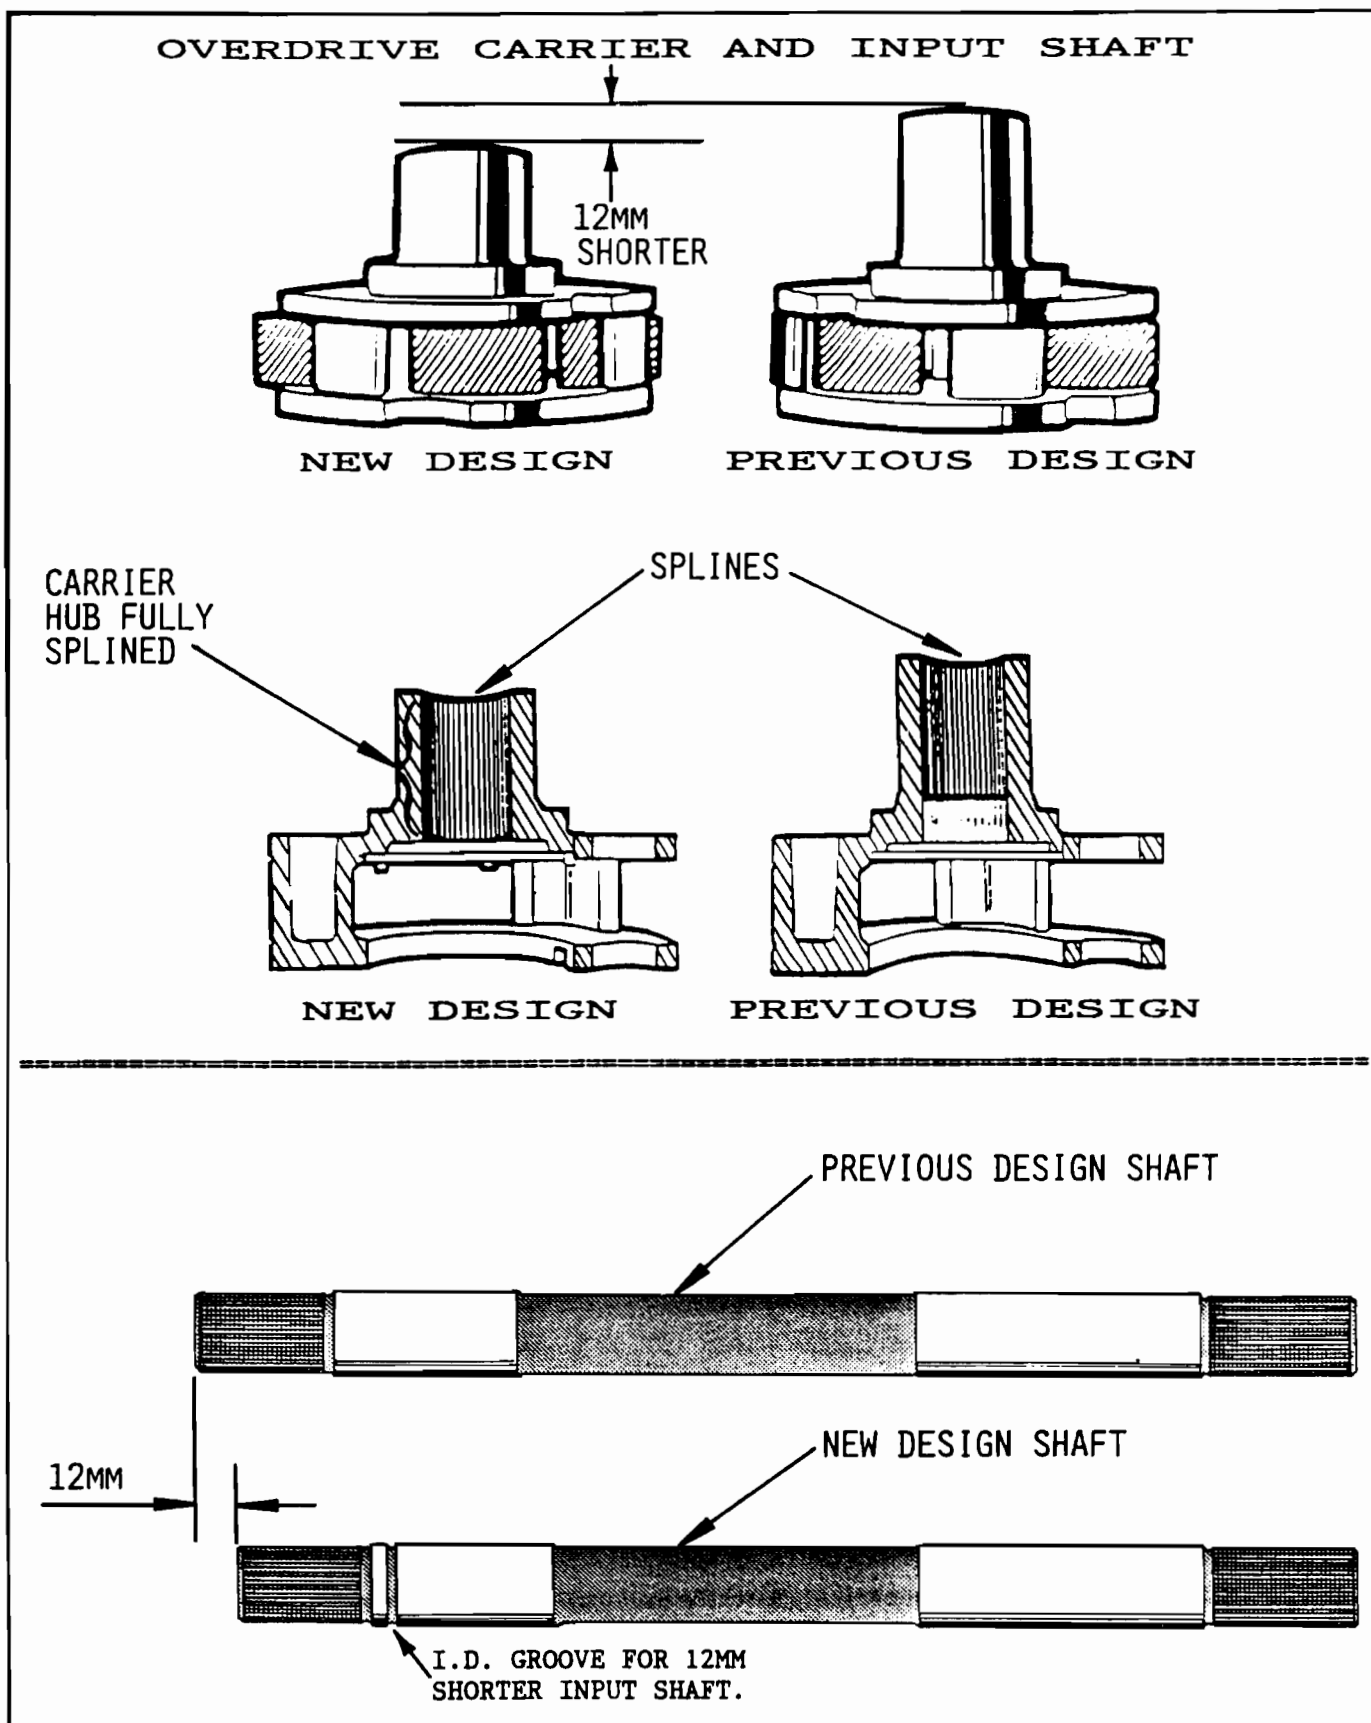
Figure 6

**SPECIAL NOTE;** There is also an updated Overdrive Carrier and Input Shaft, available under OEM part number **F4TZ-7B446-B**, to help improve durability. Both pieces have different dimensions than the previous parts, as shown in Figure 6. The new overdrive carrier hub is 12mm (.472) shorter than the previous model, and the internal splines now run the full length of the hub. The Input Shaft is also 12mm (.472) shorter than the previous models, to accommodate the new overdrive carrier, and has I.D. groove cut shaft for identification see Figure 6.

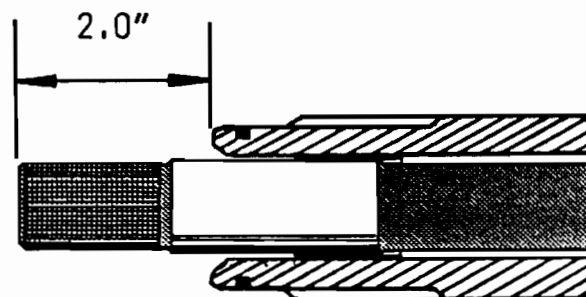
INCORRECT

PREVIOUS (LONG) INPUT SHAFT USED  
WITH NEW DESIGN OVERDRIVE CARRIER

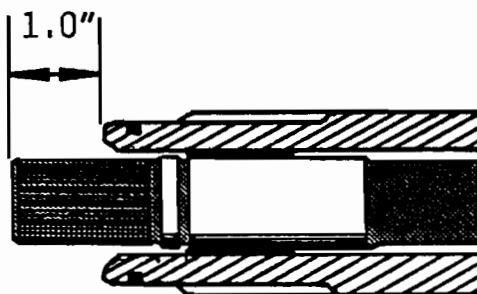
INCORRECT

NEW DESIGN (SHORT) INPUT SHAFT USED  
WITH PREVIOUS OVERDRIVE CARRIER

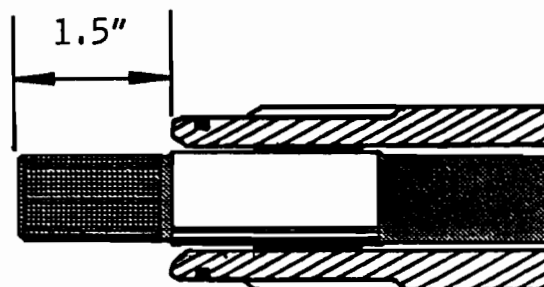
CORRECT USAGE

THE INPUT SHAFT MUST EXTEND 1.5" PAST THE END OF THE PUMP STATOR  
IF THE CORRECT INPUT SHAFT AND OVERDRIVE CARRIER WERE USED.

Refer to Figure 7 to ensure that you have built the unit with the matching components. The Input Shaft must extend 1.5" past the end of the oil pump stator, if the correct input shaft and overdrive carrier were used. Refer to Figure 7 for proper assembly dimensions.
