*1995 SEMINAR INFORMATION*  
**"HOW TO SURVIVE IN 95"**

# "HOW TO SURVIVE IN '95"

## INTRODUCTION

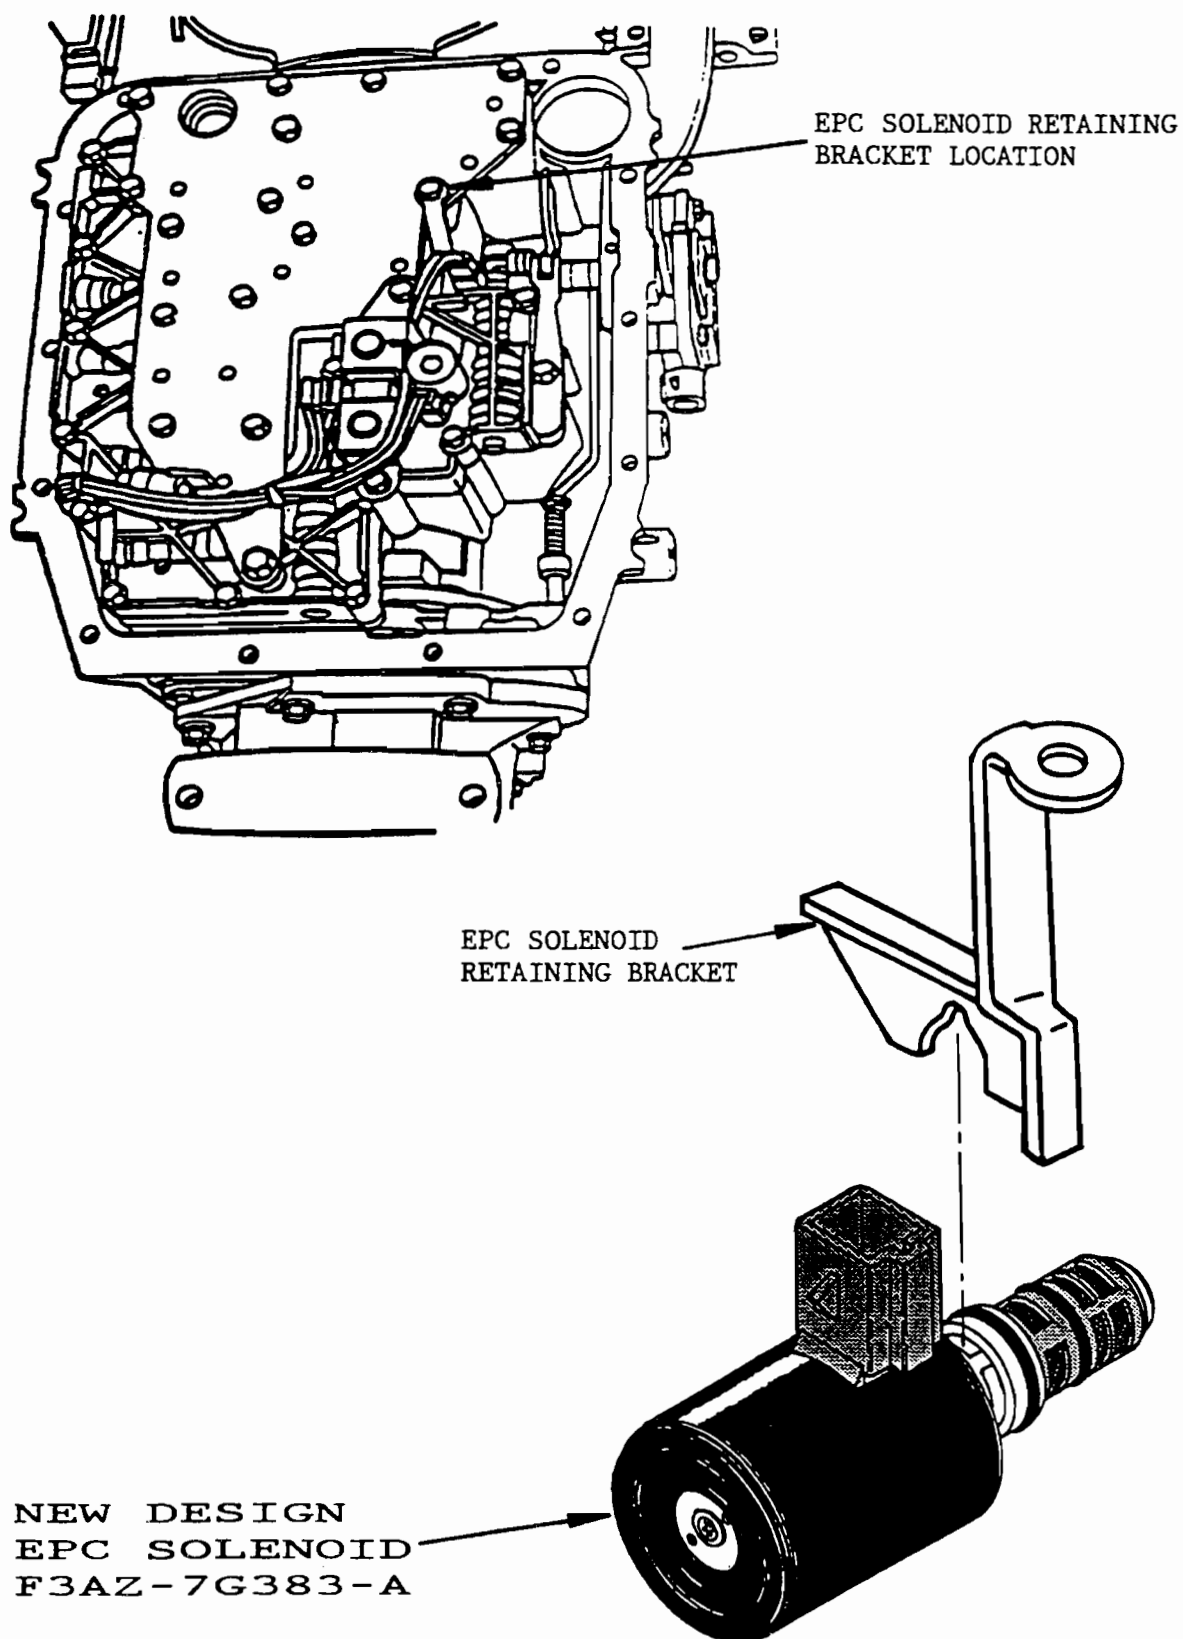
Figure 1

# EPC SOLENOID AND BRACKET

Number (1)-There is now a new design EPC solenoid available under OEM part number F3AZ-7G383-A. ALWAYS replace the EPC solenoid with the new design, and ensure that the retaining bracket is secured in the proper position. The retaining bracket must be installed with the FORK of the bracket over the body of the EPC solenoid, and the bracket secured with valve body bolt in the location shown in Figure 1. The EPC solenoid may have to be repositioned slightly for the fork of the bracket to engage in position. Refer to Figure 1. Manual shift lever must be removed from the case to replace the EPC Solenoid.

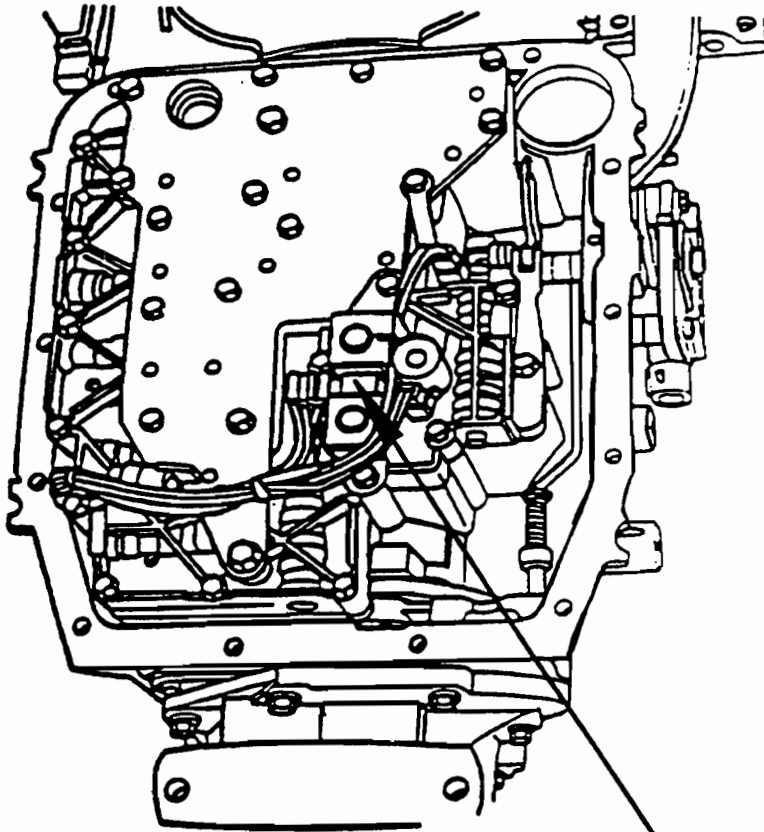
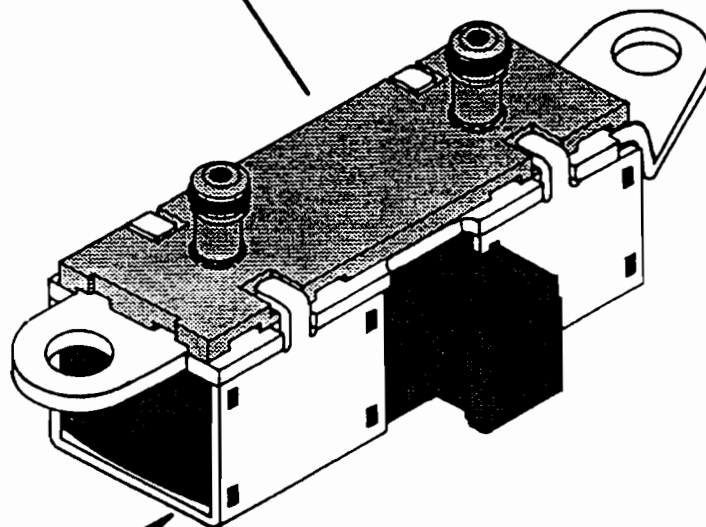
Figure 2

NEW DESIGN  
SHIFT SOLENOID ASSEMBLY  
F4AZ-7G484-A

Number (2)-There is now a New Design Shift solenoid Assembly available under OEM part number F4AZ-7G484-A. ALWAYS replace the Shift Solenoid Assembly with the new design, as shown Figure 2.

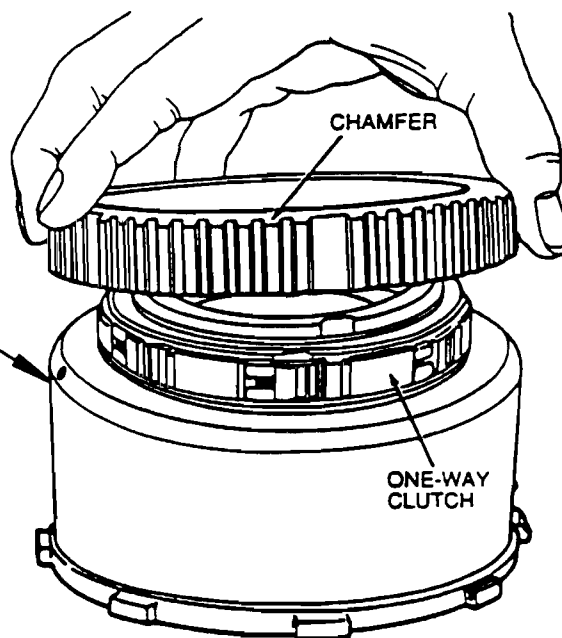
Figure 3

NEW DESIGN REVERSE DRUM AND  
INTERMEDIATE ROLLER CLUTCH ASSEMBLY

F4AZ-7D044-A

ALWAYS replace the Reverse Drum and Intermediate Roller Clutch Asm. with the new design F4AZ-7D044-A as shown in Figure 3. Or install the spiral snap ring from a THM 125 / 440 T4 final drive (part number 11501326) in place of the original snap ring for the intermediate roller clutch retainer.

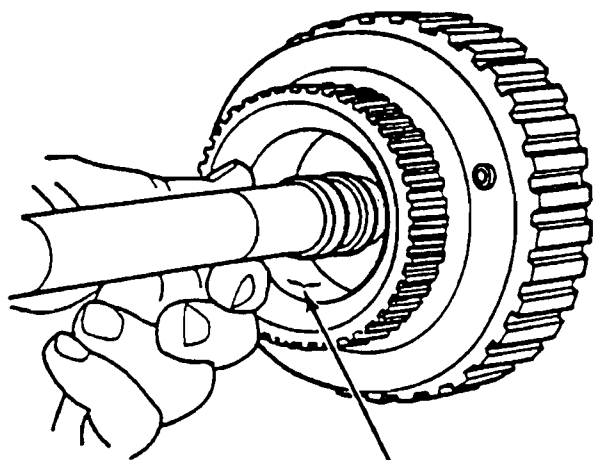
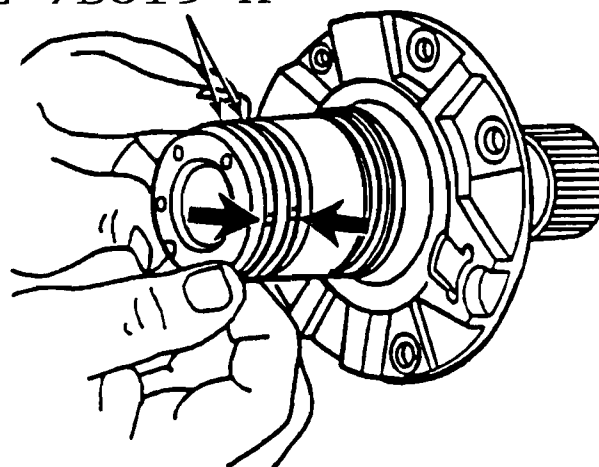
Figure 4

NEW DESIGN FORWARD CLUTCH SEALING RINGS

INSPECT FORWARD CLUTCH  
CYLINDER BORE FOR DAMAGE

Number (4)-There are new design Forward Clutch Sealing Rings, available part number **F4AZ-7D019-AA** that are plated ALWAYS replace the forward clutch sealing rings with the new design as shown in Figure 4.

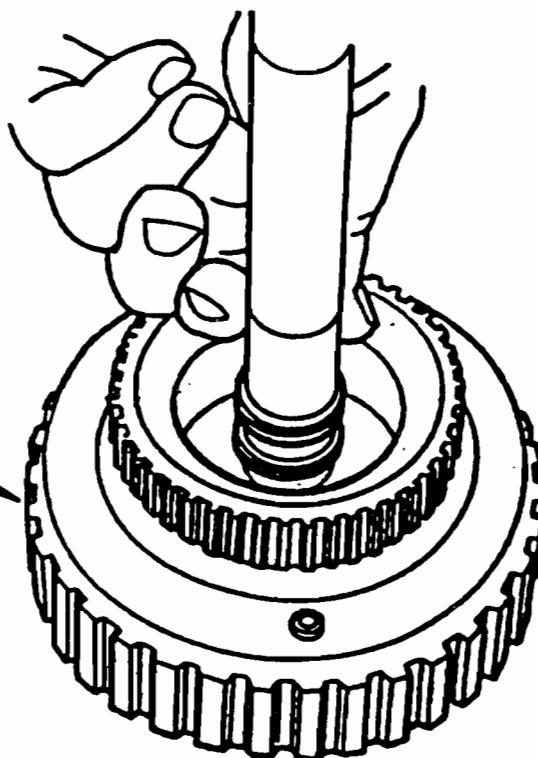
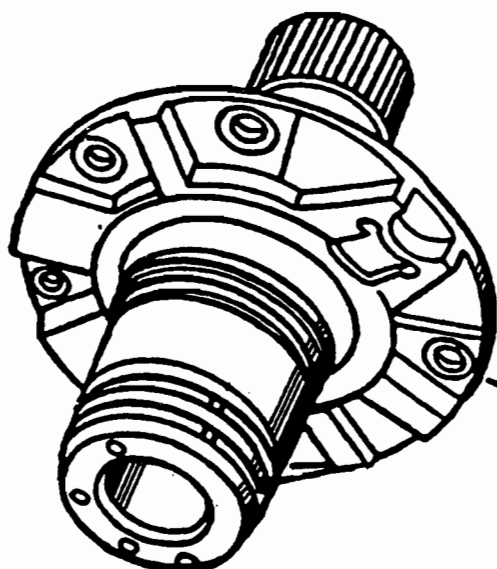
Figure 5

Number (5)-Some early model units were built with forward drum and/or Pump Support (stator), with a defective micro finish where the sealing rings ride in the pump support. Replacing these parts will eliminate these concerns. The new design forward drum part number is **F3LY-7F207-A** and the new design Pump Support now available under part number **F4AZ-7A108-A** (See Figure 5).

NEW DESIGN  
FORWARD CLUTCH DRUM  
F3LY-7F207-A

NEW DESIGN  
PUMP SUPPORT  
F4AZ-7A108-A

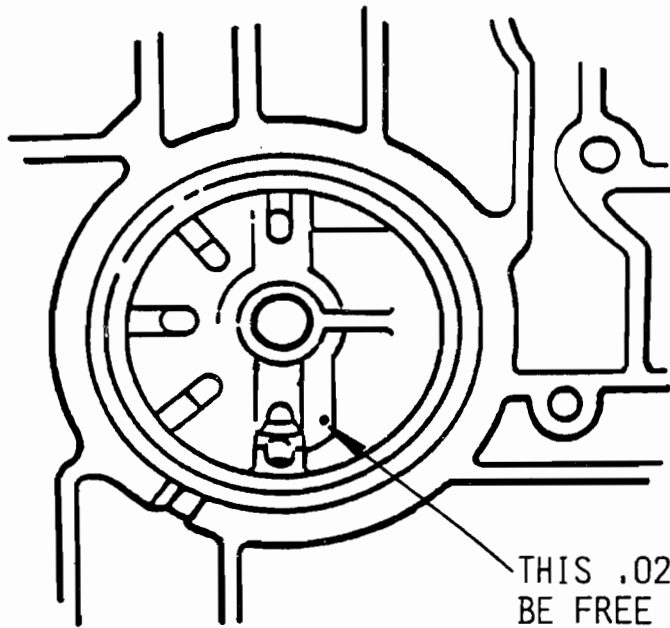
Figure 6

Number (6)-Inspect the .020" bleed orifice located in the overdrive servo bore, in the location as shown in Figure 6. This bleed orifice is difficult to see, but **MUST** be there, and **MUST BE OPEN**, for the overdrive band apply properly. ALWAYS inspect this bleed orifice to ensure that it is free of all contamination, and open to the inside of the case (See Figure 6).

THIS .020" BLEED ORIFICE MUST  
BE FREE FROM CONTAMINATION.

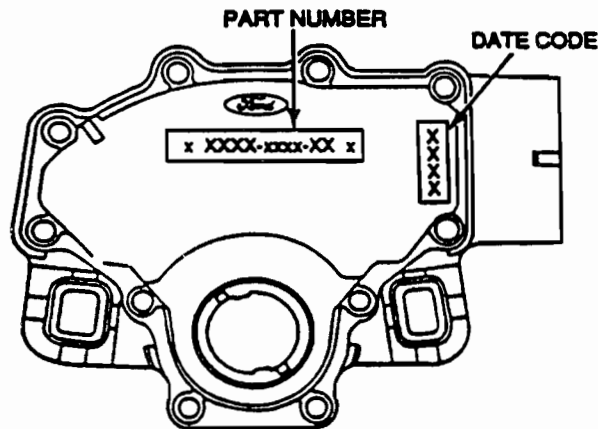
Figure 7

The date code is stamped on the outer cover as shown in Figure 7.

BUILD DATE CODES			
YEAR CODE		MONTH CODE	
1991 - 1	JAN - A	APR - D	JUL - G
1992 - 2	FEB - B	MAY - E	AUG - H
1993 - 3	MAR - C	JUN - F	SEP - J
			OCT - K
			NOV - L
			DEC - M

THERE IS NO LETTER "I" IN THE DATE CODE.

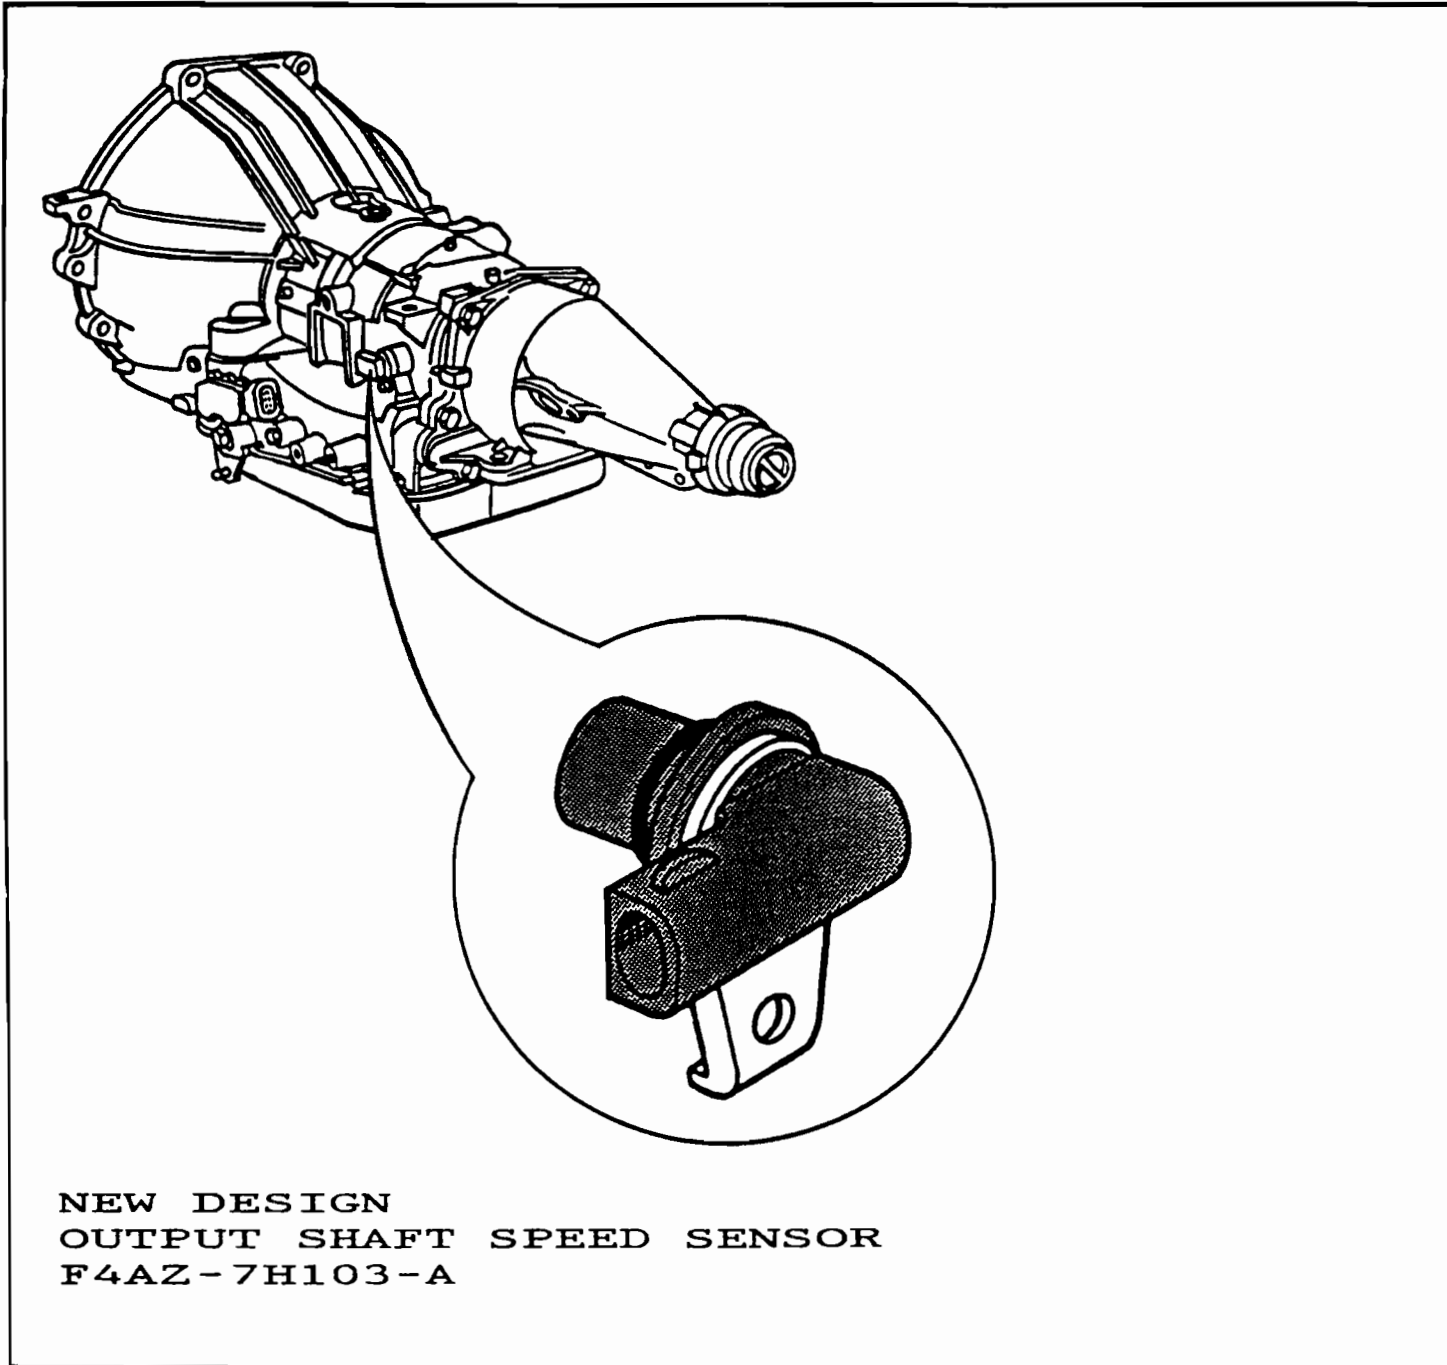
Figure 8

Number (8) There is a New Design Output Shaft Speed Sensor, available under part number **F4AZ-7H103-A** (See Figure 8).

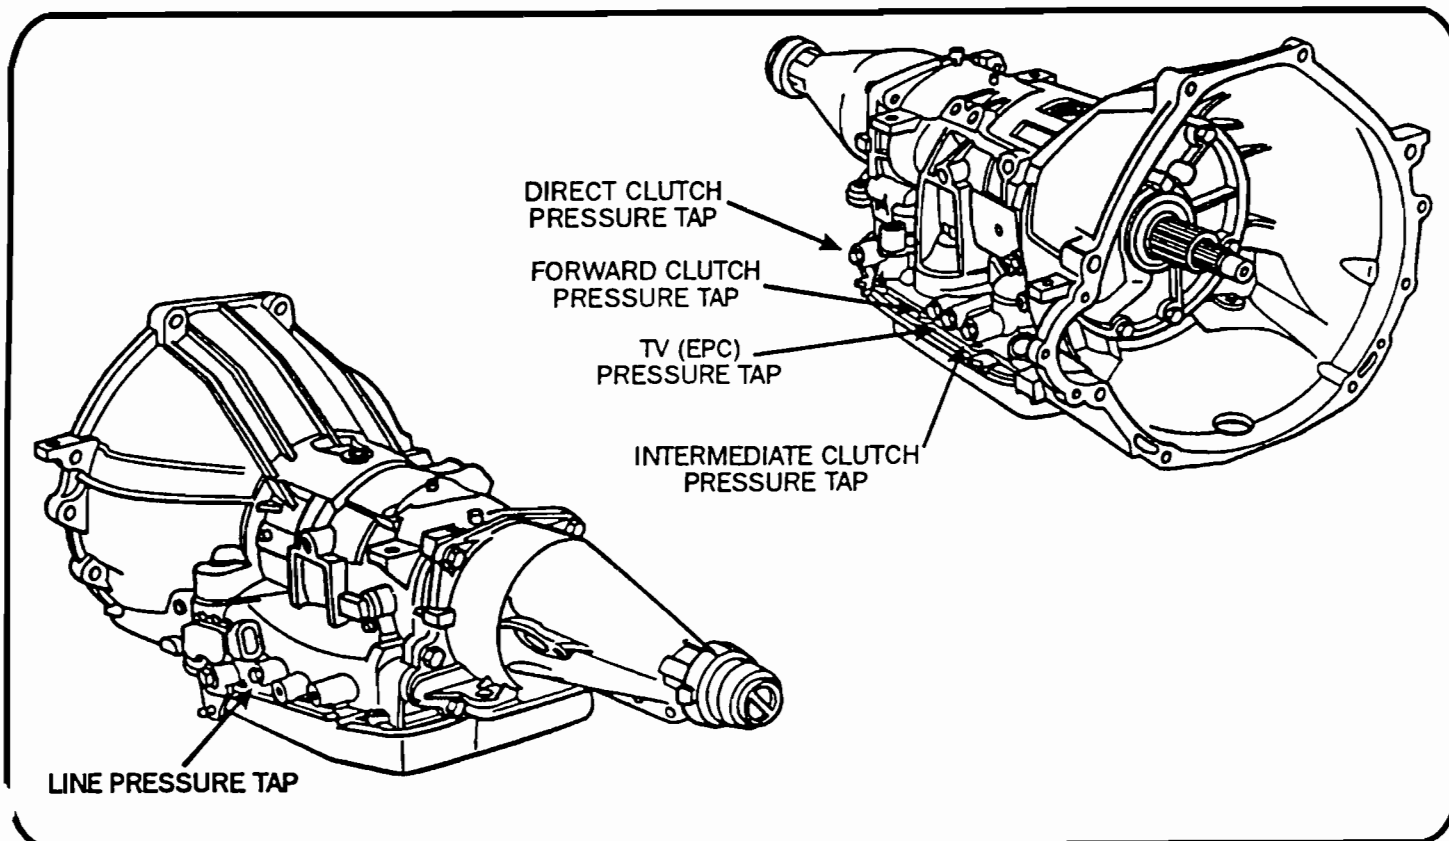
Number(13)—**ALWAYS** check and verify all line pressures, and that you have a line pressure rise with throttle opening, **BEFORE** the vehicle is delivered back to the customer. Use the Chart in Figure 9 for line pressure specifications, and the locations of the various pressure taps.

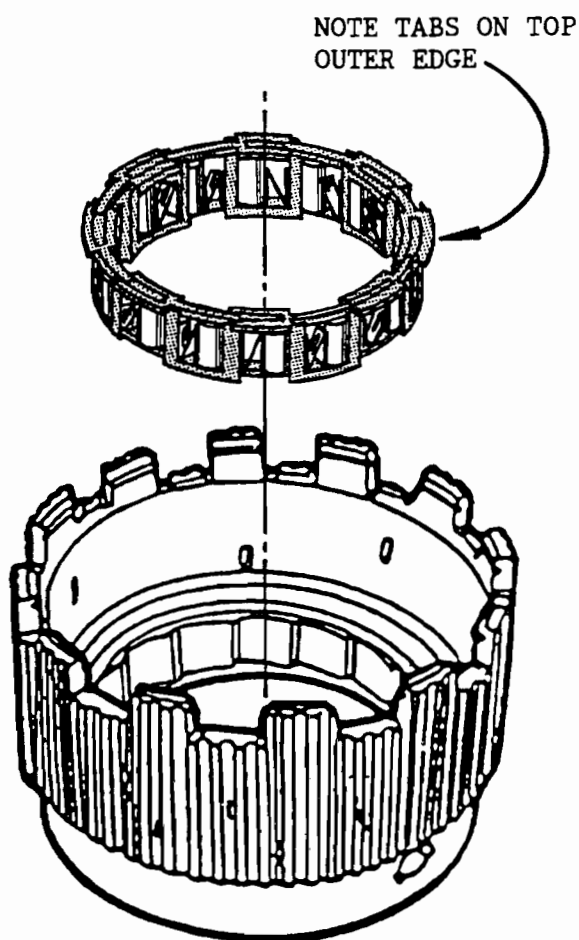
## INCORRECTLY INSTALLED

CAUTION: IF ROLLER CLUTCH IS INSTALLED  
IN THIS DIRECTION, THE CLUTCH  
WILL FREEWHEEL BOTH DIRECTIONS.

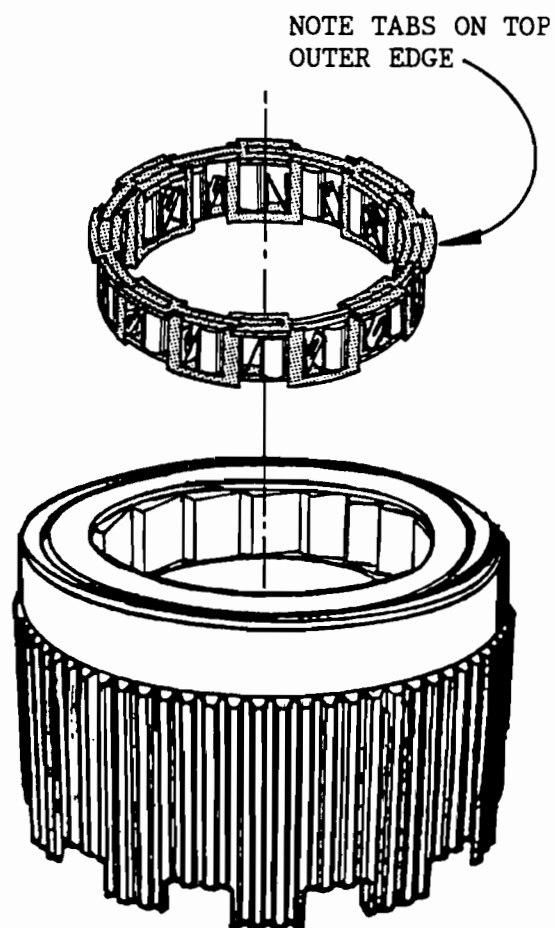
Figure 2

DISCARD BOTH SNAP RINGS. THEY ARE NOT  
USED WITH THE PLASTIC ROLLER CLUTCH.

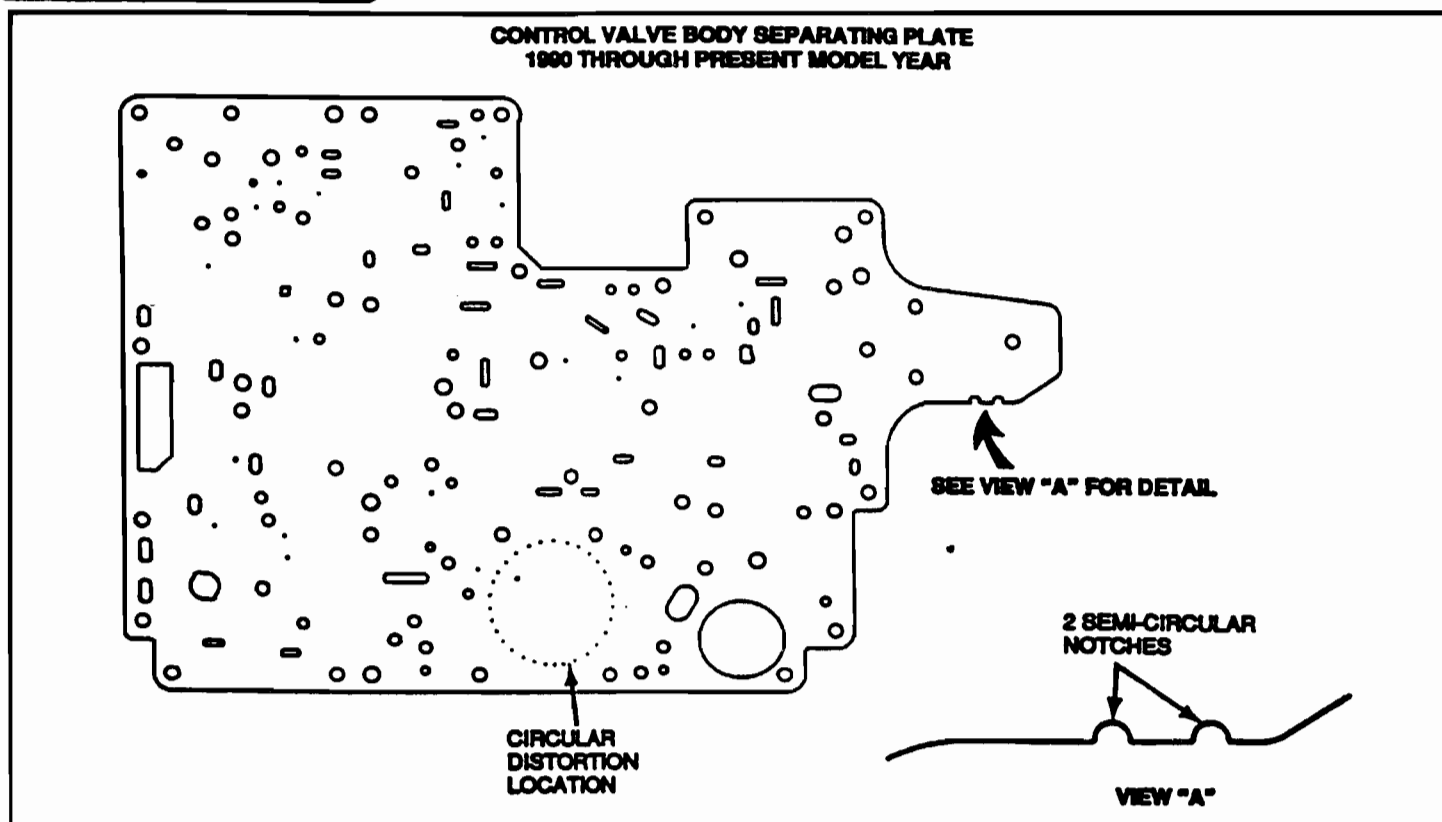
Figure 2

**CORRECTION;** Remove the valve body spacer plate, and inspect for spacer plate distortion in the area shown in Figure 2. Both valve body gaskets must be removed to see the distortion.  
If spacer plate is distorted, replace it with OEM part number **F4TZ-7A008-A**, and re-install using new valve body gaskets. Refer to Figure 3 for the new spacer plate I.D.
