TRANSMISSION SEMINAR 1991

NEW DESIGNATION SYSTEM FOR HYDRA-MATIC PRODUCTS

THM 4L60 (700-R4) SOFT UPSHIFTS AND OTHER THINGS

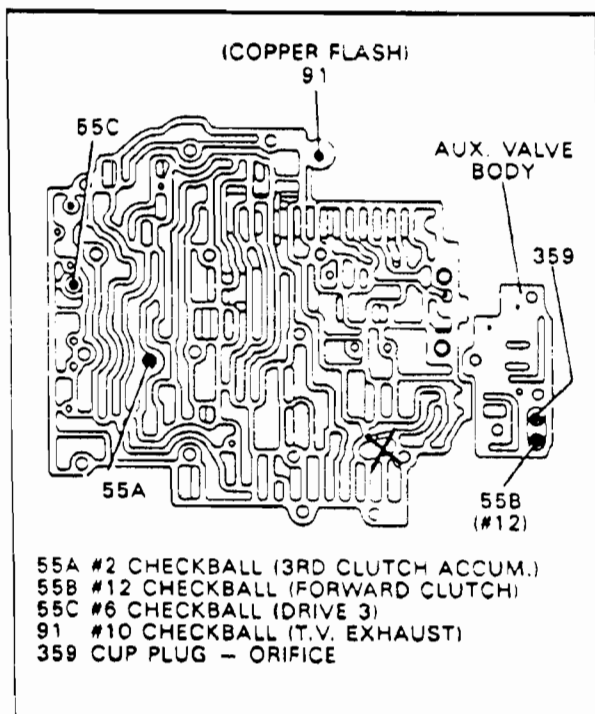
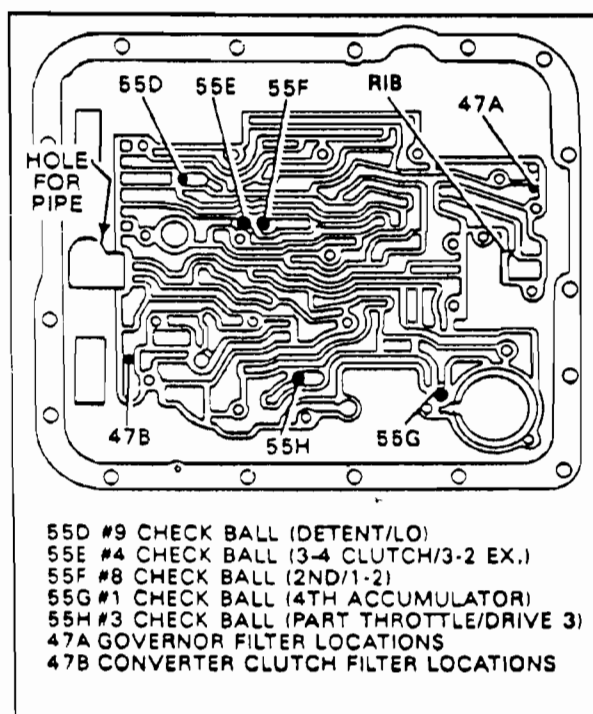
Figure 3

Do not install a checkball in the location marked with an "X", as shown in Figure 3. The result will be, NO 2ND GEAR, as it blocks D4 oil from getting to the 1-2 shift valve.

Do not install the number 9 checkball (Det/Lo) in the "Bathtub" in the case on any 1988 or later model (See Figure 3). This will create a tie-up on the 1-2 shift, and wipe out the Lo/Reverse Clutches and 2/4 Band.

If you have very high and harsh upshifts, you can remove the number 10 checkball (T.V. Exhaust), and usually eliminate the problem (See Figure 3).

CHECKBALL LOCATIONS
1987 MODELS ONLY - WITH AUX. V.B.

NOTE: DO NOT INSTALL CHECKBALL IN THE "BATHTUB" IN THE VALVE BODY ON ANY 1987 MODEL, WITH THE AUXILIARY VALVE BODY.

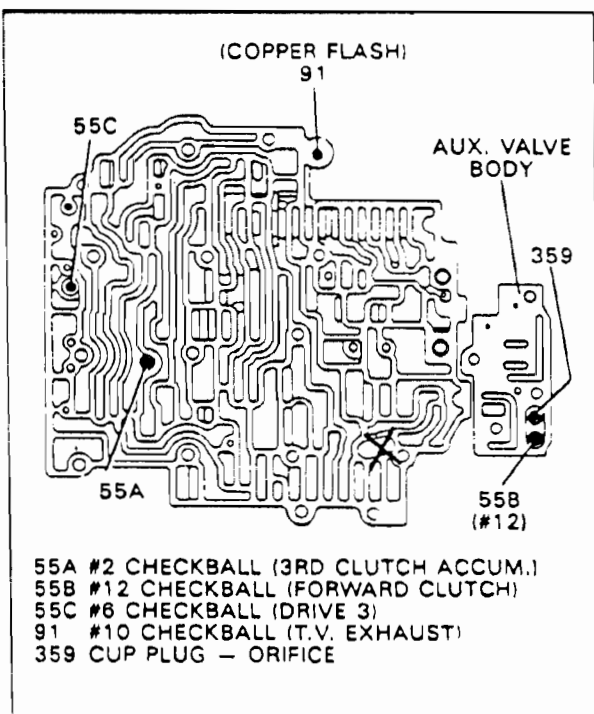
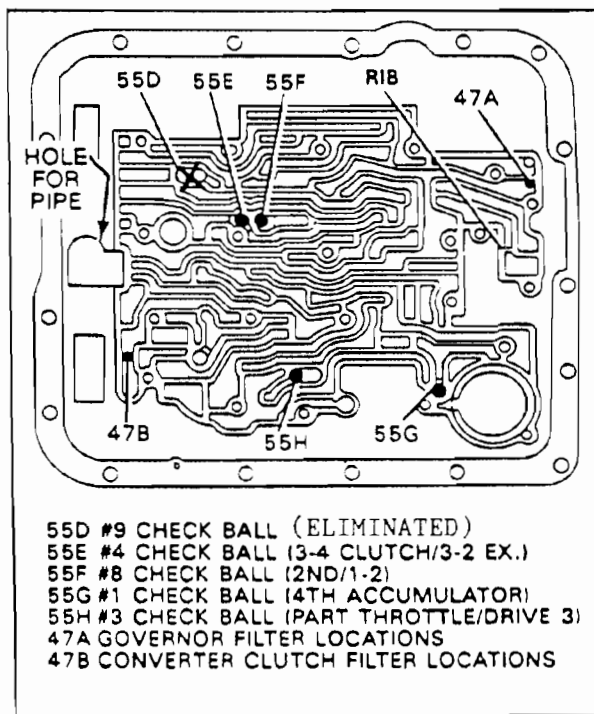
Figure 5

CHECKBALL LOCATIONS
1988 MODELS ONLY - WITH AUX. V.B.

NOTE: DO NOT INSTALL CHECKBALL IN THE "BATHTUB" IN THE VALVE BODY, NOR IN THE "BATHTUB" IN THE CASE, ON ANY 1988 MODELS. (SEE ABOVE ILLUSTRATIONS).

NOTE: 1988 MODEL SPACER PLATES ARE IDENTIFIED WITH A 2 LETTER CODE STAMPED INTO THE SPACER PLATE. THE FIRST LETTER WILL ALWAYS BE A "B", AND WILL NOT INTERCHANGE WITH PREVIOUS MODEL SPACER PLATES. (SEE ABOVE ILLUSTRATION).

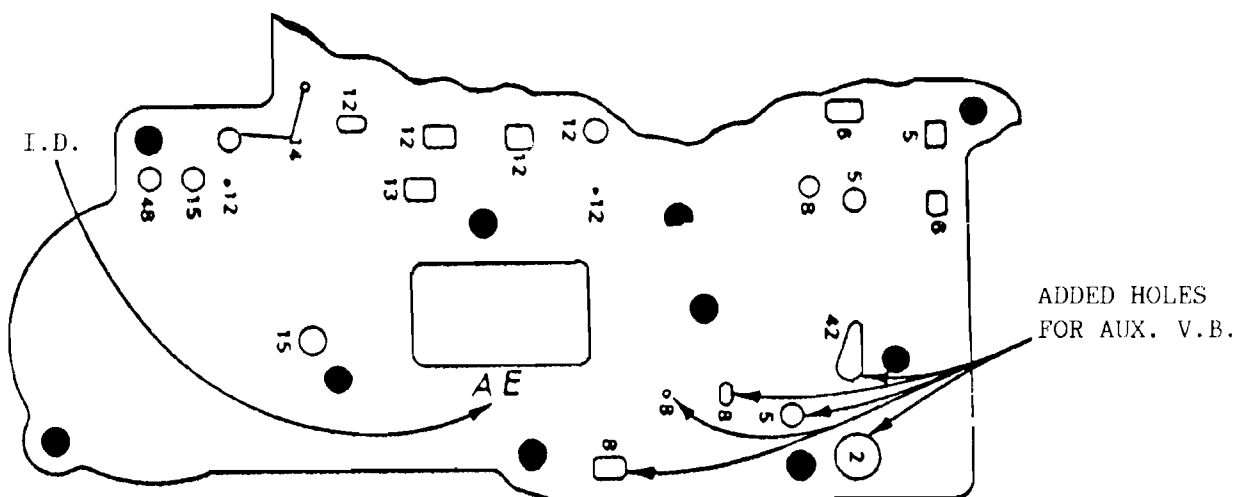
NOTE: 1987 MODEL SPACER PLATES ARE IDENTIFIED WITH A 2 LETTER CODE STAMPED INTO THE SPACER PLATE. THE FIRST LETTER WILL ALWAYS BE AN "A", AND WILL NOT INTERCHANGE WITH ANY OTHER MODELS.

NOTE: DO NOT INSTALL CHECKBALL IN THE "BATHTUB" IN THE VALVE BODY ON ANY 1987 OR LATER MODEL, THAT HAS THE AUXILIARY VALVE BODY.

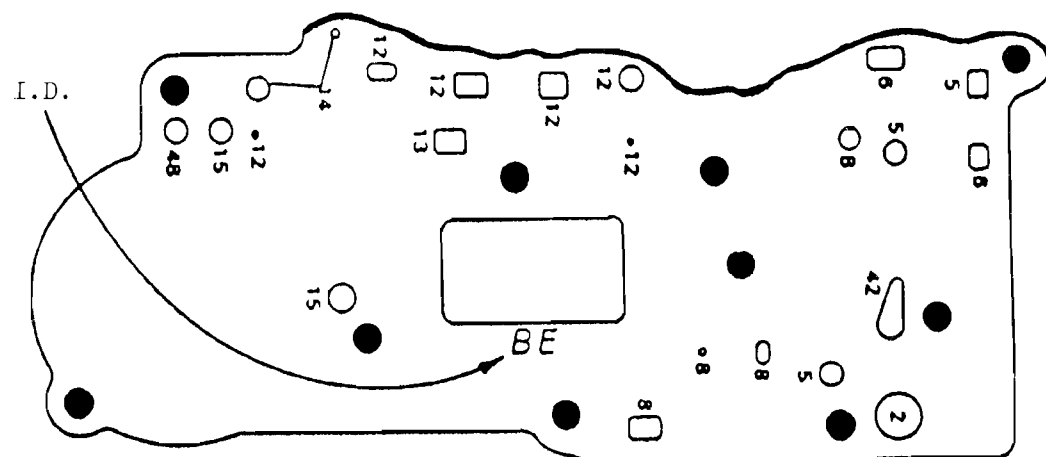
Figure 6

NOTE: 1988 MODEL SPACER PLATES ARE IDENTIFIED WITH A 2 LETTER CODE STAMPED INTO THE SPACER PLATE. THE FIRST LETTER WILL ALWAYS BE A "B", AS SHOWN ABOVE, AND WILL NOT INTERCHANGE WITH ANY PREVIOUS MODEL SPACER PLATES.

NOTE: DO NOT INSTALL CHECKBALL IN THE "BATHTUB" IN THE VALVE BODY, NOR IN THE "BATHTUB" IN THE CASE, ON ANY 1988 MODELS. (SEE FIGURE 5)

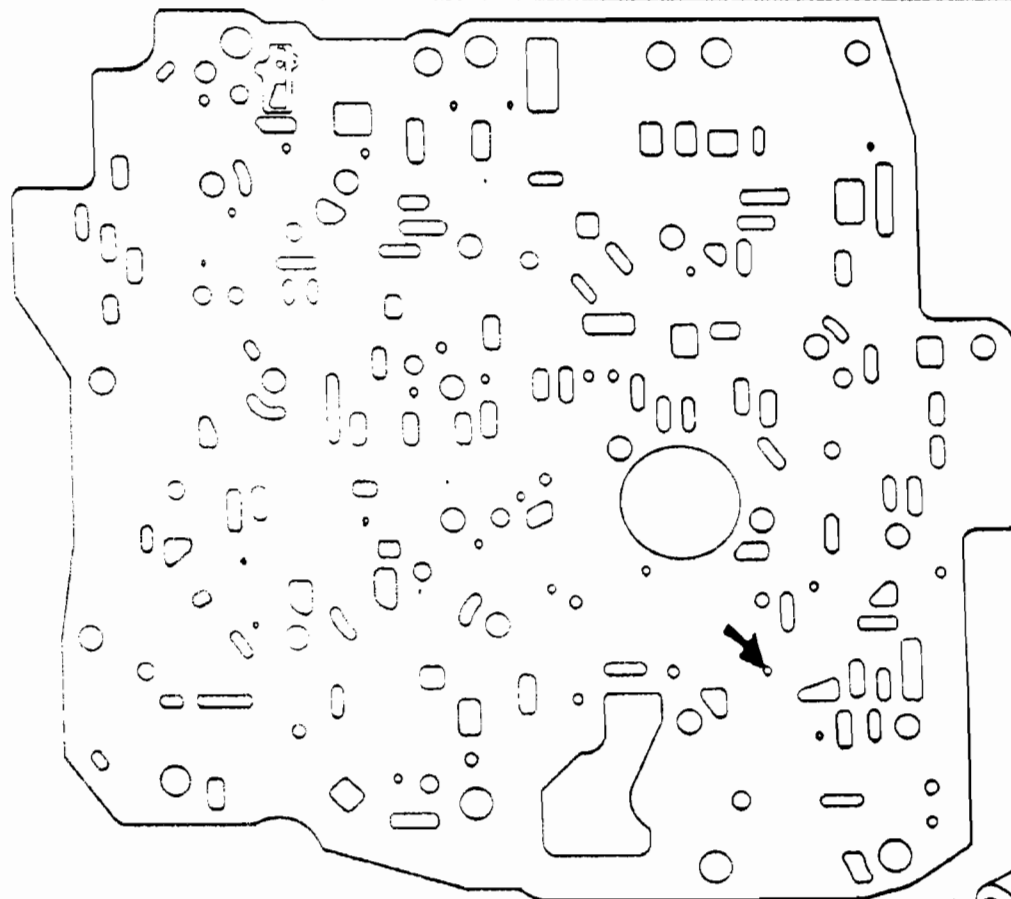
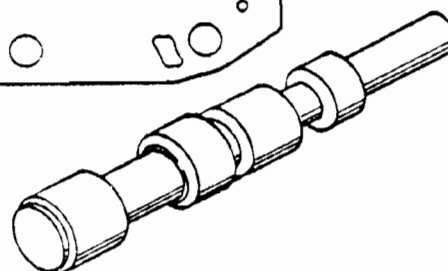
(1) T.V. CONTROLLED T.C.C. REGULATOR VALVE - On this system lands one, two, and three are all the same diameter, and requires a spacer plate WITH a T.V. hole as shown in Figure 16.

There are currently two different styles of the T.V. controlled converter regulator valve as shown in Figure 16. The 1st design is identified by "2 Narrow Rings", and the 2nd design is identified by a "Wide Band". The 2nd design valve improves T.C.C. apply feel because land No. 2 is .018" longer than the 1st design. Refer to Figure 16 to compare the length.

THIS TYPE OF CONVERTER CLUTCH REGULATOR VALVE REQUIRES
SPACER PLATE WITHOUT HOLE SHOWN BY ARROW ABOVE.

CORRECTION: Install spacer plate and T.C.C. regulator valve that are compatible with one another. Refer to Figures 16 and 17.

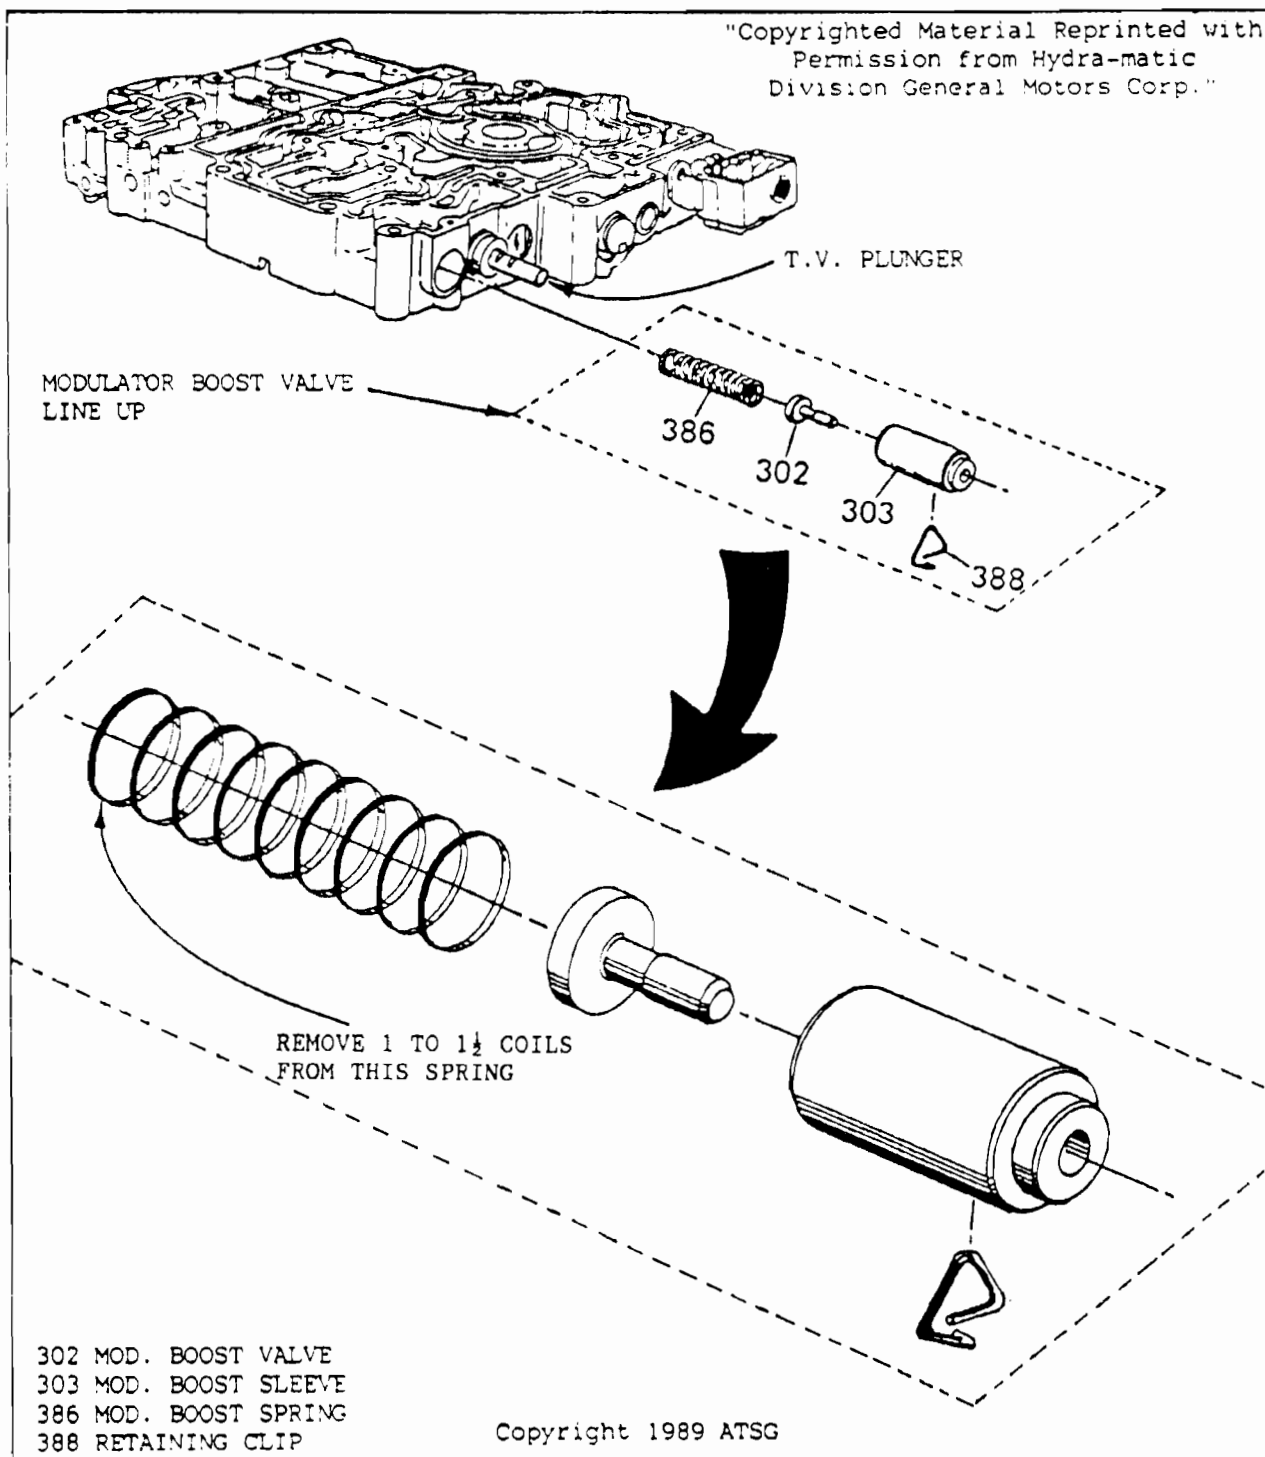
Figure 18

- COMPLAINT:** 2nd clutch pack with a very short life span, usually associated with a 1-2 slip, or a 1-2 slide bump.
- CAUSE:** The cause may be a lack of line pressure rise to sufficiently apply the second clutch pack. We also recommend OEM "Koline" steel plates in this pack, and "Vespel" sealing rings on the driven sprocket support.

- CORRECTION:** Shorten the modulator boost valve spring by $1/4"$, or approximately 1 to $1\frac{1}{4}$ coils. The modulator boost valve spring is located in the pressure regulator line up, which is directly next to the T.V. plunger in the valve body (See Figure 18). This will allow line pressure to rise at less of a throttle opening and greatly increase 2nd clutch durability. This modification should be done on "ALL" THM 440-T4 transaxles during the rebuilding process.

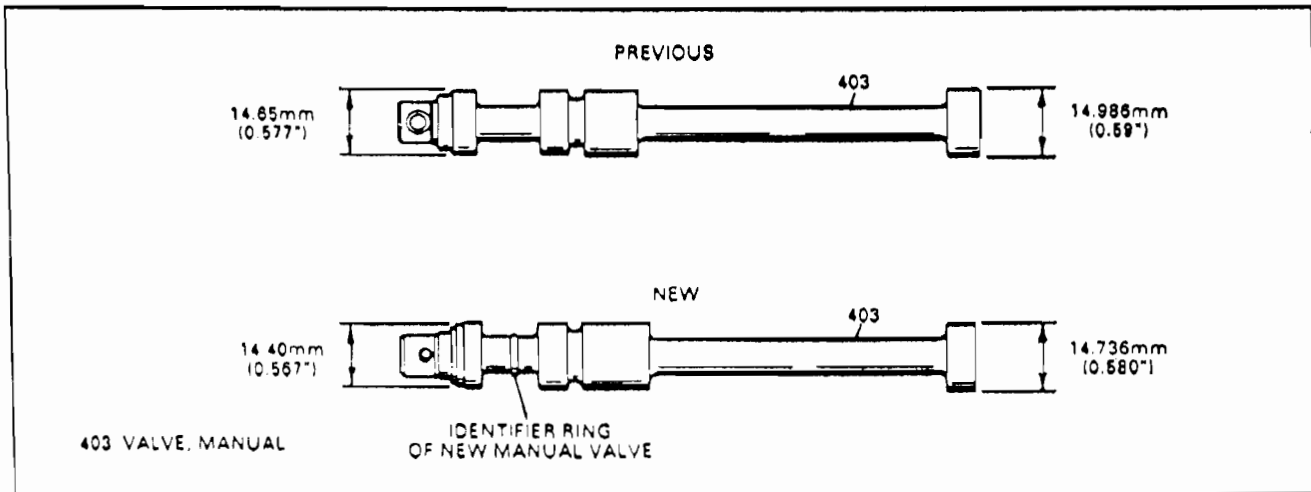
Figure 23

- (1) **NEW CHANNEL PLATE** - Will have porting changes for the new manual valve and new inside detent lever. The porting changes will help ensure that the 2 ports will never be opened at once to cause burnt 4th clutch assembly. The bore for the new manual valve will be reduced by .010" to accommodate the new manual valve. This will make the previous and new parts non-interchangeable (See Figures 22 and 23).

- (2) **NEW MANUAL VALVE** - Will have changes to the valve lands and reduced .010" in diameter for the new porting changes in channel plate. The previous and new manual valves are not interchangeable. The new manual valve can be identified by a ring between the first two lands as shown in Figure 23.

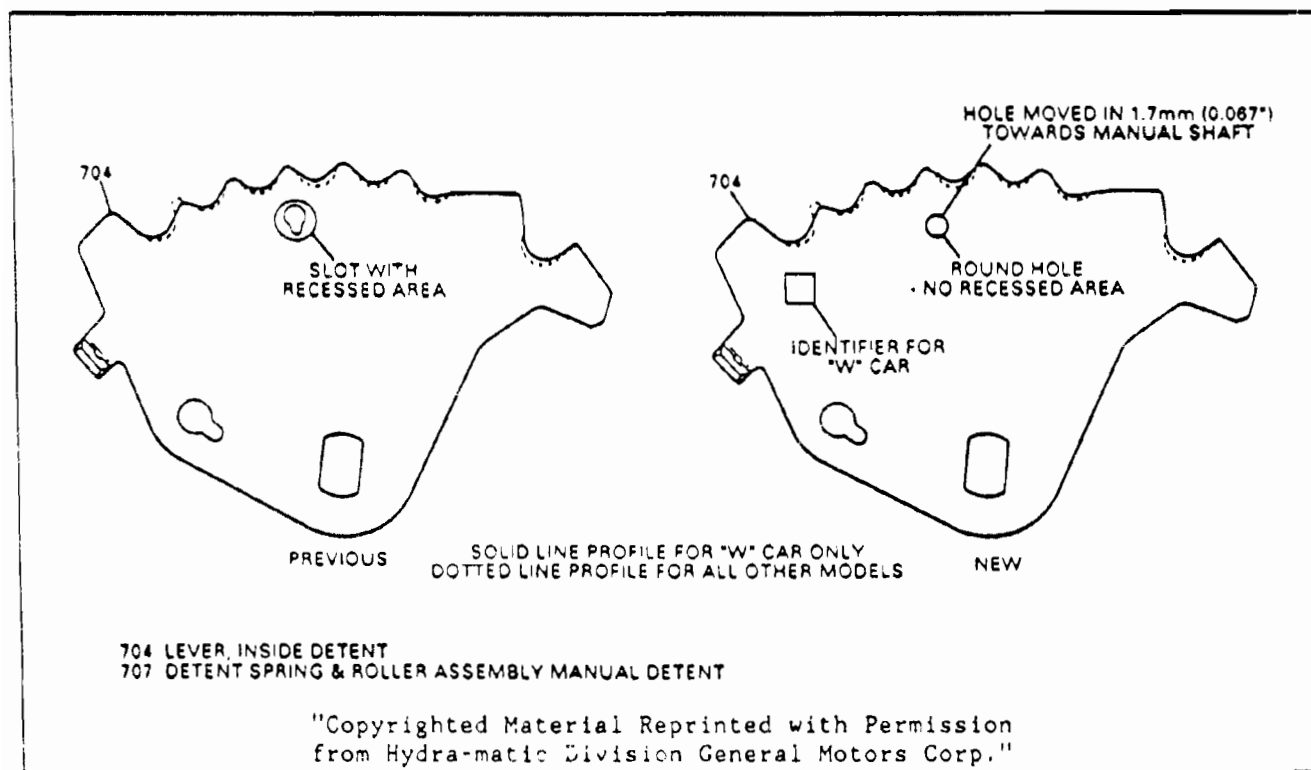
- (3) **NEW INSIDE DETENT LEVER** - Will have the manual link hole location changed to provide a different "Throw" of the manual valve, and the hole is now round instead of "Keyhole" shaped. Since the "W" car detent lever is different than all others, it will have square identification hole punched in it. The previous and new inside detent levers will not interchange. Refer to Figure 24 for I.D.

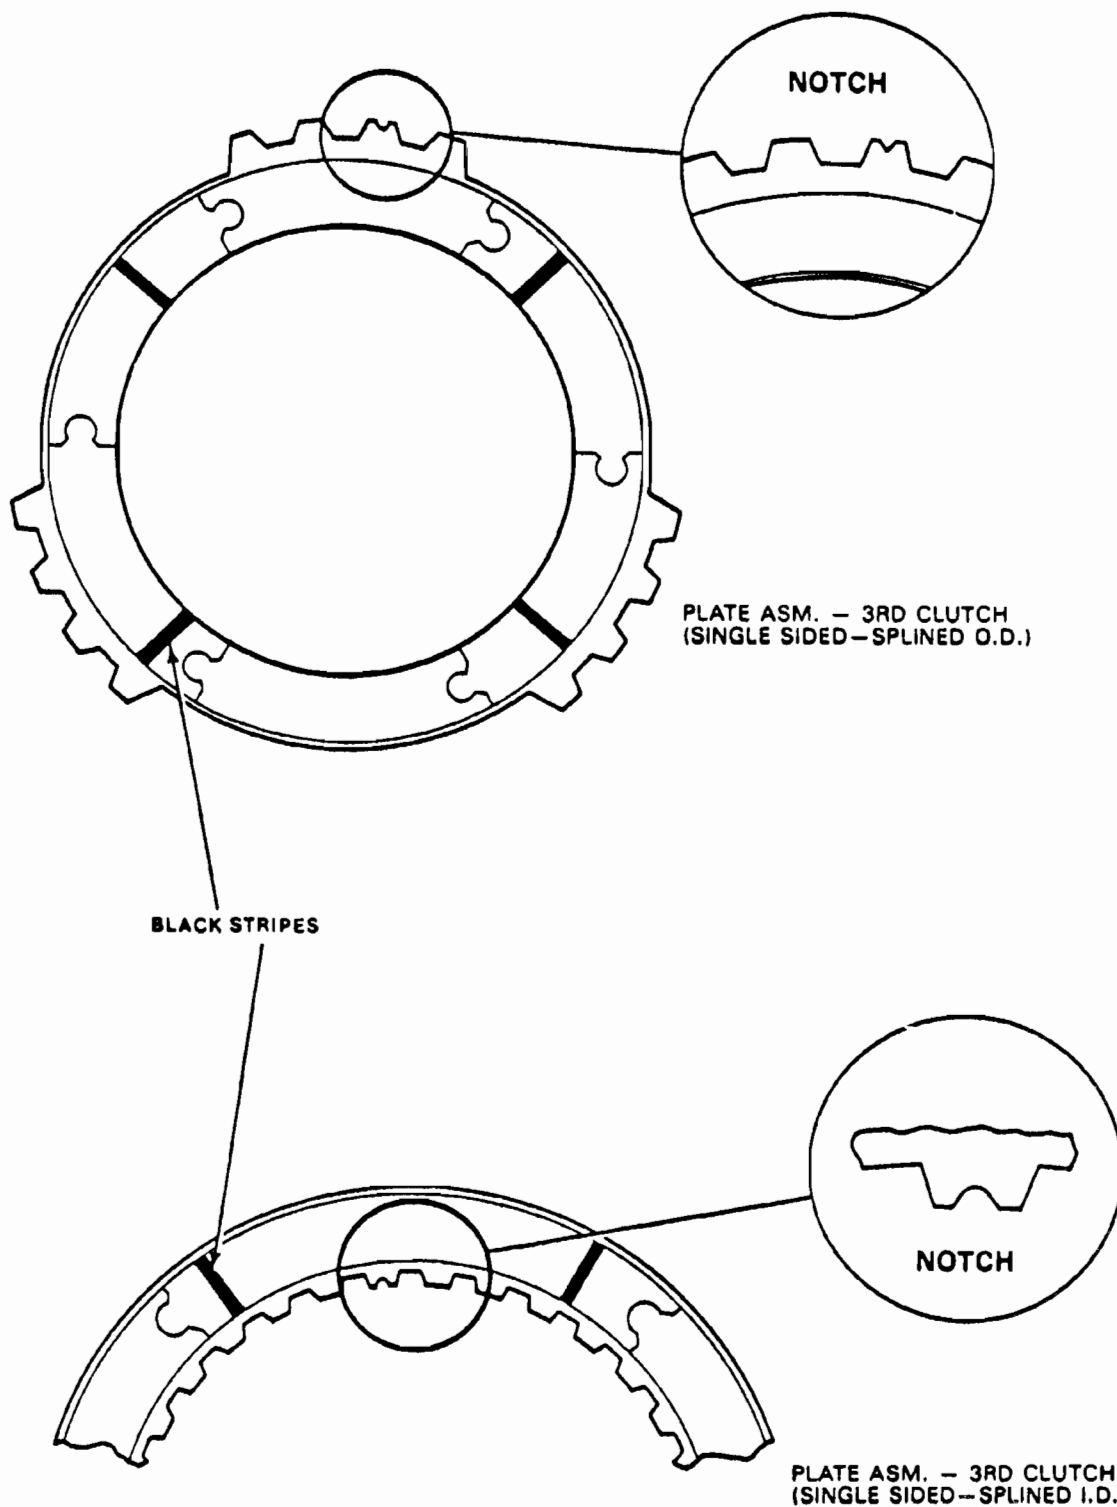
Figure 25
AUTOMATIC TRANSMISSION SERVICE GROUP

- (1) 3RD CLUTCH PLATES - Change of Fiber Material on the 3rd clutch plates, and can be identified by four (4) black stripes and/or "Notch" cut in one of the teeth, and/or NO identification (See Figure 25).
- (2) NEW MODEL CODES - Were assigned when the fiber material changed on the 3rd clutch plates (See Figure 26).
- (3) SPACER PLATE - Was changed on some models. To identify the new spacer plate, see Figure 27.
- (4) VALVE BODY CALIBRATION - As Follows: (Refer to Figure 28).
 - A. 2-3 accumulator valve spring (Most Models).
 - B. 3-2 control valve spring (All Models).
 - C. 1-2 accumulator valve spring (CPH Models Only).

- (1) Harsh shifts and possibly a tie-up condition (Worse at Altitudes) on 2-3 and 3-2 shifts if the PREVIOUS 3rd clutch plates are installed into a transaxle built after March 17, 1989 (New Model Codes).
- (2) A slide-bump on 2-3 and 3-2 shifts if the NEW 3rd clutch plates (Black Stripe) are installed into a transaxle built before March 17, 1989 (Old Model Codes) without installing one of the "Calibration Update Kits". Refer to Page 37 of this booklet for OEM part numbers under Service Information.

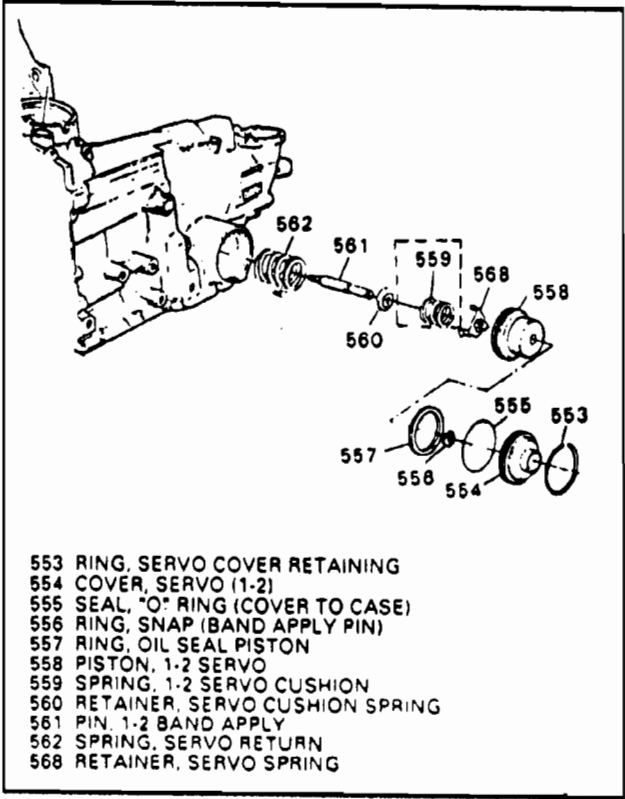
Figure 29

NOTE: The updated valve body assembly will have an update level "Laser Etched" into the casting by the servo pipes. Refer to Figure 27 for the identification numbers.
- (5) 1-2 SERVO CUSHION SPRING - New 1-2 servo cushion spring can be identified by light blue and orange paint (See Figure 29).
- (6) 1-2 ACCUMULATOR SPRING - New calibration on CPH model only (See Figure 30).

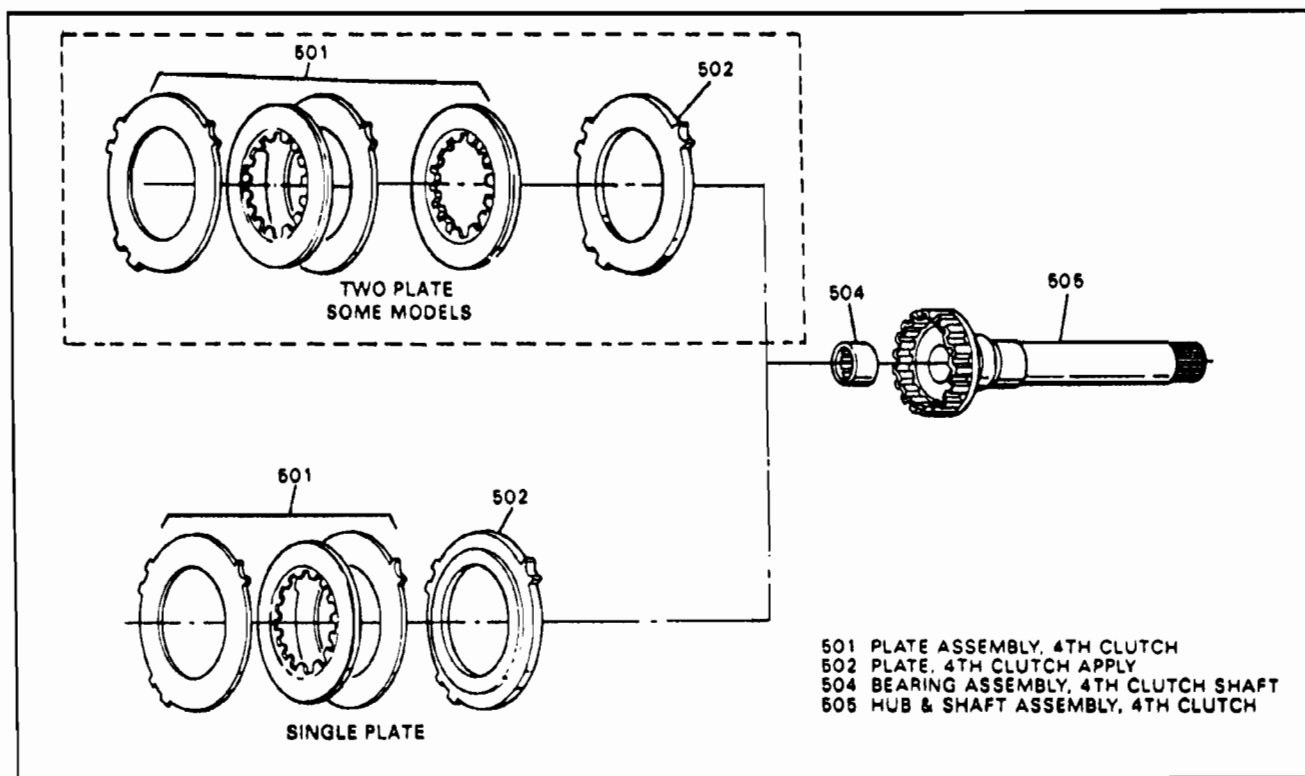
Figure 33

CHANGE: A new "Two Plate" 4th clutch assembly was used to replace the Single Plate 4th clutch assembly for SOME MODELS ONLY on the 1990 THM 440-T4 transaxles (See Figure 33).

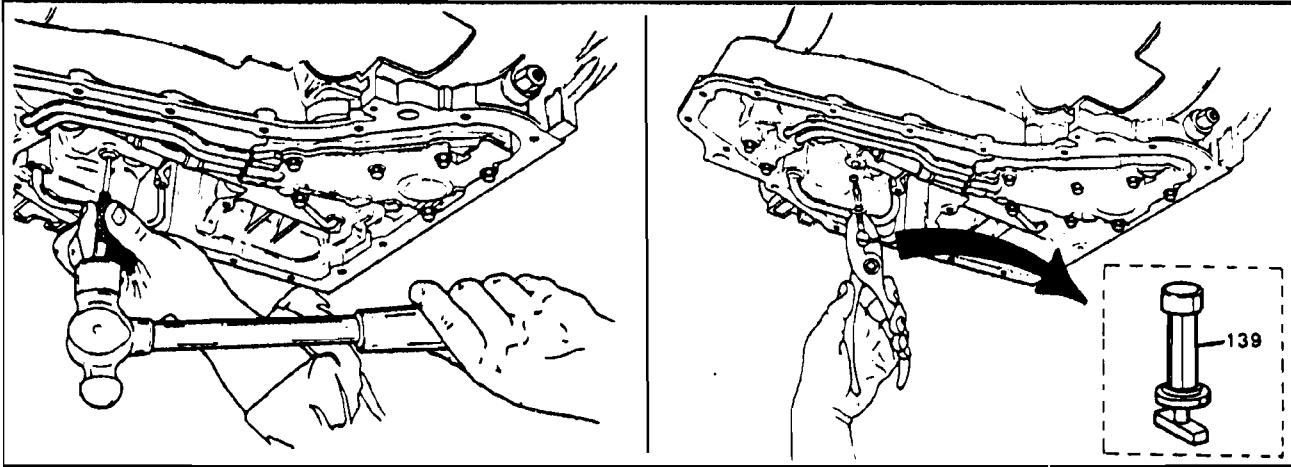
Figure 43

- (1) 1-2 BAND ASSEMBLY - The target area on the new 1-2 band, where the band apply pin engages, has been made wider and has "Wings" added to prevent the pin from ever missing the "Target" area (See Figure 42).
- (2) 1-2 BAND STOP ASSEMBLY - The 1-2 Band Stop has been eliminated as it is no longer needed (See Figure 43).

The new style 1-2 Band Assembly can be used to service ALL past models, but the 1-2 Band Stop MUST be removed and discarded (See Figure 43).

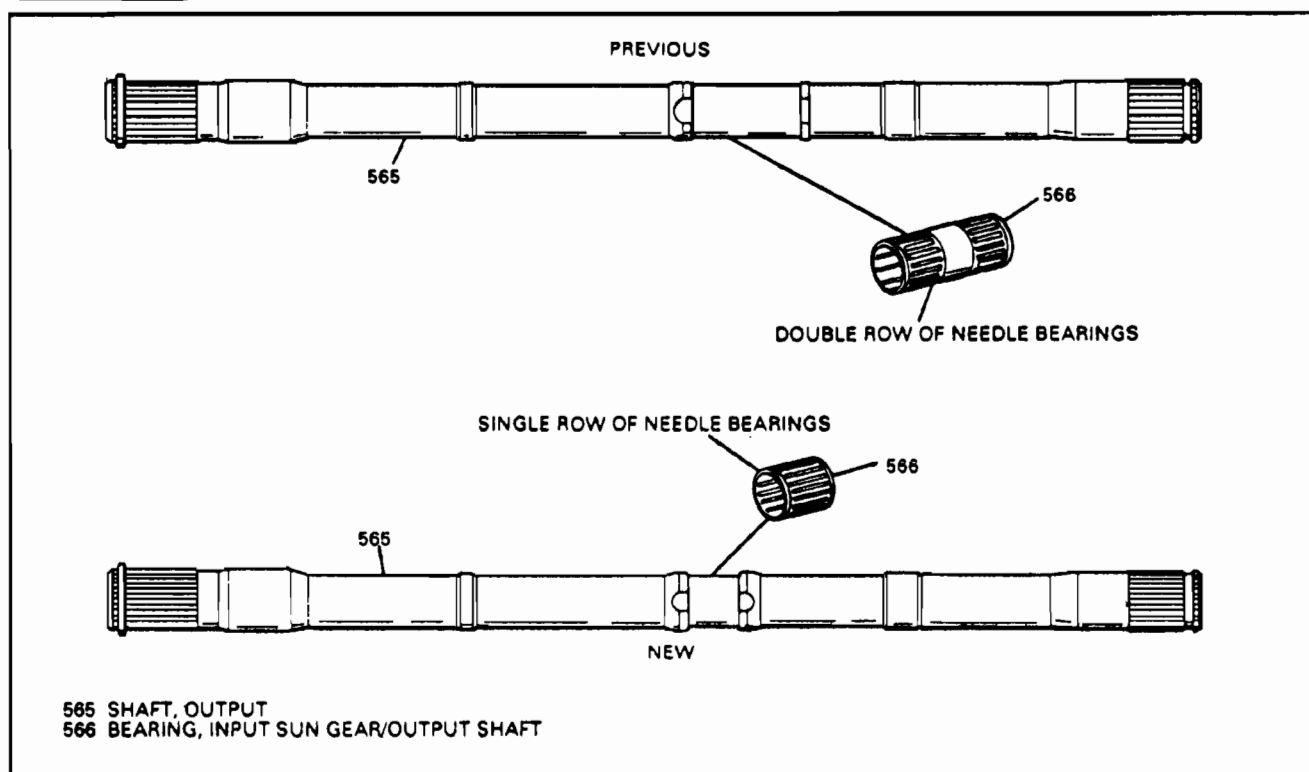
Figure 45

- (1) **OUTPUT SHAFT/BEARING** - The new bearing has a single row of needle bearings instead of a double row, and the output shaft is machined different to accommodate the new bearing (See Figure 45). This change will improve lube oil flow to the 3rd roller clutch and input sprag.
- (2) **3RD ROLLER CLUTCH ASSEMBLY** - The new 3rd roller clutch outer race has four (4) less lube holes than previous models. The four lube holes are in line with the very end of the rollers (See Figure 46). Elimination of these holes helps keep the rollers from "Skewing" (Running at an Angle), thus generating less heat.

Output Shaft and Bearing Assembly (New Style).....	8668990
Needle Bearing Only (New Style).....	8675032
3rd Roller Clutch Assembly (New Style).....	8677016

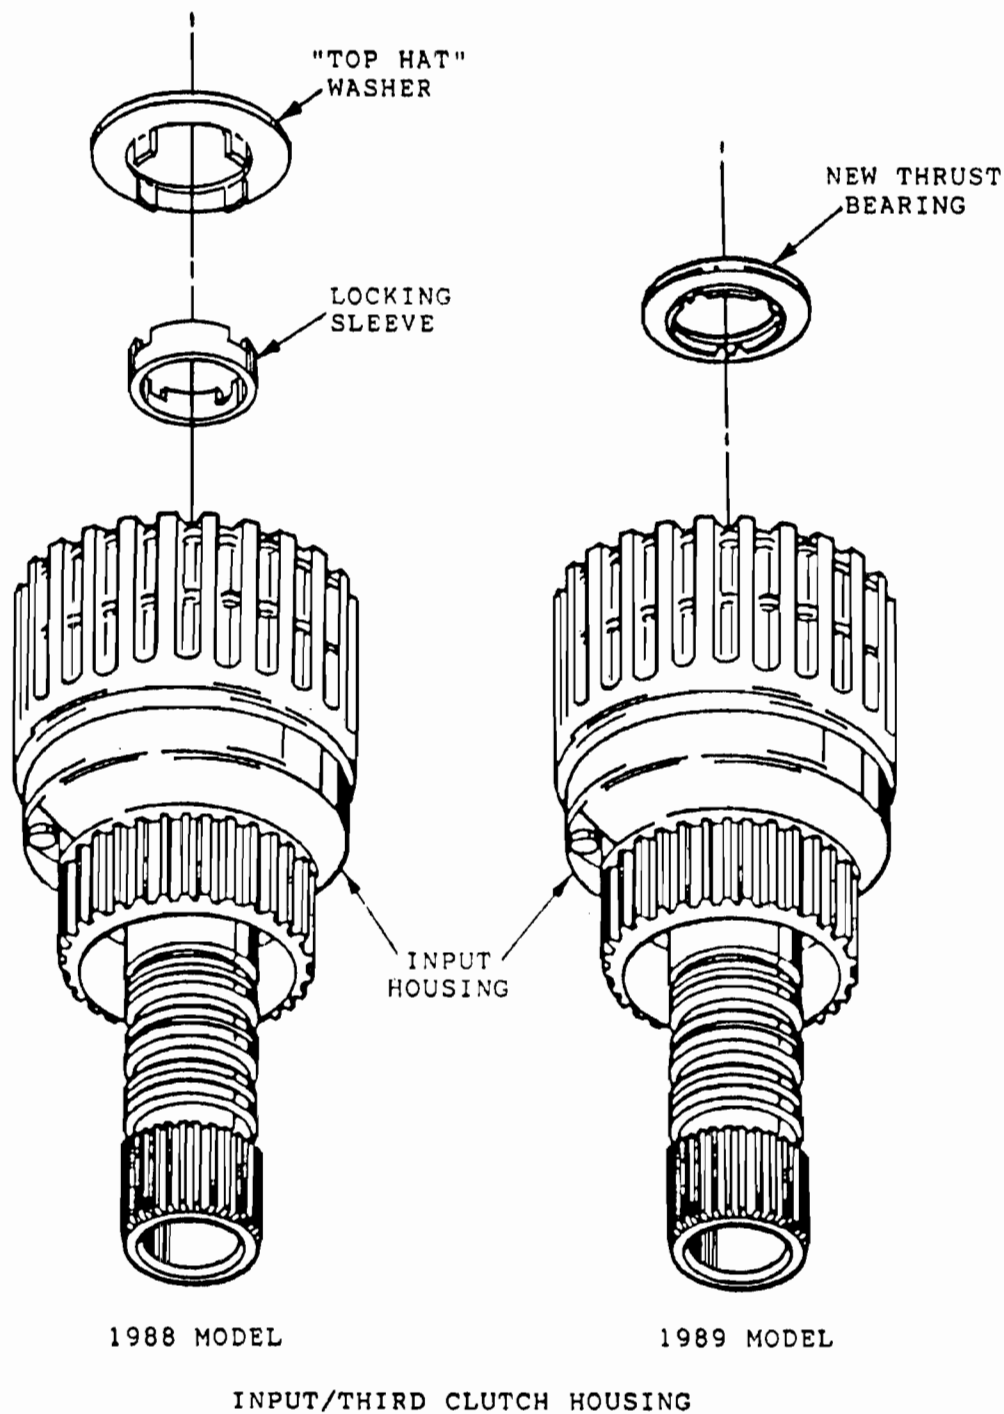
Figure 47

CHANGE: A new Thrust Bearing Assembly replaces the "Top Hat" Thrust Washer and Lock-up Sleeve in the input housing (See Figure 47) The new bearing and related parts went into production on all 1989 models on November 28, 1988 (Julian Date 333).

1. New design Input Housing.
2. New design Thrust Bearing Assembly.
3. New design 3rd Roller Clutch Complete.
4. Instruction Sheet.

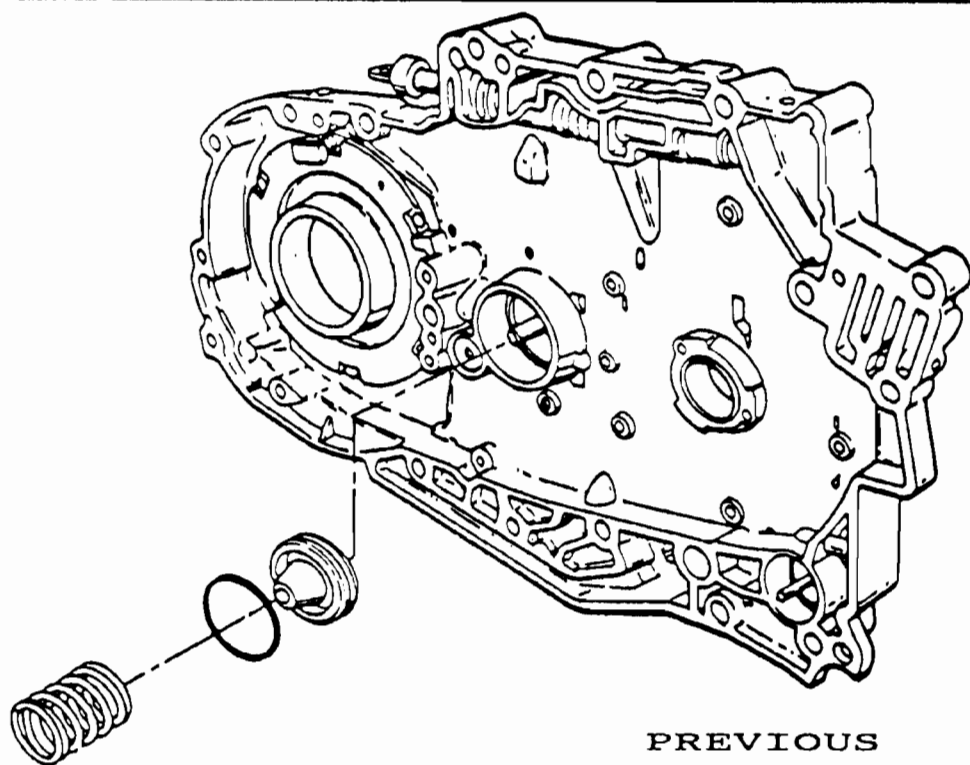
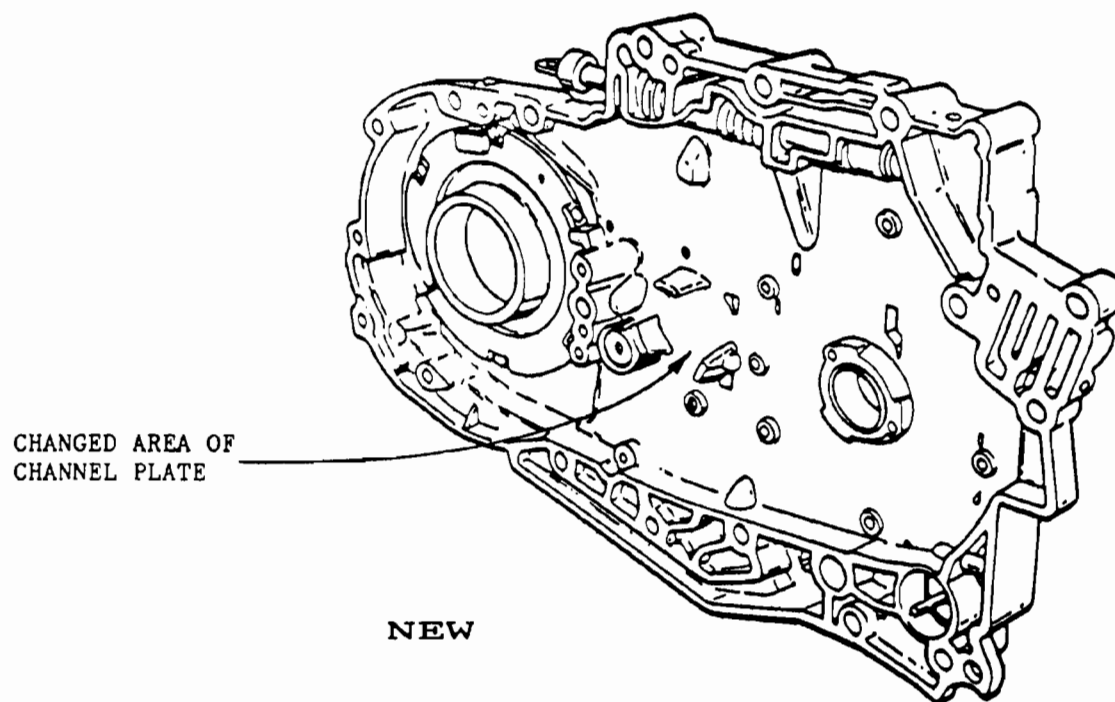
Figure 50

CHANGE: The Input Clutch Accumulator has been eliminated from the channel plate (See Figure 50).

NEW WAVED PLATE - - - - -	8675257
.049" STEEL PLATES - - - - -	8651446

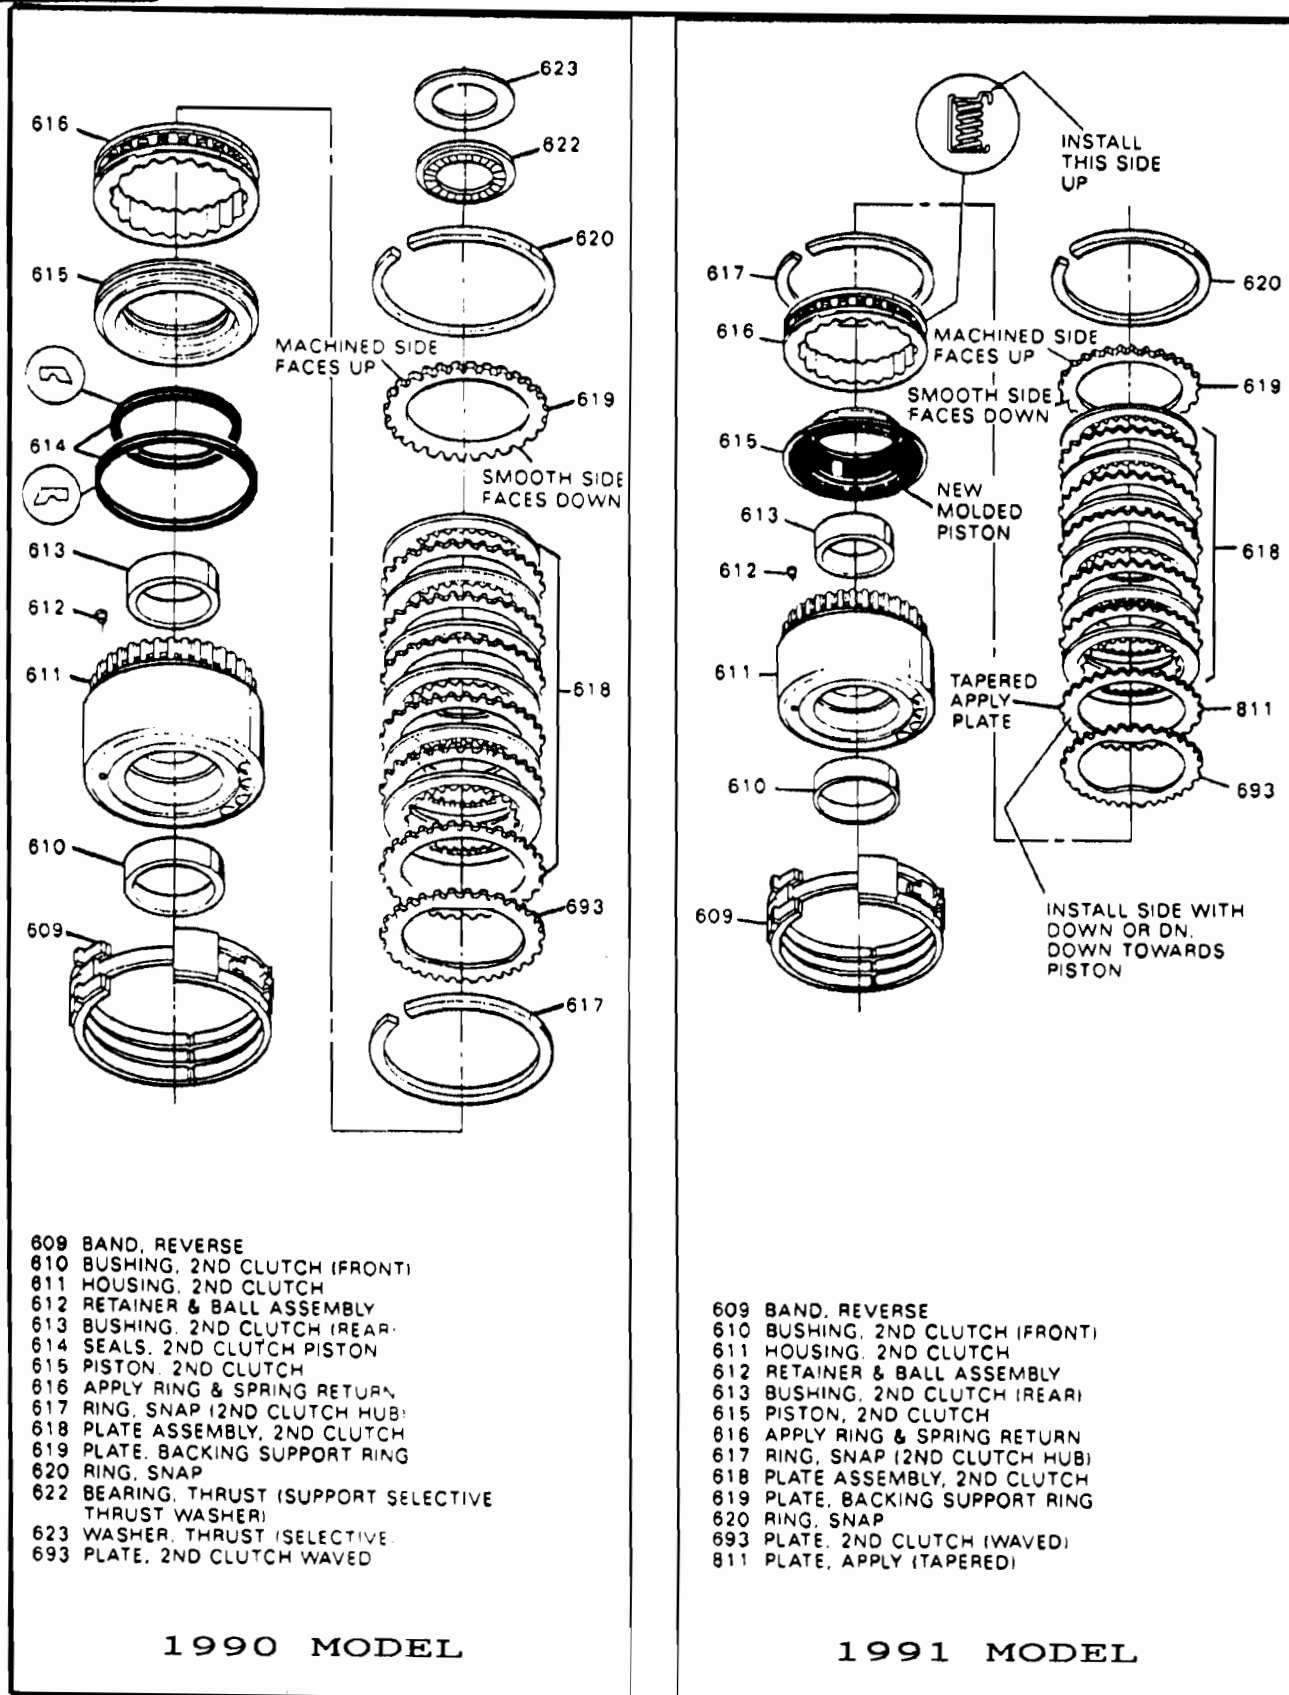
Figure 53

- (1) 2ND CLUTCH HOUSING - Snap ring grooves moved and revised clutch stack up, along with dimensional changes on the center journal area so as to accomodate the new moulded piston and seal assembly (See Figure 53).
- (2) 2ND CLUTCH PISTON - Now has moulded seal assembly on the piston (See Figure 53).
- (3) APPLY RING AND RETURN SPRING ASSEMBLY - Revised dimensions to accomodate the new moulded piston assembly, and the revised clutch stack-up. (See Figure 53).
- (4) REVISED CLUTCH STACK - Includes a new "Apply" plate in the stack-up and one less "Koline" steel plate (See Figures 53 and 55).

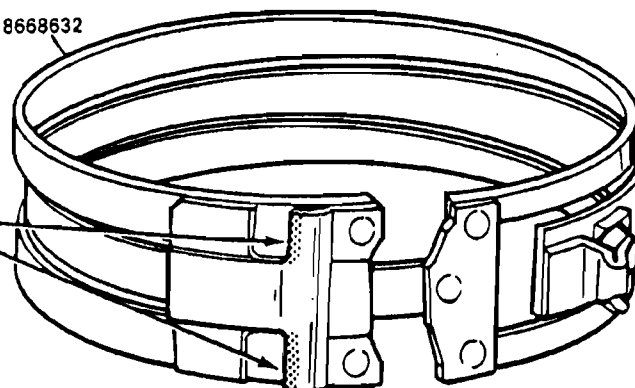
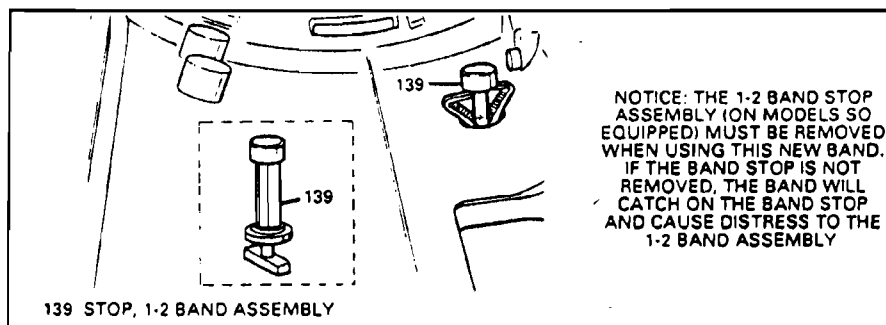
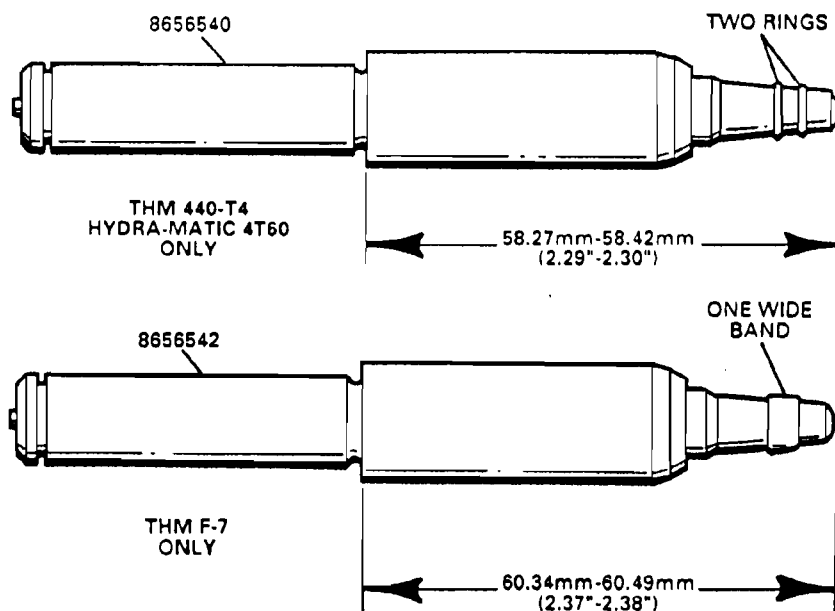
Figure 56

- (1) 1-2 BAND ASSEMBLY - A new manufacturing process machines the area where the case anchor pins contact the band (See Figure 56). With this new process, all of the 1-2 bands are the same size, and the selective band apply pins are eliminated.
NOTE: THE 1-2 BAND STOP LOCATED IN THE BARREL OF THE CASE (ON MODELS SO EQUIPPED) MUST BE REMOVED AND DISCARDED WHEN USING THE NEW BAND.

- (3) SELECTIVE BAND PINS - Eliminated, there is now only ONE size band apply pin required for the 1-2 band, and only ONE size band apply pin required for the reverse band (See Figures 56 and 57).

NOTICE: THE 1-2 BAND STOP
ASSEMBLY (ON MODELS SO
EQUIPPED) MUST BE REMOVED
WHEN USING THIS NEW BAND.
IF THE BAND STOP IS NOT
REMOVED, THE BAND WILL
CATCH ON THE BAND STOP
AND CAUSE DISTRESS TO THE
1-2 BAND ASSEMBLY

The new 1-2 band assembly will retro-fit back to all previous models, with the proper band apply pin installed (See Figure 56).

USE ONE OF THE FOLLOWING BAND APPLY PINS
WITH THE NEW BAND
DEPENDENT ON
TRANSAXLE

IMPORTANT:
THE BAND APPLY PINS SHOWN ABOVE
WILL BE THE ONLY PINS
THAT WILL BE REQUIRED
FOR THE ENTIRE NORMAL SERVICE LIFE
OF THE BAND

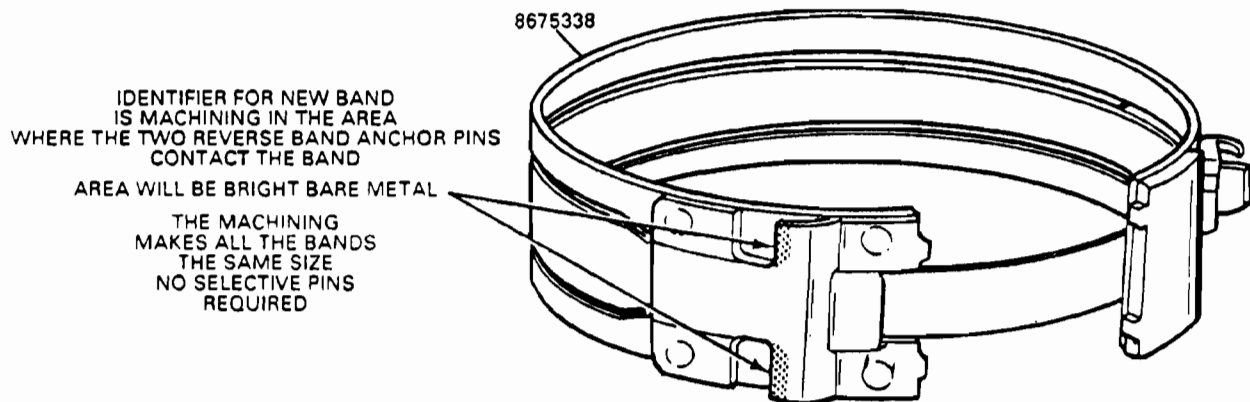
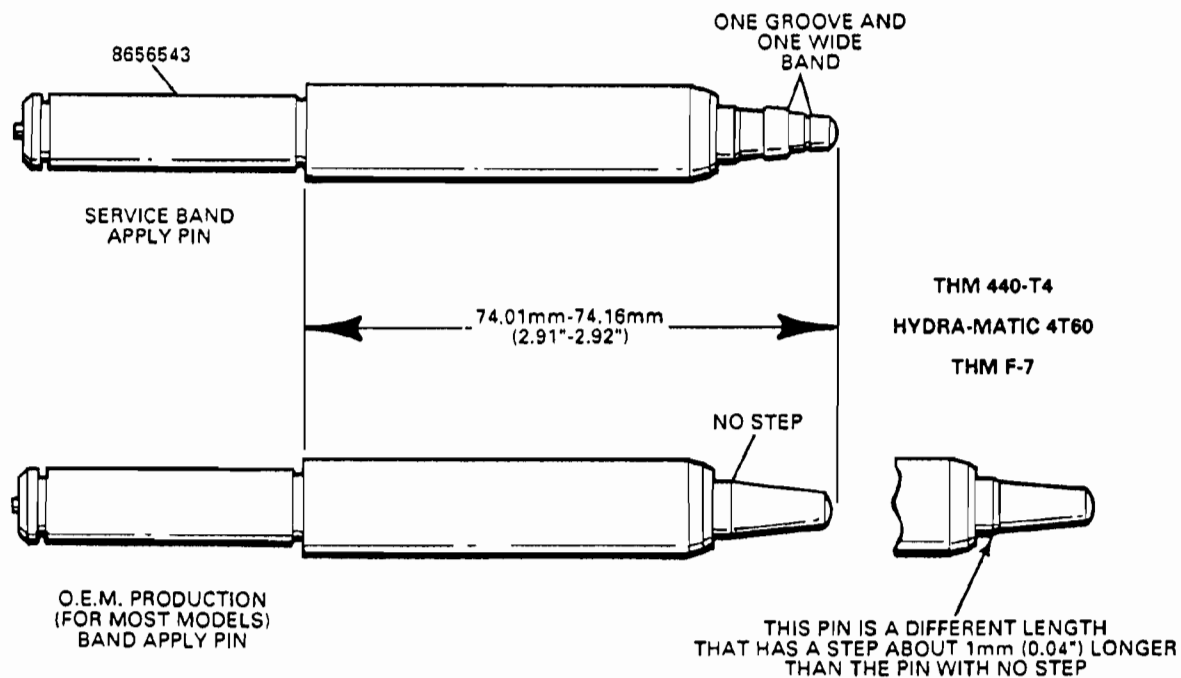
Figure 57

- (2) REVERSE BAND ASSEMBLY - A new manufacturing process machines the area where the case anchor pins contact the band (See Figure 57). With this new process, all of the reverse bands are the same size, and selective band apply pins are eliminated. The new reverse band also has the new friction material to help decrease reverse engagement concerns.

The new reverse band assembly will retro-fit back to all previous models, with the proper band apply pin (See Figure 57), and it also has the new friction material to help decrease reverse engagement concerns.

USE ONE OF THE FOLLOWING BAND APPLY PINS WITH THE NEW BAND

IMPORTANT:
THE BAND APPLY PINS SHOWN ABOVE
WILL BE THE ONLY PINS
THAT WILL BE REQUIRED
FOR THE ENTIRE NORMAL SERVICE LIFE
OF THE BAND
