TRANSMISSION SEMINAR 1991

NEW DESIGNATION SYSTEM FOR HYDRA-MATIC PRODUCTS

THM 4L60 (700-R4) SOFT UPSHIFTS AND OTHER THINGS

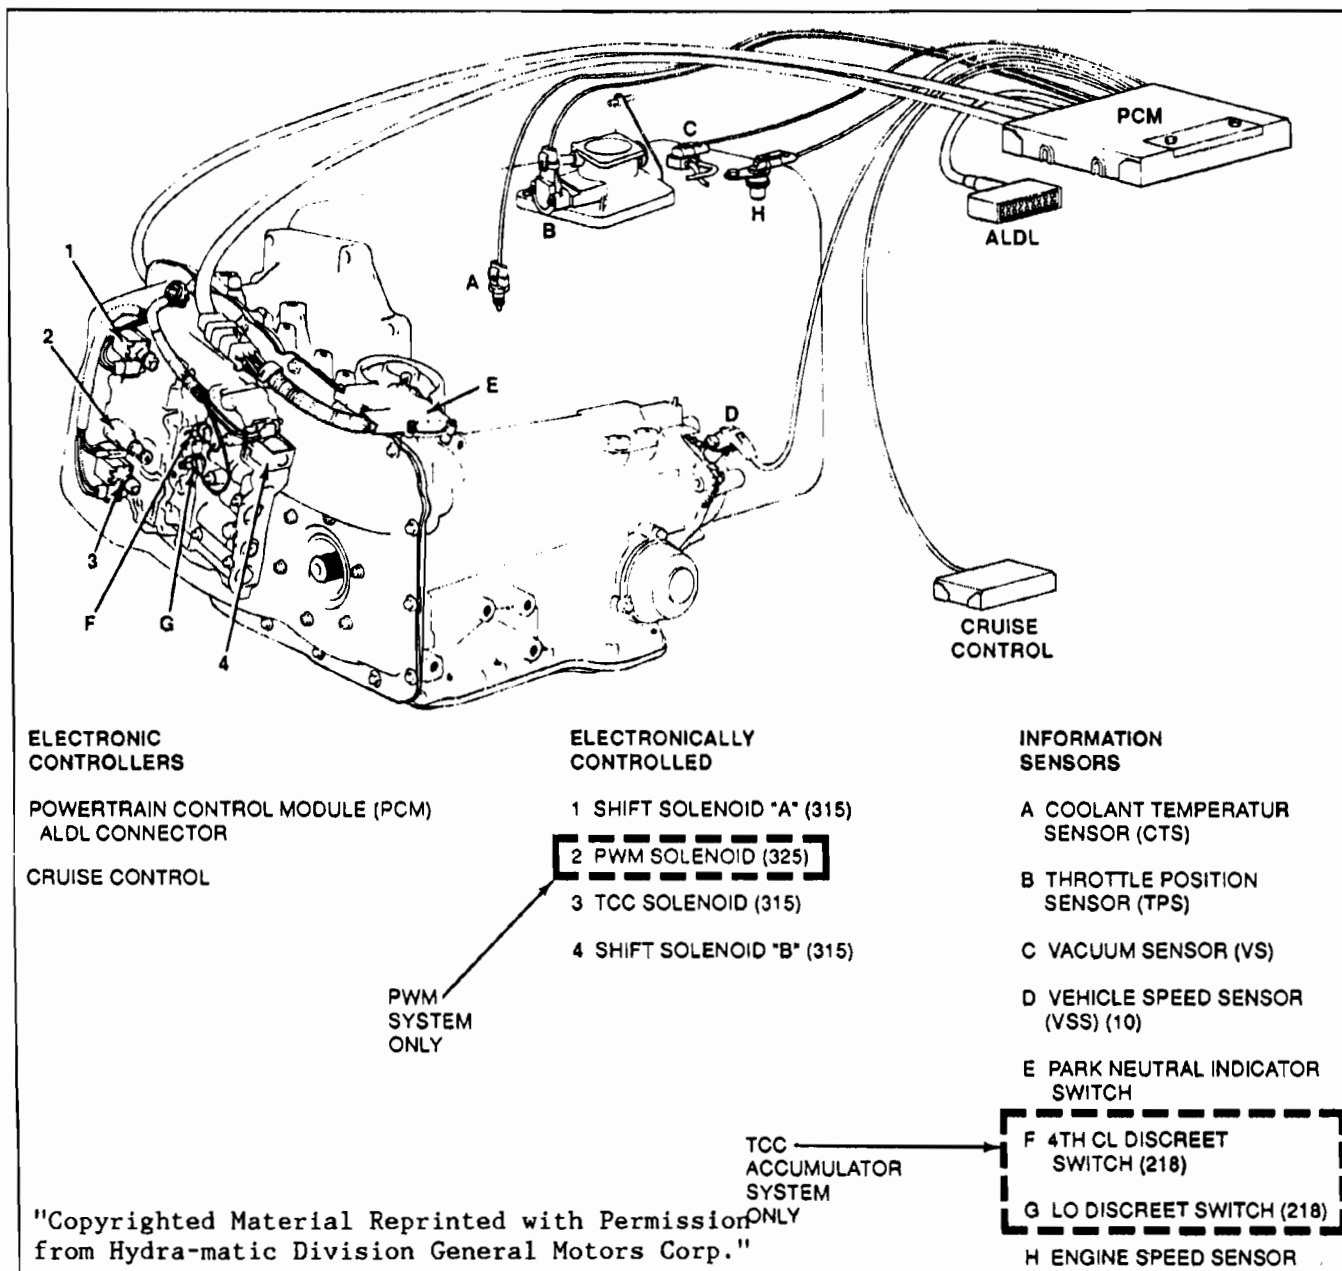
Figure 61

Notice also that there is a fourth solenoid on the valve body called a Pulse Width Modulated (PWM) Solenoid (See Figure 61). The PWM solenoid receives a ground signal from the Powertrain Control Module (PCM). This ground signal is pulse width modulated (Variable), depending on throttle opening (TPS), and controls the amount of line pressure sent to the back side of the TCC Regulator Valve and thus control converter clutch apply "Feel". This provides for accurate control of the actual value of regulated converter apply pressure. For failure mode considerations the PWM is normally open. This means that when the PWM solenoid is OFF (No Voltage), the PWM supply port is open to the PWM output port. This results in a maximum TCC apply pressure when the PWM is OFF. In the unlikely event that the PWM has failed, or is disconnected, and the TCC enable solenoid is still operated, the TCC/VCC will be applied with maximum pressure.

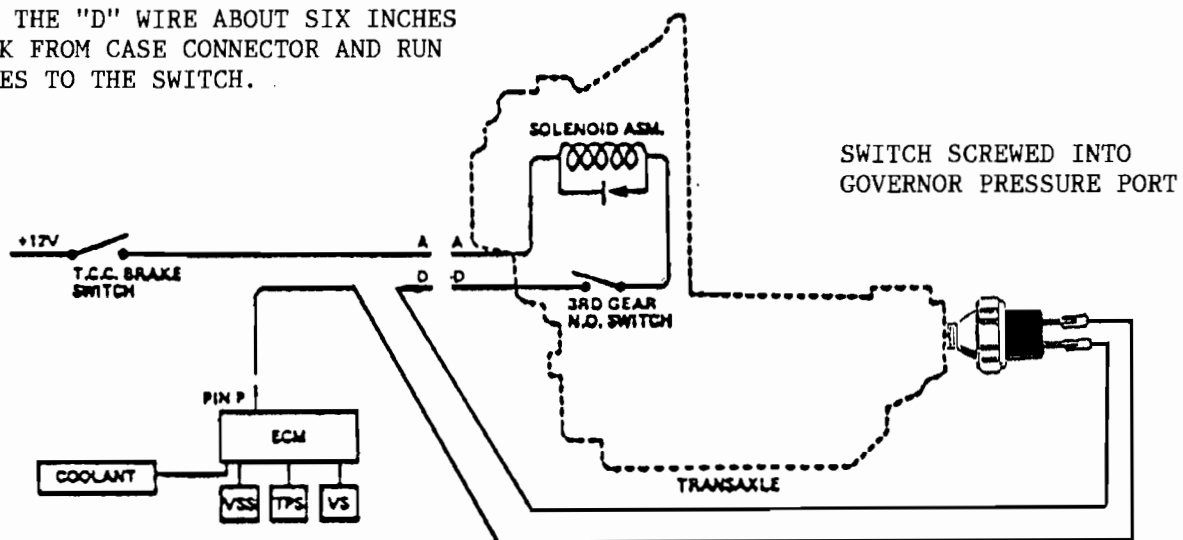
Figure 64

NOTE: WILL WORK ON 82-86 MODELS
ONLY WHEN USED INTERNALLY
AS THIS PORT IS NOT GOV.
PRESSURE ON 1987 - UP.

CUT THE "D" WIRE ABOUT SIX INCHES
BACK FROM CASE CONNECTOR AND RUN
WIRES TO THE SWITCH.

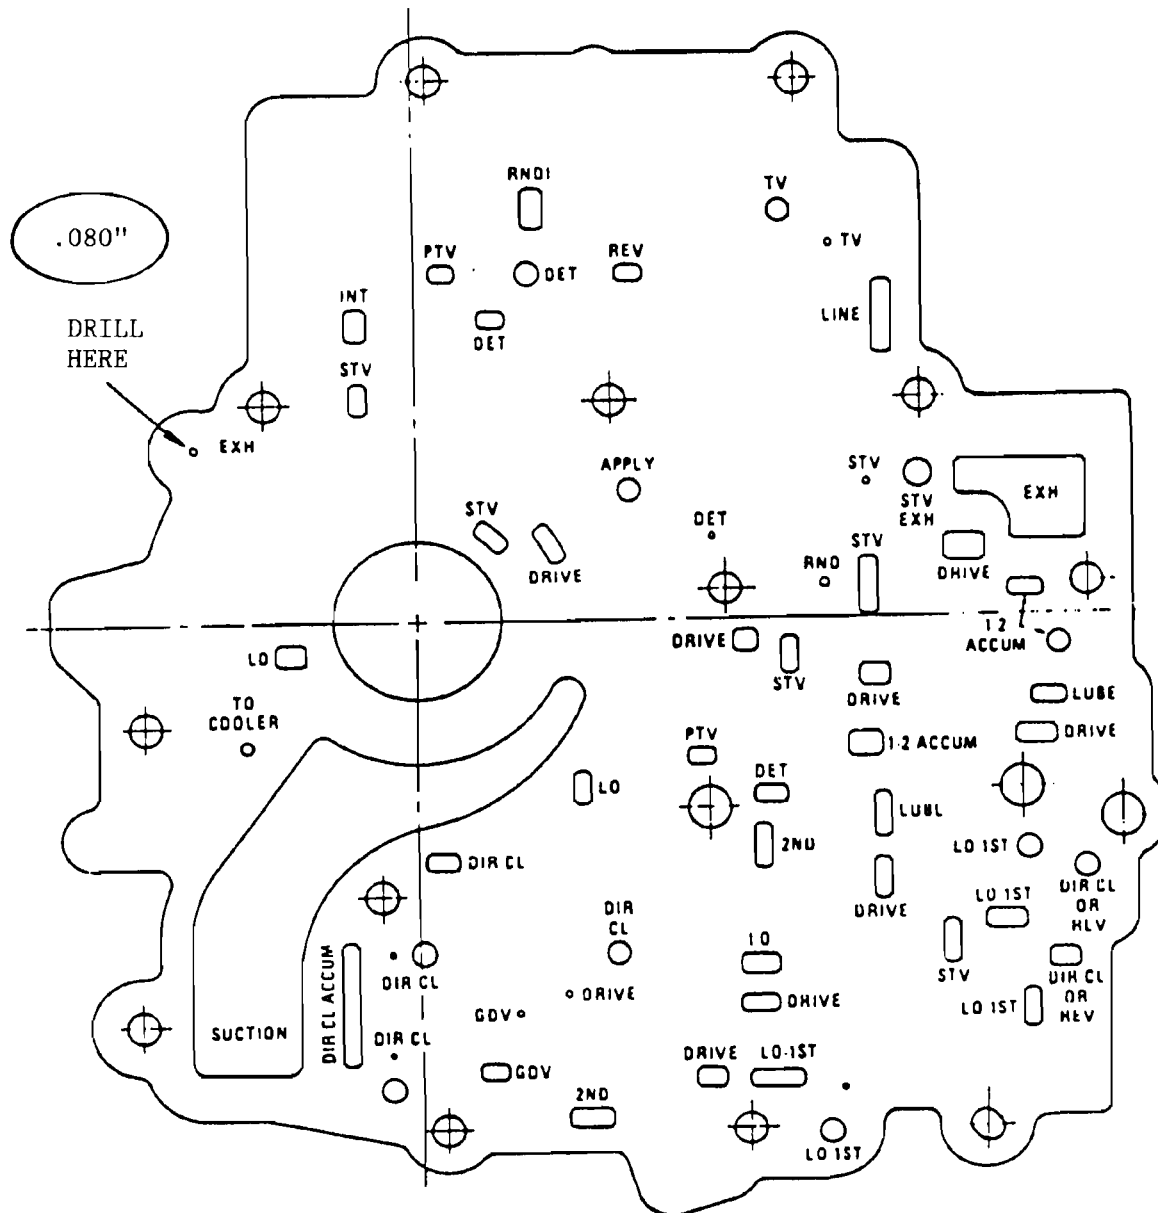
Figure 66

CAUSE: One cause may be low converter charge pressure. Another cause may be slow drain of converter release oil from the front side of the converter clutch piston.

CORRECTION: Install a stronger converter clutch regulator valve spring, OEM part number 8637887, or use a return spring from a 700 reverse input housing return spring assembly. Also drill the converter clutch exhaust hole in the spacer plate to .080". Refer to Figures 65 and 66.

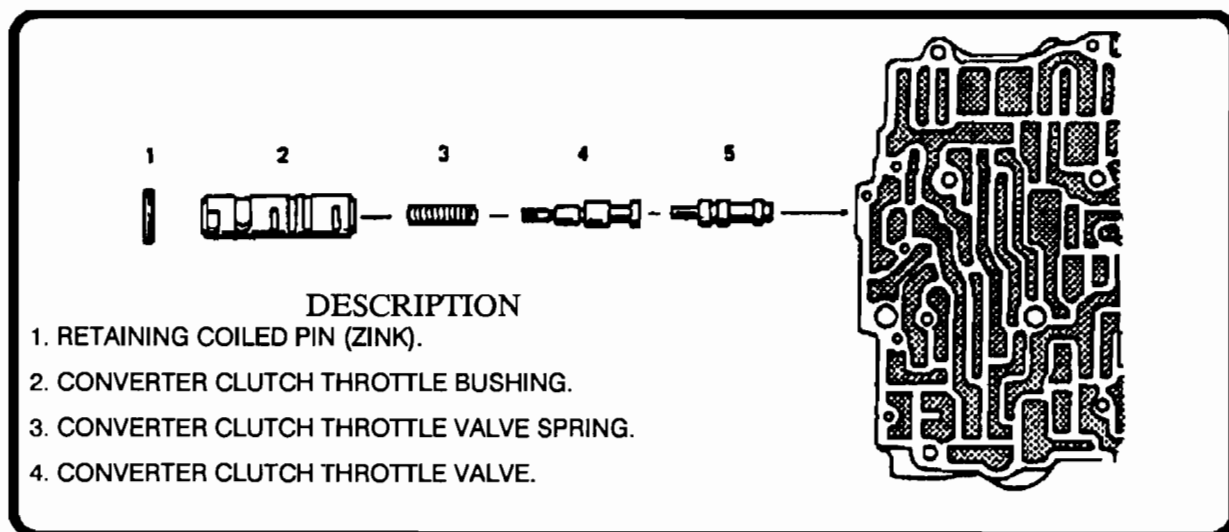
FIGURE 70 (EARLY DESIGN)

A condition of no converter clutch apply, or no second gear, may result from mismatch of valve bodies & separator plates. An early plate installed on a late valve body may result in no converter clutch apply. A late plate installed on a early valve body may result in no second gear condition. Refer to figure 69 to identify the the separator plates.

If valve body has a converter clutch valve line up (FIGURE 70) it is an early valve body and must be used with an early plate.

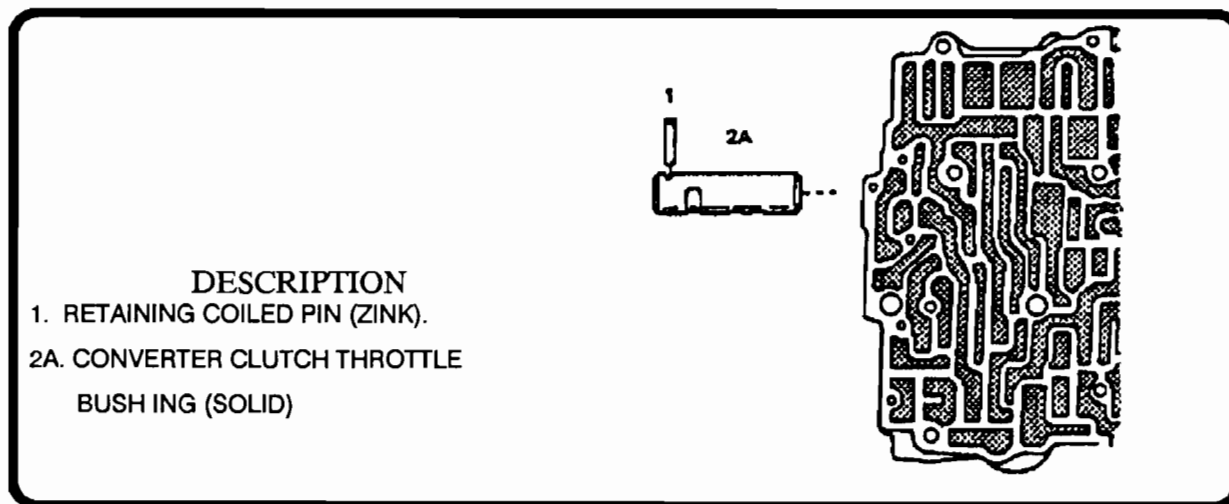
FIGURE 71 (LATE DESIGN)

If valve body has a plug in the converter clutch valve line up (FIGURE 71) it is a late valve body and must be used with a late plate.
