1999 SEMINAR INFORMATION

"TECH ON TIME FOR '99"

INDEX

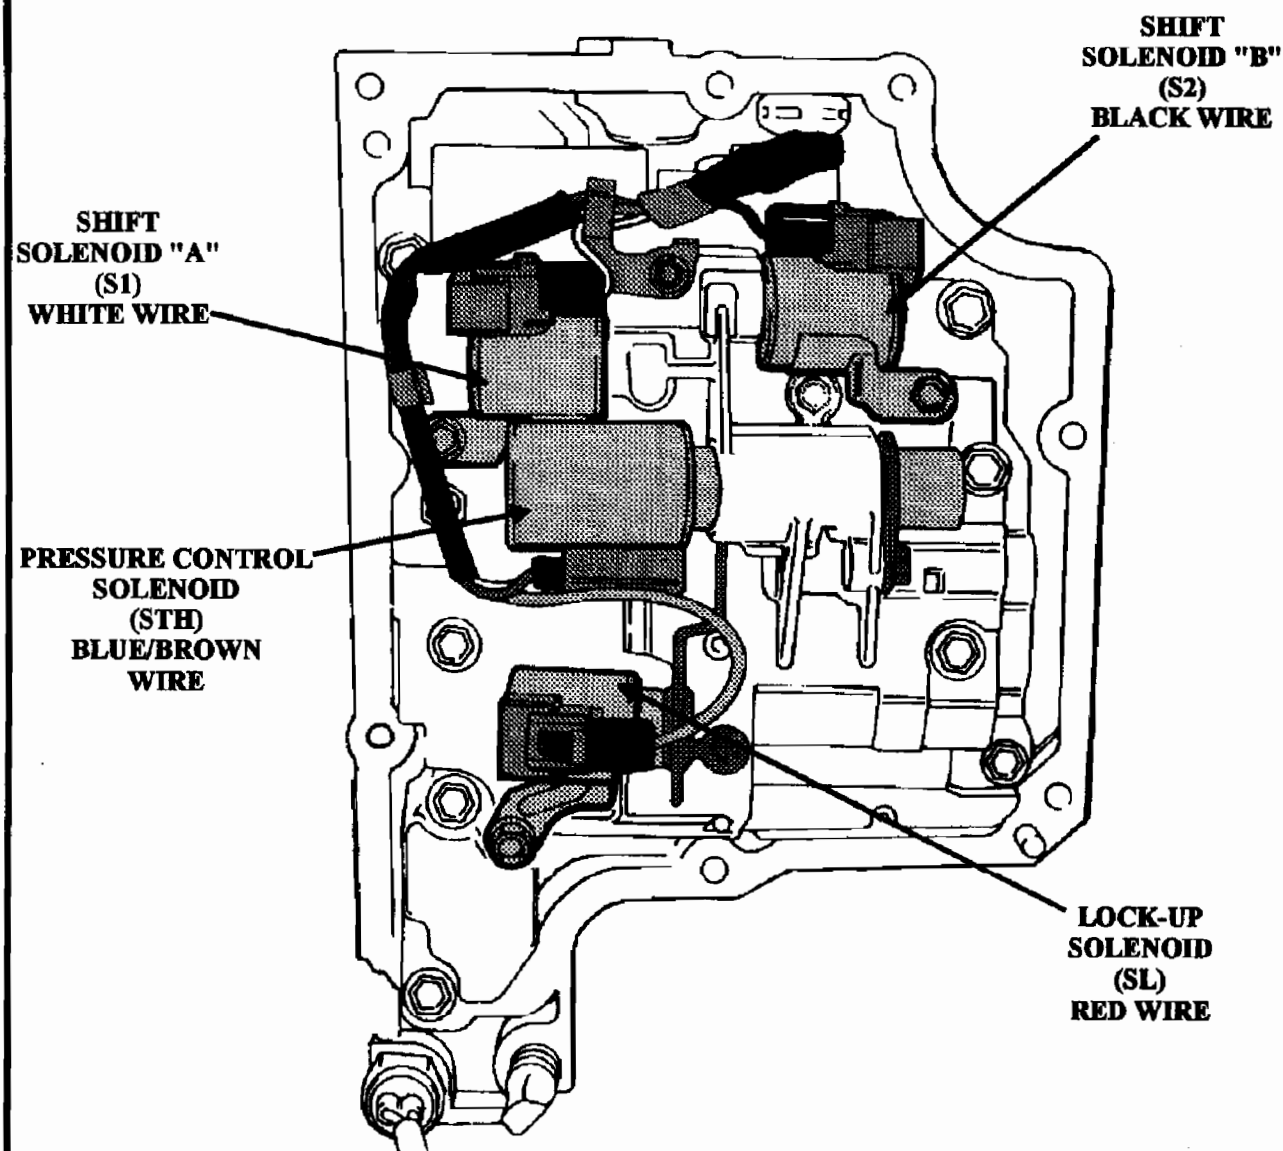
Figure 2

CAUTION: SL1 SOLENOID WIRE AND SL2 SOLENOID WIRE CAN BE SWITCHED

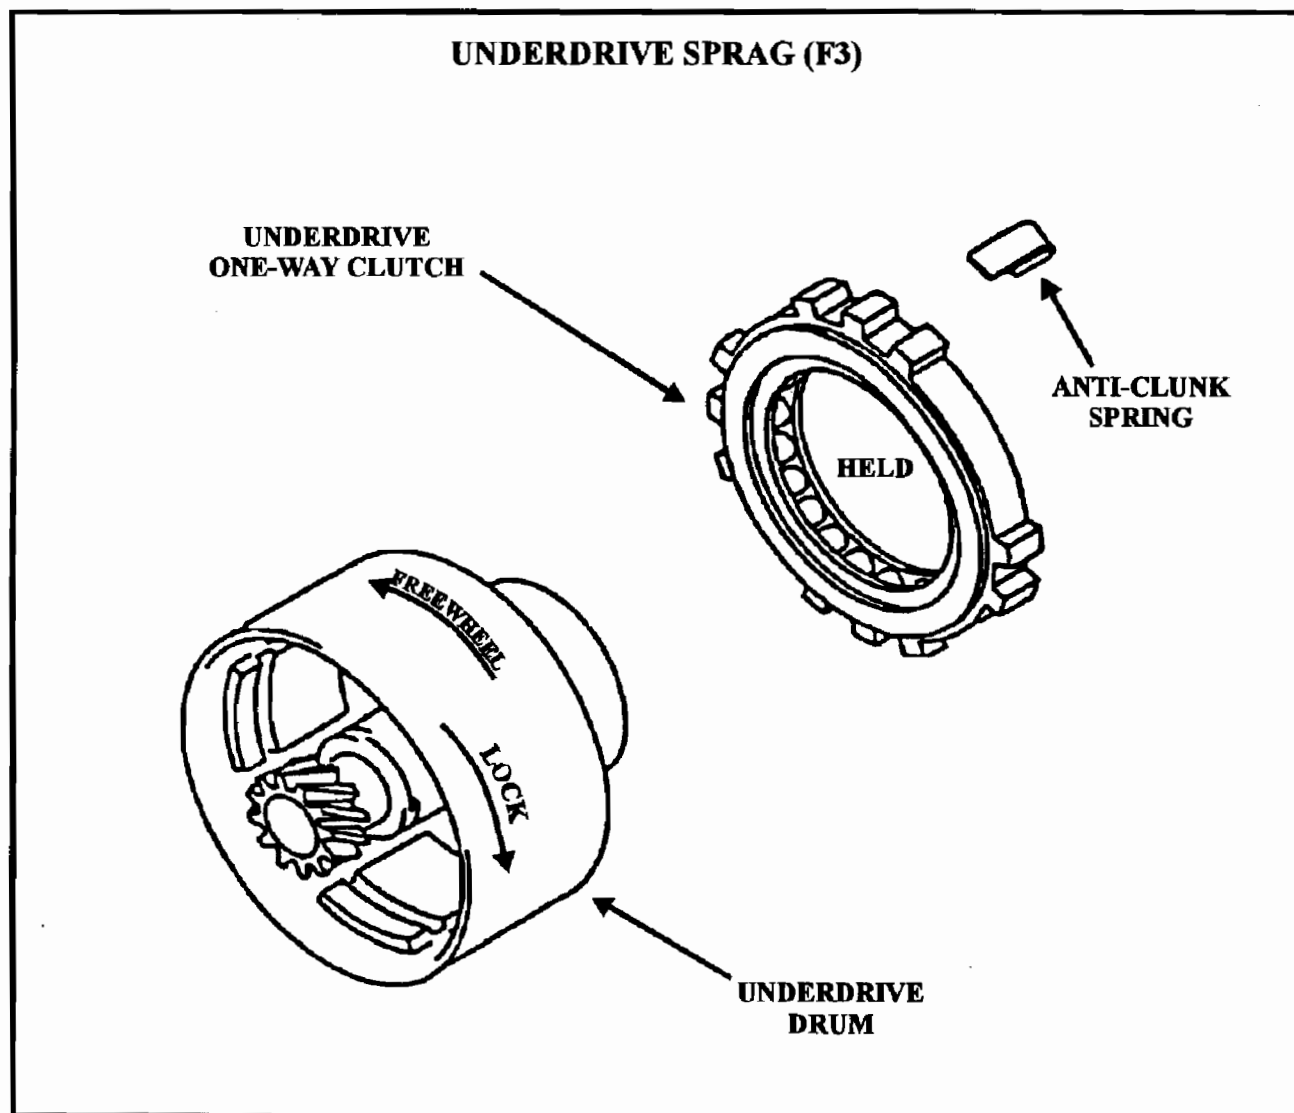
Figure 5

Figure 3 shows the correct sprag rotation for the LOW sprag (F2) and figure 4 shows the correct sprag rotation for the INTERMEDIATE sprag (F1), while figure 5 shows the correct sprag rotation for the UNDERDRIVE sprag (F3).

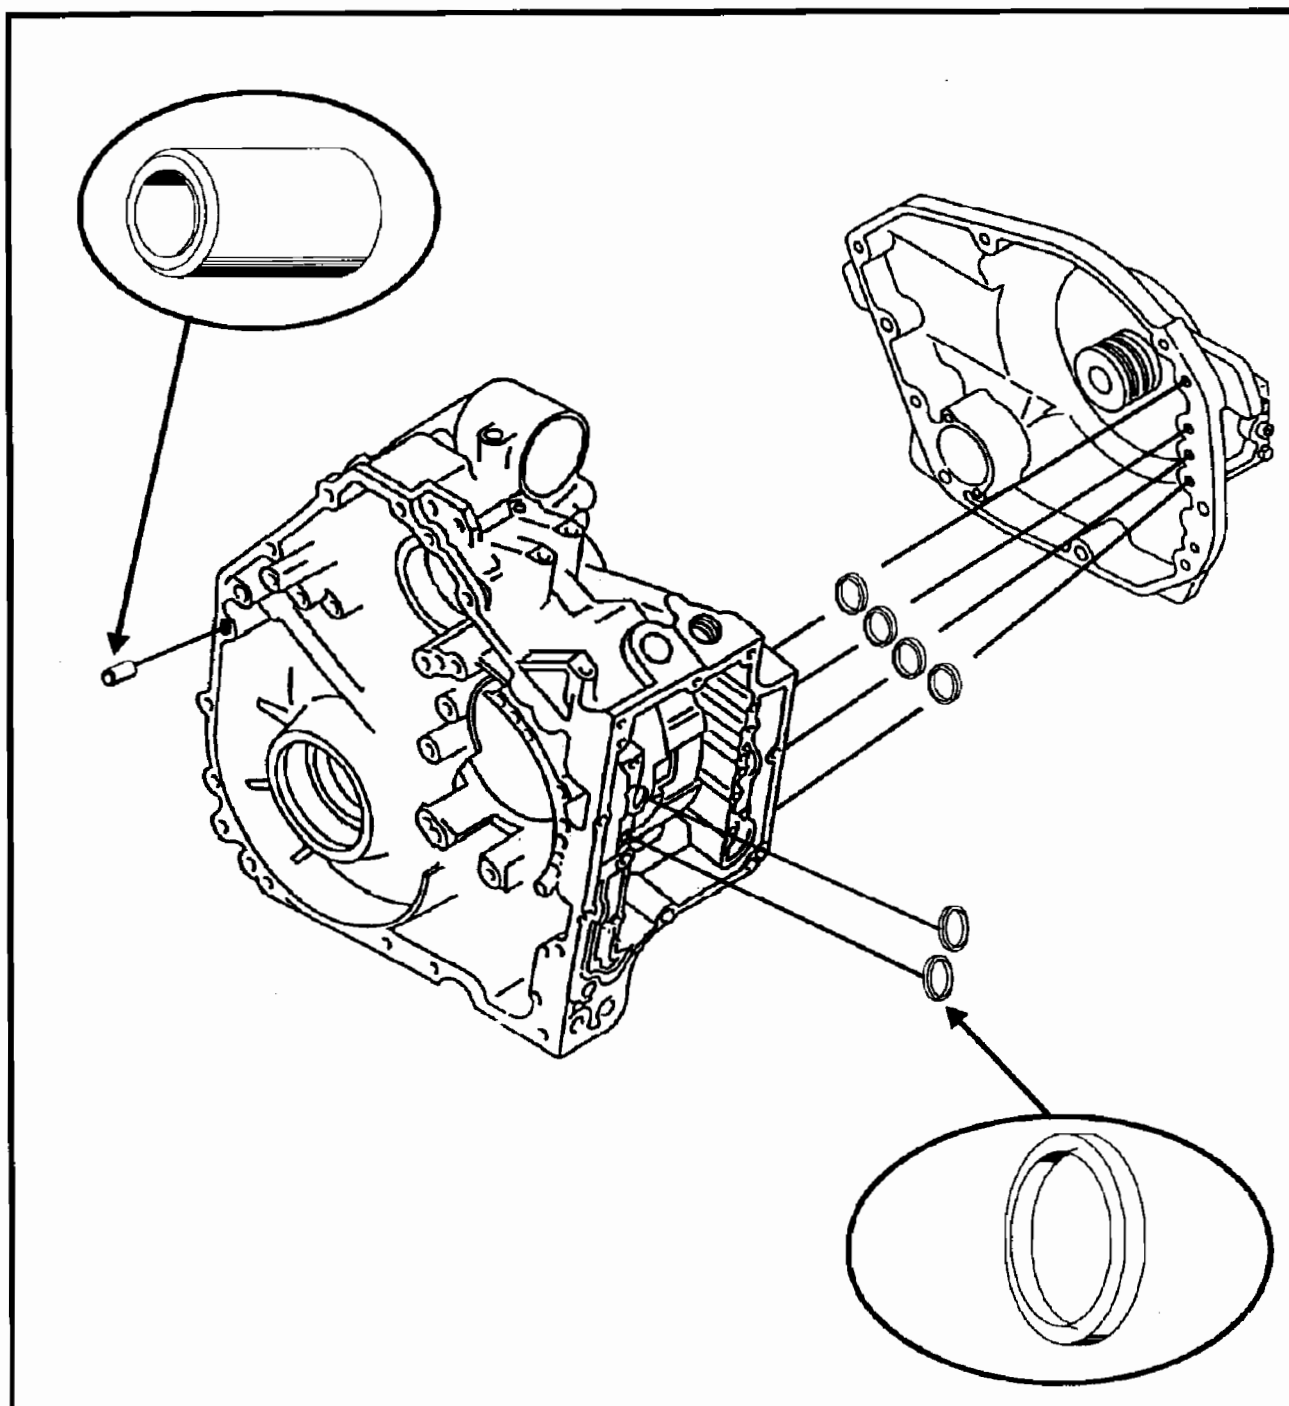
Figure 8

There are some very important seals located between the main transmission case and the rear cover, and between the main transmission case and the valve body and a very important seal between the main transmission case and the converter housing. All are illustrated in figure 8.

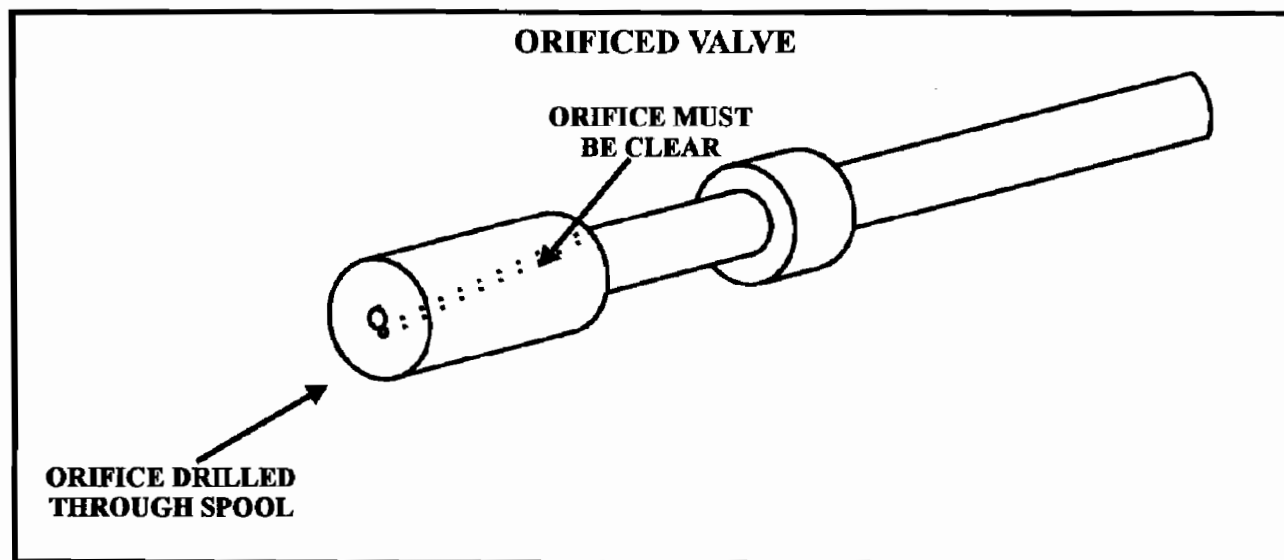
Figure 9 illustrates one of three valves that have an orifice drilled through its spool, in the event the unit had considerable trash in the pan, it imperative these valves be removed and the orifices be cleaned out.

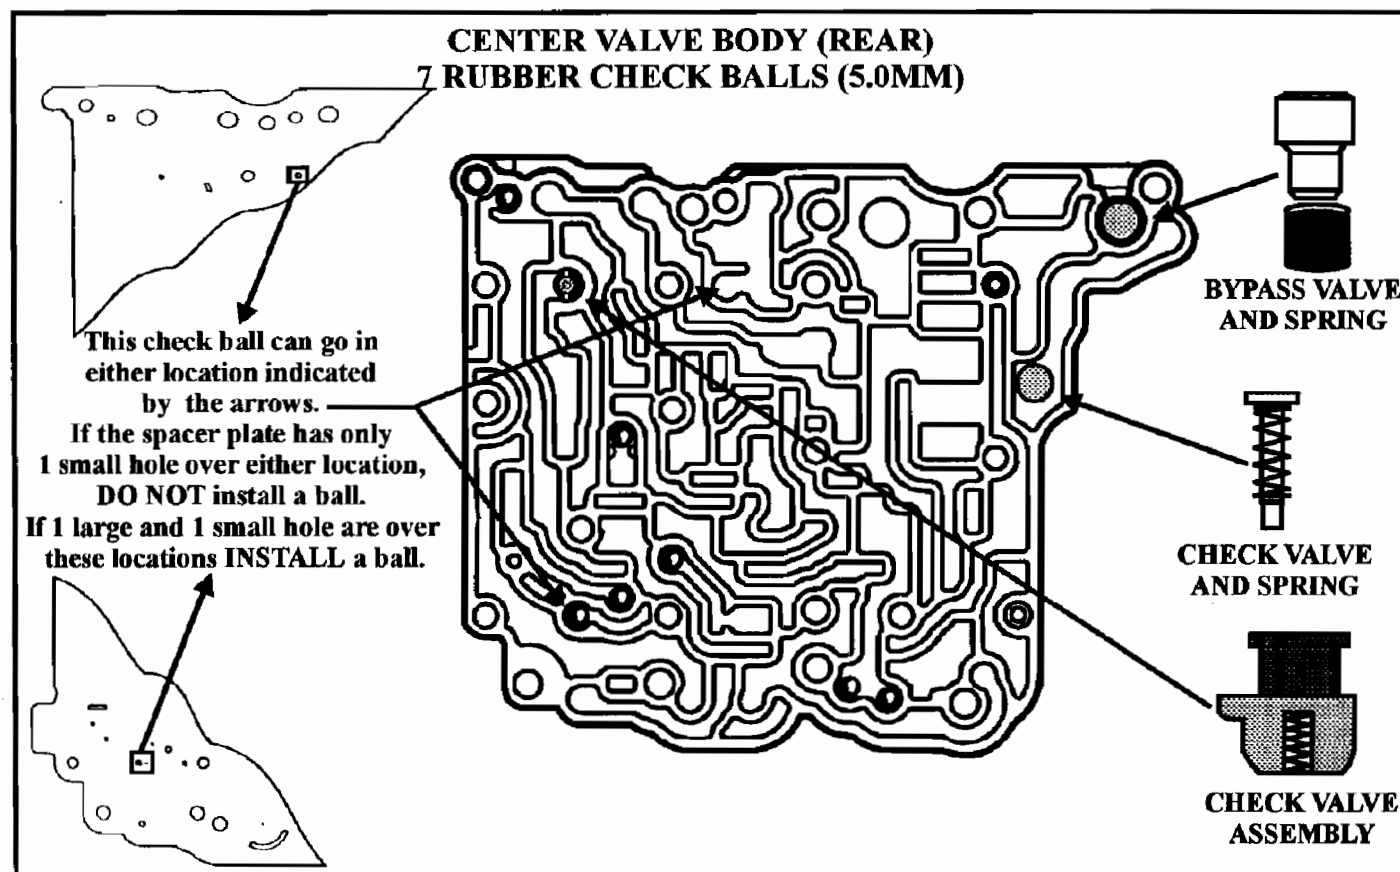
Figure 12

CAUTION: The check ball locations indicated with the spacer plate segments in figure 12 are spacer plate sensitive.

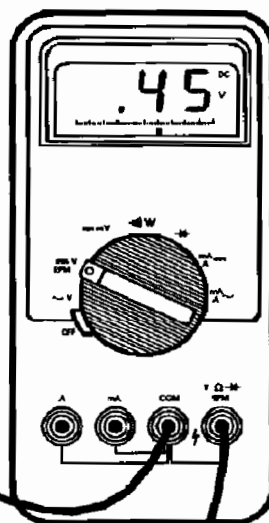
Figure 1

STEP 1: Back probe the red wire at the solenoid harness connector as shown in Figure 1. The voltage reading should indicate 1.5-2.5 volts at closed throttle and .5 volts at wide open throttle. If the voltage indicates 1.5-2.5 volts at closed throttle and does not drop to .5 volts at wide open throttle, go to ELECTRONIC CONCERNS for throttle position sensor checks. If the voltage drops but yet the pressure does not rise, go to HYDRAULIC CONCERNS **A:** for transmission related repairs.

THROTTLE OPENING	VOLTAGE	PRESSURE
CLOSED	1.5-2.5 V	65 psi
WIDE OPEN	.50 V	180 psi

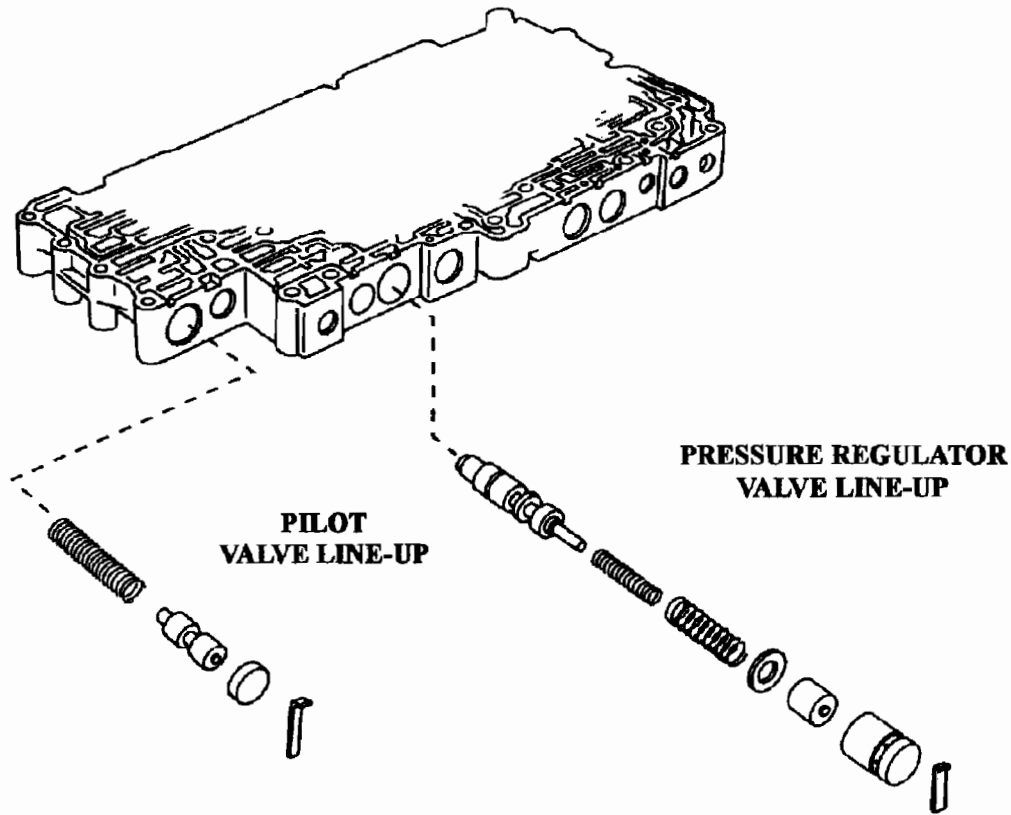
Figure 2

- Check Pressure Regulator and Pilot Valve for sticking or binding in their bores as shown in Figure 2.
- Replace the solenoid pack as shown in Figure 3 with NISSAN part number 31940-27X66
- Check the bellhousing for score marks or wear on the slide mating surface as shown in Figure 4. NOTE: If the bellhousing is worn it may need to be replaced or machined.
- Check the slide seal for proper assembly and the pivot pin for wear as shown in Figure 5.

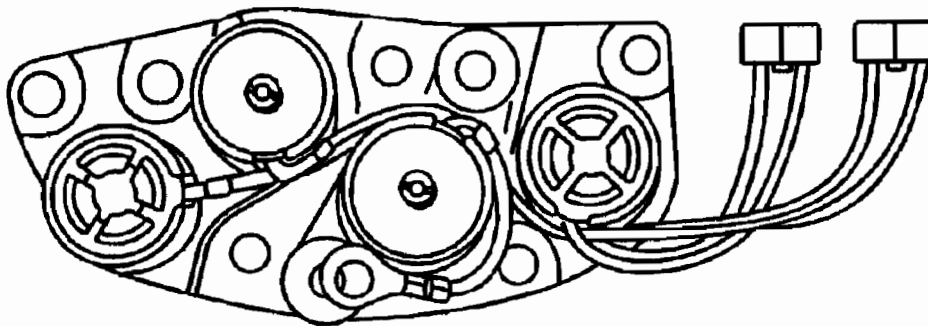
SOLENOID PACK
NISSAN PART NUMBER
31940-27X66

- Check the Pressure Regulator and Pilot Valve for sticking or binding in their bores as shown in Figure 2.
- Replace the solenoid pack as shown in Figure 3 with NISSAN part number 31940-27X66.

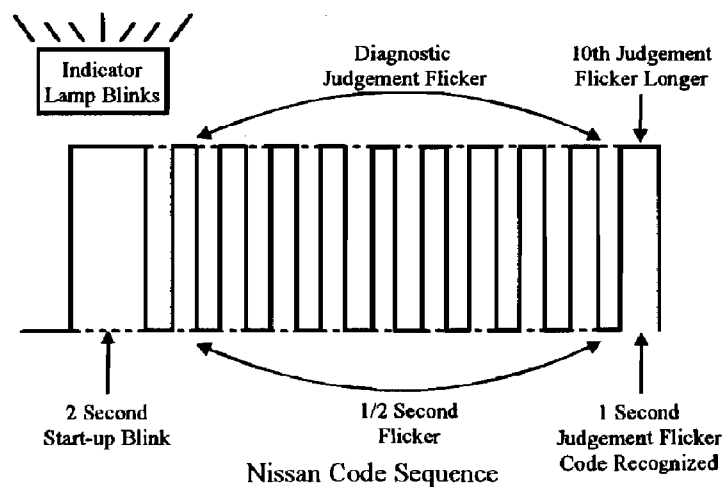
NOTE: THE 10th JUDGEMENT FLICKER IS LONGER THAN THE OTHER 9 FLICKERS. THIS INDICATES A PRESSURE CONTROL SOLENOID CIRCUIT CODE. IF ALL 10 FLICKERS ARE THE SAME LENGTH THAT WOULD INDICATE NO CODES.

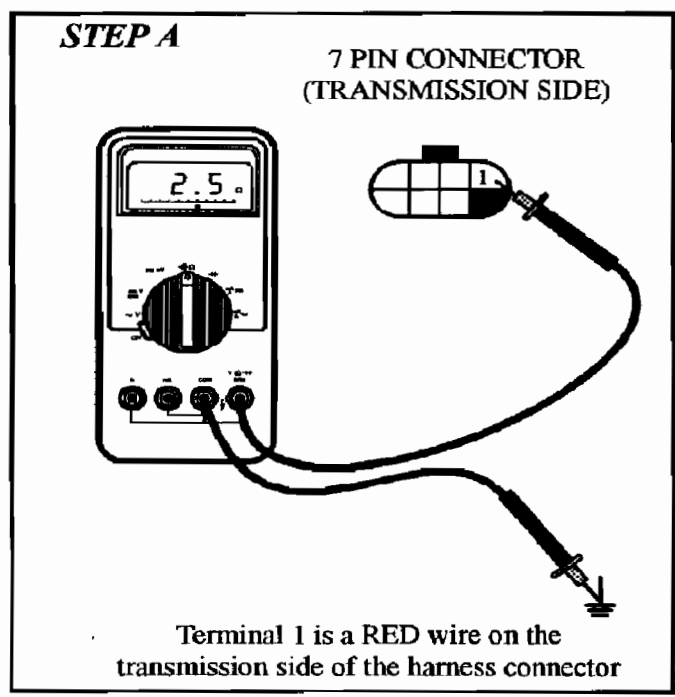
STEP A

Terminal 1 is a RED wire on the transmission side of the harness connector

1. Repair internal wire harness.
2. Replace solenoid pack Nissan part No. 31940-27X66

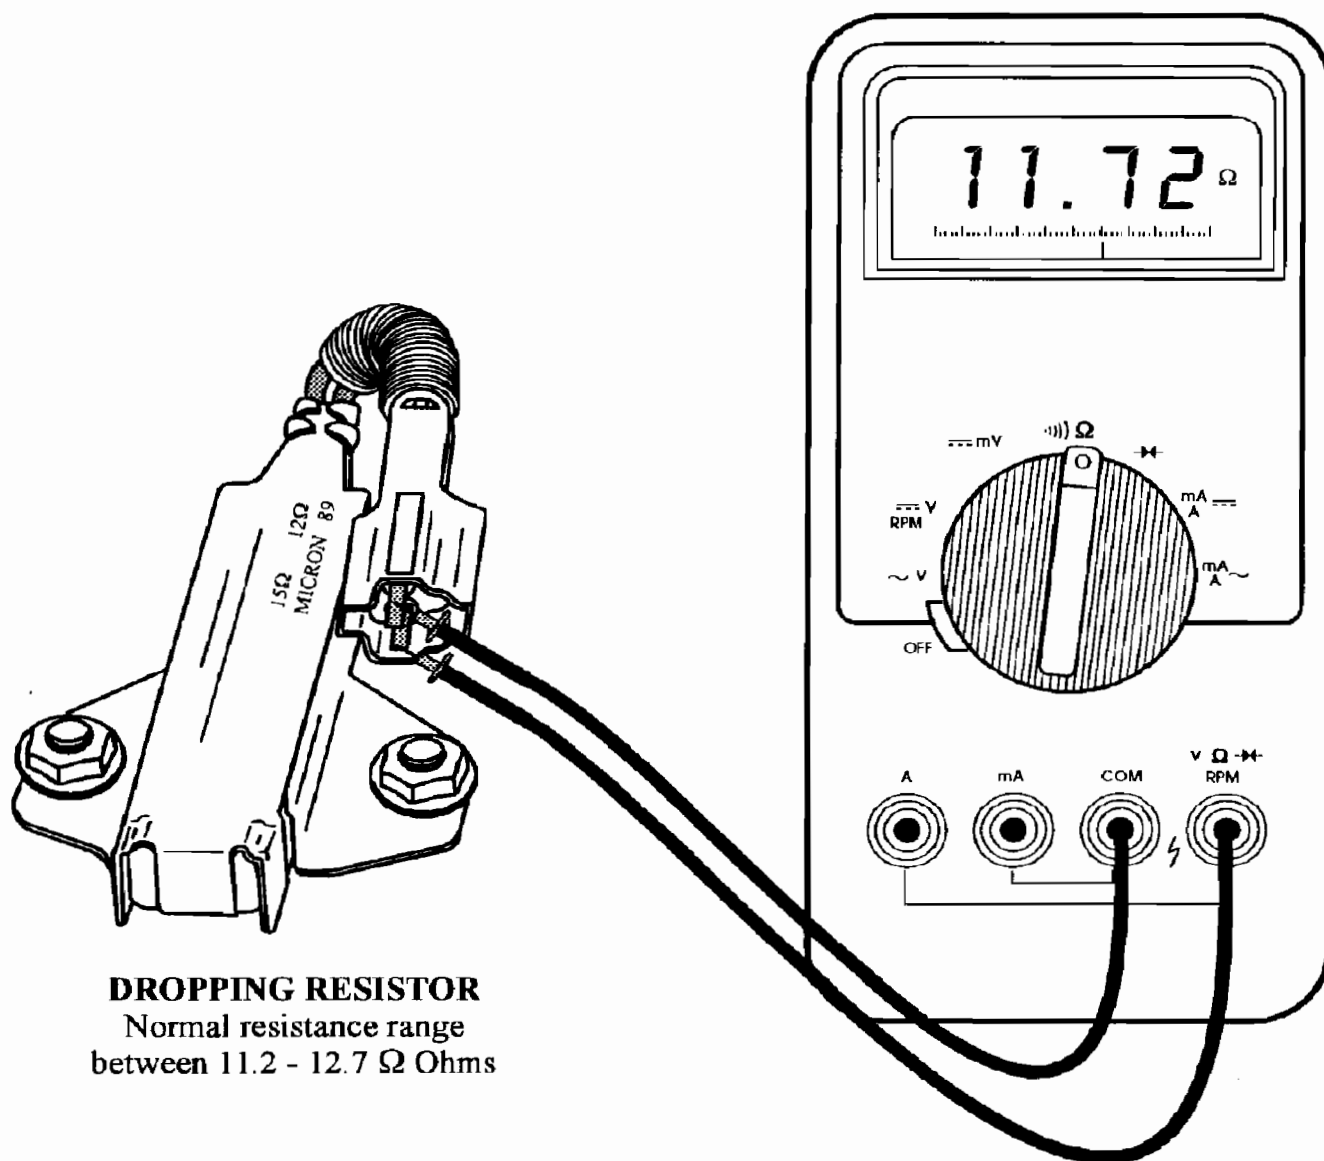
DROPPING RESISTOR CHECK

Locate the dropping resistor, as shown in the chart in Figure 1, and disconnect the 2 pin harness connector. Place ohm meter across the 2 terminals of the dropping resistor. The ohm meter should indicate between 11.2 and 12.7ohms. Replace as needed.

DROPPING RESISTOR
Normal resistance range
between 11.2 - 12.7 Ω Ohms

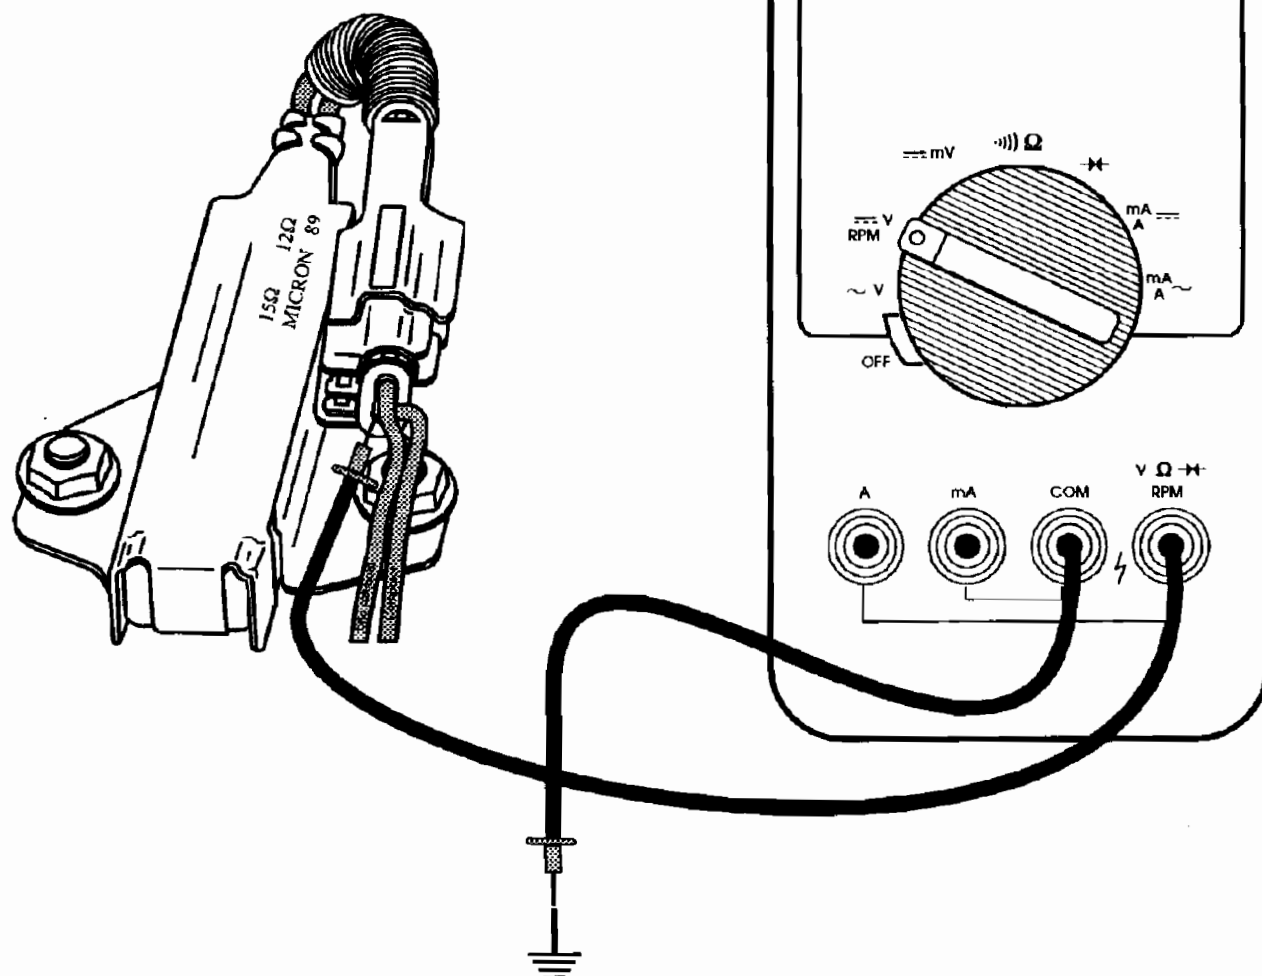
Figure 3

DROPPING RESISTOR VOLTAGE CHECK

Locate the dropping resistor according to the chart shown in Figure 1 and carefully back-probe the vehicle harness connector. Attach the red lead of a D.V.O.M. to one of the terminals of the dropping resistor indicated in the figure below, attach the black lead to a good known ground, such as the battery negative terminal. Switch the meter "ON" to the DC volt setting and check voltage. Normal voltage range for the wire coming from the computer is 7-12 volts at closed throttle and .45 volts at full throttle. Normal voltage range for the wire going to the pressure control solenoid is 2.5-3.5 volts at closed throttle and .45 volts at full throttle.

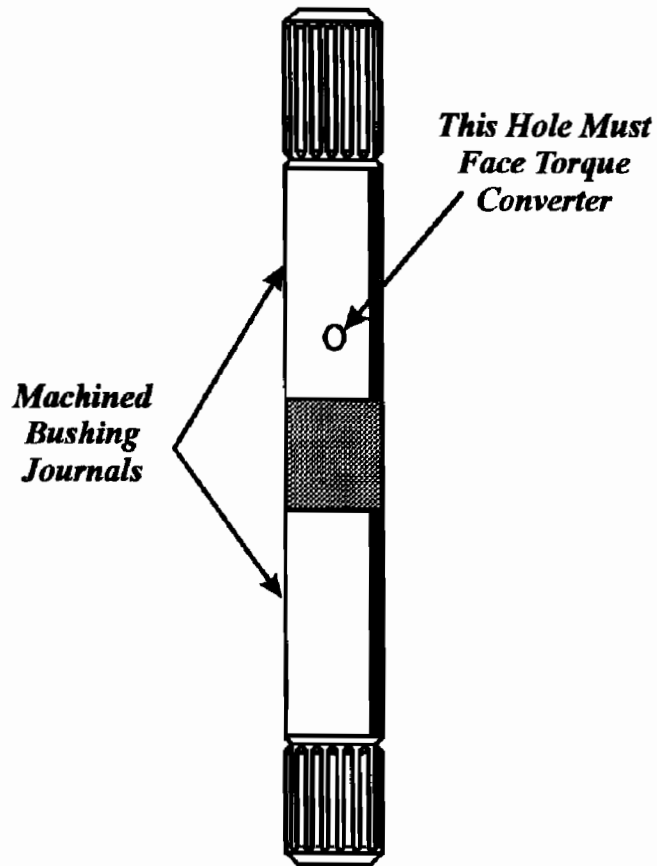
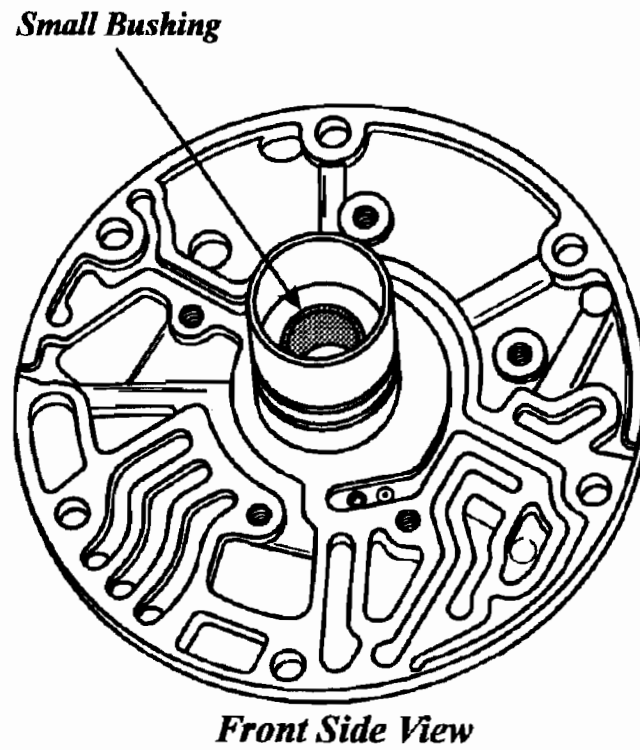
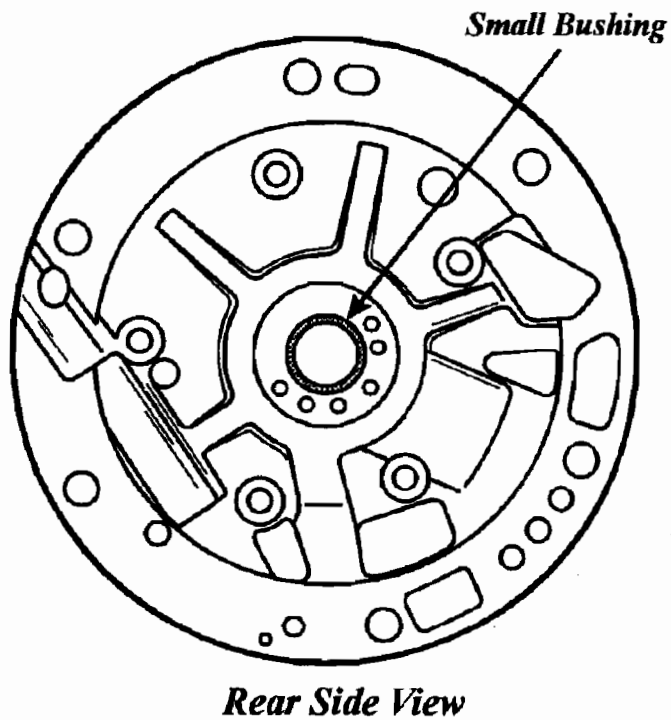
Figure 1

Refer to Figure 1, - This intermediate shaft has machined bushing journals on both ends of the shaft and requires two small bushings, one on the front side and one on the rear side in the overdrive drum support, as illustrated in Figure 1. The lube hole in the intermediate shaft ***must*** face the torque converter. Failure to install it properly will result in overdrive planetary failure.

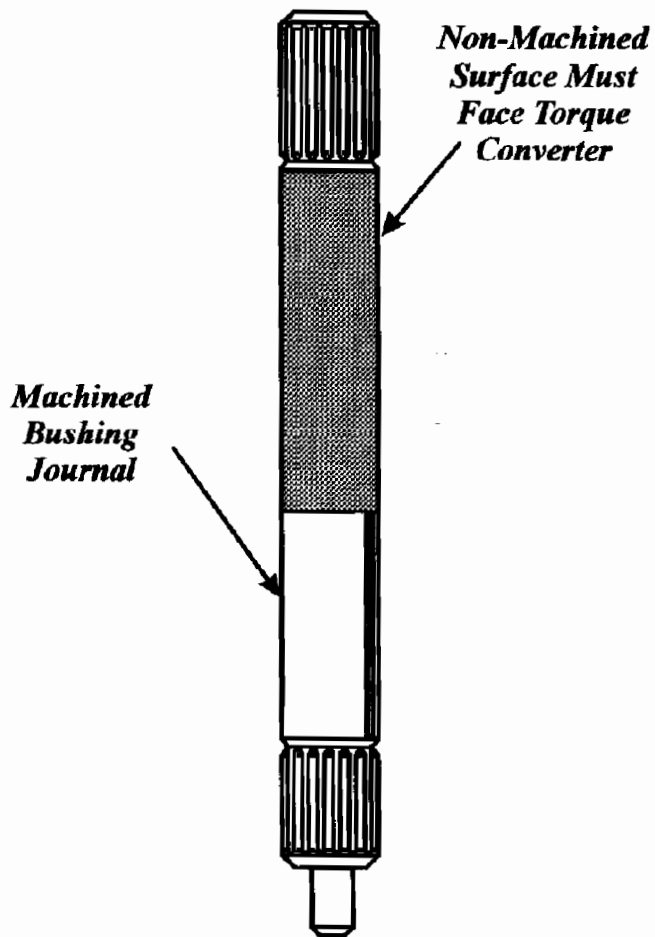
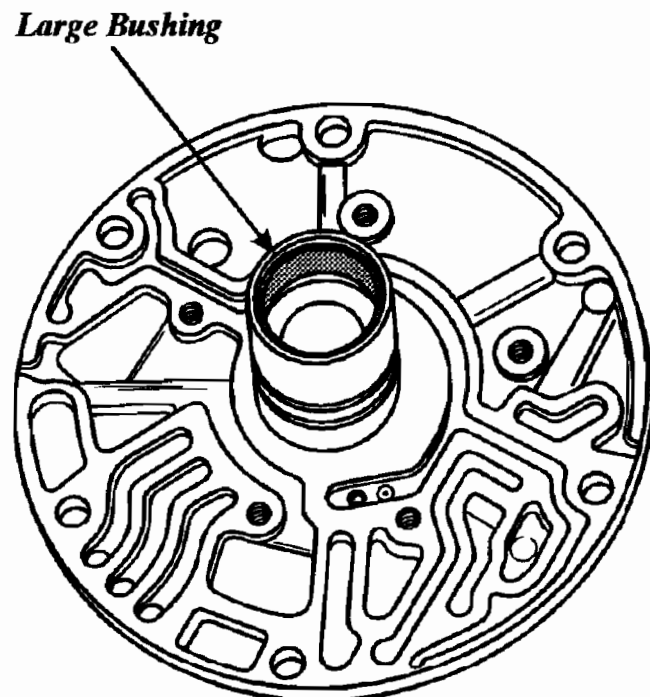
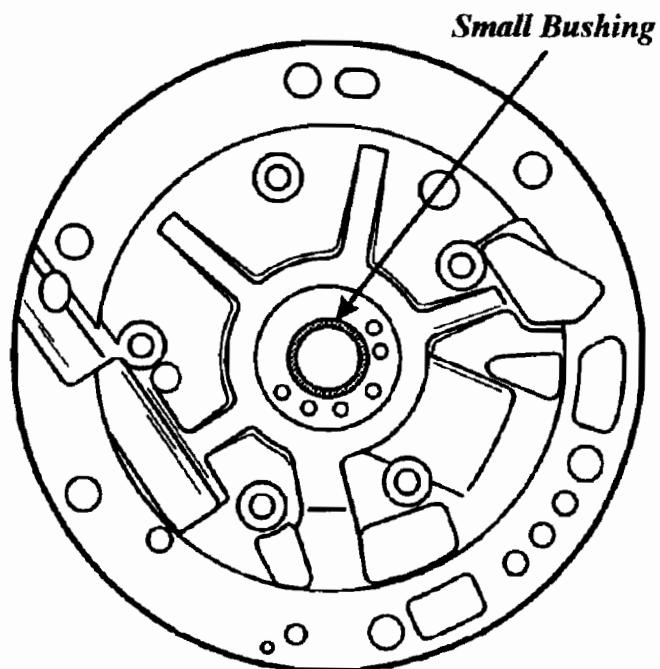
Figure 3

Refer to Figure 3, - This intermediate shaft has a machined bushing journal on only the rear side of the shaft and requires one small bushing on rear side and one large bushing on the front side in the overdrive drum support, as illustrated in Figure 3. Notice that this intermediate shaft also has a pilot on the rear side of the shaft and is used only in the turbo-charged versions. The small bushing supports the intermediate shaft and the large bushing supports the overdrive internal ring gear, which in turn supports the front of the shaft. The non-machined end of this intermediate shaft ***must*** face the torque converter.

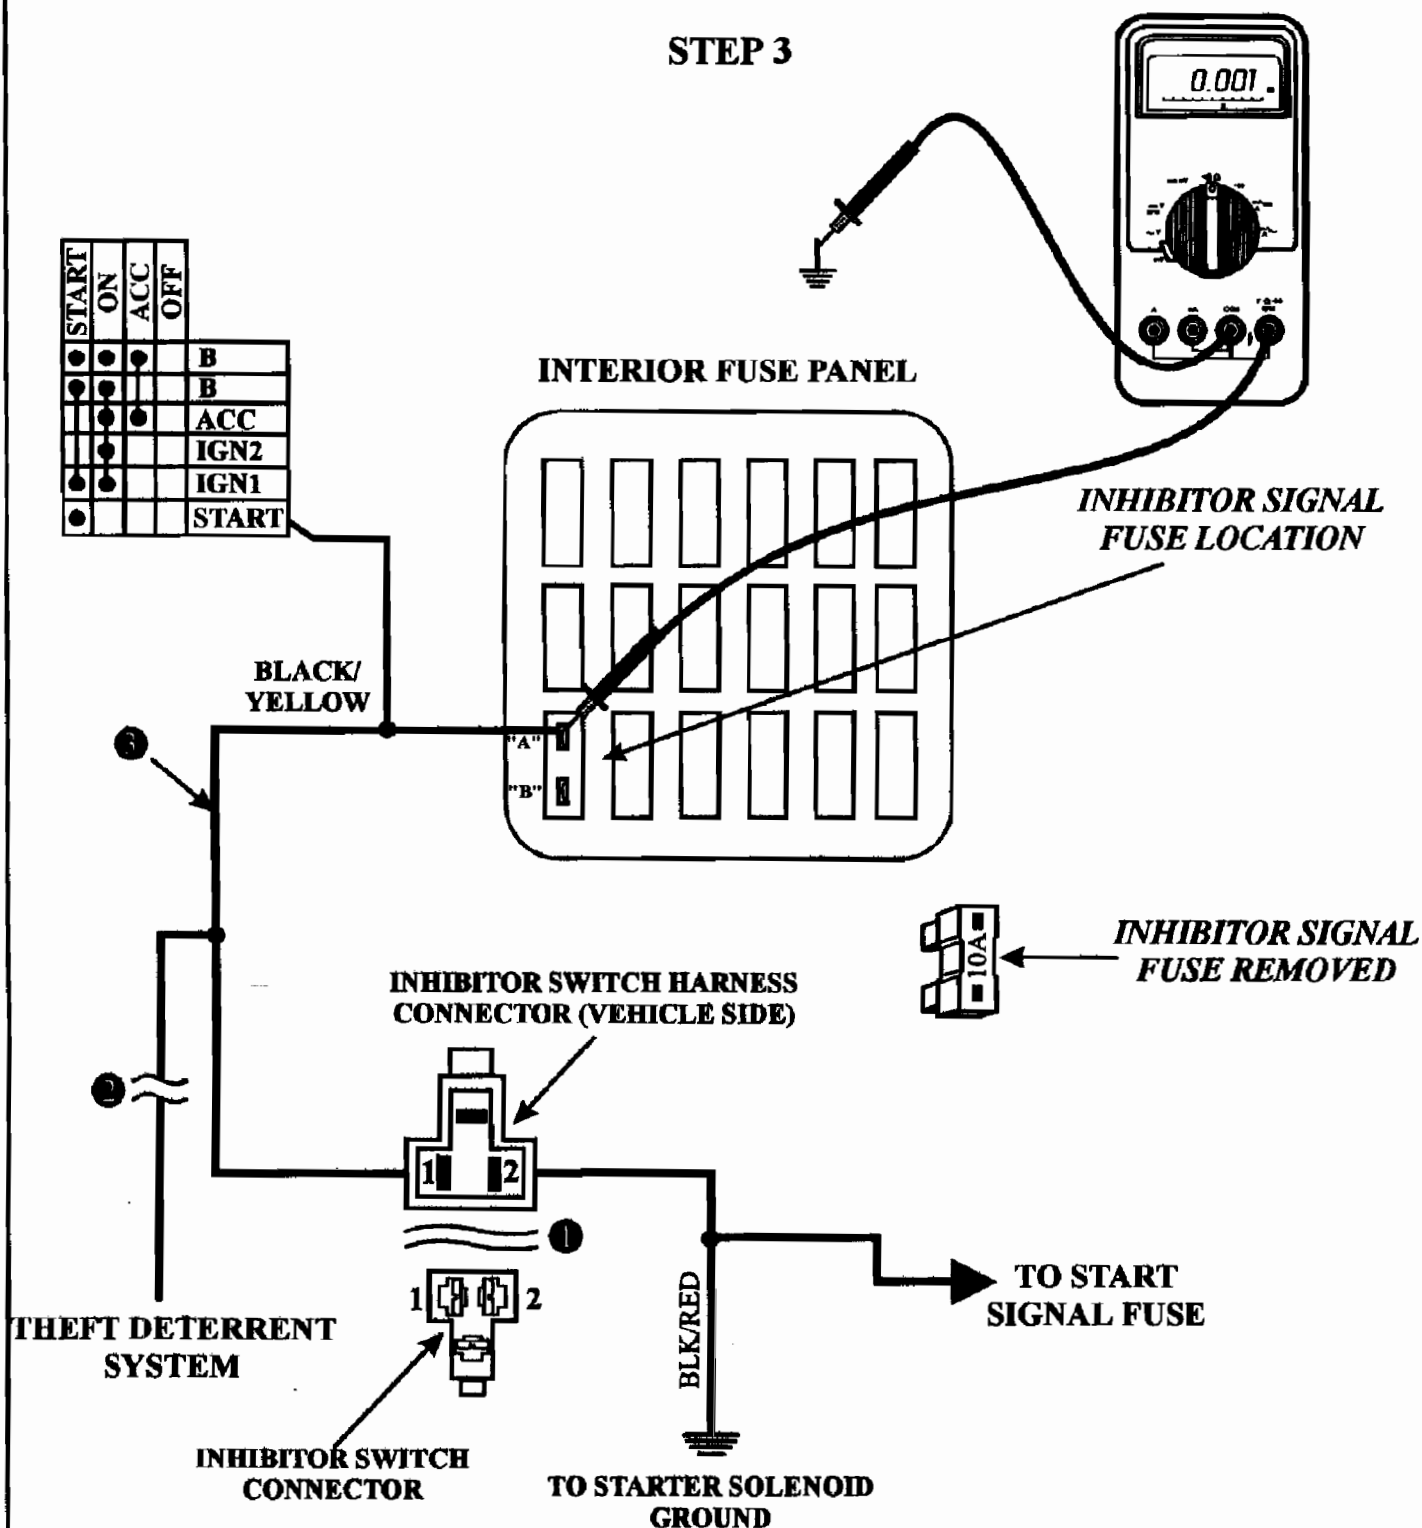
Figure 3

- ① IF CONTINUITY IS INDICATED IN ALL RANGES, DISCONNECT INHIBITOR SWITCH
- ② IF CONTINUITY IS INDICATED IN ALL RANGES, WITH INHIBITOR SWITCH DISCONNECTED, LOCATE THEFT DETERRENT SYSTEM AND DISCONNECT WIRE LEADING TO TERMINAL "A."
- ③ IF CONTINUITY IS INDICATED IN ALL RANGES, WITH INHIBITOR SWITCH DISCONNECTED, AND THEFT DETERRENT SYSTEM DISCONNECTED, REPAIR GROUNDED WIRE.

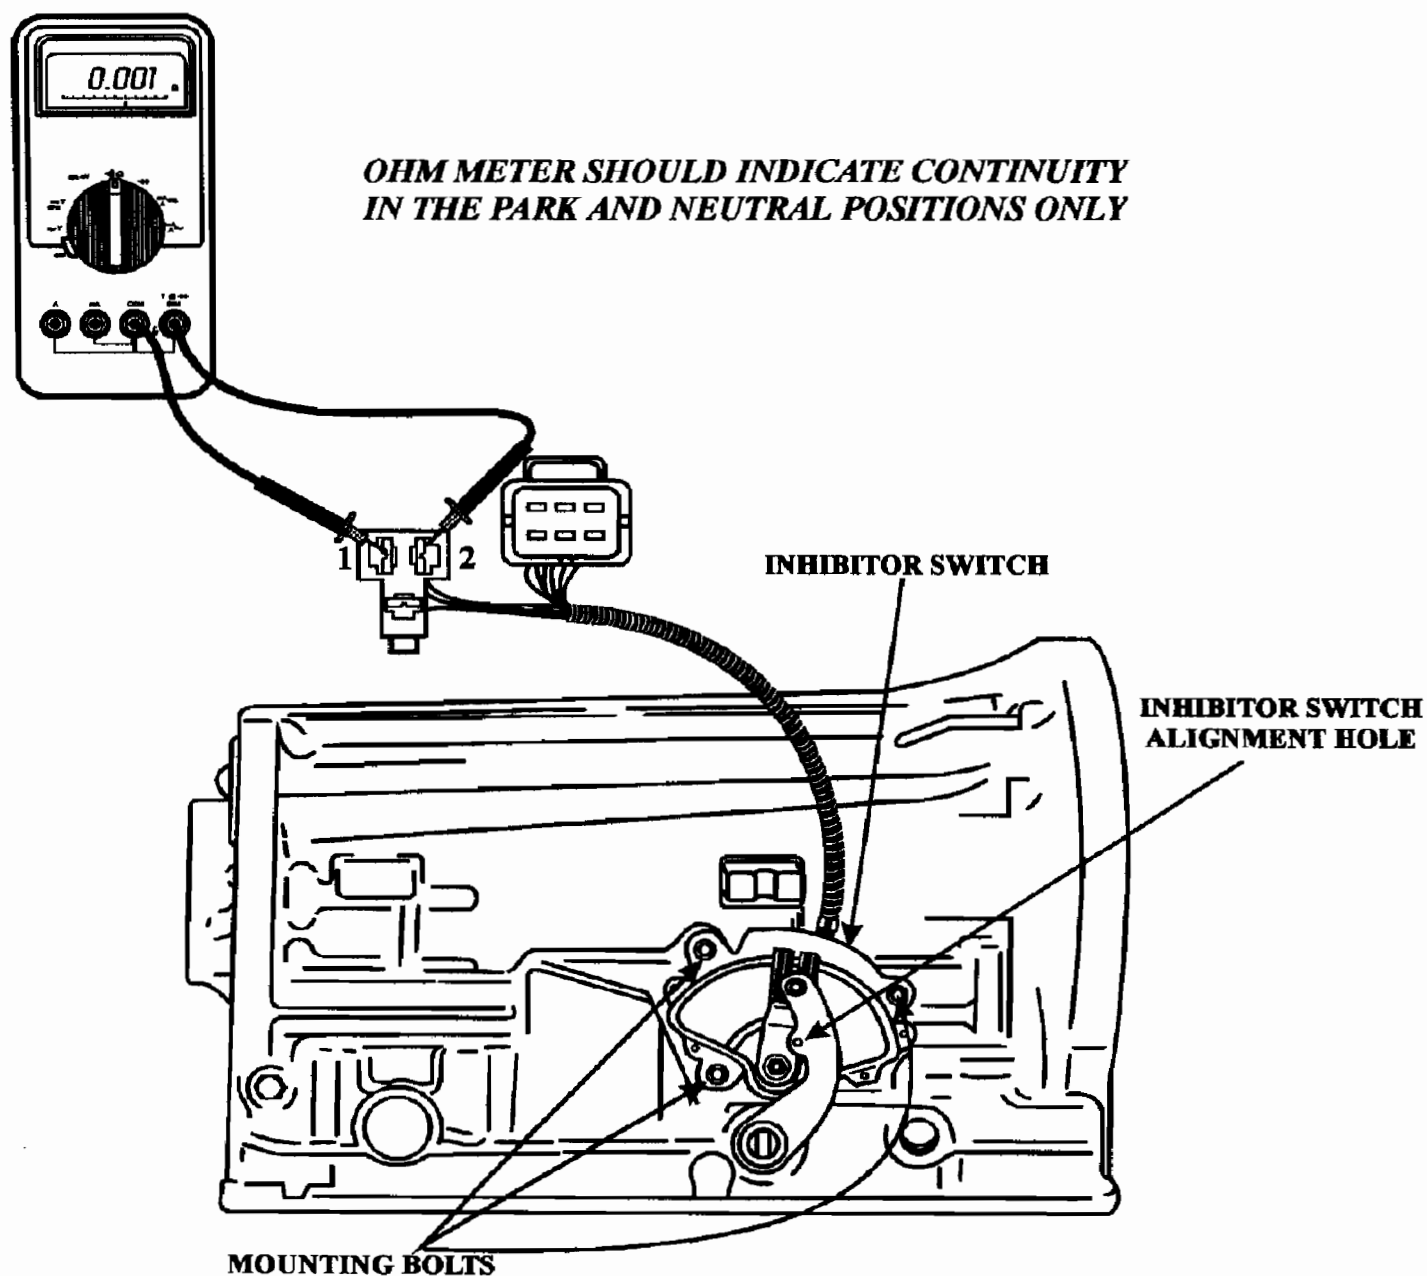
SLIDE**STEP 4**

**INHIBITOR SWITCH ADJUSTMENT**

Place the selector lever in Neutral. Loosen the 3 mounting bolts that attach the inhibitor switch to the case and adjust the inhibitor switch until a 5/32 drill bit will pass through the selector lever, inhibitor switch lever into the inhibitor switch guide hole.

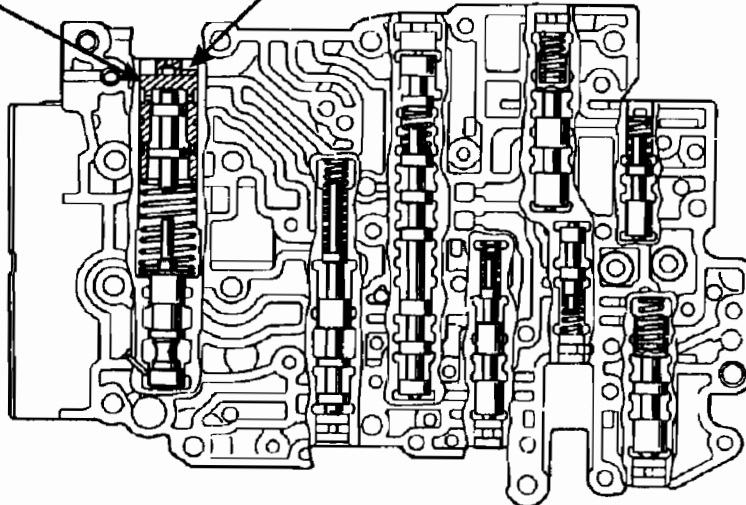
540-E LOWER VALVE BODY

**BOOST SLEEVE
LOCATION**

**ADJUSTABLE
STEP**

NOTE: THE BOOST SLEEVE ON 540-E HAS AN ADJUSTABLE STEP. ENSURE THAT THE RETAINER IS IN THE SAME LOCATION AS BEFORE.

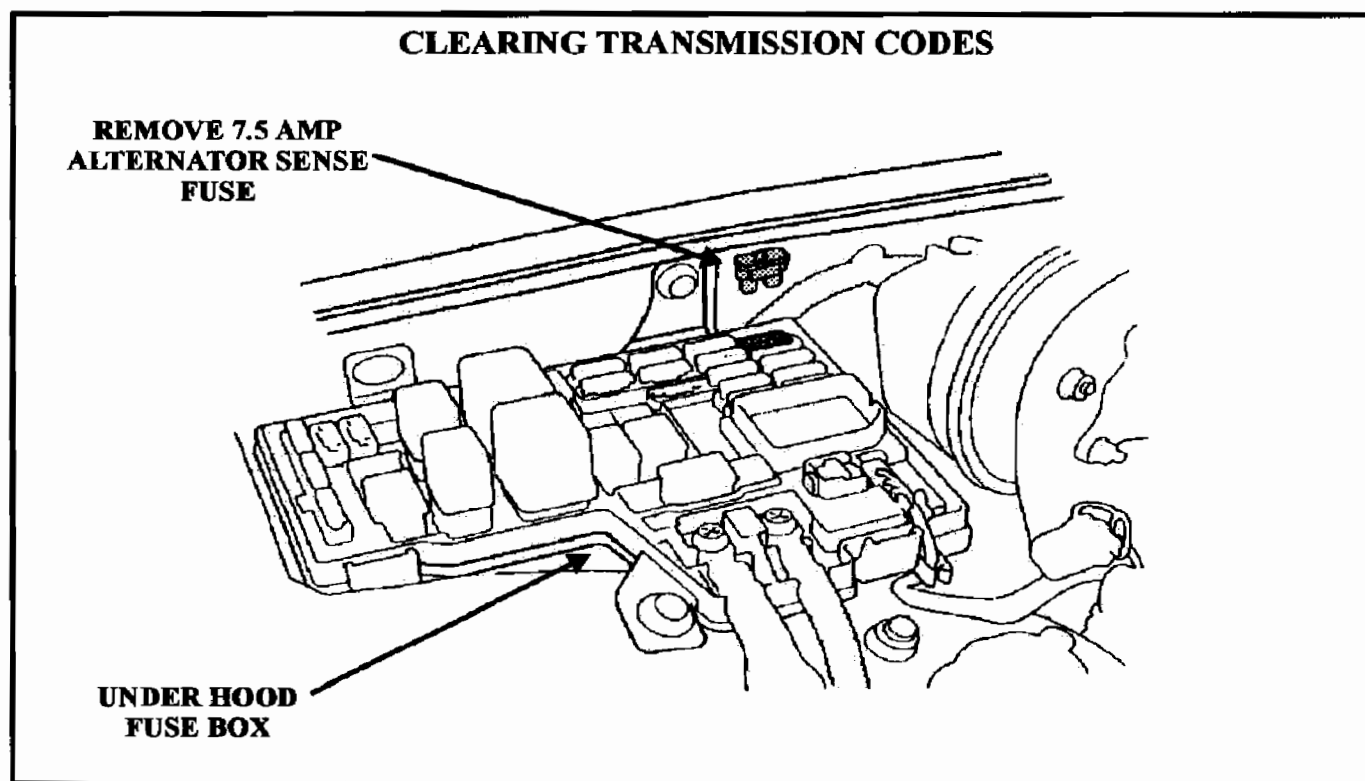
Figure 15

When clearing transmission codes, rather than disconnecting the battery and losing the radio theft codes, pull the 7.5 amp Alternator Sense Fuse in the under hood fuse box as seen in figure 15.

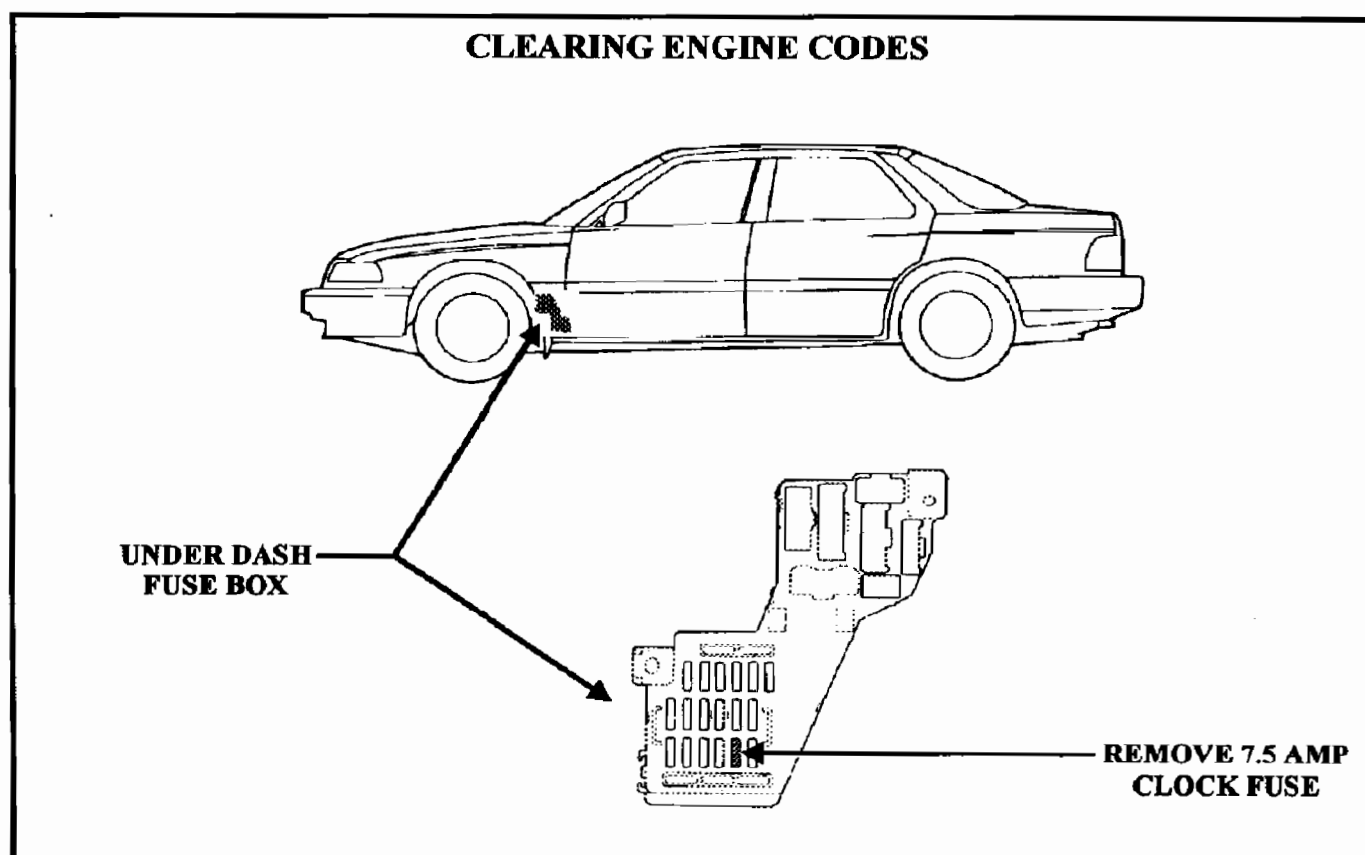
Figure 16

When clearing engine codes, pull the 7.5 amp Clock Fuse located in the under dash fuse box as seen in figure 16.
