1999 SEMINAR INFORMATION

"TECH ON TIME FOR '99"

INDEX

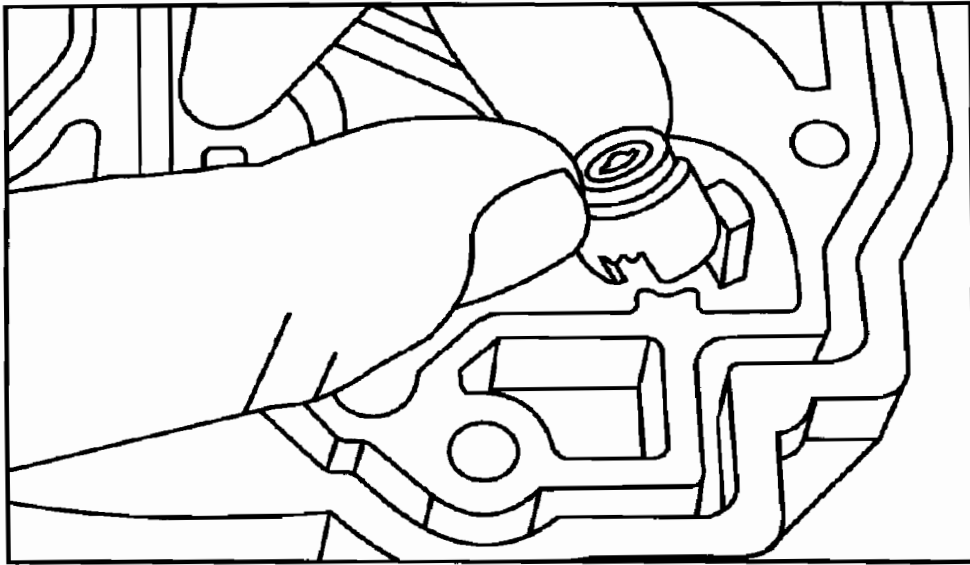
Figure 1

CAUSE: The cause may **seem** to be broken governor gears but it is not the actual cause. The gears break when the Rear Pump Check Valve located in the Rear Valve Body (See Figure 1) breaks traveling pieces into the Rear Pump seizing the gears. The rear pump is driven by the governor only when the engine is not running. When the engine is running, hydraulic pressure disengages the rear pump from the governor. This means that the governor gears will break only when the vehicle rolls or is pushed without the engine running. If the rear pump is not inspected for seized gears, the governor gears may be replaced returning all up shifts misleading the technician that the problem has been resolved. Once the vehicle is pushed or it rolls without the engine running, it will be back into the shop with broken governor gears again.

REAR PUMP CHECK VALVE

CORRECTION: 1. Replace the rear pump check valve in the valve body (See Figure 1) and both governor gears. Remove all debris from the rear pump ensuring proper gear rotation.

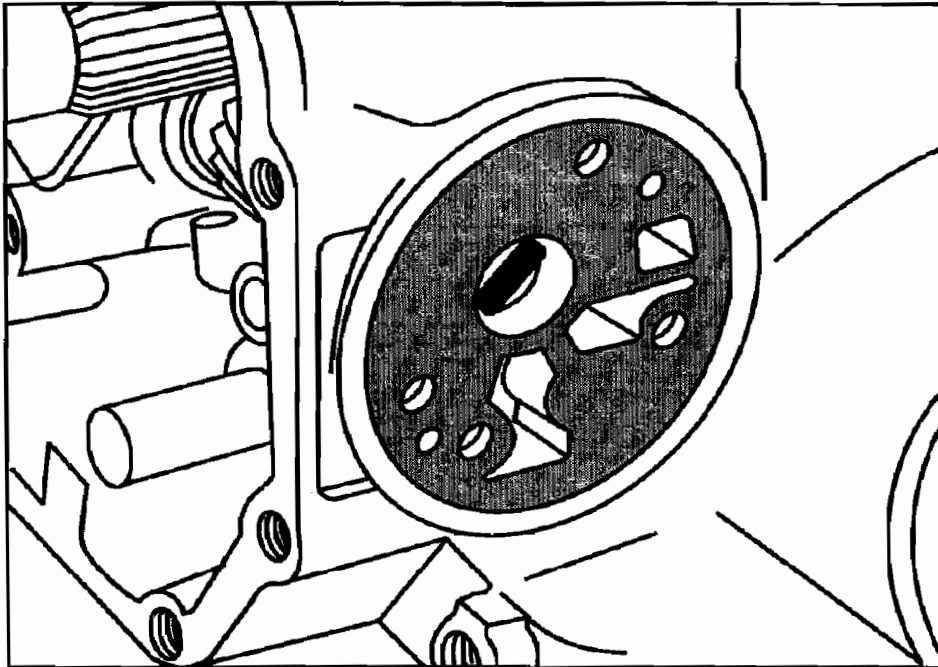
Figure 2

REAR PUMP REMOVED

2. A quicker method may be to remove the rear pump entirely (See Figure 2) replacing it with a Retro-fit cover (See Figure 3) and change both governor gears. This would eliminate removing and dis-assembling the valve body to replace the rear pump check valve. However, the removal of the rear pump will eliminate push start capabilities.

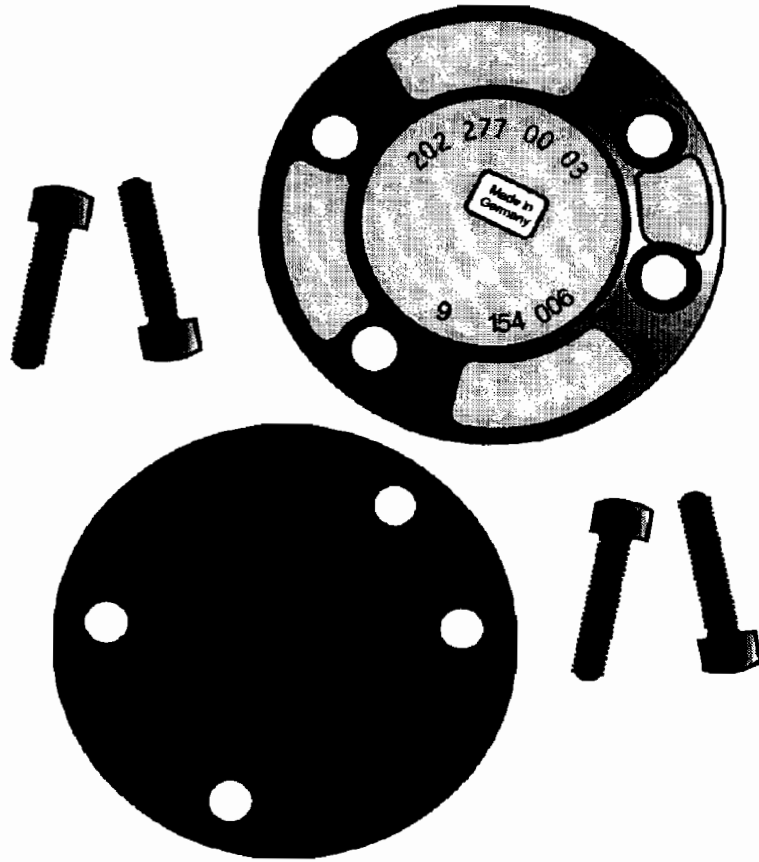
Figure 3

RETRO-FIT COVER
