AUTOMATIC TRANSMISSION SERVICE GROUP

SEMINARS 1990

TECHNICAL INFORMATION PACKAGE

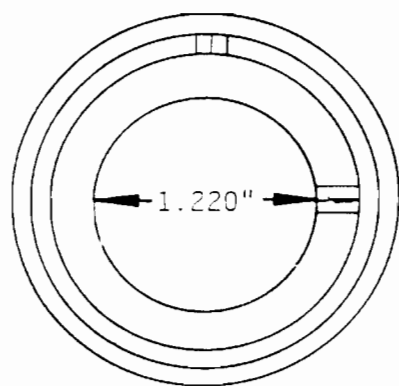
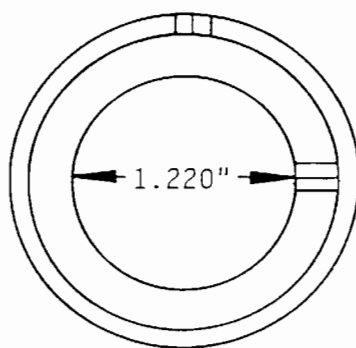
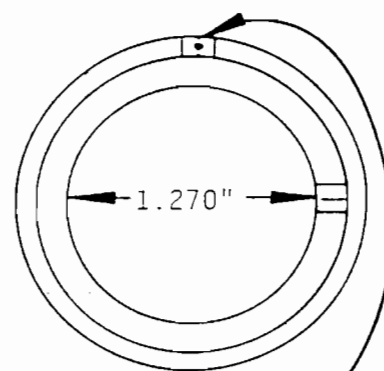
Figure 1

- (1) The new forward clutch housing will retro fit back to all previous models but you MUST use the 3rd design "Dimpled" washer.
- (2) The 1st design plastic washer, and the 2nd design bronze washer will not fit the new forward clutch housing.
- (3) If the 3rd design "Dimpled" bronze thrust washer is used on the previous forward clutch housing, it will create premature wear on the housing and washer.

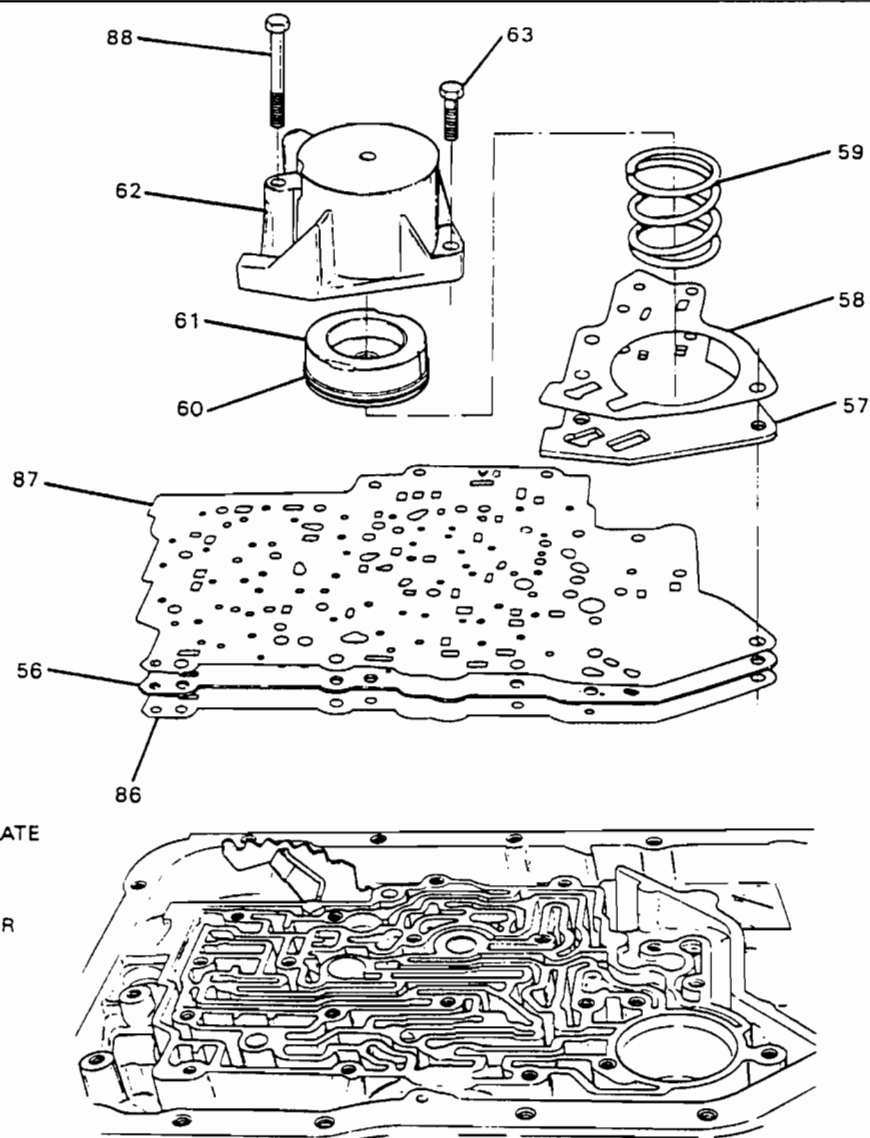
CAUSE: The cause may be an incorrect 1-2 throttle valve spring (See Figure 1). This affects ONLY 1987-1988 models CCF, CHF, CRF, CTF, CYF, and CZF.

CORRECTION: Replace the 1-2 throttle valve spring, available under OEM part number 8643619. Refer to Figure 1 for proper assembly of valves and sleeves.

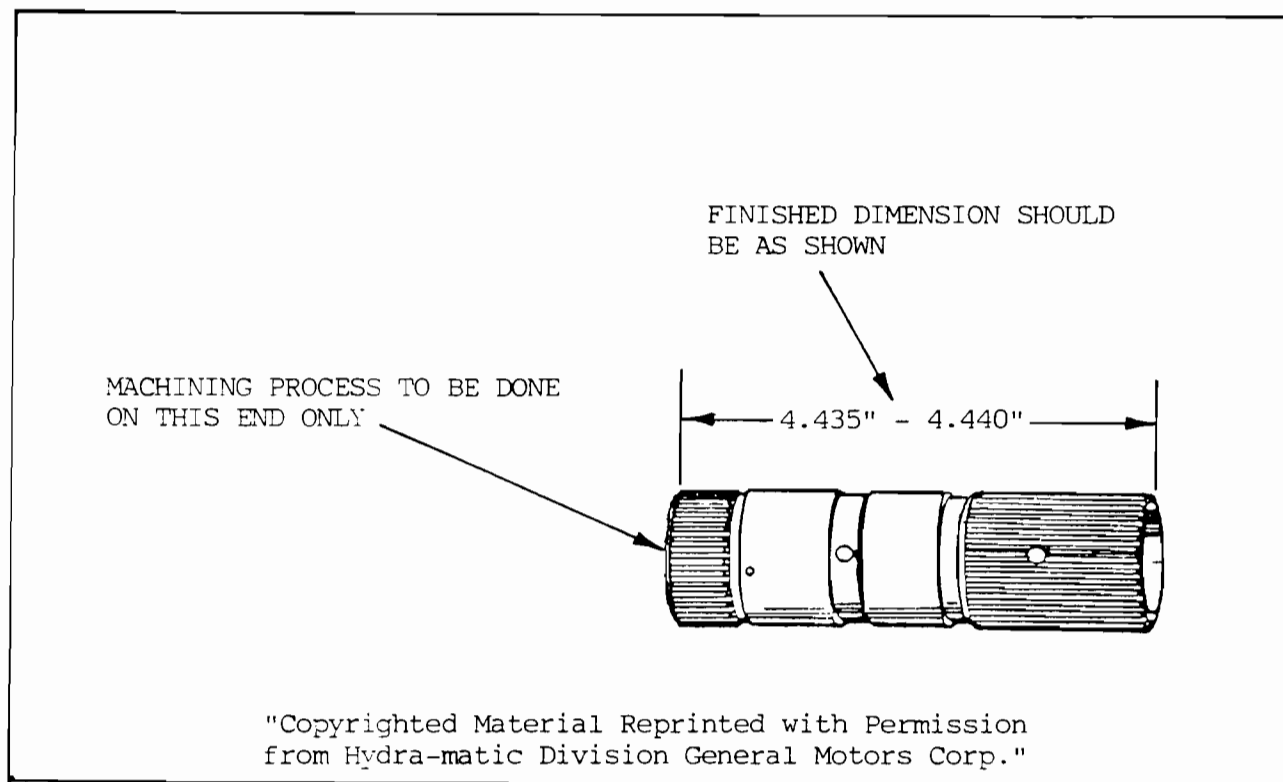
Figure 1

- COMPLAINT: Plastic lube dam located between the carriers (See Figure 2) in two pieces, appearing as if it had been machined.
- CAUSE: Final drive sun gear shaft is too long, and cuts plastic lube dam in half.
- CORRECTION: Machine final drive sun gear shaft, ON THE SHORT SPLINED END ONLY, to the dimension shown in Figure 1. Finished dimension should be 4.435" - 4.440". Non-machined final drive sun gear shaft will measure 4.480" - 4.490". Measure all final drive sun gear shafts to insure proper length.

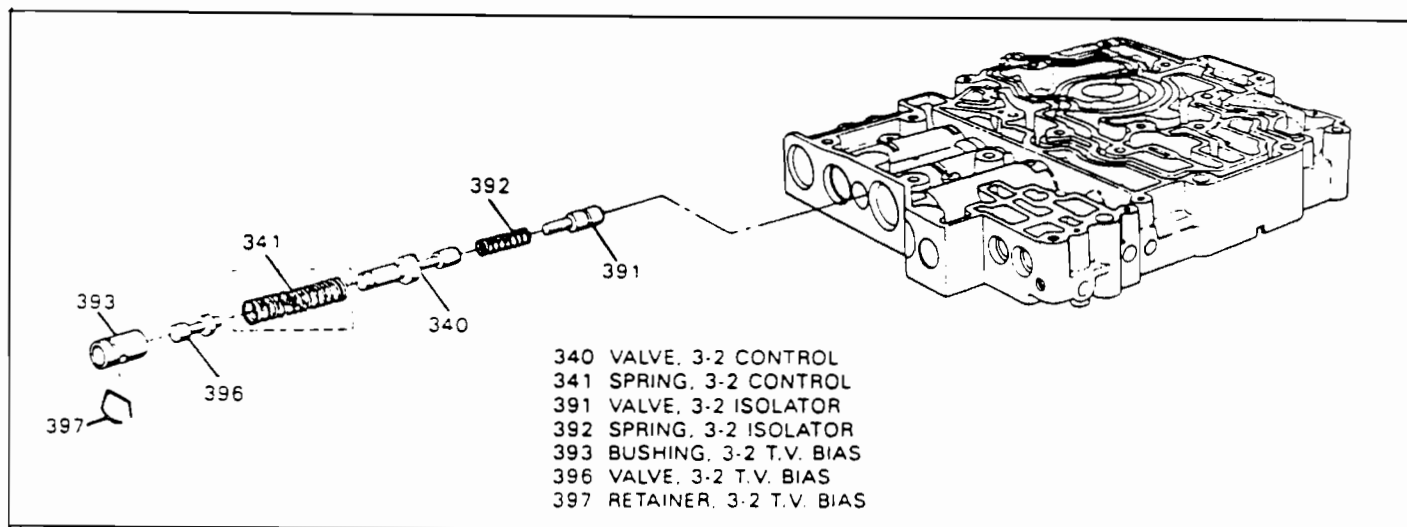
CAUSE: Improper timing for release of the third clutch and re-application of the 1-2 band.

CORRECTION: Install a new 3-2 Control Valve Spring, now available in a service package from OEM. See "Service Information" in this bulletin for proper part numbers, and refer to Figure 1 for installation procedure.

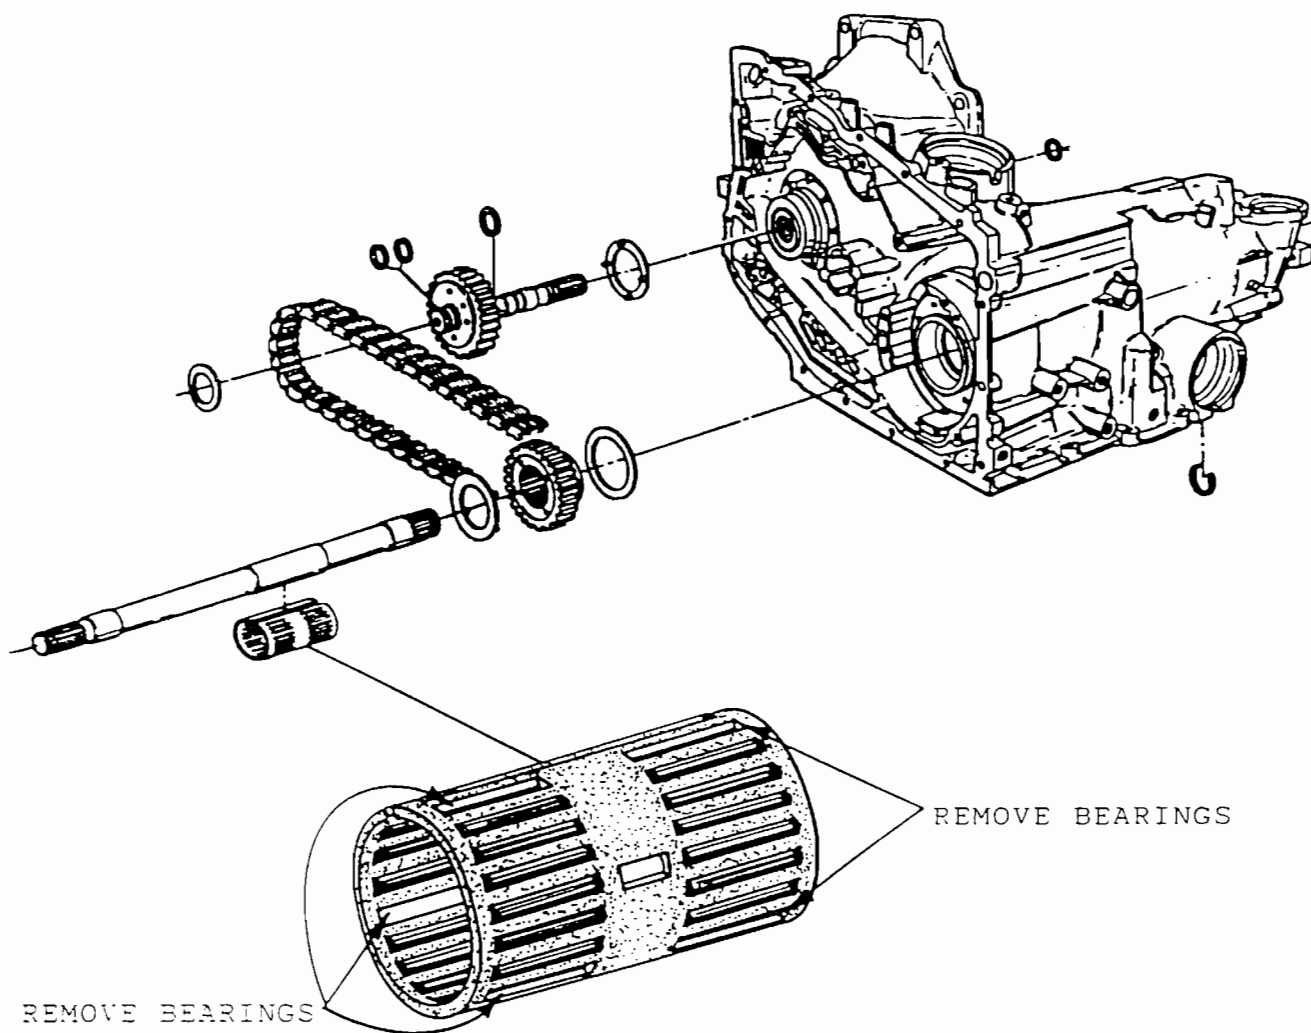
Figure 2

CAUSE: Lack of lube oil to 3rd roller clutch and input sprag.

REMOVE INDIVIDUAL NEEDLE BEARINGS IN THREE EQUALLY SPACED LOCATIONS AROUND THE BEARING TO PROVIDE THREE "TROUGHES" FOR ADDITIONAL LUBE OIL TO FLOW.

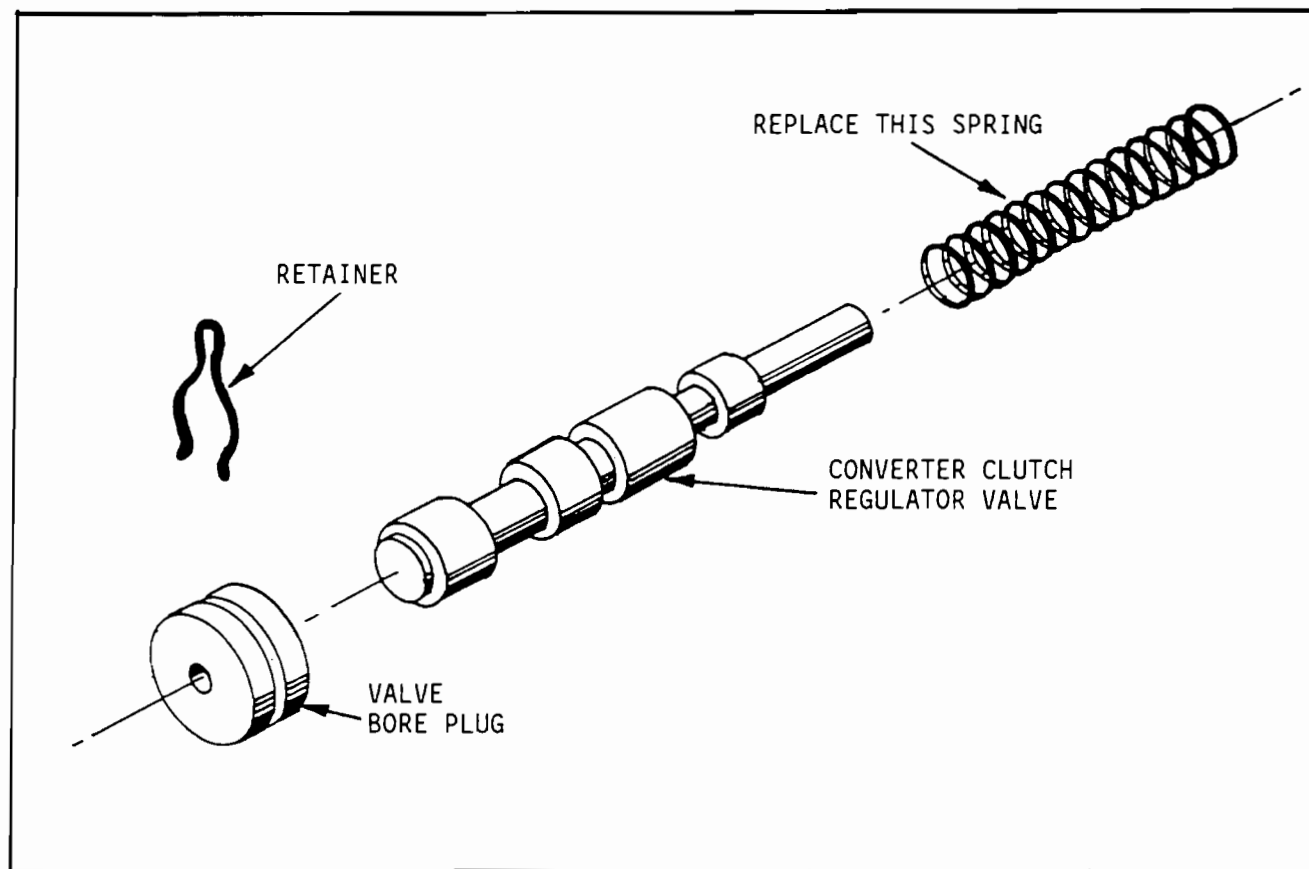
Figure 1

THM 440-T4 CONVERTER CLUTCH SHUDDER

CAUSE: The cause may be, not enough converter apply pressure as the factory has it calibrated at about 45 PSI.

CORRECTION: There is now available from the aftermarket suppliers a spring for the converter clutch regulator valve that raises the apply pressure to 61 PSI, and eliminates converter clutch shudder (See Figure 1).

The new spring is available under part number SGSF-440.

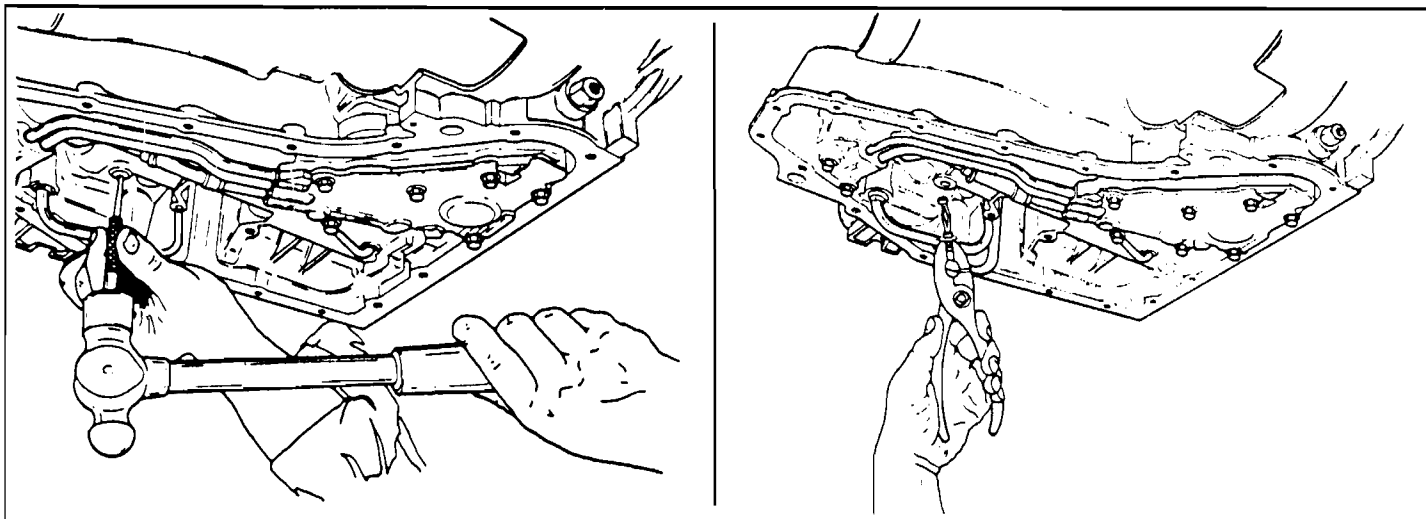
Figure 1

CAUSE: The cause may be the 1-2 Band Stop (139) being below specification, allowing the 1-2 band to shift off location causing the 1-2 band apply pin to miss the 1-2 band while stroking, and creating a loss of drive only. You will still have reverse.

CORRECTION: Replace the 1-2 Band Stop (In The Vehicle) using the following procedure;

1. Remove the bottom transaxle oil pan, and oil filter.
2. Using a 3/16" punch and hammer, tap the black plastic adjusting tab in the center of the 1-2 band stop, into the 1-2 Band Stop Assembly, just enough so that the stop can be removed with pliers. (See Figure 1).
3. Install a "New" 1-2 band stop into the J-38229 installation tool, then push the 1-2 band stop into the hole in the case and while pushing up on the base, squeeze the handle of J-38229 installation tool to its preset stop (See Figure 2).
4. Cut off the remaining adjusting tab with diagonels, as shown in Figure 3.
5. The 1-2 band stop height can be checked during a overhaul. First ensure that the stop is not loose in the case. With the transaxle dis-assembled, the 1-2 band stop should protrude 9/16" through the case as shown in Figure 4.

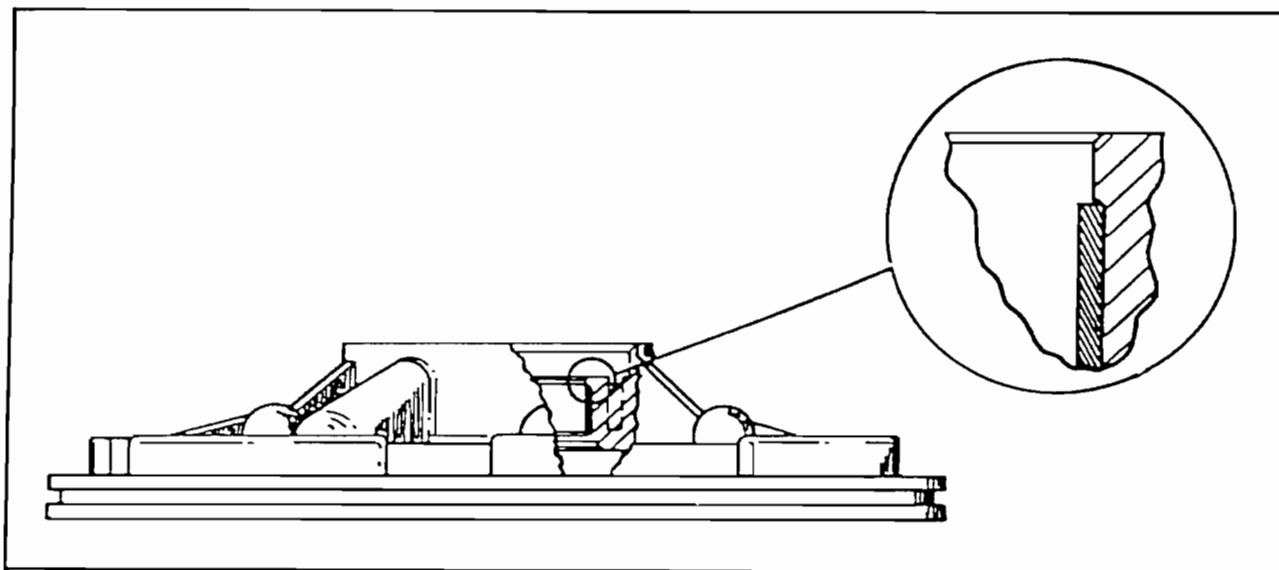
Figure 1

Because of the step added to the bore in the pump body, removal and installation procedures must be revised. The bushing must now be "Pressed Out" towards the pump rotor side, and "Pressed In" from the pump rotor side.

Care must be used when pressing the new bushing in, so as not to exert too much pressure, and break the added step in the pump bushing bore. Refer to Figure 1.

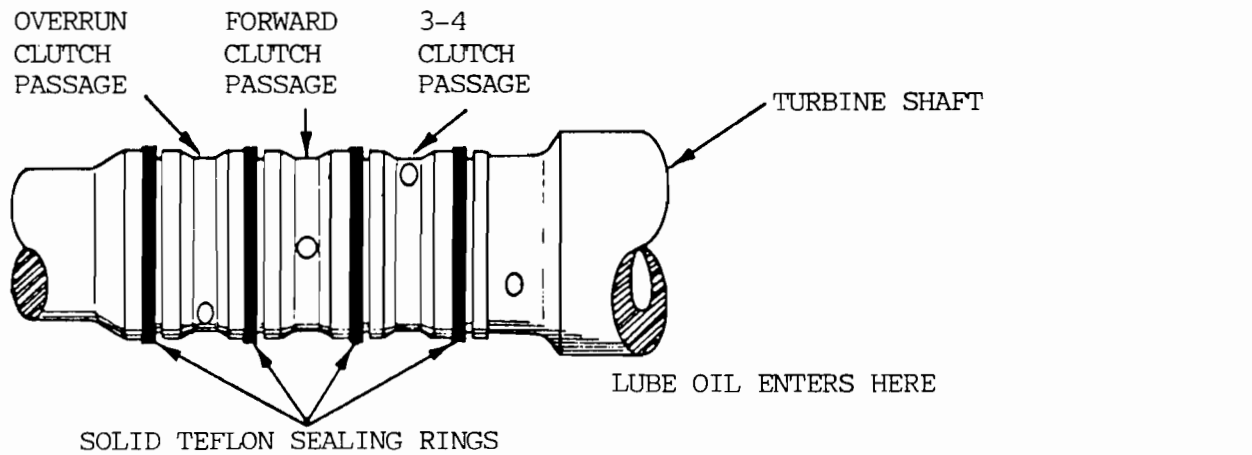
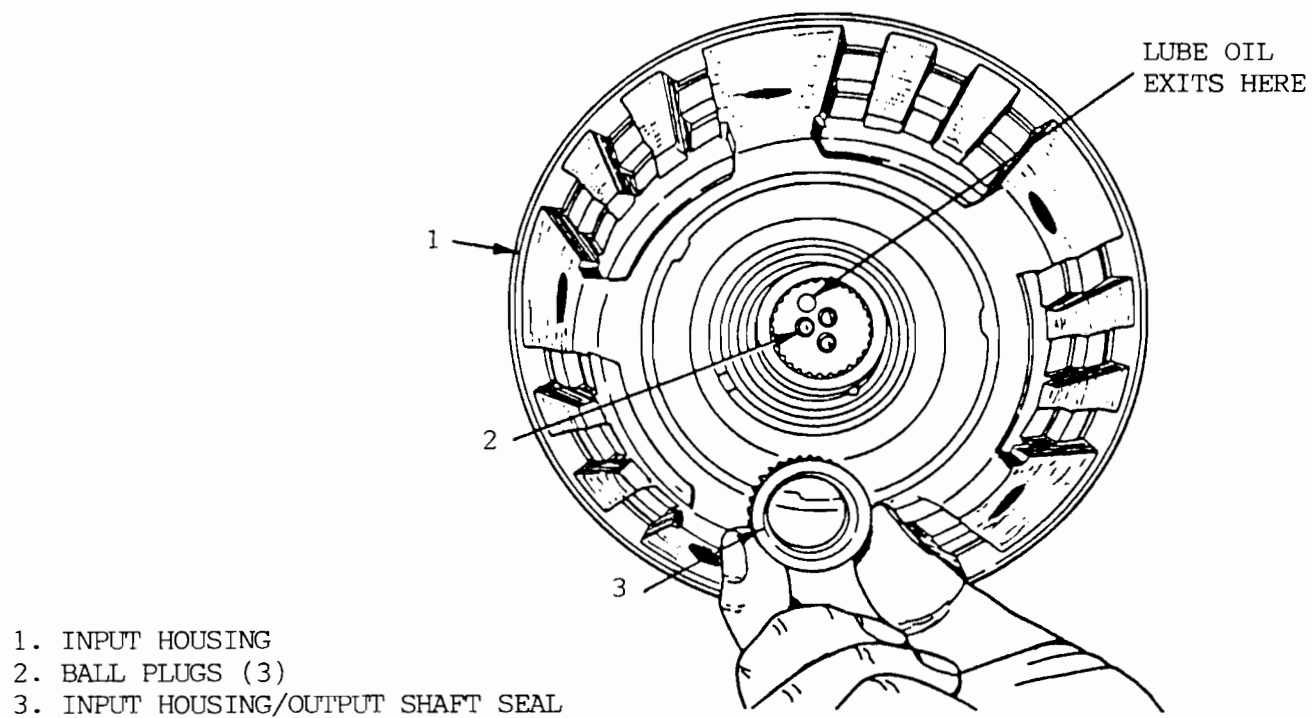
Figure 1

PREMATURE PLANETARY FAILURE

COMPLAINT: Repeated failure of the rear planetary carrier and related parts.

CAUSE: Lack of lube oil to planetary carrier and related parts.

The reaction ring gear support was also modified to accommodate the added oil deflector, and must be used if the reaction carrier with the oil deflector is used. This update is recommended by ATSG.

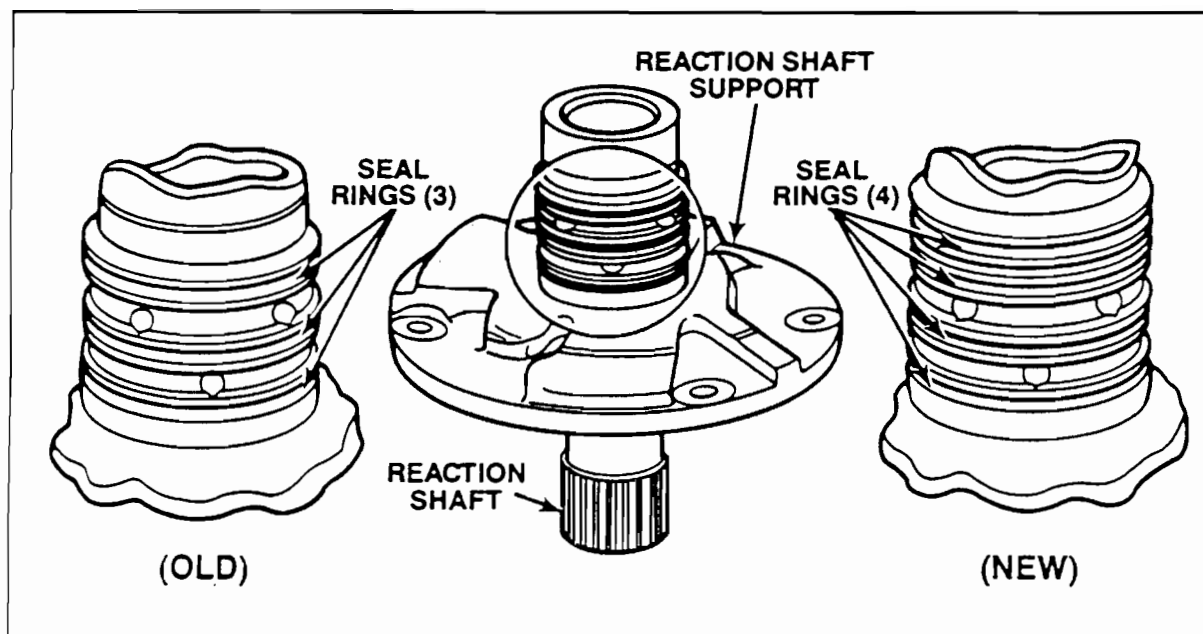
Figure 1

TORQUEFLITE A604 UPDATED REPAIR PACKAGE

There is now available from OEM a new repair package, part number 4549248, that includes a new 4 ring front pump reaction shaft (See Figure 1), and a new input clutch hub with shallower "O" ring grooves to increase the compression of the "O" rings (See Figure 3). The new 4 ring front pump reaction shaft (Figure 1) provides better sealing for the overdrive clutch, and the new input clutch hub with shallower "O" ring grooves (Figure 3) provides better sealing for both the underdrive clutch and the reverse clutch. Both of these updated parts are highly recommended to provide better durability for the A604 transaxle.

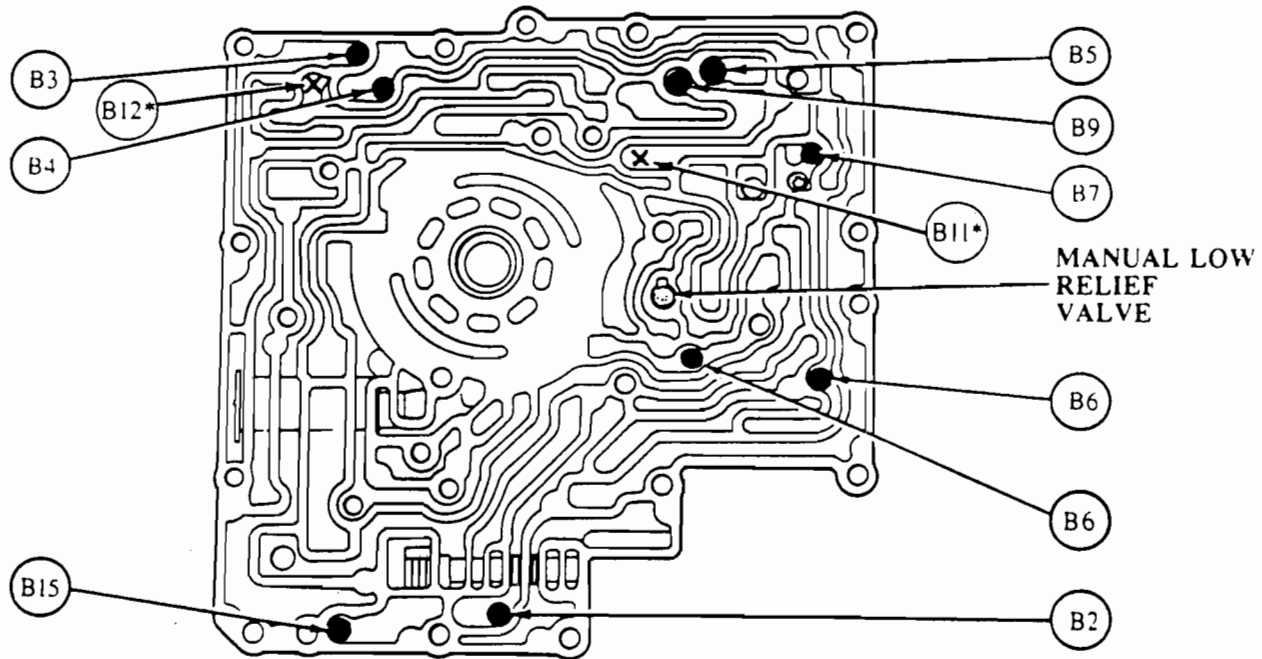
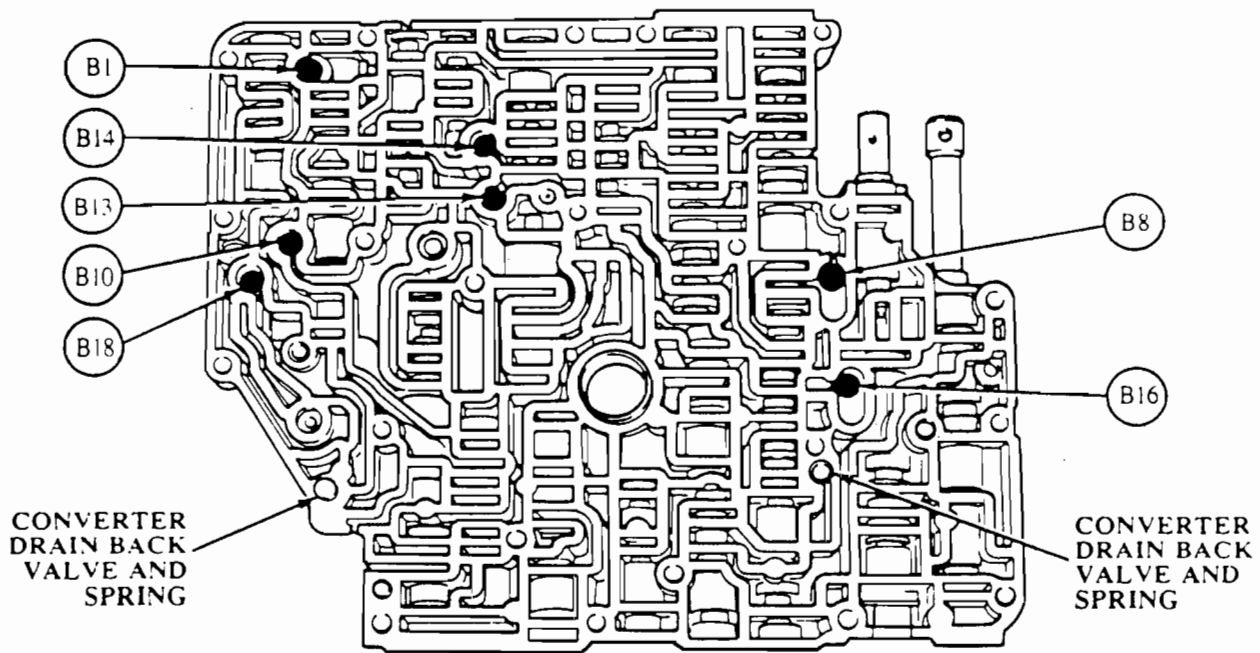
If debris is found in valve body, be sure to inspect all checkballs. They have a habit of deteriorating, and spreading through the valve trains. New checkballs are now available under OEM part number E7DZ-7E195-A, and come five in a package. See Figure 2 for proper checkball locations, as some of the manuals are wrong. See Figure 3 for checkball function.

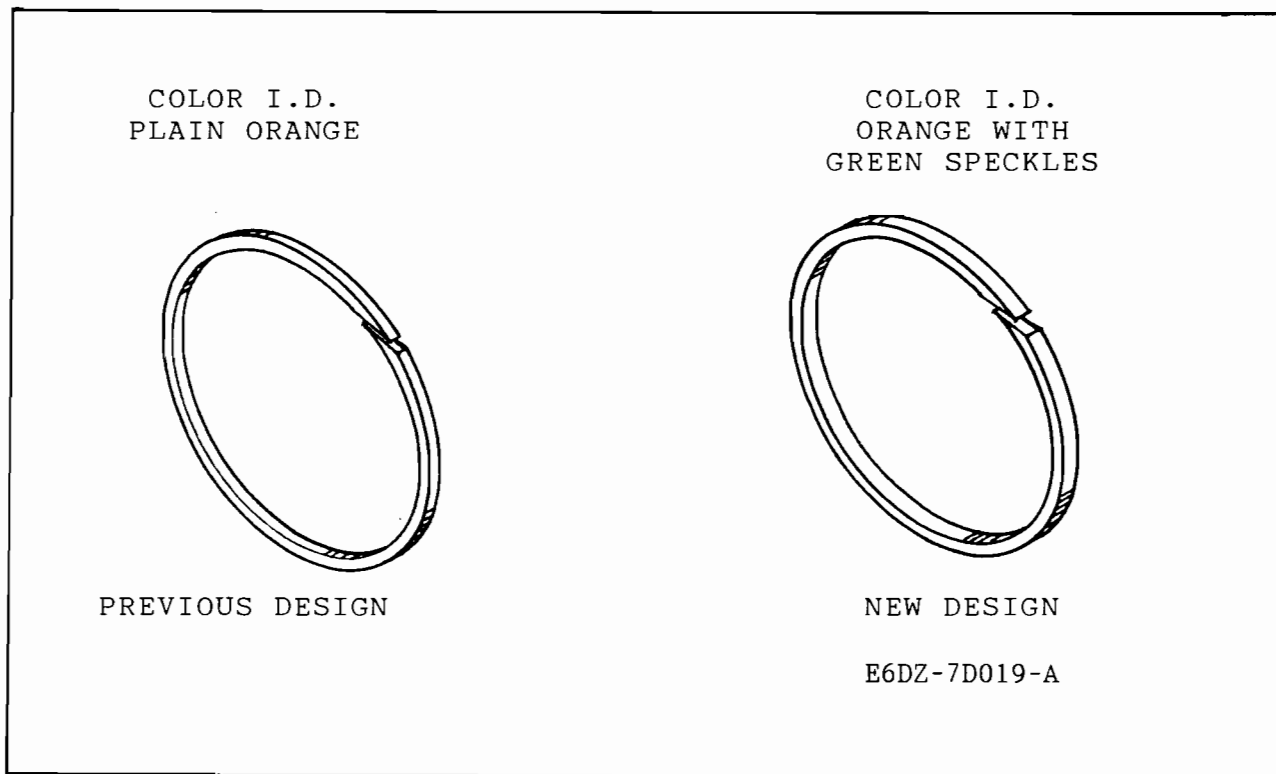
Figure 1

The five sealing rings on the driven sprocket support have been re-designed to help eliminate leakage. The width of the sealing rings has been increased by approximately .015", and the new color I.D. is orange with green speckles (See Figure 1). The previous design sealing rings were plain orange color.

The new design sealing rings are available under OEM Part Number E6DZ-7D019-A, and should be used on all previous model AXOD's.

DO NOT USE PREVIOUS DESIGN SEALING RINGS.
