"2007" SEMINAR INFORMATION

AUTOMATIC TRANSMISSION SERVICE GROUP

Seminar Information

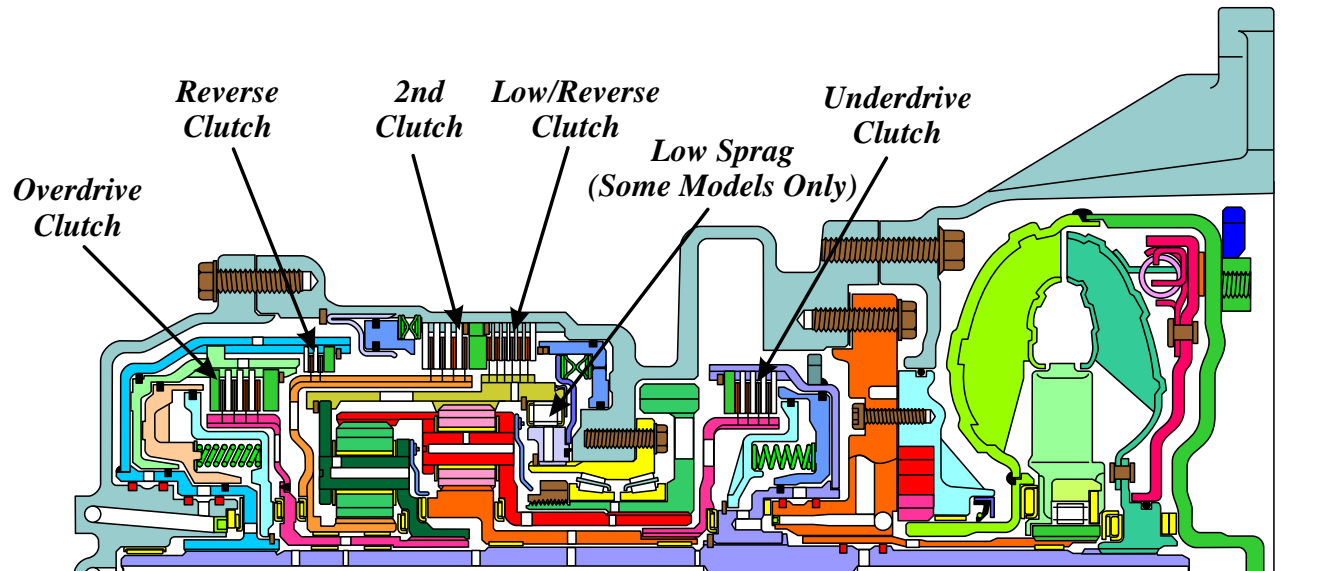
MITSUBISHI F4A41, F4A42, F4A51 COMPONENT AND SOLENOID APPLICATION CHART

CAUSE: The cause may be a bad Low Sprag. Figure 1 shows the computer strategy of the Low Reverse Clutch application thru the Low Reverse Solenoid. The chart shows the Low Reverse Clutch is turned OFF at 6 mph. It is the responsibility of the Low Sprag to hold from 6 mph up until the 1-2 upshift occurs. The Low Sprag also has to come back on during the 2-1 downshift. If the sprag does not hold it will cause the neutralizing effect. Notice that when the selector is in Manual Low, the Low Reverse Clutch stays ON while in 1st gear.

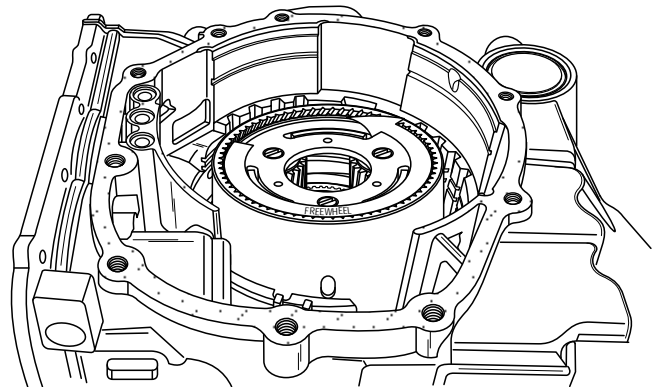
Figure 3

***PLANETARY SHOULD
FREEWHEEL COUNTER-CLOCKWISE
AND LOCK CLOCKWISE***

CORRECTION: Replace the Low Sprag as shown in Figure 2 and ensure the inner and outer races are good. Refer to Figure 2 to ensure the sprag is assembled correctly in the Output Internal Ring Gear, and verify that the carrier freewheels in the correct direction as shown in Figure 3.

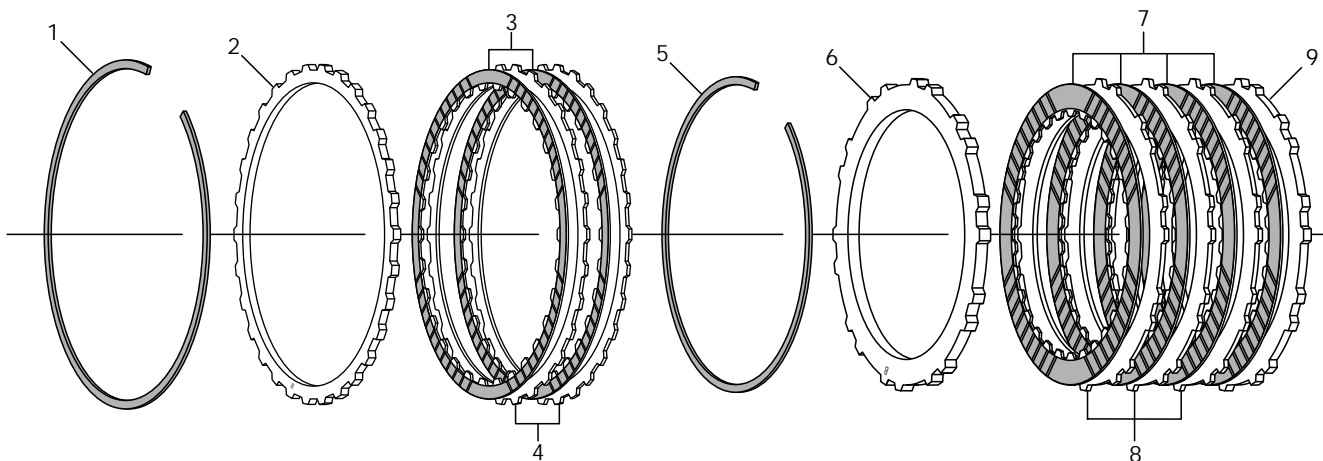
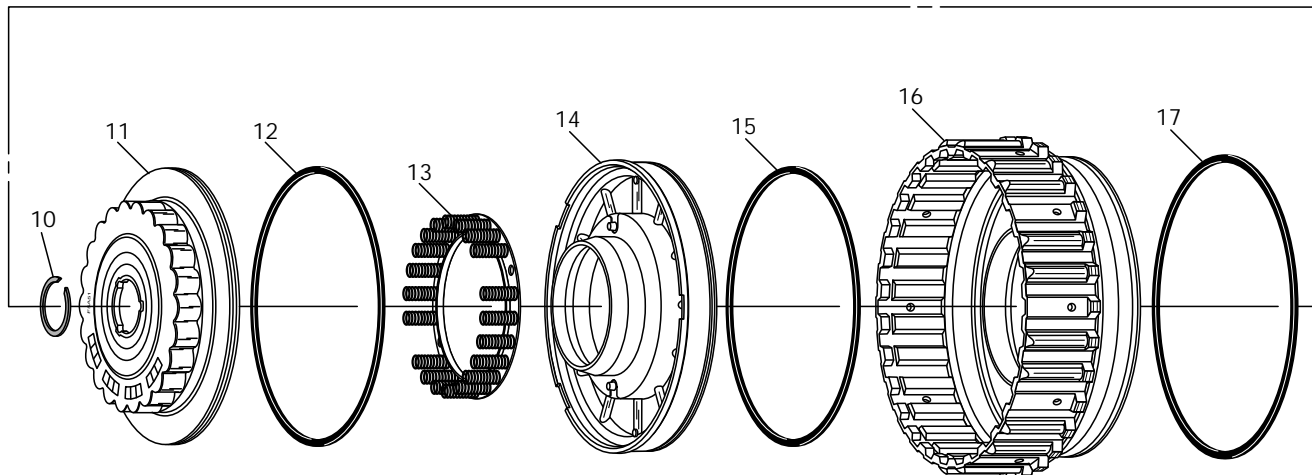
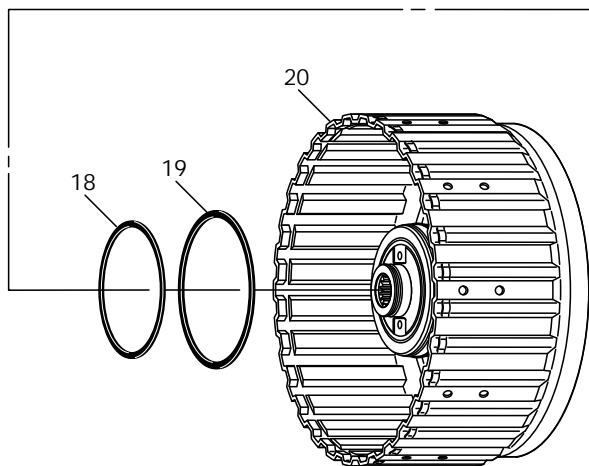
Figure 1

CAUSE: The cause may be, that the Overdrive / Reverse Clutch Drum is cracked around the weld on the back of the drum as shown in Figure 1. **CAUTION:** This crack is easy to miss!

CORRECTION: Replace the Overdrive / Reverse Clutch Drum and renew the piston seals as shown in Figure 2.

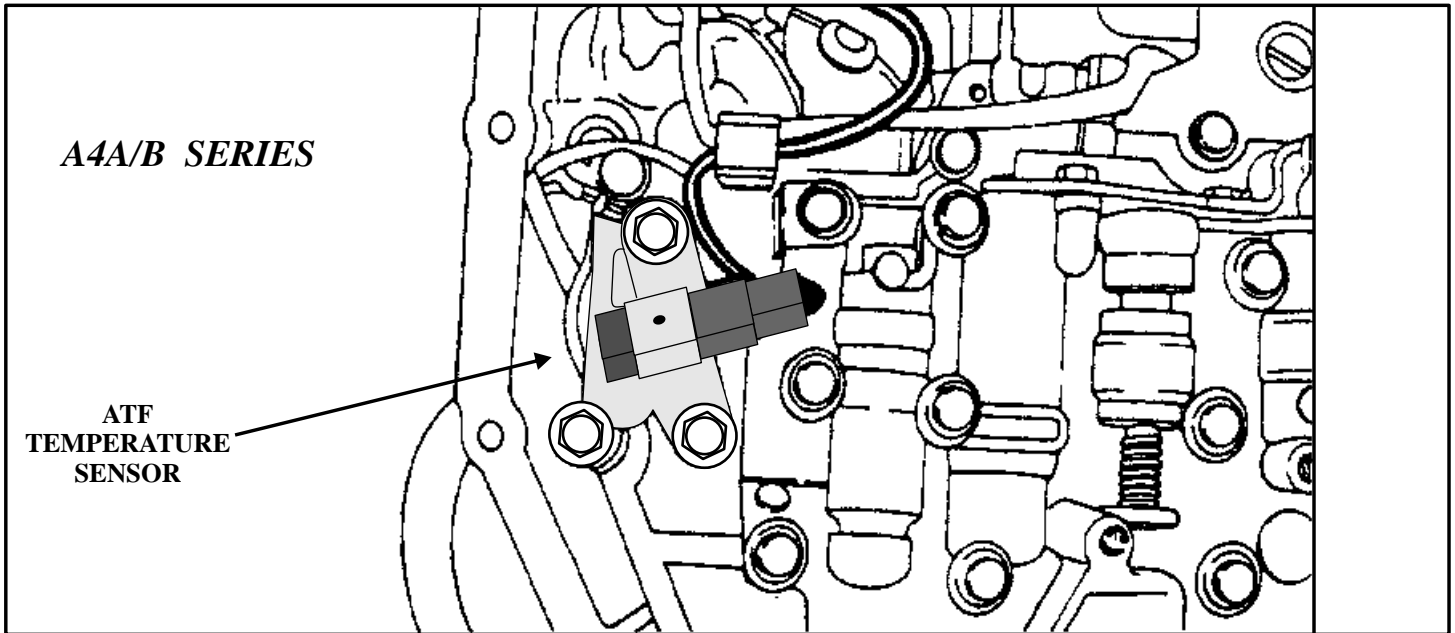
Figure 1

CAUSE: A Transmission Fluid Temperature Sensor malfunction resulting in storing any of the above mentioned codes can cause the complaints listed above.

CORRECTION: Replace TFT sensor or repair sensor wiring. The ATF Temp Sensor location for the A4BF1, A4AF2, A4AF3 and A4BF2 is shown in Figure 1. The ATF Temperature Sensor location for the F4A40/50 series is shown in Figure 2.

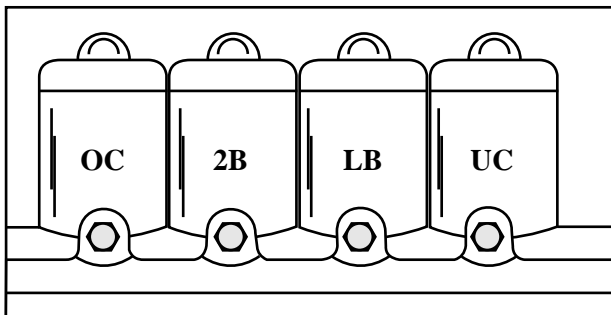
PRESSURE SPECIFICATIONS

CAUSE: The cause may be that the Pressure Regulator Spring may be losing it's tension or is shrinking from the extreme heat of the planetary failure. *Note: The planetary failure is usually due to Torque Converter Clutch failure clogging the cooler causing a loss of lubrication.*

CORRECTION: To correct this condition, first verify what the base pressures are on the Underdrive clutch and the Low Reverse Brake in the Drive Position, as shown in Figure 1. If the Pressure is below 147-152 in both ports, remove the valve body and inspect the pressure regulator valve for sticking in it's bore. If it is free, refer to the specs in Figure 2 to verify the specs of the spring. If the spring is below 1.760, " the adjustment, as shown in Figure 3 will have to be turned counterclockwise to increase the Base Line Pressure and replace the pressure regulator valve spring if necessary.

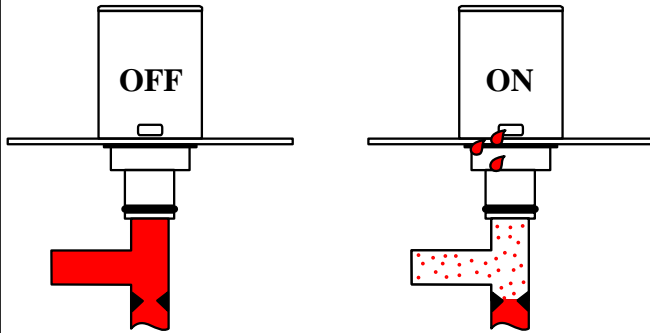
Copyright © 2007 ATSG

Duty solenoid C (Transfer Clutch Solenoid) is a normally applied solenoid. When the solenoid is off it holds pressure to stroke the Transfer Clutch Control Valve. When it is pulsed on, it exhausts the pressure and spring pressure closes the valve.

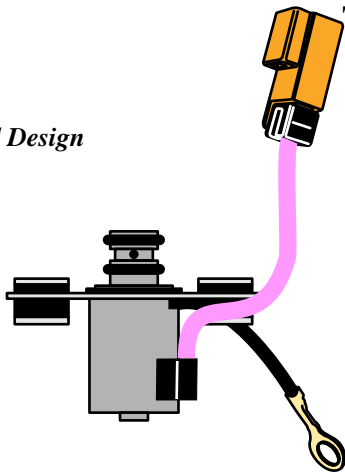
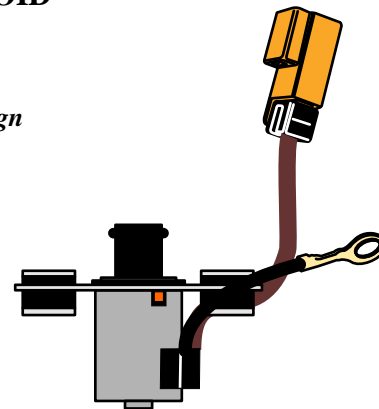
Figure 17

The design of the Transfer Clutch Solenoid has also changed, the previous as well as the current design solenoid can be seen in Figure 17. The diagrams in Figure 18 illustrate the hydraulic differences between the current and previous solenoid and transfer clutch valve bodies.

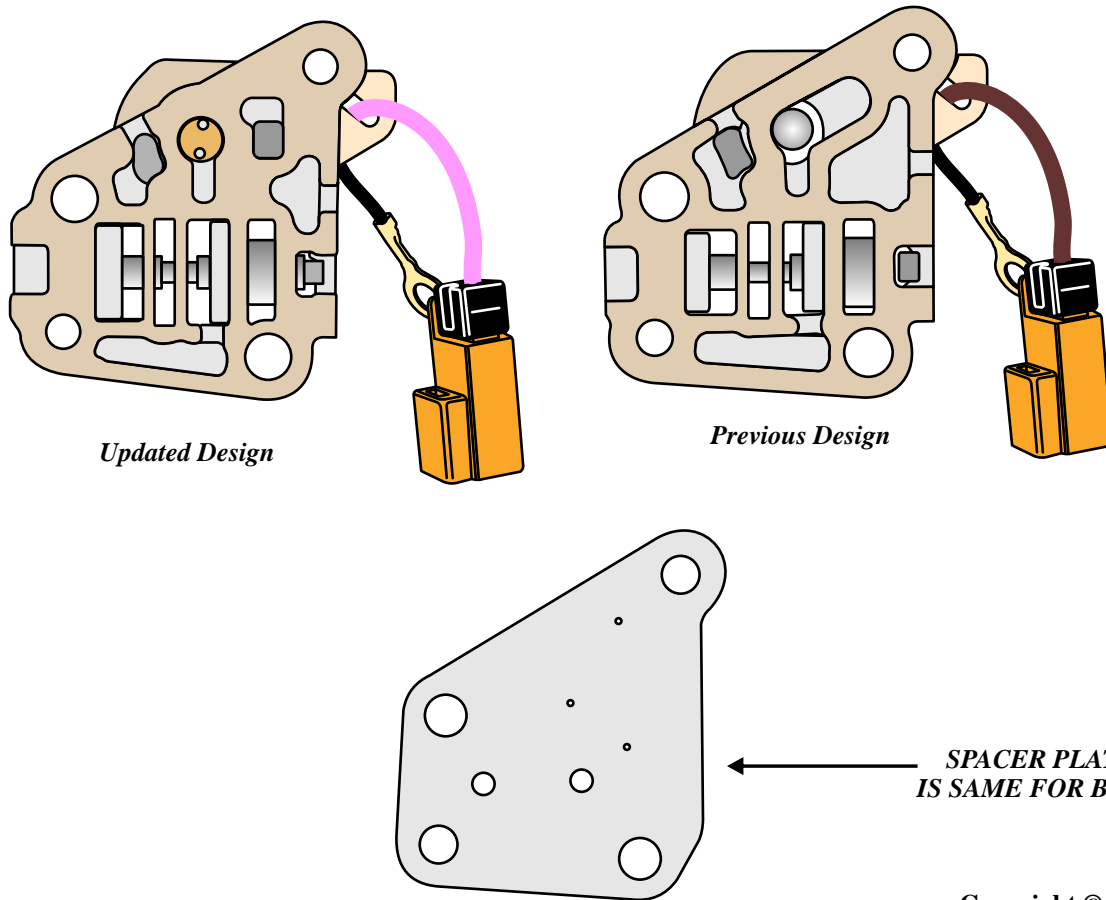
Figure 19

The transfer clutch valve body spacer plate ***did not change***, however the valve body passages did which are illustrated in Figure 19. The transfer clutch valve was also redesigned which is shown in Figure 20. These transfer clutch control components were redesigned to reduce what Subaru calls oil pressure vibration.

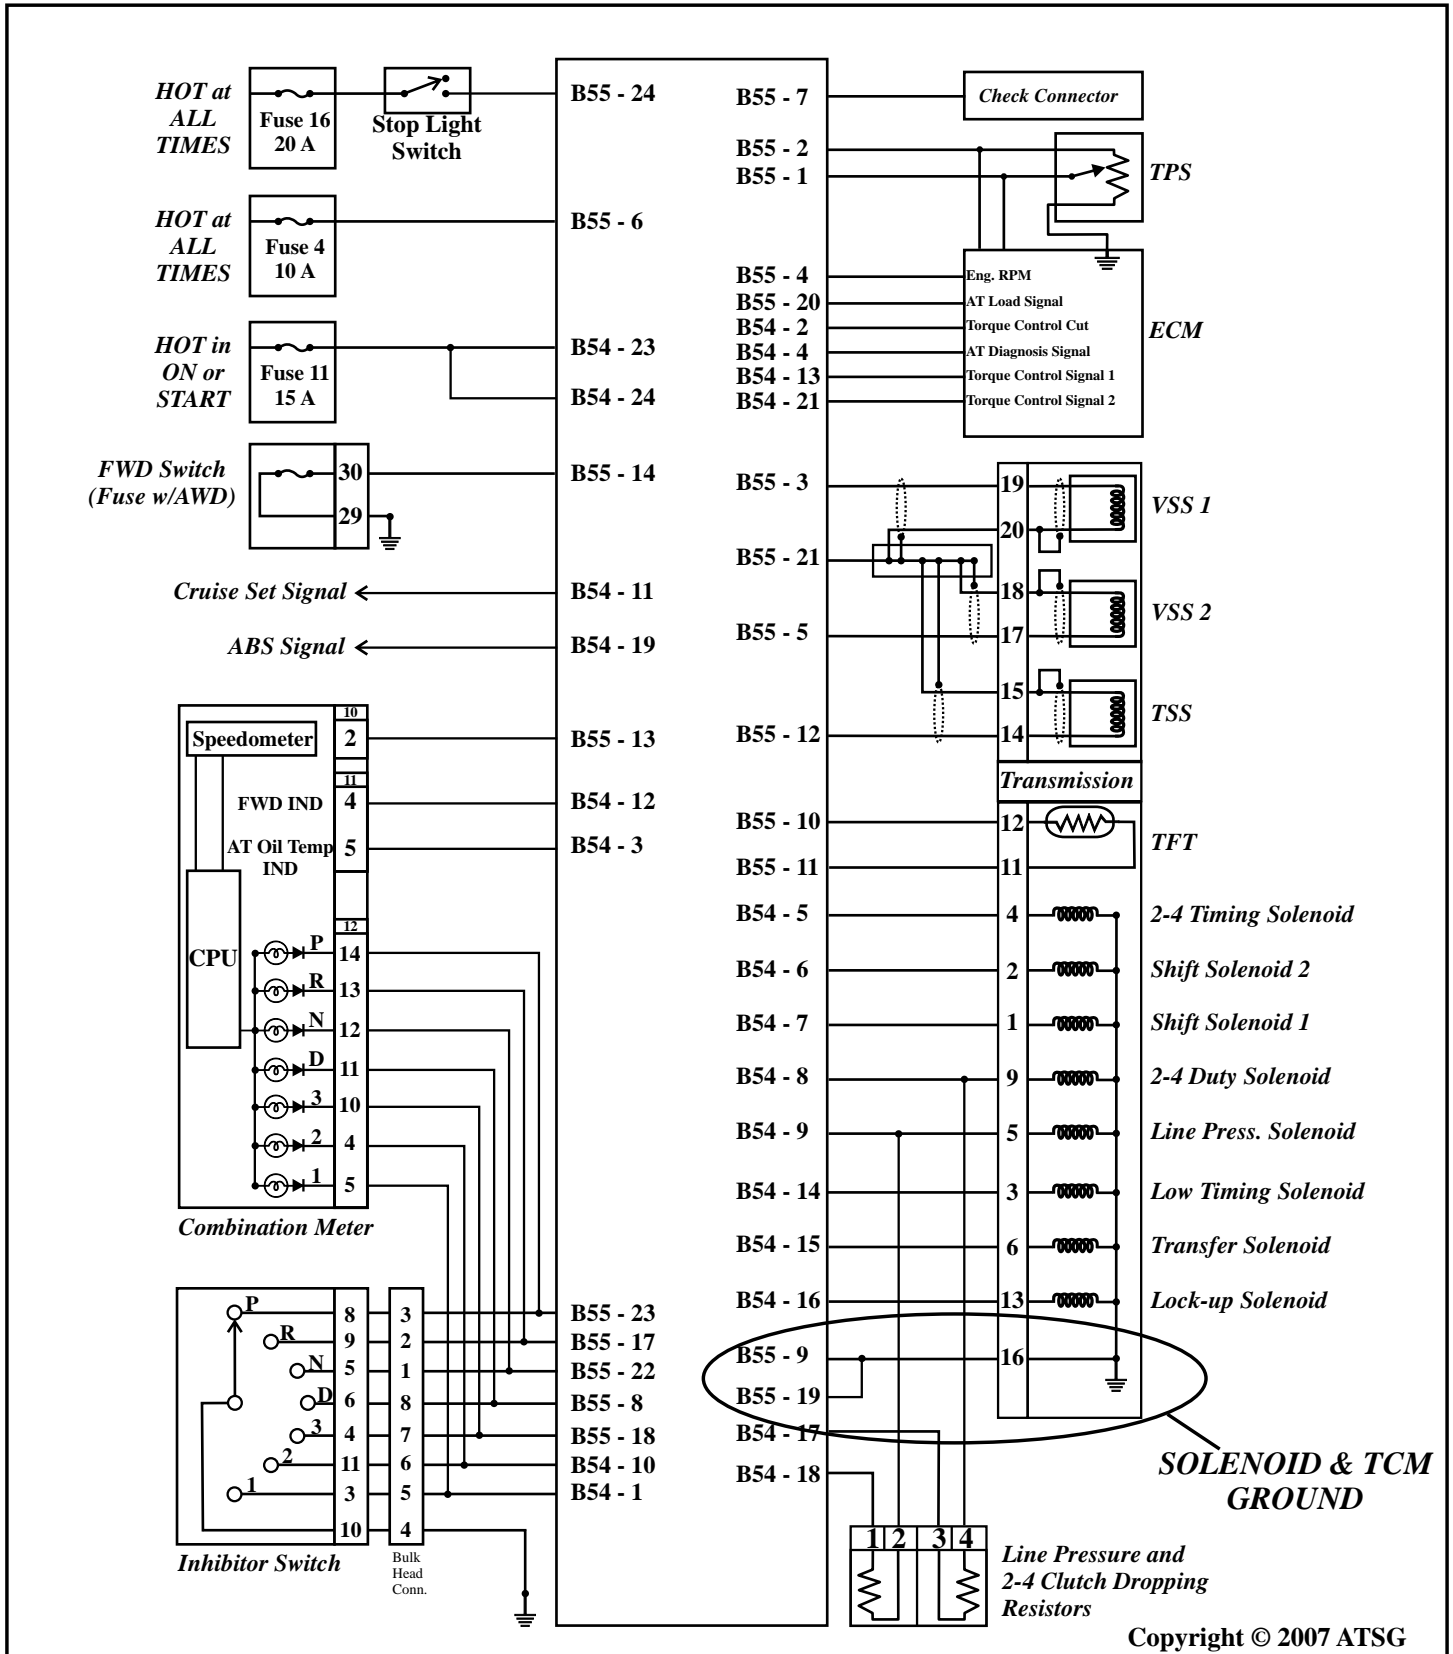
Figure 1

CAUSE: Referring to the wire diagram in Figure 1, the ground circuit for the TCM can be seen as it is located inside the transmission which is also ground for the internal solenoids. The physical ground point can be seen in Figure 2. It is a typical wire/eyelet which a valve body bolt goes through. the ground wire then travels through the case connector at terminal 16 as shown in Figure 3, and then continues to terminals 9 and 19 at the TCM where it serves as ground for the TCM as well.

CORRECTION: Make certain this ground is in good condition as well as tight to insure it is a good ground. Since it serves as ground for both the transmission solenoids as well as the TCM, a variety of complaints could arise as a result of this ground being faulty.

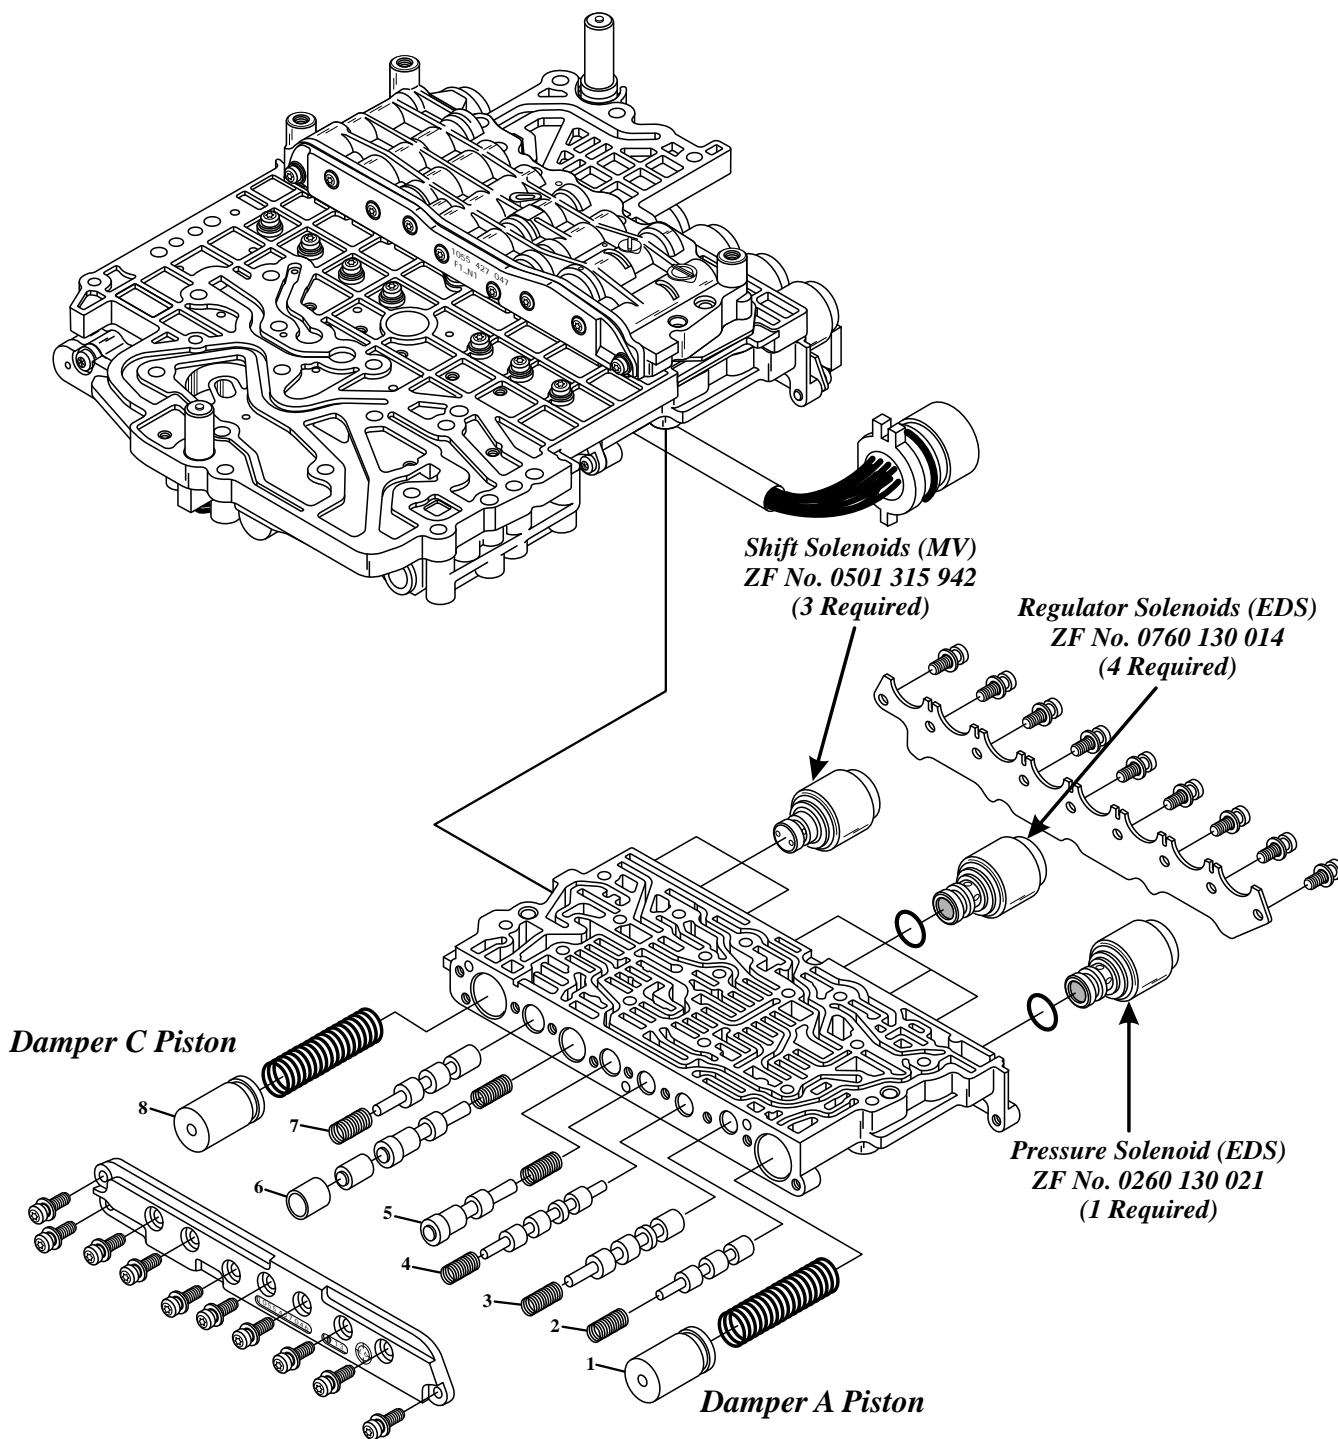
Figure 3

CAUSE: Inside the lower rear valve body there are two hard plastic damper pistons (Figure 3), one for the A clutch and the other for the C clutch. The A clutch is used for forward while the C clutch is used for reverse (Figure 2). The original design has a center pedestal at the bottom of the piston which punches out over time causing a leak in their respective circuits (Figure 1). Damage to the A or C clutch may occur and if the valve body is not disassembled during the re-build, the original complaint will remain.

Updated Damper Piston.....ZF Part # 1058-327- 017
Audi Aluminum Piston.....ZF Part # 1058-327-087
