TIME OUT

INTRODUCTION

THM 4L60 (700-R4) SOFT UPSHIFTS AND OTHER THINGS

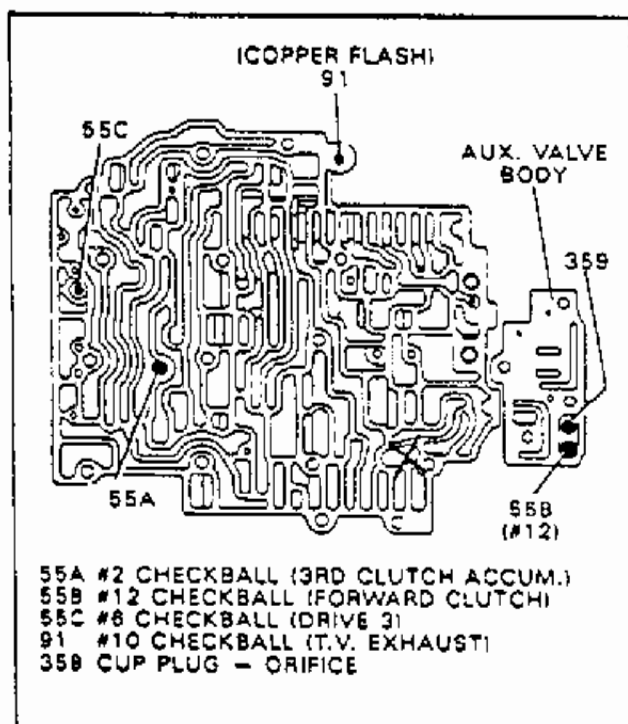
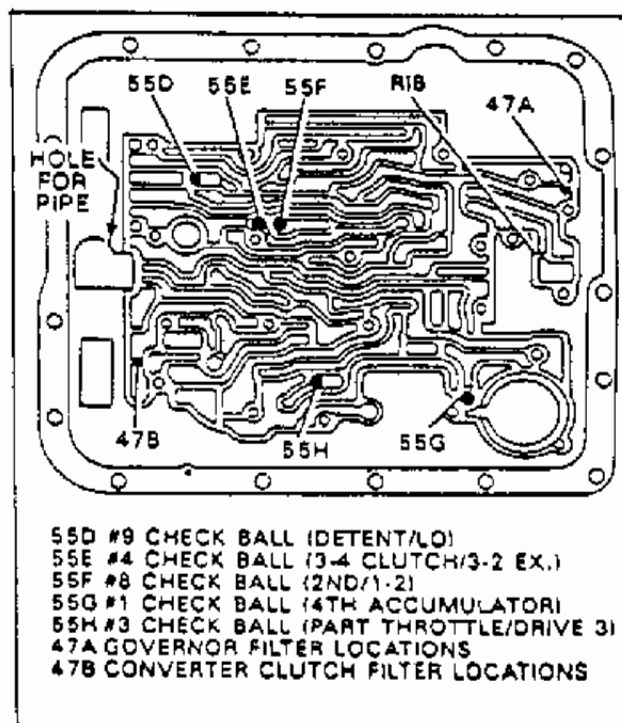
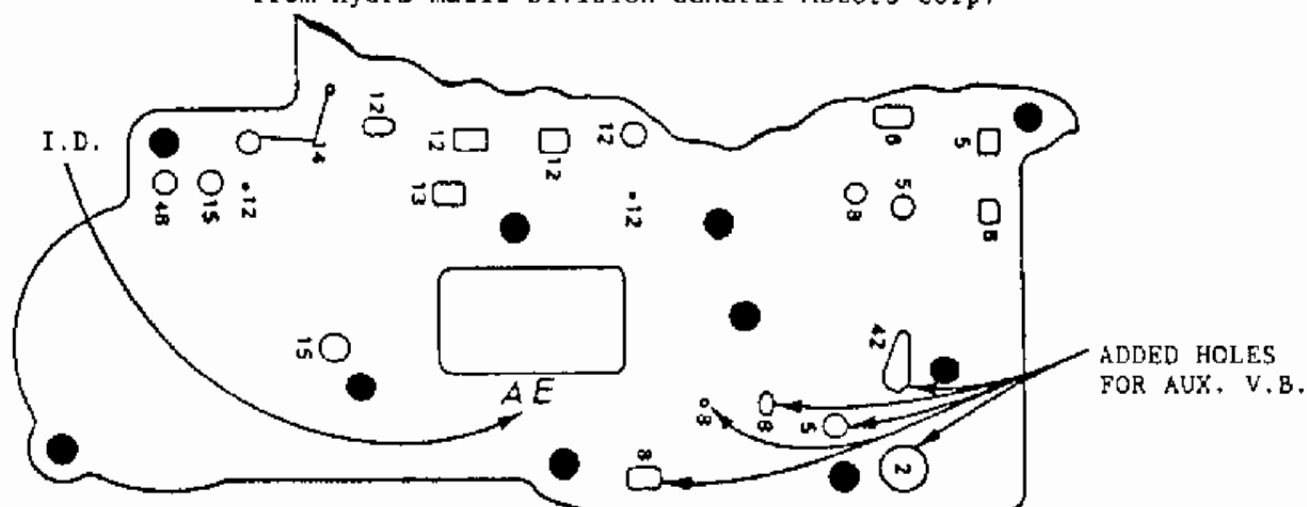
Figure 3

Do not install a checkball in the location marked with an "X", as shown in Figure 3. The result will be, NO 2ND GEAR, as it blocks D4 oil from getting to the 1-2 shift valve.

Do not install the number 9 checkball (Det/Lo) in the "Bathtub" in the case on any 1988 or later model (See Figure 3). This will create a tie-up on the 1-2 shift, and wipe out the Lo/Reverse Clutches and 2/4 Band.

If you have very high and harsh upshifts, you can remove the number 10 checkball (T.V. Exhaust), and usually eliminate the problem (See Figure 3).

Do not install the number 12 checkball on top of the orifice cup plug in the auxiliary valve body. It goes next to the orifice cup plug as shown in Figure 2. If you install it improperly, the checkball falls through the spacer plate into the D4 passage, and is forced into the governor screen blocking all of governor feed oil, and creates "No Upshift". It may also be an intermittent problem, as the checkball sometimes falls away from the screen allowing D4 oil to the governor (See Figure 3).

NOTE: DO NOT INSTALL CHECKBALL IN THE "BATHTUB" IN THE VALVE BODY ON ANY 1987 MODEL, WITH THE AUXILIARY VALVE BODY.

NOTE: 1987 MODEL SPACER PLATES ARE IDENTIFIED WITH A 2 LETTER CODE STAMPED INTO THE SPACER PLATE. THE FIRST LETTER WILL ALWAYS BE AN "A", AND WILL NOT INTERCHANGE WITH ANY OTHER MODELS.

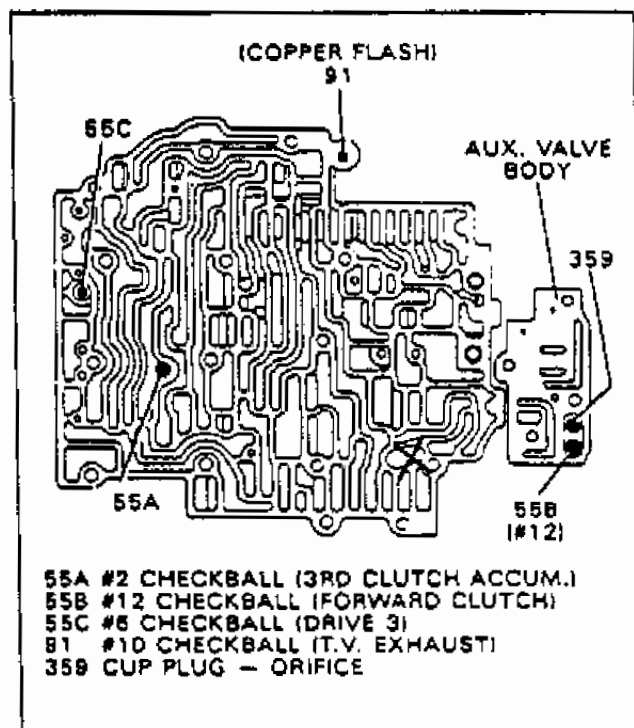
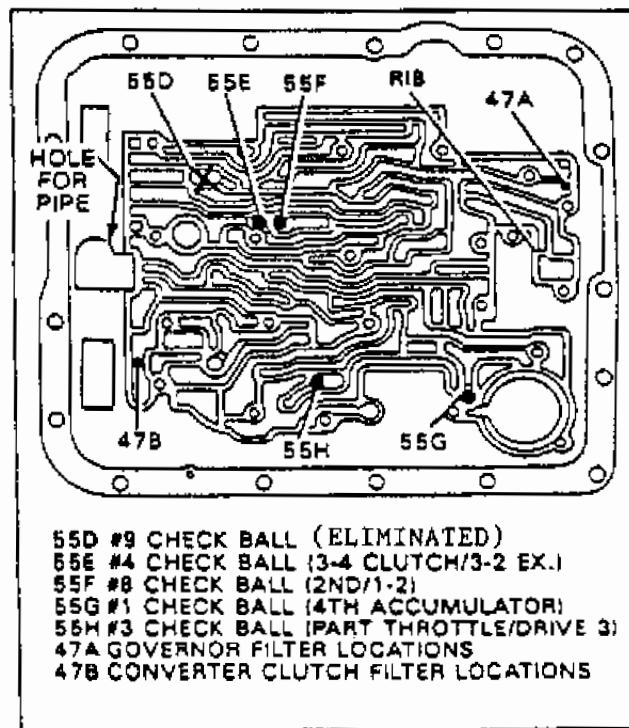
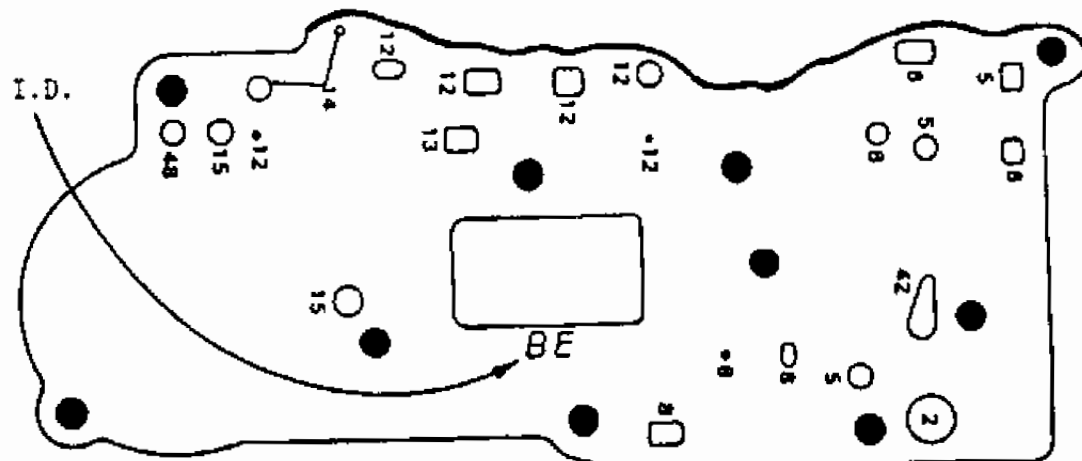
Figure 4
AUTOMATIC TRANSMISSION SERVICE GROUP

NOTE: DO NOT INSTALL CHECKBALL IN THE "BATHTUB" IN THE VALVE BODY, NOR IN THE "BATHTUB" IN THE CASE, ON ANY 1988 MODELS. (SEE ABOVE ILLUSTRATIONS).

NOTE: 1988 MODEL SPACER PLATES ARE IDENTIFIED WITH A 2 LETTER CODE STAMPED INTO THE SPACER PLATE. THE FIRST LETTER WILL ALWAYS BE A "B", AND WILL NOT INTERCHANGE WITH PREVIOUS MODEL SPACER PLATES. (SEE ABOVE ILLUSTRATION).

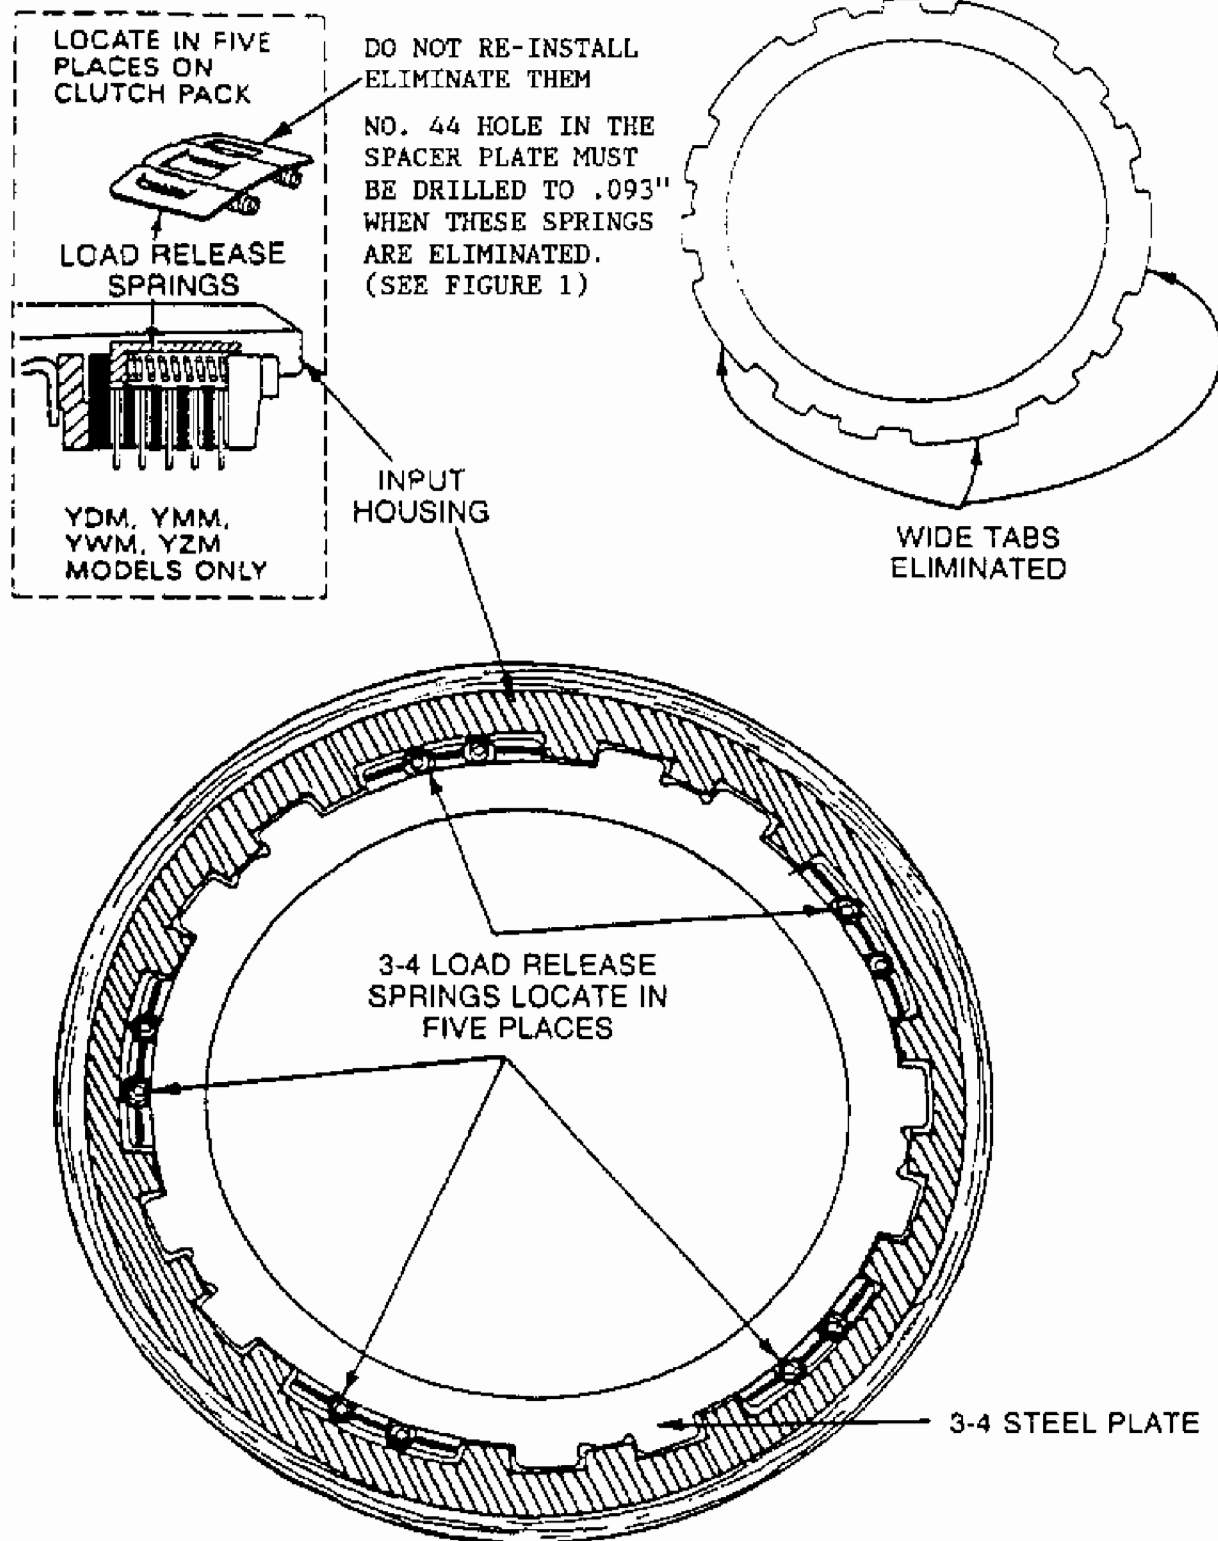
Figure 8

CHANGE: Load Release Springs are added to the 3-4 clutch pack on "F" and "Y" cars only (See Figure 8).

- (1) 3-4 Load Release Springs – Added on YDM, YMM, YWM, and YZM models only, and locates in five places around the 3-4 clutch pack (See Figure 8).
The 3-4 clutch pack now requires some special attention on the stack up. The wide tabs on the 3-4 steel plates were eliminated to make room for the load release springs (Figure 8). However, there is still "One" flat steel plate WITH the wide tabs required in the new 3-4 clutch pack. It goes on top of the stepped apply plate, and provides a "Seal" for the 3-4 load release springs (See Figure 8).

NOTE: THESE SPRINGS WERE ADDED TO ALL MODELS BEGINNING IN 1989, AND SHOULD BE ELIMINATED, ALONG WITH DRILLING THE NO. 44 HOLE IN THE SPACER PLATE AS SHOWN IN FIGURE 1. THESE MODIFICATIONS WILL IMPROVE THE 3-4 CLUTCH DURABILITY.

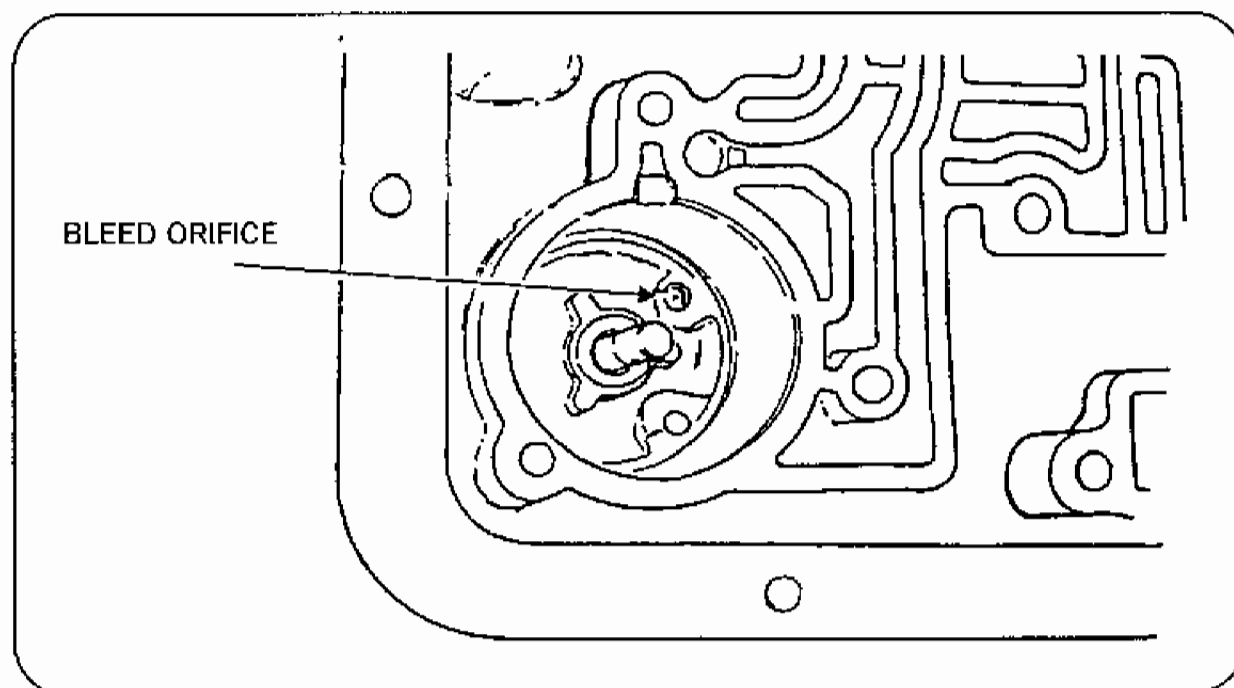
Figure 14

CAUSE #3: The bleed orifice cup plug is missing from the case in the bottom of the 3-4 accumulator bore (See Figure 14).

CORRECTION #3: Replace the missing bleed orifice, part # 8628864 (See Figure 14).

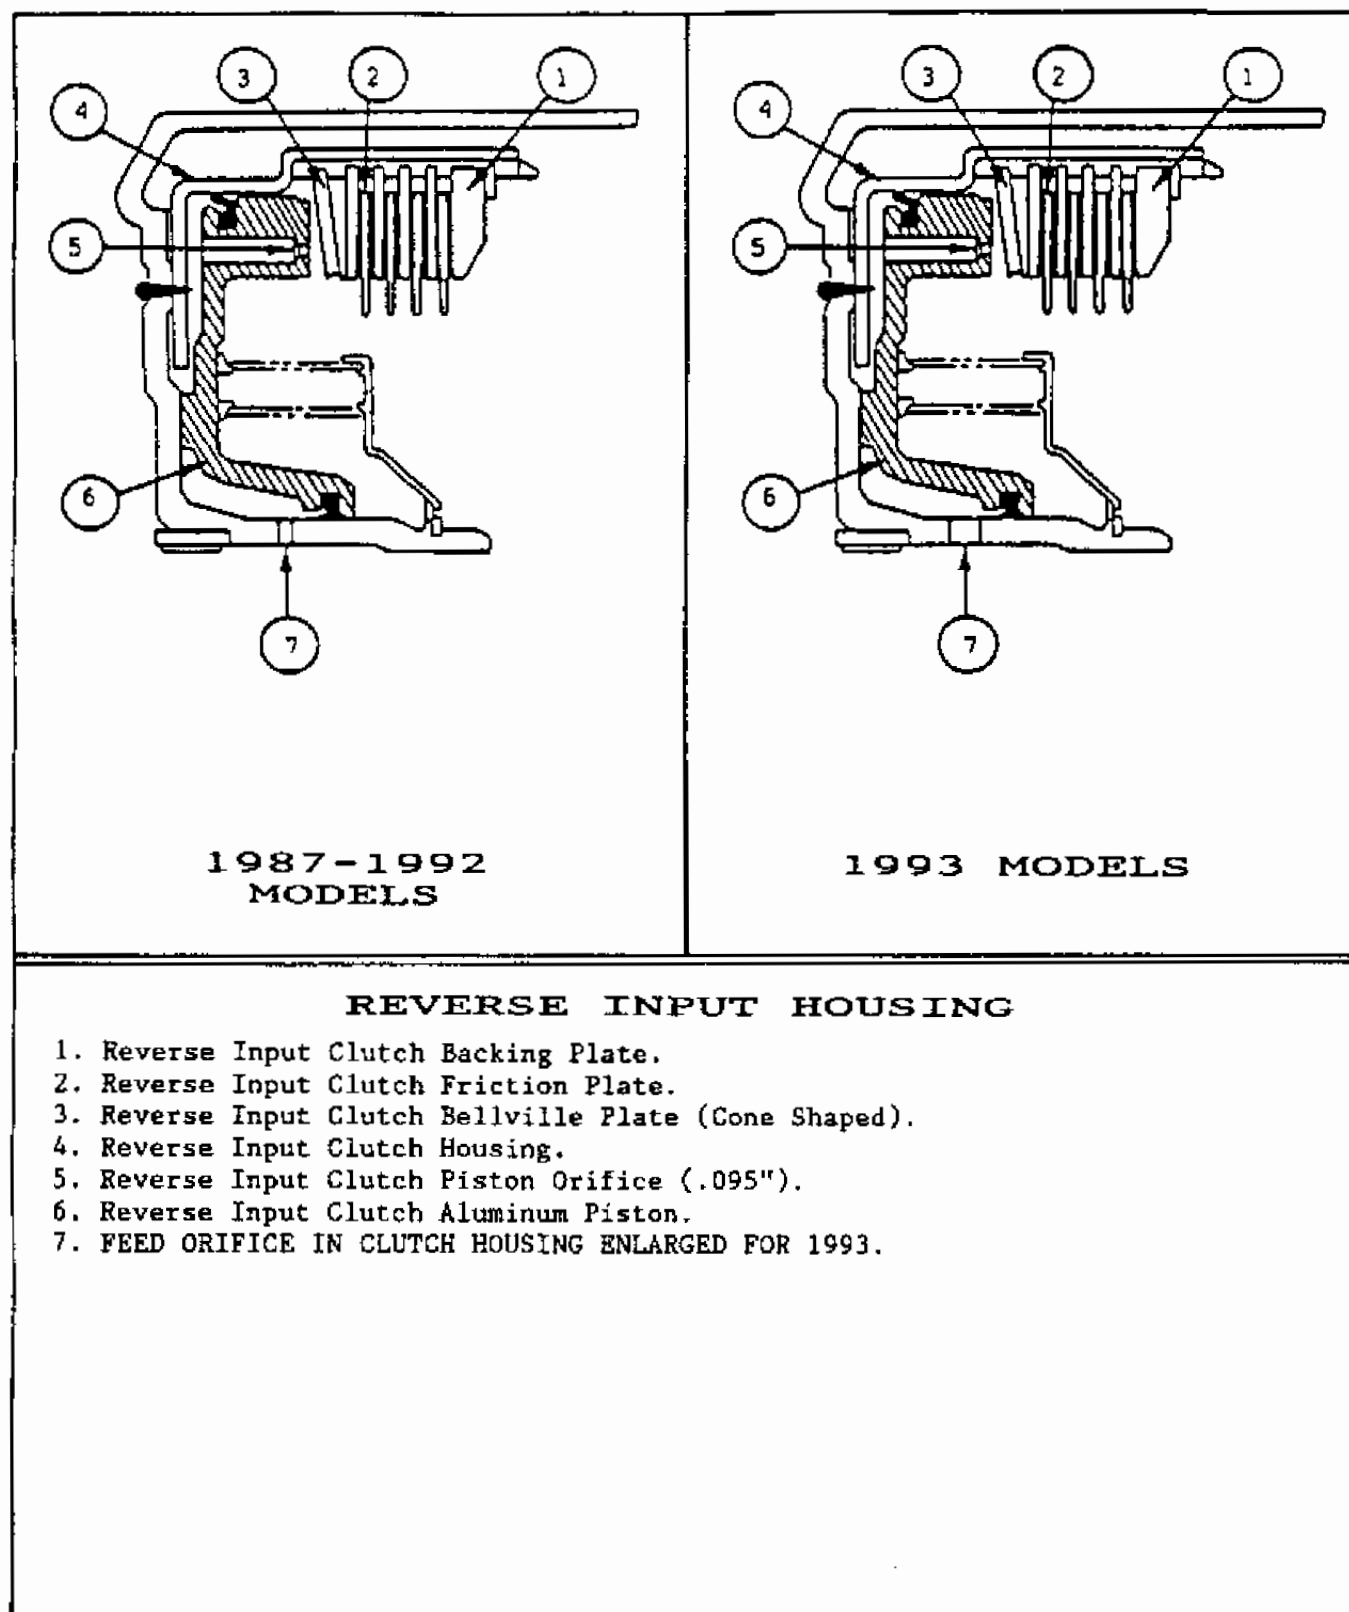
Figure 19

CHANGE: The Reverse Input Housing for ALL 1993 model THM 4L60 transmissions has the oil feed hole enlarged (Large Square Hole), from the previous .095" round feed hole (See Figure 19).

- (1) REVERSE INPUT HOUSING - Feed hole has been enlarged from .095" round hole to large square hole, and this is the ONLY identification as they both require the aluminum piston (See Figure 19).

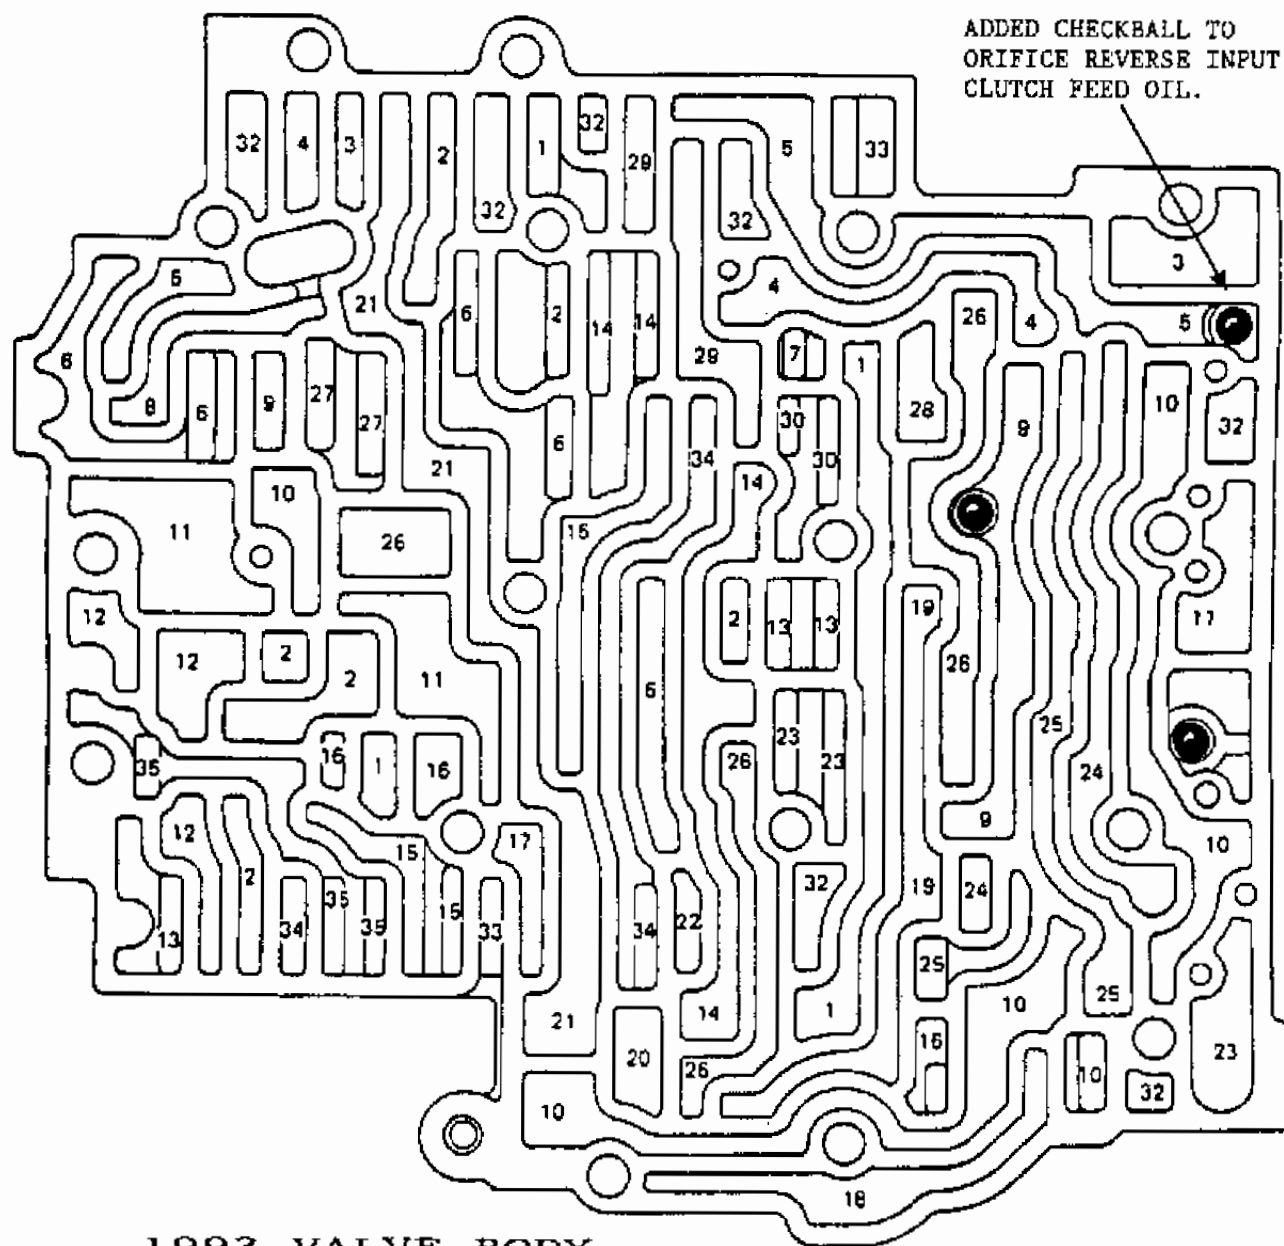
- (2) VALVE BODY CASTING - Changed with the addition of checkball in location shown in Figure 20 (NOT IN BATHTUB). This checkball was added to orifice feed oil to the reverse input clutch (See Figure 20).

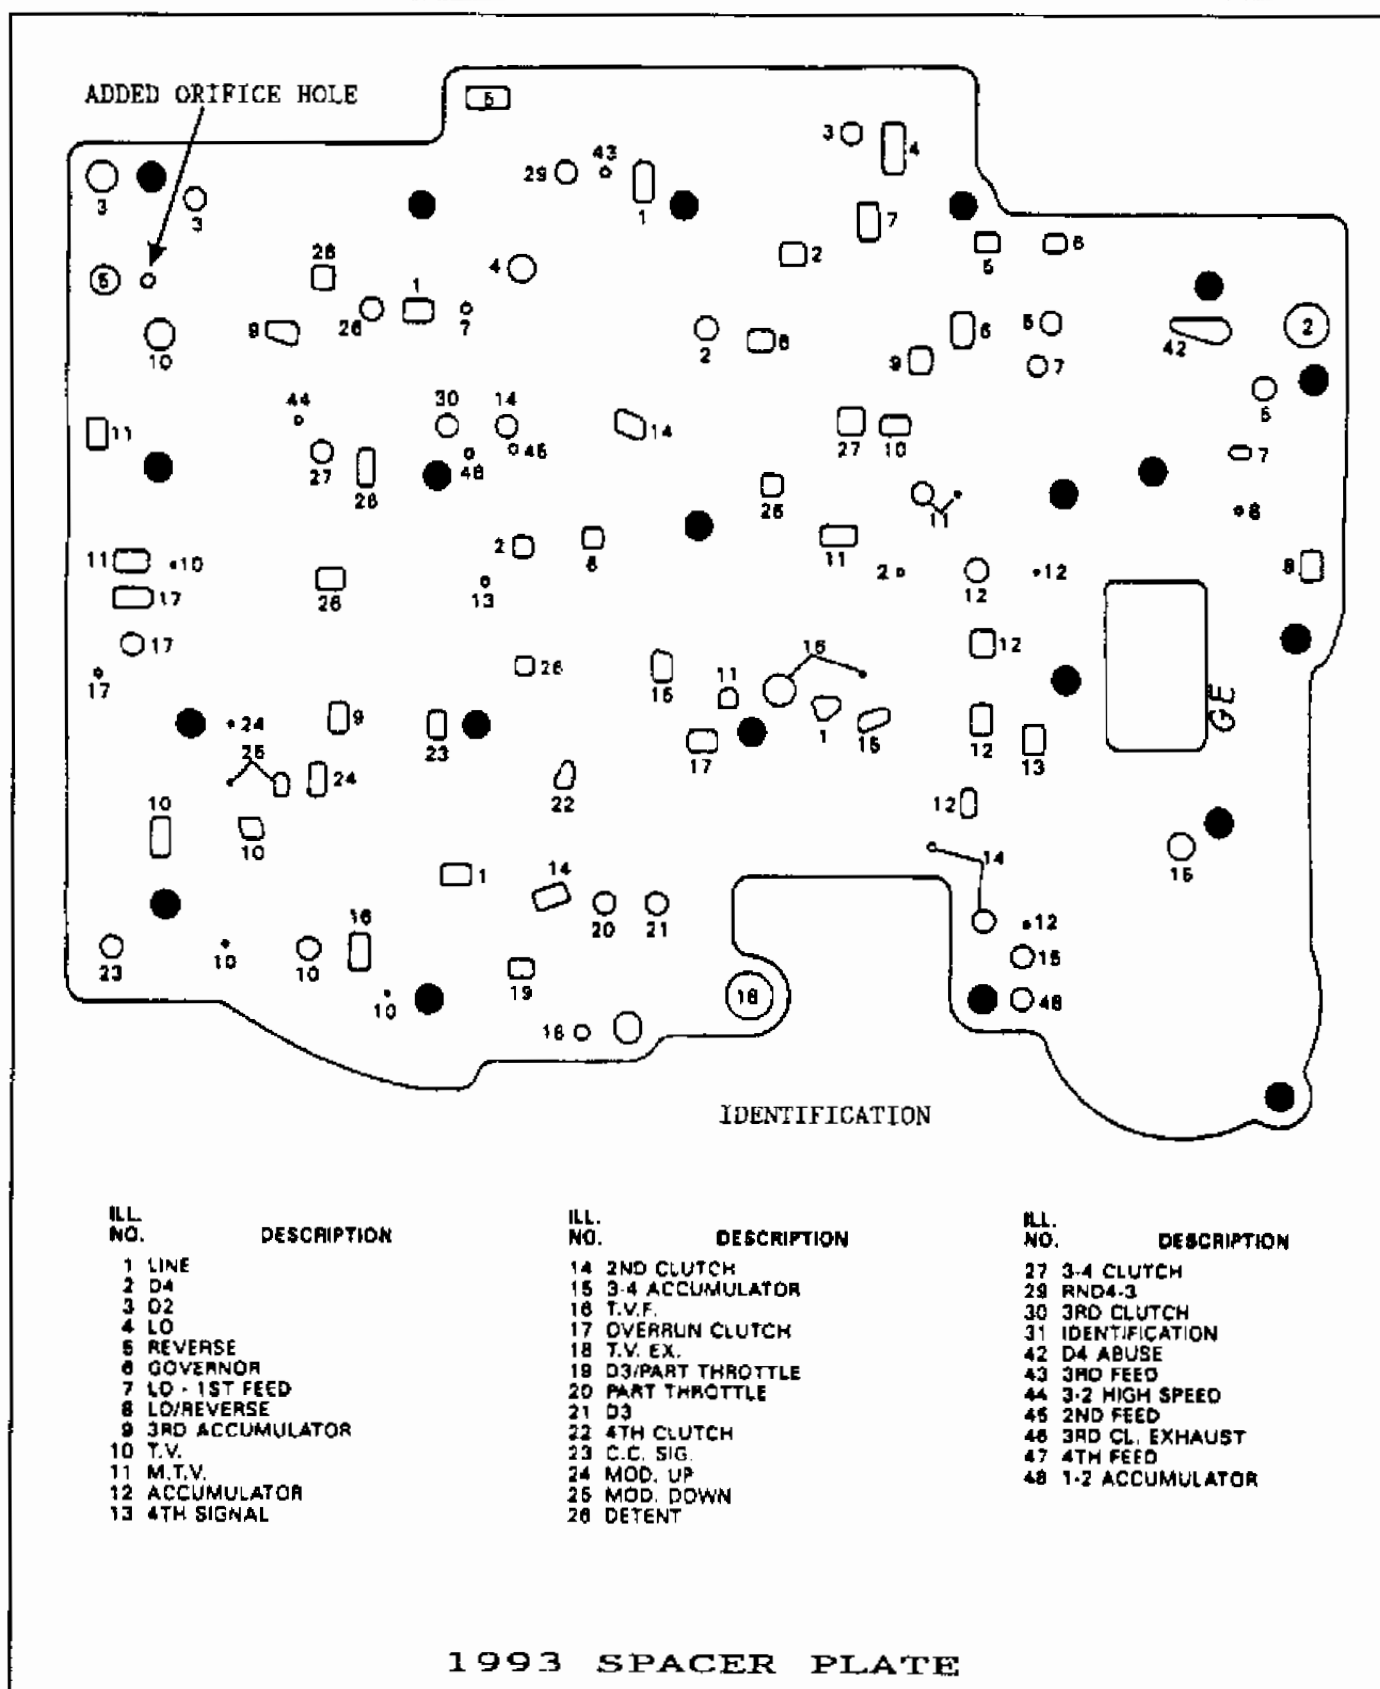
Figure 21

- (3) VALVE BODY SPACER PLATE - Orifice for the new checkball added in location shown in Figure 21, which is now the orifice for feed oil to the reverse input clutch. The 1993 spacer plate is identified with a two digit code stamped into the spacer plate as shown in Figure 21. However, the 1993 code letter can be prefixed with an "E", "G", or "H". Refer to the chart in Figure 22. Some 1992 spacer plates were also prefixed with an "E", so do compare the chart in Figure 22, with the chart in Figure 23, so as not to get the wrong spacer plate.

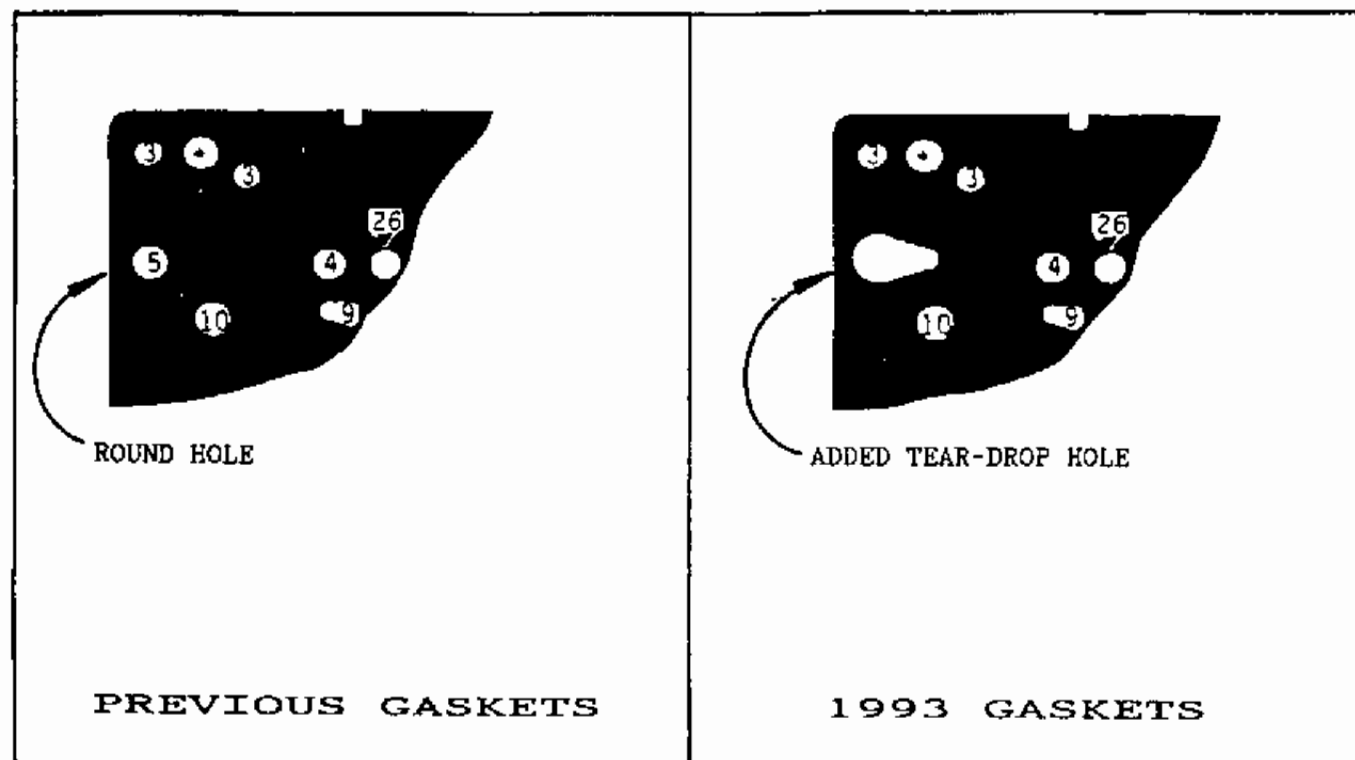
Figure 24

- (4) VALVE BODY GASKETS - Both gaskets now have a "Tear-Drop" hole at checkball and orifice location in spacer plate, instead of the round hole found in the previous gaskets (See Figure 24).

- (3) VALVE BODY SPACER PLATE - Not recommended to be used on any previous models, and 1992 plates WILL NOT work on 1993 models.
- (4) VALVE BODY GASKETS - New gaskets can be used on previous models back thru 1987. The previous gaskets CANNOT be used on any 1993 models, as they will block the reverse input clutch feed orifice in the spacer plate.

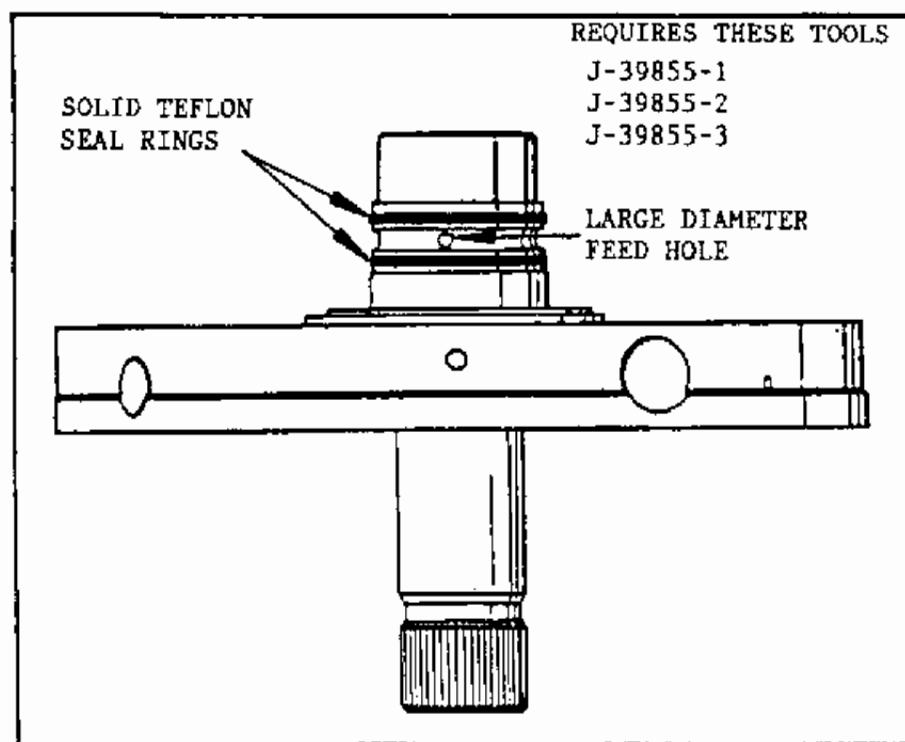
Figure 25

- (5) PUMP COVER SEALING RINGS - Will now be "Solid" Teflon seals for use with the new reverse input housing with the large square feed hole, and does require a new installation and re-sizing tool (See Figure 25).

- (5) PUMP COVER SEALING RINGS - Will retro-fit back on ALL previous models, but will require installation and re-sizing tools J-39855-1, J-39855-2, and re-sizer J-39855-3.

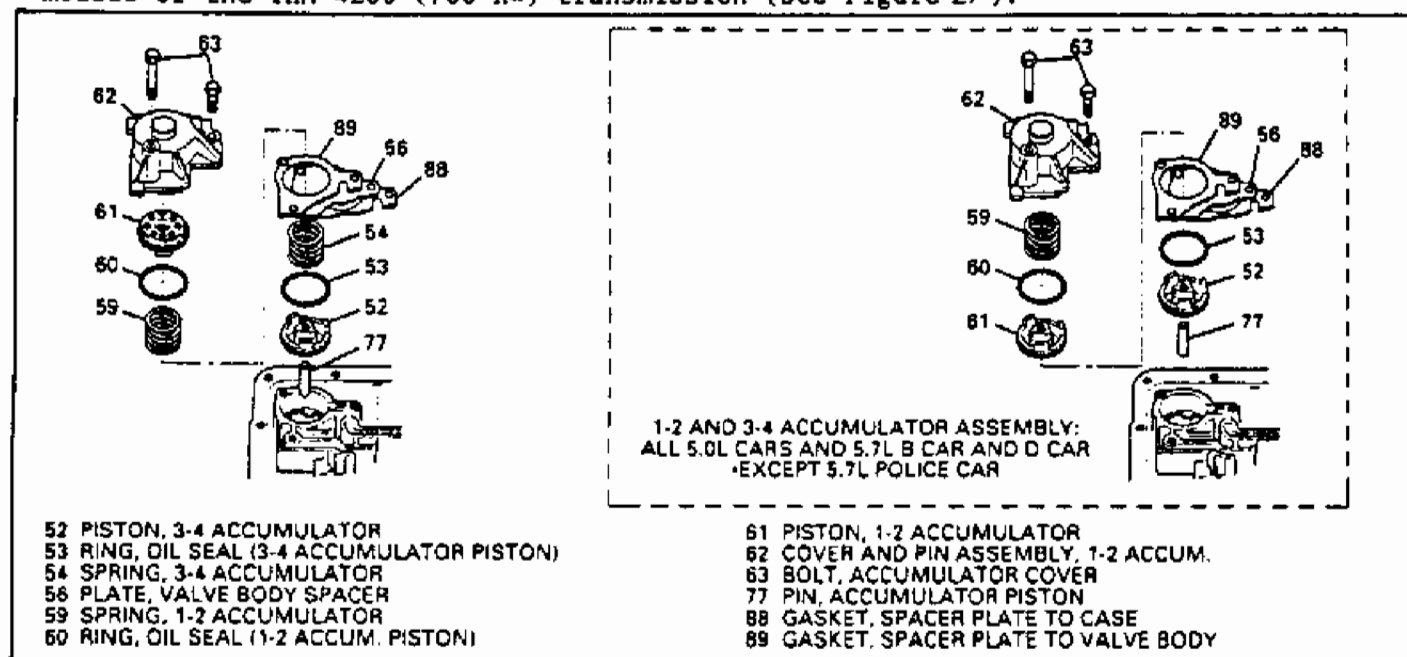
Figure 26

Beginning with the Start of Production for 1993, SOME MODELS of the THM 4L60 (700-R4) transmissions were built with a new calibration that eliminates the 3-4 accumulator spring, and INVERTS the 1-2 accumulator piston and spring (See Figure 26).

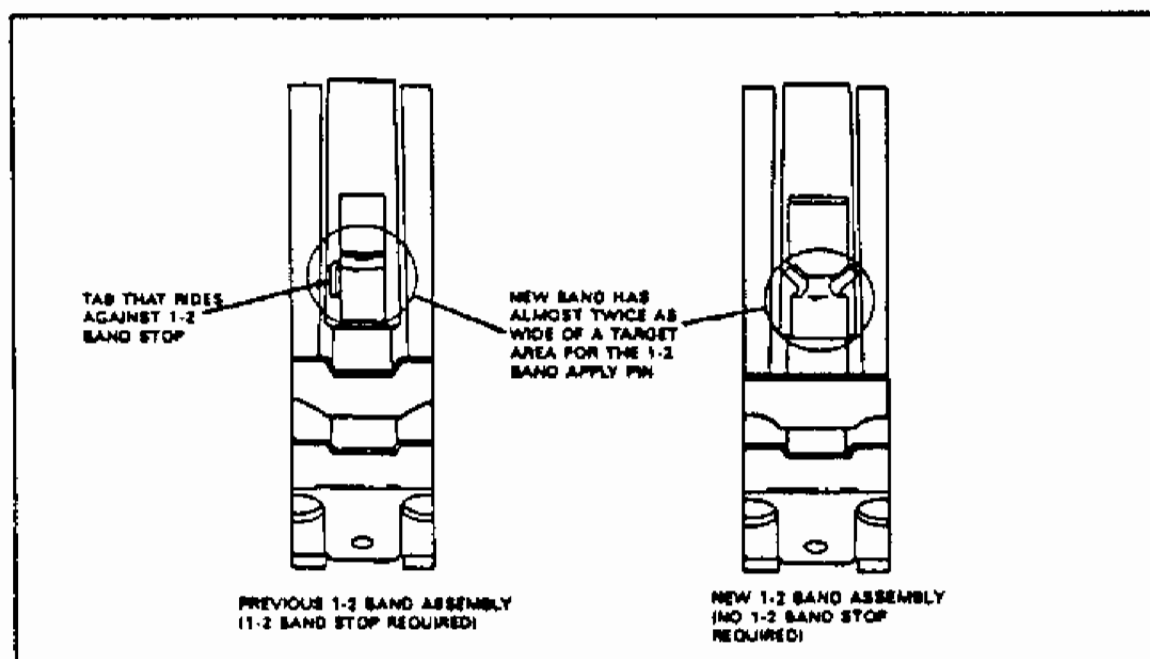
Figure 31

CHANGE: A new style 1-2 Band Assembly (See Figure 31) went into production beginning on January 16, 1990 (Julian Date 016) in all THM 440-T4 transaxles.

- (1) 1-2 BAND ASSEMBLY - The target area on the new 1-2 band, where the band apply pin engages, has been made wider and has "Wings" added to prevent the pin from ever missing the "Target" area (See Figure31).
- (2) 1-2 BAND STOP ASSEMBLY - The 1-2 Band Stop has been eliminated as it is no longer needed (See Figure32).

The new style 1-2 Band Assembly can be used to service ALL past models, but the 1-2 Band Stop MUST be removed and discarded (See Figure32).

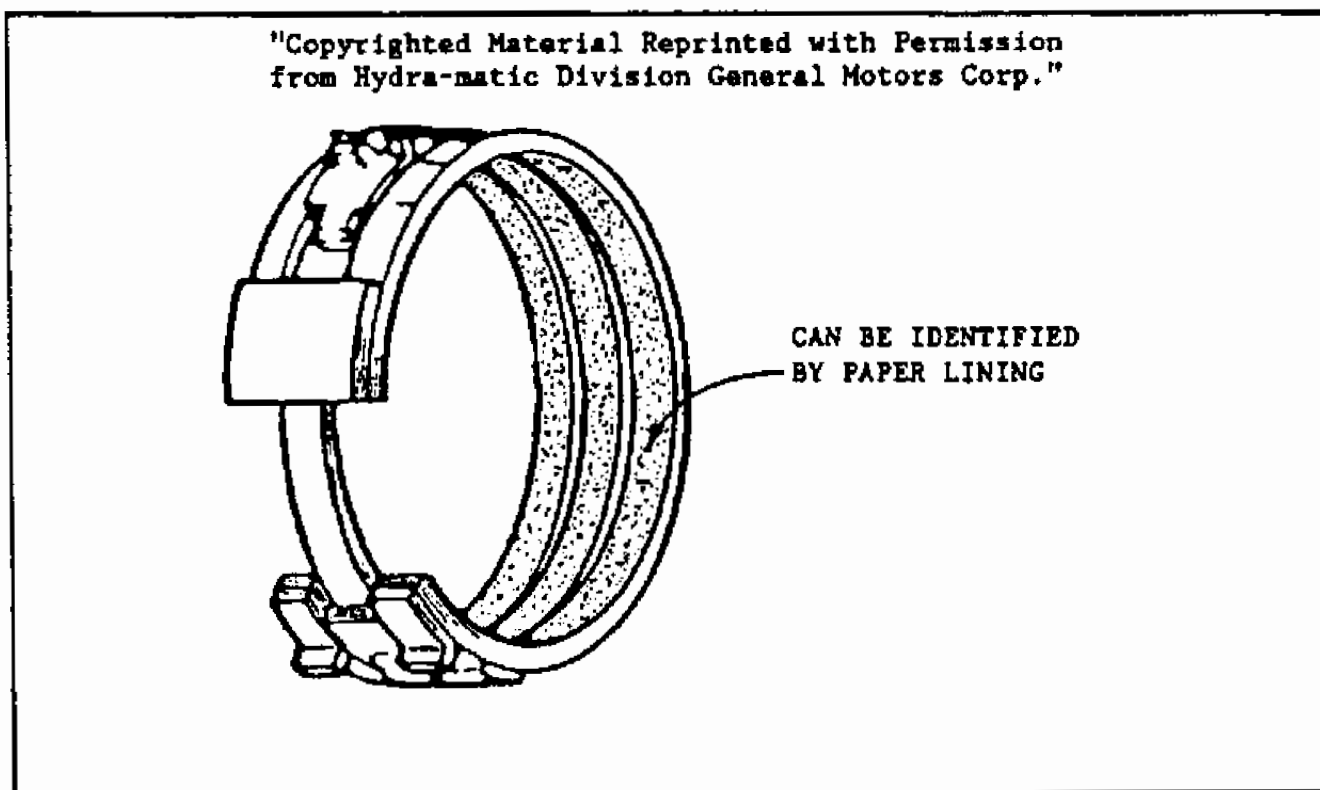
Figure 33

- (1) **REVERSE BAND ASSEMBLY** - The lining on the reverse band has once again been changed, and can be identified by the "Paper" lining on the band itself (See Figure 33).

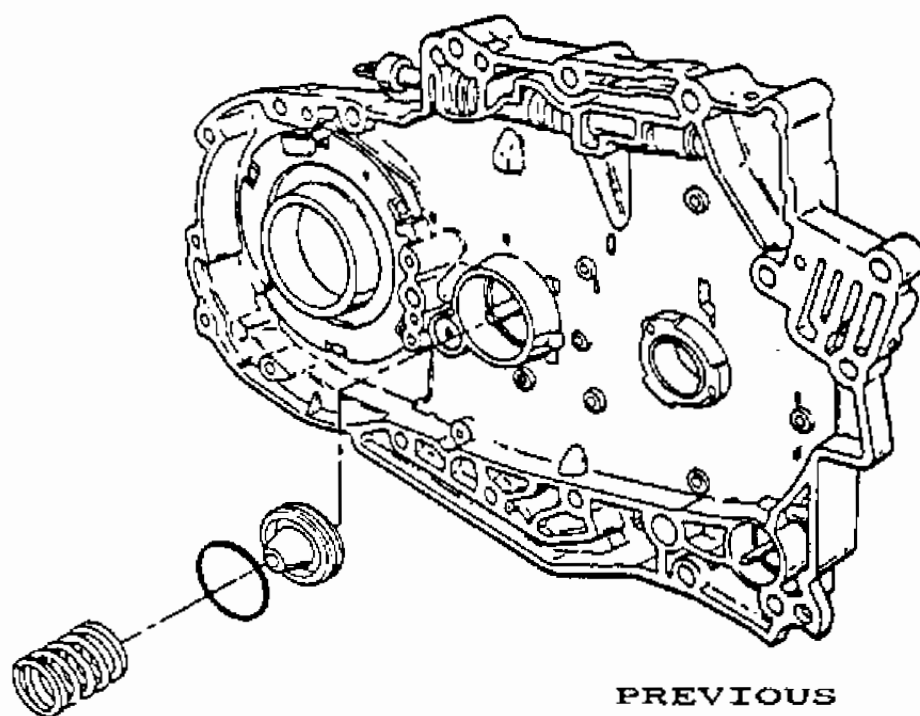
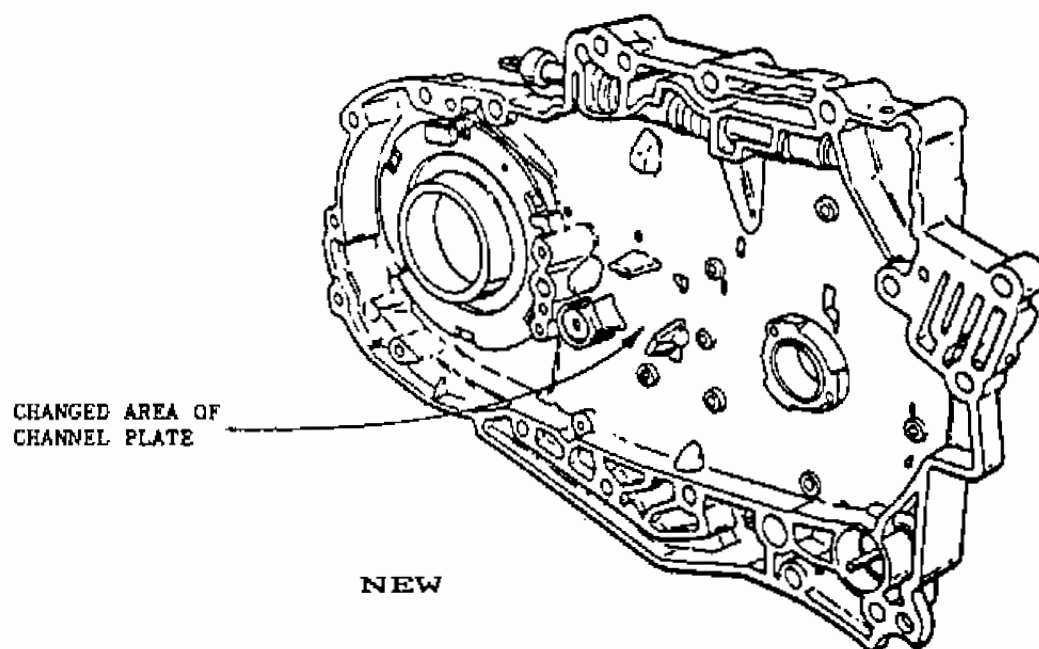
Figure 34

CHANGE: The Input Clutch Accumulator has been eliminated from the channel plate (See Figure 34).

NOT RECOMMENDED TO INTERCHANGE WITH PREVIOUS MODELS.

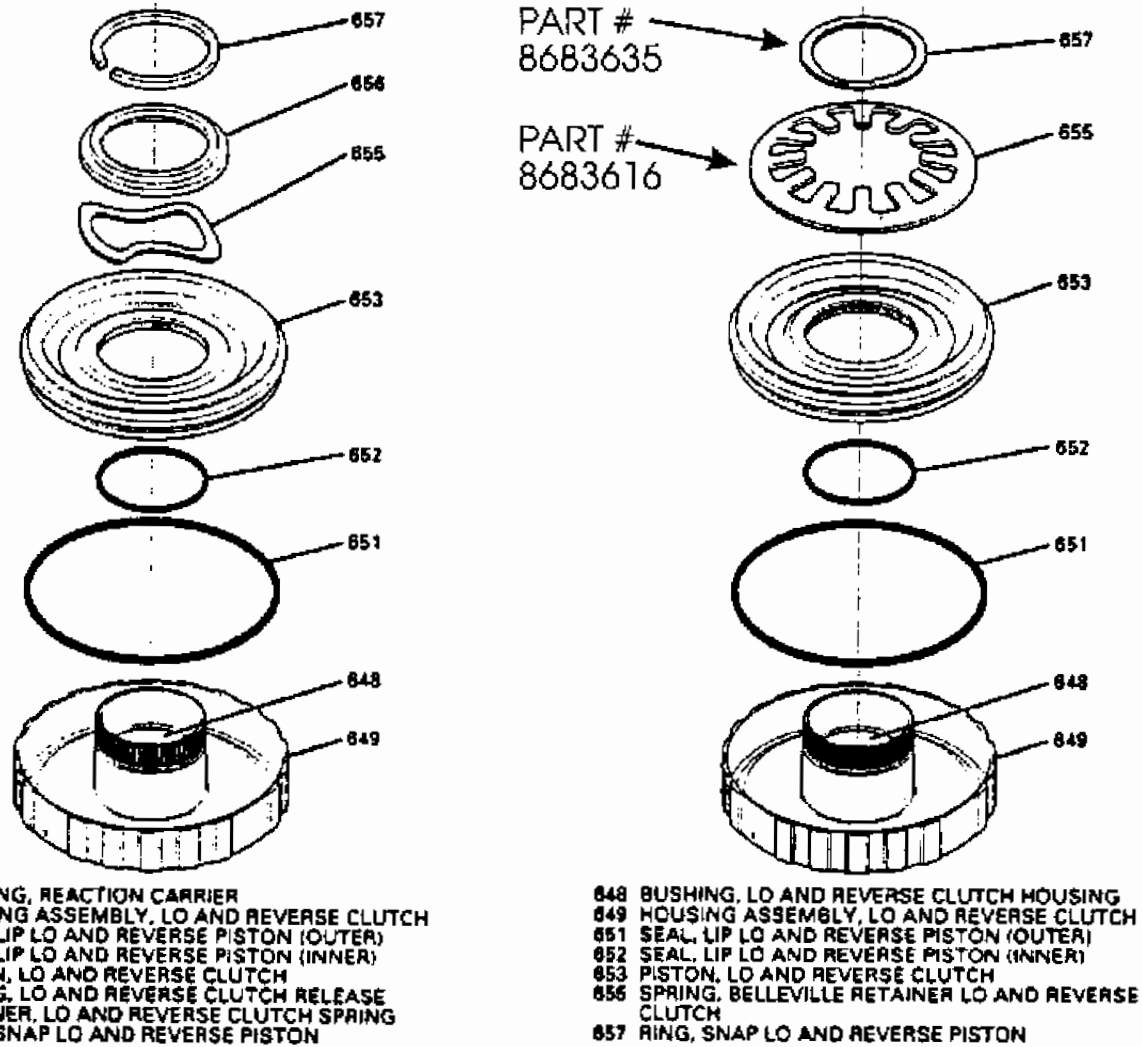
Figure 38

- (1) LOW/REVERSE RETURN SPRING - Changed to the "Belleville" design instead of the previous "Wave" design, and the spring retainer is eliminated.
(See Figure38).
- (2) LOW/REVERSE RETAINING RING - Changed to a spiral retaining ring instead of the previous snap ring (See Figure38).

NOTE: NO CHANGES WERE MADE TO THE HOUSING OR PISTON.

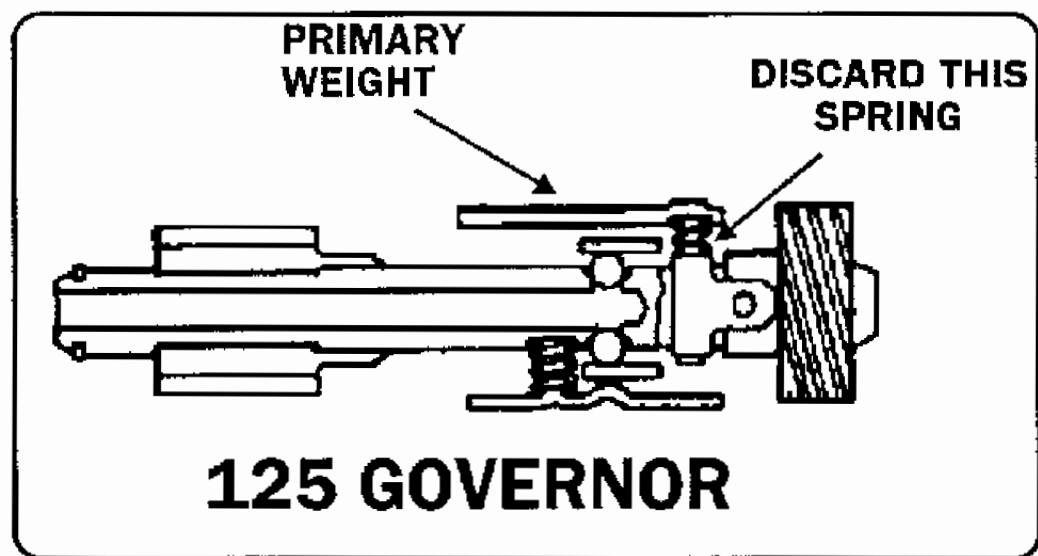
Figure 1.

CAUSE: If the valve body and the auxillary valve body are not mismatched, the problem may be a poor compression of the valve body gaskets. This will send too much oil to the governor.

CORRECTION: Re-torque All of the 6 mm. valve body bolts to 8 Ft Lbs. and All of the 8 mm. valve body bolts to 18 Ft. Lbs. If 2nd gear starts are still a problem, remove the spring from the "primary"(Large) weight of the governor and discard it. (See Figure 1)

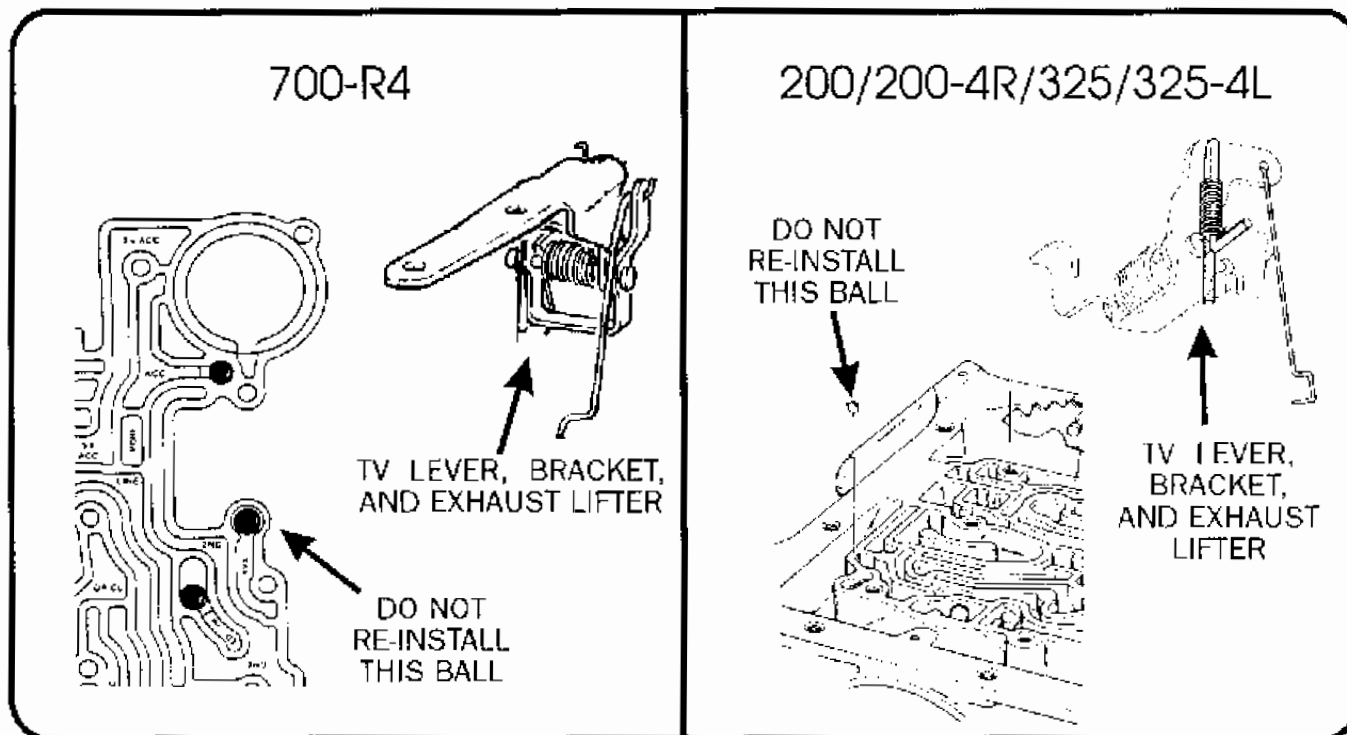
Figure 1

- COMPLAINT:** Very late upshifts which cannot be changed by adjusting the TV cable. If a pressure test is performed, all pressures will be high.
- CAUSE:** The TV exhaust lifter on the Throttle valve linkage may not be keeping the TV exhaust ball (See Figure 1) off of its seat. This ball will cause high line pressure and late shifts if it is permitted to block the metered exhaust passage in the valve body.
- CORRECTION:** Remove the valve body and spacer plate and discard the TV exhaust ball. During an overhaul do not reinstall this ball in the case.

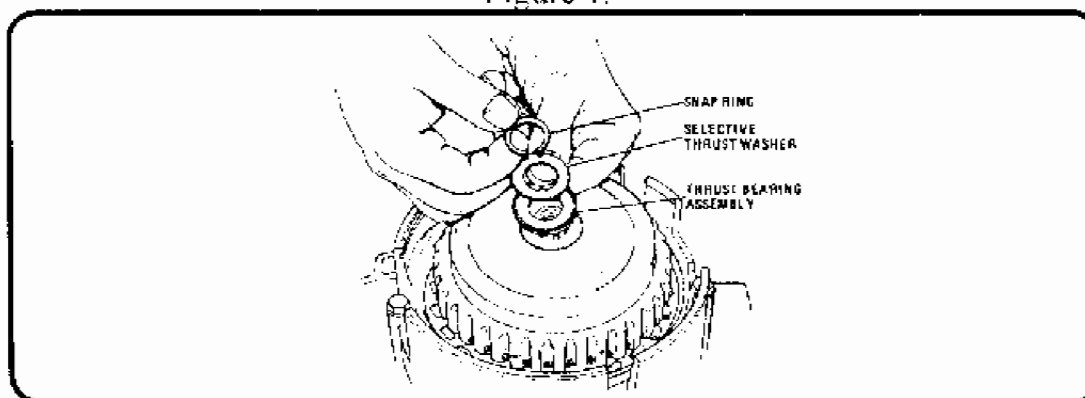
Figure 2.

COMPLAINT: After an overhaul, a 325-4L transmission returns with the overdrive ring gear broken. There may be no apparent cause as these parts may have checked out as good during the overhaul, and everything else looks okay.

CAUSE: The cause may be that the overdrive clutch housing is not centered on the case cover. When the overdrive clutch housing is not centered, excessive side force is applied to the drive sprocket by the overdrive carrier. This jams the carrier gear into the ring gear causing the explosion.
