TIME OUT

INTRODUCTION

THM 4L60 (700-R4) SOFT UPSHIFTS AND OTHER THINGS

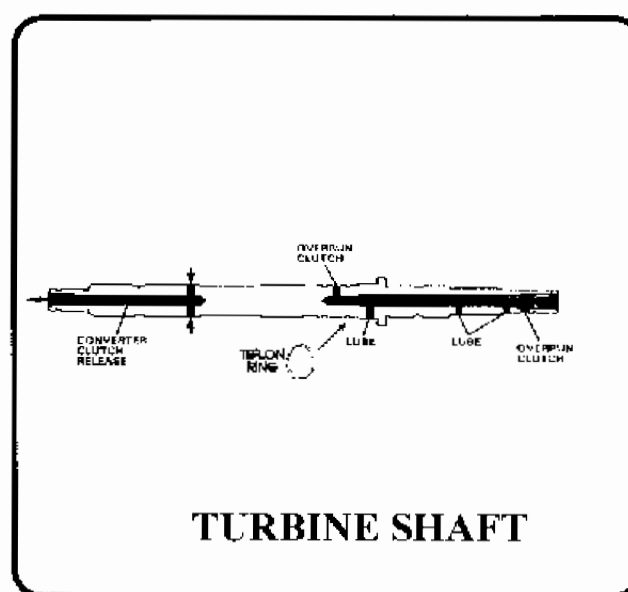
Figure 2.

COMPLAINT: Overdrive Carrier, sun gear, and roller clutch burnt up and/or broken into pieces.

CAUSE: Loss of lube oil to the overdrive carrier area. If the solid teflon sealing ring located on the rear of the sprocket support is damaged or missing, **See Figure 1.** lube oil will not be able to get to the overdrive carrier. Also if the steel sleeve in the drive sprocket support has moved toward the overdrive carrier, lube oil will be blocked to the overdrive carrier resulting in destroyed gears. If the turbine shaft teflon rings are damaged or have worn grooves in the sprocket support, lube oil will be lost. **See Figure 2.**

CORRECTION: Check the seal on the turbine shaft to make sure that it fits properly into sprocket support sleeve, and that the sleeve is not grooved. Carefully check the sprocket support where the steel sleeve is pressed in at the rear. If there is evidence that the sleeve may have moved, then the sprocket support should be replaced. Next, check the solid teflon ring on the rear of the sprocket support for wear or damage. Replace as necessary. It is a good idea to blow air through all of the passages shown in **Figure 1** to assure that there are no restrictions.

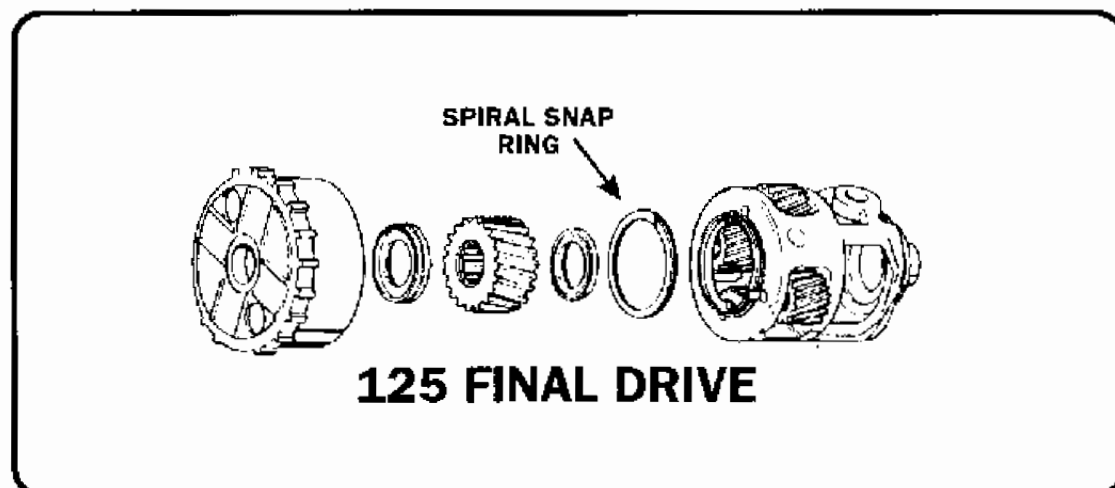
Figure 2.

COMPLAINT: The intermediate roller clutch outer race retainer snap ring pops off and the roller clutch fails. **See Figure 1.**

CAUSE: During a forced 4-2 downshift, the forward clutch may not reapply fast enough. An overspeed condition of the reverse drum will occur causing the snap ring and retainer to blow off of the drum.

CORRECTION: Replace the roller clutch and install an "acquired" spiral snap ring. The spiral snap ring from a 125 or 440-T4 final drive (See Figure 2), will usually work fine. On some reverse drums it may be necessary to file the snap ring groove slightly.

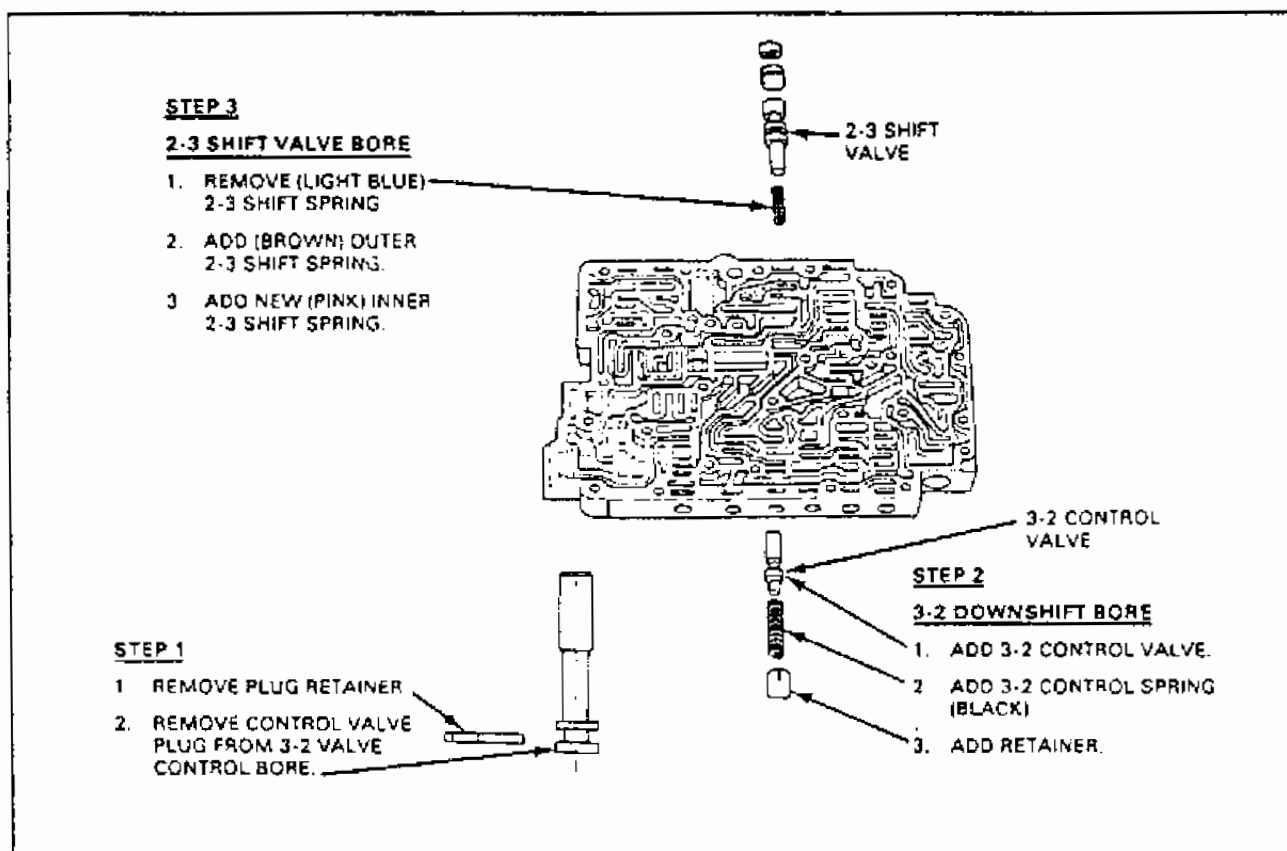
Figure 1

CAUSE: The cause may be shift point variances in the 2-3 upshift and the 3-2 downshift pattern.

CORRECTION: Install a new design main control service kit, OEM part number E6FZ-7A230-A, that revises the part throttle 2-3 upshift and 3-2 downshift pattern. Refer to the following procedure.

1. Remove and discard the 3-2 control valve plug and retainer. (See Figure 1)
2. Install the new 3-2 control valve, control valve spring, and flat plate retainer from the main control service kit. (See Figure 1).
3. Replace the 2-3 shift valve spring with the two spring "Nested" assembly from the main control service kit (See Figure 1).

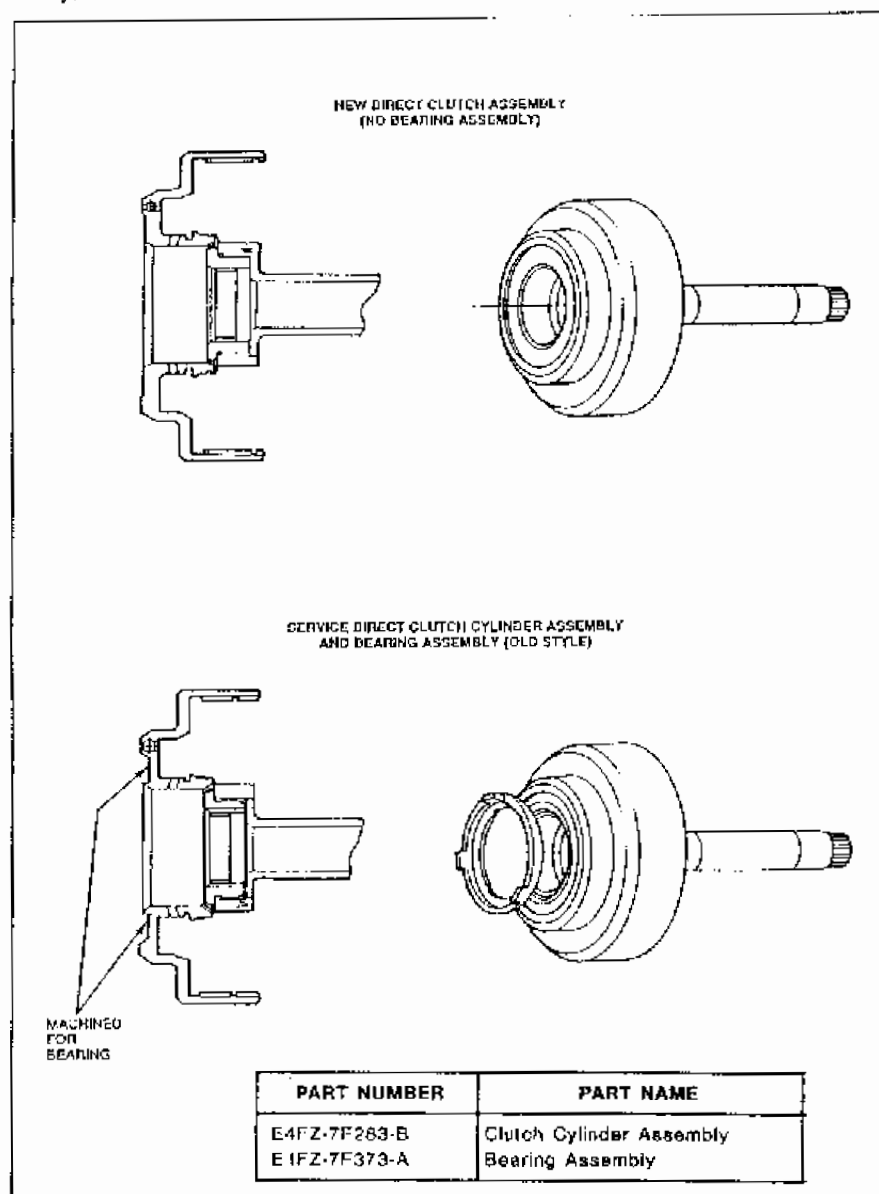
Figure 1

ISSUE: A new direct clutch assembly is currently in production which does not require a direct clutch bearing, Figure 1. For service, the only available direct clutch cylinder will be the cylinder which requires a bearing assembly.

CAUTION: FAILURE TO USE THE BEARING ASSEMBLY WITH THE MACHINED CYLINDER (E4FZ-7F283-B) WILL RESULT IN DAMAGE TO THE INTERMEDIATE CLUTCH ASSEMBLY.

ACTION: If direct clutch cylinder replacement is required, it must be replaced with a clutch cylinder assembly and bearing assembly.

NOTE: THE BEARING (E1FZ-7F373-A) WILL ALSO REMAIN AVAILABLE FOR SEPARATE PURCHASE.

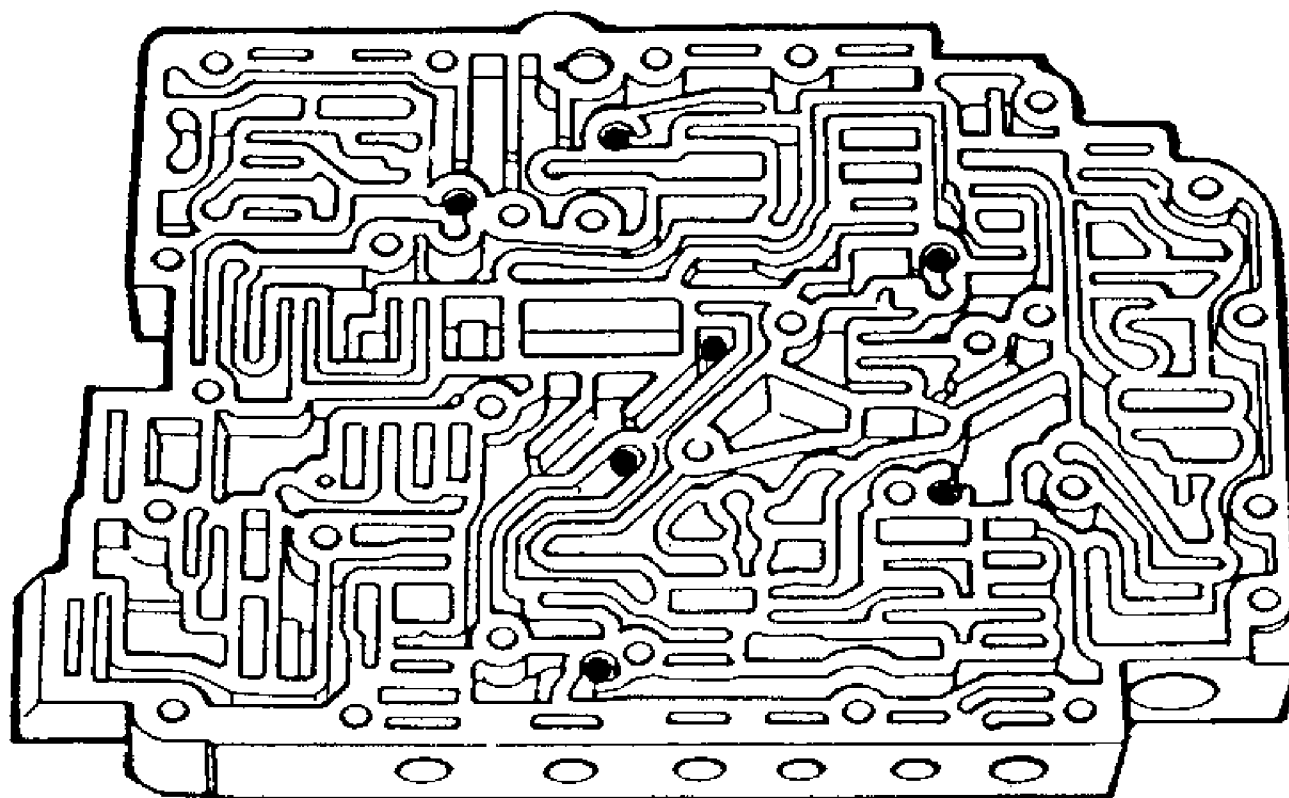
Figure 3

The number of main control check balls and their locations for the ATX transaxle as published in the 1989 Tempo/Topaz-Escort Car Shop Manual, Section 17-25-82 is incorrect. The correct number of main control check balls for the 1.9L ATX transaxle is seven (7) not six (6). Failure to install the seventh check ball will cause a harsh 2-3 upshift.

These valve bodies require seven (7) checkballs placed in the locations shown in Figure 3, and is for following vehicles:

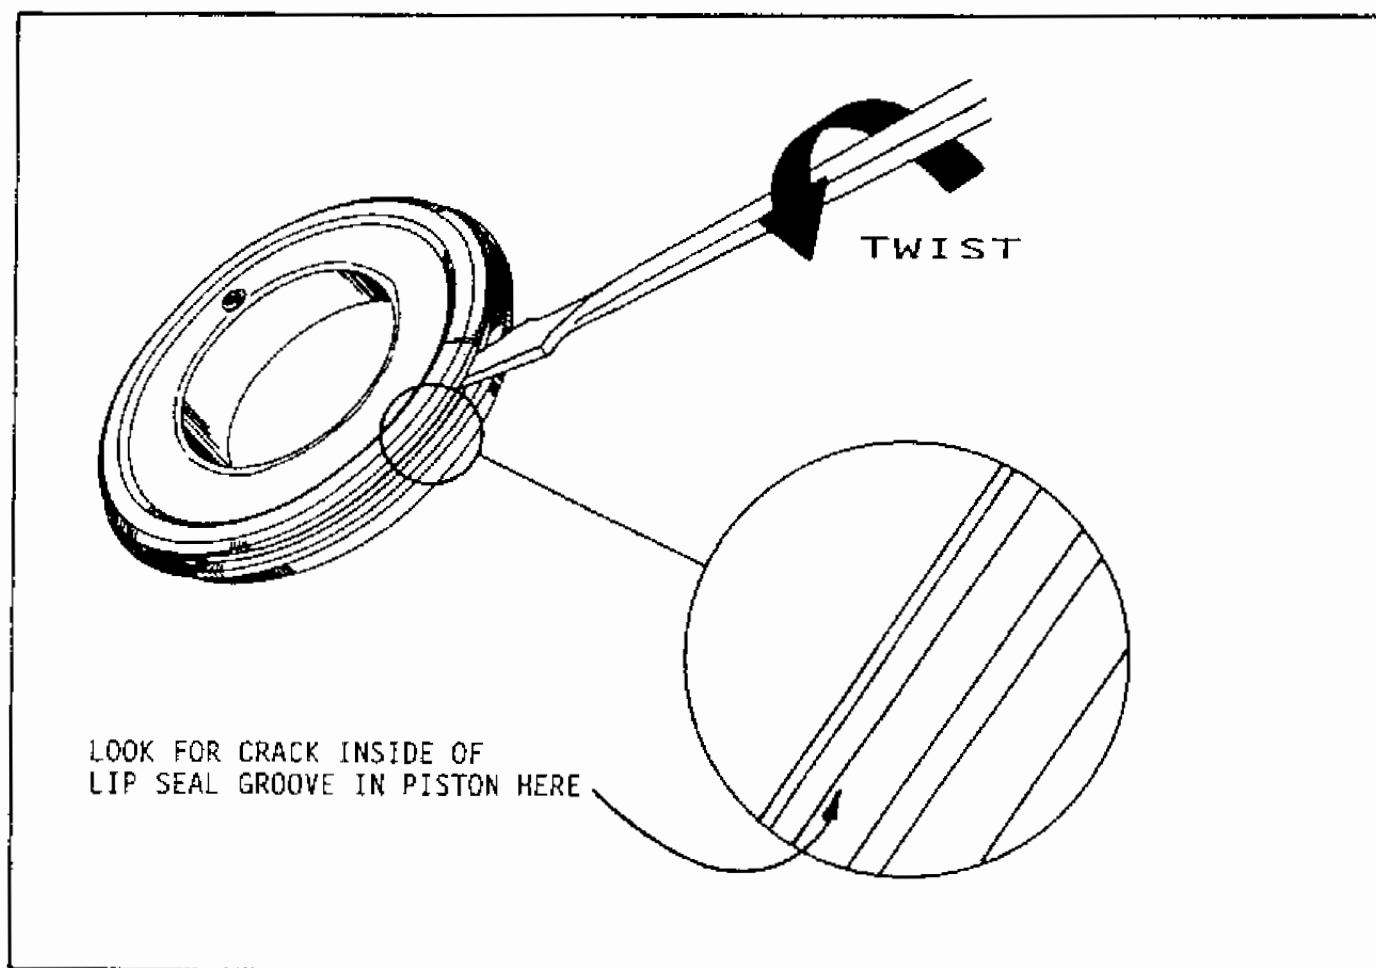
Figure 1

COMPLAINT: Flare or slip on 2-3 shift, or premature failure of direct clutches.

CAUSE: The cause may be a cracked direct clutch piston. For procedure to check the piston, see Figure 1.

CORRECTION: Replace the direct clutch piston.

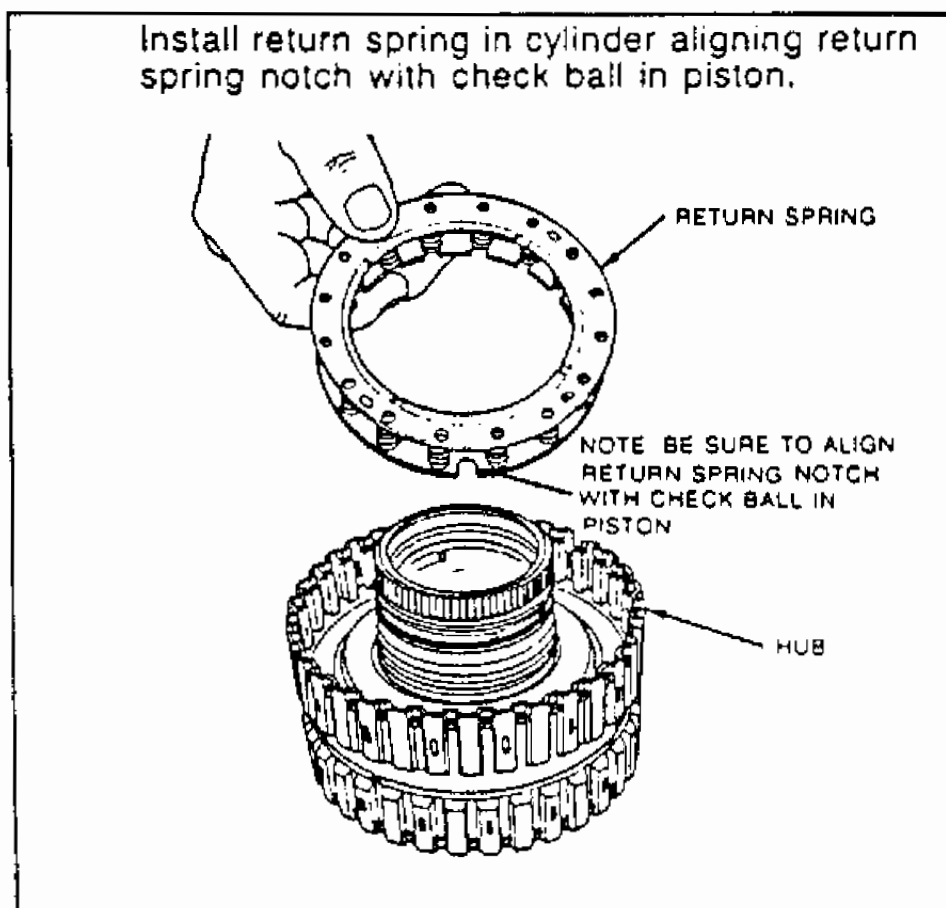
Figure 1

COMPLAINT: An extended 3-4 shift with possible direct clutch failure or a NO 3-4 shift condition.

CAUSE: This condition may be caused by a partially or fully blocked oil flow of the direct clutch piston check ball.

CORRECTION: Special care must be taken during the overhaul operation when re-assembling the direct clutch return spring over the direct clutch piston. Make sure that the notch in the spring bottom retainer (See Figure 1) is positioned properly over the check ball so it will not block or restrict oil flow of the piston check ball assembly. Refer to Figure 1.

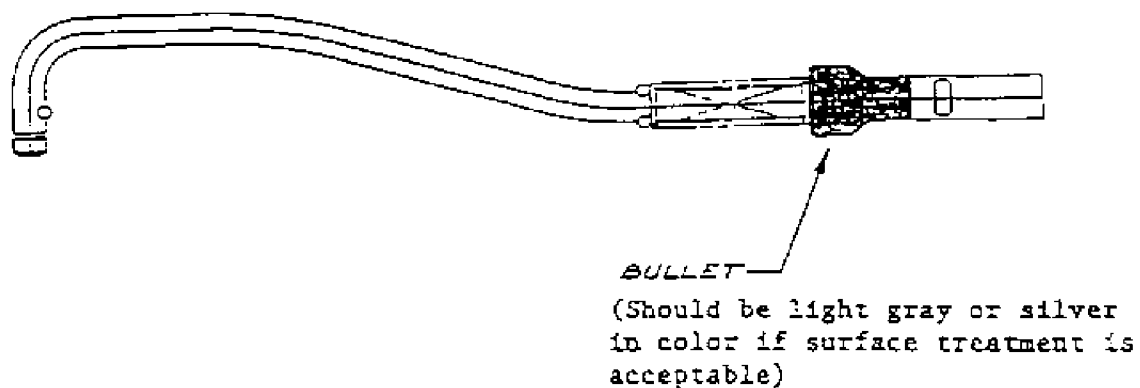
Figure 1

Inspect shift cable and linkage for proper routing and adjustment. If routing and adjustment are proper, the condition may be due to improper surface finish of the bullet end of the park sprag rod (Figure 1).

NOTE: Only transaxles built between 12-2-81 and 7-12-82 with serial numbers 7432-XXXX to 7654-XXXX are suspect for this condition.

1. Remove the transaxle oil pan.
2. Remove the "E" clip retaining the park sprag rod to the valve body (Figure 2).
3. Remove the park sprag rod from the transaxle assembly and inspect the bullet end of the rod (Figure 1). If the bullet end surface is dark blue or black, replace the park rod assembly with PN 4207130 containing a bullet that is silver or light gray in color.
4. Reinstall "E" clip, install the transaxle oil pan, and refill with automatic transmission fluid.

NOTE: The manual shift lever (at the transmission) may have been bent if the vehicle operator has attempted to force a transmission with an improperly finished rod out of the park position. Therefore, after replacing the park sprag rod, check the shift lever and replace if lever is bent.

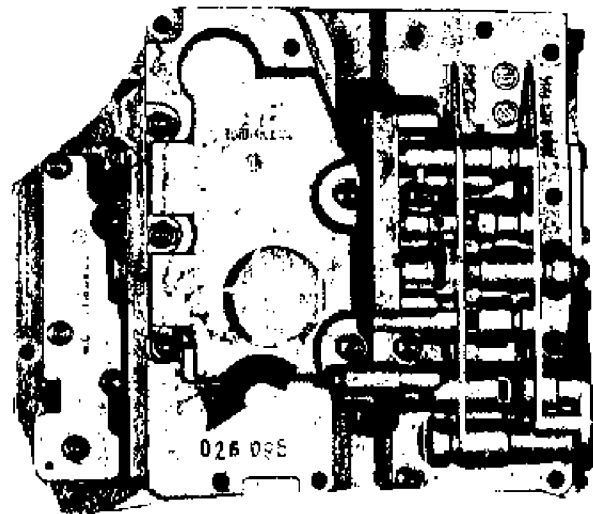
Figure 1.

- CAUSE:** Because the Forward (A) clutch must be re-applied on the 4-3 downshift, the cause may be that the Forward clutch accumulator orifice may be too large or new clutch material differences may affect the rate of clutch application, causing a harsh feel.

See arrow on cover to locate identification numbers.
Production numbers beginning with 026 or 132 are early model.
Production numbers beginning with 052, 068, or higher are late model.

- CORRECTION:** The Forward (A) clutch accumulator orifice has been reduced in later valve bodies. To determine the update level of the valve body, refer to the first three numbers stamped on the filter cover. **See Figure 1.** If the valve body is the early style with either the 026 or 032 filter cover, check the valve body orifice (A) and reduce it as necessary to .047 in. **See Figure 2.** If this does not correct the problem, or if the valve body filter cover is 052, 068, or higher, then it will be necessary to install a lighter spring into the Forward (A) clutch accumulator. The pressure regulator spring from a 350 valve body will fit nicely and soften the clutch as it reapplies during a coast downshift. **See Figure 3** for the location of the Forward (A) clutch accumulator.
