"2006" SEMINAR INFORMATION

AUTOMATIC TRANSMISSION SERVICE GROUP

"Top Tech Tricks for 2006"

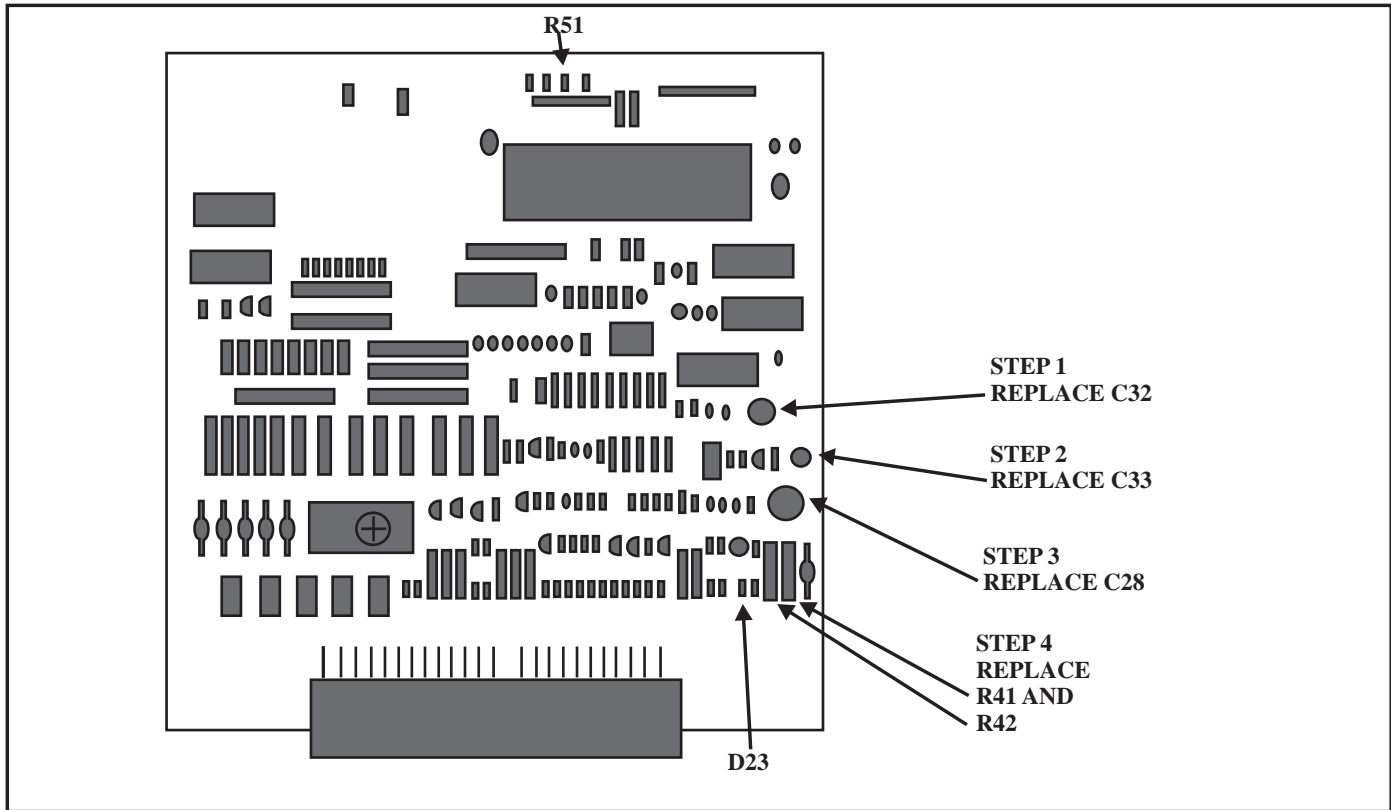
Figure 1

CAUSE: One cause of this problem is a bad computer. A specific logic circuit has fried due to other problems in the power supply section of the computer.

"S" OR "D4" LIGHT ALWAYS ON AND STUCK IN HIGH GEAR

CORRECTION: Repair the affected areas of the computer, or replace the computer.

- Step 1: Remove and replace C32 with 330 μ F Capacitor (see figure 1)
- Step 2: Remove and replace C33 with 33 μ F Capacitor (see figure 1)
- Step 3: Remove and replace C28 with 220 μ F Capacitor (see figure 1)
- Step 4: Remove and replace R41 and R42 with 15 Ohm 1/2 Watt resistors (see figure 1)
- Step 5: Solder a Jumper wire from the trace where pins 1 and 14 of the main connector are, and the small pad in the middle of the ground plane where R51 is connected. (see figures 2 and 3)
- Step 6: Make a solder bridge between the ground plane and the next trace in (which goes to the top of the board, then to R51) (see figures 2 and 3)
- Step 7: Make a cut in the trace you just bridges to just above the bridge. (see figures 2 and 3)
- Step 8: Make a cut in the trace that starts at D23 (see figures 2 and 3)

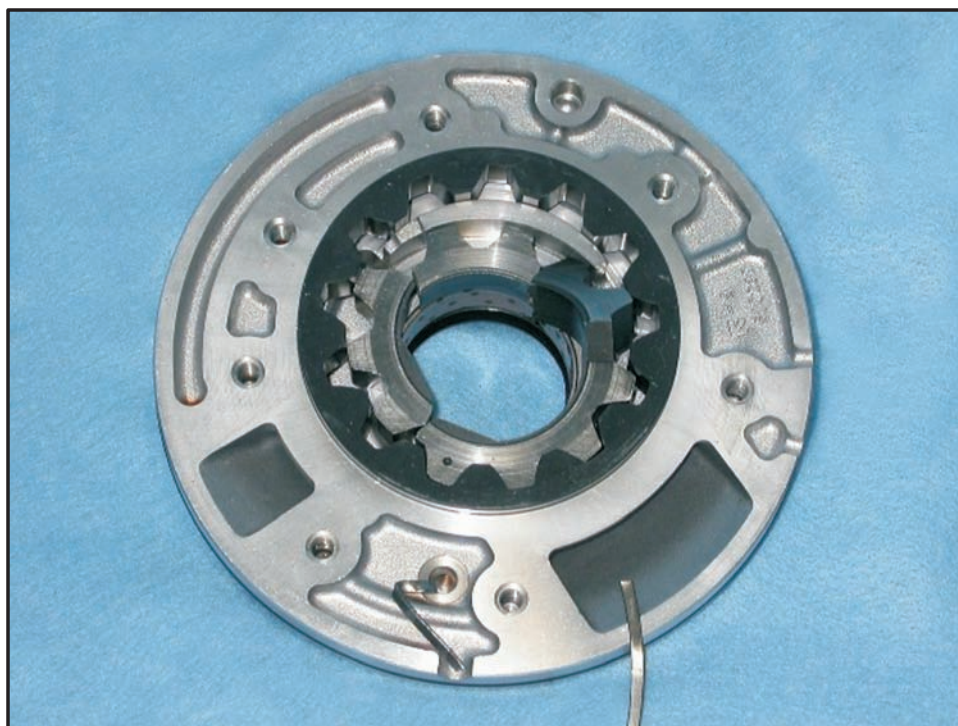
Figure 3

COMPLAINT: Vehicles equipped with the F4A51 transaxle may exhibit a no move condition. Fluid level may read high and condition is described as good.

CAUSE: The cause may be broken pump gears and or severely damaged pump assembly. Pieces of Low/Reverse spiral cushion wave spring (Figure 1) located on top of the Low/Reverse clutch assembly (Figure 2) may be found lodged between the pump gears (Figure 3). When the filter is cut open, there is a 3 to 4 inch section of filter media that is not crimped along edge of filter halves during assembly. This allows the broken wave spring to enter the pump assembly (Figure 4).

CORRECTION: Replace pump and filter. Some after market filters have been found to have no problems with the filter media assembly.

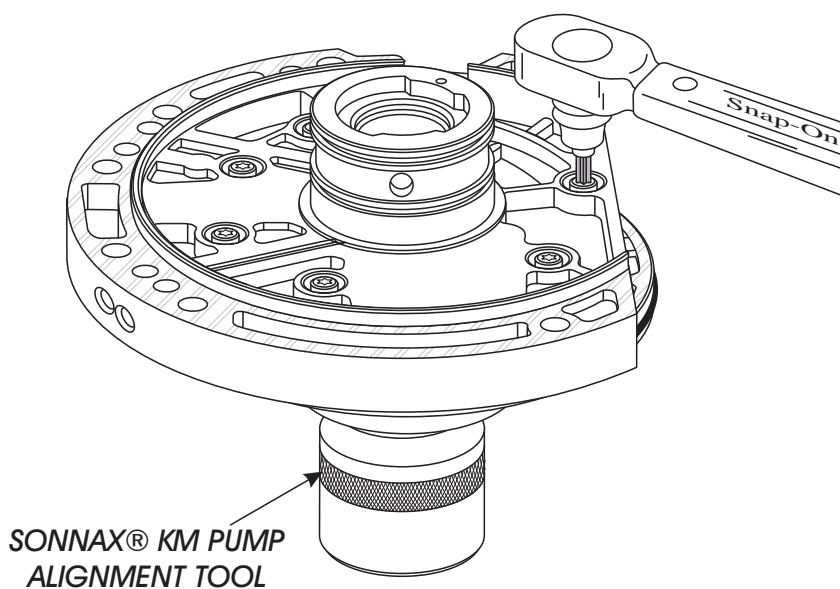
Figure 6

Note: One other issue that plagues this transmission is front seal leak and or damaged pump bushing after rebuild within as little as a few minutes during road test or in a couple of days. The original pump assembly is aligned during manufacturing and there are no leading edges or alignment pins to align the pump. There is an alignment tool available from Sonnax part number #41005-TL (Figure 5). With the alignment tool in place torque the pump bolts to 80 - 85 inch pounds as shown in figure 6.

**TORQUE COVER TO BODY BOLTS TO
9 NM (80 - 85 IN. LB.) WITH THE
ALIGNMENT TOOL IN PLACE**

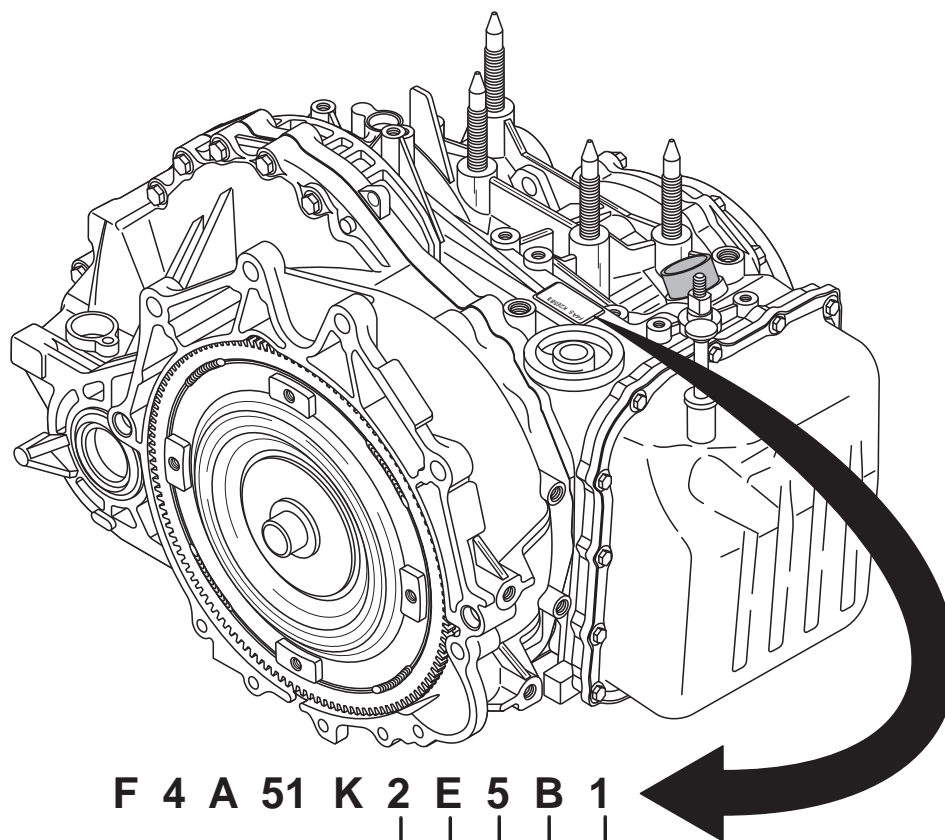
Figure 1

COMPLAINT: Mitsubishi vehicles equipped with the F4A40/50 series transaxle, may exhibit erratic shifts or Diagnostic Trouble Codes related to gear ratio errors, such as P0732, 2nd gear ratio error P0733 3rd gear ratio error, P0734 4th gear ratio error, after transaxle replacement.

CAUSE: The cause may be, a wrong transaxle, or gear train parts, were installed into the vehicle that contained incorrect ratios that are incompatible with the vehicles computer.

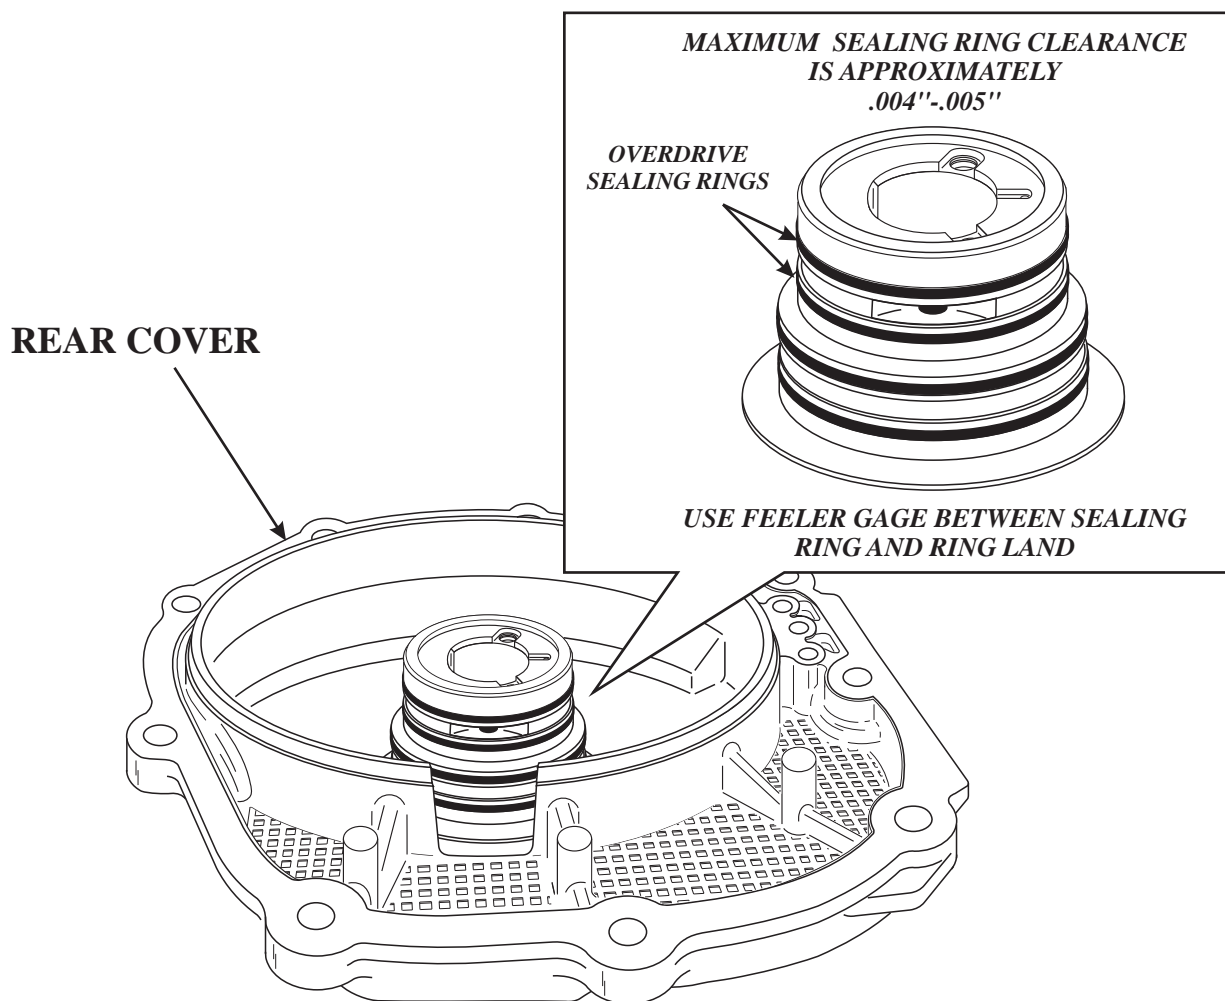
Figure 2

CAUSE: The cause may be, worn sealing ring lands where the Underdrive and or Overdrive Clutch sealing rings ride, creating leakage in the Underdrive or Overdrive Clutch circuit.

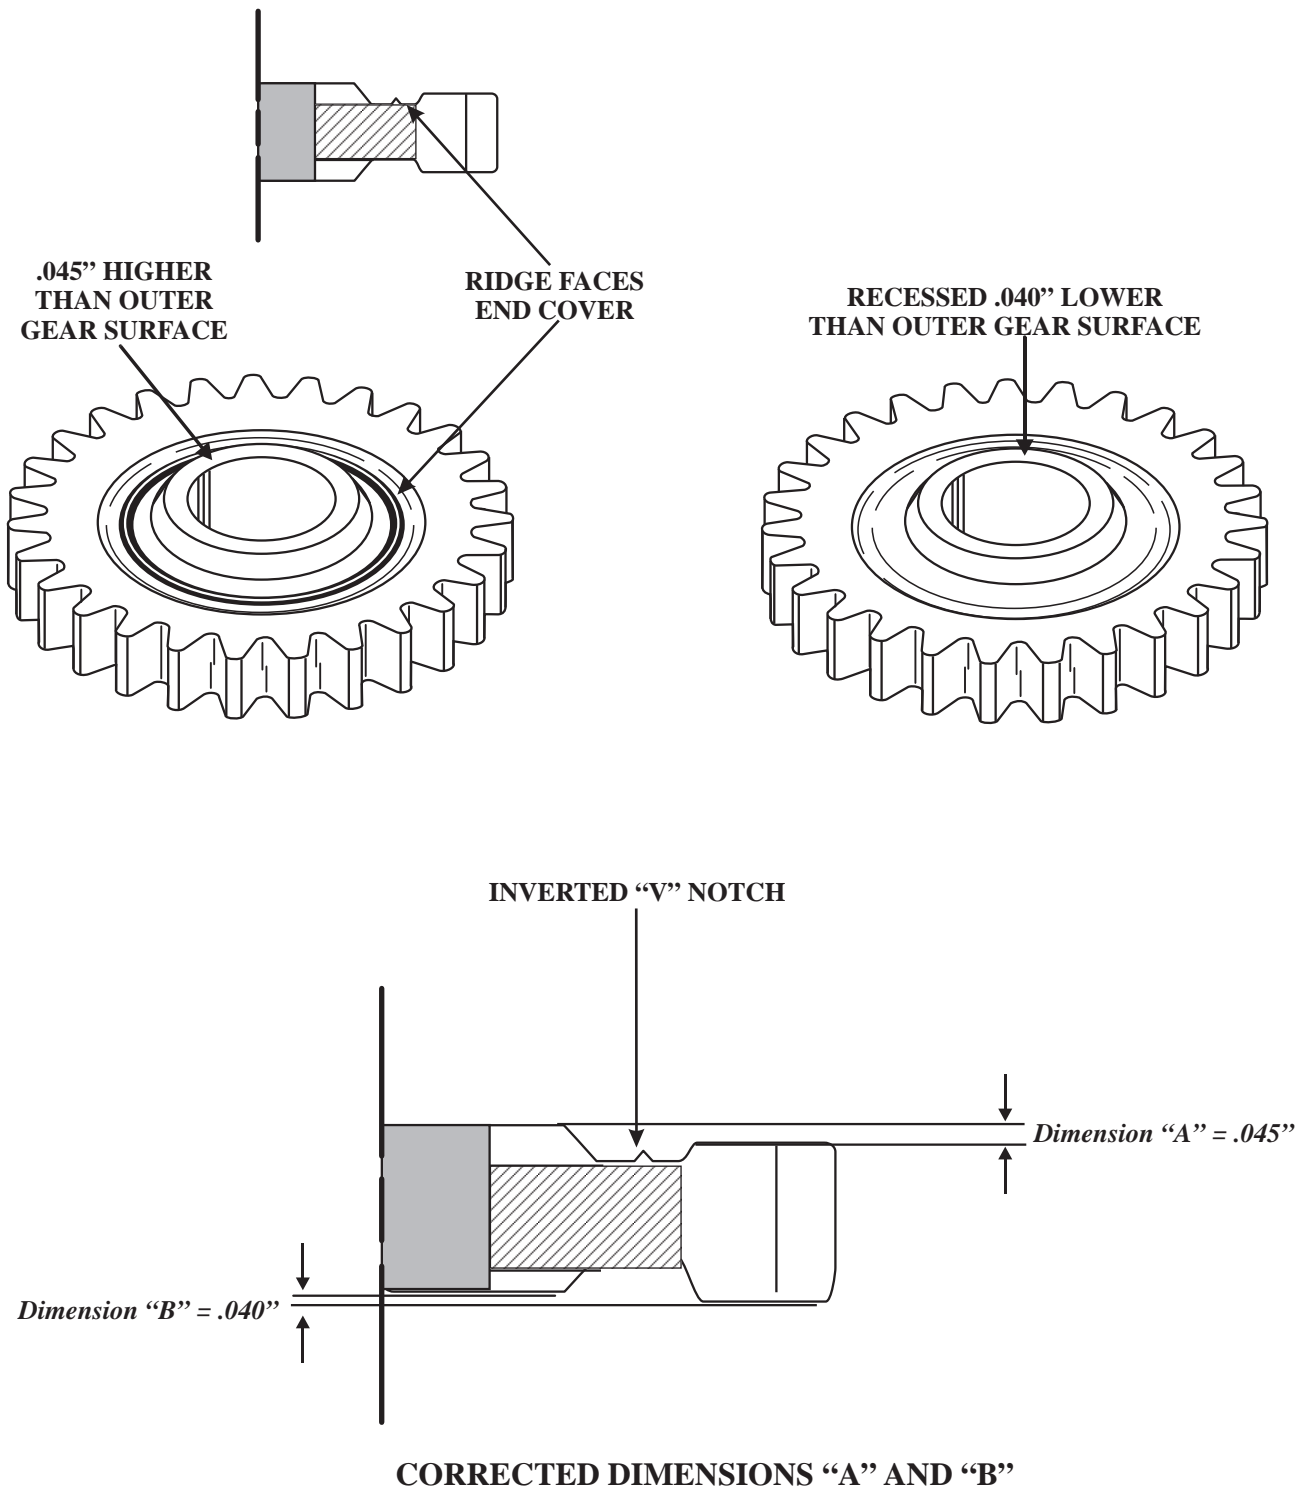
The measurements shown in Figure 2 should also aid in determining in which direction the gear must be installed.

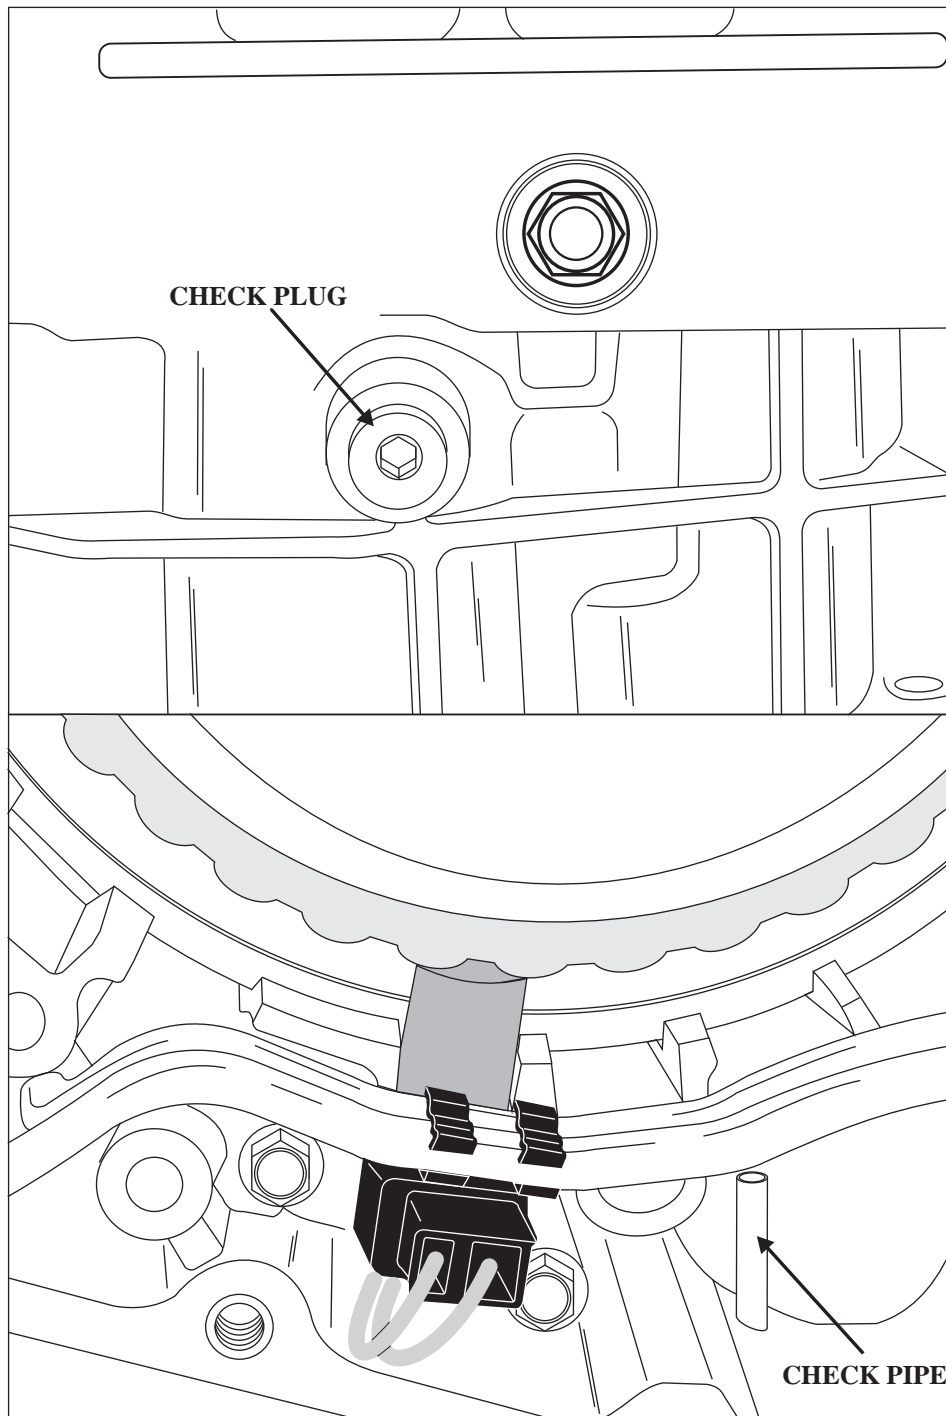
Figure 1

CAUSE: The fill and check plugs are not obviously recognizable, in some instances the fill plug looks like a vent.

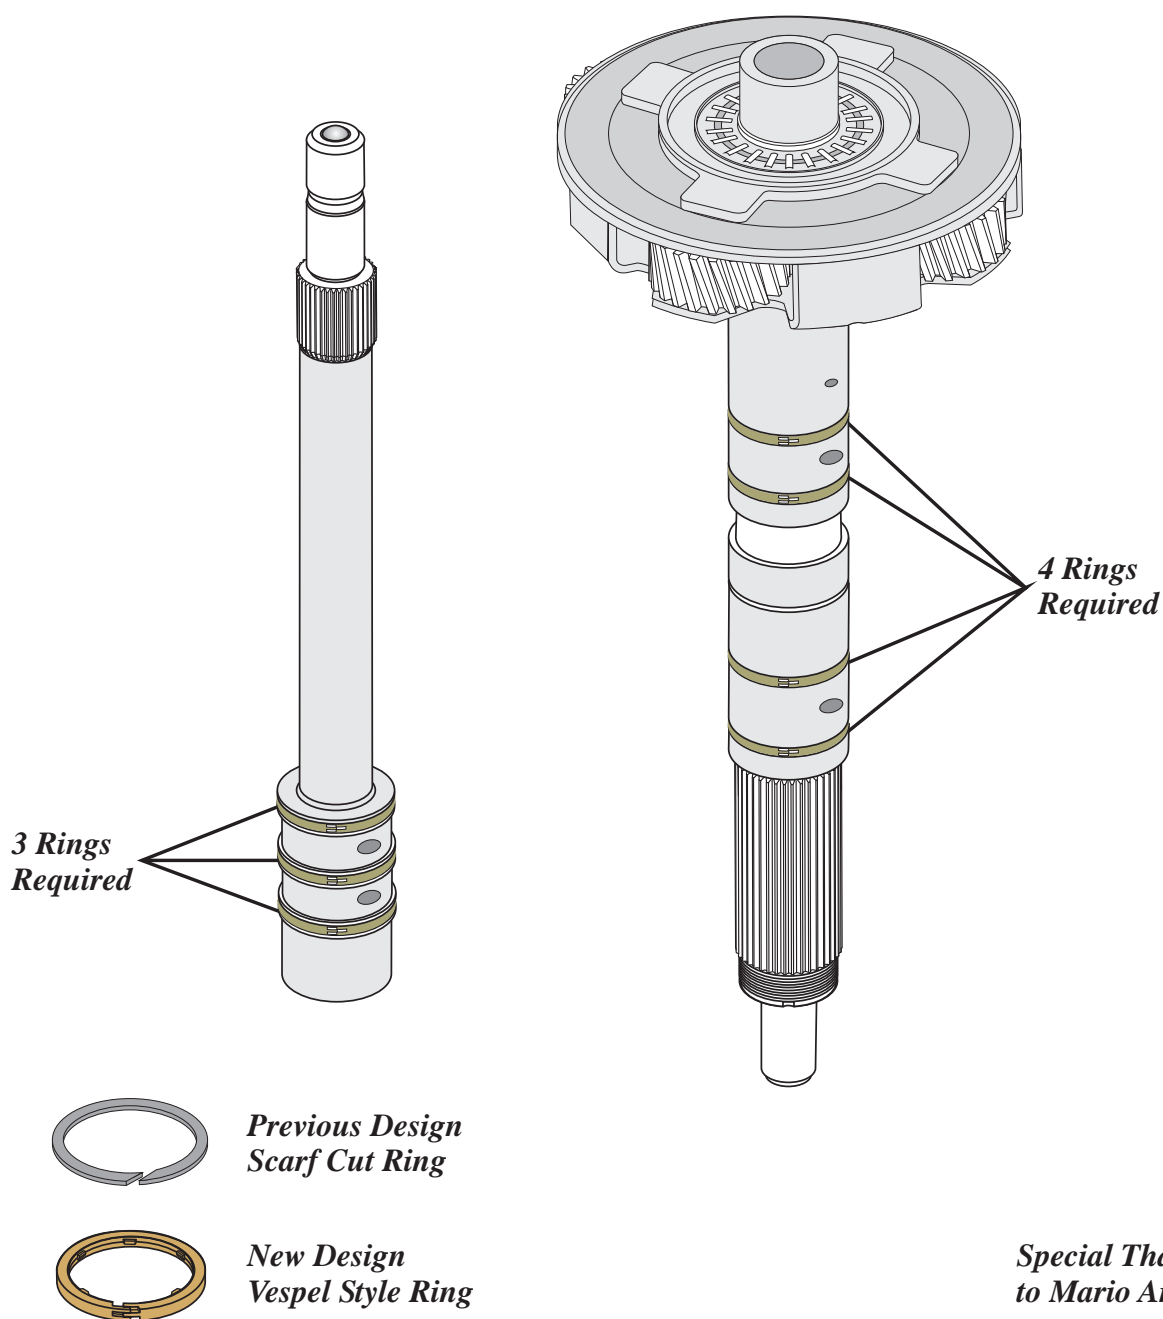
COMPLAINT: Before or after a rebuild, a 722.6 Mercedes transmission may experience one or more shift complaints such as delayed engagements, flared up shifts, flared kick down shifts, implausible ratio codes, coast downshift clunks, TCC slip codes, no movement in reverse and/or no movement forward. It has been determined that the first design Pressure Regulator Control Valve Spring is not broken and when the unit is removed, all frictions look good.

CAUSE: Low retention of OEM scarf cut sealing rings for the K2 clutch drum on the input shaft as well as the output shaft rings for the K3 clutch drum (See Figure 1). The rings on the input shaft could cause a loss of pressure for the K2 clutch and/or the converter clutch while the rings on the output shaft could lose K3 clutch pressure. The severity of the leak would determine the degree of shift complaints.

CORRECTION: Since pressure testing with a gauge is not available, it is highly recommended to update the rings to the newer style as seen in figure 1 and replace the sprags, especially if the F1 sprag has 16 elements and the F2 has 14. These are early sprags and are prone to slipping. Both sprags have been updated to 20 elements each (See Figure 2 and 3).

Input Shaft Rings (3 required) part number only gets you one ring.....220-272-04-55
Output Shaft Rings (4 required) part number only gets you one ring.....220-272-03-55
F1 20 Element Sprag.....A722-270-00-31
F2 20 Element Sprag.....A220-270-01-31
TCM/ETC M112*026-545-84- 32/26
TCM/ETC M113*026-545-73- 32/26
*Mercedes Bulletin 30/99-2 Group 27

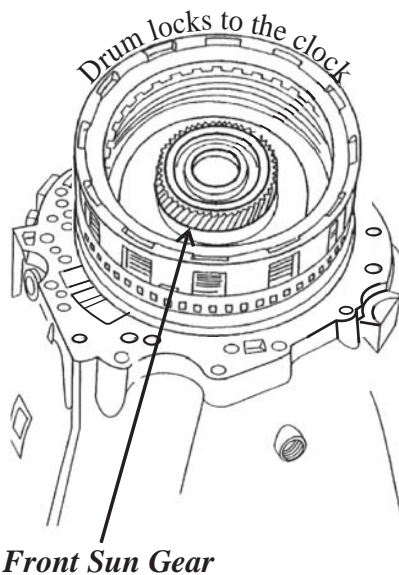
Figure 2

This sprag has been updated from a 16 element sprag to a 20 element sprag. The original plastic sprag body is black while the replacement is brown. Both designs have an arrow embossed into it as indicated above. This arrow points to the pump. When the F1 Sprag is assembled correctly, the K1 clutch drum locks to the clock and freewheels counter clockwise while on the pump tower. The part number for the new sprag is: A 722 270 00 31. The earlier sprag is known to slip causing gear ratio codes.

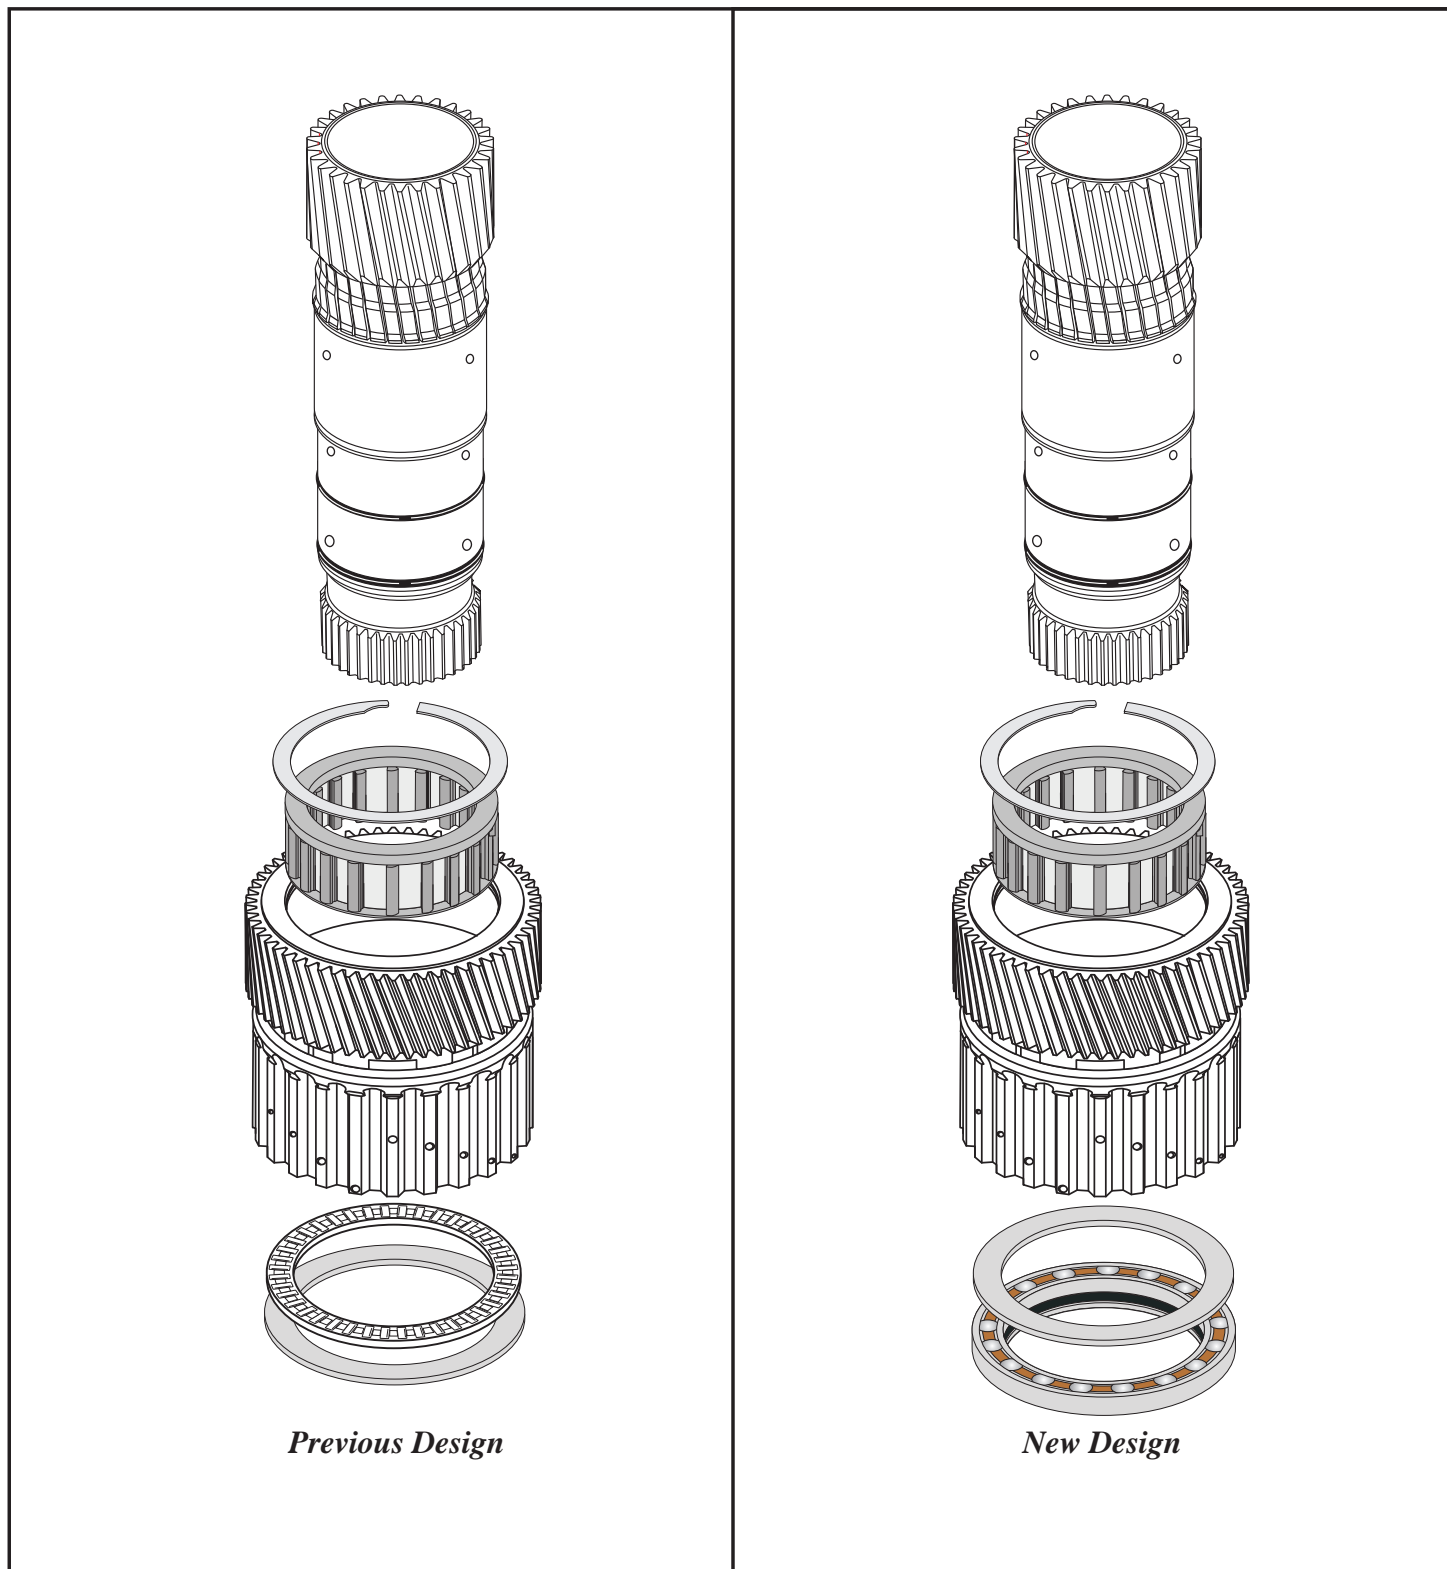
Figure 1

CAUSE: The new design K3 Clutch Hub and Rear Sun Gear have a flat spacer and ball bearing pressed into the hub assembly which replaces the previous design open face needle bearing and washer design (See Figure 1). In many cases, a brand new K3 clutch hub did not have the bearing fully pressed into the hub up against that flat spacer. This prevents the hub from being positioned correctly causing the insufficient clearance for the final retaining snap ring (Figure 2).

CORRECTION: Fully seat the bearing into the K3 Hub Assembly.

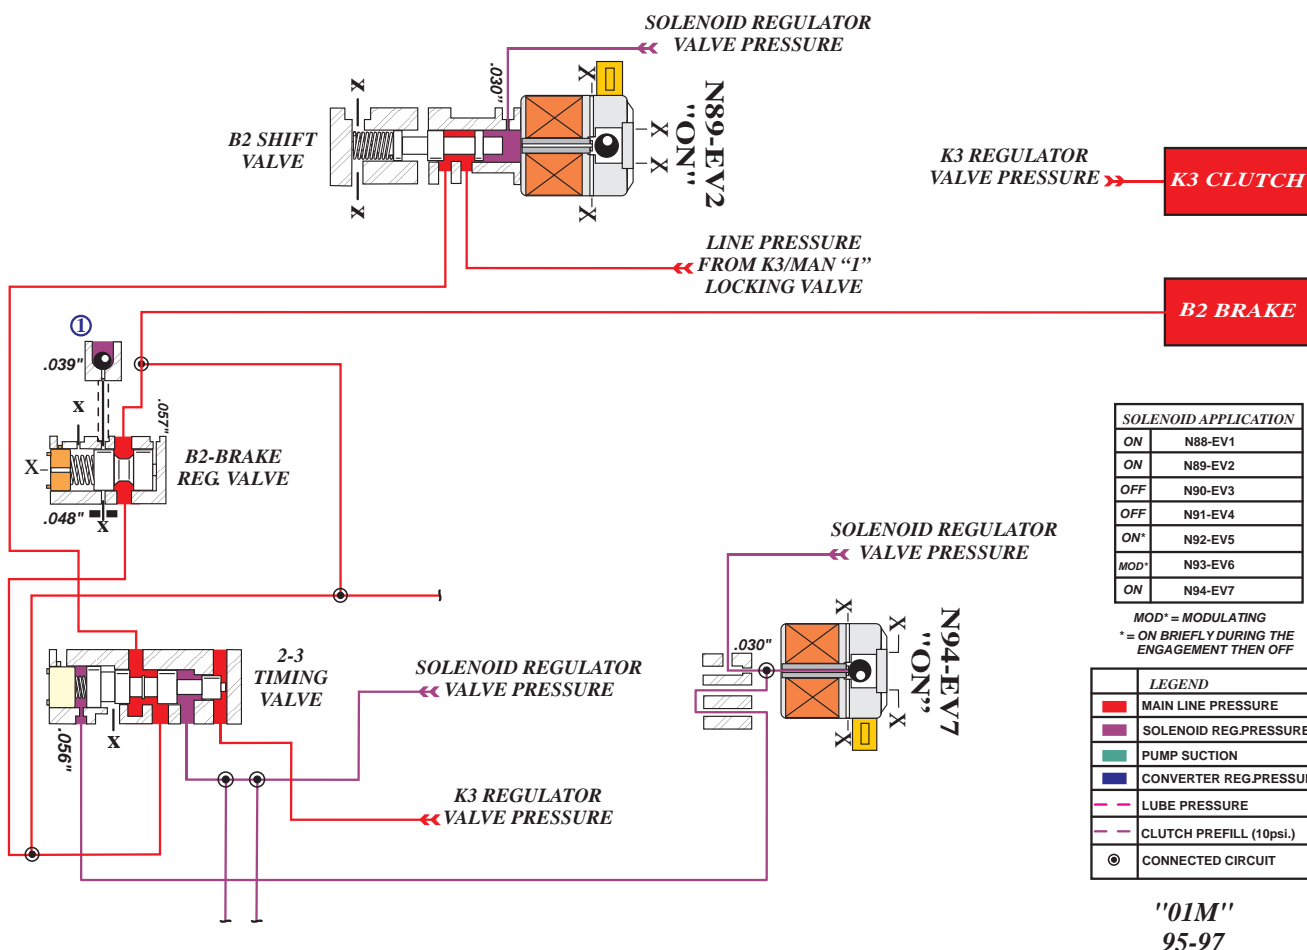
Figure 1

This partial hydraulic schematic shows an intact hydraulic circuit without a leak. Solenoid Regulator Valve pressure is fed to Solenoid Valve EV7. The solenoid is energized and closed by an electrical signal causing pressure to build which is then sent to the spring side of the 2-3 Timing Valve; this assists the spring in keeping the 2-3 timing valve in a closed position. Line pressure from the K3/Manual 1 Locking Valve is fed to Solenoid Valve EV2 which is also energized and closed by an electrical signal allowing line pressure to pass through the valve and then be directed to the 2-3 Timing Valve. Once line pressure passes through the 2-3 Timing Valve, it flows to the B2 Regulator Valve and on to apply the B2 Brake

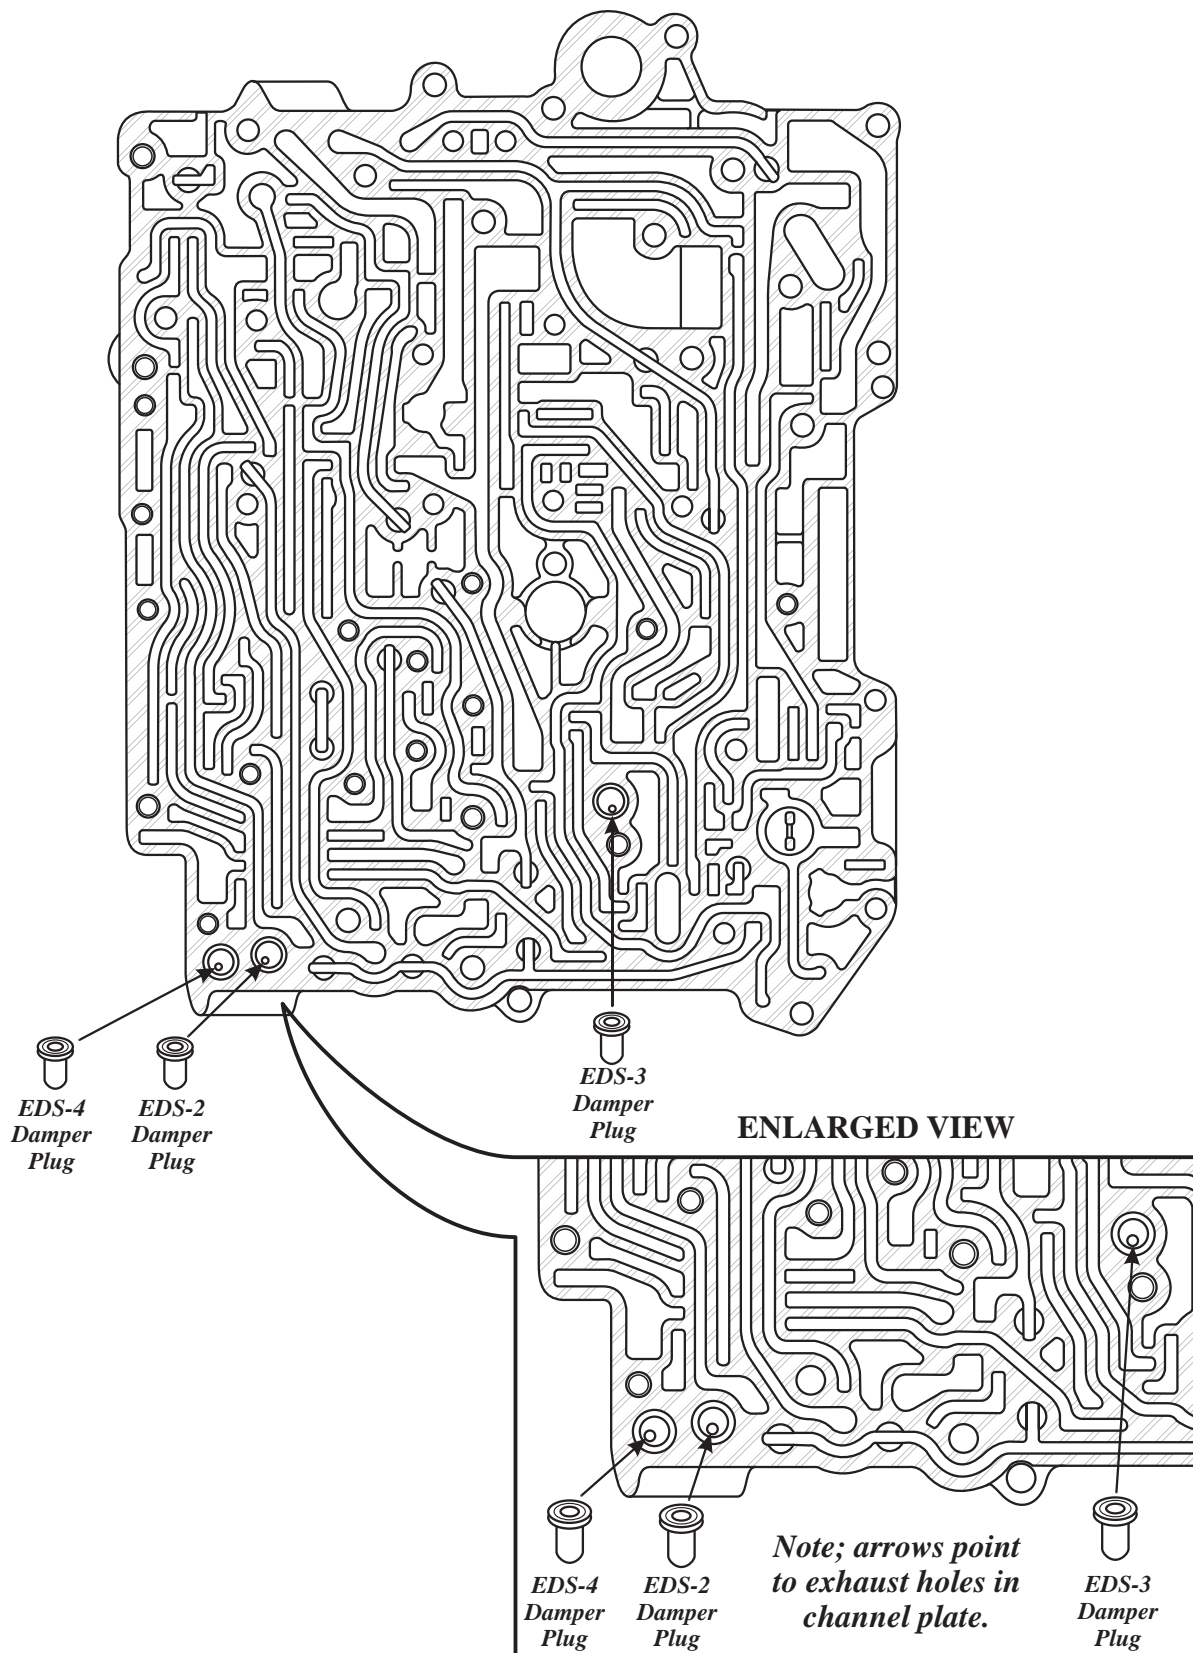
**EARLY CHANNEL PLATE
WITH RUBBER PLUGS**

CORRECTION: Replace the rubber damper assembly, or use the updated aluminum plugs which requires the updated channel plate and spacer plate. Refer to Figure 2 this picture shows the channel plate with the EDS damper plug locations, and also an enlarged view which shows the early style rubber plugs and focuses on the exhaust holes in the channel plate. These rubber damper plugs were used in ZF5HP19 models through 1999. During model year 2000, ZF introduced an updated damper assembly. Figure 4 shows worm track differences in the later channel plate and also an enlarged view which depicts the later style damper pistons and illustrates the bore size difference in the channel plate for the later damper pistons. Refer to Figure 3. This drawing illustrates the same partial hydraulic circuit in Figure 1, *except*, it shows the new design EDS 3 accumulator piston. Notice the top of the accumulator piston, there is no orifice like in the previous plug, instead the surface is solid and in the bottom of the plug is a rubber insert that provides the cushion, or accumulation. The solid top obviously prevents rupturing and these new pistons eliminate the problem.

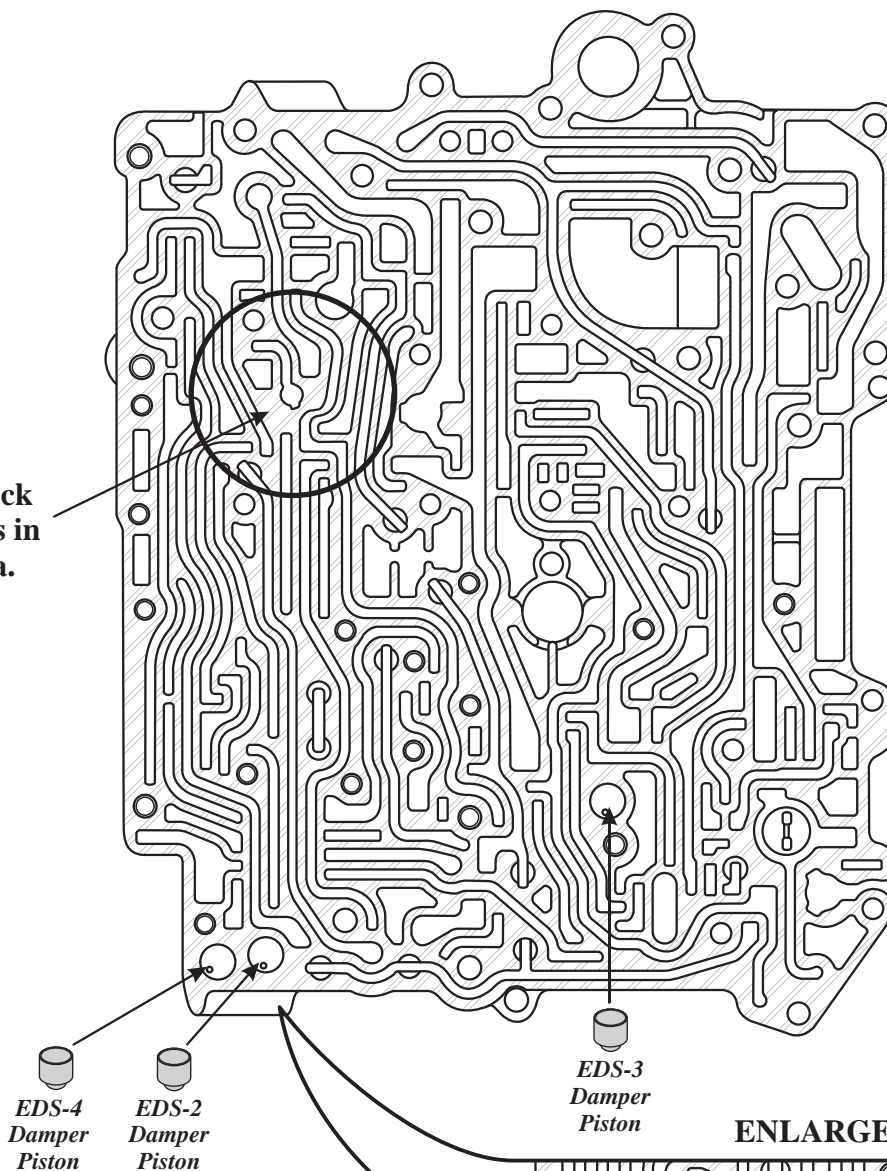
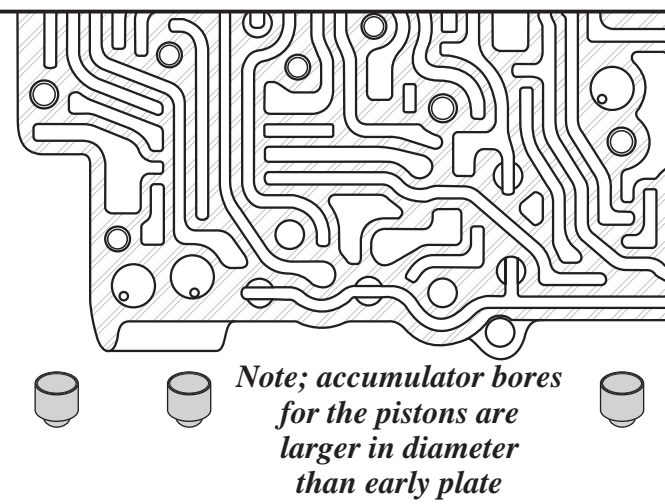
Figure 4

Refer to Figure 4. The text in the enlarged view states the accumulator bores in the channel plate are larger in diameter than the early plate. The bores are larger in diameter to accommodate the updated pistons. The diameter of the accumulator plug bore in the early channel plate is approximately .315 inches and houses the rubber damper plug. The outside diameter of the accumulator piston bore in the later channel plate is approximately .471 inches in diameter for the updated piston. Figure 5 shows the early valve body separator plate, and Figure 6 shows the later separator plate. Note the differences in hole size and configuration between the two plates. ***They are not interchangeable.*** Therefore, if you have a rubber damper that is ruptured, you will have to use a new rubber damper. If you want to use the later style piston to prevent a future incident, you will need to purchase a new channel plate, separator plate and pistons from a **ZF-AUTHORIZED** distributor. Most overhaul kits will come with both the rubber plugs and the newer pistons so if you have an overhaul kit you will only need to purchase the new style separator and channel plate.

**LATER CHANNEL PLATE
WITH ACCUMULATOR PISTONS**

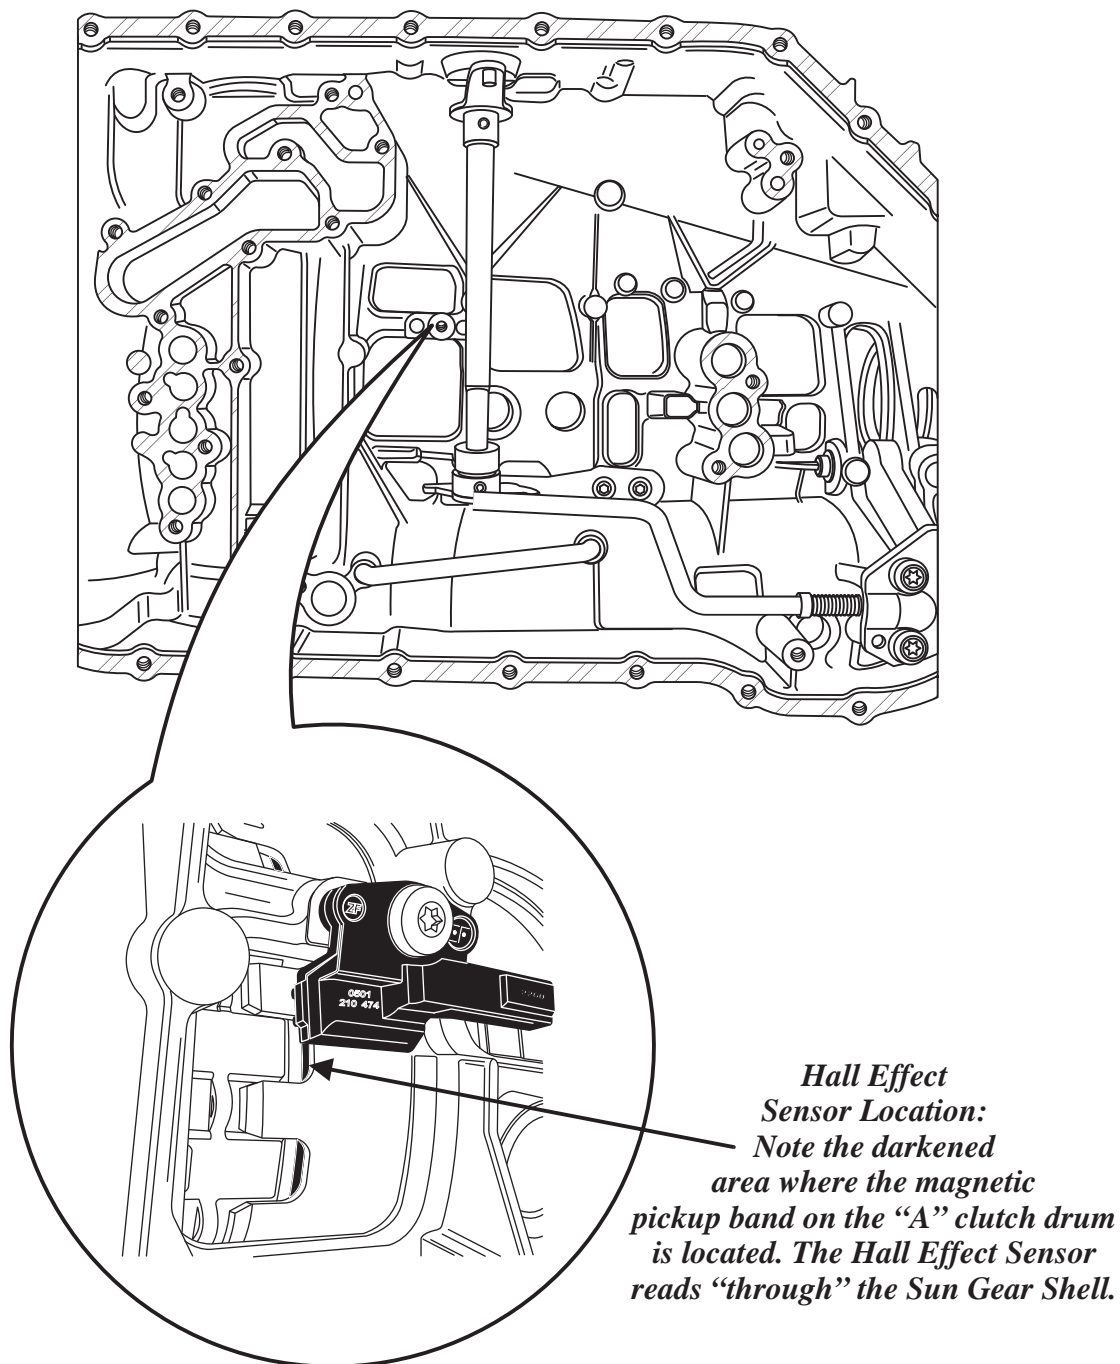
ZF-5HP-19FL/FLA
HALL EFFECT SENSOR
TURBINE SENSOR LOCATION

**THE TURBINE SENSOR ON HALL EFFECT SENSOR MODELS
IS BOLTED TO THE TRANSMISSION CASE, AND GETS IT'S READING
FROM THE BLACK MAGNETIC PICKUP BAND ON THE FORWARD CLUTCH
DRUM WHICH MEASURES "A" CLUTCH DRUM SPEED. THIS SENSOR
MEASURES ACTUAL INPUT SPEED.**

CORRECTION: Use the information provided in the following figures to ensure correct transmission application and internal component installation. Refer to Figure 1 for a listing of vehicles that use the Pulse Generator type sensor. Figure 1 also provides an illustration of the transmission identification tag. Refer to Figure 2 for a listing of vehicles that use the Hall Effect Sensor. The Pulse Generator and Hall Effect Sensor are not located in the same area of the transmission. Refer to Figure 3 for internal harness layout and connector id for units using the Pulse Generator. Refer to Figure 4 for internal harness layout and connector id for units using the Hall Effect Sensor. Refer to Figure 5 for location and id of the Pulse Generator, refer to Figure 6 for location and id of the Hall Effect Sensor.

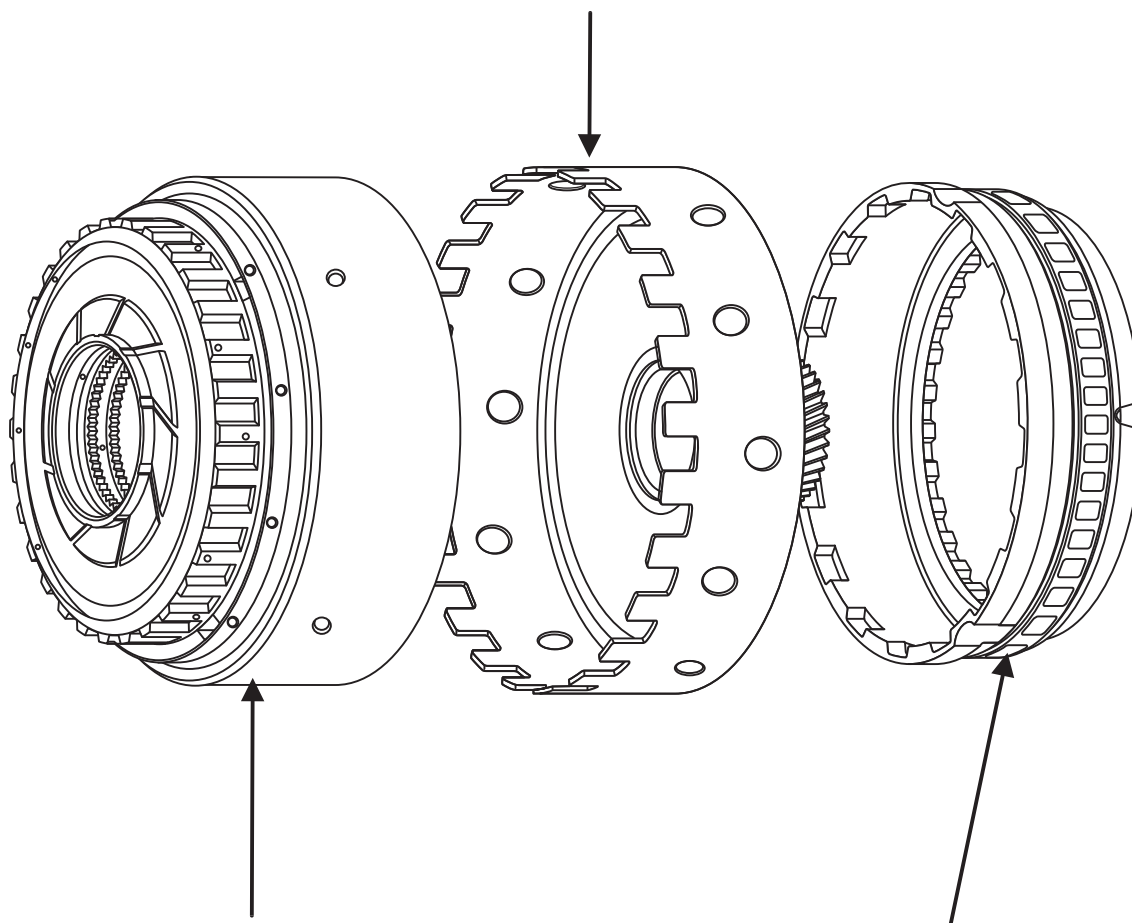
ZF5HP19FL/FLA PULSE GENERATOR UNITS "A" CLUTCH DRUM, SUN GEAR, SPIDER CLUTCH BELL

The Sun Gear for Pulse Generator models will attract a magnet. This Sun Gear is designed for use in Pulse Generator transmissions only.

"A" Clutch Drum for Pulse Generator models does not have magnetic band around outside of clutch drum. This drum is designed for use in Pulse Generator transmissions only.

The Spider Clutch Bell for Pulse Generator models has a metal sleeve installed around the outside of the hub where the Pulse Generator gets its reading. This hub is designed for use in Pulse Generator transmissions only.
