"2006" SEMINAR INFORMATION

AUTOMATIC TRANSMISSION SERVICE GROUP

"Top Tech Tricks for 2006"

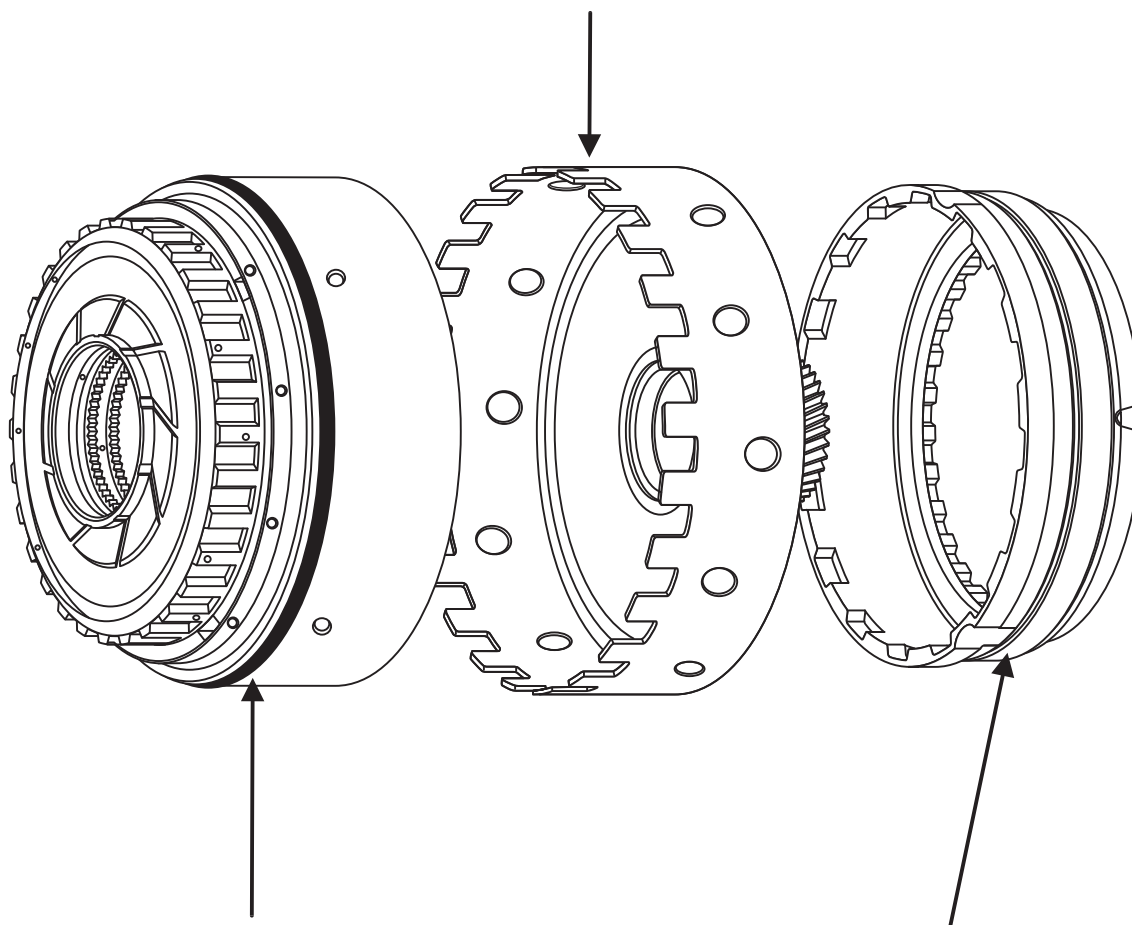
ZF5HP19FL/FLA HALL EFFECT SENSOR UNITS "A" CLUTCH DRUM, SUN GEAR, SPIDER CLUTCH BELL

The Sun Gear for Hall Effect Sensor models will not attract a magnet. This Sun Gear is designed for use in Hall Effect Sensor transmissions only.

The "A" Clutch Drum for Hall Effect Sensor models has a magnetic band around outside of clutch drum. The Hall Effect Sensor reads through the Sun Gear and picks up a pulse from the magnetic pickup band around the drum. The black magnetic band contains 36 small magnets around the outside of the drum. This drum is designed for use in Hall Effect Sensor transmissions only.

The Spider Clutch Bell for Hall Effect Sensor models does not have the metal sleeve installed around the outside of the hub. This hub is designed for use in Hall Effect Sensor transmissions only.

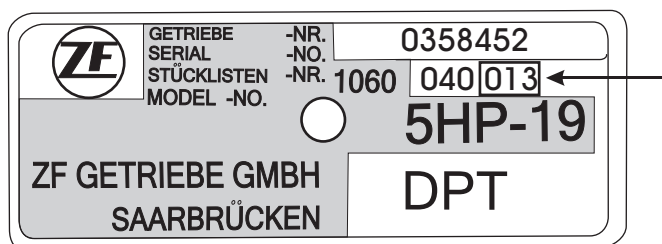
TAG AND MODEL IDENTIFICATION

The last three digits on the tag will identify the part number needed listed in Service Information for the correct D clutch housing

The part number for the D clutch housing according to the tag identification shown above is 1060 373 002

CORRECTION: Replace the D clutch housing with the correct part number, based on the tag number located in Figure 1.

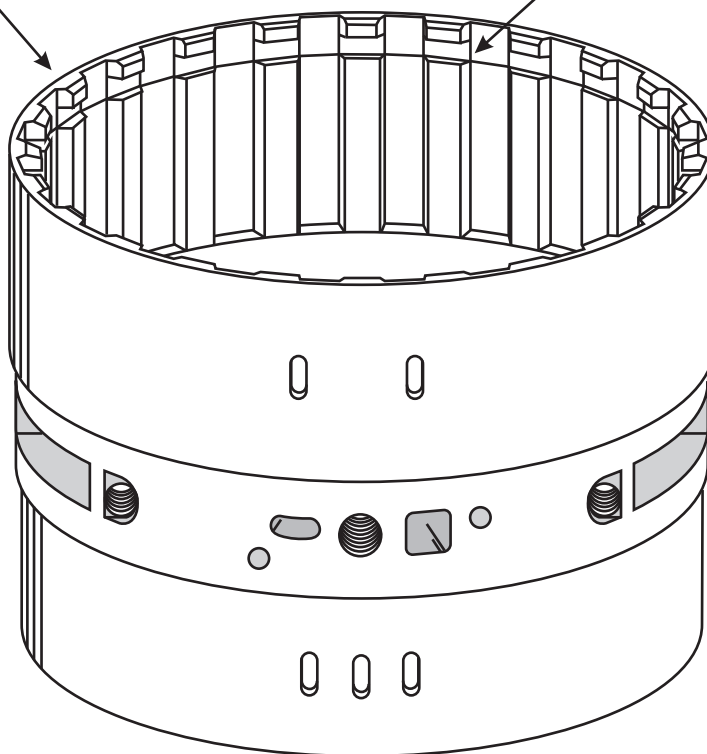
Figure 2

CAUSE: The cause may be, a broken D clutch housing, as shown in Figure 2, causing no application of the D clutch which is the Low Reverse Clutch.

The top of the snap ring area of the housing breaks

The snap ring groove depth has been redesigned to help prevent breaking

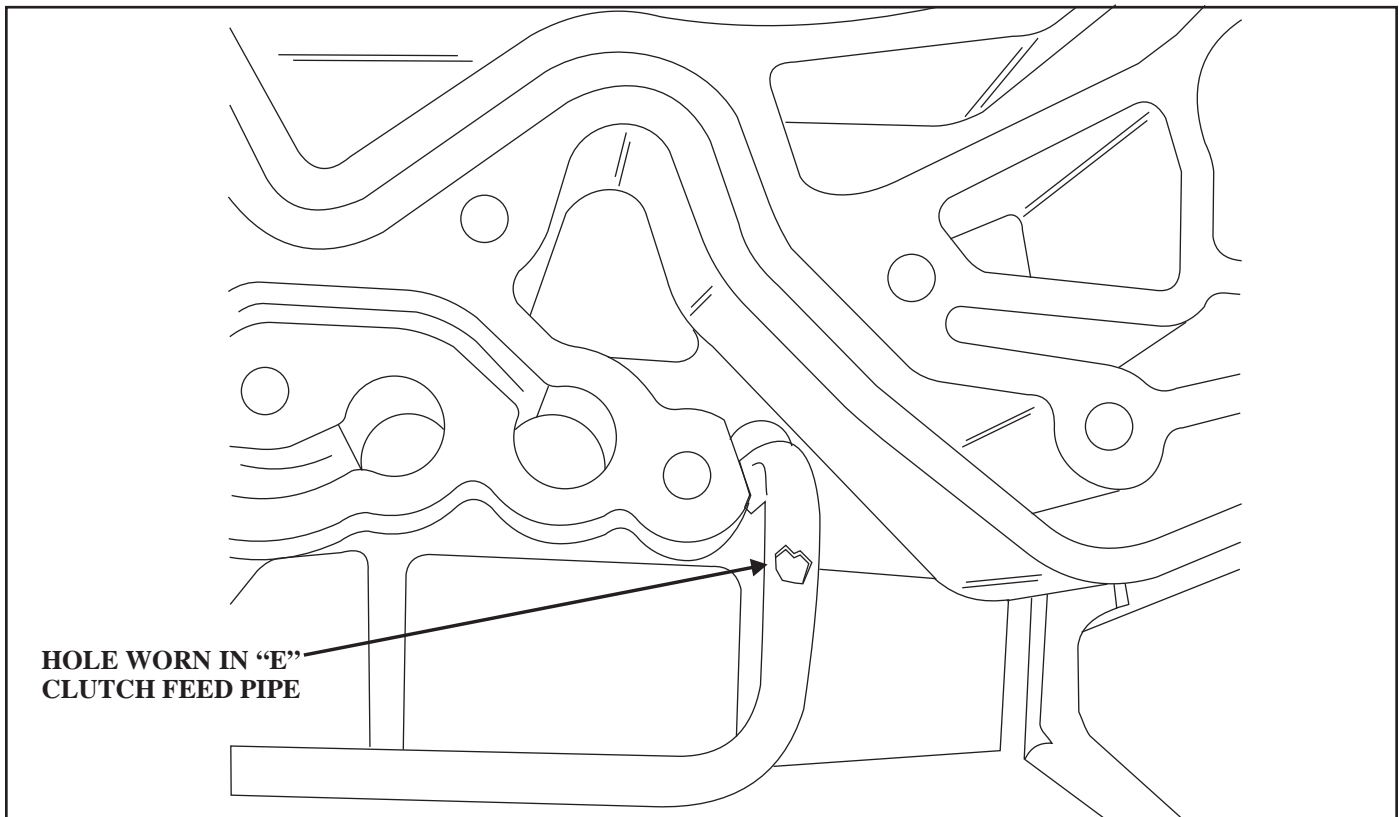
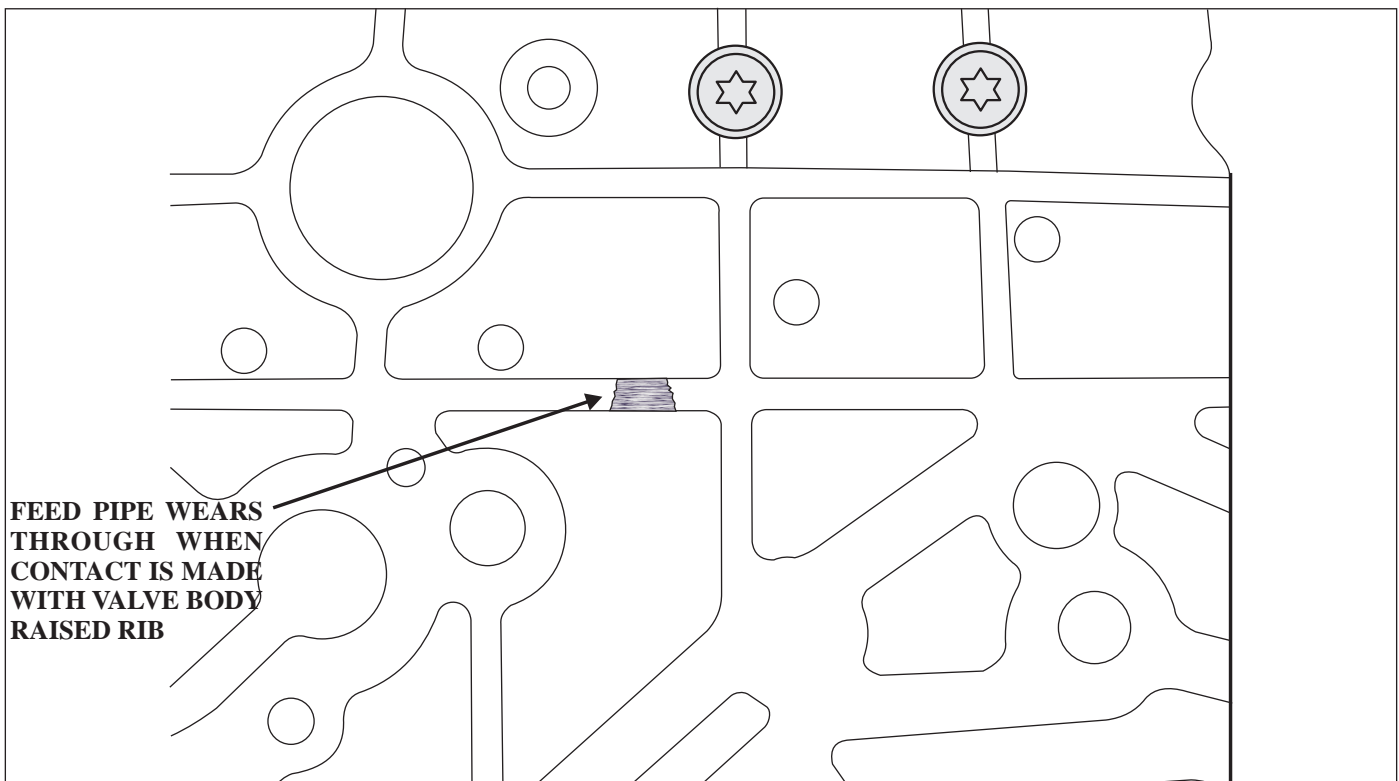
"E" CLUTCH FEED PIPE DAMAGE

CAUSE: The "E" clutch feed pipe has made contact with the valve body casting and has had a hole rubbed through the pipe, (Refer to Figures 1 and 2).

Either repair the pipe as shown in Figure 3 if the pipe is unavailable or purchase a new feed pipe using the part number listed below under service information from an authorized ZF distributor.
