1997 SEMINAR INFORMATION

"THE RIGHT DIRECTION FOR '97"

INTRODUCTION

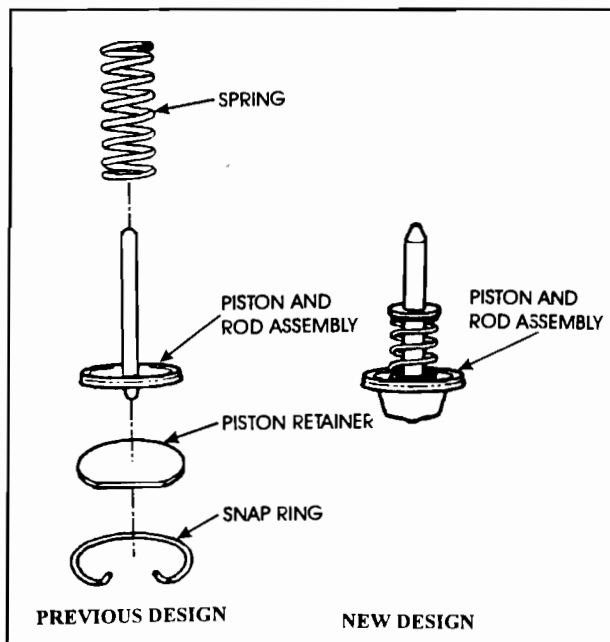
Figure 1

- (1) When replacing the intermediate Band Apply Servo Assembly becomes necessary, either design level (Previous or new) can be used in a previous model transmission case, as the new design level part will retro fit back to all previous model units.
- (2) When using the new design piston and seal assembly in a previous model unit, discard the piston retainer and snap ring.
- (3) If you have a later model transmission without the snap ring groove in the piston bore, *only* the new design piston and seal can be used.

ACTION: Until the new design parts (Figure 1) are fully stocked, the current service parts (Figure 1) must be used to replace the new design parts. When replacing either the new design bonded seal piston or the overdrive/intermediate cylinder assembly, replace both with current level (previous design) overdrive piston, inner piston seal and the overdrive/intermediate cylinder. Refer to part replacement chart for correct part usage.

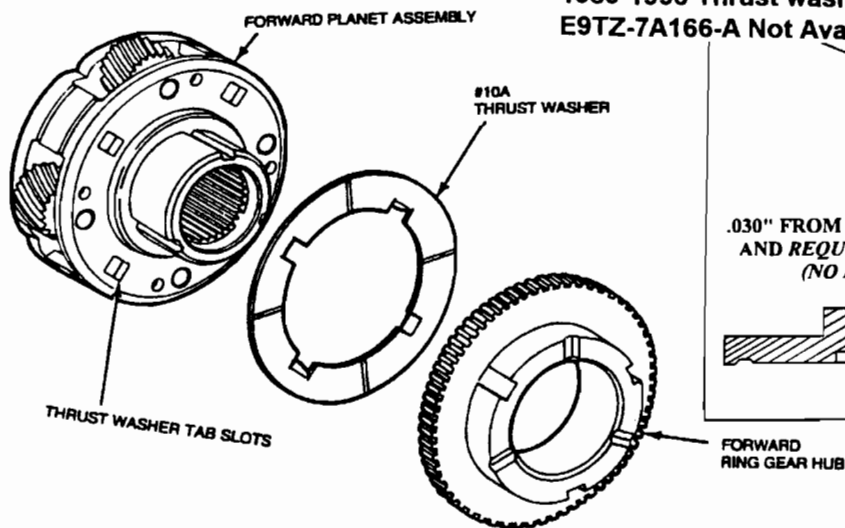
EARLY FORWARD RING GEAR HUB

ISSUE: Some 1996 and all 1997 E4OD transmissions have been built with a needle bearing located between the forward planetary carrier and forward ring gear hub. This is a revised design for 1997 which was pulled ahead for a running change for 1996. This needle bearing replaces the # 10A thrust washer. The slots in the planet carrier for the thrust washer tabs were also removed. The forward ring gear hub was changed to accomodate the needle bearing instead of the thrust washer.

If the forward planetary carrier has slots (Figure 1) for the thrust washer tabs, it does NOT have to be replaced unless it is damaged. The planetary carrier must have slots to be used with the #10A thrust washer. Either planetary assembly with or without slots CAN BE USED WITH THE BEARING. Refer to Figure 1 and the part application Chart for correct part usage.

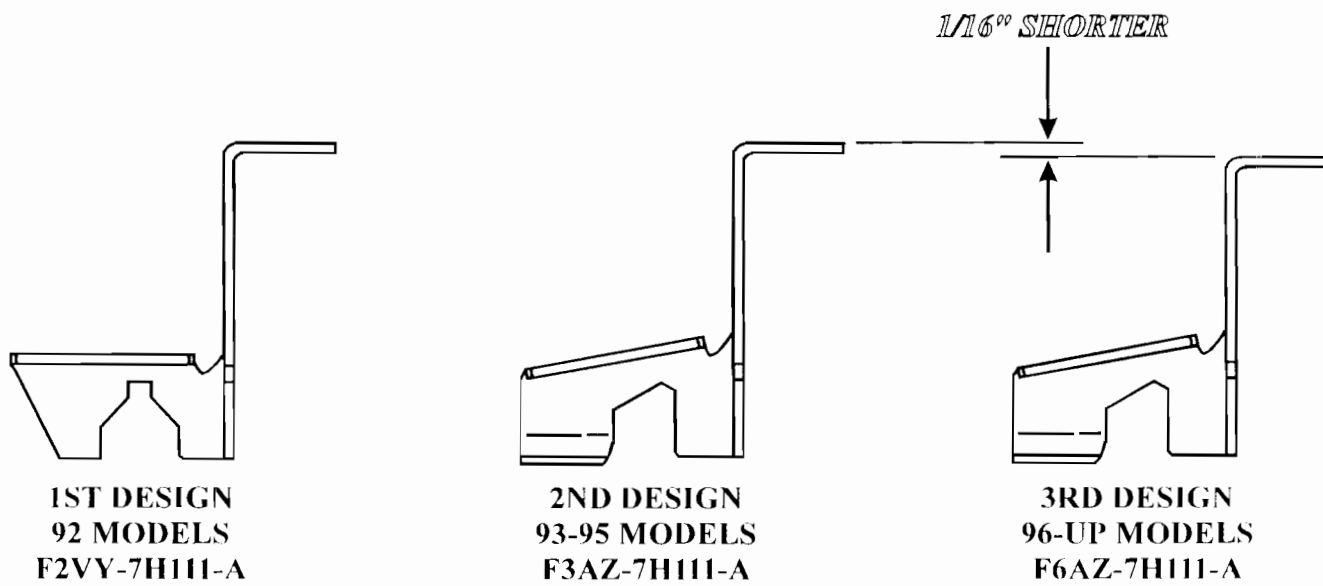
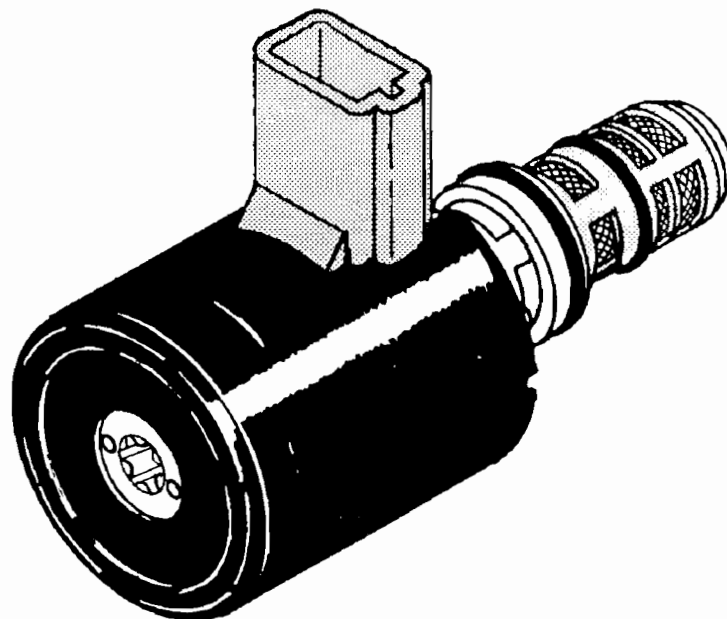
Figure 1

EPC SOLENOID RETAINER DIFFERENCES

EPC SOLENOID
PART NUMBER F3AZ-7G383-A
(INCLUDES F3AZ-7H111-A RETAINER)

- (1) When the EPC Solenoid is replaced, the 2nd design solenoid is the only one available, and comes with the proper retainer which *must* be used on 1992-1995 models (See Figure 1). The new design solenoid will retro-fit to 1992 models.
- (2) The only retainer that can be used on 1996 models is the one that is 1/16" shorter to accommodate the thinner valve body plate that was used in 1996 (See Figure 1).

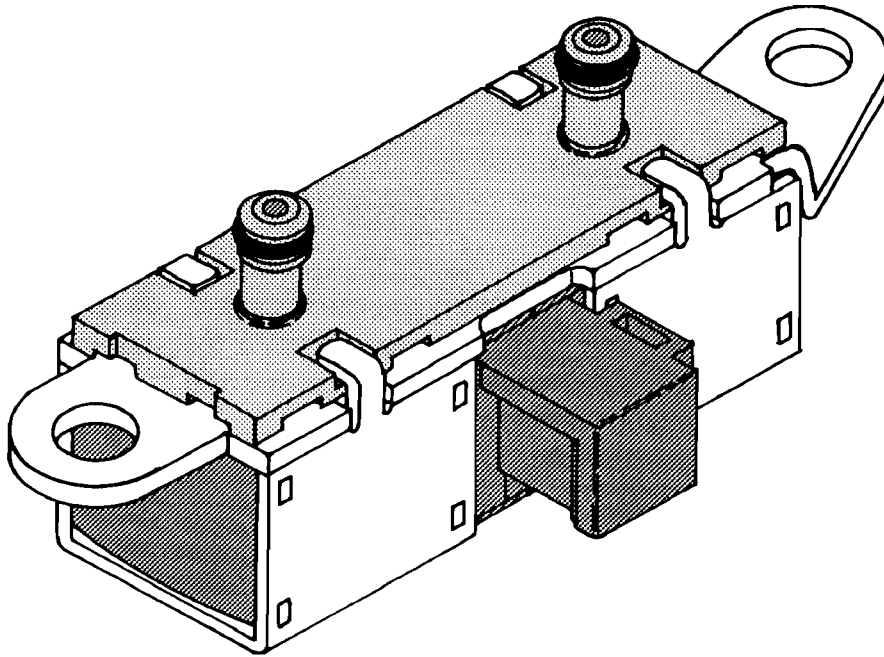
Figure 2

CAUSE: The cause may be, a partially clogged Shift Solenoid No. 2, which will stroke the 3-4 shift valve far enough to exhaust some of the forward clutch oil.

**SHIFT SOLENOID ASSEMBLY
PART NUMBER F5AZ-7G484-A**

CORRECTION: Install two pressure gages to check line pressure and forward clutch pressure, as shown in Figure 1. With the transmission in Drive, both gages should read the same and should be approximately 55-75 PSI.
If the forward clutch gage reads lower than the line pressure gage, *and all internal parts are known to be good*, replace the Shift Solenoid Assembly with OEM part number F5AZ-7G484-A (See Figure 2).

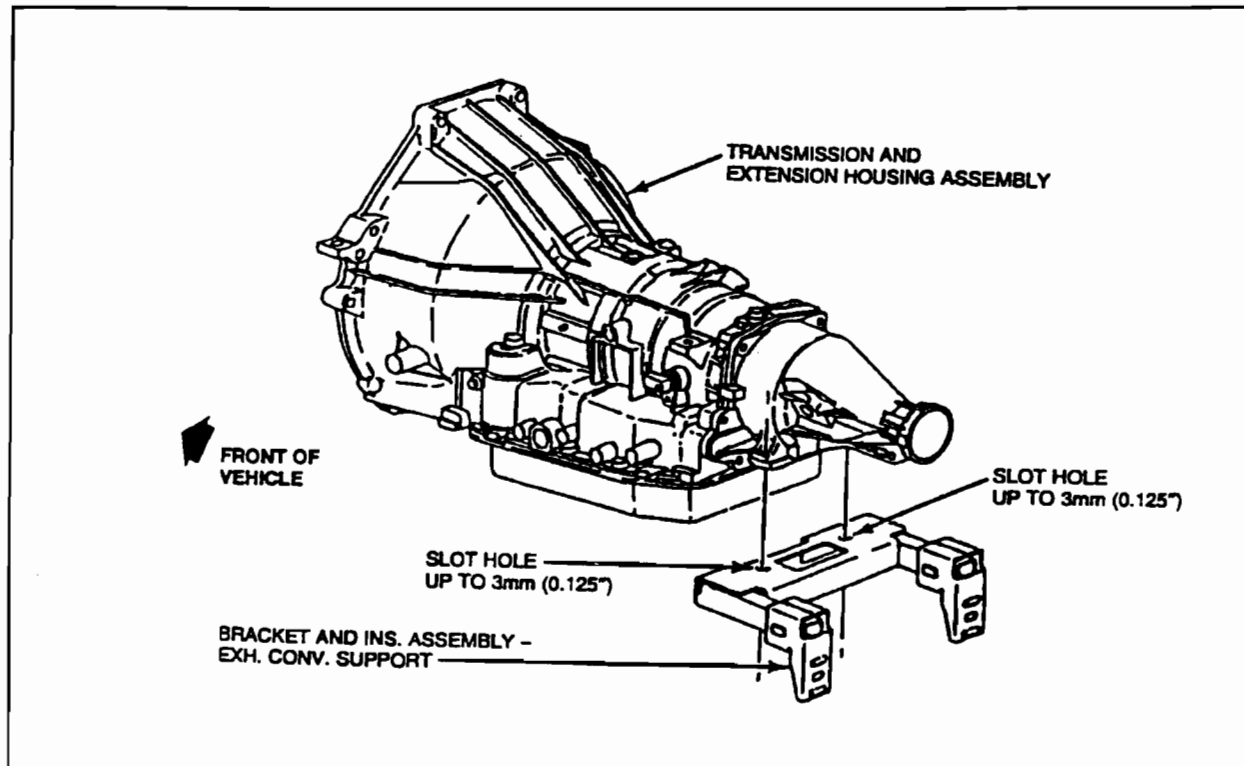
Figure 1

COMPLAINT: Leaking of transmission fluid may occur at the transmission extension housing on some vehicles. Verify the area of the leak.

CAUSE; This may be due to loads on the transmission extension housing affecting the joint clamping load(*where the extension housing bolts to the case*). This leak location is often mis-diagnosed as a pan gasket leak.

CORRECTION: If leak is from the extension housing gasket, replace with the revised steel backed gasket (F6AZ-7086-A) and slot the holes in the rear bracket assembly (Figures 1 and 2) refer to the following service procedures in the following note:

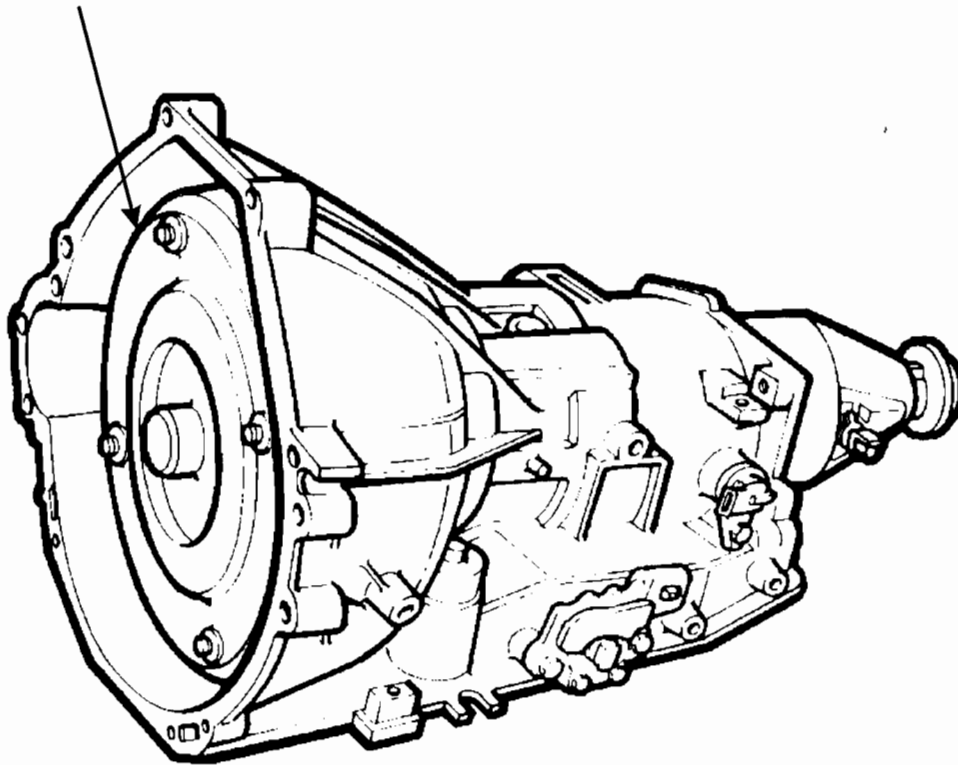
Figure 1

CAUSE: The cause may be, insufficient diameter of the converter clutch.

**NEW DESIGN LEVEL TORQUE CONVERTER NOW AVAILABLE
WITH 7/8" LARGER DIAMETER CLUTCH PLATE.**

CORRECTION: There is now available from Ford Motor Company, new design level converters for the AODE/4R70W transmissions, that have an increased diameter converter clutch plate (Approx. 7/8" Larger), that will eliminate the condition above. Refer to the chart shown in Figure 2, for the proper part number for your application.

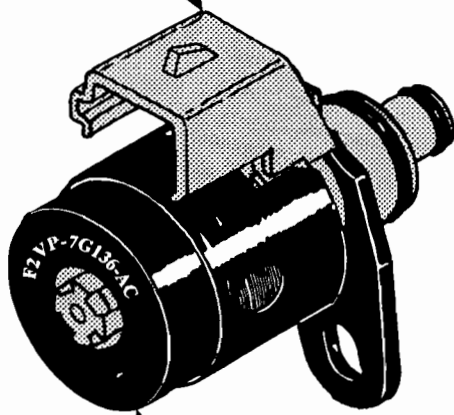
CAUSE: The cause may be, an incorrect Torque Converter Clutch (TCC) Solenoid, with low resistance (1.0 - 3.0 ohms), mistakenly installed in *some* 4R70W transmissions. Refer to Figure 1. The resistance should be 10-16 ohms on *some* models.

**1.0 - 3.0 OHMS RESISTANCE
TCC SOLENOID**

"BLACK" PLASTIC
ELECTRICAL CONNECTOR

F2VP-7G136-AC STAMPED
IN THIS END OF SOLENOID

Step 3: *If* the valve body I.D. code is G2T, G3T, or G2U, *and* resistance on the TCC solenoid measures 1.0-3.0 ohms, *replace* the TCC Solenoid with OEM part number F5AZ-7G136-A. The resistance on these models should be 10-16 ohms.

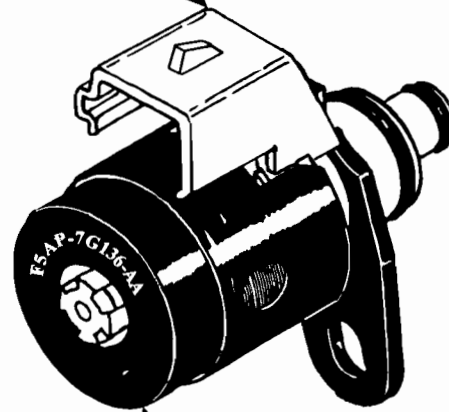
**10 - 16 OHMS RESISTANCE
TCC SOLENOID**

"WHITE" PLASTIC
ELECTRICAL CONNECTOR

F5AP-7G136-AA STAMPED
IN THIS END OF SOLENOID

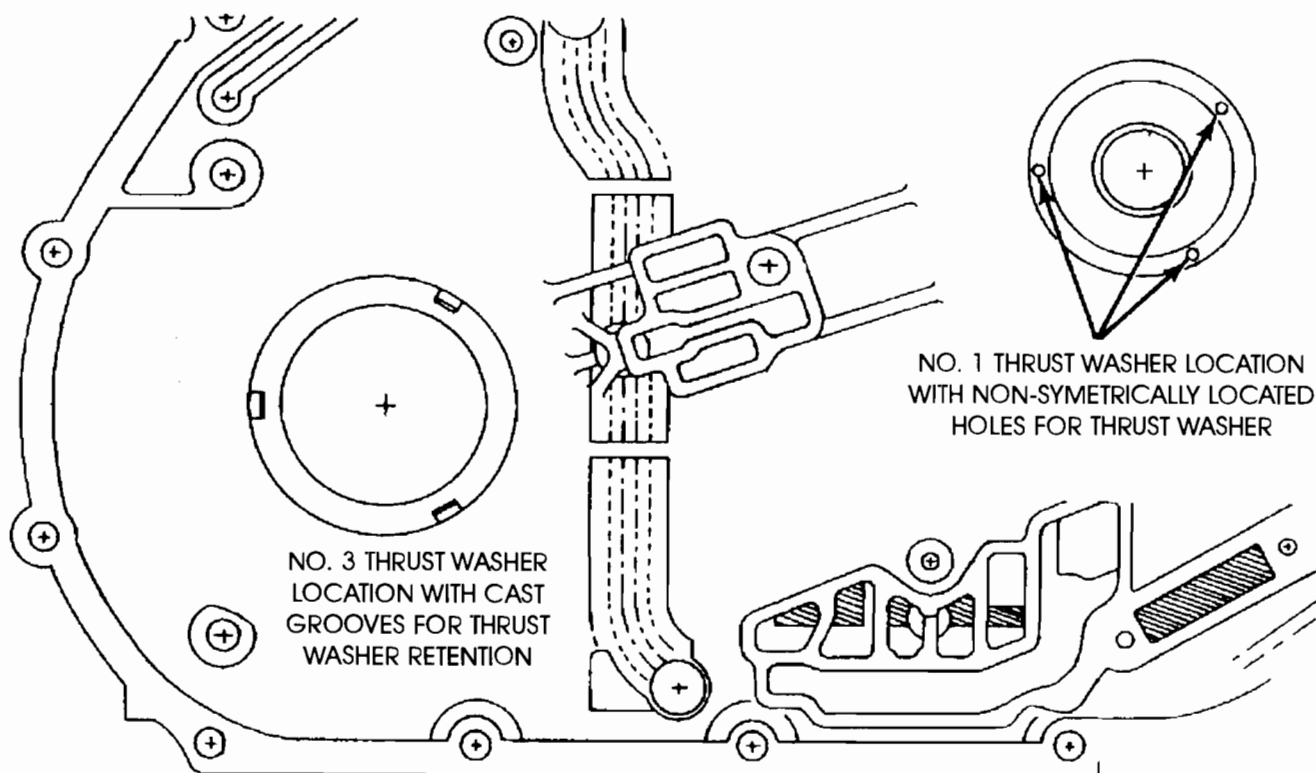
Figure 2

REQUIRES THE PLASTIC NO. 1
THRUST WASHER WITH TABS THAT
ARE NON-SYMETRICALLY LOCATED
PART NUMBER E6DZ-7G099-A

If replacement of the number 1 and/or the number 3 thrust washer becomes necessary, inspect the chain cover in the thrust washer tab areas to determine the correct thrust washers required. Refer to Figures 2 and 3.

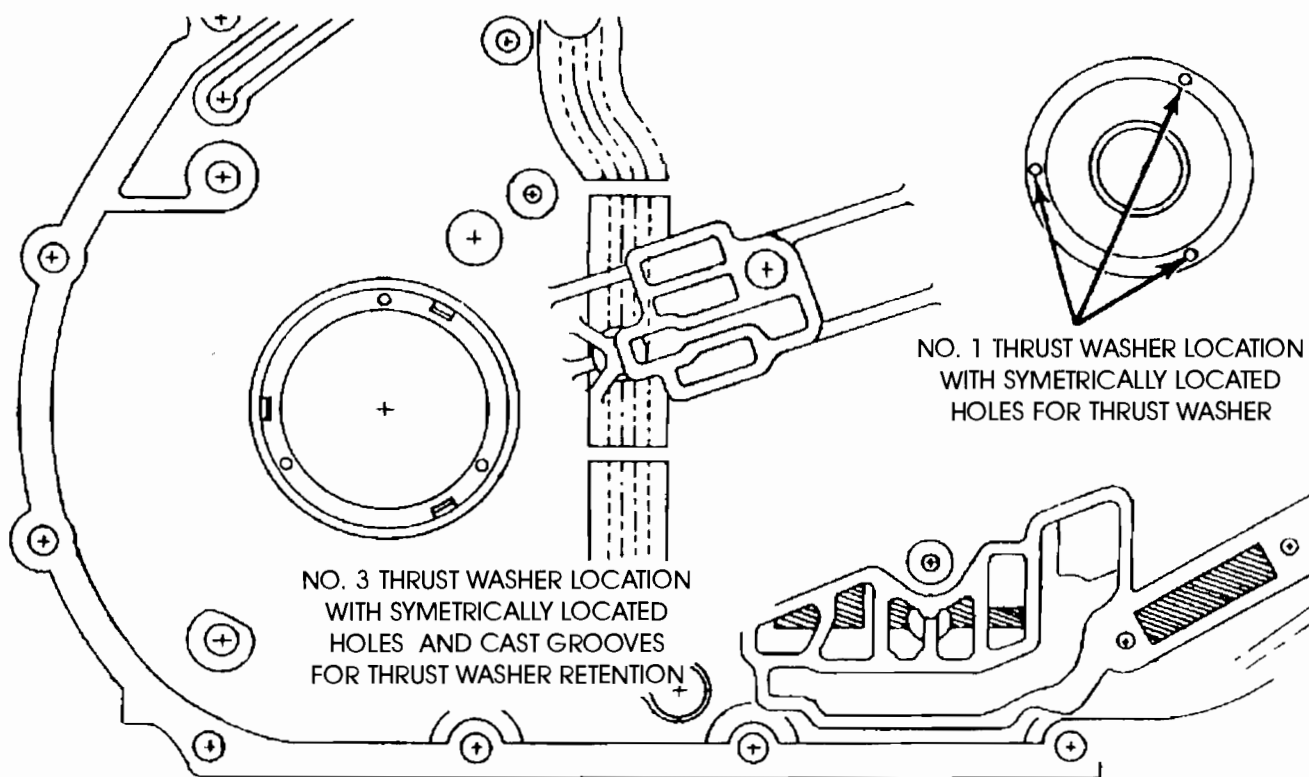
Figure 3

REQUIRES THE PLASTIC NO. 1
THRUST WASHER WITH TABS THAT
ARE SYMETRICALLY LOCATED
PART NUMBER F5DZ-7G099-A

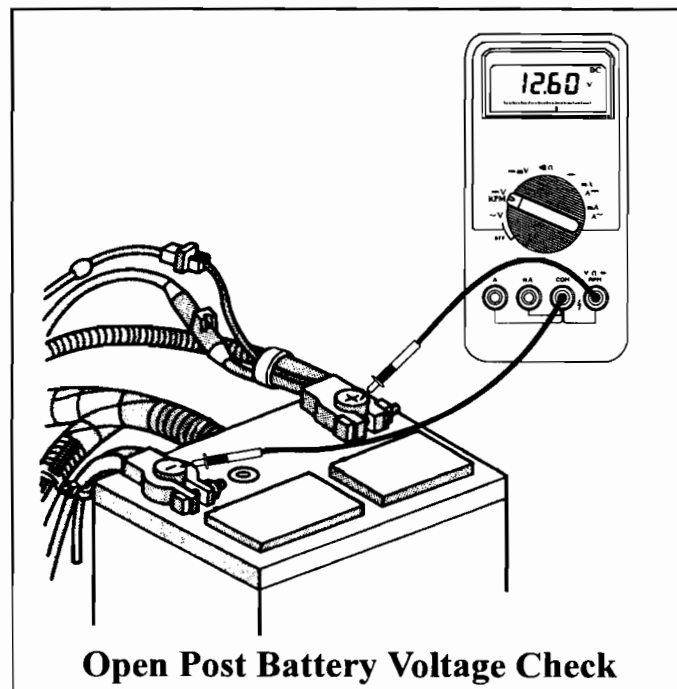
Figure 1

A fully charged battery should measure approximately 12.60 volts. However, 12.40 volts is the average seen and is acceptable. If battery voltage is below 12.00 volts, the result may be erratic computer behaviour. Refer to the table in Figure 2 for the typical voltage values in relationship to percentage of charge.

Using a Digital Volt Ohm Meter (DVOM) set to DC volts, measure the open post battery voltage by placing the negative lead to the negative battery post and the positive meter lead to the positive battery post as shown in Figure 1.

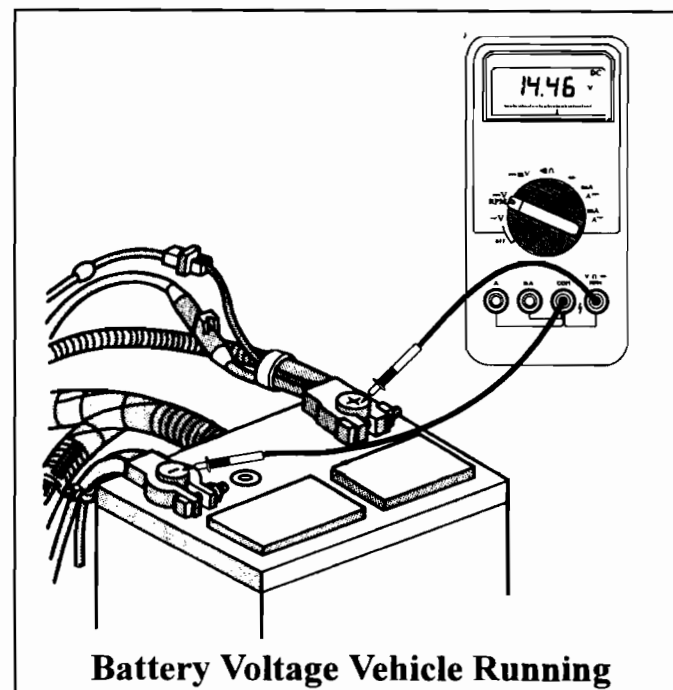
Figure 3

With the volt meter connected to the battery as shown in Figure 1, start the vehicle. Turn on the headlights and blower motor to put a load on the voltage system. Approximately 13.5 to 14.4 volts should be seen (See Figure 3). If 15 volts or higher is seen, this may indicate an overcharging alternator which may result in erratic computer behaviour. This problem needs to be rectified before going to the next step.

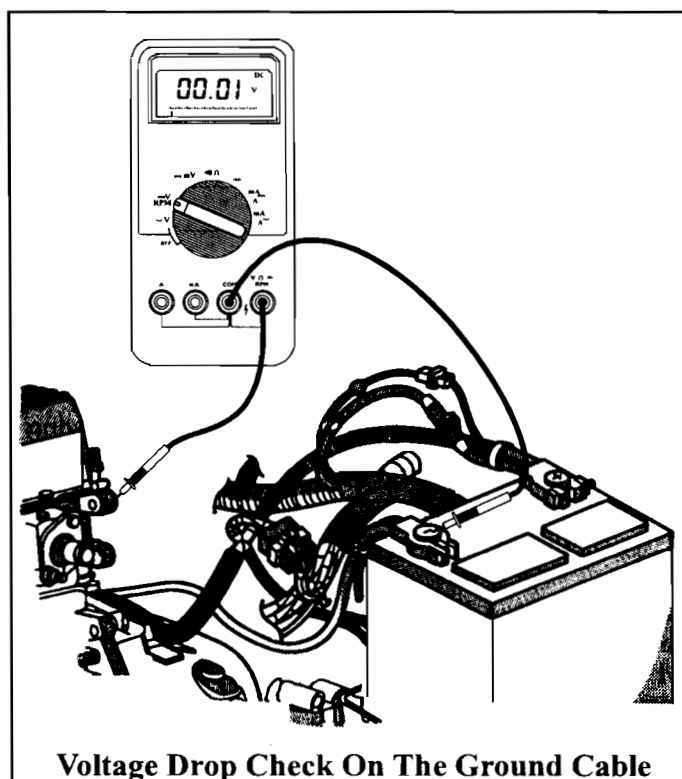
Figure 4

The next step is to perform a voltage drop test across the ground cable. This checks for corrosion or bad connections with the main ground cable itself. To do this, keep the vehicle running and turn on as many accessories as possible, i.e. headlights, AC, radio, etc. With the meter set to DC volts, place the negative lead of the meter to the negative post of the battery. Place the positive lead of the meter to either the body or engine block (See Figure 4). No more than 0.10 volts should be seen. A good ground will usually show 0.00 or 0.01 volts. If 0.20 or more is seen, clean and/or replace the main ground cable to obtain a 0.00 or 0.01 reading.

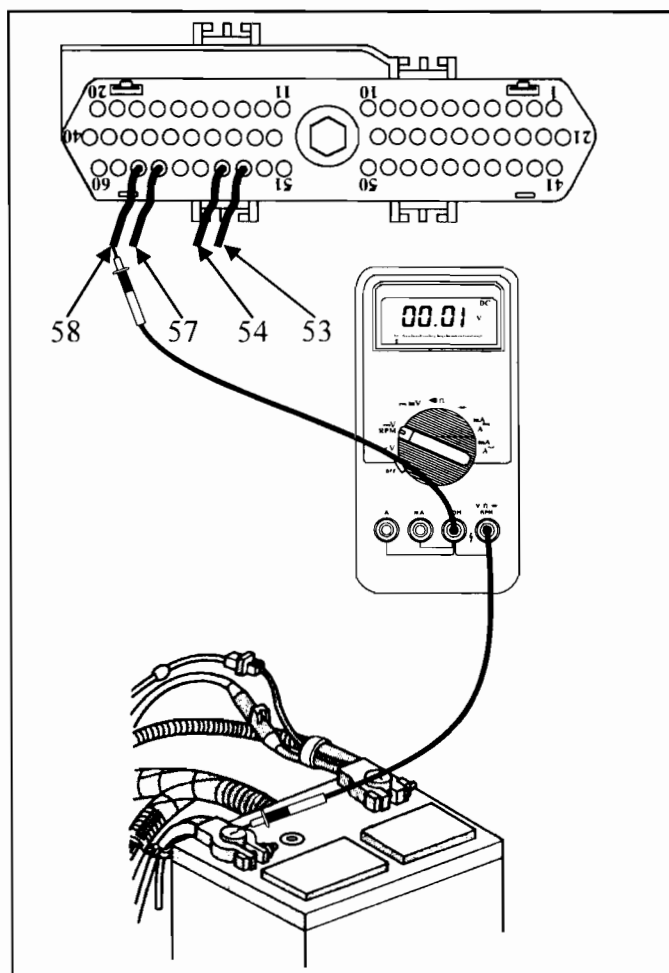
Figure 5

In this step, first locate the transaxle controller. If the vehicle being checked is a van, the controller is on the passenger side firewall. If it is a passenger car, the controller is located in the passenger side fender behind the headlight. Once the controller is located, pop the plastic harness cover away from the wires going into the connector (Do not remove the center bolt). Once the cover is removed and the 60 way connector can be viewed from the wire side, locate the transaxle controller ground wires 53, 54, 57 and 58 (See Figure 5). Start the vehicle and turn on as many accessories as possible. With the volt meter set to DC volts, place the positive lead of the meter to the negative battery post. Carefully back probe each ground wire as shown in Figure 5. No more than 0.10 volts can be seen. If more than 0.10 volts is seen, that ground wire is bad.

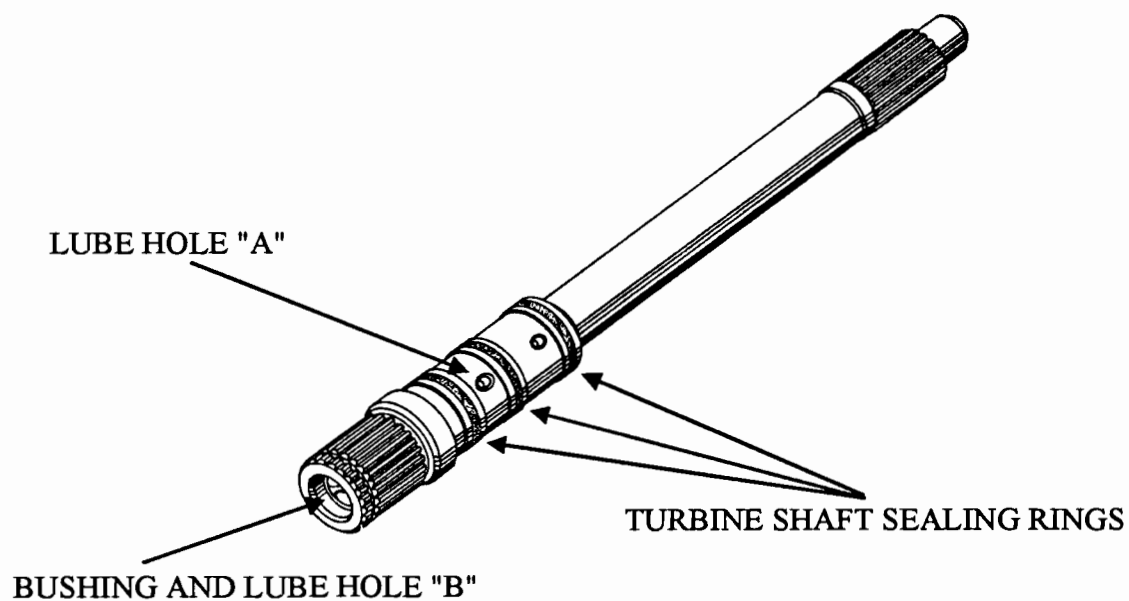
Figure 1
Automatic Transmission Service Group

1. Inspect "Turbine Shaft" sealing rings and the sleeve area in the rear of the pump cover for wear. Apply compressed air into hole "A" in turbine shaft and ensure the air exit's through hole "B" freely. (See Figure 1)

2. Inspect the bushing in the rear of the turbine shaft for wear or scoring. Ensure that the bushing clearance to the Underdrive clutch hub shaft is no more than .003" to .006." (See Figure 1)

INSPECT FOR "SEALING RING" WEAR OR SCORING

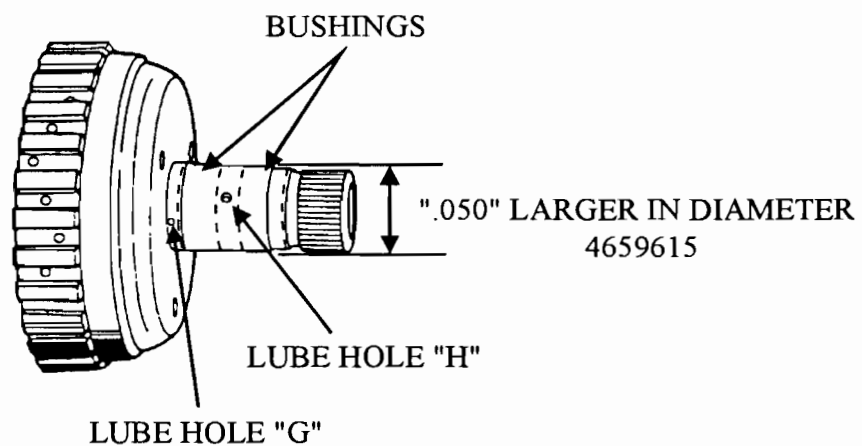
Figure 3
Automatic Transmission Service Group

4. Inspect the bushings inside of the "Overdrive Clutch Hub Shaft" for wear or scoring and ensure a snug fit on the "Underdrive Clutch Hub Shaft." Inspect lube holes "G" and "H" and ensure that the bushings are not covering or restricting the lube holes. Replace the overdrive clutch hub and shaft as necessary. (See Figure 3)

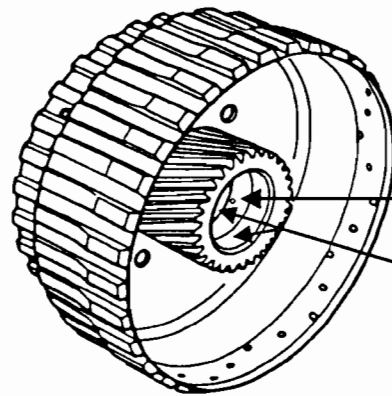
Figure 4

5. Inspect the bushings in the "2-4 Sun Gear Hub" for wear or scoring and ensure a snug fit on the "Overdrive Clutch Hub Shaft." Inspect the bushing placement and ensure that the bushings have not "Walked" together causing the two .076" holes, "I" and "J", to be blocked or restricted. A small "Paper Clip" or "Scribe" bent at a 90° angle will serve as a good tool to check for restrictions in these lube holes. (See Figure 4)

2 LUBE HOLES "I" & "J"
180° APART
SUN GEAR BUSHINGS
.050" LARGER IN DIAMETER
4659618

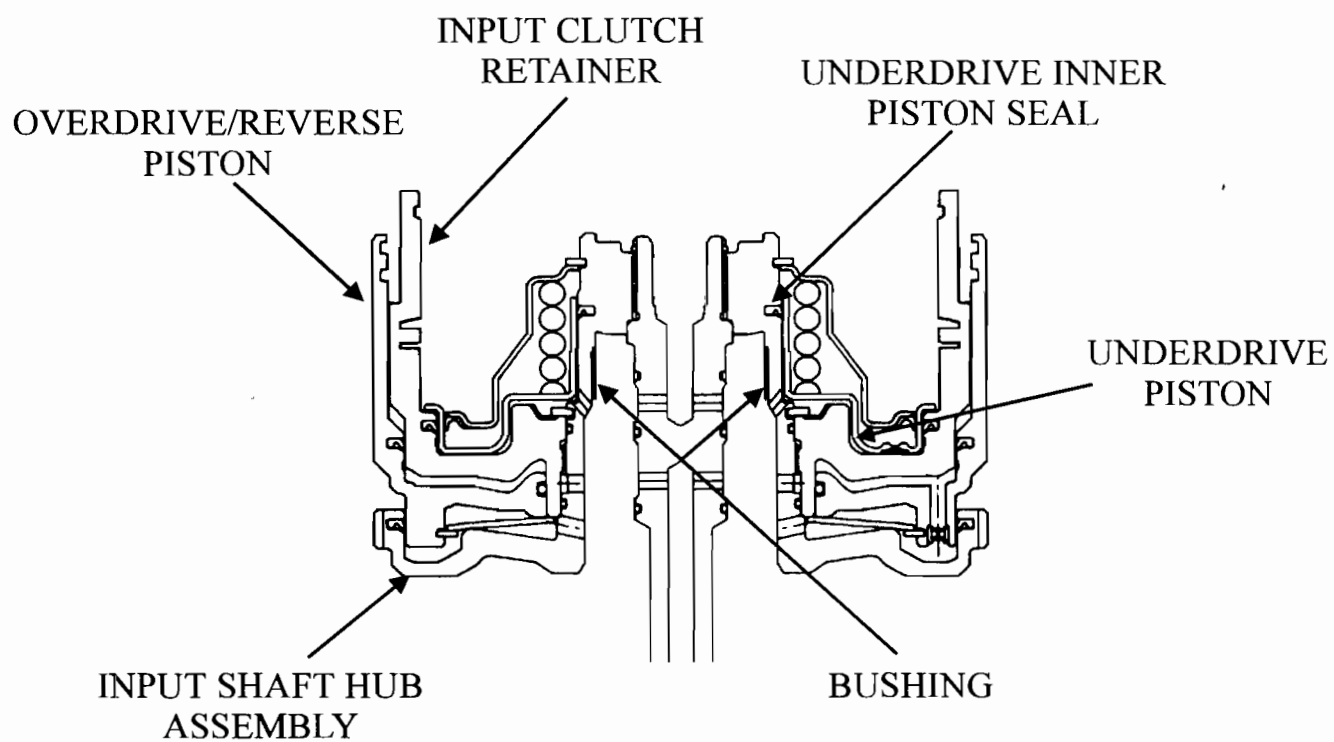
Figure 2

1. Leakage at the pump cover sealing rings and or the bushing in the "Input shaft hub assembly," allowing a pressure loss, and allowing the possibility of a harsh re-engagement of the Underdrive clutch when downshifting from Overdrive back to 3rd or 2nd gear.

1. Use "Solid Teflon Sealing rings" on the pump cover. Ensure that they are "White or Tan with Red and/or Green Speckles." If your overhaul kit does not furnish these sealing rings for you, use the "Center support sealing rings" from a "4L80-E." **NOTE :** The solid teflon sealing rings can be easily installed and sized with the "Input shaft hub assembly." Inspect the bushing journal at the end of the pump cover for wear or scoring (see Figure 2). Inspect the bushing in the "Input shaft hub assembly" and check for a snug fit on the pump cover. (See Figure 2)

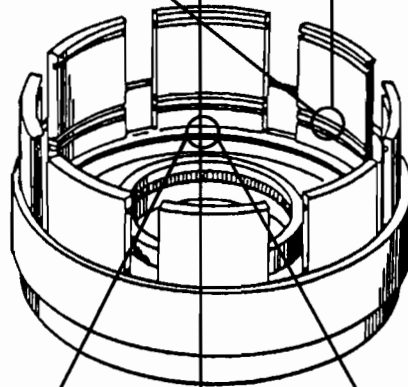
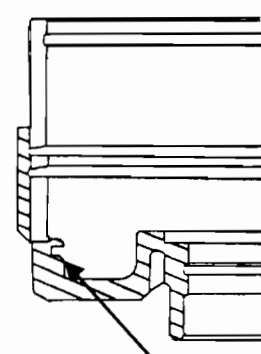
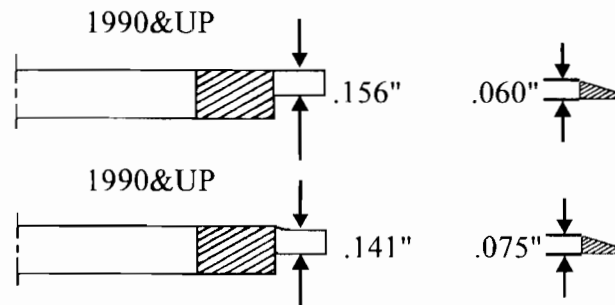
Figure 3

2. Incorrect usage of the Underdrive Overdrive retainer plate and or "Tapered" snap ring.
3. Incorrect usage of the Underdrive "Outer" piston seal, and or leakage of the inner piston seal.

LIP SEAL GROOVE
.040" SHALLOWER TO
ACCOMMODATE
NEW OUTER LIP
SEAL

UNDERDRIVE / OVERDRIVE REACTION PLATE
LUG THICKNESS TO TAPERED SNAP RING USEAGE

FOR FURTHER INFORMATION OF UNDERDRIVE / OVERDRIVE REACTION PLATE
SELECTIVES SEE ATSG BULLETIN NO. 93-07

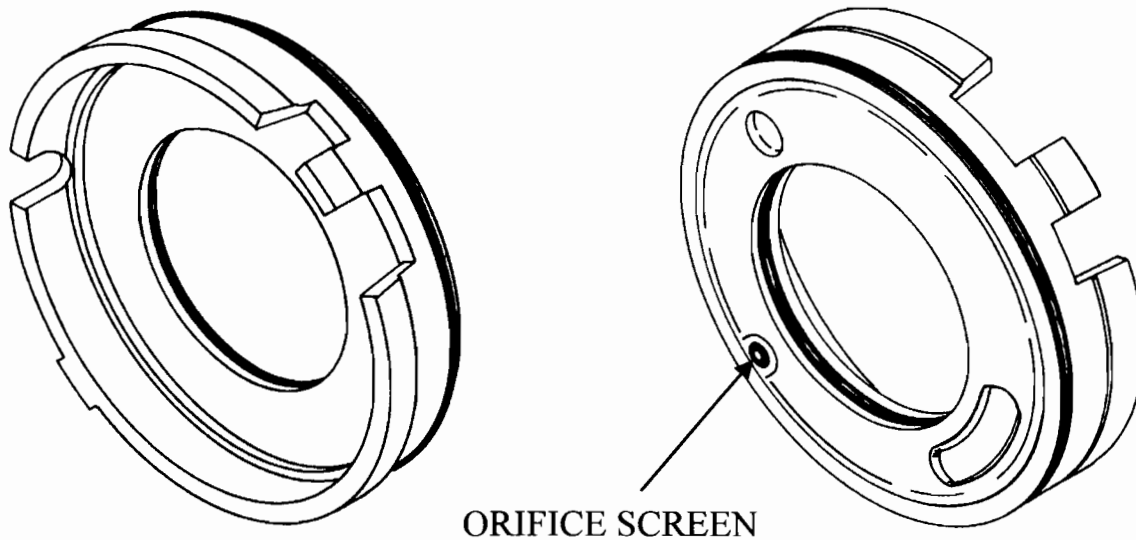
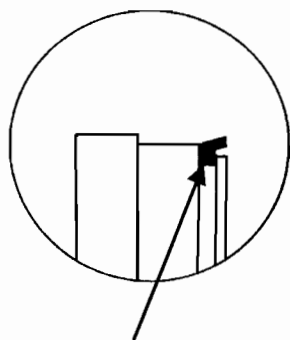
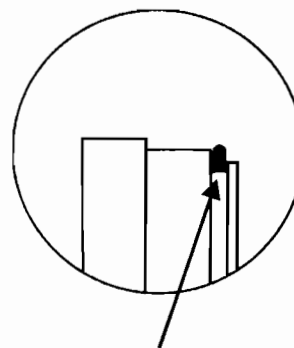
Figure 4

4. Leakage at the Low / Reverse piston seals, orifice screen, or Low / Reverse piston retainer and gasket, due to warpage at the attaching bolt holes or loose retainer attaching bolts.

NOTE: USE PART NUMBER **4431672** 1993 & UP LOW REVERSE PISTON. IT IS .002" SMALLER IN DIAMETER ABOVE THE OUTER PISTON SEAL. THIS WAS DONE TO PREVENT THERMAL BINDING IN THE PISTON RETAINER.

4. Inspect the Low Reverse piston and ensure that the updated "D"-rings are used. Inspect the rear of the piston to ensure that the "Orifice Screen" is in place and is not damaged (See Figure 4). Replace piston with part # 4431672 if the transmission was produced prior to 1993. Replace piston retainer with part # 4431648 and replace the gasket under the piston retainer (See Figure 5). Coat the attaching bolts with "Loctite"® and torque them to 40 inch lbs. **NOTE: Be careful not to over-torque as the threads in the case can be easily "Stripped."**

NEW DESIGN "D-RING" KIT PART NO. 4778883
(Contains both Inner and Outer seals)

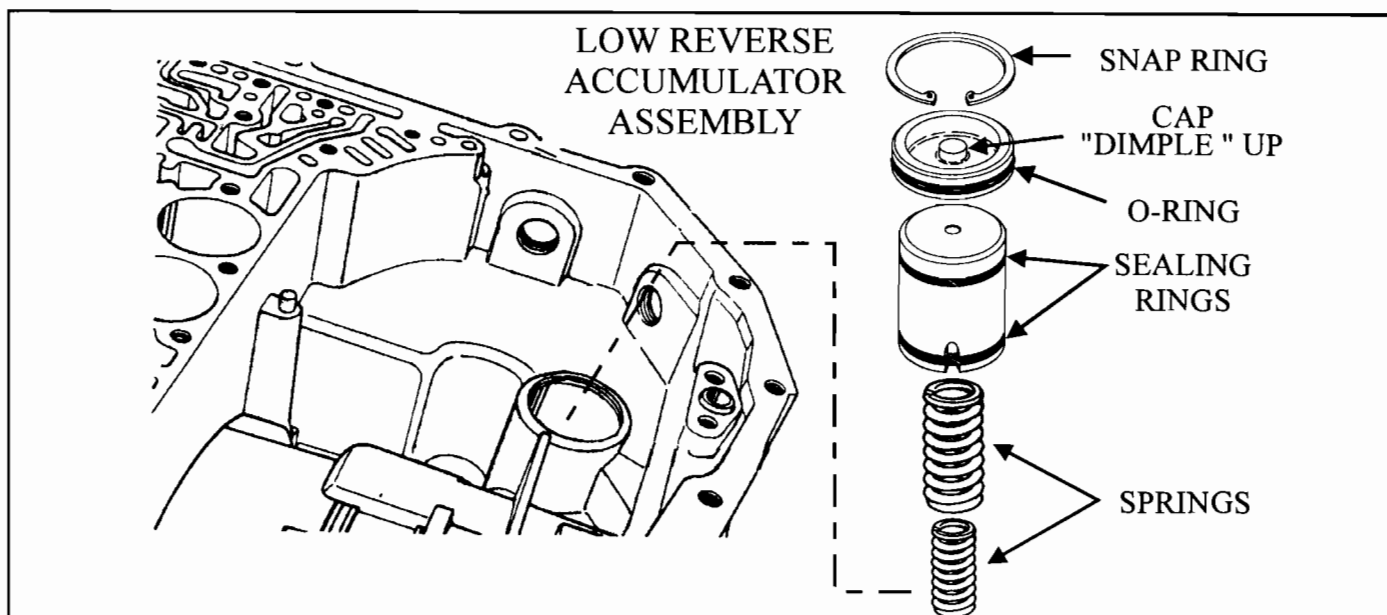
5. Leakage at the Low Reverse clutch accumulator rings and / or the O-ring on the accumulator cap, or the cap installed backwards.
6. Underdrive and Overdrive accumulator pistons installed backwards.

5. Inspect the Low Reverse accumulator scarf cut sealing rings for damage and proper fit. Install the accumulator springs, piston, cap and snap ring as shown in Figure 6

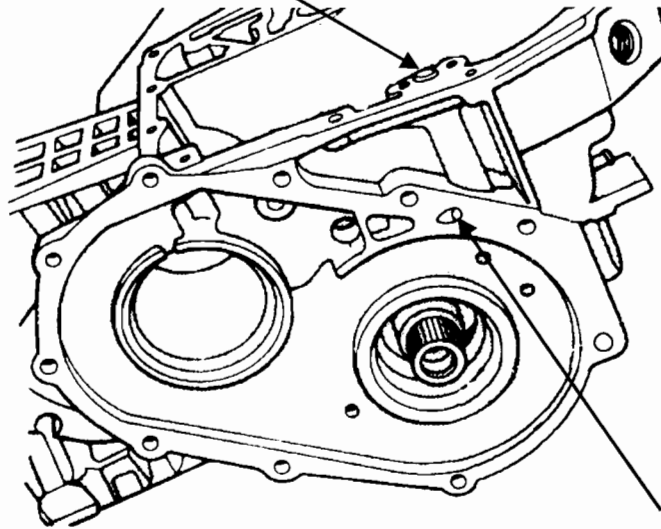
9. A leak at the large check ball staked into the rear of the case, connecting the Low Reverse feed passage to the Low Reverse accumulator, causing a loss of Low / Reverse clutch oil.

"NO" LEAKAGE ALLOWED FROM
STEEL BALL STAKED IN CASE

NOTE: THE LOW REVERSE ACCUMULATOR, ALL CLUTCH AND STEEL PLATES
MUST BE ASSEMBLED BEFORE AIR CHECKING. THE ORIFICE SCREEN
IN THE LOW REVERSE PISTON WILL LEAK A SMALL AMOUNT OF AIR,
THIS IS NORMAL

7. Inspect the valve body separator plate where it seats around the Low Reverse feed pipe, shown in Figure 7, for "Dent's" that may have been caused by a mis-alignment of the valve body to the case. Torque valve body to case attaching bolts to 105 inch lbs.

8. Refer to Figure 7 to locate the "Large Steel Ball" staked into the rear of the case. Ensure "NO" leakage around the ball when air checking the Low Reverse clutch.

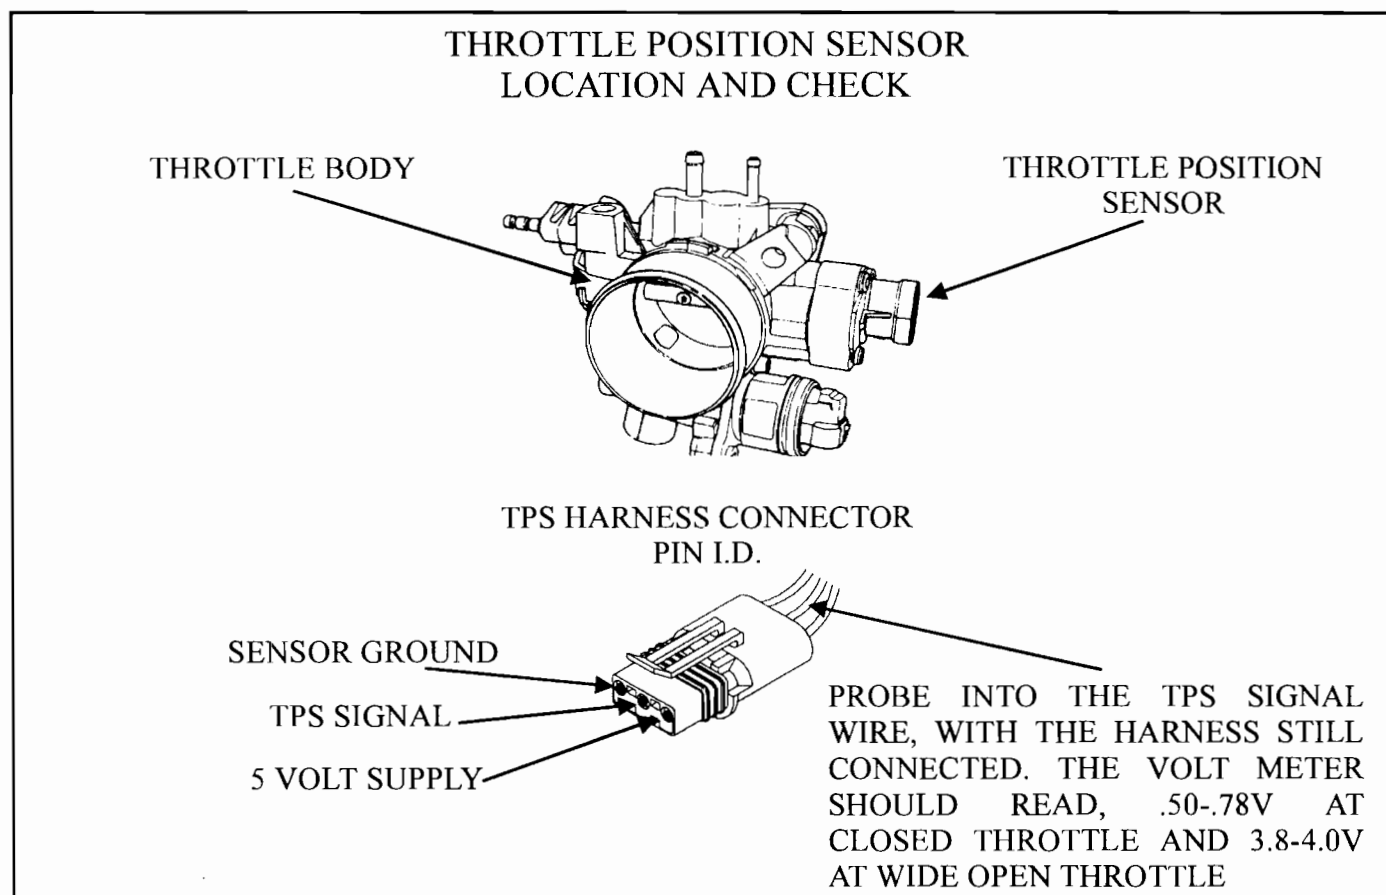
Figure 10

2. Inspect "Throttle Position Sensor" voltage either with a hand held scanner or a volt meter and ensure that the "Base" or "Closed" throttle voltage reading is between .50-.78V, and the "Full" throttle voltage reading is between 3.8-4.0V. (See Figure 10) If the base throttle stays above 1.0 volt or if excessive or intermittent voltage or signal changes occur, harsher downshifts may result.

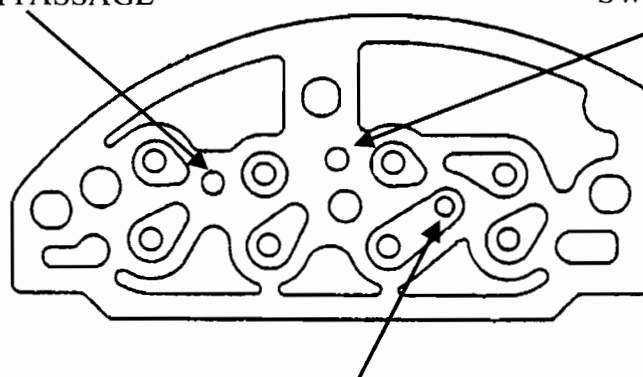
PRESSURE SWITCH TEST: ALL THREE PRESSURE SWITCHES ARE TESTED WITH 50PSI. OF AIR PRESSURE APPLIED TO THE PASSAGES SHOWN ABOVE AND AN OHMMETER. WITH NO AIR APPLIED TO THE SWITCH THE OHMMETER SHOULD READ NO CONTINUITY. WITH AIR APPLIED TO THE SWITCH THE OHMMETER SHOULD READ 0 OHM'S.

3. To test the Solenoid pack install a scanner to the diagnostic connector and select "ATM" or "Actuator" test's. Connect a pressure guage to the corresponding pressure port (see Figure1) and observe the operation of the solenoid and the reaction on the pressure guage. **NOTE: the vehicle must have the drive wheels in the air and the selector in Overdrive and the Parking Brake engaged before starting this test. Consult your scanner reference manual.** If a solenoid does not respond consistently, this may indicate that the solenoid pack needs replacement. It has been noted that not all TCM's will activate the ATM or Actuator test. If you can not initiate the test, refer to Figures 11 and 12 to test the solenoid pack.

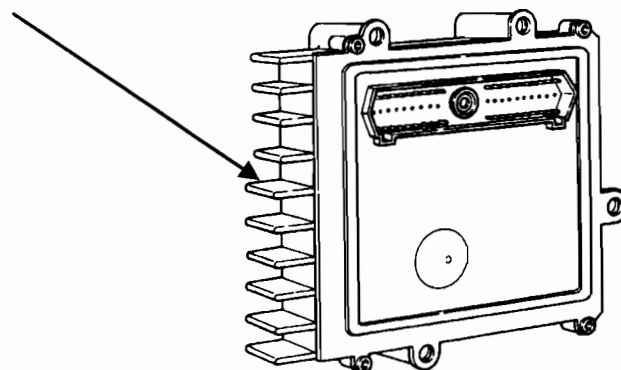
Figure 13

TRANSMISSION CONTROLLER
WITH "COOLING FIN'S"

4. After all Hydraulic / Mechanical concerns have been addressed the Transmission Control Module (TCM) may need "Flashed", (Reprogramed), or replaced. The main requirements for a "Flashable" TCM. are:

1. Must **have** "Cooling" Fin's." (See Figure13)
 2. Must **not have** one of the following part numbers: 4686174, 4686175, 4686208, 4686209, 4686223, 4686224, 4686490 or 4686491.

If the TCM **does not** have "Cooling Fins," or **has** one of the part numbers listed above, contact your Chrysler dealer for a replacement TCM. Chrysler Technical Service Bulletin 18-24-95 refer's to "Flashing" procedures and a full list of updated TCM part numbers and important information concerning "Pin 49" on Spirit and Acclaim models.

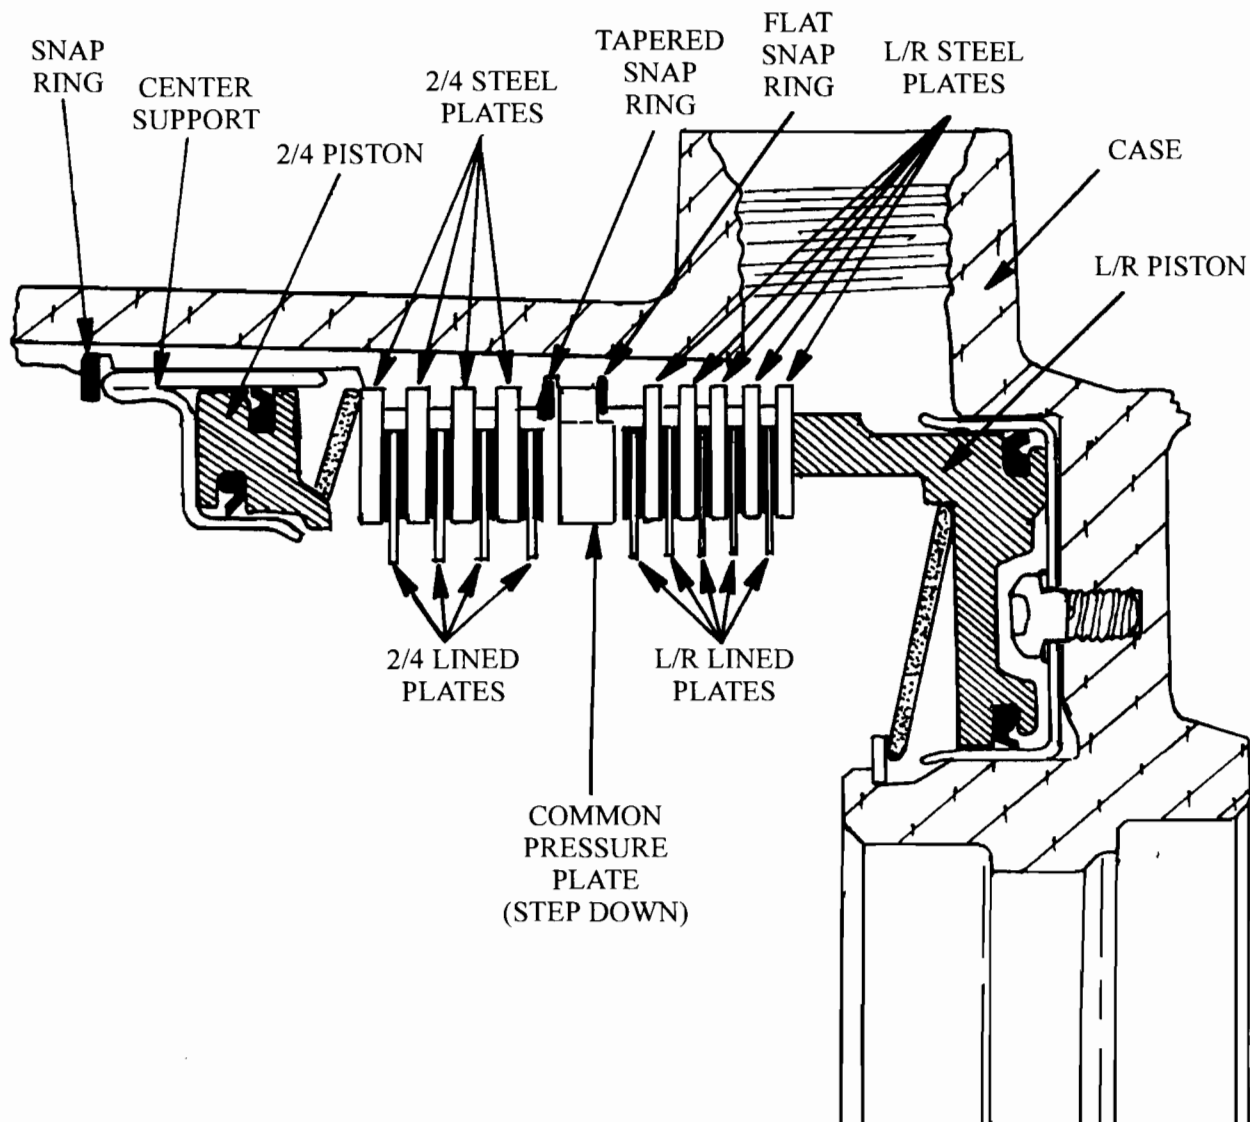
Figure 1

TWO/FOUR AND LOW/REVERSE CLUTCH PLATES

LOW/REVERSE CLUTCH PACK TAKES 5 STEEL PLATES (.070") AND 5 LINED PLATES (.070")

TWO/FOUR CLUTCH PACK TAKES 4 STEEL PLATES (.100") AND 4 LINED PLATES (.085")

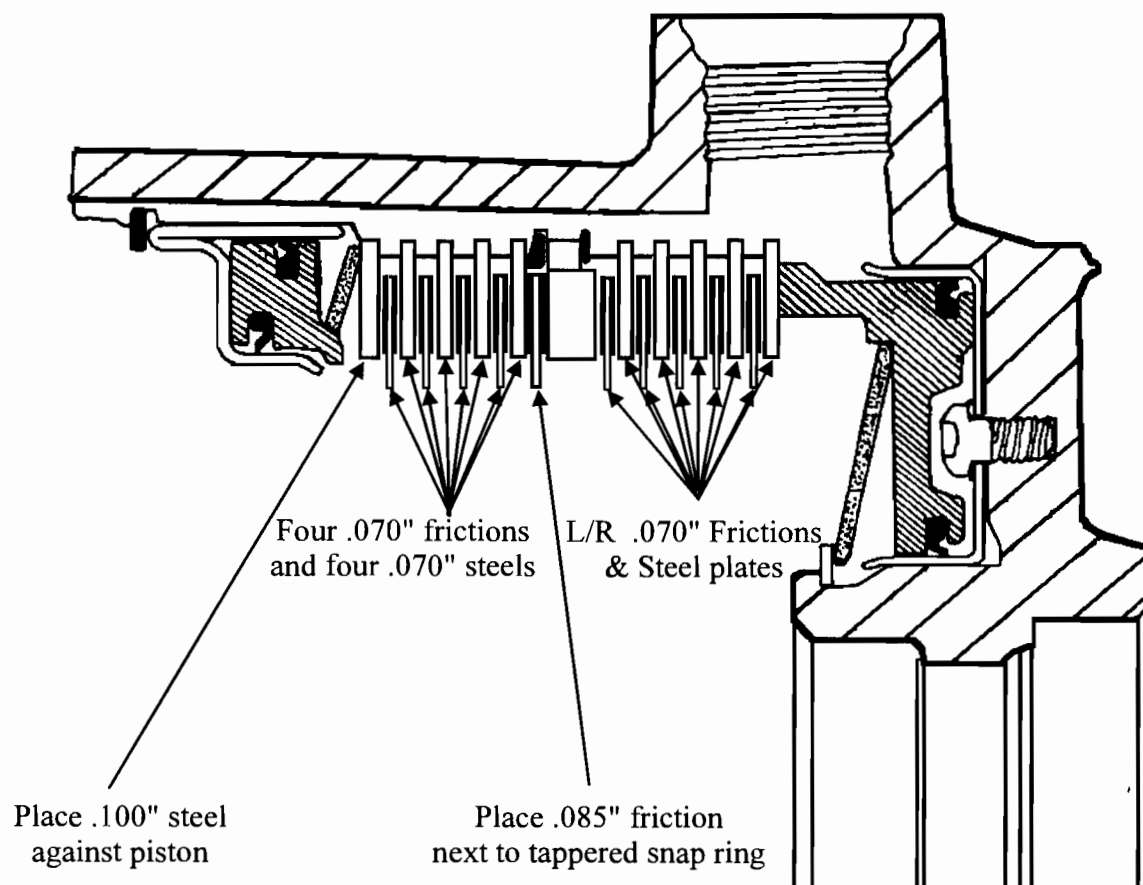
Figure 2

2/4 CLUTCH STACK UP FOR INCREASED CAPACITY
