1997 SEMINAR INFORMATION

"THE RIGHT DIRECTION FOR '97"

INTRODUCTION

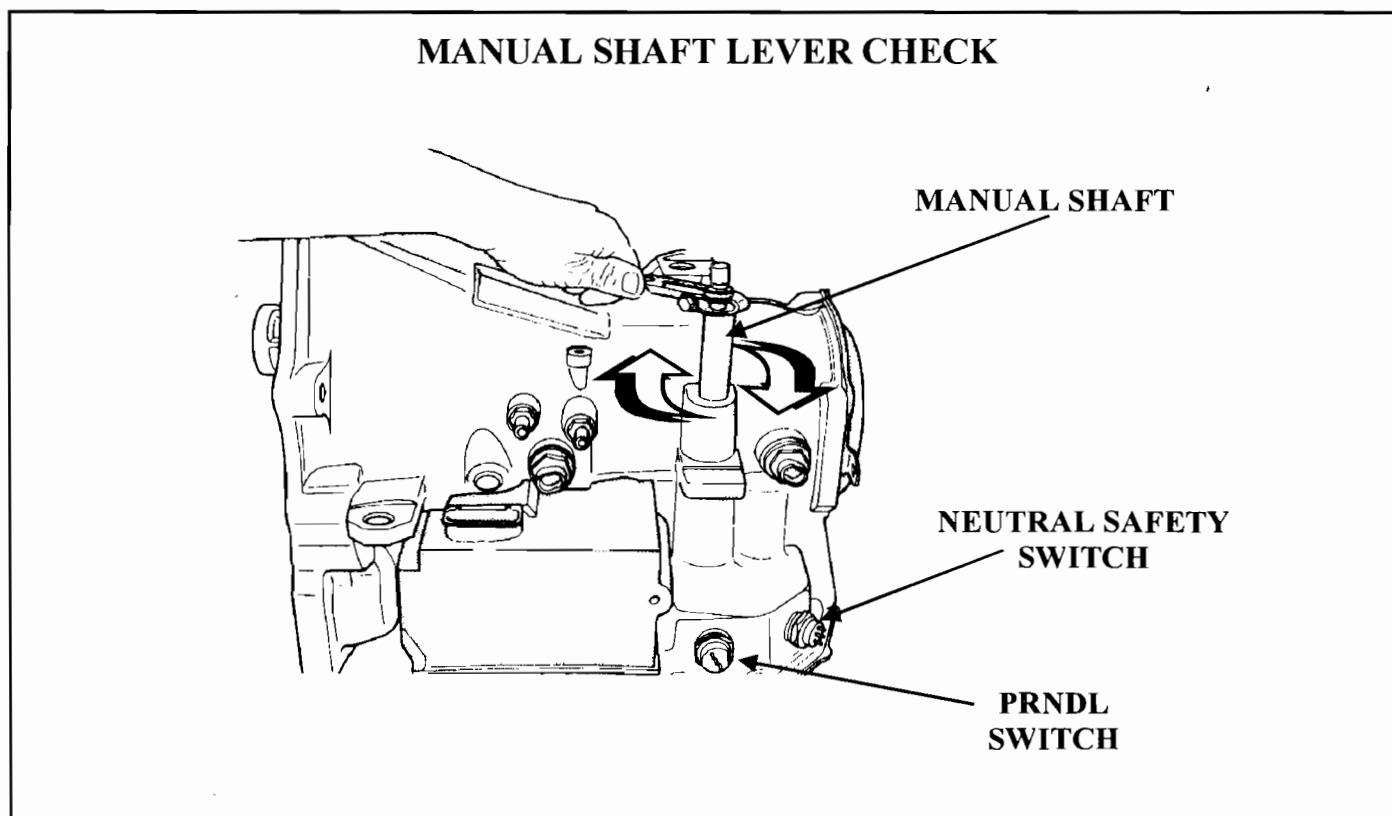
Figure 1

CAUSE: The cause may be, a bad Neutral Safety or PRNDL switch, a binding Manual shaft or a bad shifter cable

CORRECTION: Disconnect the shifter cable from manual shaft lever shown in Figure 1. Rotate the manual shaft lever through all ranges. If the lever rotates freely, replace the shifter cable. If the lever is still hard to move, loosen or remove the Neutral Safety and/or PRNDL switch and rotate the manual shaft lever. If the lever rotates freely, replace the Neutral Safety and/or PRNDL switch. If the lever is still hard to move, remove the valve body and inspect the manual shaft for straightness and remove any corrosion or rust from the shaft.

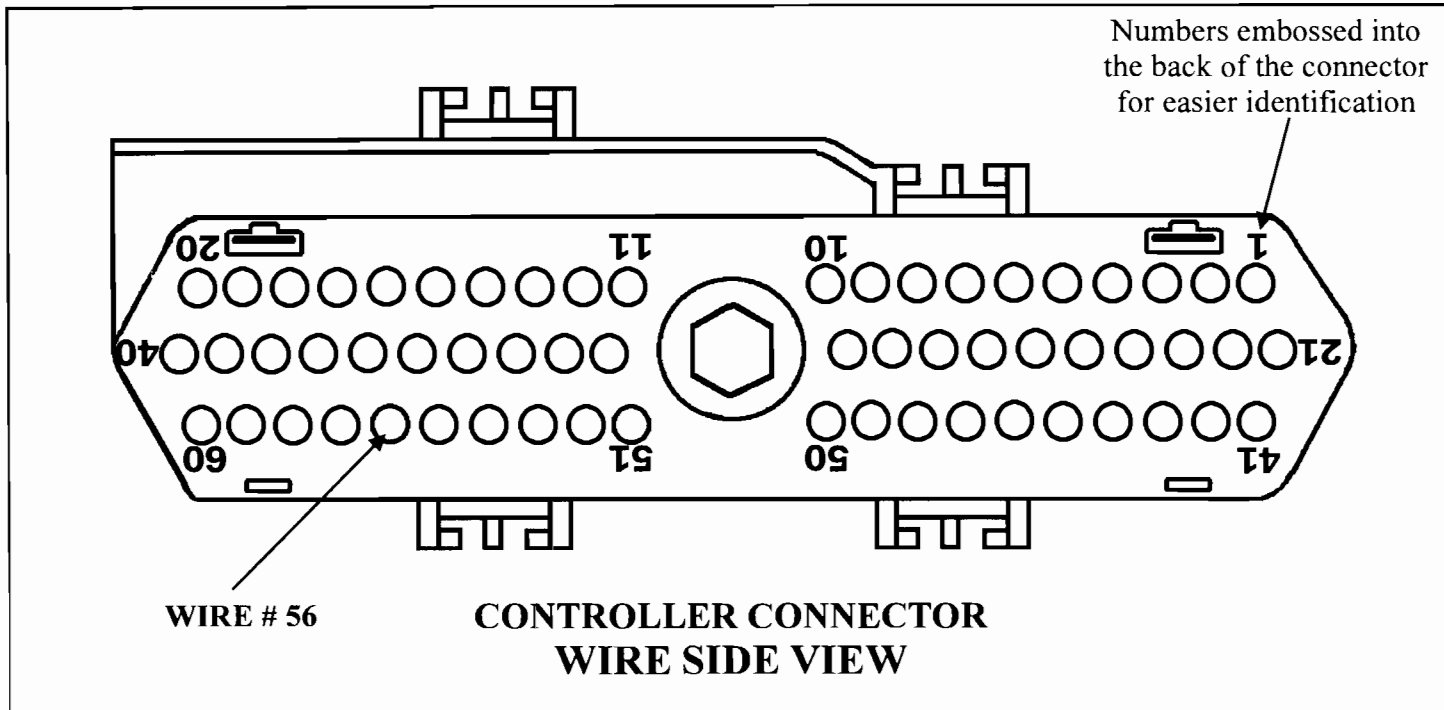
Figure 1

COMPLAINT: Vehicle stuck in a failsafe condition with a scanner read out of either a code 12 or 15 or no codes at all. Other symptoms may be the scanner indicates that the transaxle module is not responding, a sudden loss of communication, or that the EATX relay exhibits a loud clicking noise.

CAUSE: The most common cause for the above condition is a defective fusible link. This fusible link supplies keep alive battery voltage to pin # 56 at the transaxle controller and switched battery voltage to the EATX relay.

CORRECTION: A quick method to verify that the fusible link is the problem, locate wire 56 in the controller (See Figure 1). Carefully remove some of the insulation from the wire and connect battery voltage to the wire with a jumper wire (See Figure 2). Once connected, if all symptoms are removed, a defective fuse or fusible link is the problem. To assist on locating the defective fusible link, all fusible links are color coded and can be found below and between the battery and driver side spring tower (See Figure 3). Refer to the chart in Figure 4 which cross references the fusible link color identification to the vehicle make and year.

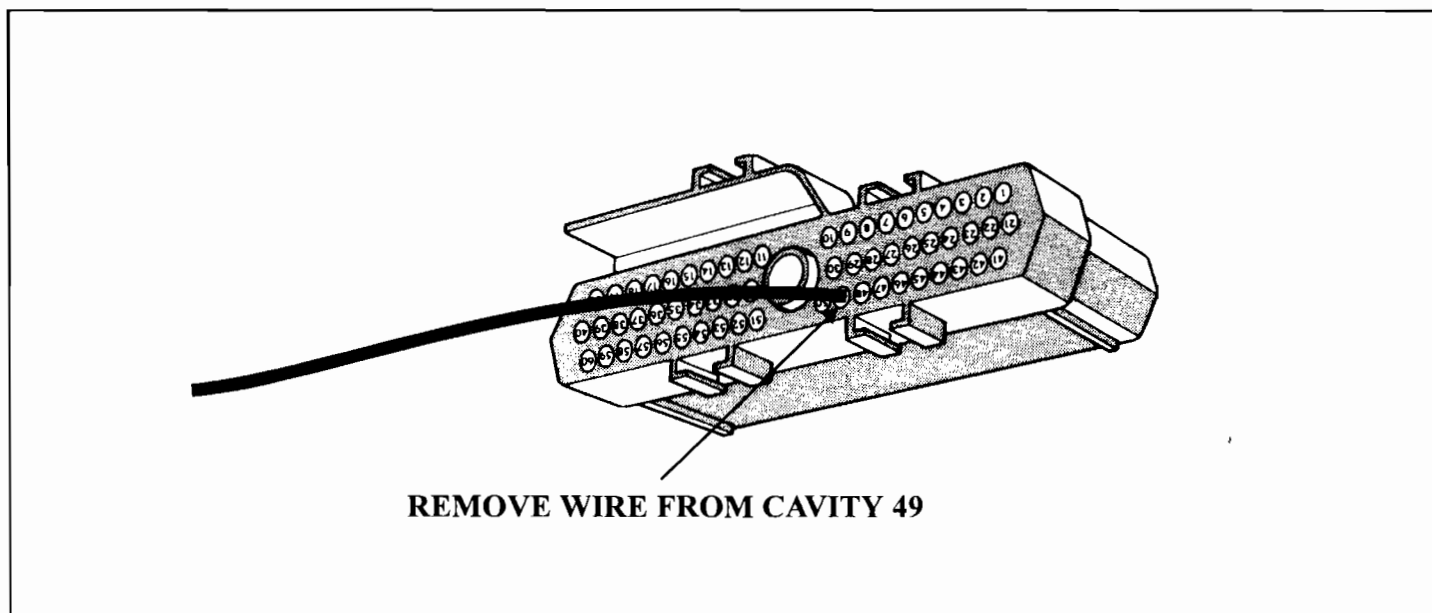
Figure 1

When flashing to or installing these TCM's, it is necessary to ensure no wire is connected at CAVITY 49 of the TCM wiring harness connector (See Figure 1). If the wire is left connected, and the vehicle is driven at speeds fast enough for the transmission to be in 4th gear/Overdrive (OD), when the brake pedal is pushed, the transmission will shift into 3rd gear or if the transmission was already in 3rd gear it will shift into OD. If the brake pedal is pushed again, the transmission will have OD enable/disable (whether or not an actual shift takes place depends on vehicle speed) and will change between enabled/disabled OD each time the brake pedal is pushed.

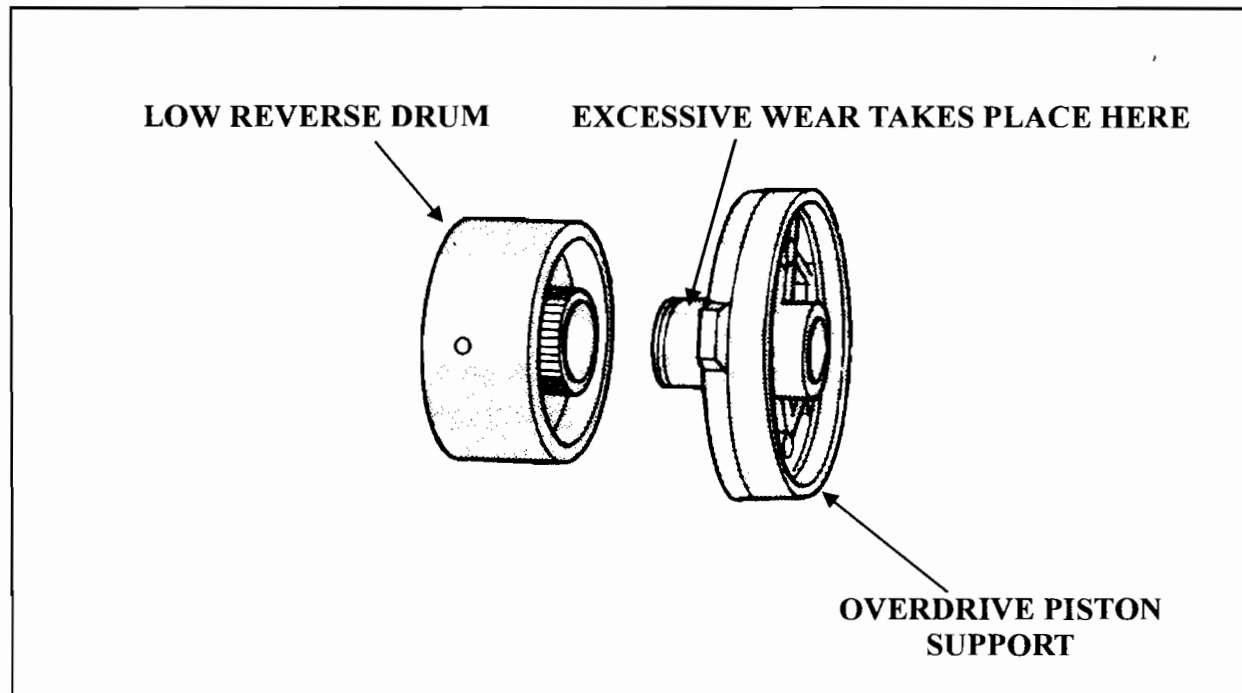
Figure 1

CAUSE: One cause may be that during overhaul, it is not uncommon to find the overdrive piston support worn excessively where the low reverse drum rides (See Figure 1). When the support was replaced, one was used from an A500/518 transmission. This allows all governor oil to be exhausted as the A500/518 support has feed and return governor holes for the governor tubes to fit into where as the 42RE does not use tubes since governor pressure is solenoid controlled off the valve body (See Figure 2). The support found on the 42RE does not have these holes which blocks any governor oil from escaping to an exhaust (See Figure 3).

CORRECTION: Replace the support with one from a 42RE transmission. In some cases, the overdrive extension housing can be removed from the transmission without removing the whole transmission from the vehicle. If this is available, remove the overdrive section and carefully drill an tap and plug the two holes in the support with pipe plugs as shown in Figure 4.

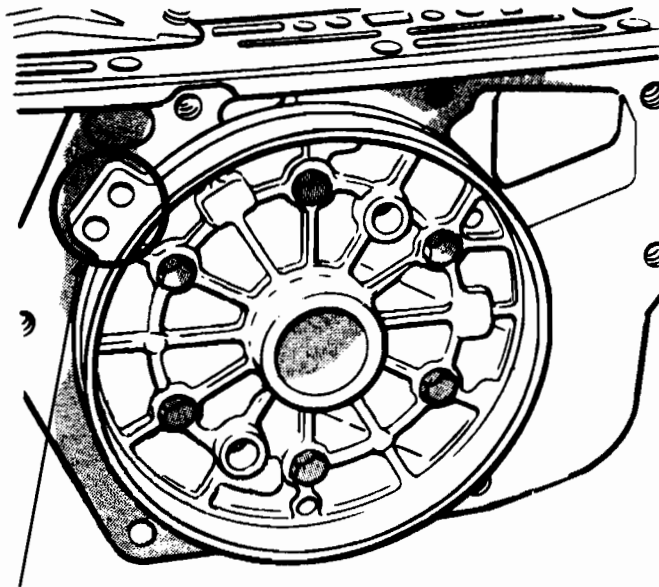
Figure 2

**GOVERNOR FEED AND RETURN
PIPE HOLES USED IN A500/518
MODEL TRANSMISSIONS ONLY**

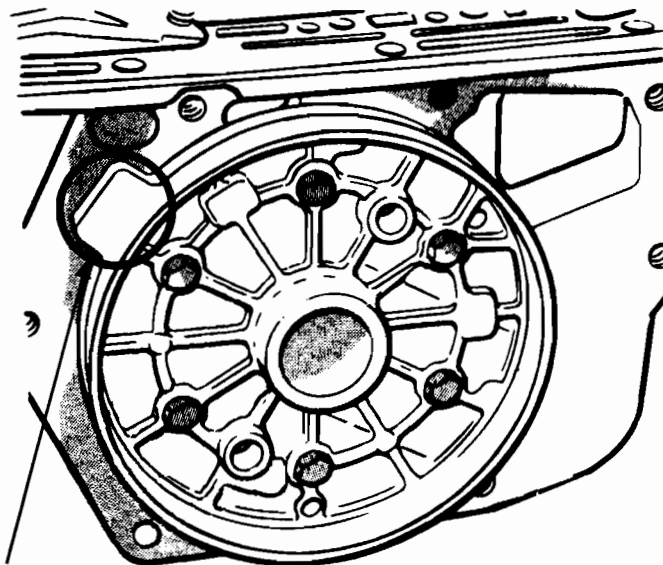
Figure 3

**NO HOLES IN SUPPORT WITH
THE 42 & 46RE
TRANSMISSIONS**

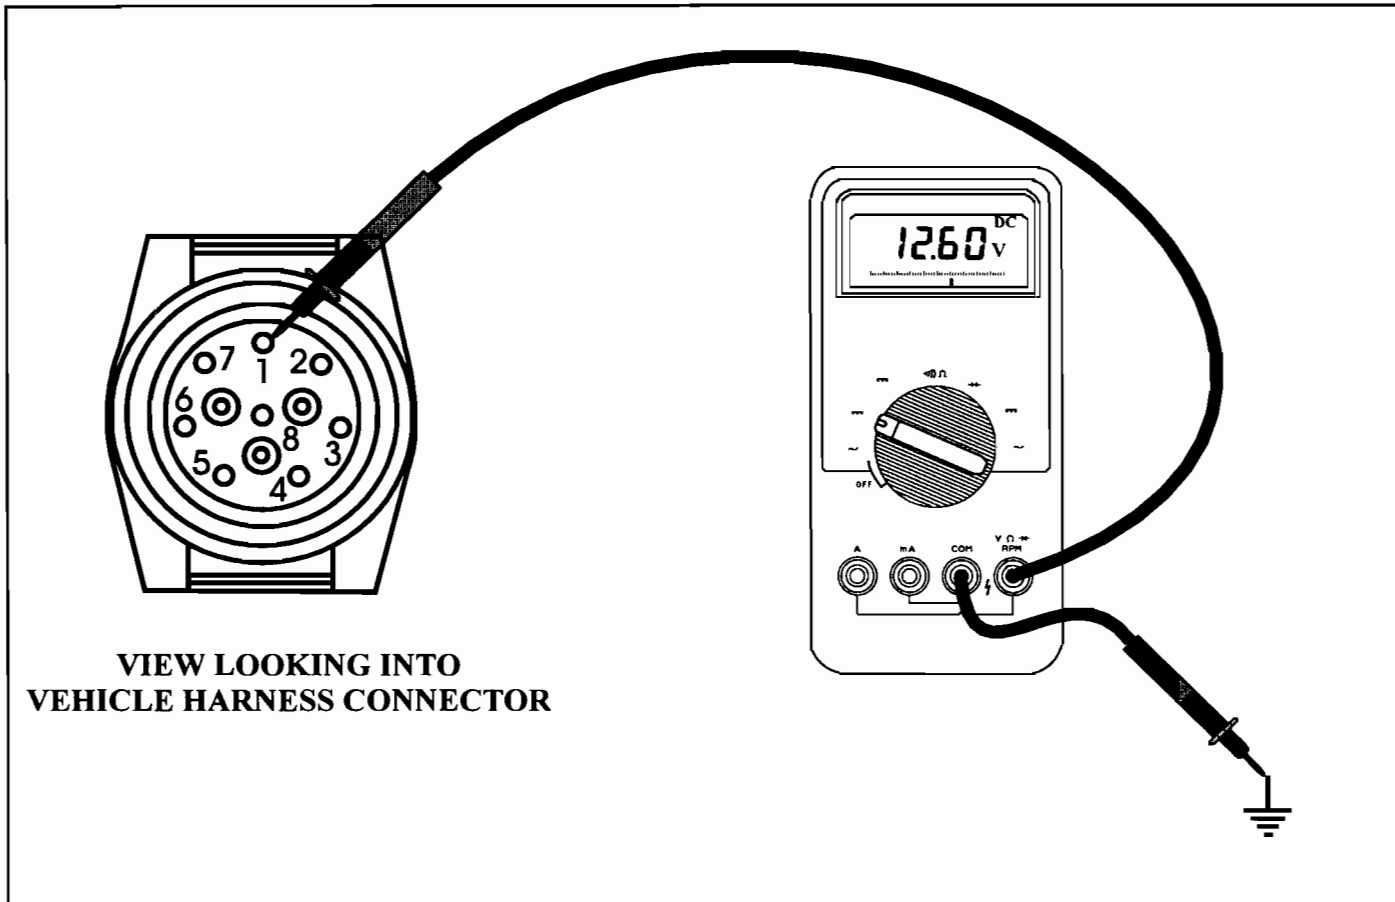
Figure 5

- (a) Check pin cavity number 1 in the vehicle harness connector for battery voltage, as shown in Figure 5. If 0 volts is seen, the computer is either defective, or the computer has lost its power source, or the wire from the computer down to pin number 1 is broken. First locate the computer which is under the dash on the drivers side, and unplug the connector as seen in Figure 6, and continue to the next step.

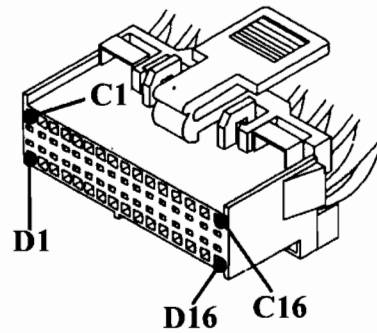
Figure 7

- (b) Locate pin cavity number D16 in the transmission control module connector, as shown in Figure 7. Perform a continuity test between cavity number D16 and pin cavity number 1 in the vehicle harness connector, as shown in Figure 8. There should be 5 ohms or less. If there is an open reading (Infinity), the wire is broken and will need to be repaired. If there is more than 5 ohms resistance observed, there is corrosion somewhere in the wiring, or a short to ground may have occurred, which means the wire will have to be replaced as well. If 5 ohms or less is seen, move on to the next step.

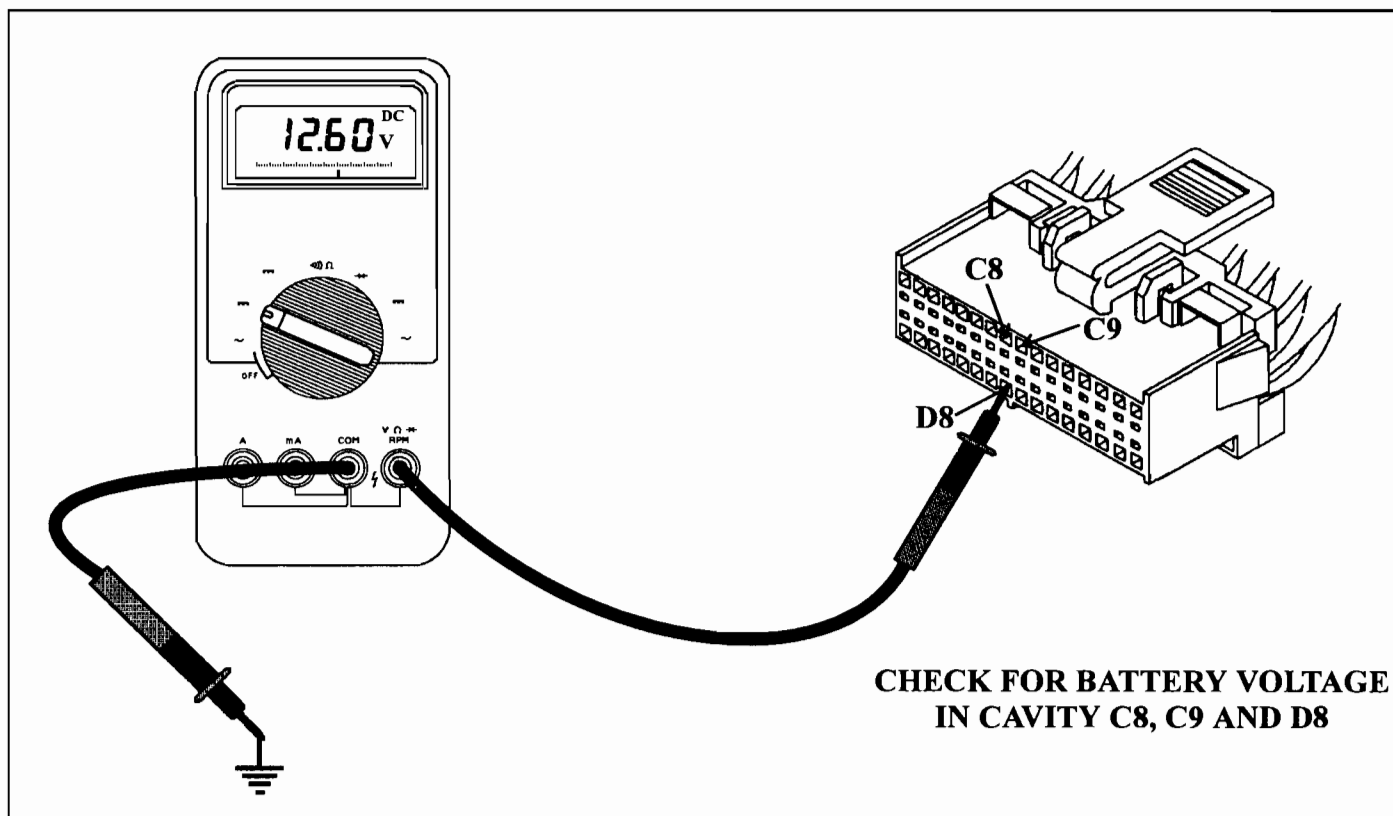
Figure 9

- (c) With the engine off and the ignition switch in the ON position, check for battery voltage in the transmission control module connector, on pins C8, C9 and D8, as shown in Figure 9. If battery voltage is lost at *any* one of these terminals, check for blown fuses in the power distribution center, located on the passenger side fender shield by the battery. Check fuses F2, F3, F6, F15, and replace as necessary, as shown in Figure 10. If battery voltage is seen at all three locations, continue on to the next step.

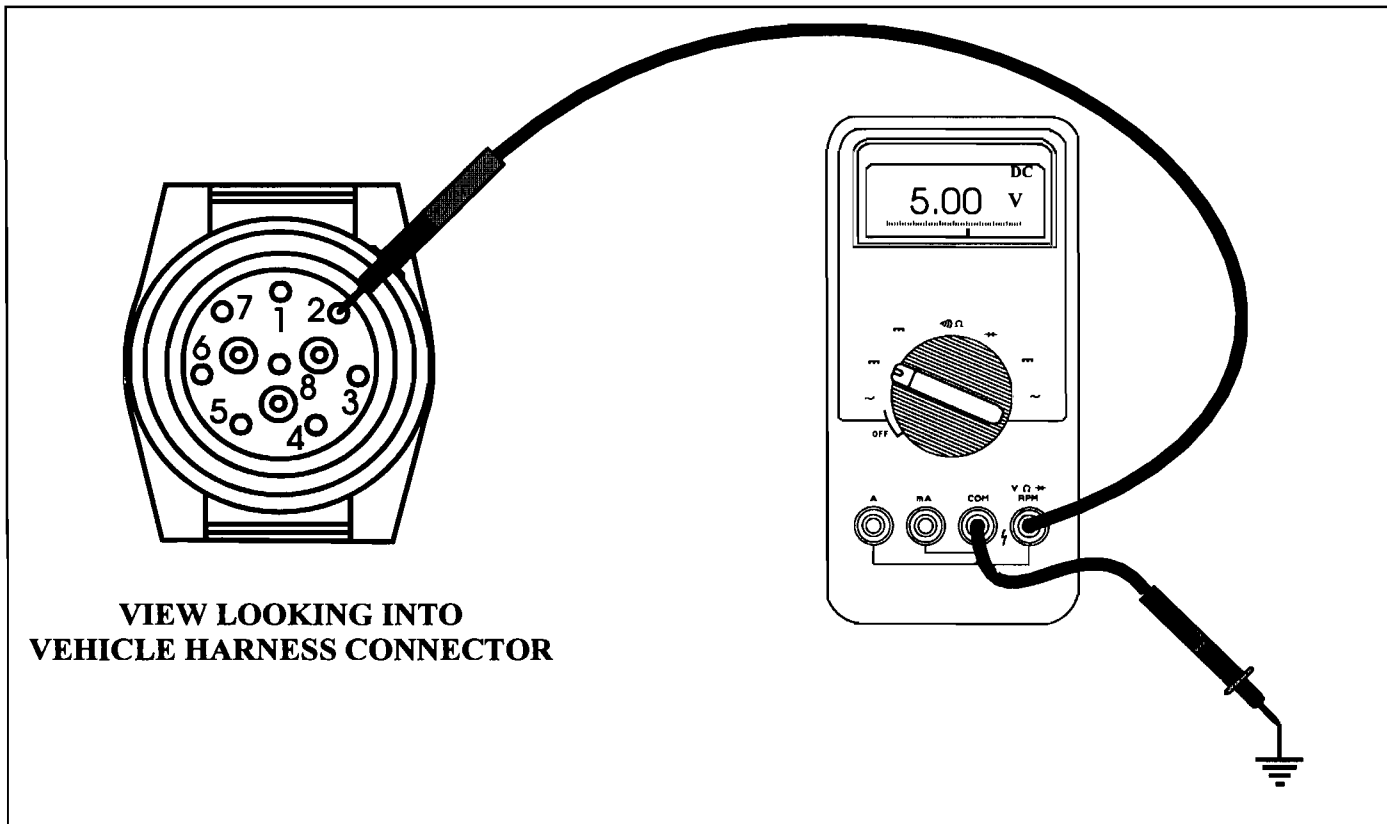
Figure 11

- (d) Plug the transmission control module connector back into the computer, and with the engine off and ignition switch in the ON position, check for 5 volts at cavity number 2 in the vehicle harness connector, as shown in Figure 11. If no voltage is seen, unplug the transmission control module connector and test for continuity between cavity C10 at the transmission control module connector and terminal number 2 at the vehicle harness connector, as shown in Figure 12. If 5 ohms or less is indicated, the computer will need to be replaced. If an open circuit is indicated, repair or replace the broken wire between C10 and terminal 2.

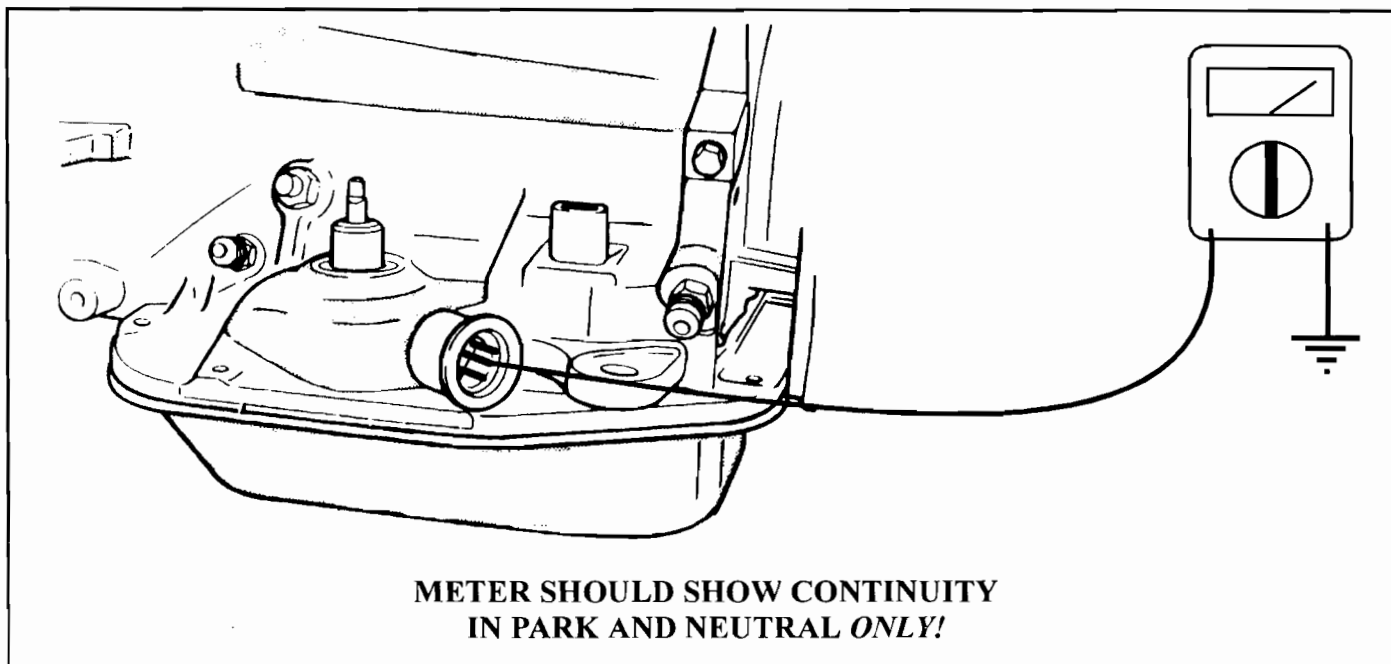
Figure 1

Note: *The wire color at the center terminal of the Park/Neutral switch is normally the wire color at the Starter Relay.*

If the Park/Neutral switch wire **does not** have continuity to ground, cut the wire at the starter relay and try again to start the engine. If the engine still starts, replace the relay.
