# "SIMPLE SOLUTIONS FOR '98"

## INTRODUCTION

***AUTOMATIC TRANSMISSION SERVICE GROUP***  
9200 S. DADELAND BLVD.  
SUITE 720  
MIAMI, FL 33156  
(305) 670-4161

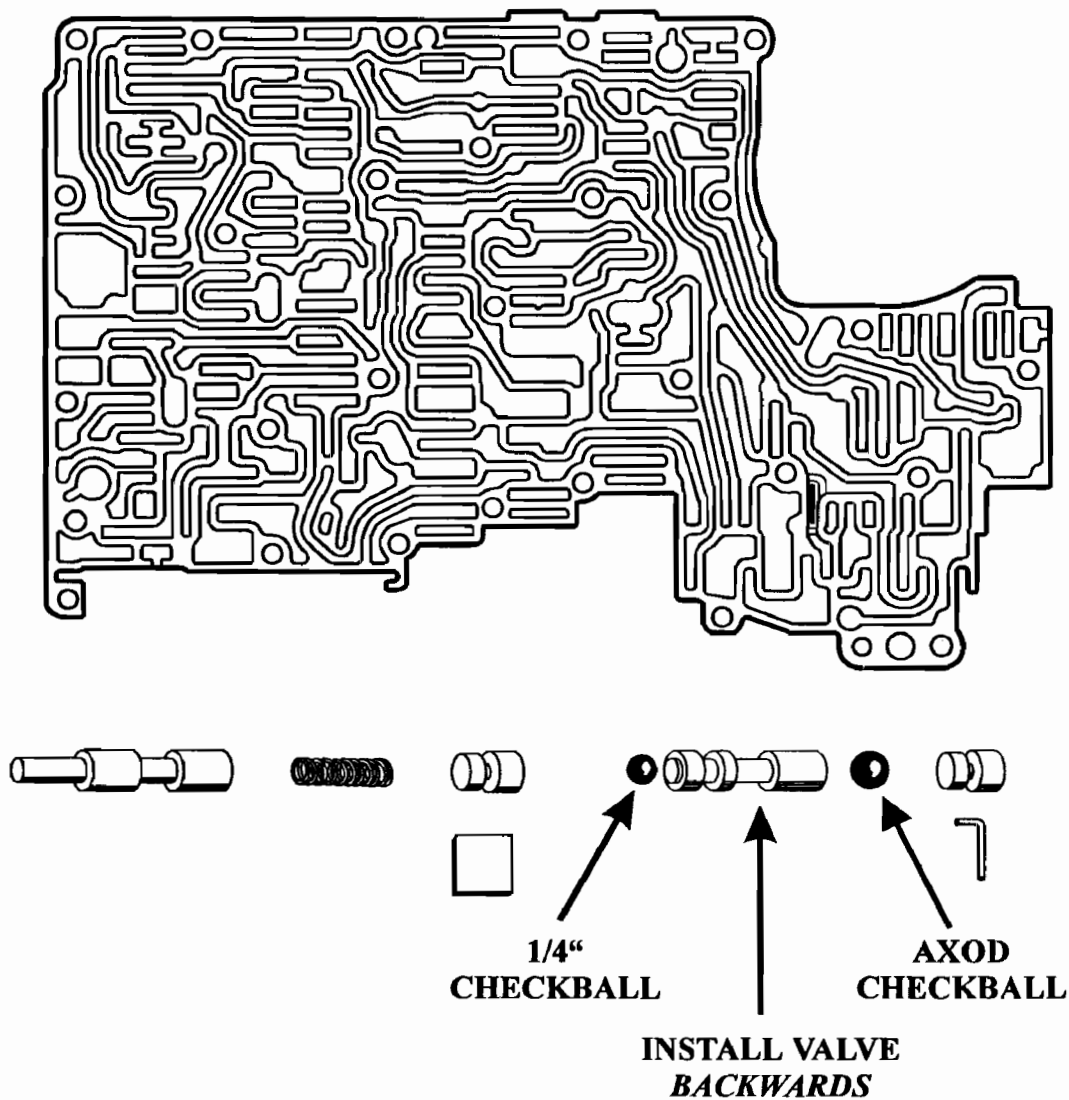
Figure 2

**COMPLAINT:** Before and/or after rebuild, the vehicle exhibits a delay to reverse, or possibly a no reverse at all condition, on later model vehicles equipped with the reverse engagement valve in the valve body.

**CAUSE:** The cause may be, a stuck or damaged reverse engagement valve.

GRIND TIP  
TO FIT IF  
NECESSARY

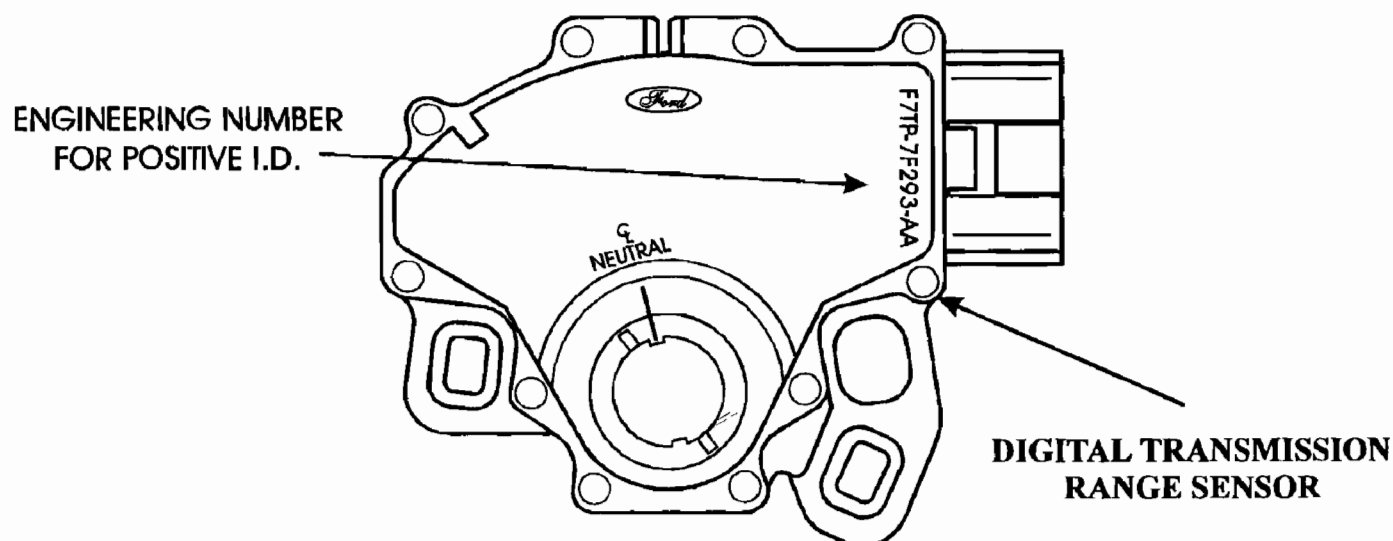
Figure 1

- (1) DTR SENSOR - Replaces the previous manual lever position sensor and is identified by the new basic part number which is -7F293-, as shown in Figure 1. The prefix and suffix will be different depending on the vehicle model and transmission type. The **only positive** identification will be the F7TP-7F293-AA engineering number on the DTR in the location shown in Figure 1.

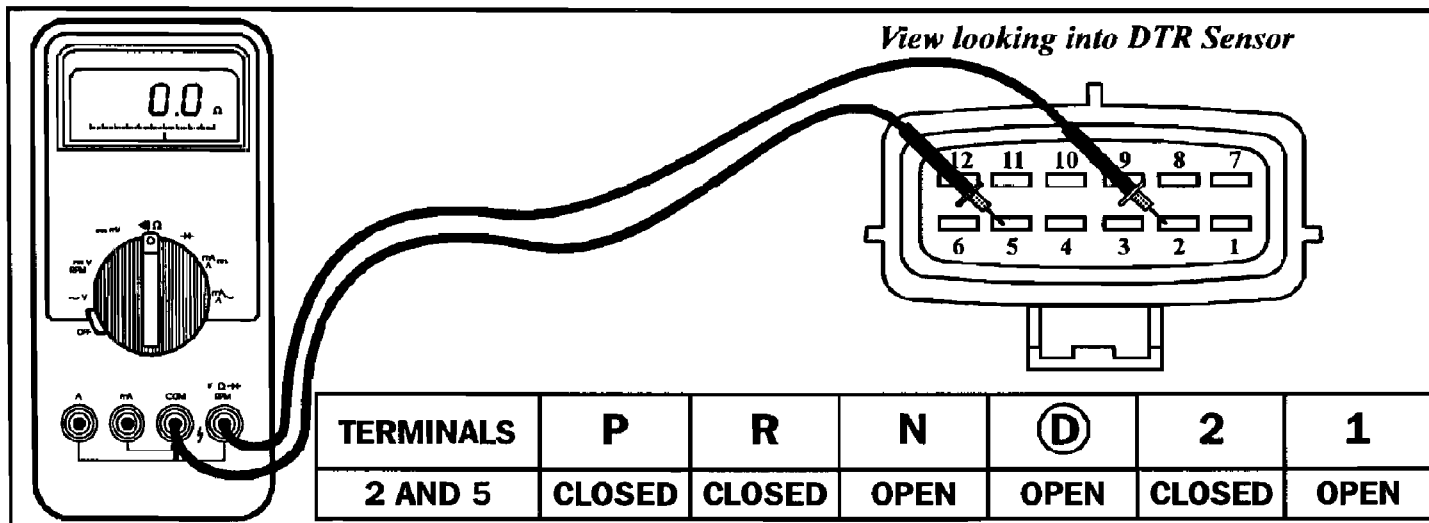
Figure 6

- (3) Testing the transmission range 2 switch is done across pins 2 and 5 of the DTR sensor, and must be checked in each selector position to determine switch integrity. Refer to Figure 6.

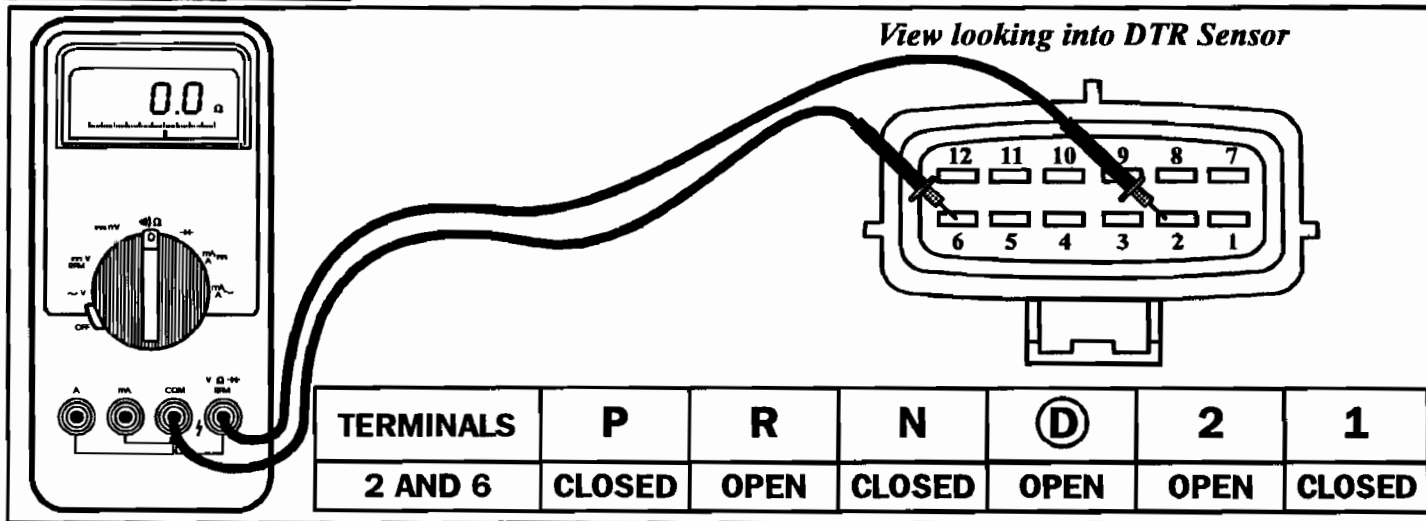
Figure 7

- (4) Testing the transmission range 4 switch is done across pins 2 and 6 of the DTR sensor, and must be checked in each selector position to determine switch integrity. Refer to Figure 7.

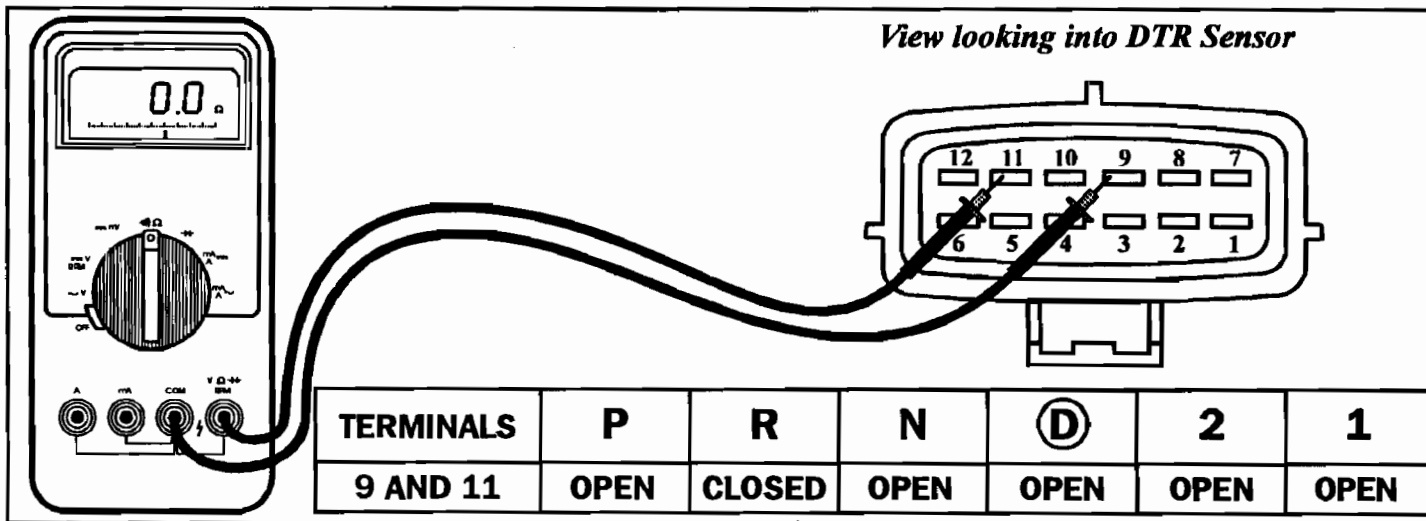
Figure 8

- (5) Testing the reverse lamp circuit is done across pins 9 and 11 of the DTR sensor, and must be checked in each selector position to determine switch integrity. Refer to Figure 8.

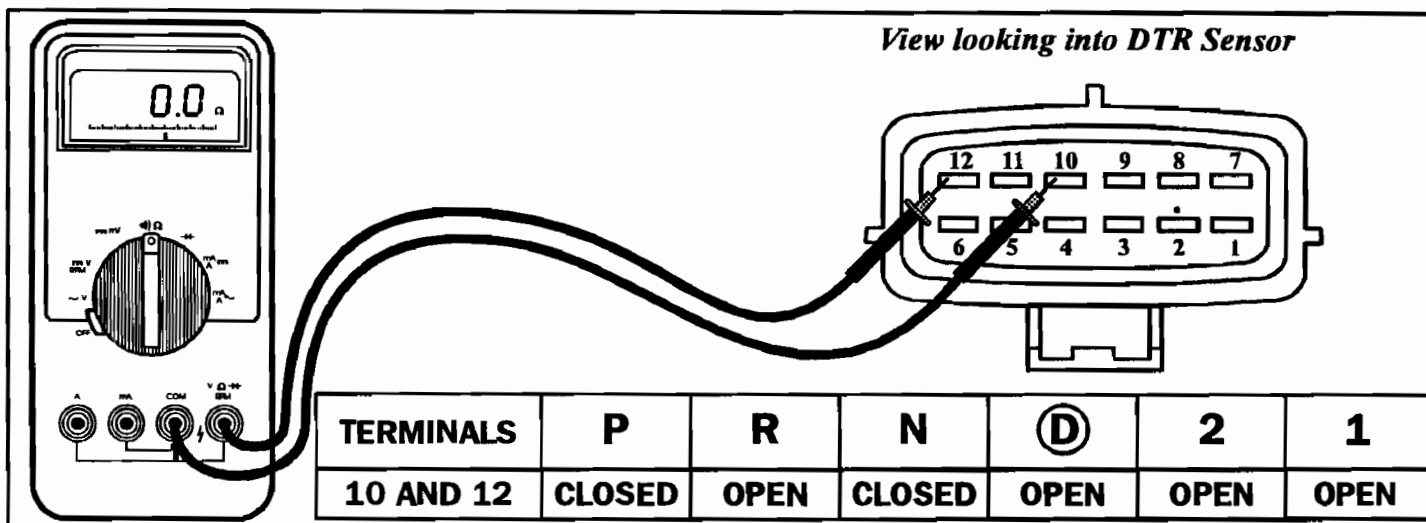
Figure 9

- (6) Testing the neutral start circuit is done across pins 10 and 12 of the DTR sensor, and must be checked in each selector position to determine switch integrity. Refer to Figure 9.

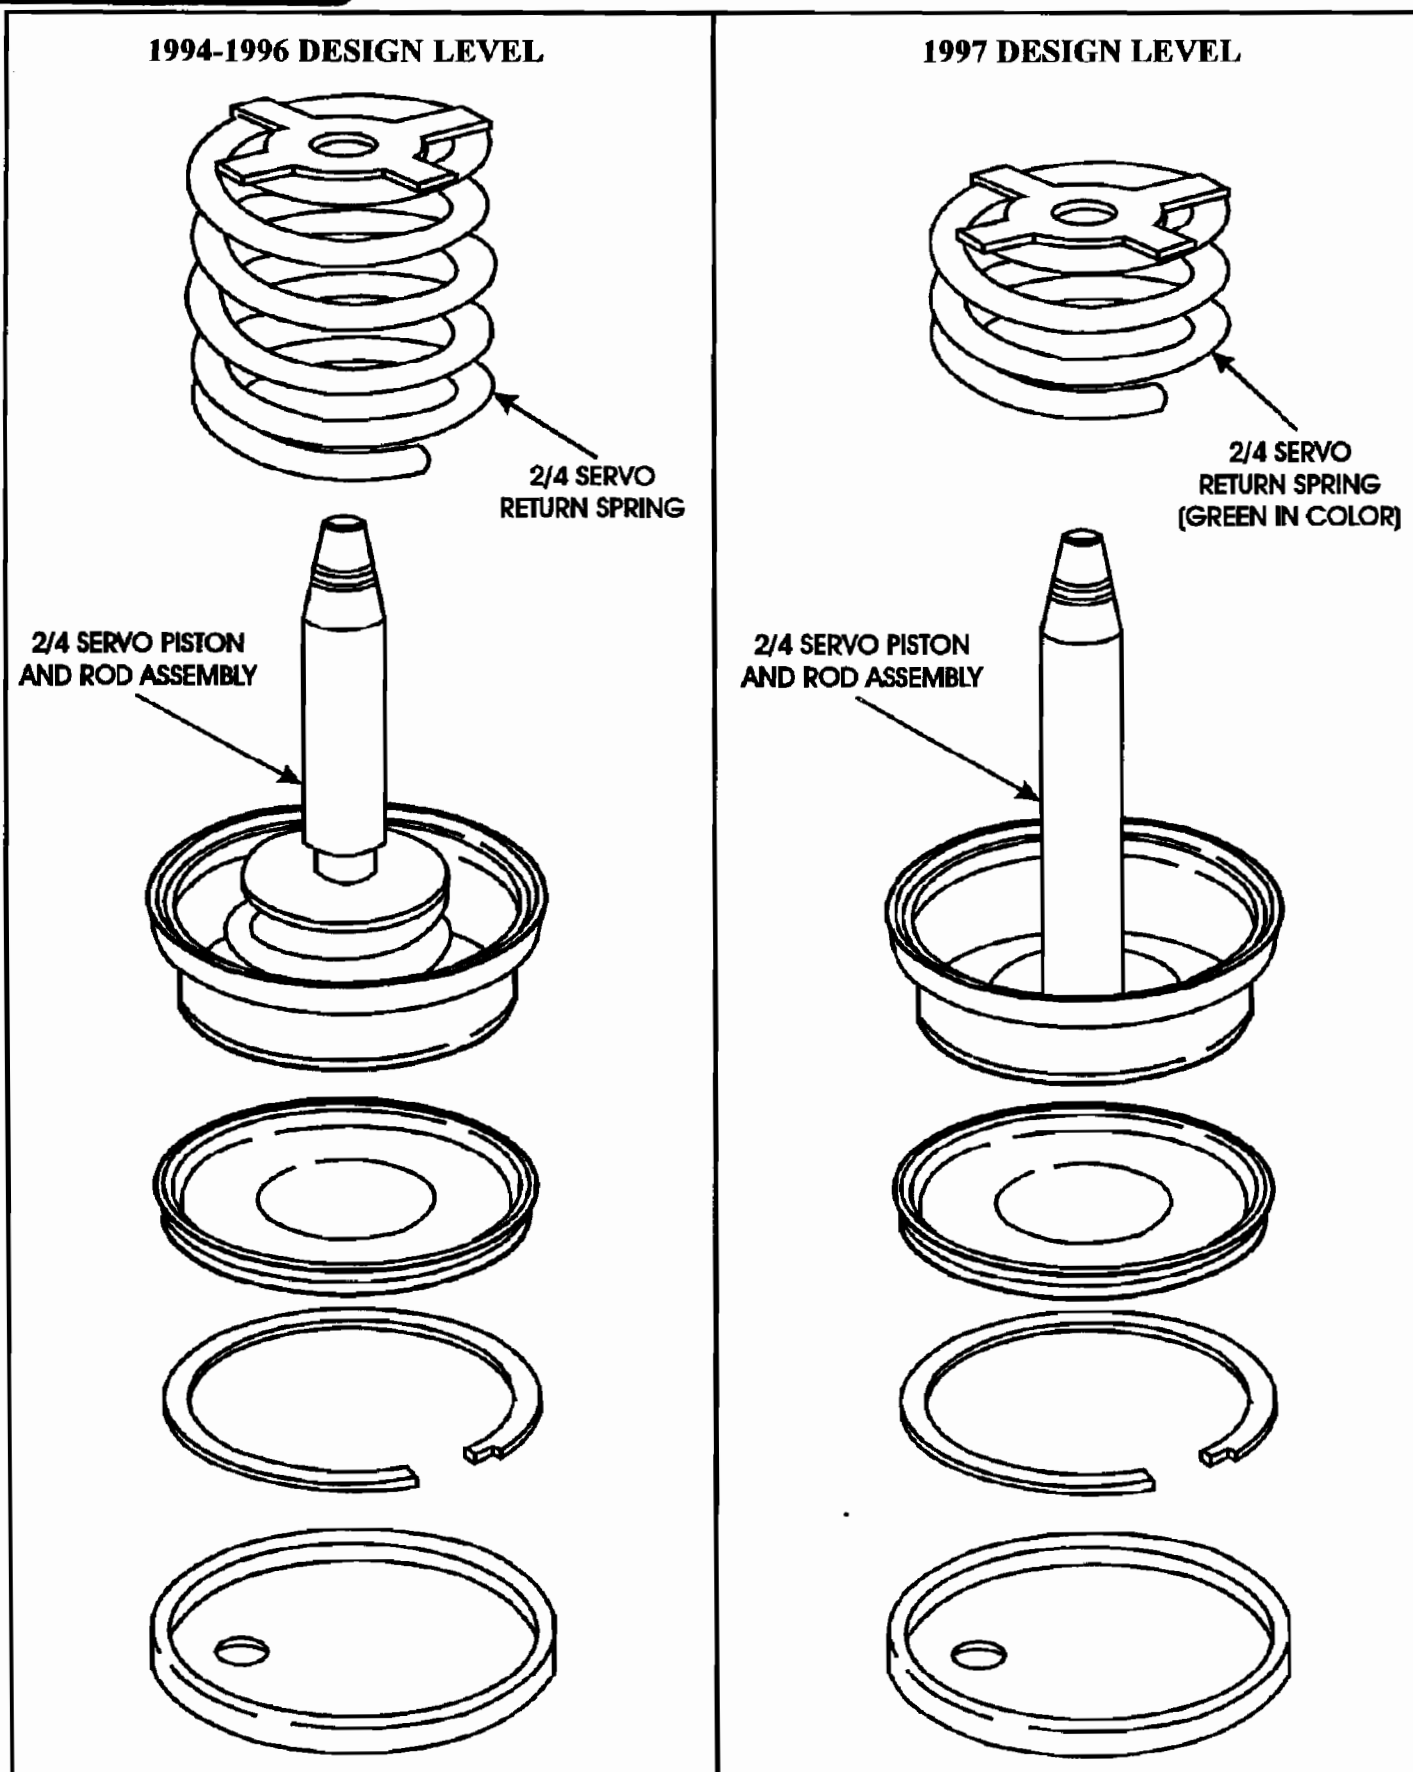
Figure 1

If replacement of the intermediate/overdrive servo piston assembly becomes necessary in a 1997 CD4E transaxle, you *must* use the new design level parts listed below.

2-4 Piston And Rod Assembly, 97 Models (No Grooves) .....	F7RZ-7H188-CA
2-4 Piston And Rod Assembly, 97 Models (1 Groove) .....	F7RZ-7H188-BA
2-4 Piston And Rod Assembly, 97 Models (2 Grooves) .....	F7RZ-7H188-AA
2-4 Servo Return Spring, 97 Models (Green) .....	F7RZ-7H073-AA

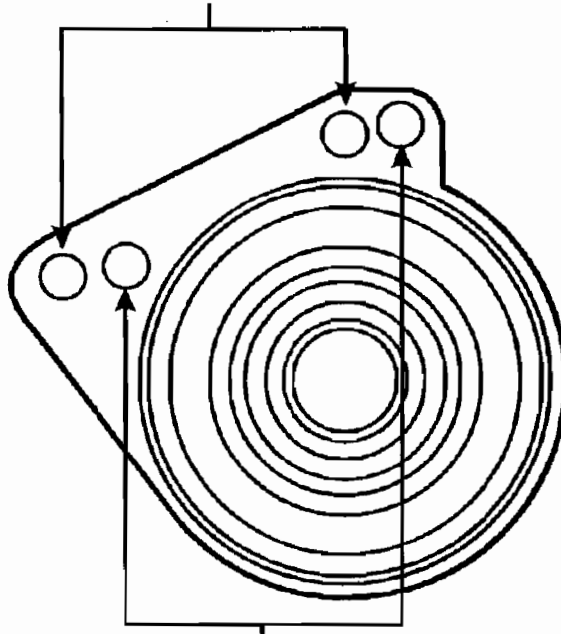
Figure 2

**COMPLAINT:** After overhaul, vehicle exhibits a leak from the right hand differential seal, noise or vibration concerns, or engine oil filter damage and subsequent engine issues.

**CAUSE:** The cause may be, inadvertently using the wrong set of mounting holes when remounting the intermediate shaft bearing and bracket assembly. For location refer to Figure 1. The original 1st design style of intermediate shaft bracket had two sets of mounting holes, one for CD4E applications, and the other set for MTX-75 (Standard Shift) applications, as shown in Figure 2.

USE THESE TWO HOLES  
FOR STANDARD TRANSAXLE

USE THESE TWO HOLES  
FOR CD4E TRANSAXLE

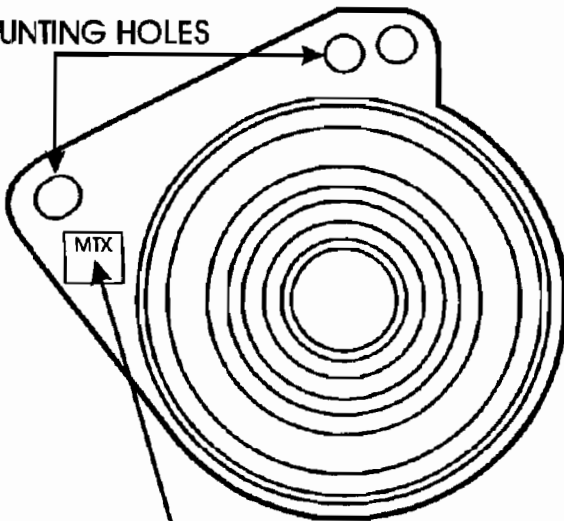
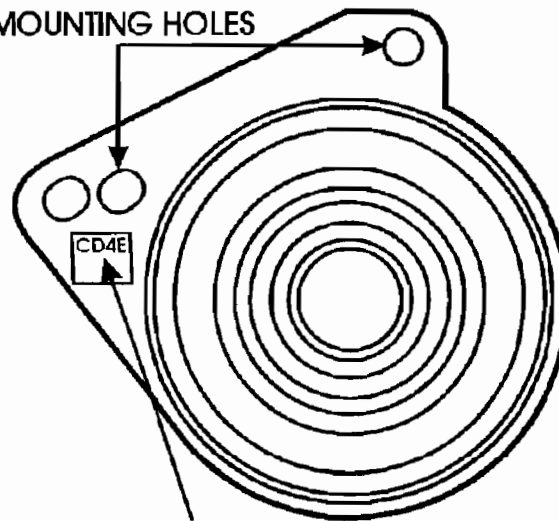
Figure 3

MOUNTING HOLES

FOR STANDARD APPLICATIONS

FOR CD4E APPLICATIONS

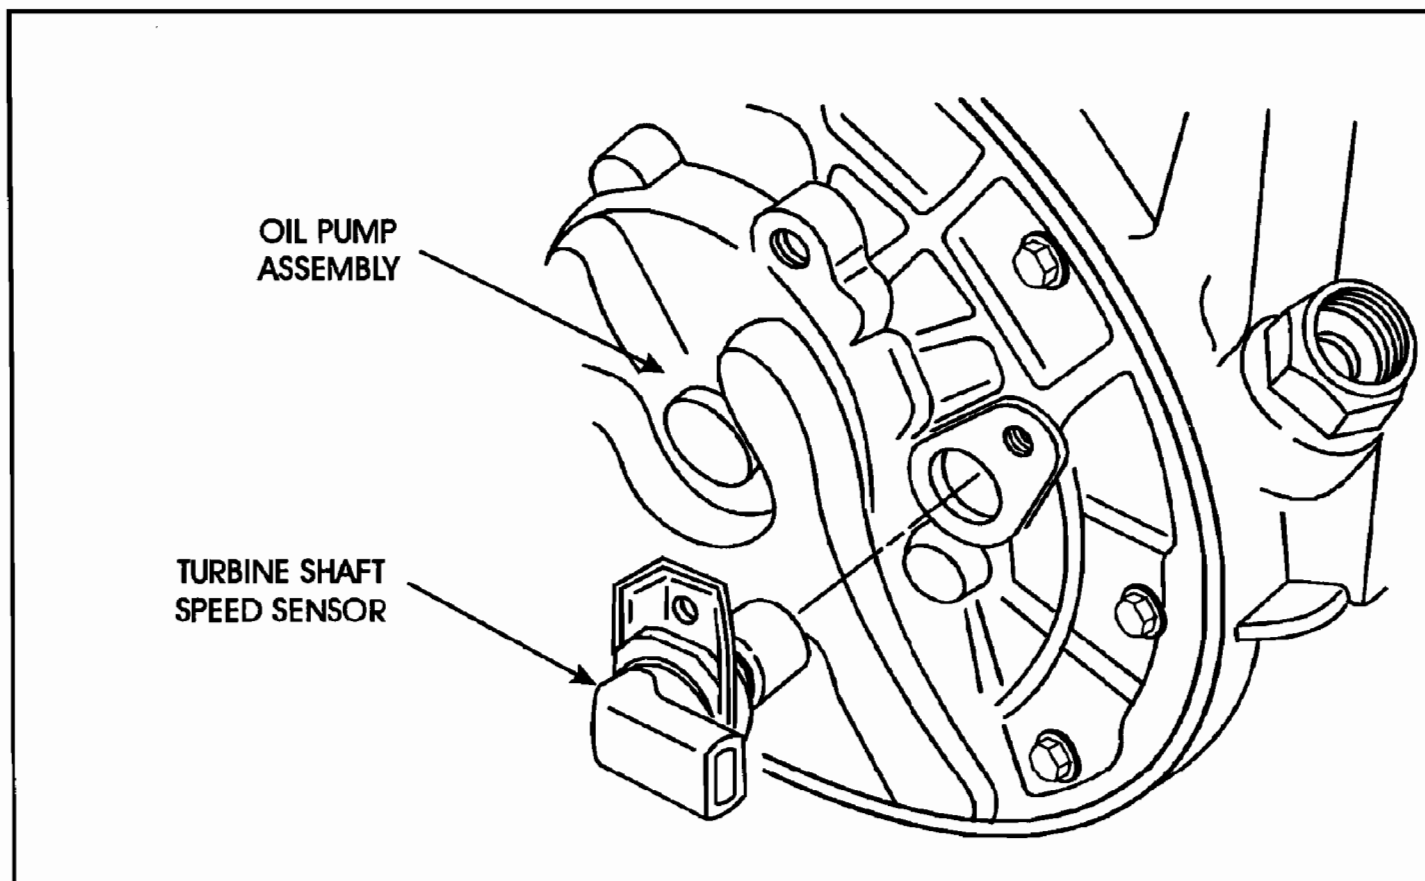
Figure 1

Some 1995 Contour, Probe and Mystique vehicles equipped with the CD4E transaxle, built from December 1994 through February 1995 with serial numbers 43350467 to 43370105 and 43410230 to 43420326 may have been assembled with incorrect turbine shaft speed sensor mounting surfaces on the pump bodies. The Turbine Shaft Speed Sensor (TSS) was modified to allow the TSS sensor to seat properly on these pump bodies. These TSS sensors were identified with a "Yellow" paint dot on the sensor itself in the location shown in Figure 2. The mis-machined pump bodies were identified with an "Orange" dot on the pump bodies in the location shown in Figure 2.

When servicing these units and TSS Sensor and/or Oil Pump assembly replacement is necessary, it will be mandatory that both pieces be replaced to prevent a clearance concern between the pump body and the Turbine Shaft Speed Sensor.

Oil Pump Assembly .....	F4RZ-7A103-A
Turbine Shaft Speed Sensor .....	F3RZ-7M101-A

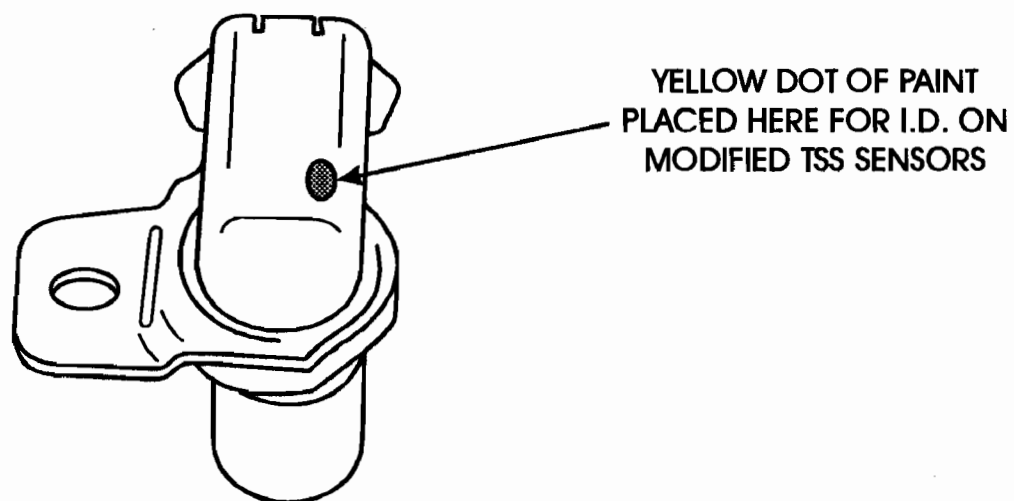
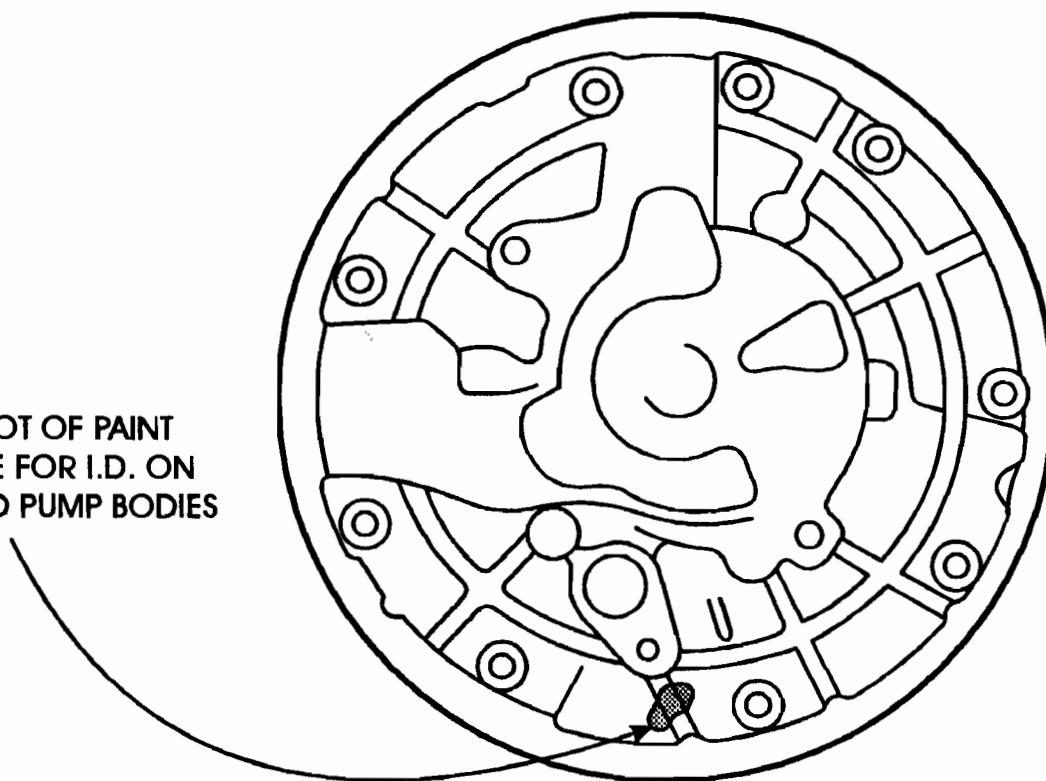
Figure 2

ORANGE DOT OF PAINT  
PLACED HERE FOR I.D. ON  
MIS-MACHINED PUMP BODIES

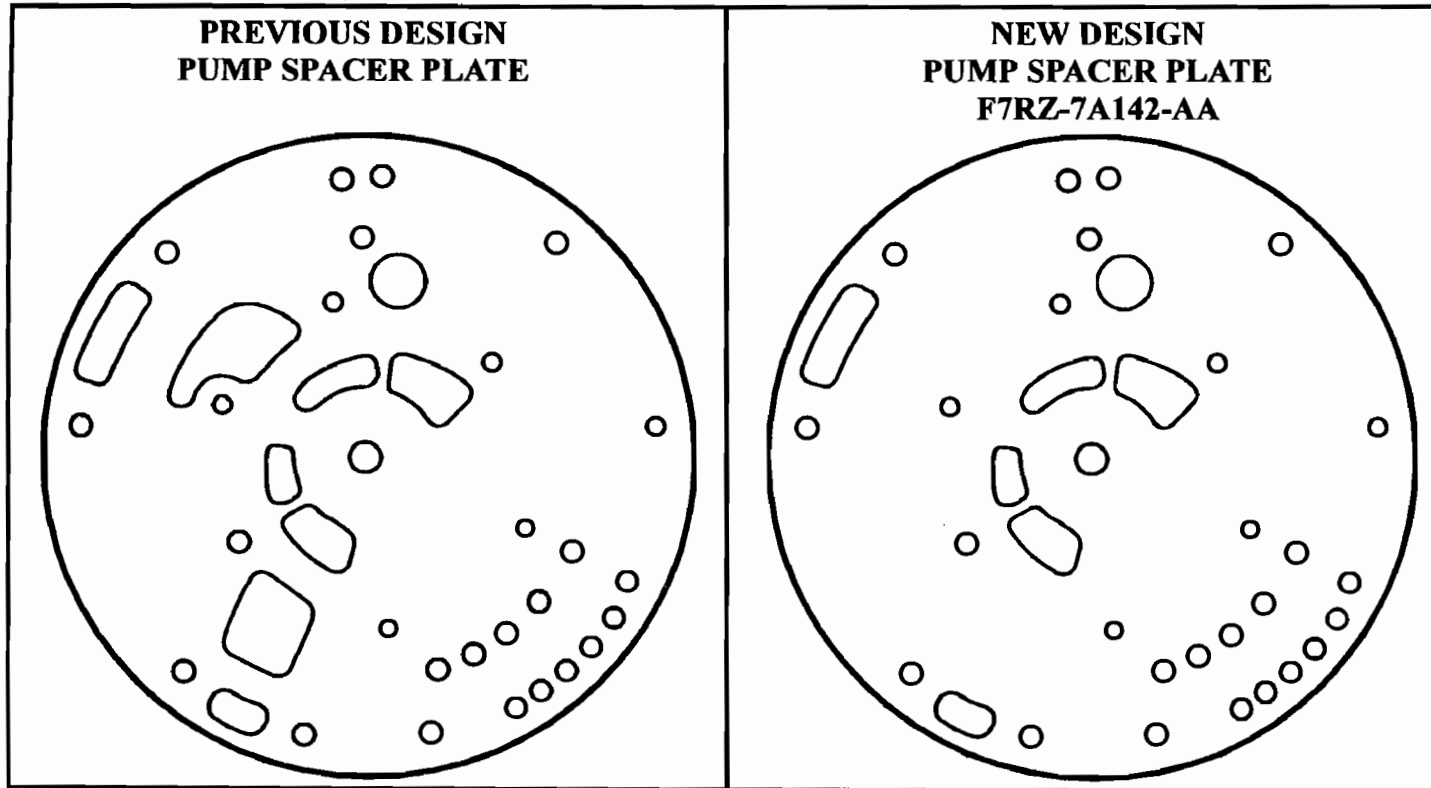
Figure 1

**CAUSE:** The cause may be, a "Blown" pump body gasket

Pump Support (New Design) .....	F7RZ-7A103-AA
Pump Spacer Plate (New Design) .....	F7RZ-7A142-AA
Pump Support Gasket (New Design) .....	F7RZ-7G331-AA

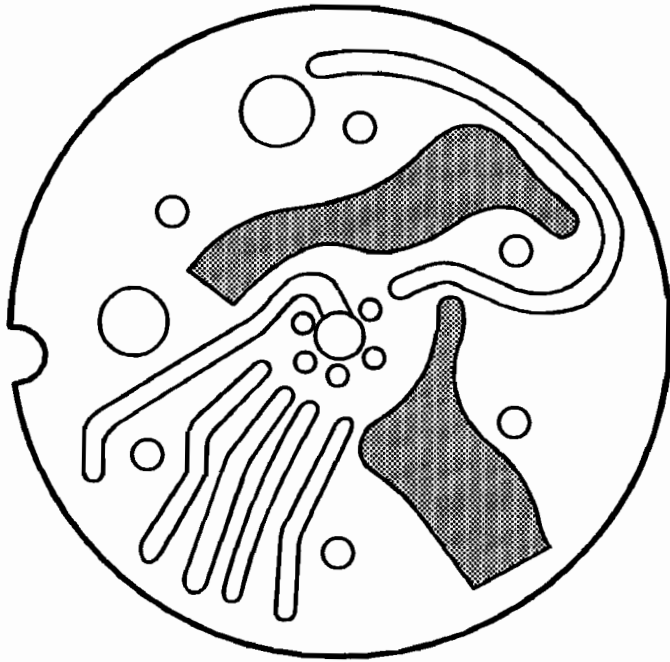
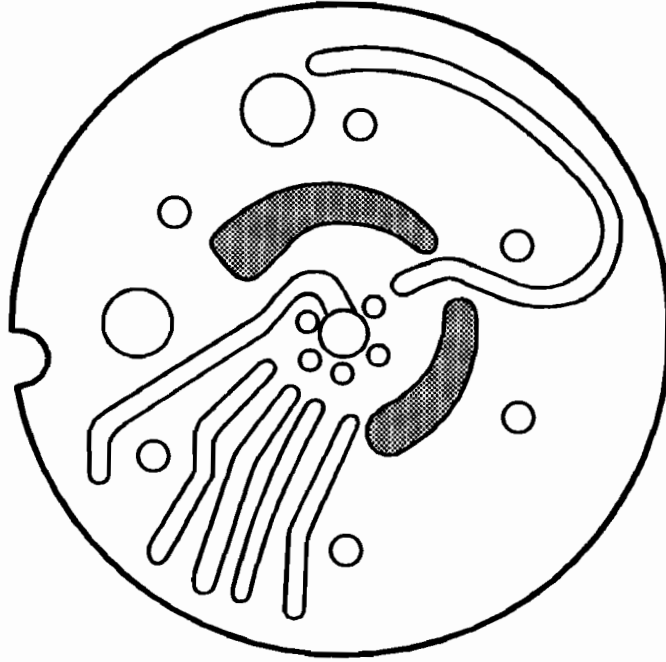
Figure 3

**PREVIOUS DESIGN  
PUMP SUPPORT**

**NEW DESIGN  
PUMP SUPPORT  
F7RZ-7A103-AA**

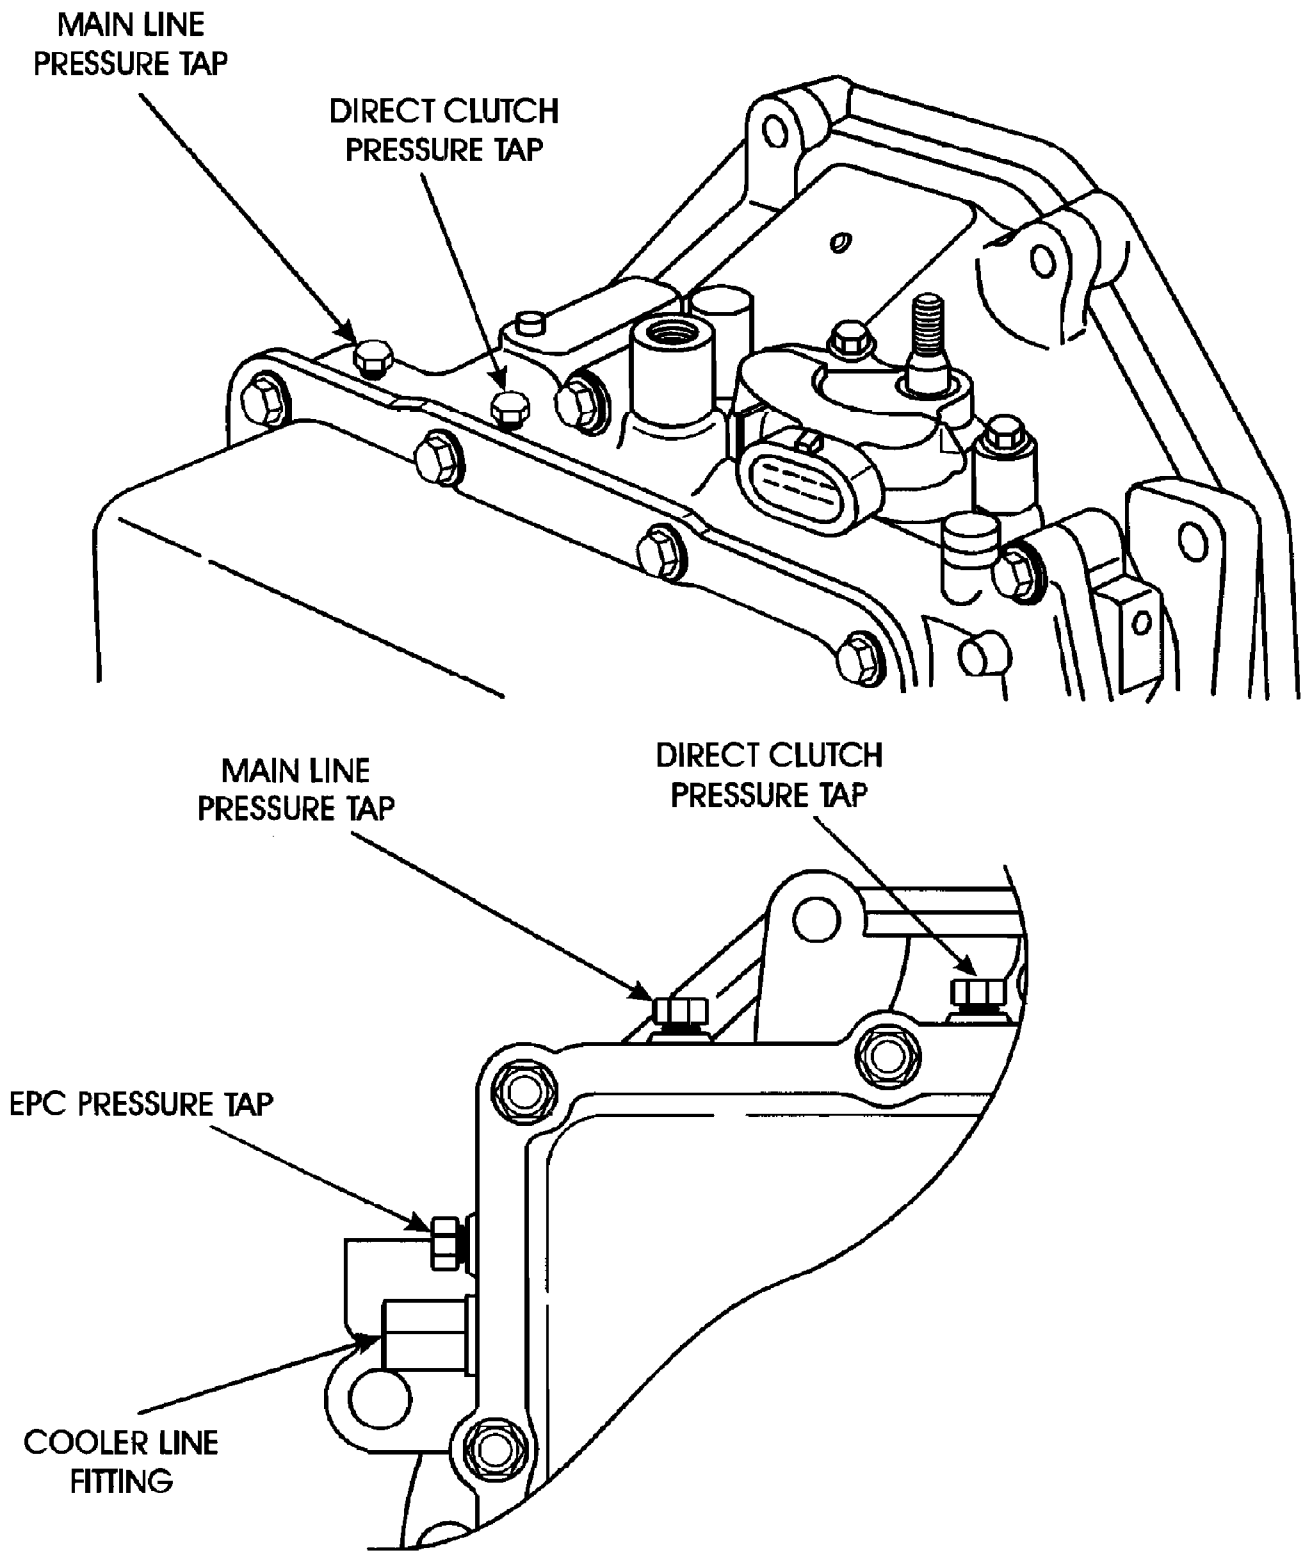
Figure 1

**CAUSE:** The cause may be, one or more of the following valves may be sticking:

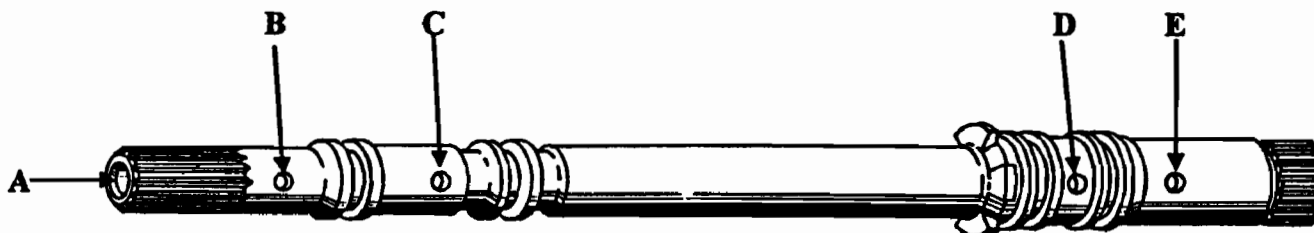
1. *The converter feed passage in the Oil Pump Drive Shaft blocked with debris or was not machined properly to allow converter feed oil to enter the converter.*
2. *The Oil Pump Drive Shaft leaking or not machined properly, allowing converter feed passage and converter release passage to be connected.*

**NOTE:** *THERE ARE ADJOINING HOLES ON THE OPPOSITE SIDE OF THE OIL PUMP DRIVE SHAFT THAT ARE NOT ILLUSTRATED.*

**APPLY AIR PRESSURE INTO HOLE "D" AND ENSURE THAT AIR PRESSURE ESCAPES THROUGH HOLE "C" ONLY.**

**CORRECTION:** Refer to Figure 1 to check the Oil Pump Drive Shaft, and clean or replace as necessary.

**NOTE:** *We have seen some replacement shafts, both reman and new that were leaking between the converter apply and release passages.*

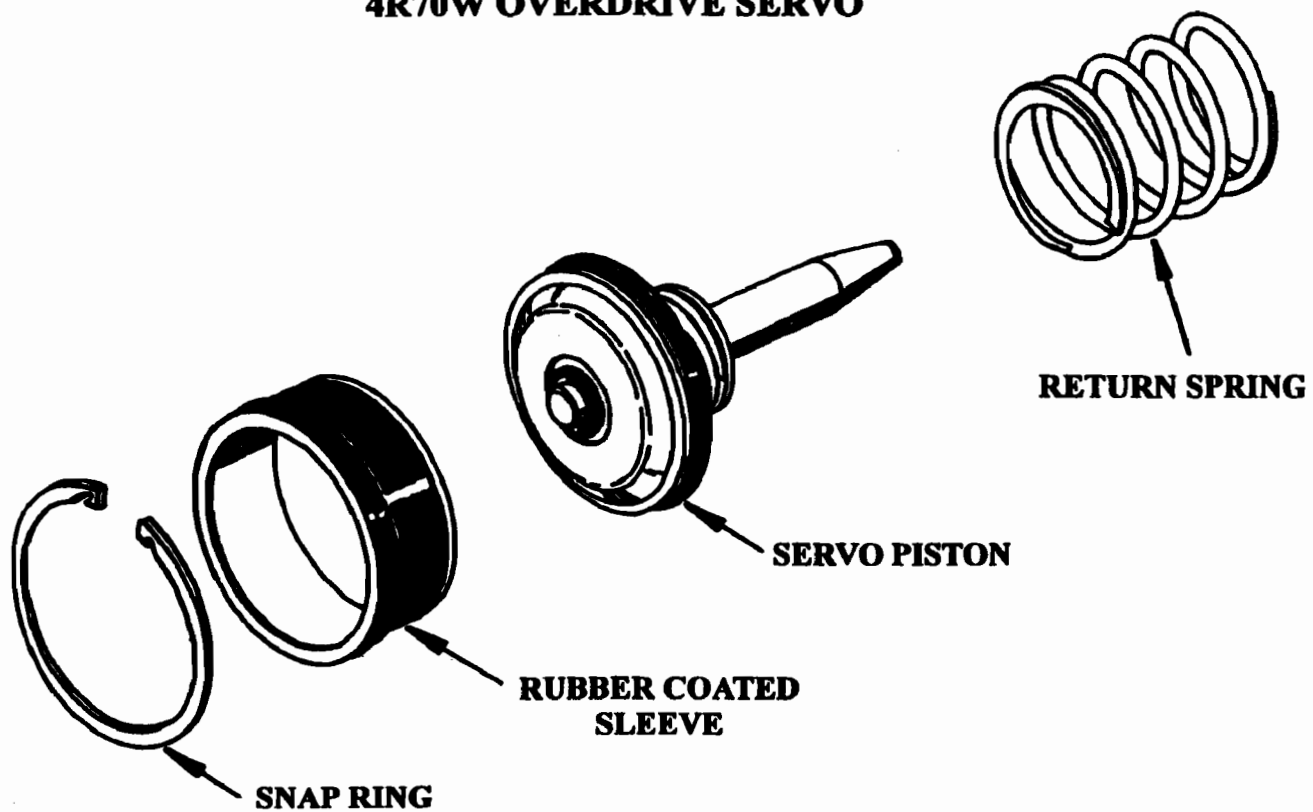
**Reference Review****4R70W OVERDRIVE SERVO**

**CAUSE:** The cause may be a mis-assembled Overdrive Servo Assembly, with the "Rubber Coated Sleeve" omitted. The 4R70W transmission is calibrated with a smaller diameter overdrive servo piston than is the AOD-E transmission. To retain a common case between the two transmissions, an additional "Rubber Coated Sleeve" is required on the 4R70W Overdrive Servo Assembly, as shown in Figure 6.

**CORRECTION:** Install the "Rubber Coated Sleeve" in the Overdrive Servo Assembly, as shown in Figure 6. If your rubber coated sleeve is missing or lost, you **MUST** buy the complete Overdrive Servo Assembly, available under OEM part number F3LY-7H188-A. It is not available individually. Overdrive servo piston dimensions are shown in Figure 5, to identify the two different overdrive pistons.

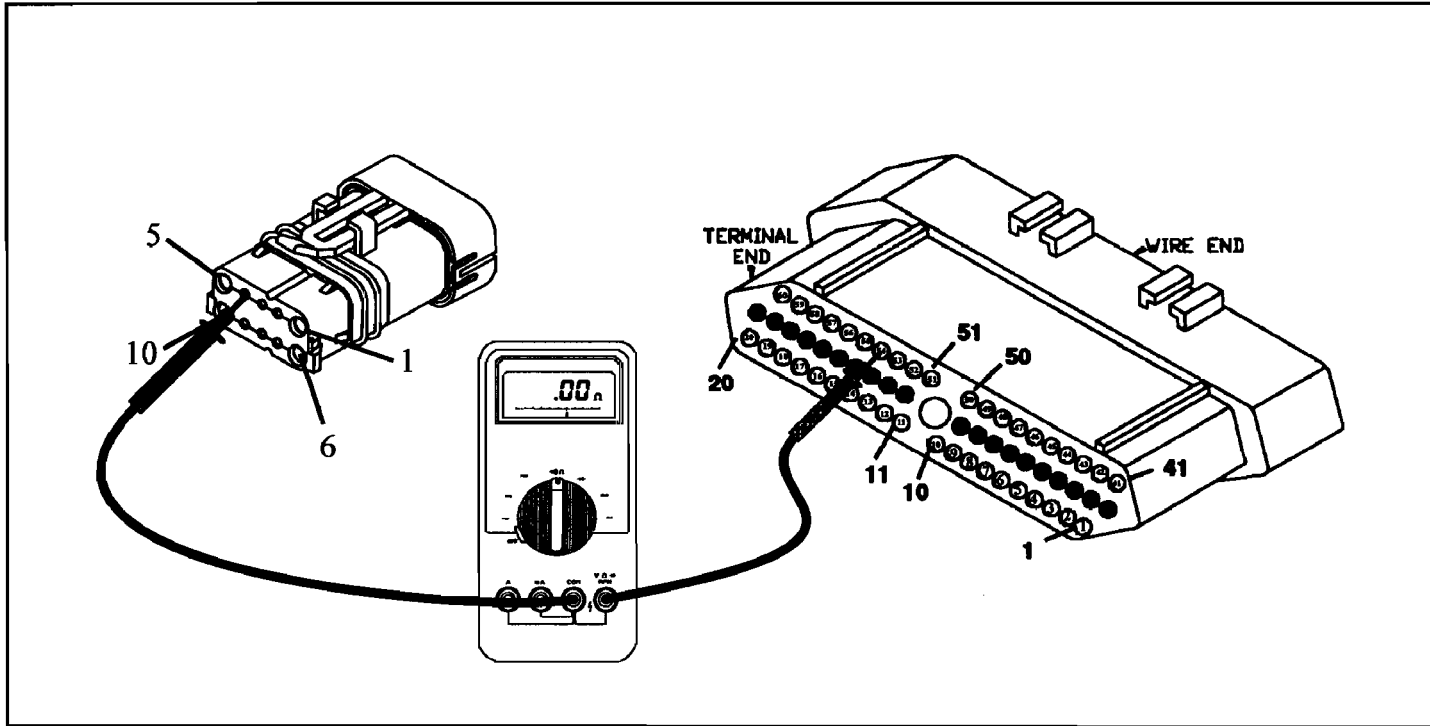
Figure 2

2. If less than 4.5 volts is observed, turn the ignition off and unplug the TCM. Change the meter to an ohms setting and check for continuity between terminal 54 in the TCM connector to terminal 4 in the TRS connector (See Figure 2). If continuity (5 ohms or less) is seen, replace the TCM. If continuity is not seen, repair or replace the wire.

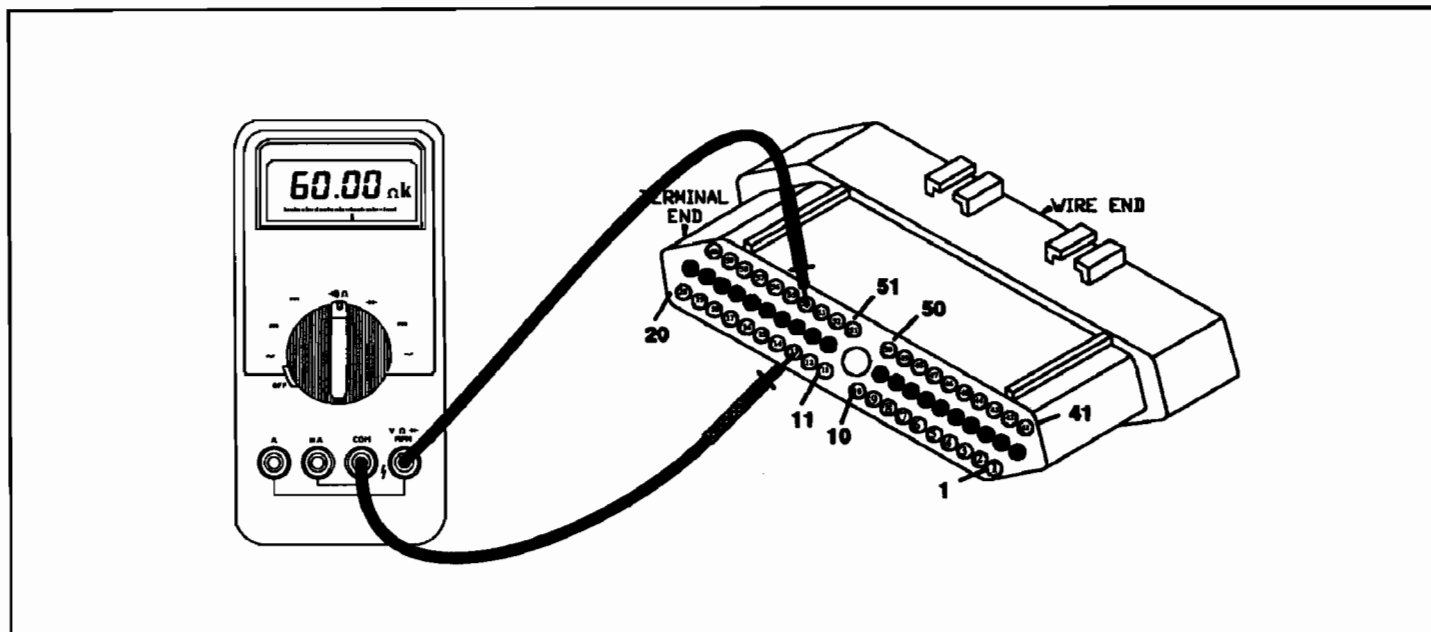
Figure 4

5. If continuity is seen, re-connect the TRS sensor and perform a resistance check on the TFT sensor from the TCM connector. Place one meter lead into terminal 13 and the other meter lead into terminal 54 (See Figure 4). The range for the sensor from cold to hot is 100,000 ohms to 150 ohms (See Table in Figure 5). If the change in resistance is proportional to the change in the transmission fluid temperature and the resistance remains within specification, change the TCM. If the resistance is out of specification or does not change in resistance proportional to temperature, change the TRS.

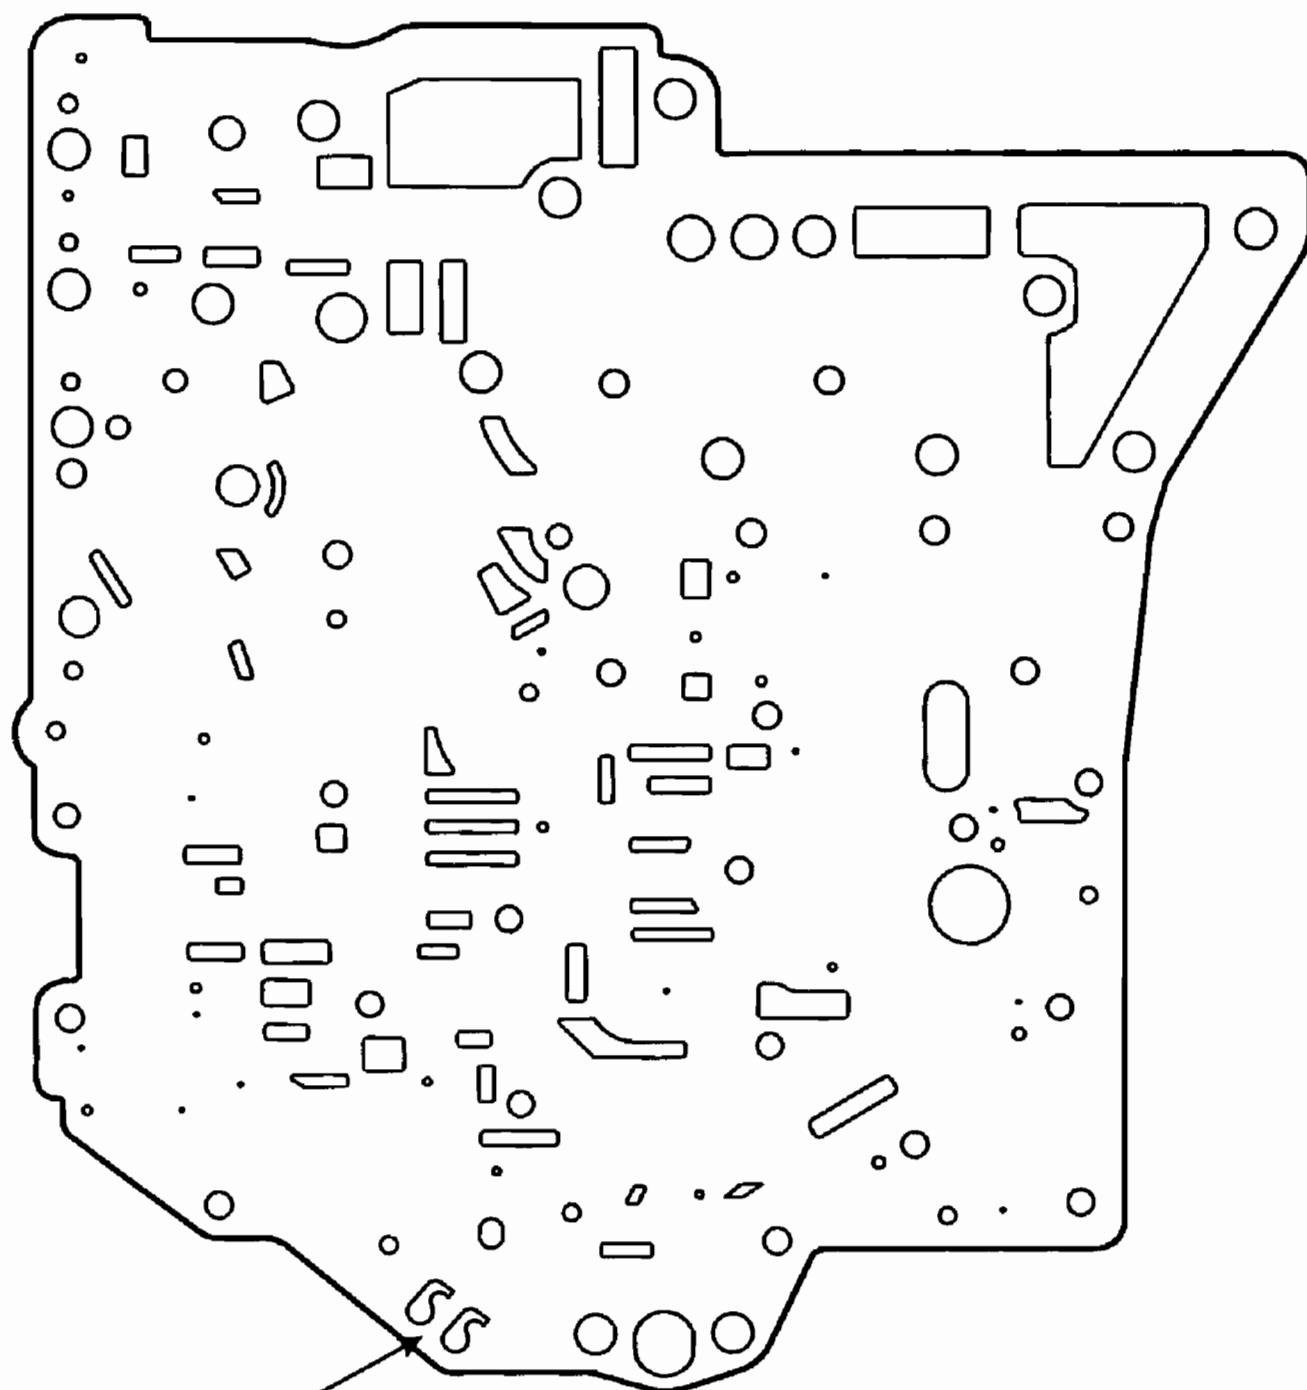
Figure 3

Number stamped for identification into new spacer plate is "66" (See Figure 3).

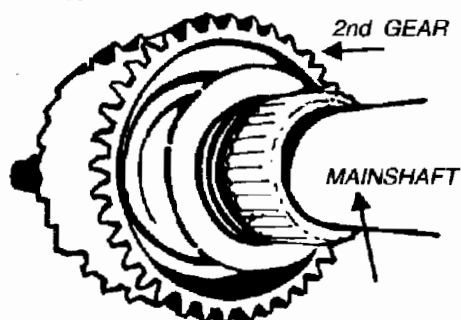
OTS 88406AW

On Honda 4 speed transmissions, the mainshaft 2nd gear wears severely from the 2nd clutch needle roller bearing. This bearing also needs frequent replacement due to wear.

Replace the needle bearing with OTS 88406AW. This high quality BRONZE THRUST WASHER is designed to withstand the wear and axial thrust load of the mainshaft 2nd gear assembly.

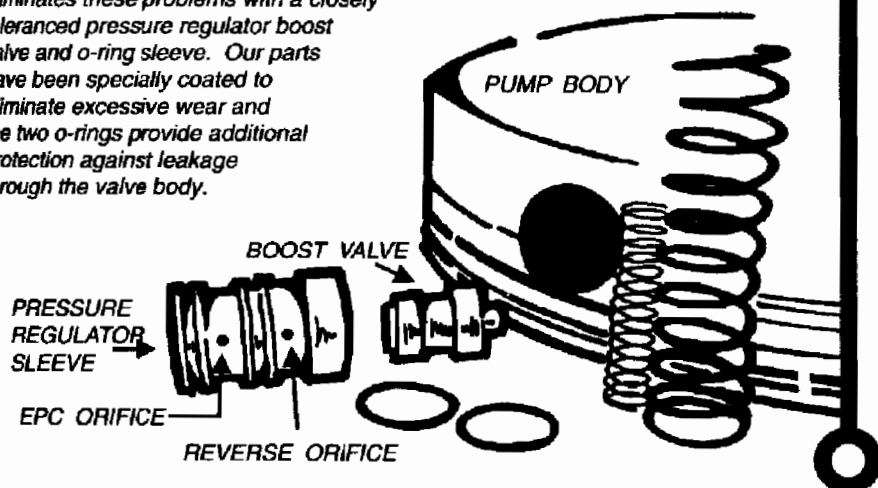
Vehicles with an E40D transmission frequently have problems with poor line rise and/or soft shifts.

The OTS REPLACEMENT ASSEMBLY 35424-01K eliminates these problems with a closely toleranced pressure regulator boost valve and o-ring sleeve. Our parts have been specially coated to eliminate excessive wear and the two o-rings provide additional protection against leakage through the valve body.
