# "SIMPLE SOLUTIONS FOR '98"

## INTRODUCTION

***AUTOMATIC TRANSMISSION SERVICE GROUP***  
9200 S. DADELAND BLVD.  
SUITE 720  
MIAMI, FL 33156  
(305) 670-4161

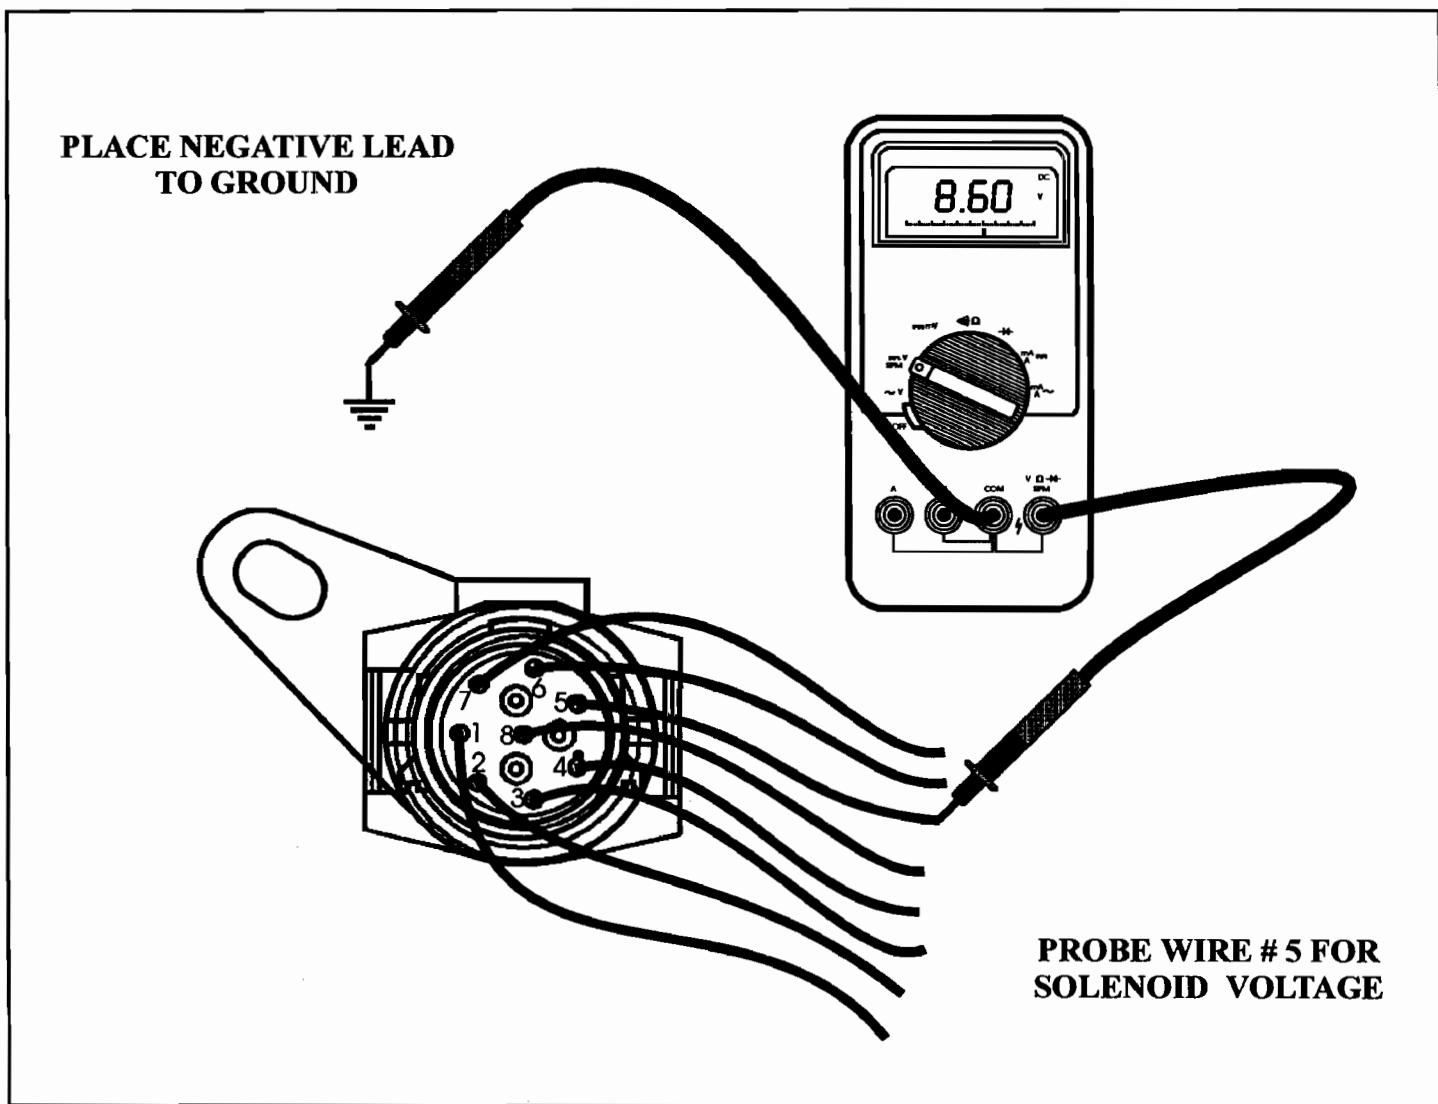
Figure 5

- (d) Maintain the ground lead to a known good ground and carefully backprobe into wire number 5 (Governor Pressure Solenoid) with the positive lead (See Figure 5). Again using the chart in Figure 6, compare the voltage values for the governor pressure solenoid, to the actual governor pressure indicated on the gauge.  
If for example at 0 MPH, the pressure gauge indicates 12 PSI, and the DVOM shows that governor pressure solenoid voltage reads 8.30 volts, The solenoid is mechanically bad (Debris) and will need to be replaced. If the pressure gauge reads 12 PSI, and 8.70 volts is seen, the VSS or the computer is malfunctioning. Unplug the Vehicle Speed Sensor and see if governor pressure drops to 0 PSI. If it does, replace the VSS. If it does not, the computer will need to be replaced.

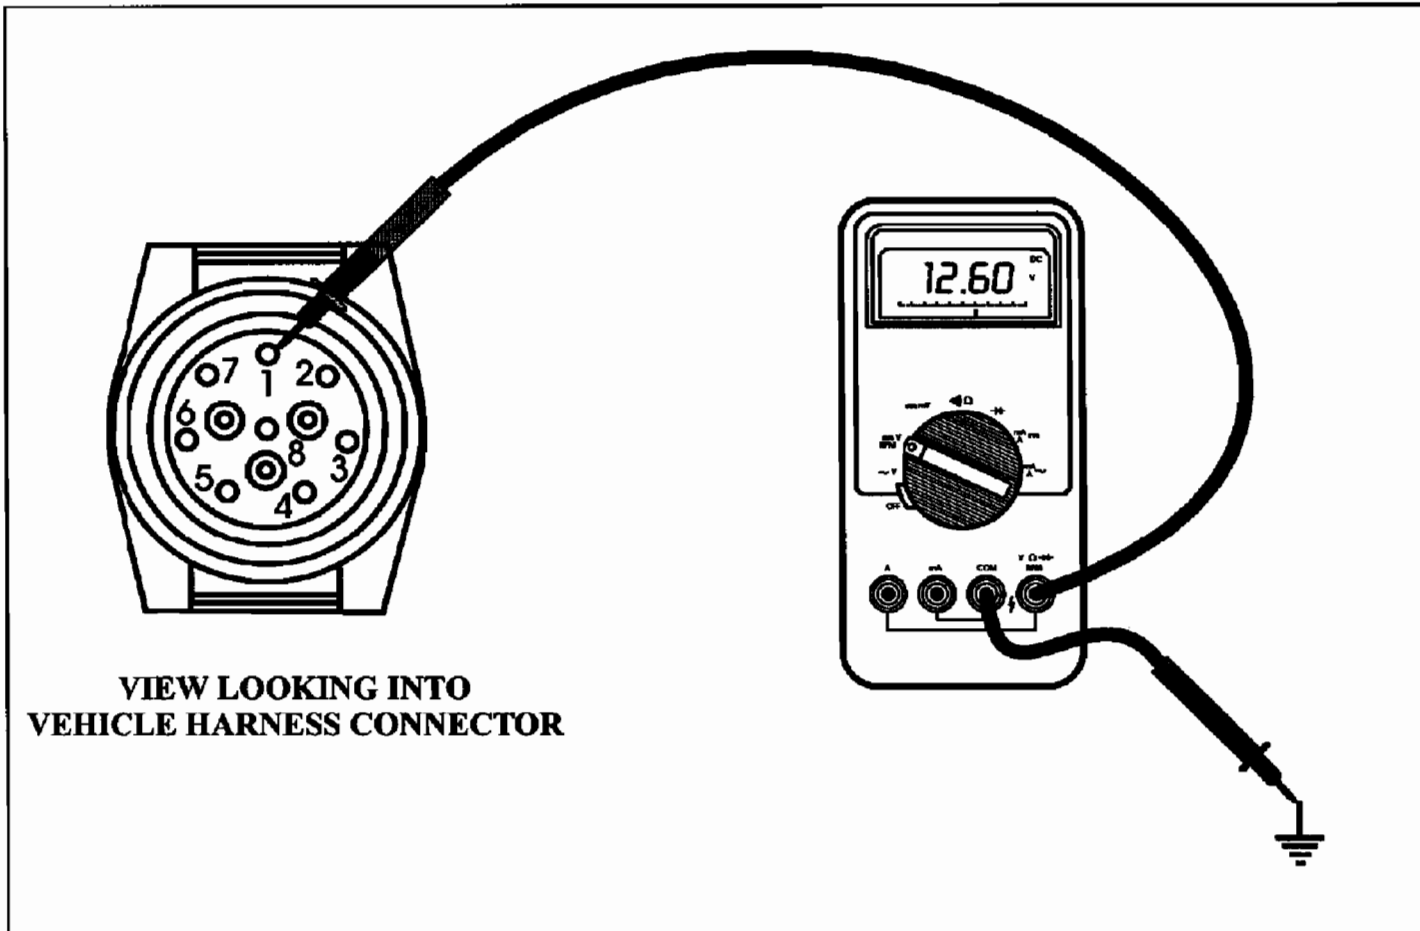
Figure 7

- (a) Check pin cavity number 1 in the vehicle harness connector for battery voltage, as shown in Figure 7. If 0 volts is seen, the computer is either defective, or the computer has lost its power source, or the wire from the computer down to pin number 1 is broken. First locate the computer which is under the dash on the drivers side, and unplug the connector as seen in Figure 8, and continue to the next step.

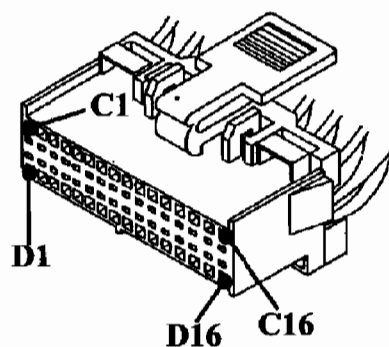
Figure 9

- (b) Locate pin cavity number D16 in the transmission control module connector, as shown in Figure 9. Perform a continuity test between cavity number D16 and pin cavity number 1 in the vehicle harness connector, as shown in Figure 10. There should be 5 ohms or less. If there is an open reading (Infinity), the wire is broken and will need to be repaired. If there is more than 5 ohms resistance observed, there is corrosion somewhere in the wiring, or a short to ground may have occurred, which means the wire will have to be replaced as well. If 5 ohms or less is seen, move on to the next step.

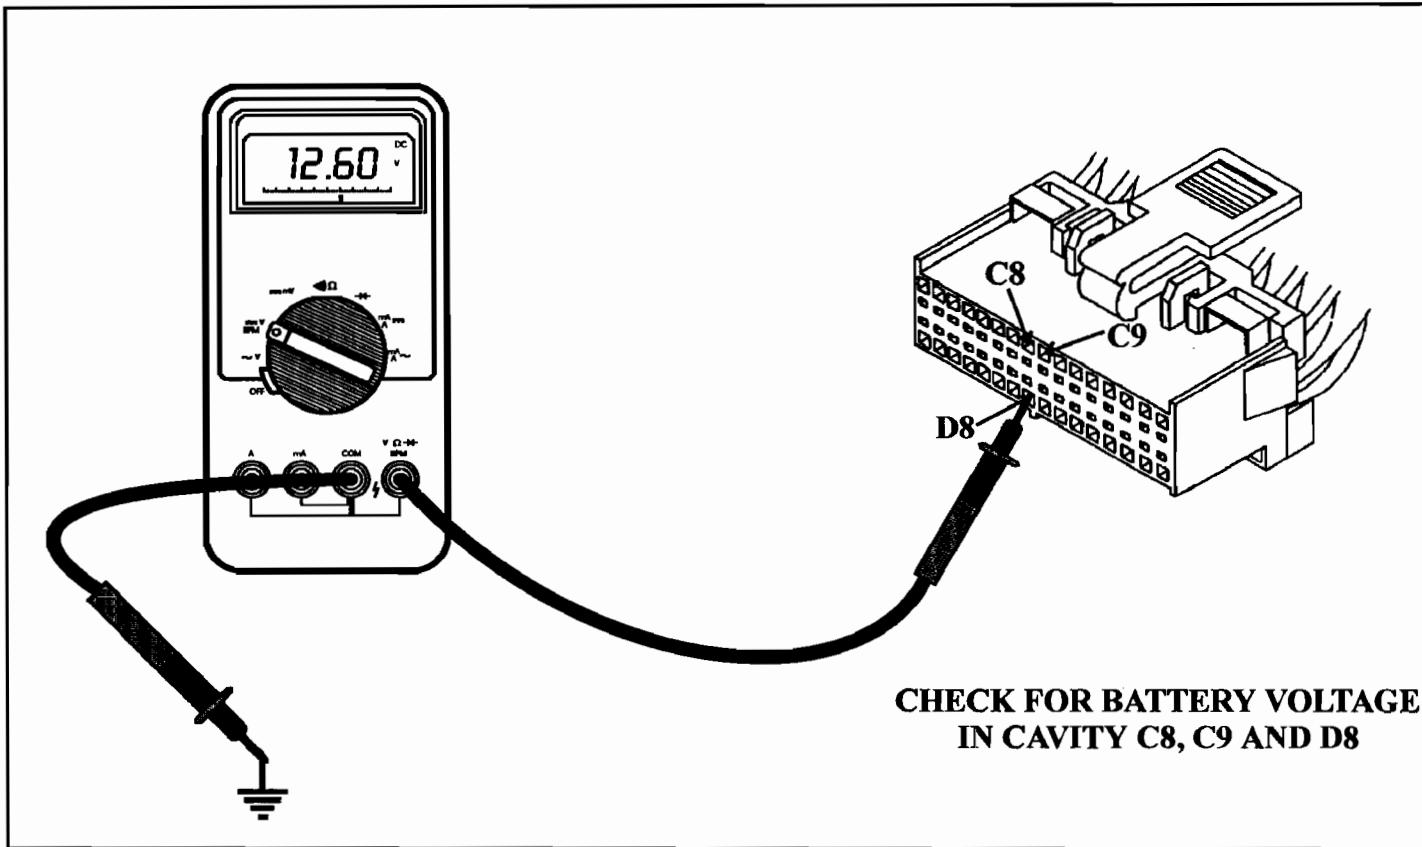
Figure 11

- (c) With the engine off and the ignition switch in the ON position, check for battery voltage in the transmission control module connector, on pins C8, C9 and D8, as shown in Figure 11. If battery voltage is lost at *any* one of these terminals, check for blown fuses in the power distribution center, located on the passenger side fender shield by the battery. Check fuses F2, F3, F6, F15, and replace as necessary, as shown in Figure 12. If battery voltage is seen at all three locations, continue on to the next step.

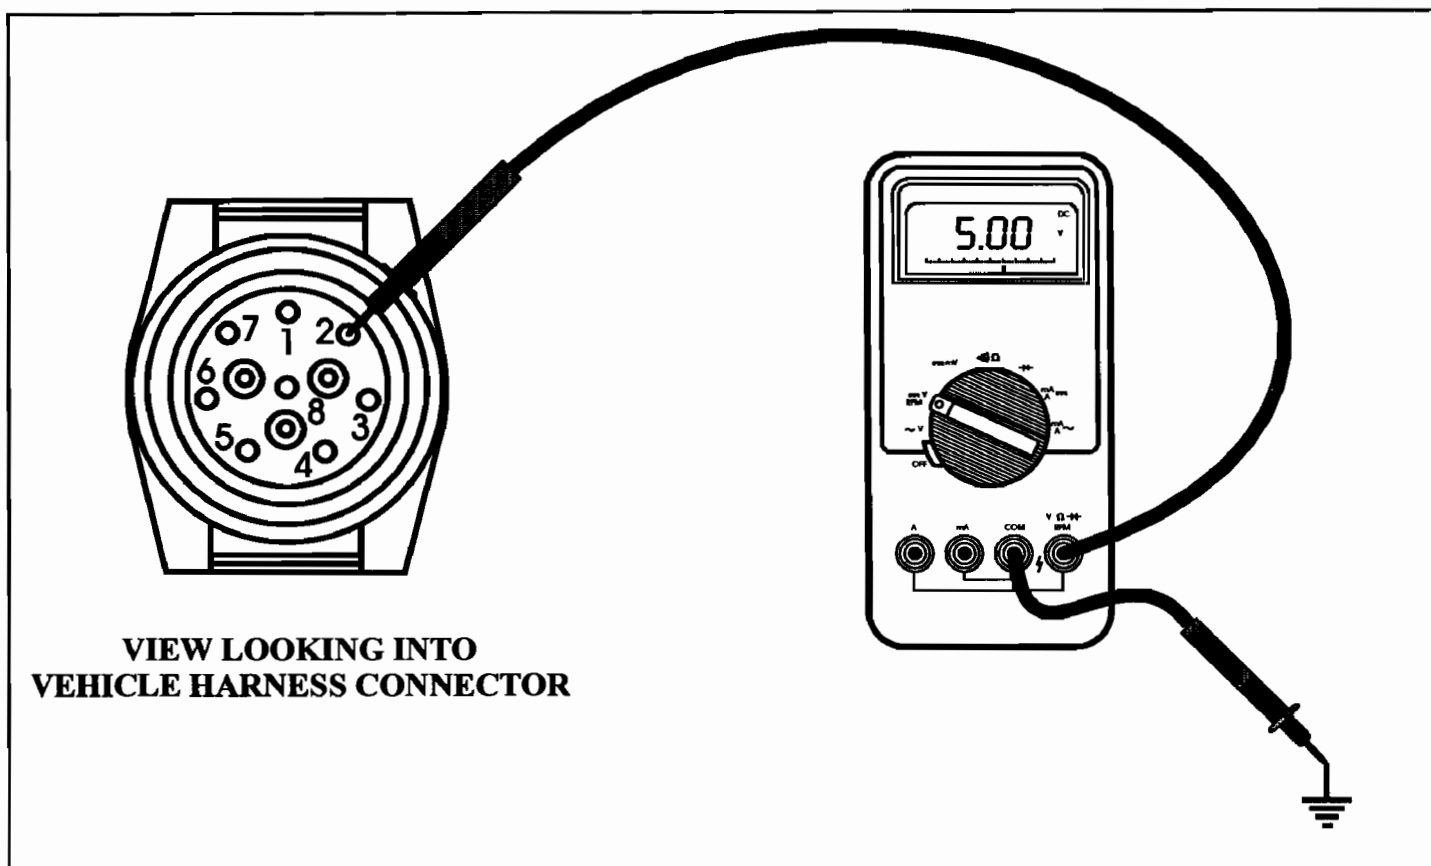
Figure 13

- (d) Plug the transmission control module connector back into the computer, and with the engine off and ignition switch in the ON position, check for 5 volts at cavity number 2 in the vehicle harness connector, as shown in Figure 13. If no voltage is seen, unplug the transmission control module connector and test for continuity between cavity C10 at the transmission control module connector and terminal number 2 at the vehicle harness connector, as shown in Figure 14. If 5 ohms or less is indicated, the computer will need to be replaced. If an open circuit is indicated, repair or replace the broken wire between C10 and terminal 2.

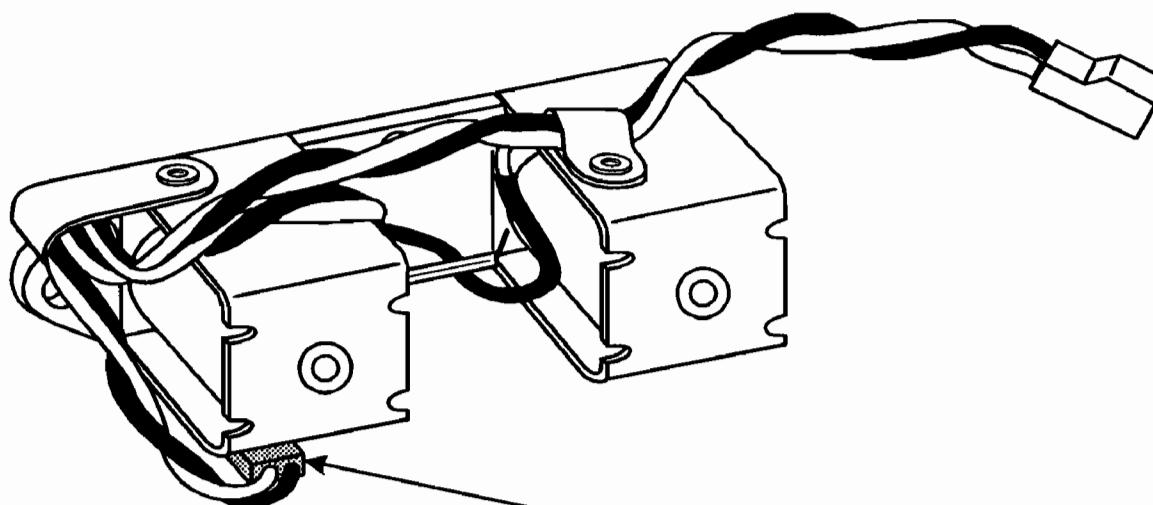
Figure 1

**CHANGE:** *Change No. 1* - Beginning at the start of production for 1996 models, all Chrysler 42RE, 44RE, 46RE and 47RE transmissions were built with a new design Governor Pressure Sensor that now incorporates the Transmission Fluid Temperature (TFT) sensor inside the Governor Pressure Sensor assembly. The previous design has the TFT pop-riveted to the solenoid assembly. Refer to Figure 1.

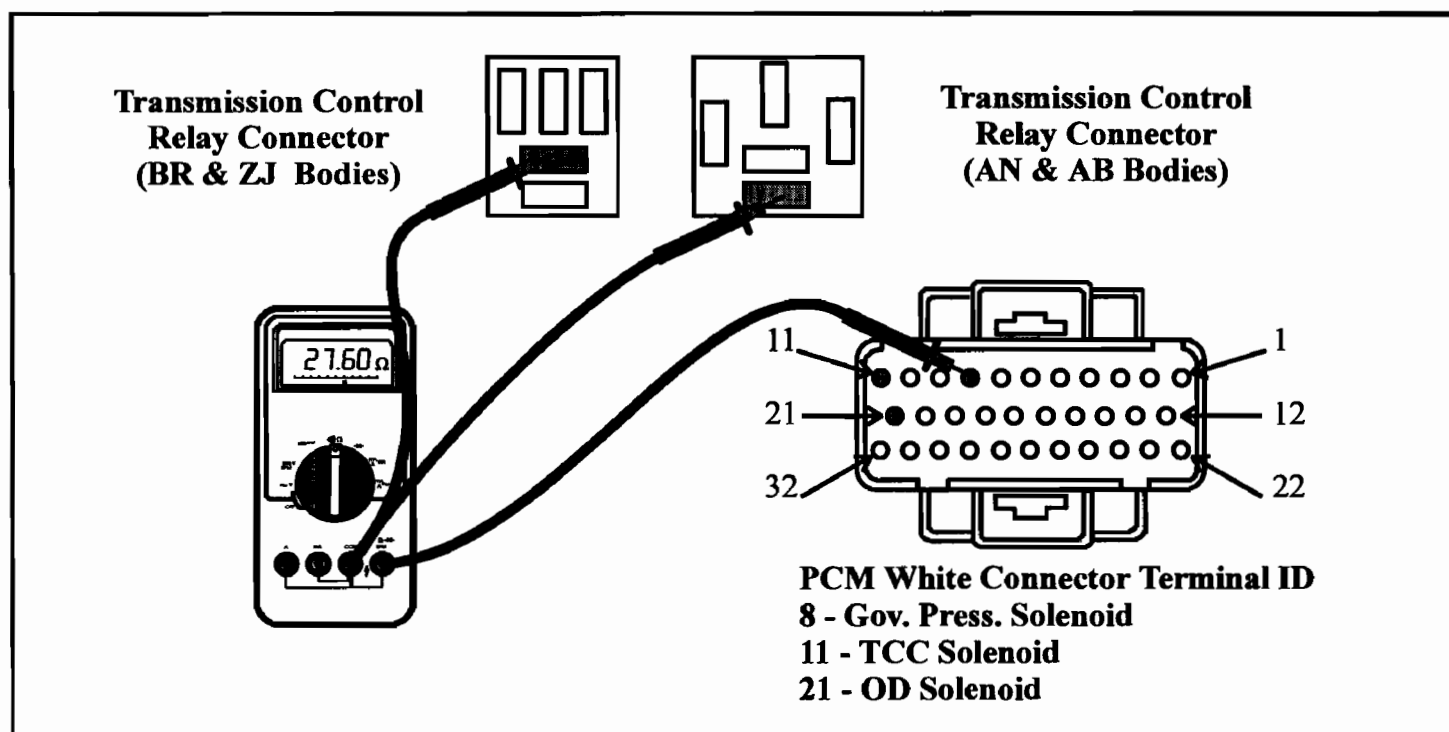
Figure 4

4. The PCM has three 32 pin connectors, black, grey and white. Unplug the middle connector which is the white connector. With the negative lead resistance checks on the Torque Converter Clutch, Governor and Overdrive solenoids may be checked at terminals 8, 11 and 21 individually (See Figure 4). Both the TCC and OD solenoids should measure between 25 and 40 ohms. The Governor Pressure Solenoid should measure between 3 to 5 ohms.

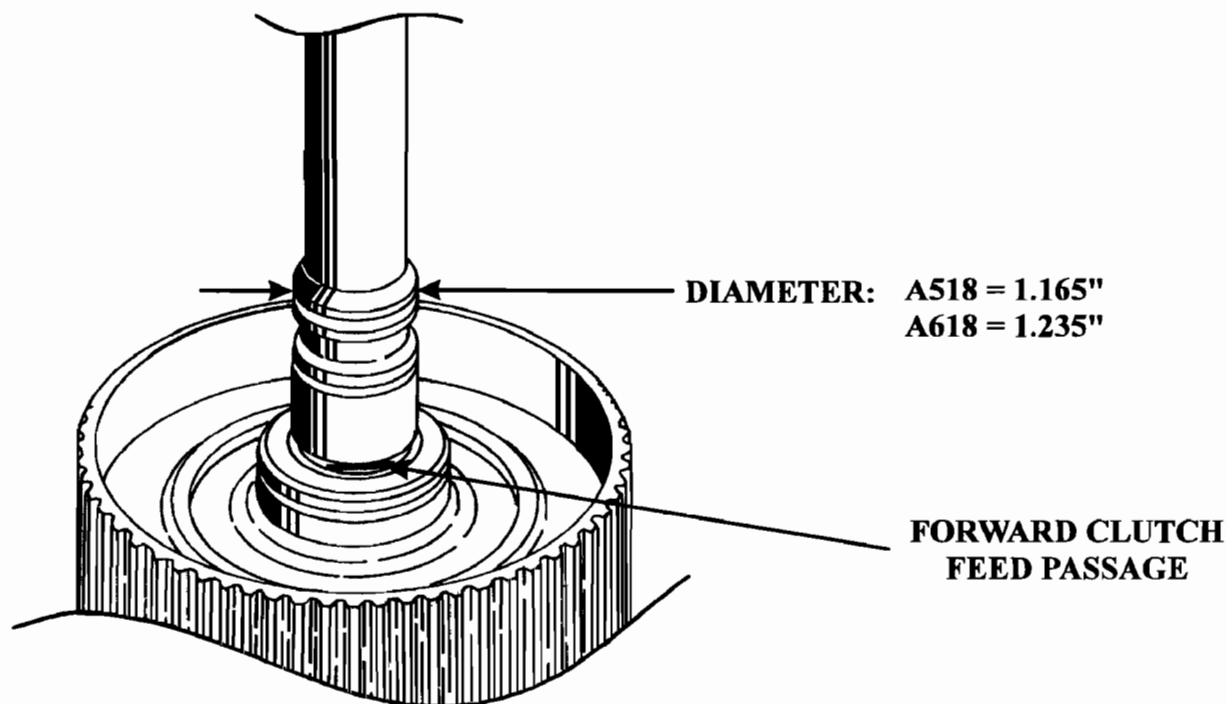
Figure 1

**CORRECTION:** Install the proper A518 stator into the unit. The biggest problem is identification of these two very similar parts. The diameter in the sealing ring area on the turbine shaft on the A518 is 1.165", and the A618 diameter in the same area is 1.235", as shown in Figure 1. Obviously the diameter on the inside of the stator where the sealing rings ride must correspond with these dimensions. When the larger diameter A618 stator is installed on the A518 turbine shaft, converter release oil goes past the sealing ring and applies the forward clutch, as long as the engine is running. Refer to Figures 1 and 2.

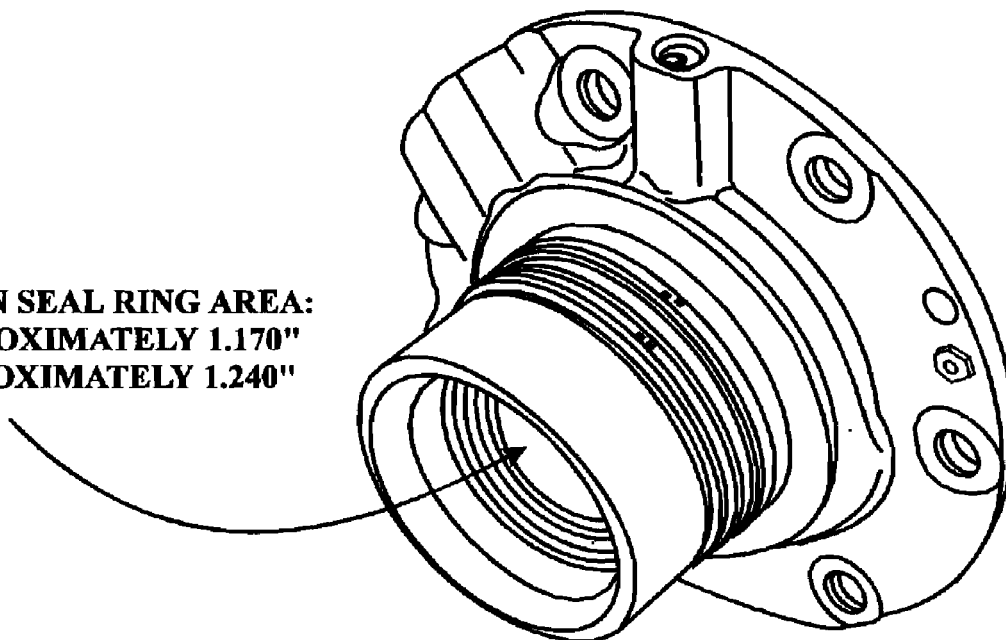
Figure 2

**DIAMETER IN SEAL RING AREA:  
A518 = APPROXIMATELY 1.170"  
A618 - APPROXIMATELY 1.240"**

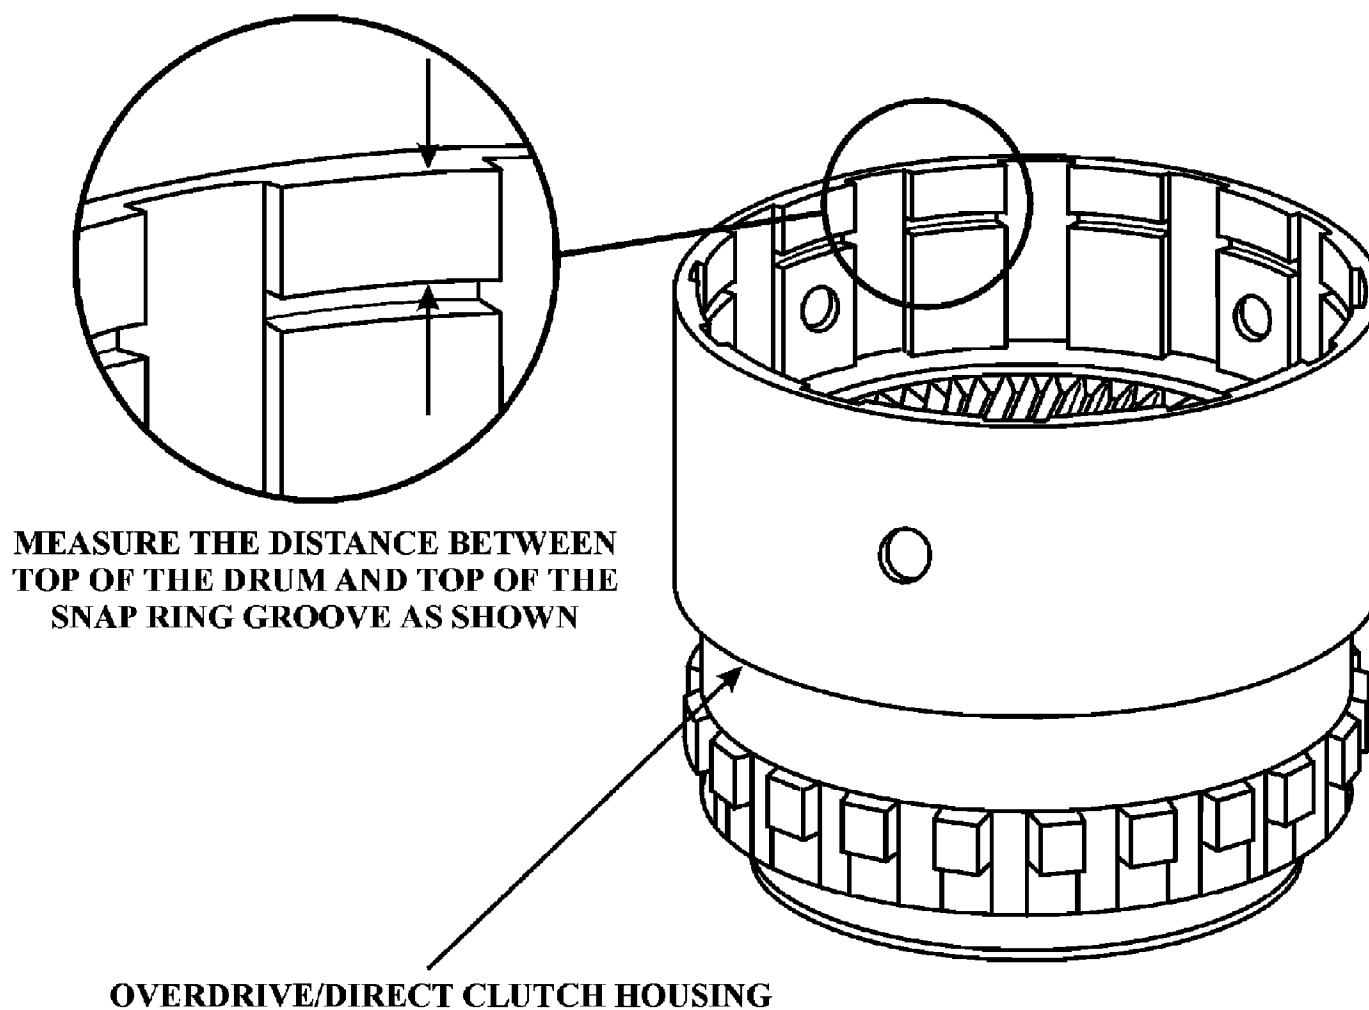
There are currently four different Overdrive/Direct clutch housings dependent on the engine size and the transmission model you are working on. If it becomes necessary to replace the drum, measure the distance between the top of snap ring groove and the top of the housing, as shown below, and use the chart below to determine the amount of friction plates and steel plates for the model you are working on. Choosing the wrong amount may create a tie-up on the 3-4 shift, or a no reverse condition.

TRANSMISSION	LINED	STEEL	MEASUREMENT
A500 (40RH) 3.9L	5	4	.485"
A500 (42RH) 5.2L	6	5	.350"
A518 (46RH)	8	7	.100"
A618 (47RH)	9	8	.090"

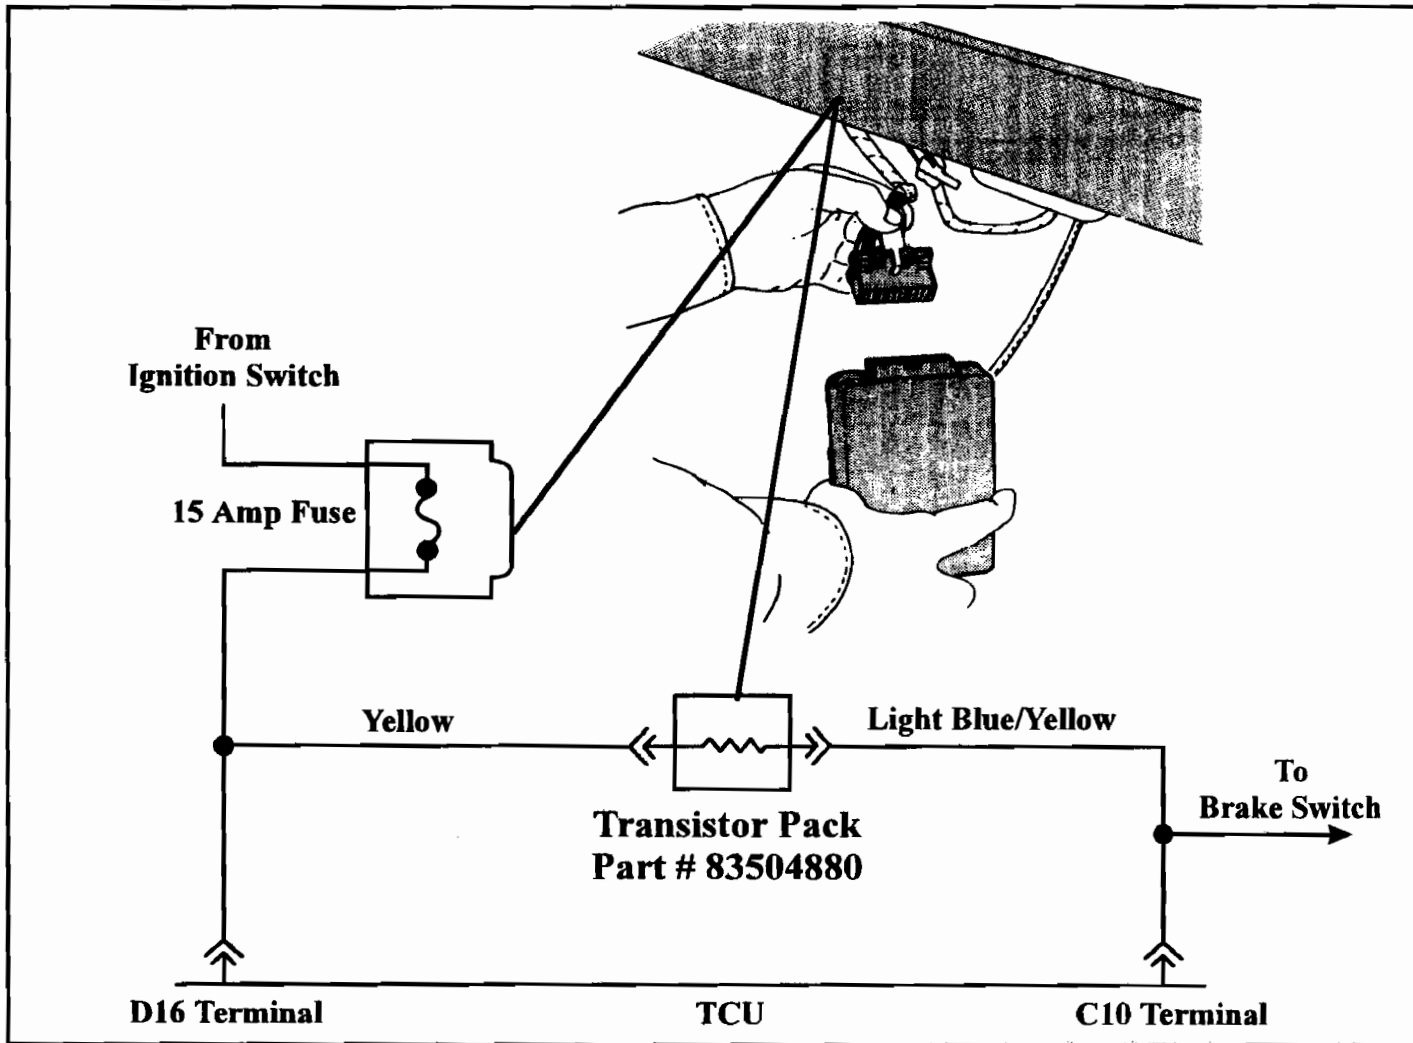
Figure 1

- COMPLAINT:** Vehicle takes off in high gear in the Overdrive range but will shift manually moving the selector through all the ranges.
- CAUSE:** One cause may be a resistor pack has shorted in the brake switch circuit to the TCM blowing a 15 amp fuse (See Figure 1). Another possibility is a severed direct battery feed wire to the TCU or a bad TCU itself.

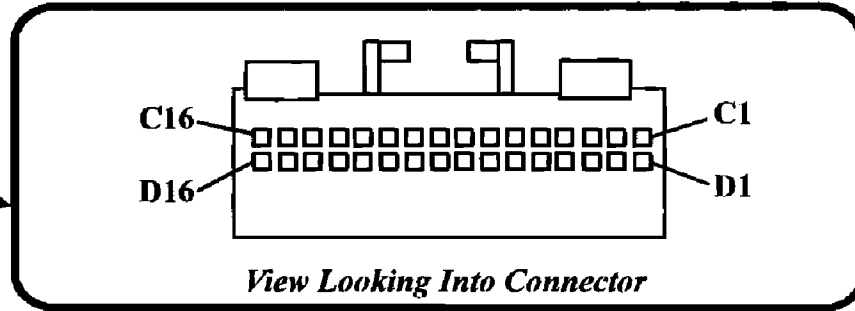
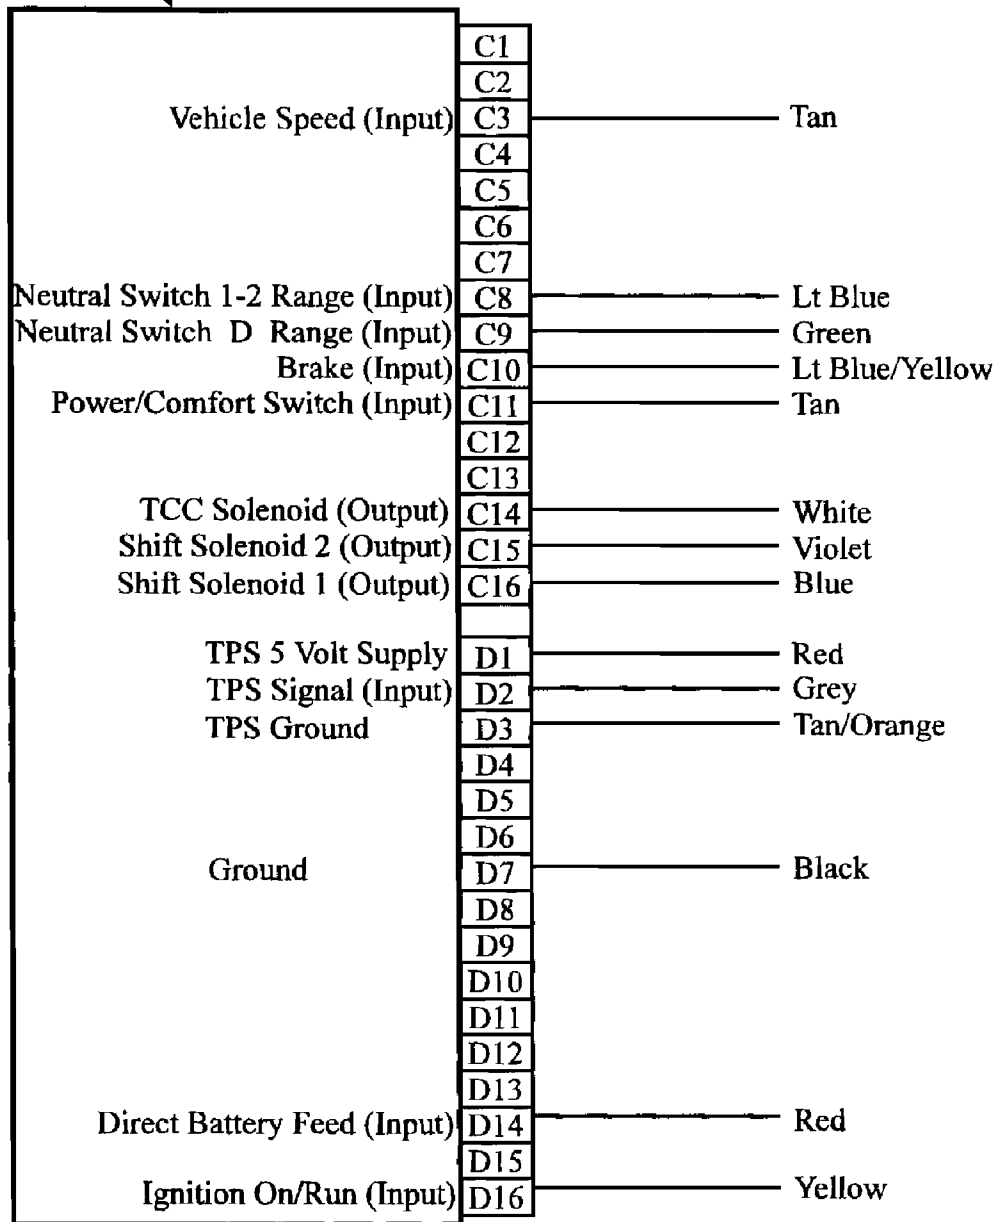
Figure 4

TRANSMISSION  
CONTROL UNIT

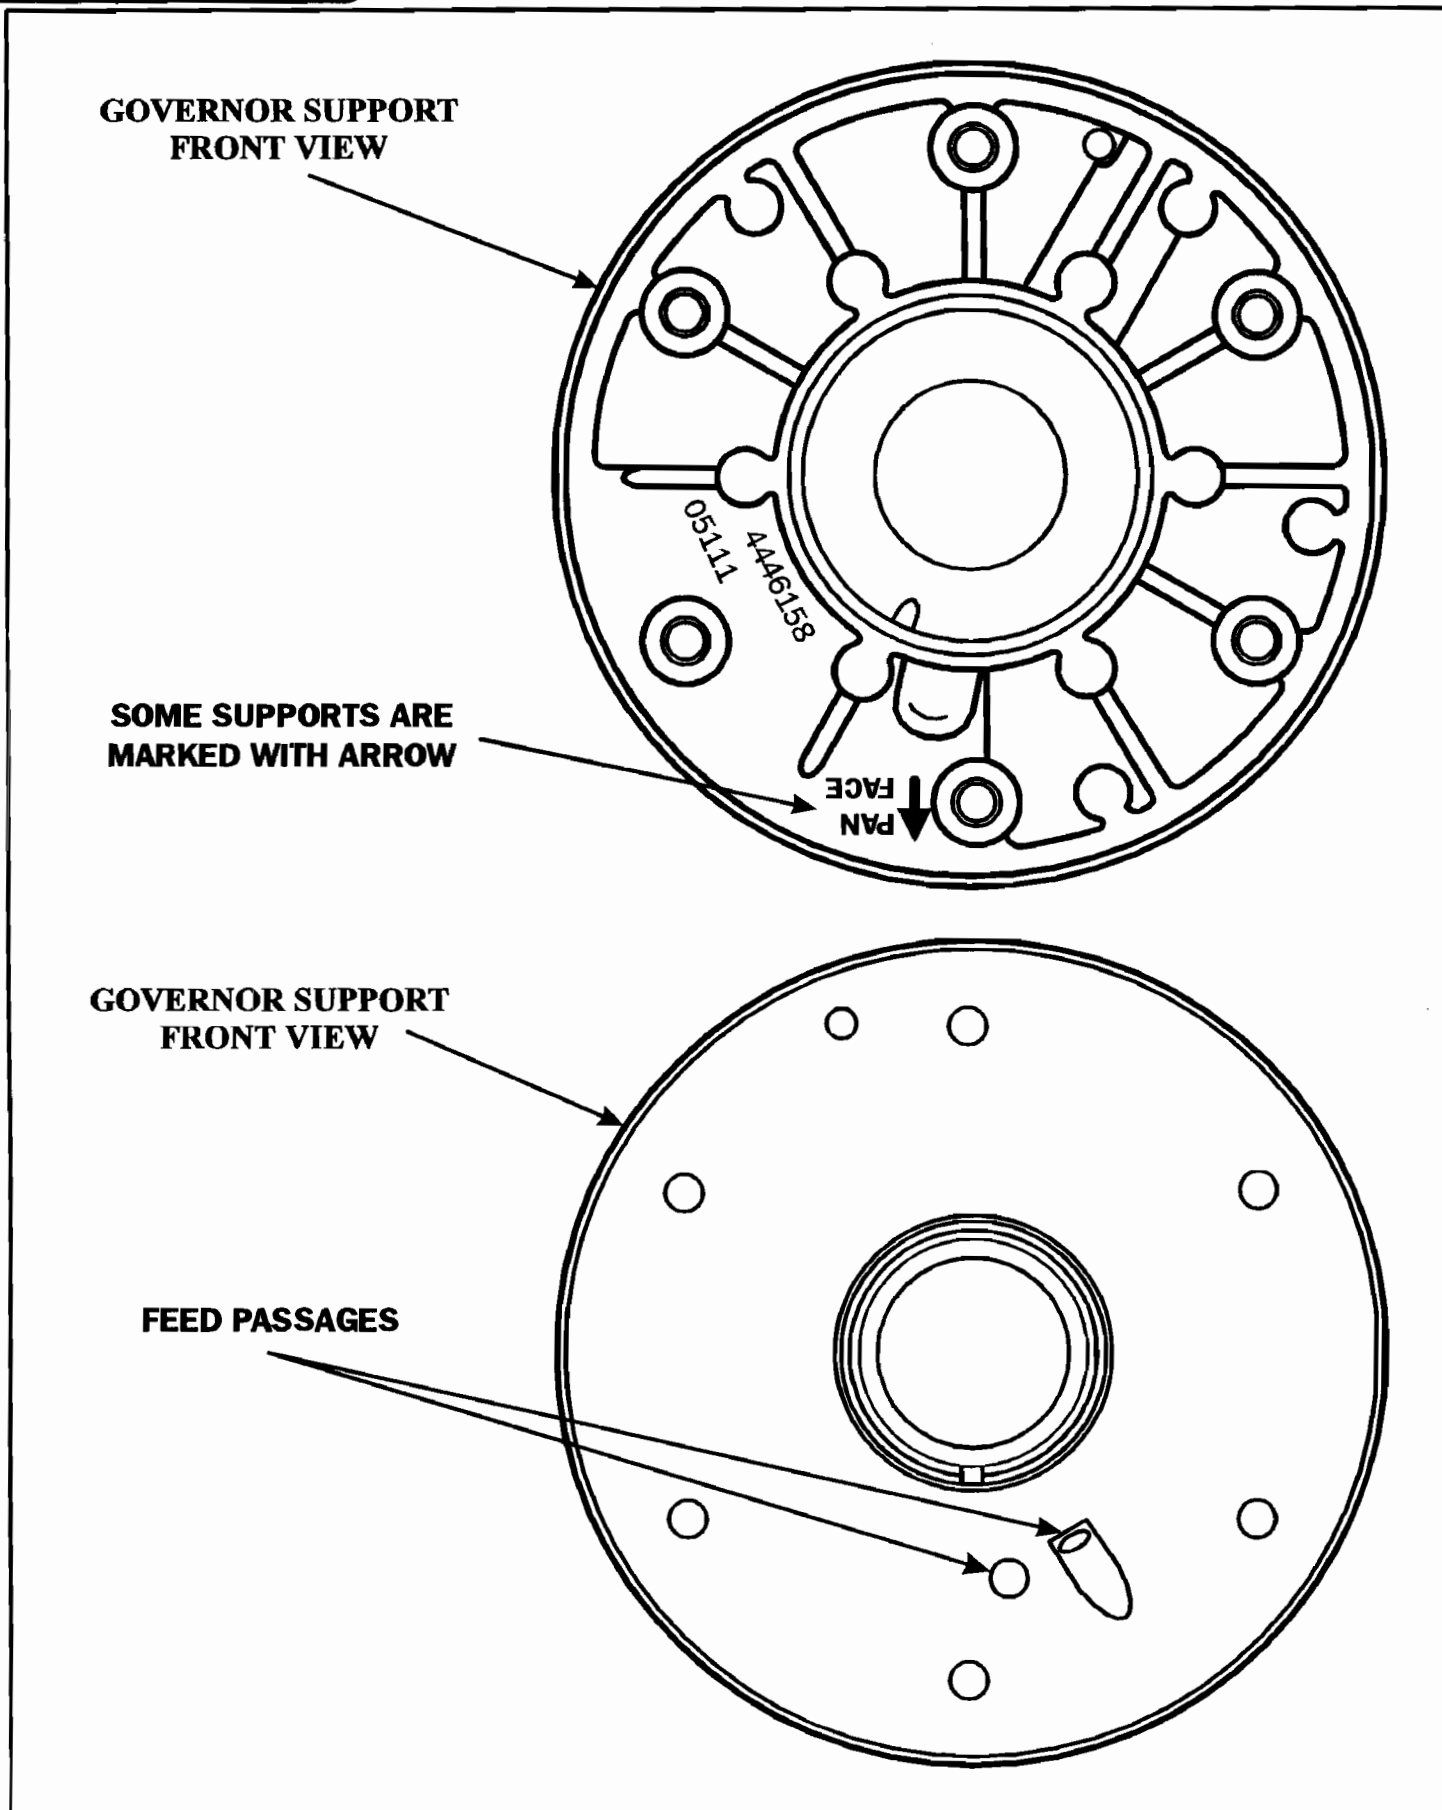
Figure 2

**CAUSE:** The cause may be, the Governor Support installed into the case incorrectly.

**INSTALLING GOVERNOR SUPPORT**

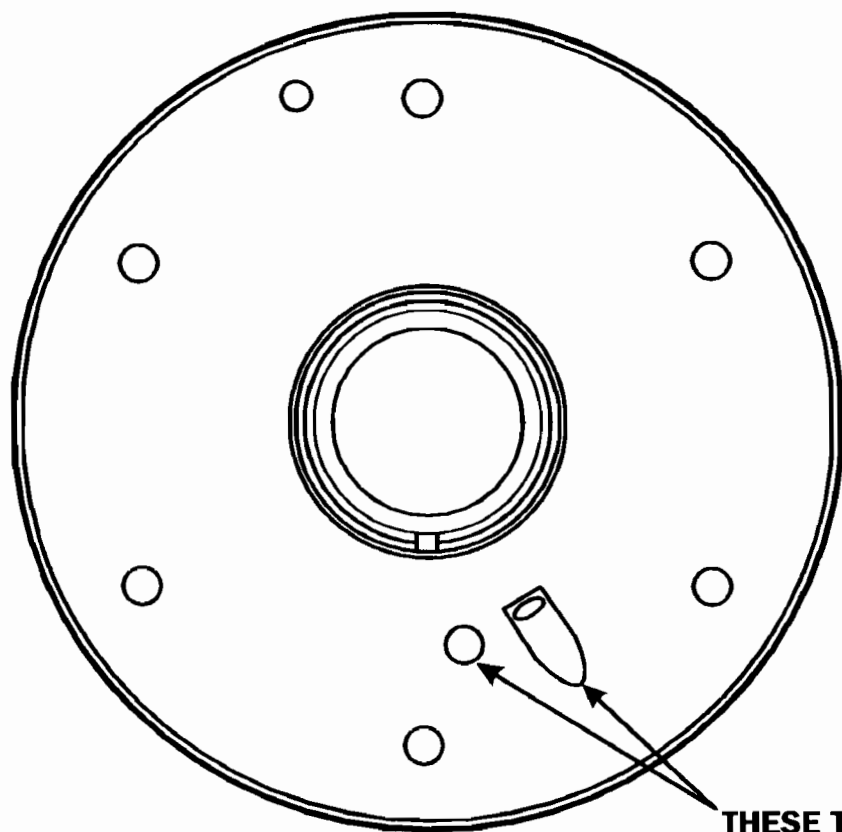
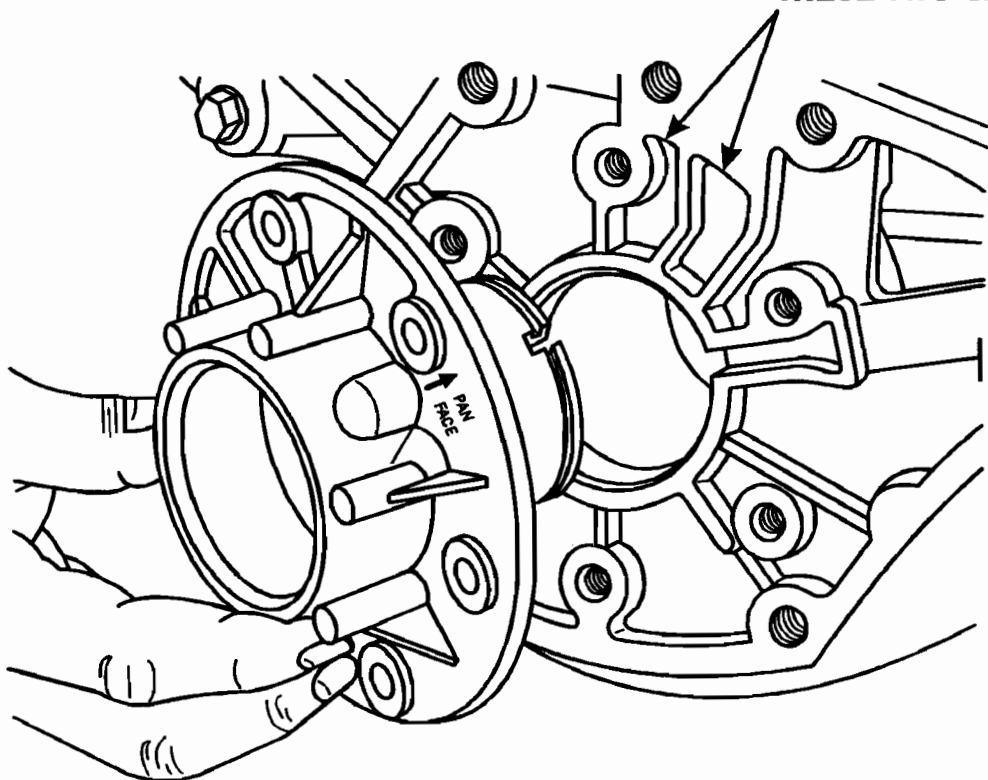
Figure 3

**THESE TWO FEED PASSAGES  
MUST BE ALIGNED WITH,  
THESE TWO CASE PASSAGES**
