# TRANSMISSION SEMINAR 1991

## TRANSMISSION SEMINAR

# 1991

*This years seminar brings the latest information on transmission changes and complaints to you the field technicians in both a video and slide format along with this printed back-up material to help you in the shop. We cover the most often asked questions on the Mitsubishi, Honda, and Toyota transmissions coming in our hot line. This information will help you when the same type problems arise on the vehicles coming into your shop. We have put together information on the Ford E4OD transmission along with other Ford units with tech hints that will speed up the process when you go through the rebuilding procedure. The Chrysler overdrive units both the A-500/518 and the A-604 units are starting to appear in our shops, both under factory warranty and customer pay. We have listed many of the parts changes and updates that will be facing you during repairs.*

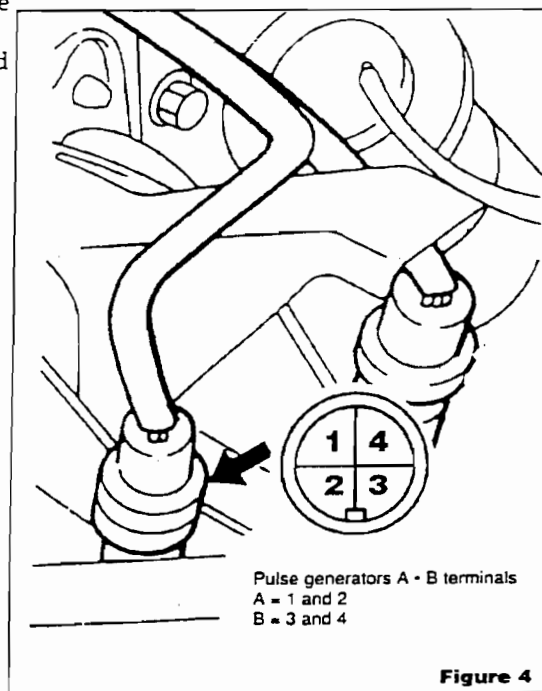
Figure 4 shows that there are four terminals on the pulse-generator connector. First we check terminals one and two. Let's say we get a reading of 510 ohms. Now we check terminals three and four and get a reading of 519 ohms. The generators are OK. The determining factor is that there is not more than a 20-ohm difference between the two generators. If it exceeds that, then generators must be replaced. When you check ohm readings that are specified in the repair

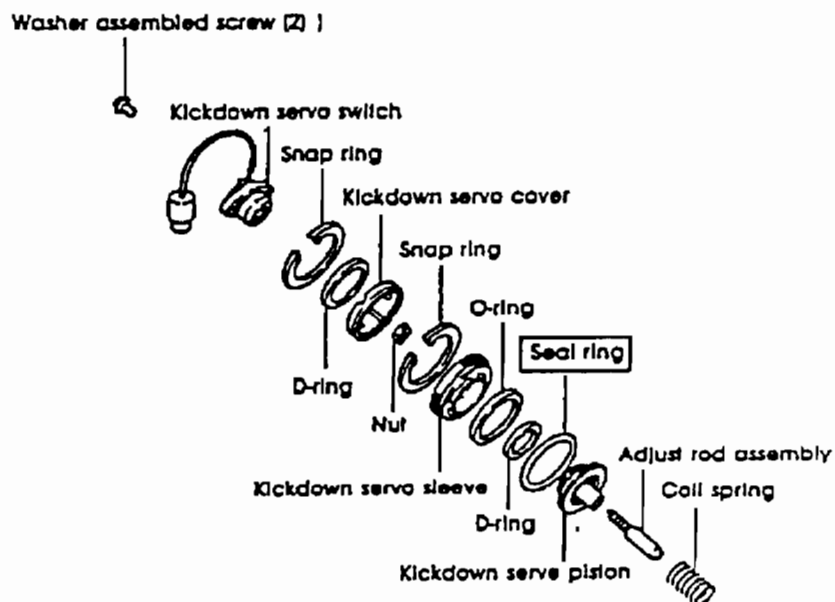
Figure 3

If hard shifts are still exhibited, remove the servo piston assembly from the transaxle and check the piston bore for wear (figure 2). If the bore wear is less than .023 in. the hard shift symptoms can be improved by installing a D-RING repair kit (P/N MD728-665). This kit contains a rubber piston seal ring instead of the carbon material seal ring installed at the factory (figure 3).

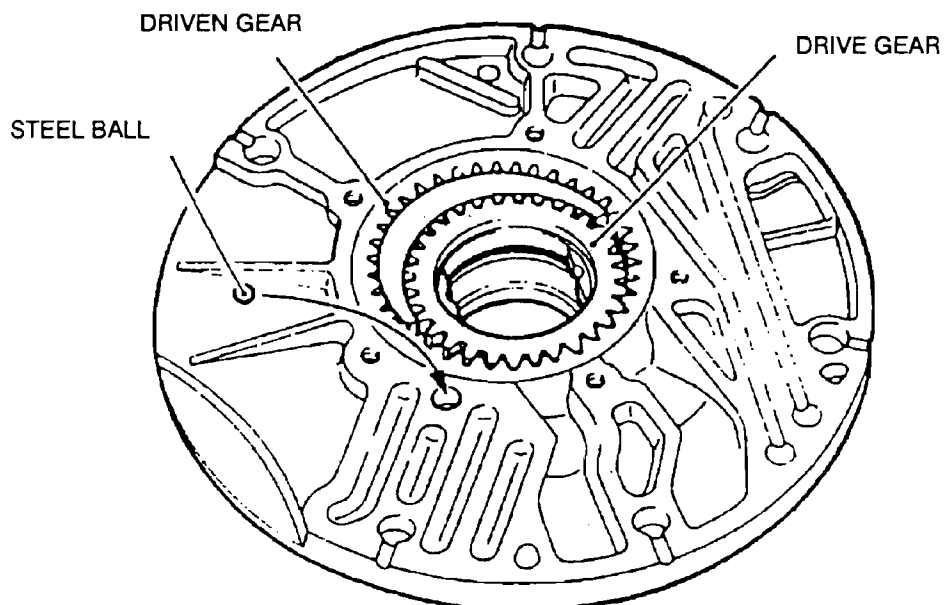
IF STEEL BALL IS LEFT OUT VEHICLE WILL HAVE NO FORWARD MOVEMENT

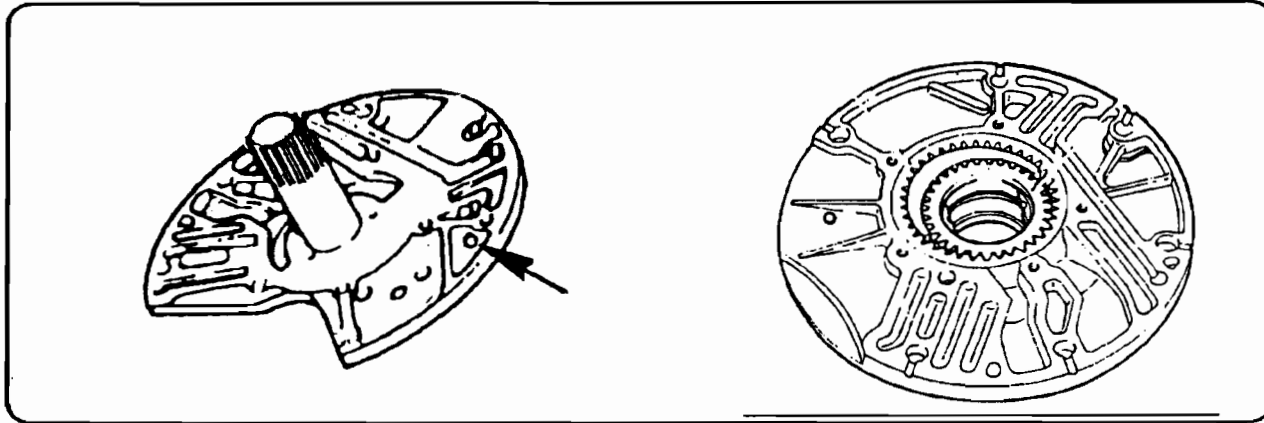
**MITSUBISHI KM 1 71**

PUMP STATOR WITH HOLE MUST GO WITH PUMP BODY WITHOUT CORRESPONDING BREATHER HOLE.

MIS-MATCH OF THESE PARTS CAN CAUSE EITHER HOLE LEAKING DIRECTLY OUT FRONT PUMP AREA  
OR BLOWING OIL OUT FILLER CAP.

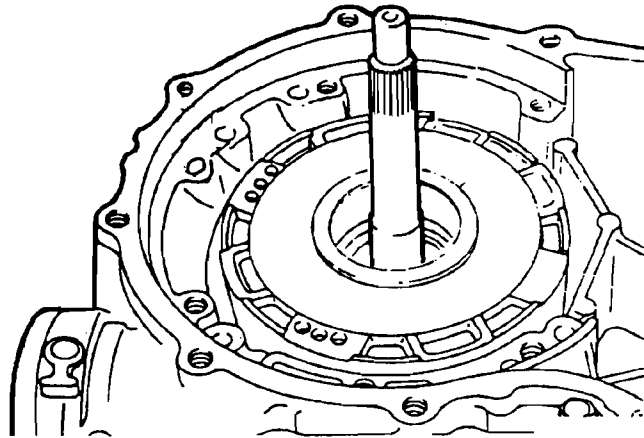
Figure 1

This Mitsubishi KM-171-2, which basically is a heavy-duty version of the KM-171, is similar to the KM-175 in the pump area. Both units use an aluminum spacer in the case between the pump and case (some KM-171 do not have the spacer, figure 1). Two gaskets are used in this application (figure 2). Both gaskets are the same (figure 3). In many of the gasket kits there are three gaskets. One of the gaskets is different from the other two (figure 4). Some technicians make the mistake of using one of each kind of gaskets instead of the required two that are alike. The result is that when the vehicle is cranked up the pump cannot draw up the fluid causing a no movement condition..

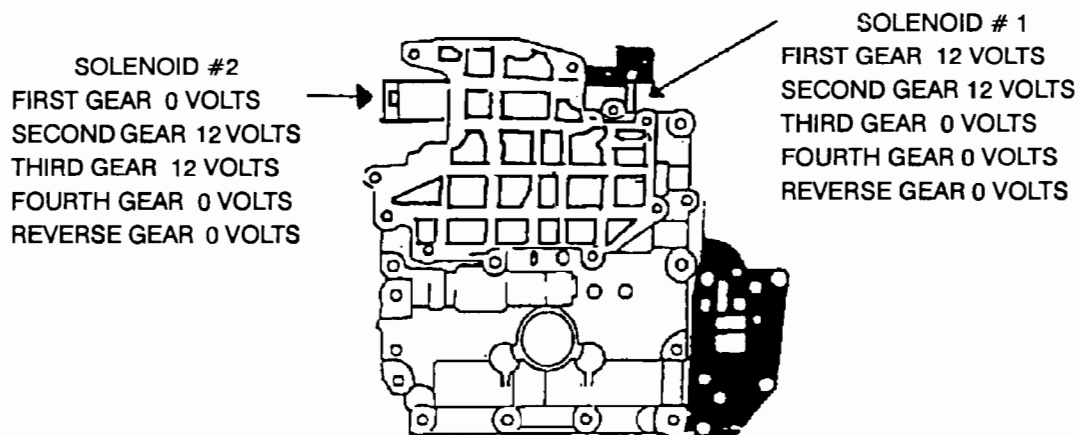
CAUTION: WHEN AIR CHECKING SOLENOIDS, THEY MUST HOLD 70 PSI WITH NO VOLTAGE

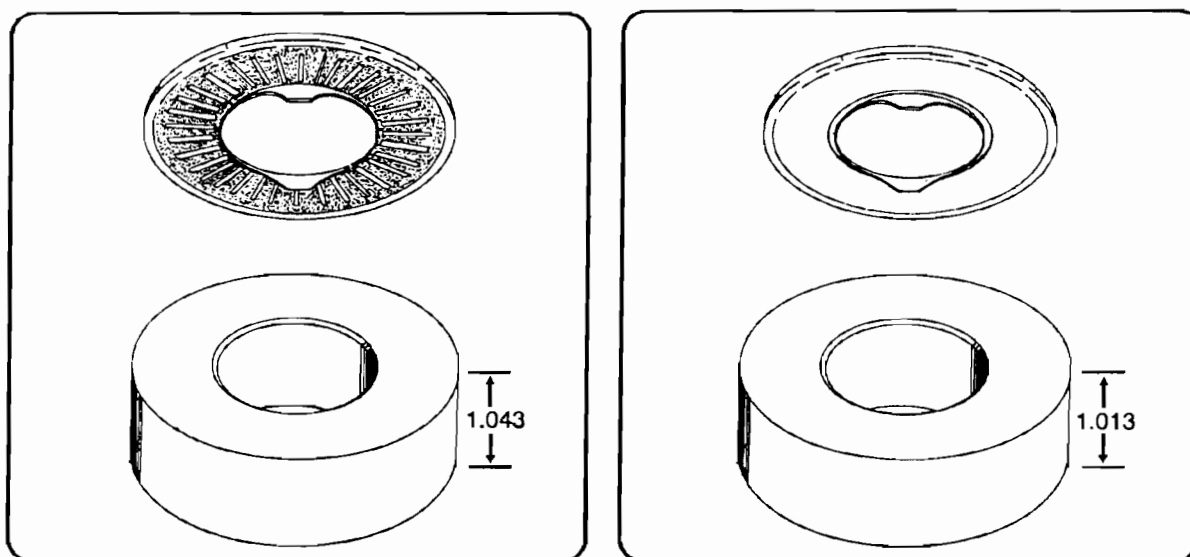
Figure 8

1. Low Roller clutch inner race: The low roller clutch inner race height has been reduced by .030" to accomodate a revised hub to race bearing. The previous (before 2/24/89) inner race height was 1.043". The new design (after 2/24/89) inner race height is 1.013". (See Fig. 8)
2. Hub To Race Bearing: The original hub to race bearing was a 2 piece (open face) design, and the new design is a 3 piece closed design bearing. The thickness of the original 2 piece bearing is .110" thick, and the new design 3 piece bearing is .140" thick, to be compatible with the new design inner race.

2 PIECE BEARING (BEFORE 2-24-89)..... E7DZ-7D422-A  
3 PIECE BEARING (AFTER 2-24-89)..... E6DZ-7A178-A

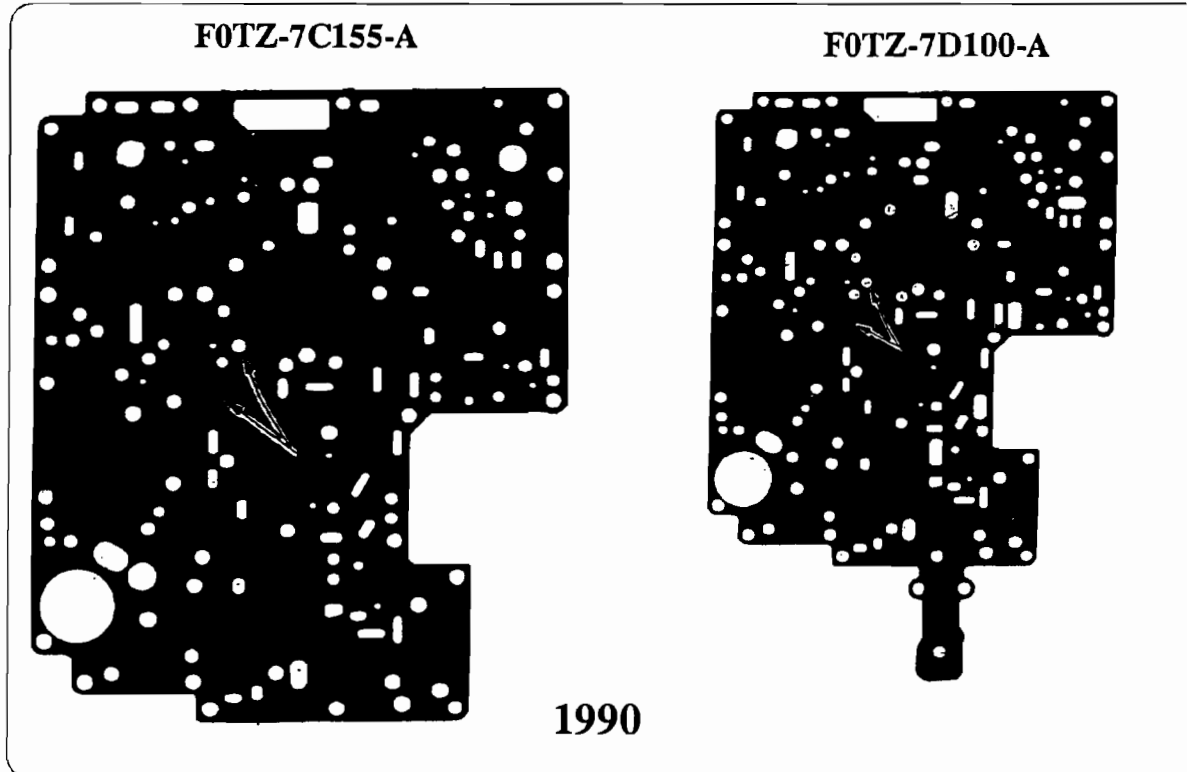
Figure 9

The 1989 and 1990 gaskets are different, and are not interchangeable. Note the differences indicated by the arrows.

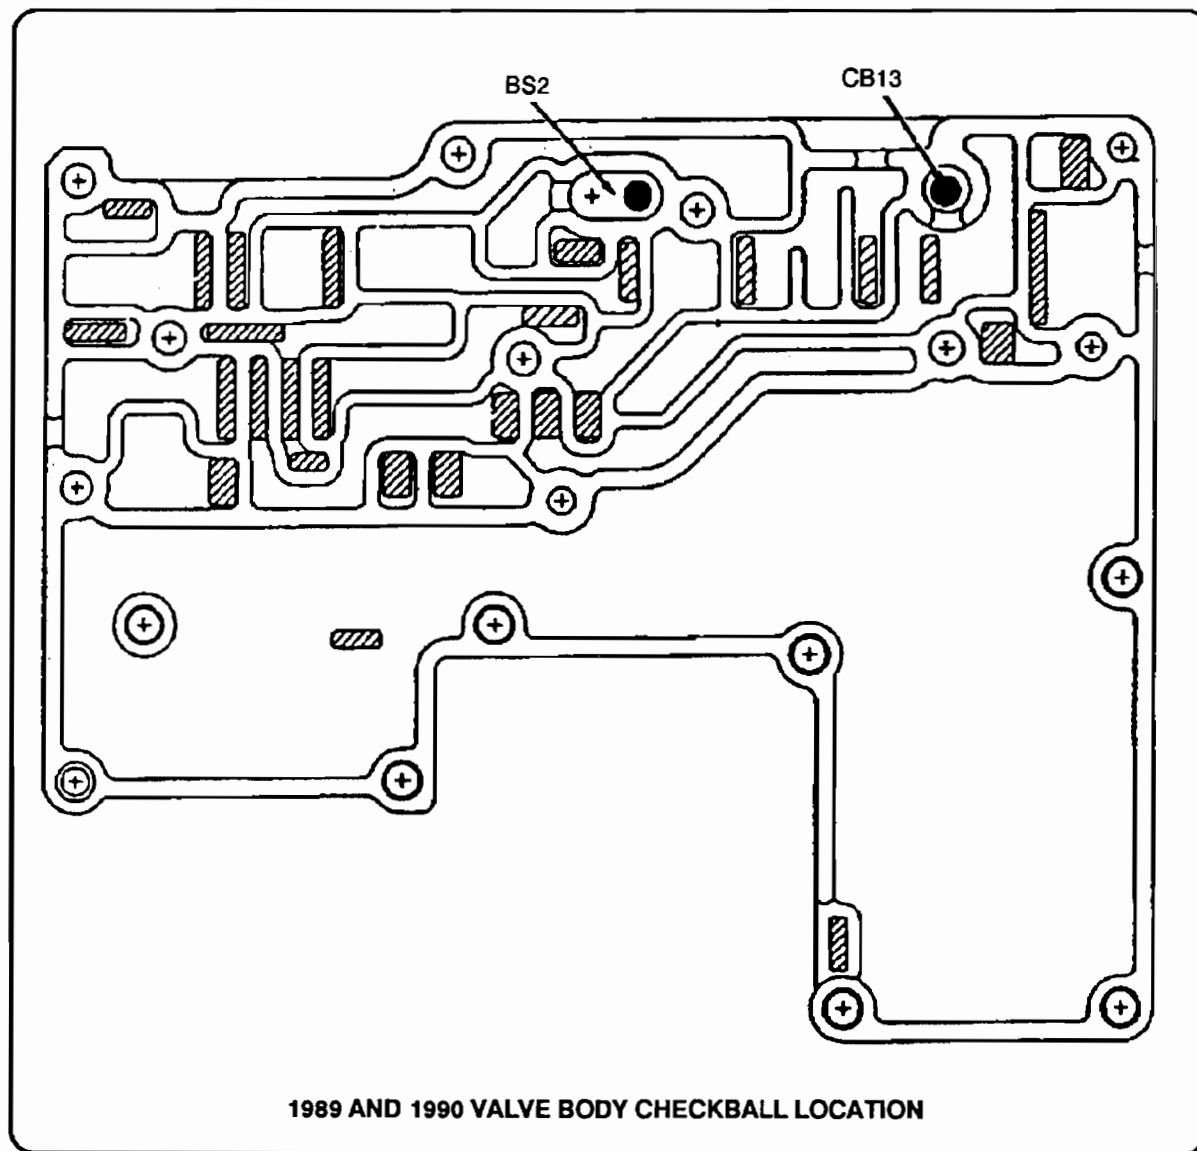
Figure 11

There has been a change in check ball locations (CASE ONLY), for all 1990 model E4OD transmissions. Valve body locations remained the same as previous models.

REFER TO FIGURE 11 FOR BOTH YEARS, FOR THE VALVE BODY CHECKBALL LOCATION.  
REFER TO FIGURE 12 FOR "1989" CHECKBALL LOCATIONS.  
REFER TO FIGURE 13 FOR "1990" CHECKBALL LOCATIONS.

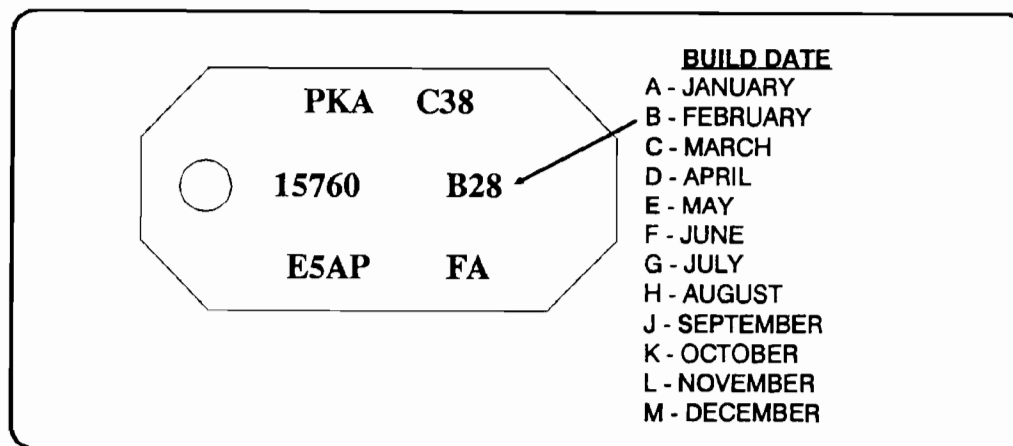
Figure 37

- Fits 1989 canender year build dates used in 1989 and 1990 models C-31 thru J-4 (See Figure 37). Consists of 1 valve body gasket, 3-4 shuttle valve, T.V. spring and separator plate. Used to address a concern of a T.V. buzz, a slide 3-4 shift or premature failure of forward or direct clutch, and/or overdrive band

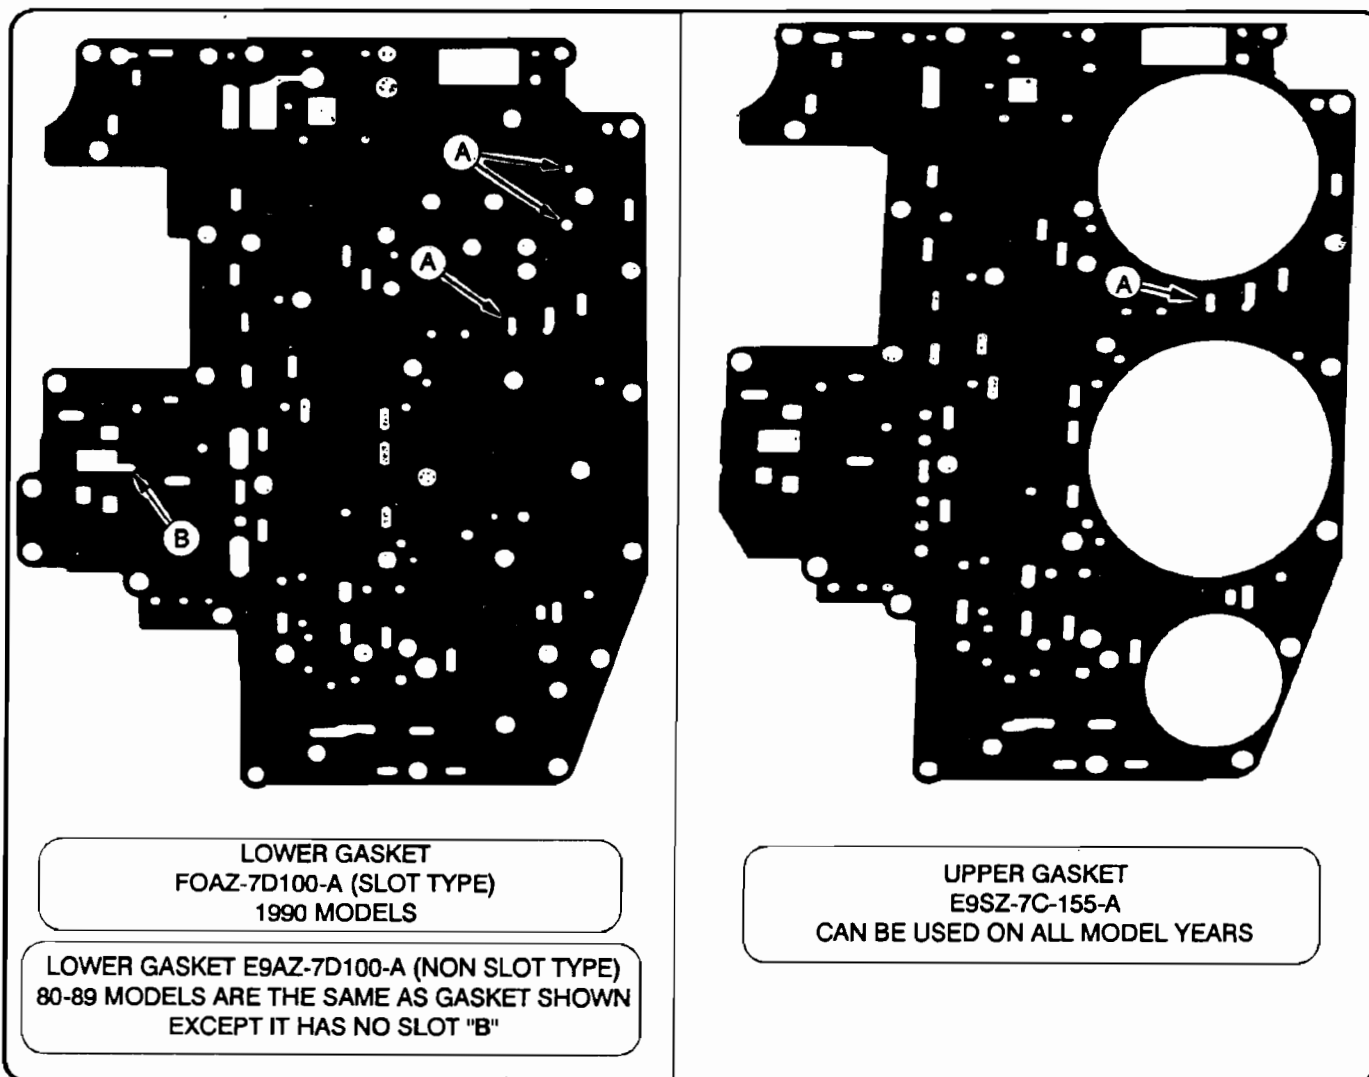
Figure 38

1. Holes marked "A" were added for 1989 model transmissions. If gaskets are used on 1989 models that do not have these holes, it will result in a 1-3-4 upshift pattern (See Figure 38).

2. This slot (B), added for 1990 models. This slot type gasket is also included in part # E9AZ-7D100-B and #E9AZ-7L228-A, ( see "factory available parts".) The slot type gasket can be used on early models **AS LONG AS THE THROTTLE VALVE SPRING IS CHANGED ALSO.** The above part numbers have the throttle spring and instructions included. An early "non slot" gasket used on a 1990 model may result in a reduction of throttle valve pressure and possible failure.

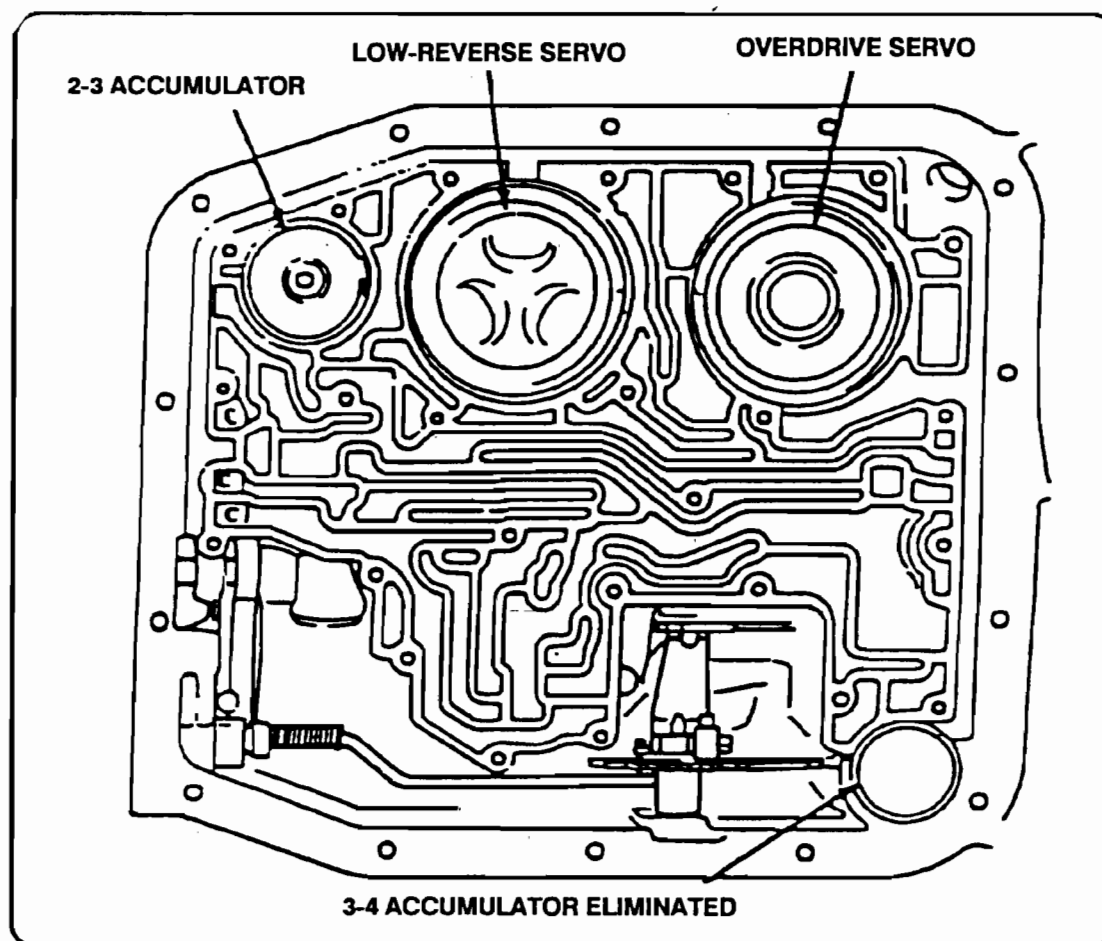
Figure 41

The 3-4 shift accumulator used in prior model year "AOD" transmissions is no longer used in 1989 "AOD" transmissions (See Figure 41) except on vehicles that are equipped with 5.8L engines. The accumulator feed hole in the main control assembly has been blocked.

Only use a 1989 control assembly to service a 1989 "AOD" transmission. The 1989 main control assembly can be used on all prior model year "AOD" transmissions even if the old main control assembly has a 3-4 shift accumulator.

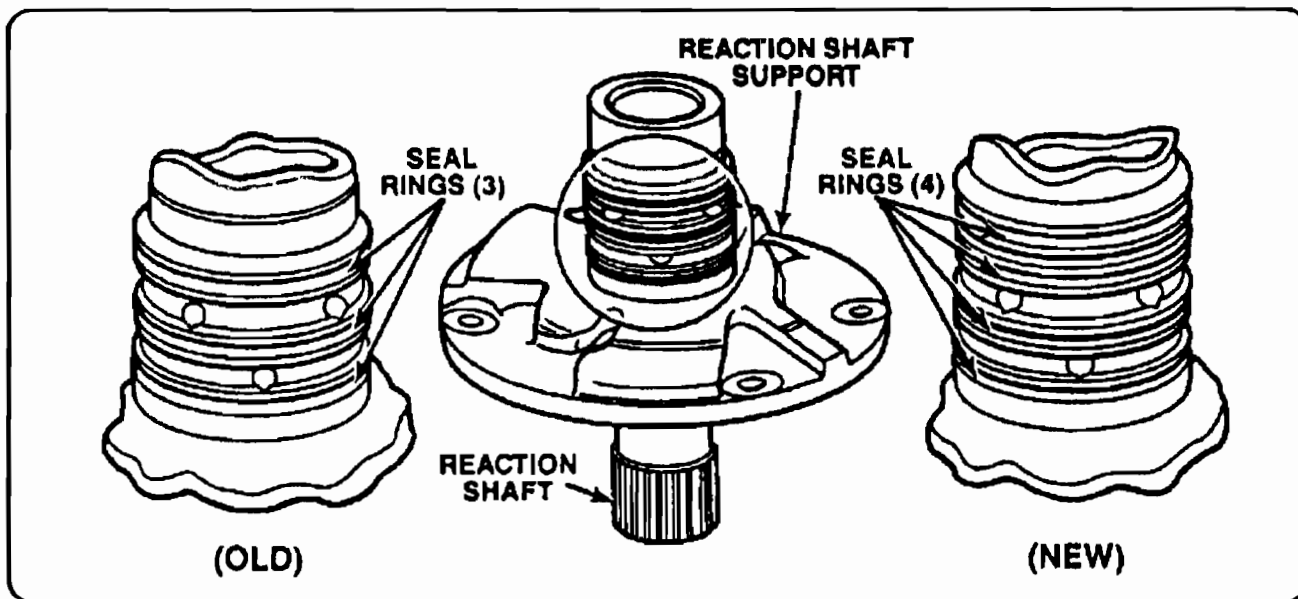
Figure 1

**CHANGE:** Beginning in April, 1989 a new Reaction Shaft Support (Stator) was introduced, with the addition of another ring groove and sealing ring. The old support has 3 sealing rings, and the new support has 4 sealing rings (See Figure 1).

- (1) REACTION SHAFT SUPPORT - The new support is longer, and has 4 sealing rings, where the old support only has three (See Figure 1).
- (2) INPUT SHAFT/CLUTCH HUB - The new Input Clutch Hub bore is machined deeper to accommodate the additional length of the reaction shaft, created by the added sealing ring (See Figure 2).  
The "O" Ring grooves are also cut shallower than the old input clutch hub, which increases the groove diameter, and provides improved compression or "Crush", between the "O" rings and the input clutch retainer. (See Figure 2).

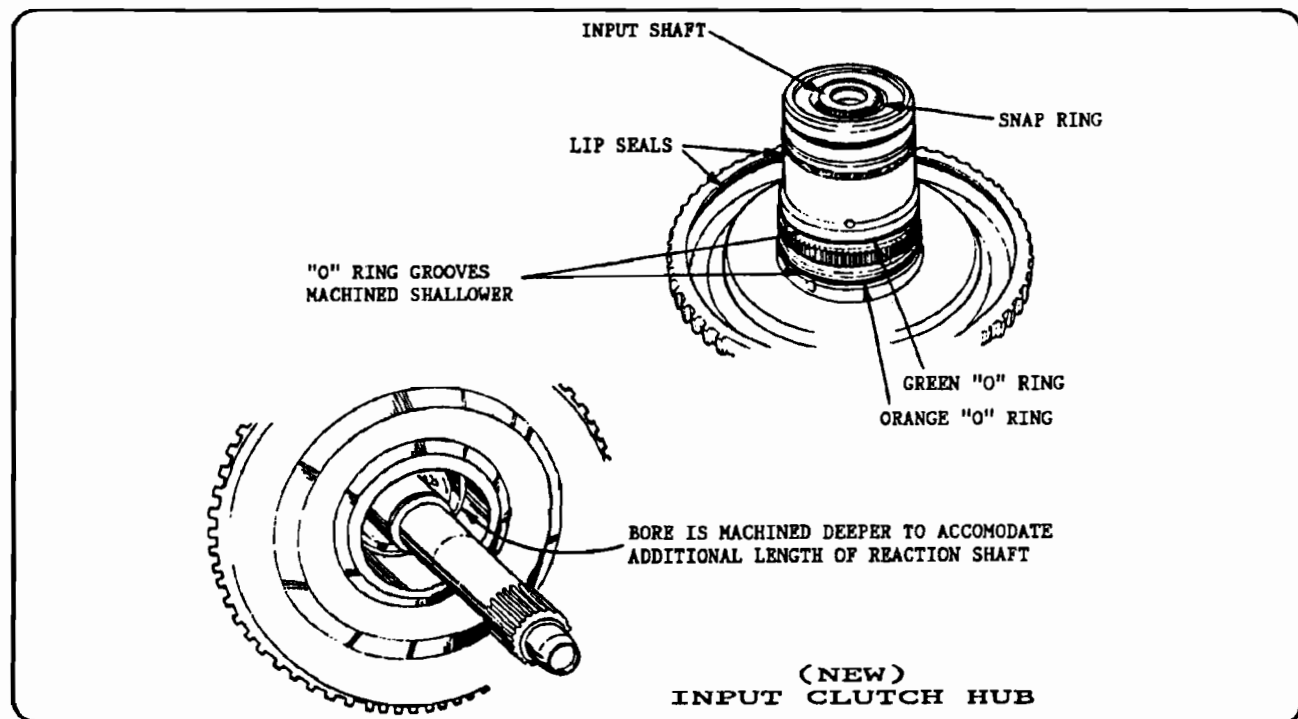
Figure 2

- (3) INPUT SHAFT/CLUTCH HUB "O" RINGS - The new "O" Rings are "Teflon Coated" for greater tear resistance during the assembly process. The coatings also identify the locations for the "O" Rings. The orange ring goes to the front, and the green one goes to the rear (See Figure 2). The early "O" rings were black.

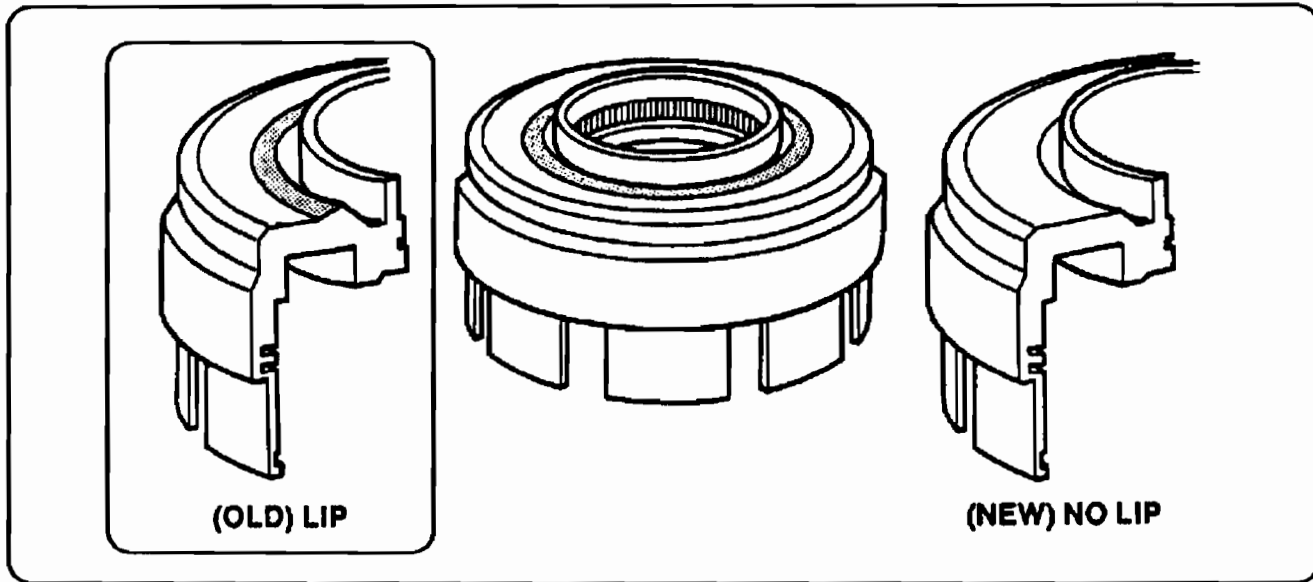
Figure 3

- (4) INPUT CLUTCH RETAINER - The Input Clutch Retainer was modified, by machining off the "Lip" (See Figure 3), to allow more travel of the overdrive/reverse piston. The old Input Clutch Retainer can be machined at the local machine shop if necessary.

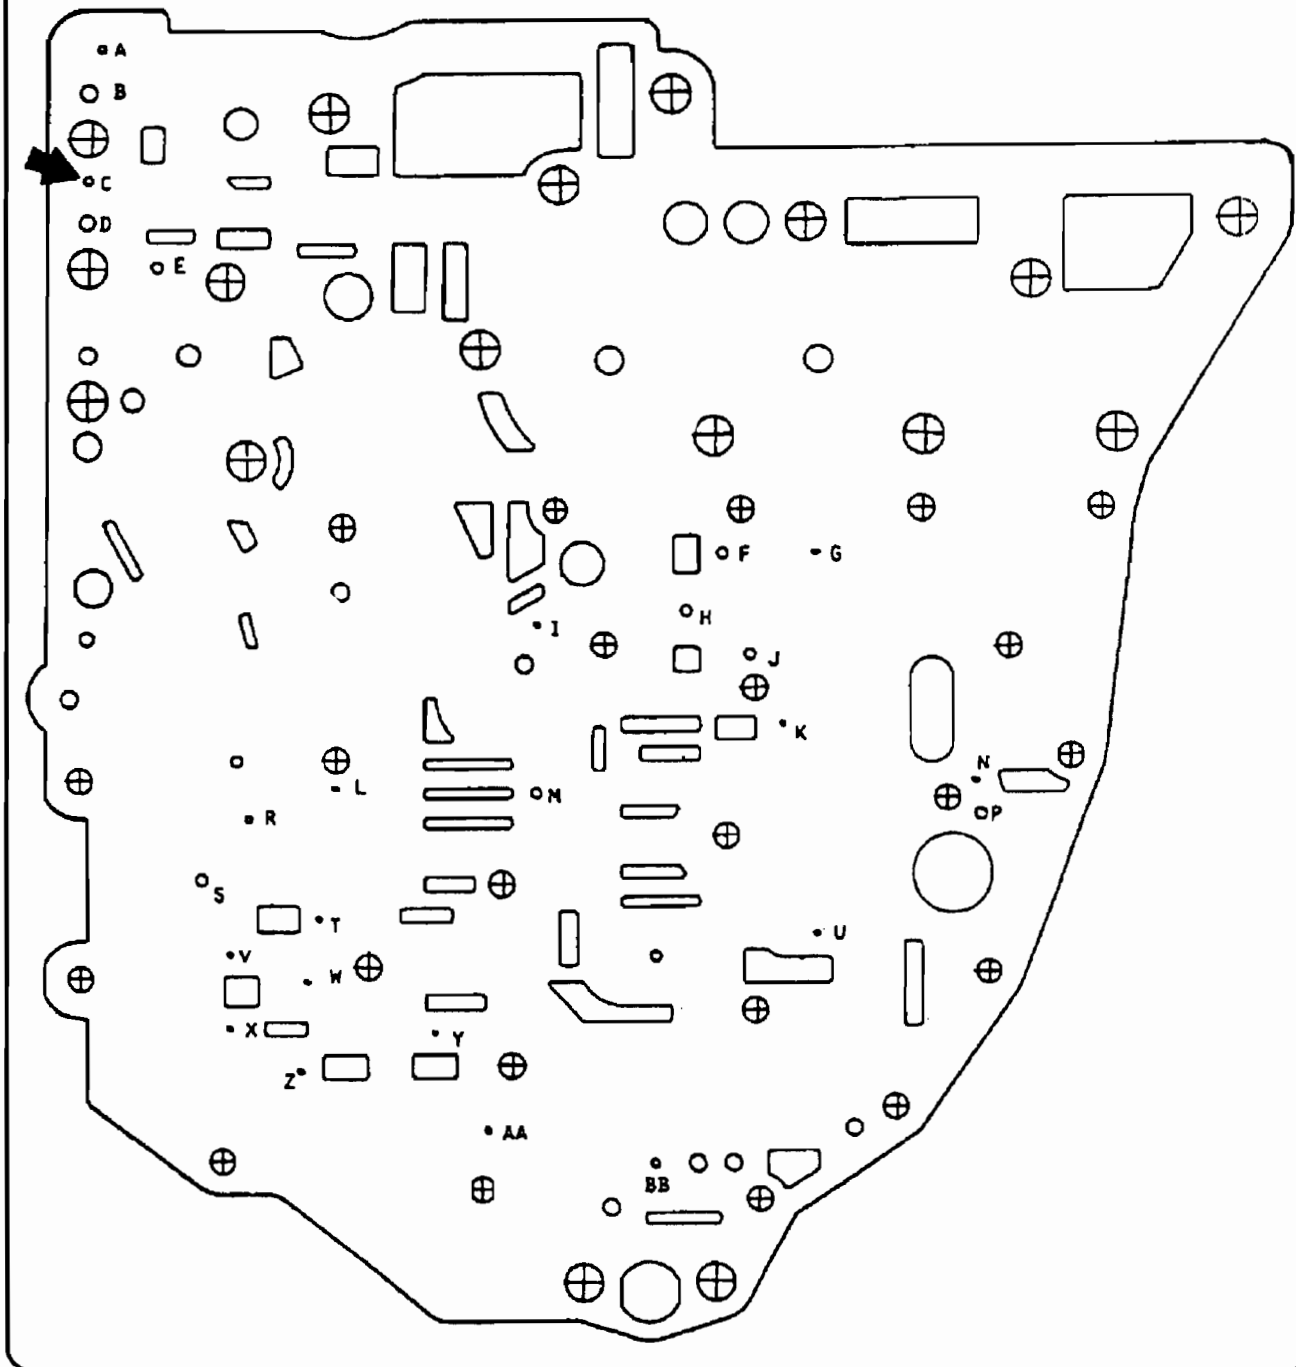
HOLE "C" ENLARGED TO .105" FOR INCREASED OIL FLOW

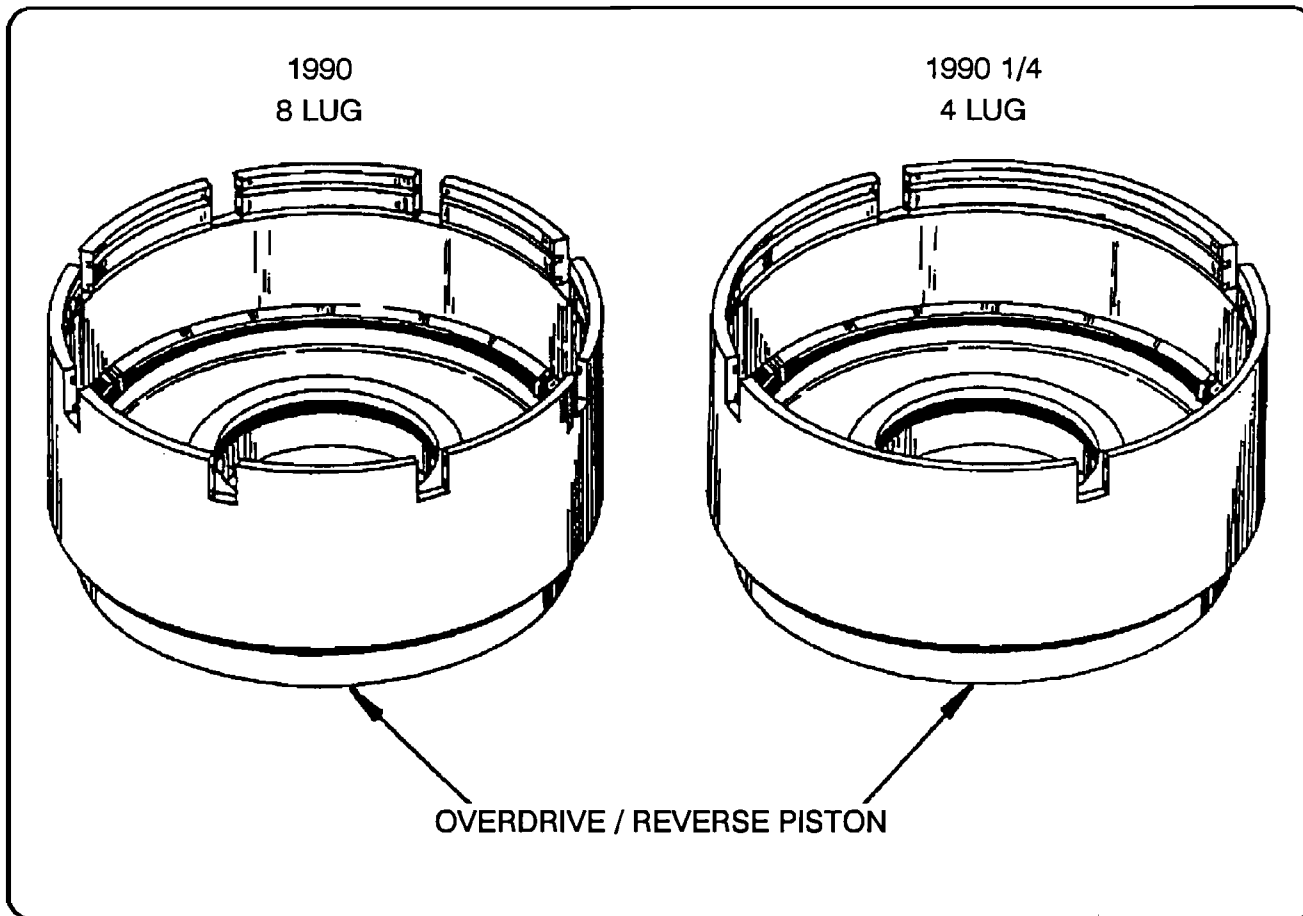
Figure 25

**CHANGE:** A new Overdrive/Reverse Piston has been introduced for 1990 1/4 model transaxles, and features four reaction plate slots instead of eight slots (See Figure 25).

- (1) OVERDRIVE/REVERSE PISTON - The new Overdrive/Reverse Piston has four slots, for the pressure plate lugs, instead of the previous eight slots and can be identified visually (See Figure 25).  
The inside diameter of the new pistons bottom corner also has a larger radius to accomodate a new 1990 1/4 Input Clutch Retainer dimensional change (See Figure 26).
- (2) OVERDRIVE/REVERSE PRESSURE PLATE - The new Overdrive/Reverse Pressure Plate has only four lugs on the outside diameter, instead of the previous eight, and can be identified visually (See Figure 27).
- (3) INPUT CLUTCH RETAINER - The new Input Clutch Retainer has a new radius on the outside diameter, to reduce the chance of damage to the lip seal during assembly (See Figure 28). This retainer has no identification marks, and is tough to identify visually. The OEM part number did not change.

OVERDRIVE / REVERSE PISTON

The revised Input Clutch Retainer WILL NOT work with the previous style 8 lug overdrive/reverse piston. Since the part number did not change, to replace an input clutch retainer built in 1990, before the change to the 4 lug overdrive/reverse piston, you MUST also change to the 4 lug design piston and pressure plate.

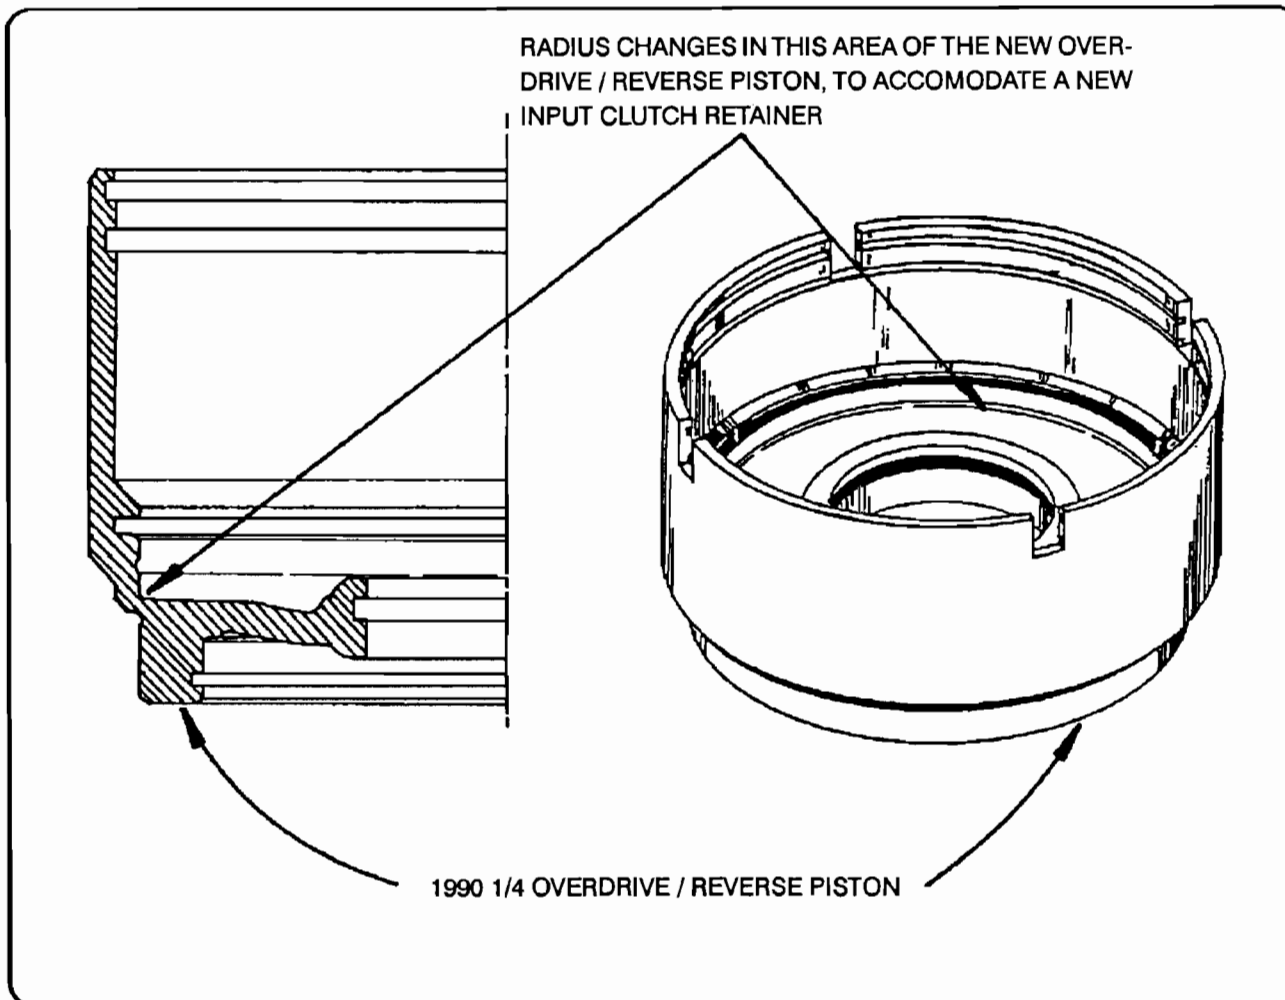
Figure 26

**CHRYSLER A-604****1990 1/4 OVERDRIVE / REVERSE PISTON  
WITH FOUR SLOTS**

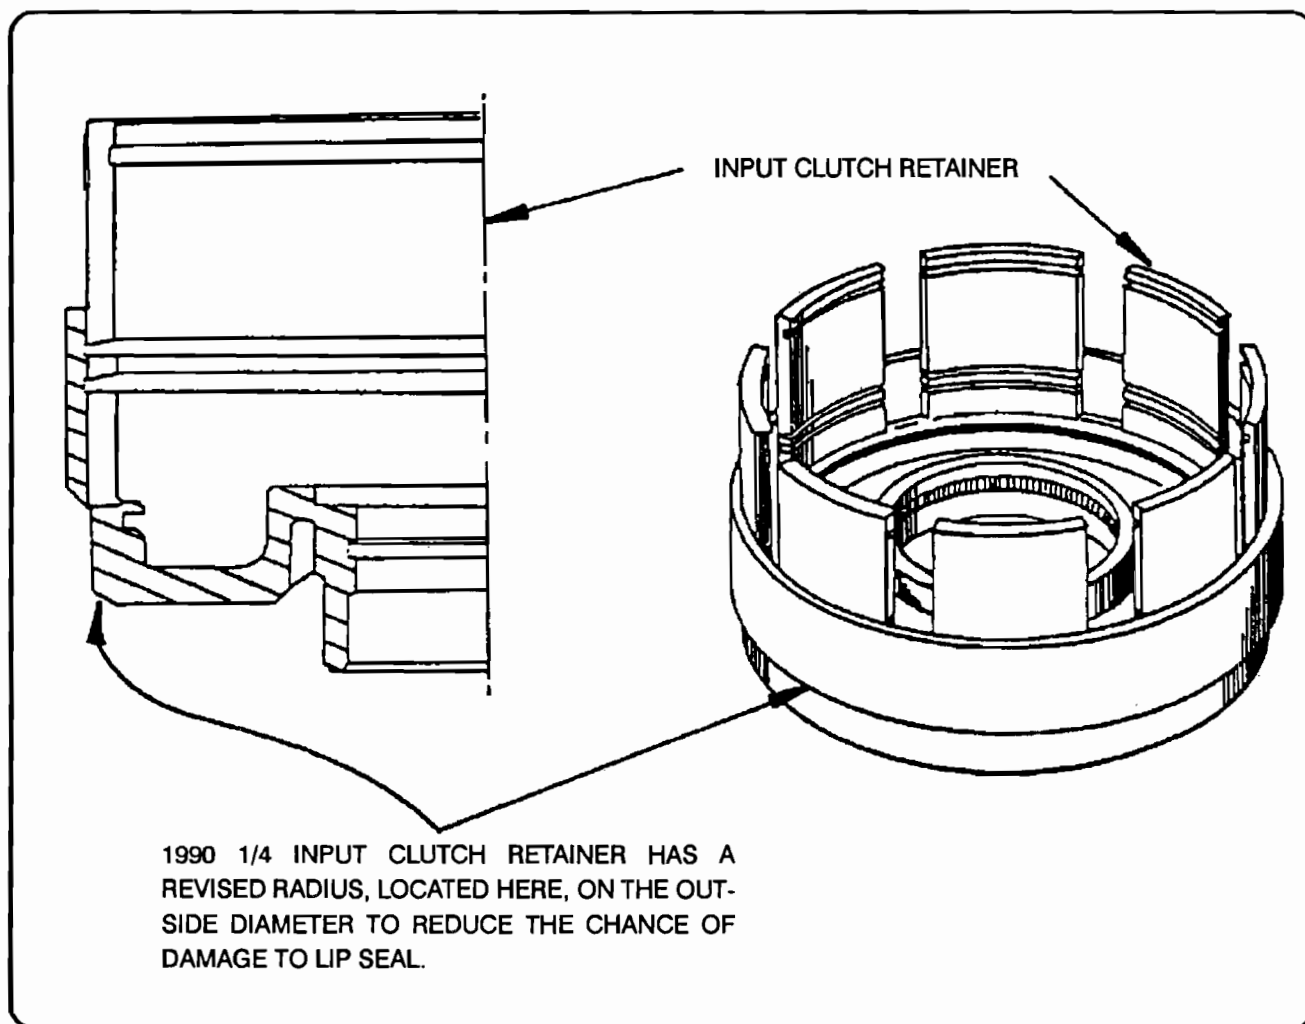
Figure 28

**CHRYSLER A-604****1990 1/4 INPUT CLUTCH RETAINER**

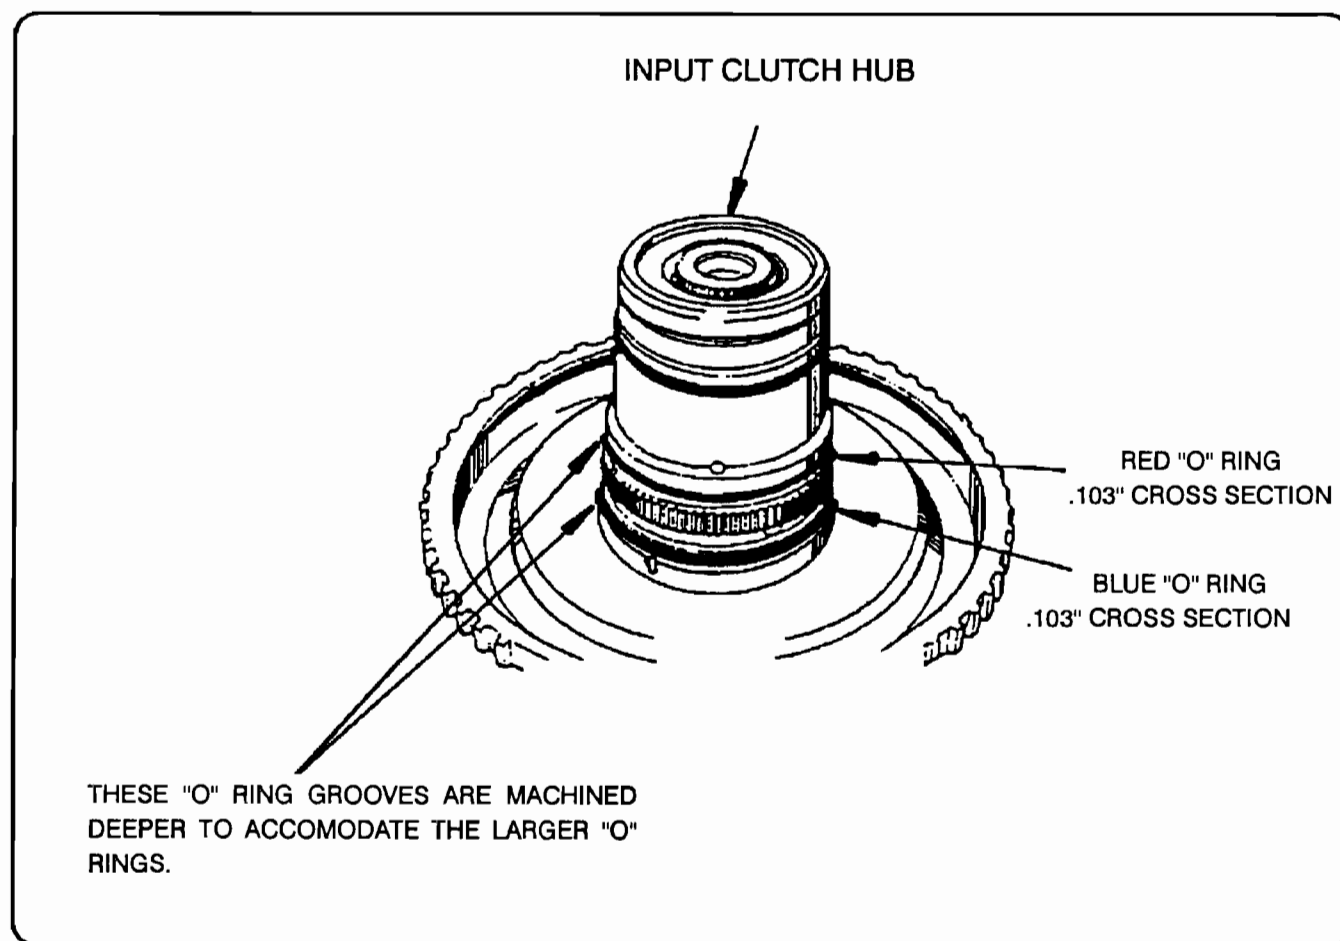
Figure 29

**CHRYSLER A-604****1990 1/4 INPUT CLUTCH HUB**

- (1) INPUT CLUTCH HUB - The "O" ring grooves on the Input Clutch Hub are cut deeper to accommodate the larger cross section color coded "O" rings (See Figure 29).
