# THE SEMINAR WITH MORE IN '94

AUTOMATIC TRANSMISSION SERVICE GROUP  
9200 S. DADELAND BLVD. STE 720  
MIAMI, FLORIDA 33156  
(305) 670-4161

## **INTRODUCTION**

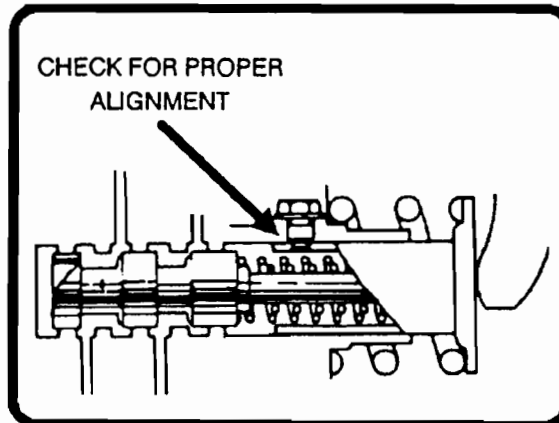
FIGURE 2

- COMPLAINT:** Harsh engagement, harsh shifts, high line pressure.
- CAUSE:** Pressure regulator retaining bolt jamming spring retainer (figure 1).
- CORRECTION:** When installing retainer and bolt make sure that the slot on the retainer lines up with the bolt hole before installing the bolt (figure 2).

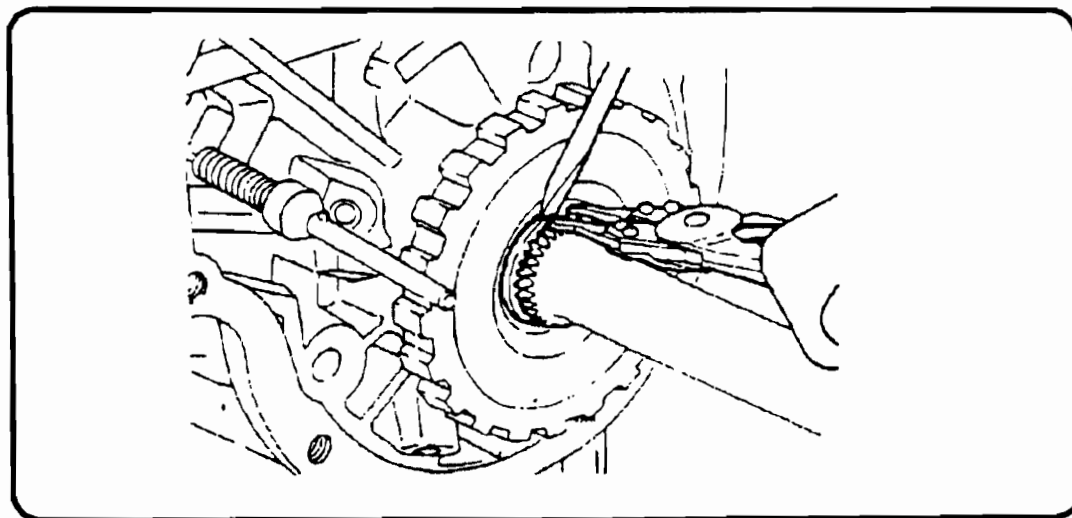
Figure 1.

During teardown, it is very difficult if not impossible to remove the front carrier to output shaft snap ring. Even if only an inspection service is being performed, the tail housing and parking gear to output shaft snap ring must be removed first. See figure 1. This will allow the output shaft to be pushed far enough forward to remove the front carrier to output shaft snap ring without damaging it. See figure 2,

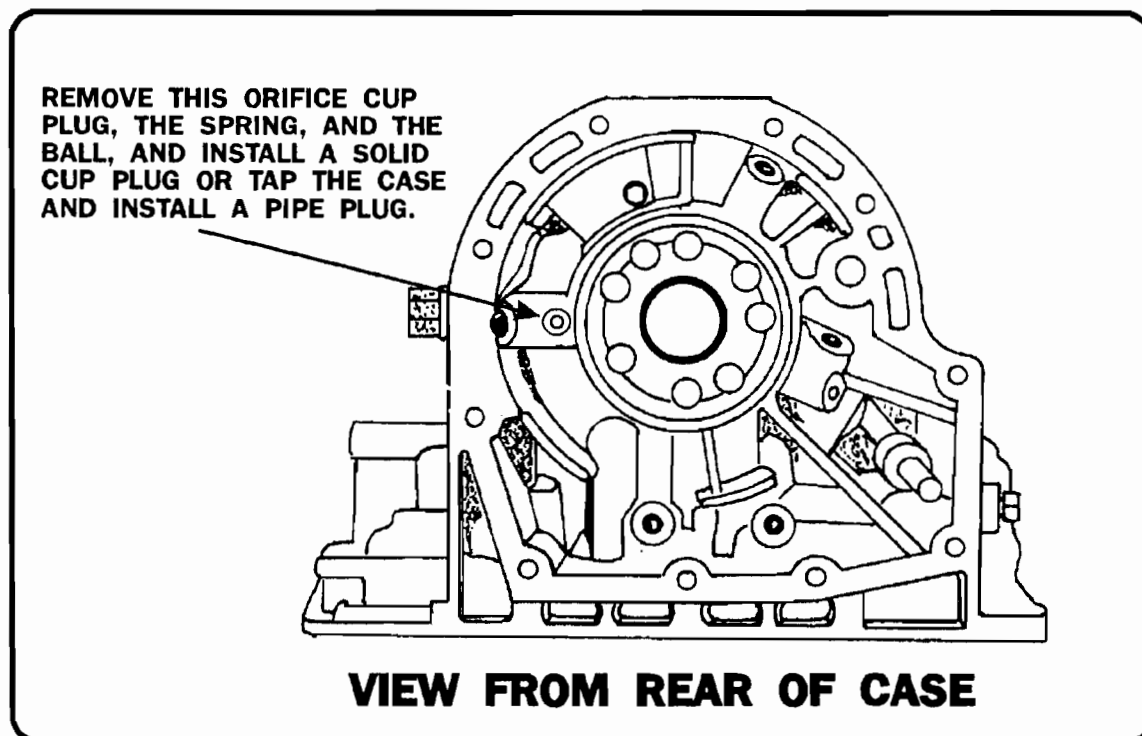
Figure 2.

**COMPLAINT:** Planetary gears failed due to lack of lubrication, while the hydraulic system and friction material does not seem to be damaged.

**CAUSE:** Lubrication may be restricted or even totally cut off due to clutch material from the converter clutch clogging the fins or tubes inside of the radiator cooler.

Check the case bushings for wear and replace them if they are worn. Also make sure that the case bushings have not moved so that they block the lubrication feed passage to the output shaft. To assure maximum lube to the output shaft and planets, remove and discard the orificed cup plug, the lube relief ball, and the spring as shown in figure 2 and and INSTALL A SOLID PLUG IN PLACE OF THE ORIFIFED CUP PLUG.

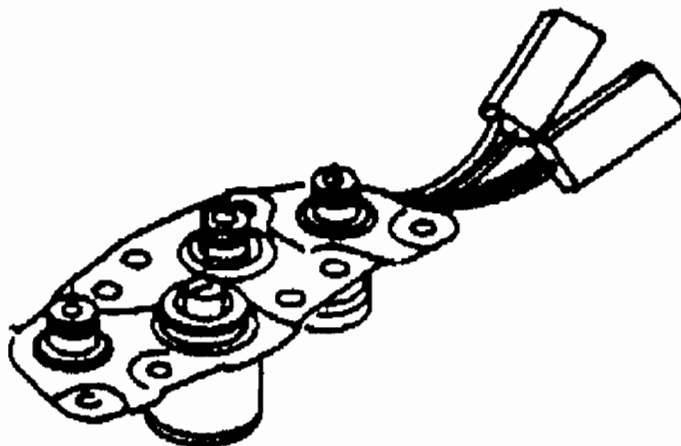
Figure 2.

**CAUSE:** No line pressure rise with throttle opening. This can be easily checked by connecting a pressure gauge to the line pressure tap on top of the case, near the front of the transaxle. See figure 1. Test the line pressure in drive at idle. It should be around **60 psi**. At increased throttle opening, pressures should smoothly increase to a maximum of around **180 psi**. at stall. If the line pressure stays at or near idle pressure, the cause is a weak or clogged pressure control solenoid.

**CORRECTION:** Remove the valve body and replace the 4-Unit Solenoid Assembly which contains the pressure control solenoid. See figure 2. The pressure control solenoid is not serviced separately. A new solenoid assembly is available from the Nissan dealer. The part number for the solenoid pack is **31940-27X66**.

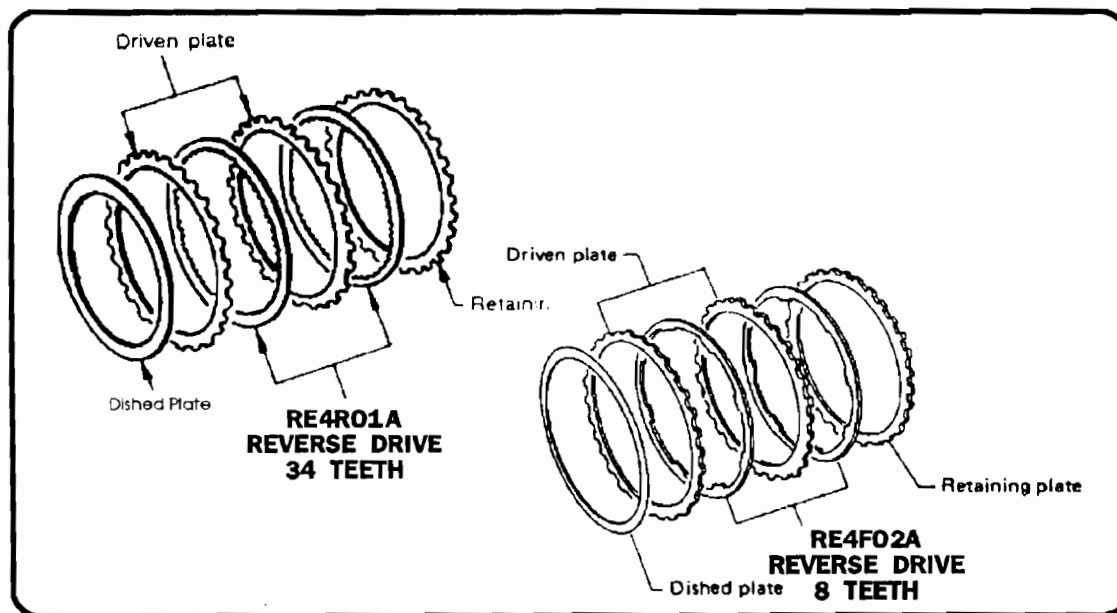
Figure 2.

Often during an overhaul of the front wheel drive Nissan 4 speeds, we find that the high clutch drum has deep grooving in the sealing ring area which renders the drum useless. Some companies are selling oversize sealing rings for the oil pump cover, so that the drum can be reused if it is honed or machined so that the rings will not tear upon installation. This has met with mixed success and is not recommended for a long term fix.

Besides changing the complete high clutch drum, the reverse lined clutches also must be changed, as well as the high clutch hub. **Figure 2** shows the differences in the reverse lined clutches from the RE4FO2A to RE4RO1A models. The reason for also changing the high clutch hub is that the RE4RO1A high clutch drum clutches have a larger inner diameter. These differences are shown in **Figure 3**.

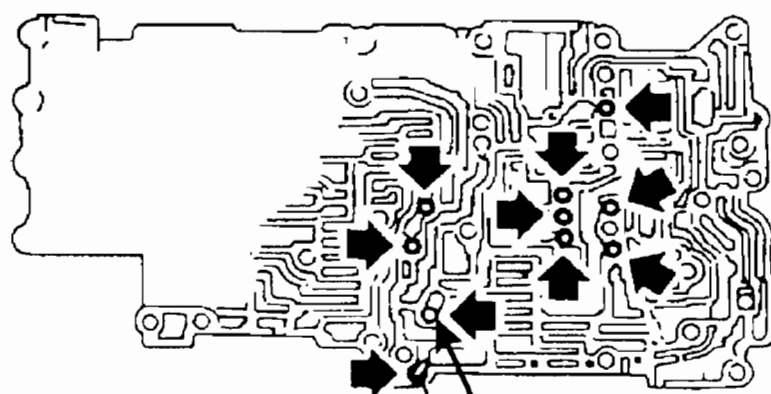
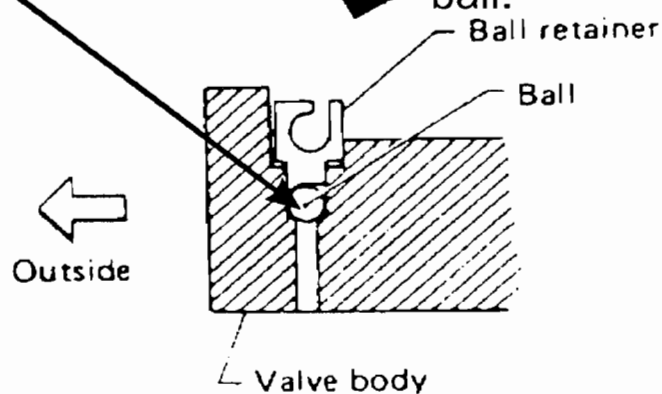
Figure 1

Slipping or no forward movement may occur if the small .187" check ball and retainer is left out of the valve body. See figure 1 for its location. Also, the bathtub ball near the bottom of the valve body is not used on some models. A 1-2 neutral or a 1-2 bind may occur depending on the mismatch. To determine if your valve body takes this ball or not, place the spacer over the bathtub. The plate will have two holes over the tub if it takes the ball, and only one if it doesn't take the ball.

This ball is .187" in size:  
If this ball is left out, a  
slipping or no forward  
movement will occur.

Some models do not take  
this ball. Your spacer plate  
will have two holes above  
the bathtub if it takes the  
ball.

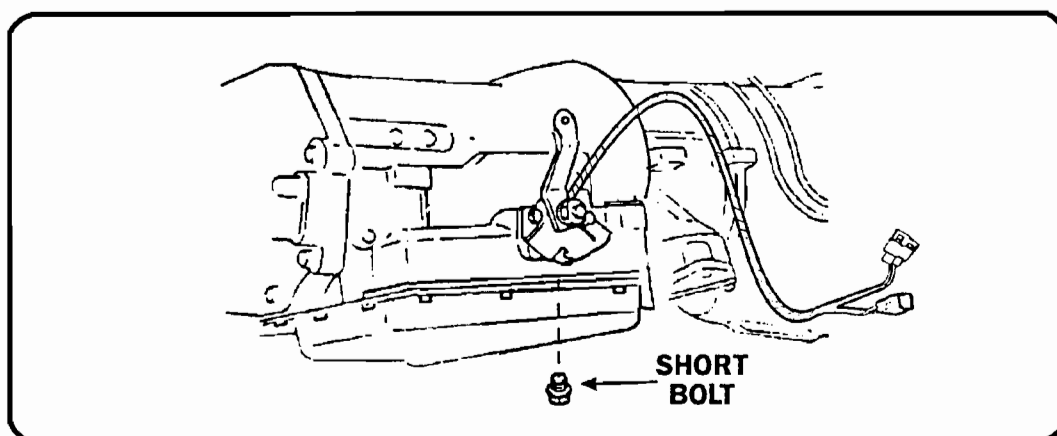
Figure 1.

Use caution when installing pan bolts into the N4AEL case. There is one short pan bolt which **MUST** go under the inhibitor(neutral) switch. **See Figure 1.** If a long bolt is put under the switch it will bind on the switch and cause it to malfunction. The result may be the loss one or more shifts.

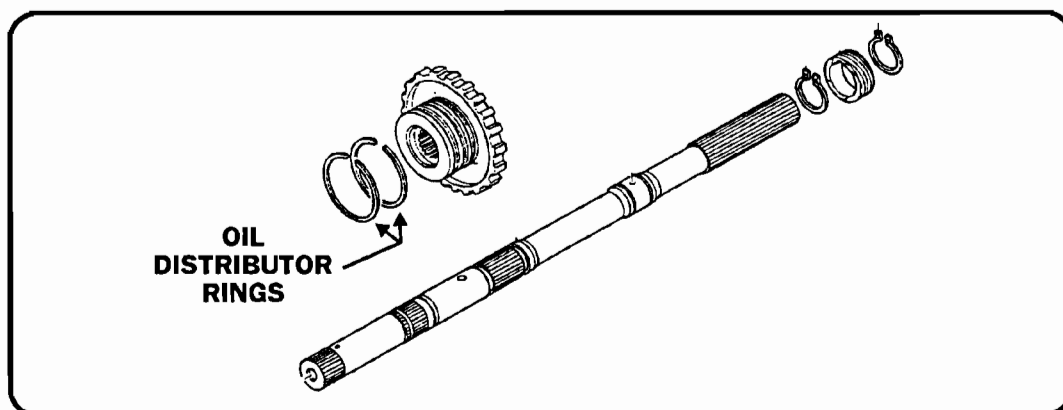
Figure 2.

The N4AEL oil distributor uses only two oil rings. **See Figure 2.** There is no ring in the front groove as there is no governor in this unit. The rings seal lubrication oil for the gear sets. Since it is drive oil which is sent to the rings, the better the rings, the less the loss of drive oil. It has been found that A4LD rubber governor rings can be used here and will provide a better seal. There will be less chance of forward clutch failure due to not enough drive oil.

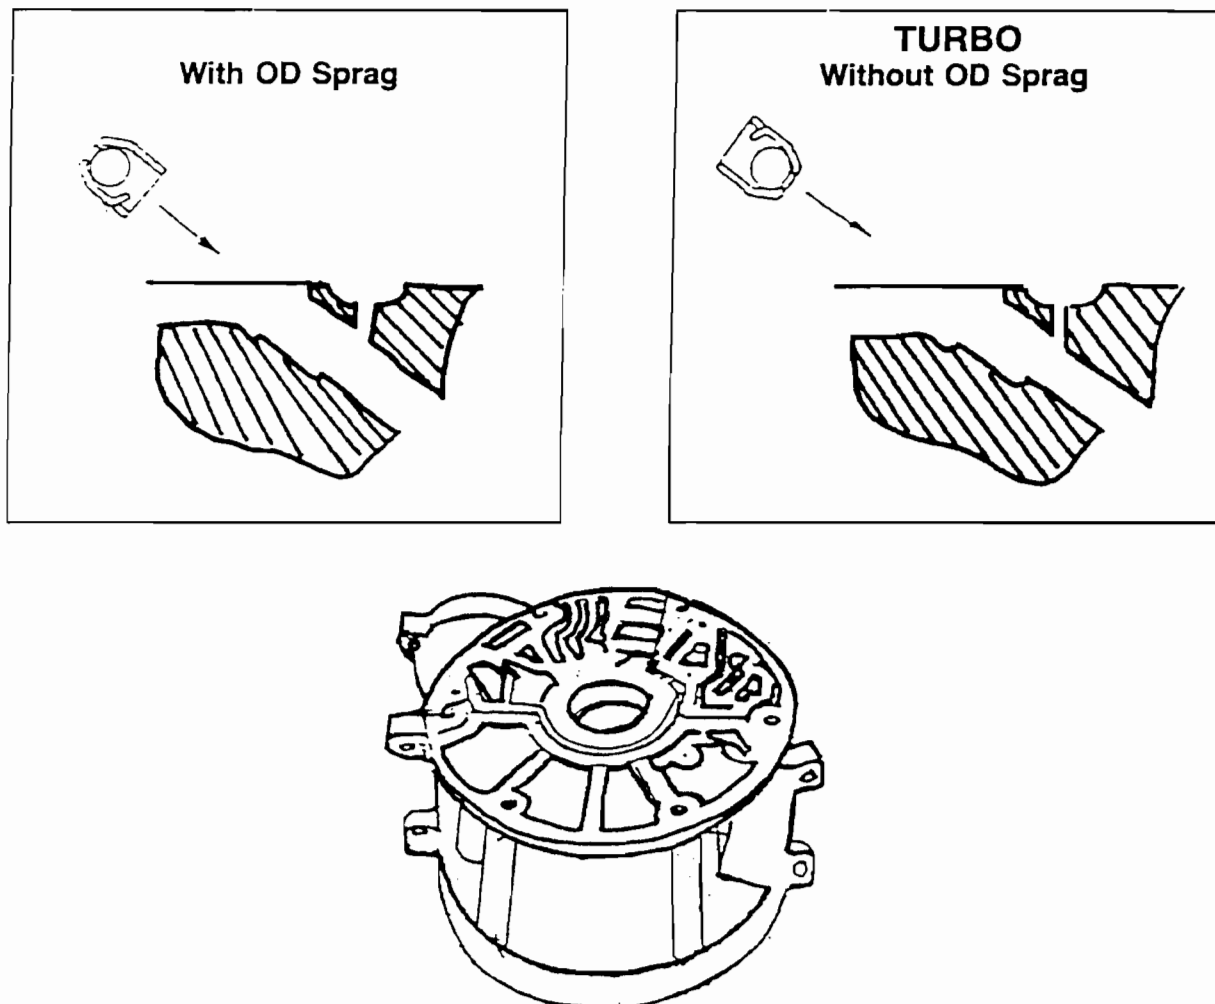
Figure 1

THE ORIFICE IN THE OVERDRIVE SECTION GOES IN BALL AND SEAT FIRST IN THE TURBO VERSION, AND OPEN CAPSULE FIRST IN THE REGULAR VERSION. THE TURBO VERSION DOES NOT HAVE A SPRAG IN THE OVERDRIVE SECTION ( SEE FIGURE 1 ),

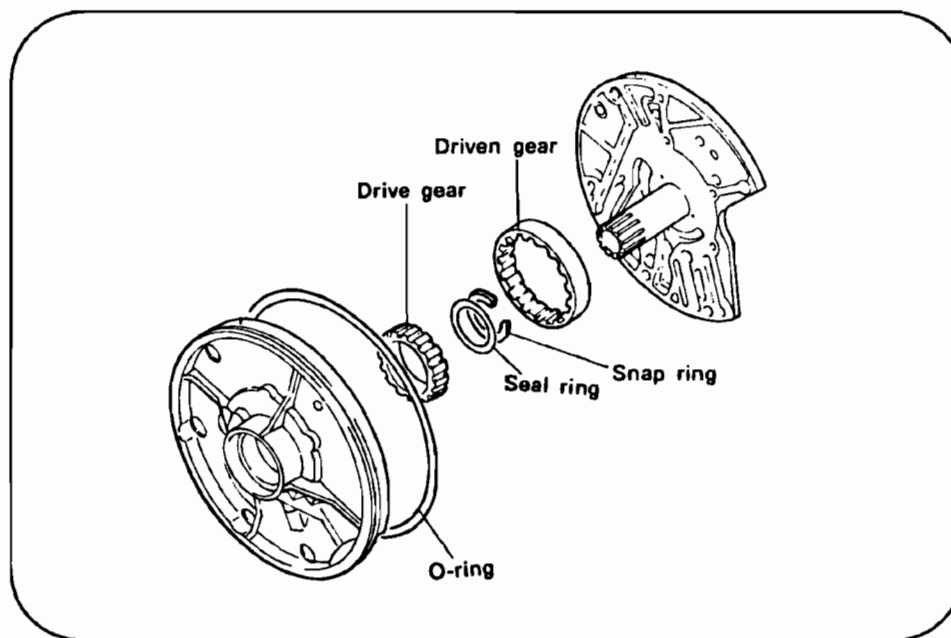
**Change:** Some KM 175 transaxle had a change made to the drive gear. The previous drive gear has a groove machined on the inside diameter to accommodate an O-ring which sealed against the converter neck. The drive gear now has an oil seal which is retained by a snap-ring. Figure 1 below shows the correct assembly procedure with the snap-ring facing the pump cover. The part number for the oil seal is: MD729928

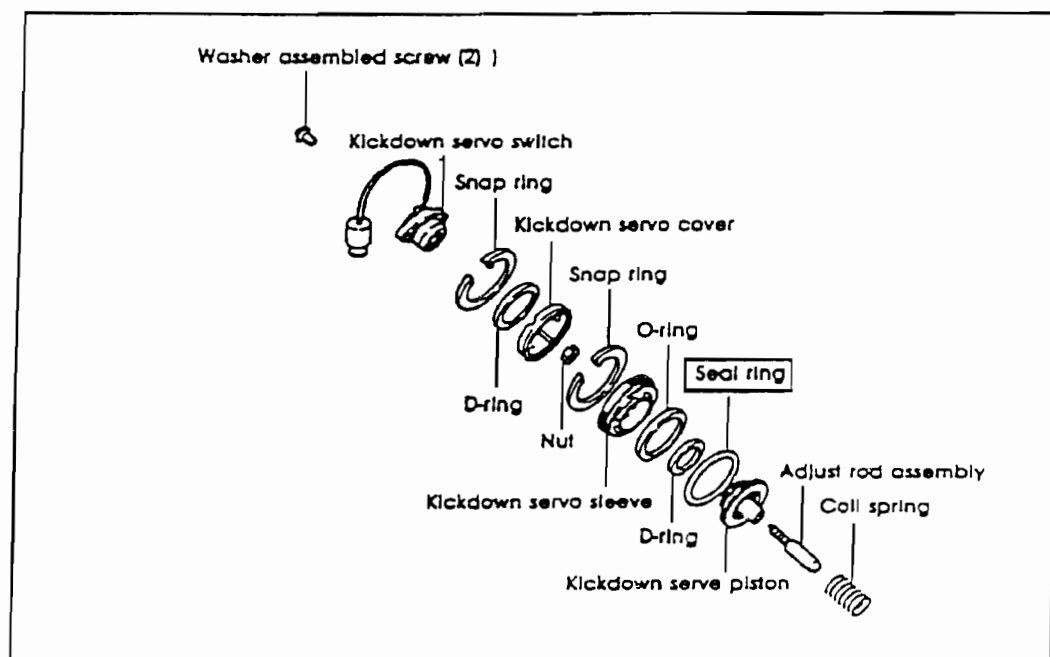
Figure 3

These symptoms may be due to the kickdown servo piston not releasing properly. This is caused by hydraulic fluid leaking past the seal ring of the servo piston as a result of wear in the piston bore (Figure 1). Because wear of the piston bore varies between vehicles, the severity of the symptoms will also vary.

If hard shift symptoms are exhibited, remove the servo piston assembly from the transaxle and check the piston bore (transaxle case) for wear (Figure 2). If the bore wear is less than 0.023 in. (0.5 mm), the hard shift symptoms can be improved by installing a D-ring repair kit (P/N MD728665). This kit contains a rubber piston seal ring instead of the carbon material seal ring installed at the factory (Figure 3).

If the piston bore wear is greater than 0.023 in. (0.5 mm), the transaxle case must be replaced using a new carbon material servo piston seal ring (P/N MD727999).

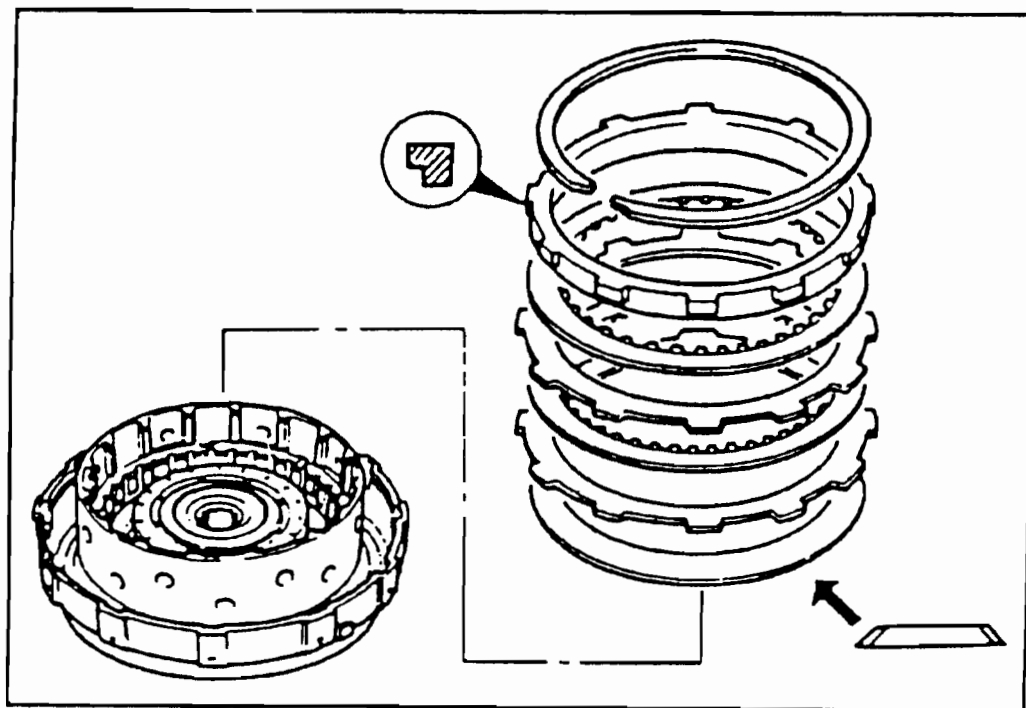
## REVERSE CLUTCH

CAUSE: Dished Plates installed incorrectly.

CORECTION: Install dished plates as shown below.

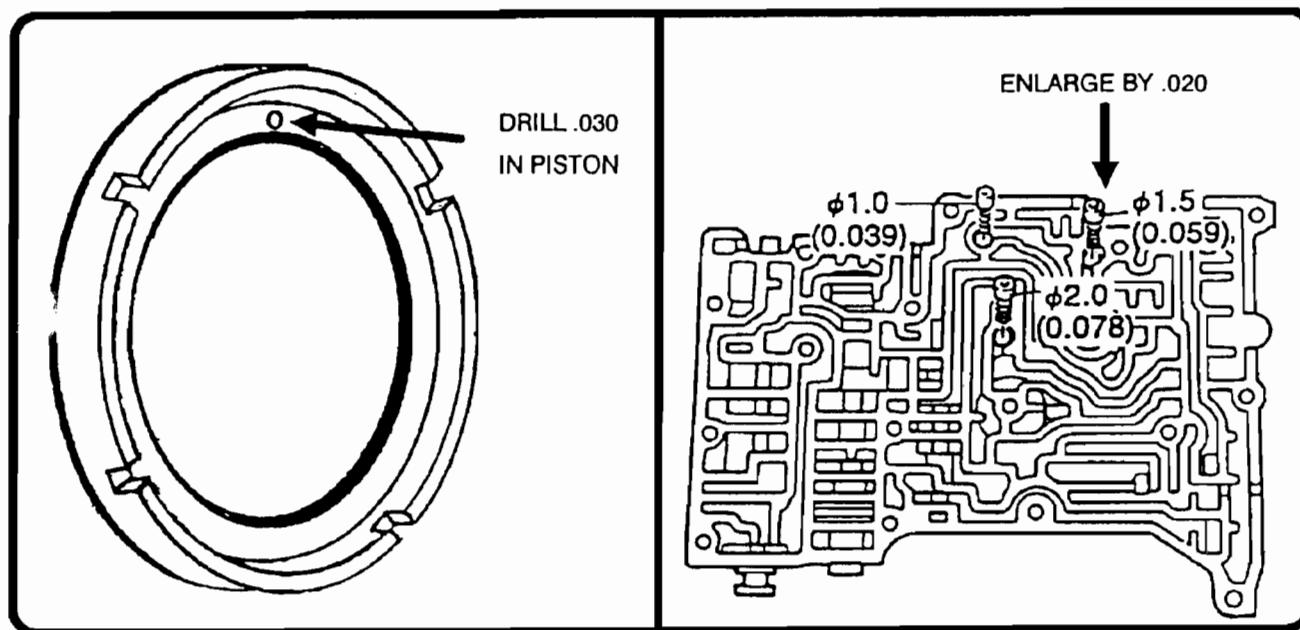
**MAZDA G4A-EL / FORD PROBE***REVERSE CLUTCH FAILURE*

**COMPLAINT:** *Repeated reverse clutch failure.*

**CAUSE:** *Cross leak causing the reverse clutch to drag while in forward gears.*

**CORRECTION:** *Drill a .030 hole through the reverse piston (figure 1), also enlarge the reverse feed orifice by .020 (figure 2). Example: measure existing orifice size, if it is .059 then enlarge to .079.*

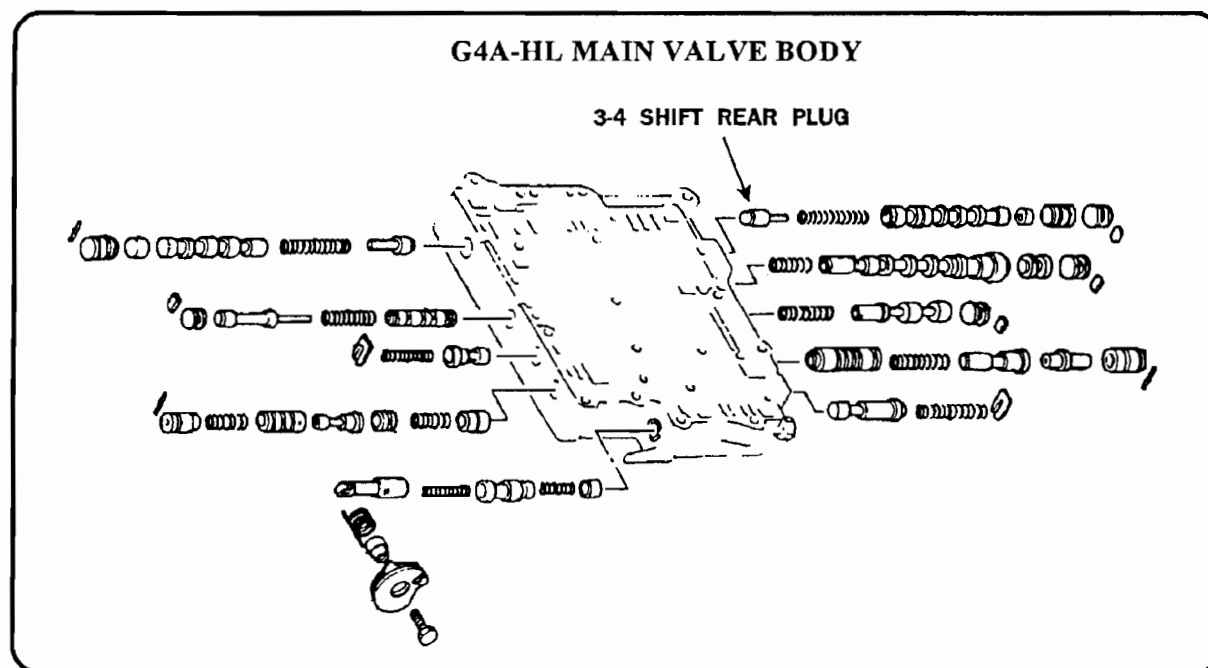
Figure 1.

**CAUSE:** The cause may be that the 3-4 shift rear plug in the main valve body (SEE FIGURE 1) travels to far and jams. This prevents the 3-4 shift valve from stroking.

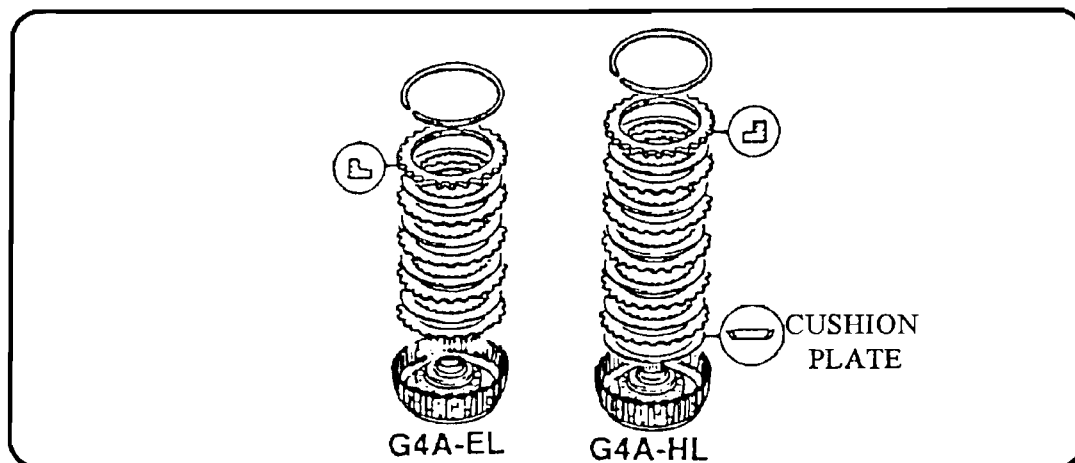
**The 3-4 Clutch Drum** In the G4A-EL (Mazda 626 and Probe vehicles) uses 5 lined clutch plates, 5 steel plates, and no cushion plate against the piston. The G4A-HL (Mazda 323 vehicles) use 4 lined clutch plates, 4 steel plates, and 1 dished cushion plate against the piston. See Figure 1.

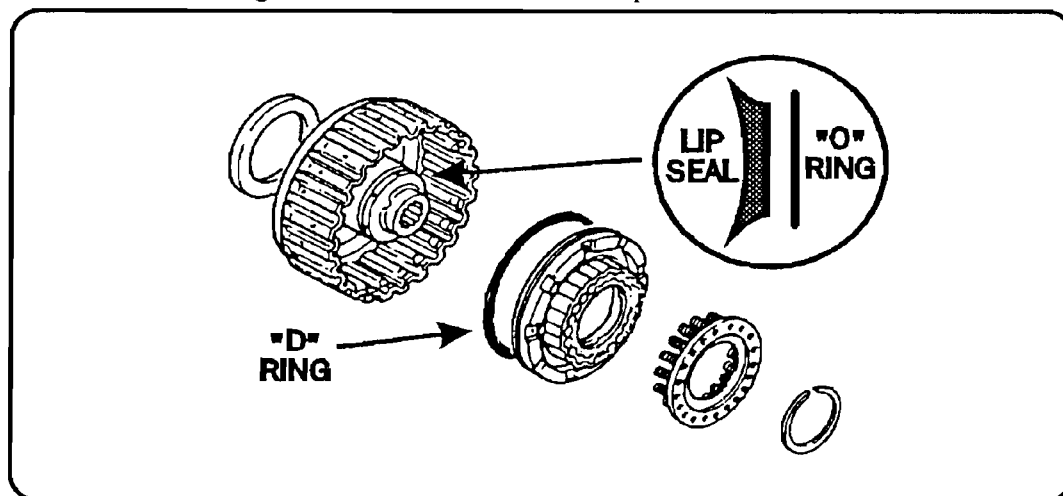
**The G4A-EL 3-4 clutch drum** uses a lip seal in the drum to seal the inner portion of 3-4 piston. The G4A-HL uses an "O" Ring to seal the inner portion of the 3-4 piston. See Figure 2. Aftermarket gasket sets may include only the "O" Ring style inner piston seal for the 3-4 clutch drum, and specify its use for both applications. Care must be taken to install the proper inner seal. A mix up of the inner seal will cause leaks in the 3-4 clutch drum..

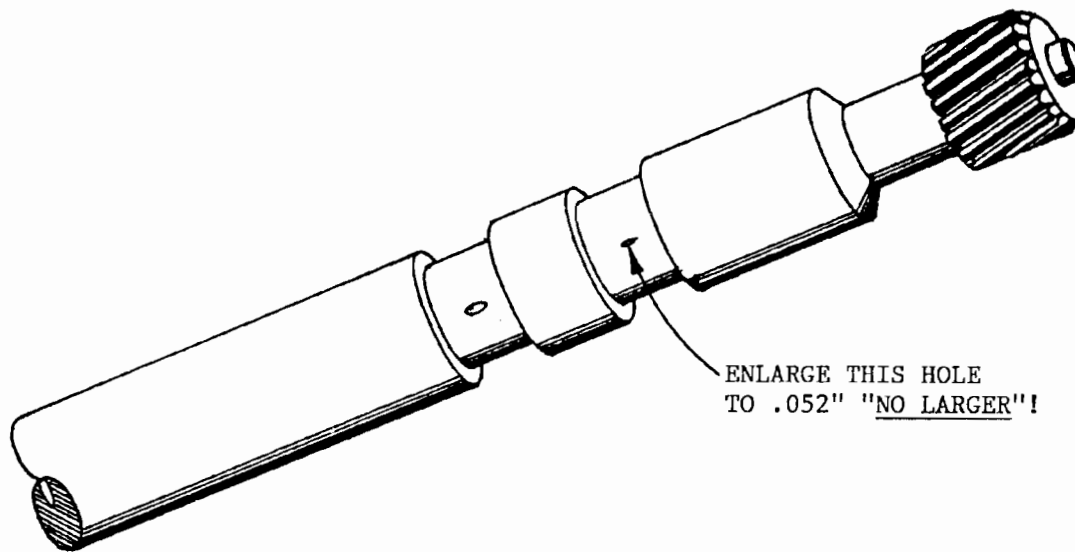
Figure 1

**CAUSE:** If all other possibilities have been eliminated, the cause may be not enough drive oil being fed to the governor. The volume of COLD oil that can get through the governor shaft orifice may not be sufficient to return governor pressure to the shift valves in the valve body.

**CORRECTION:** Enlarge the small governor shaft feed hole from the present size to .052", "NO LARGER". The governor feed hole is the one that is closest to the governor gear, as shown in Figure 1. The difference in size is very minimal and not much material will be removed from the governor shaft. Be certain to clean all material from governor and the governor shaft after this procedure.

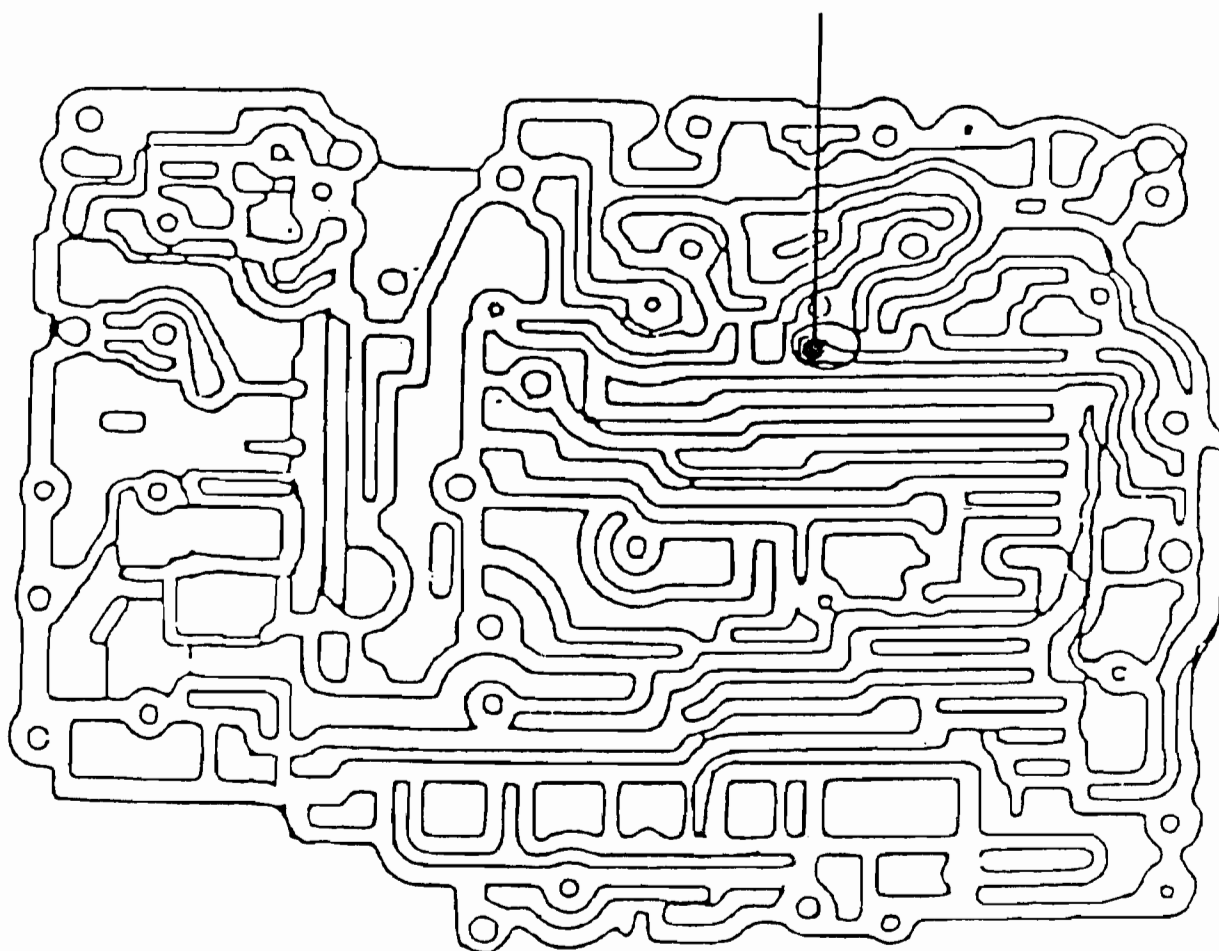
**B 2** CHECK BALL, ( $\phi 5.5$  mm/0.217 in.)

**CAUSE:** MISSING VITON CHECK BALL

**CORRECTION:** INSTALL CHECK BALL IN CORRECT LOCATION

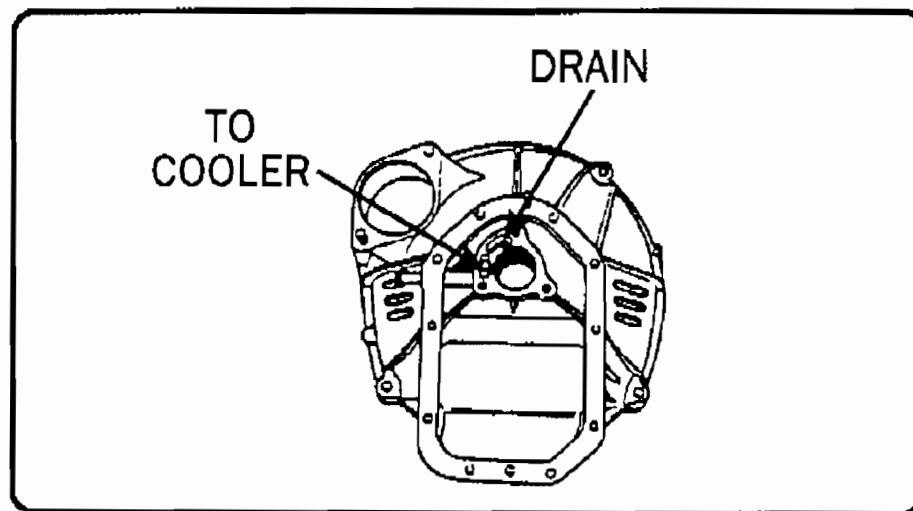
Figure 1.

**CAUSE:** The converter bushing may be pushed back in the converter housing preventing the oil coming out of the converter from getting past the stator shaft and out to the cooler. When the bushing is replaced, it can easily be pushed in so far that it can block the "converter out" passage. See figure 1. Also the stator support gasket may block fluid to the "converter out" passage due to mis-assembly or use of excessive sealant.

**CORRECTION:** 1. Check converter hub to bushing clearance. It should be no more than .0045 in. If it is more, then the bushing must be replaced.

2. When replacing the converter bushing, check that you leave sufficient clearance between the bushing and the rear of the stator support.

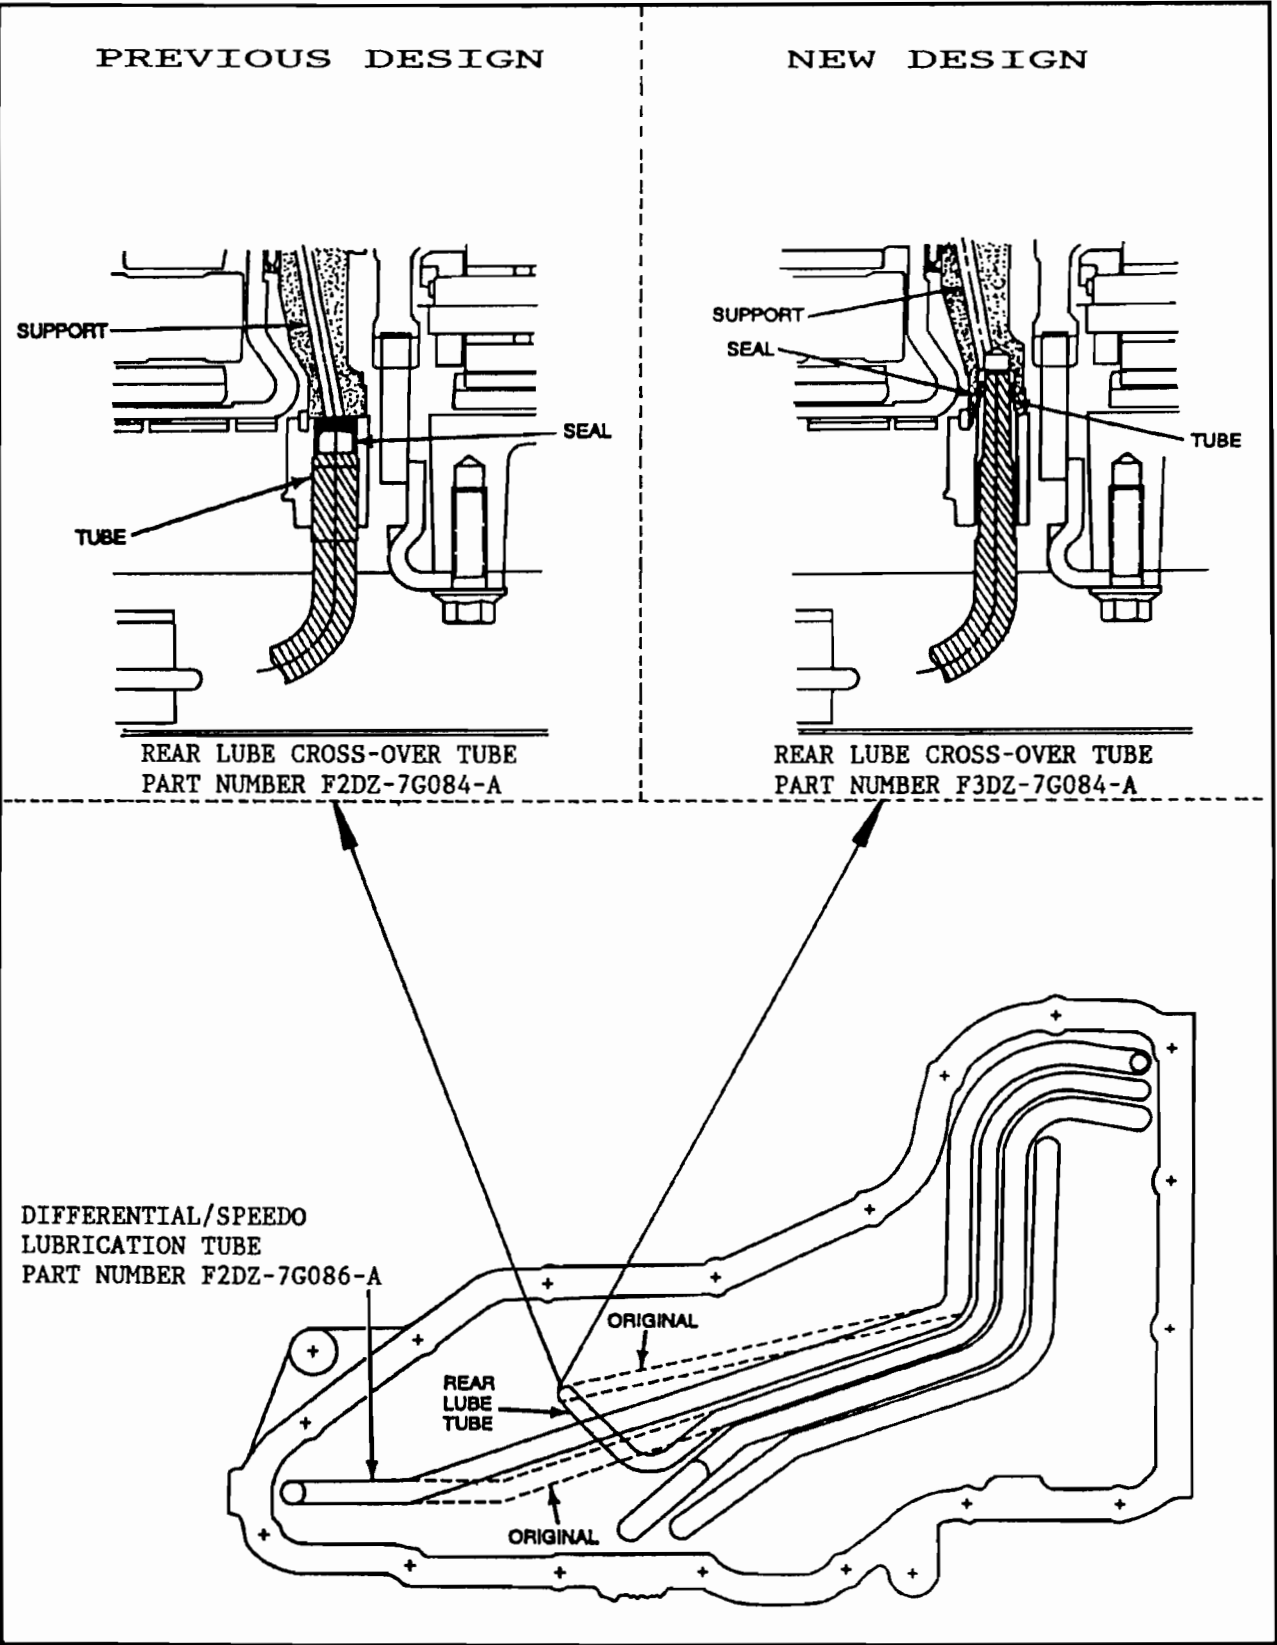
Figure 1

If the seal is damaged, a delay to drive will be the result, as this is in the drive oil circuit.

**NOTE:** The new design lube tube should be installed INTO THE NEW REAR LUBE SEAL FIRST, and then press the other end into the case, to prevent seal damage.

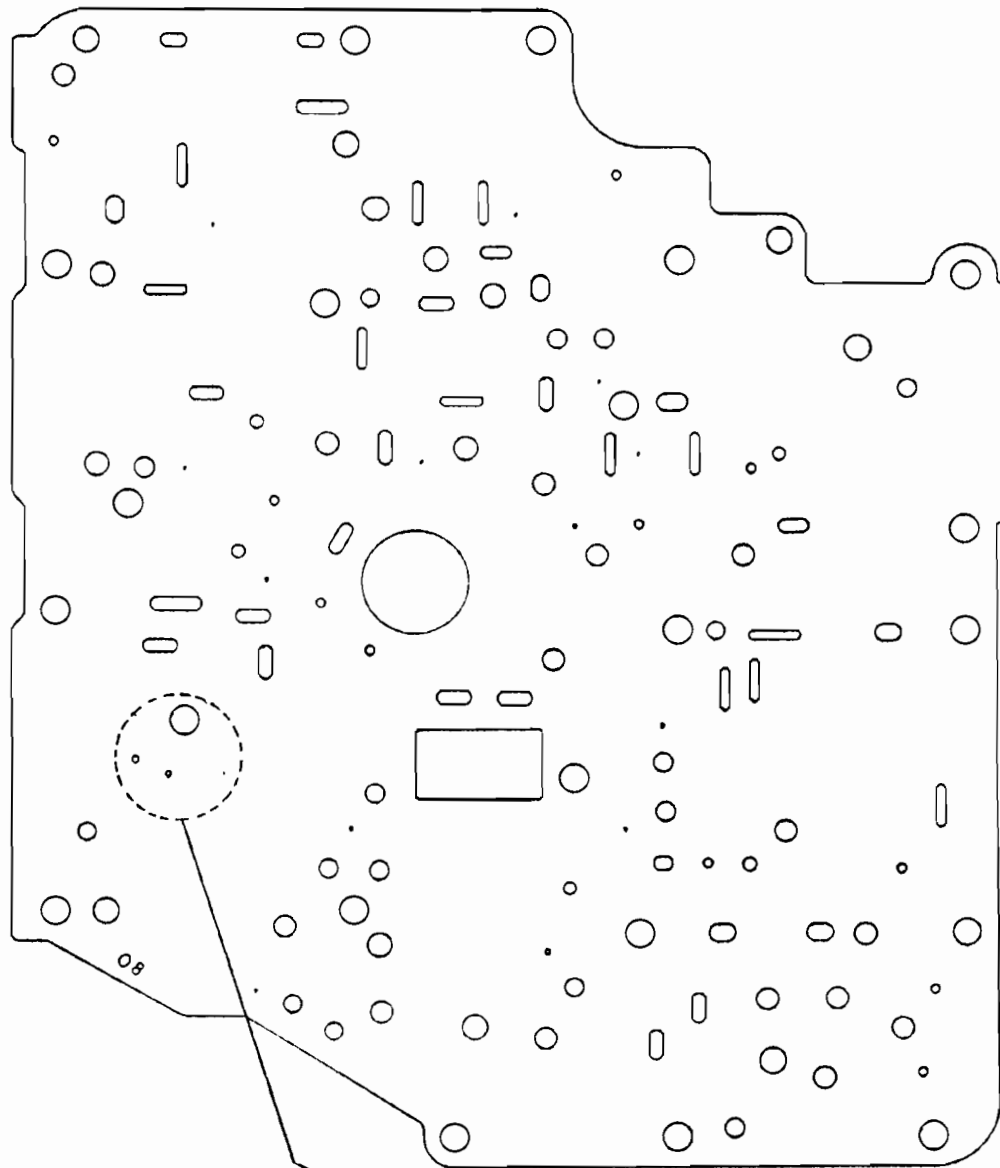
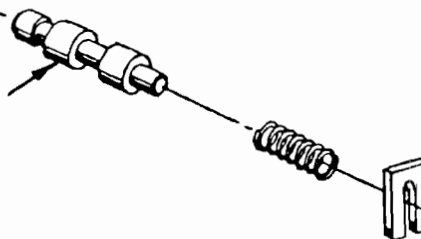
Figure 5

"LATE" 1991 ONLY: Uses the style backout valve in the valve body that is shown in Figure 5, and the spacer plate difference is shown inside the dotted circle. Compare to Figure 4.

THE VALVE BODY SPACER PLATES MUST BE COMPATABLE WITH THE TYPE OF BACKOUT VALVE YOU ARE USING, AS SHOWN IN FIGURES 4 AND 5.

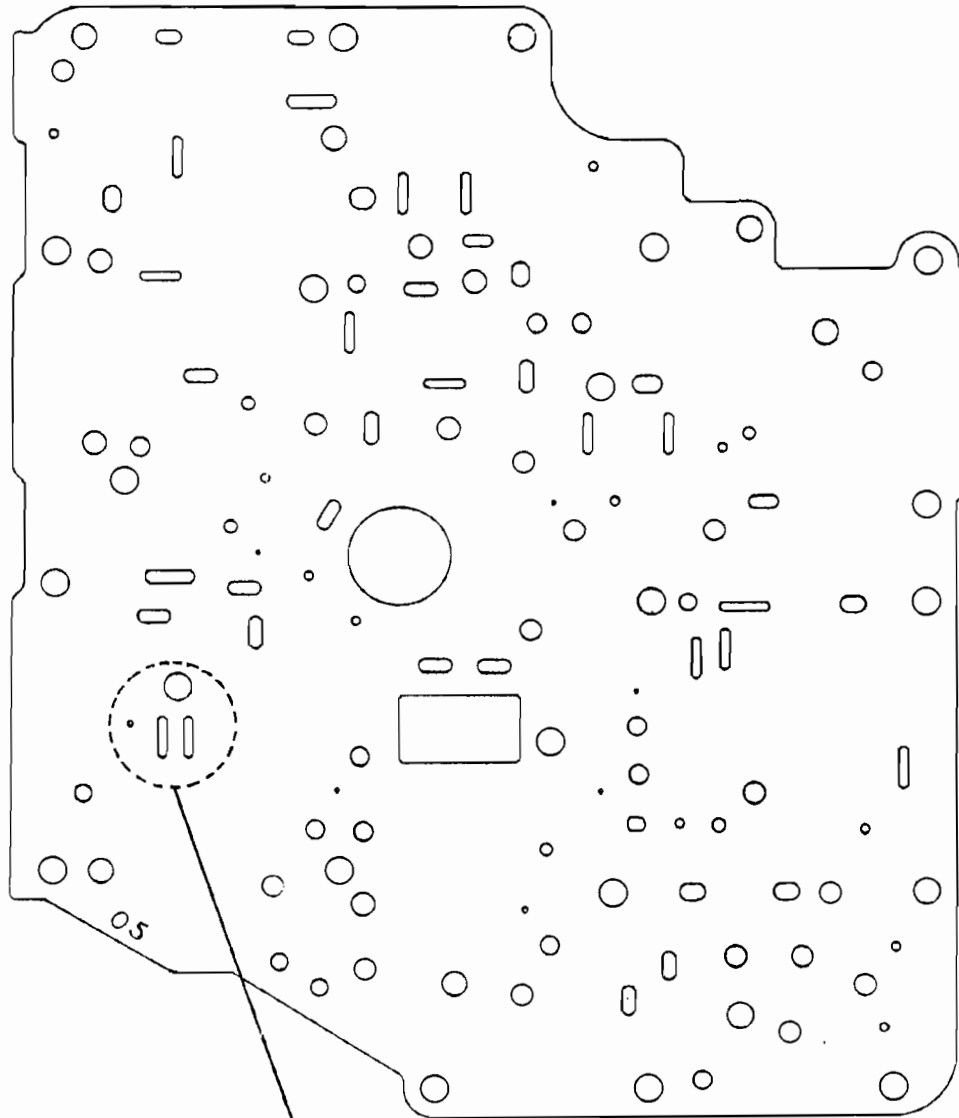
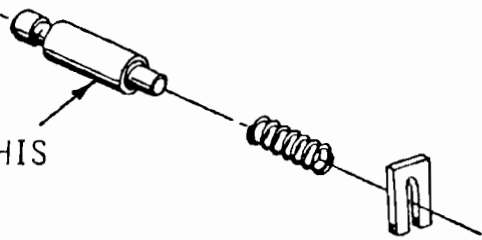
Figure 4

"EARLY" 1991 ONLY: Uses the style backout valve in the valve body that is shown in Figure 4, and the spacer plate difference is shown inside the dotted circle. Compare to Figure 5.

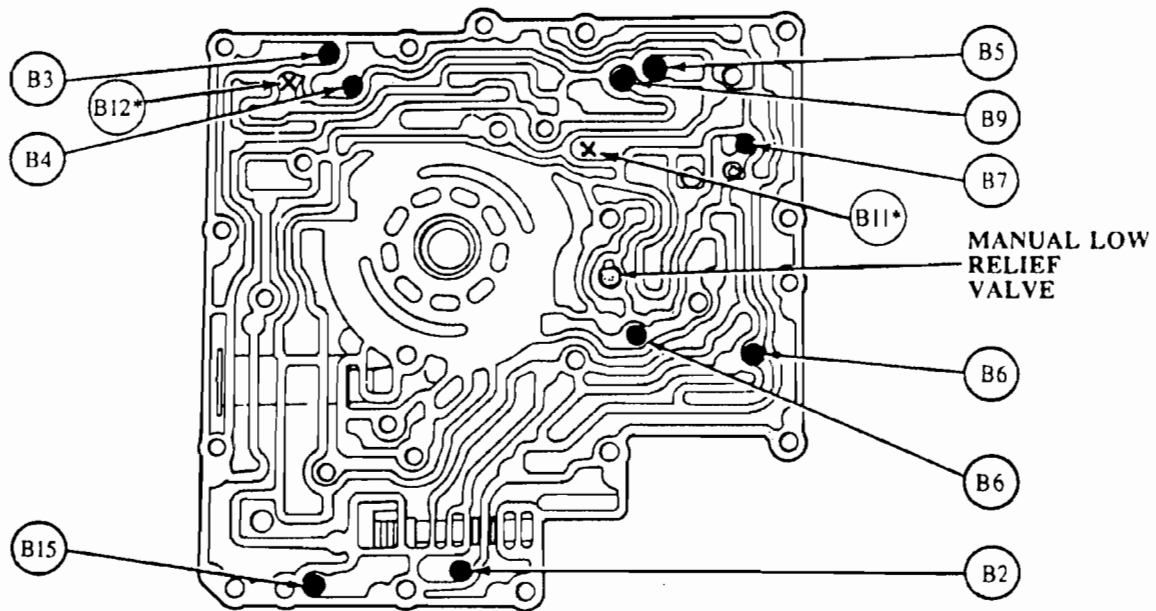
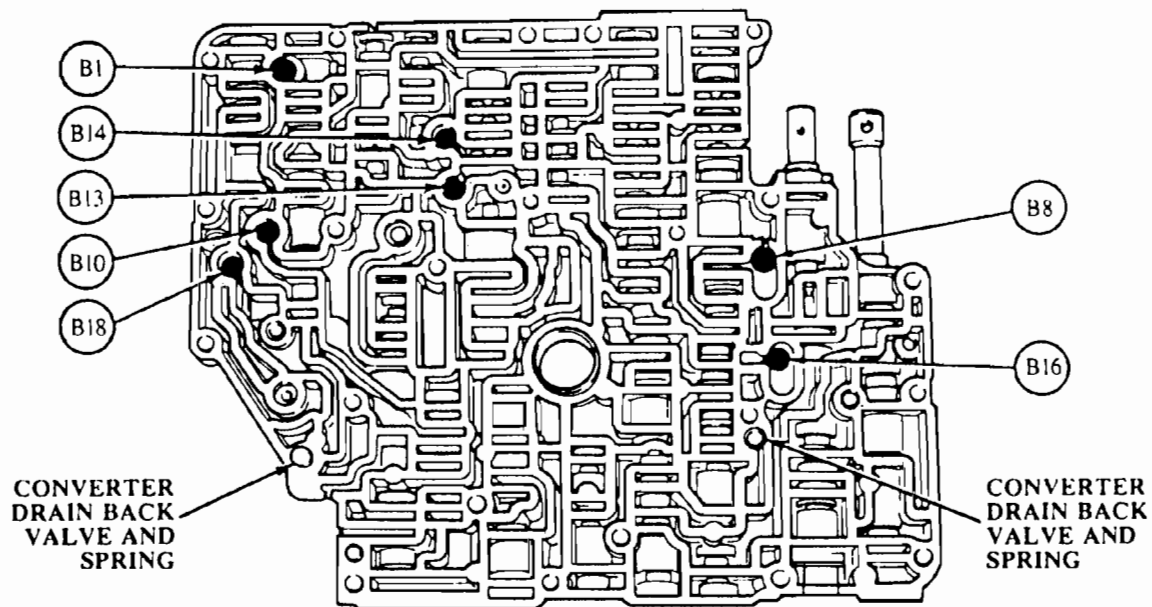
If debris is found in valve body, be sure to inspect all checkballs. They have a habit of deteriorating, and spreading through the valve trains. New checkballs are now available under OEM part number E7DZ-7E195-A, and come five in a package. See Figure 2 for proper checkball locations, as some of the manuals are wrong. See Figure 3 for checkball function.

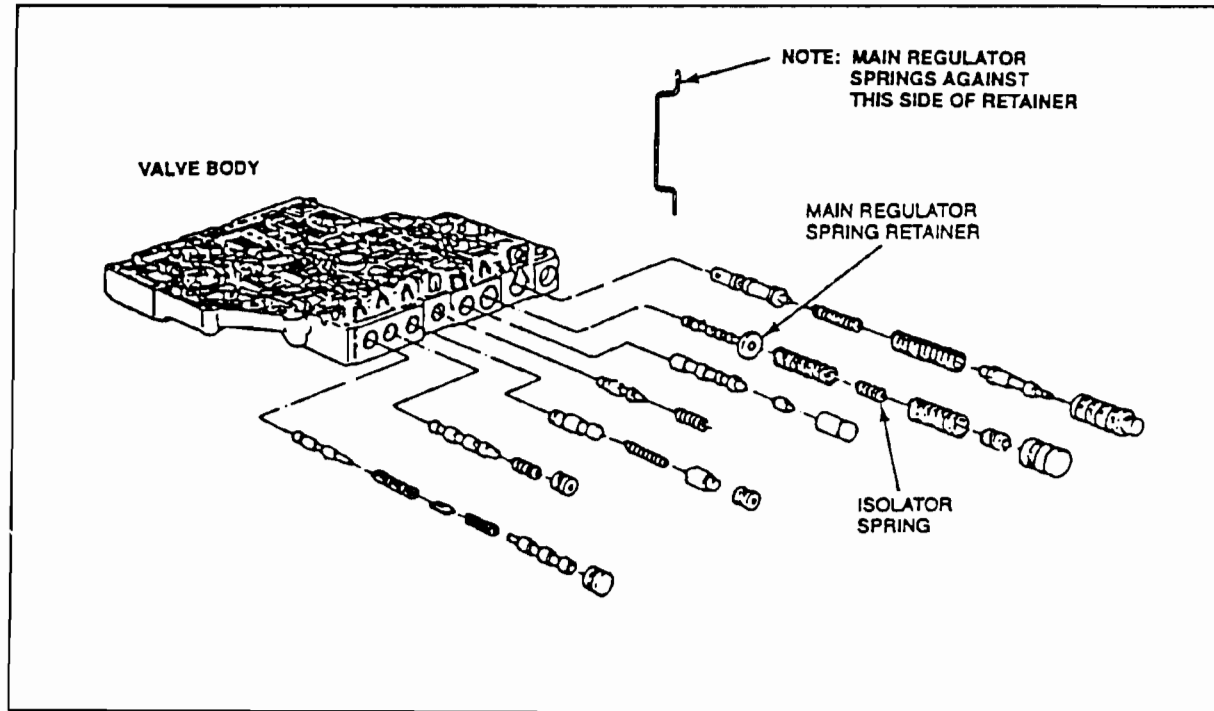
CAUSE: NO. 1. A "Shudder" during a 1-2 upshift will occur if the main pressure regulator "Isolator" spring is not installed after cleaning the valve body (See Figure 1). This is caused by fluctuations in main line pressure at the time of the 1-2 shift.

NO. 2. Harsh and/or delayed upshifts can be caused by the pressure regulator spring retainer being installed backwards. This will create high main line pressure (See Figure 1).

1. Main Pressure Regulator Spring (Largest Diameter).
2. Main Regulator Boost Spring (Medium Diameter).
3. Main Regulator Isolator Spring (Smallest Diameter).

NO. 2. Insure that the main regulator spring retainer is installed in the proper direction (See Figure 1). The retainer is very similar to the one used in the AOD valve body, but is installed in the opposite direction of the AOD.
