# THE SEMINAR WITH MORE IN '94

AUTOMATIC TRANSMISSION SERVICE GROUP  
9200 S. DADELAND BLVD. STE 720  
MIAMI, FLORIDA 33156  
(305) 670-4161

## **INTRODUCTION**

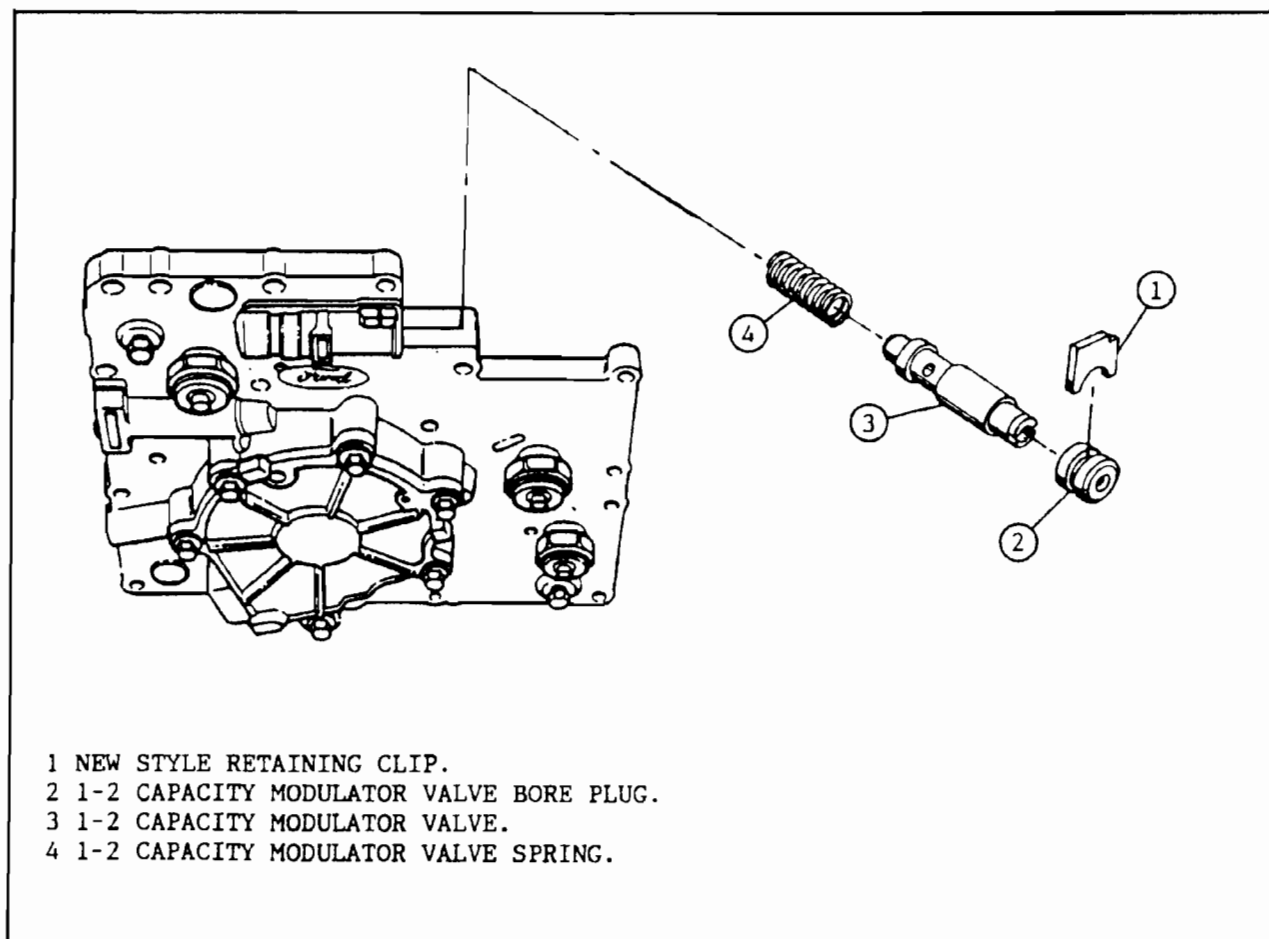
Figure 1

**COMPLAINT:** Soft or mushy 1-2 shift and/or 2-3 shift.

**CAUSE:** The cause may be a lack of oil volume to the intermediate and/or direct clutch packs.

**CORRECTION:** FOR SOFT 1-2 SHIFT:  
Replace the 1-2 capacity modulator valve spring with the Red spring manufactured by Shift Technology Products (Part # K006). The kit also comes with a new style bore plug retaining clip. Assemble into the oil pump as shown in Figure 1.

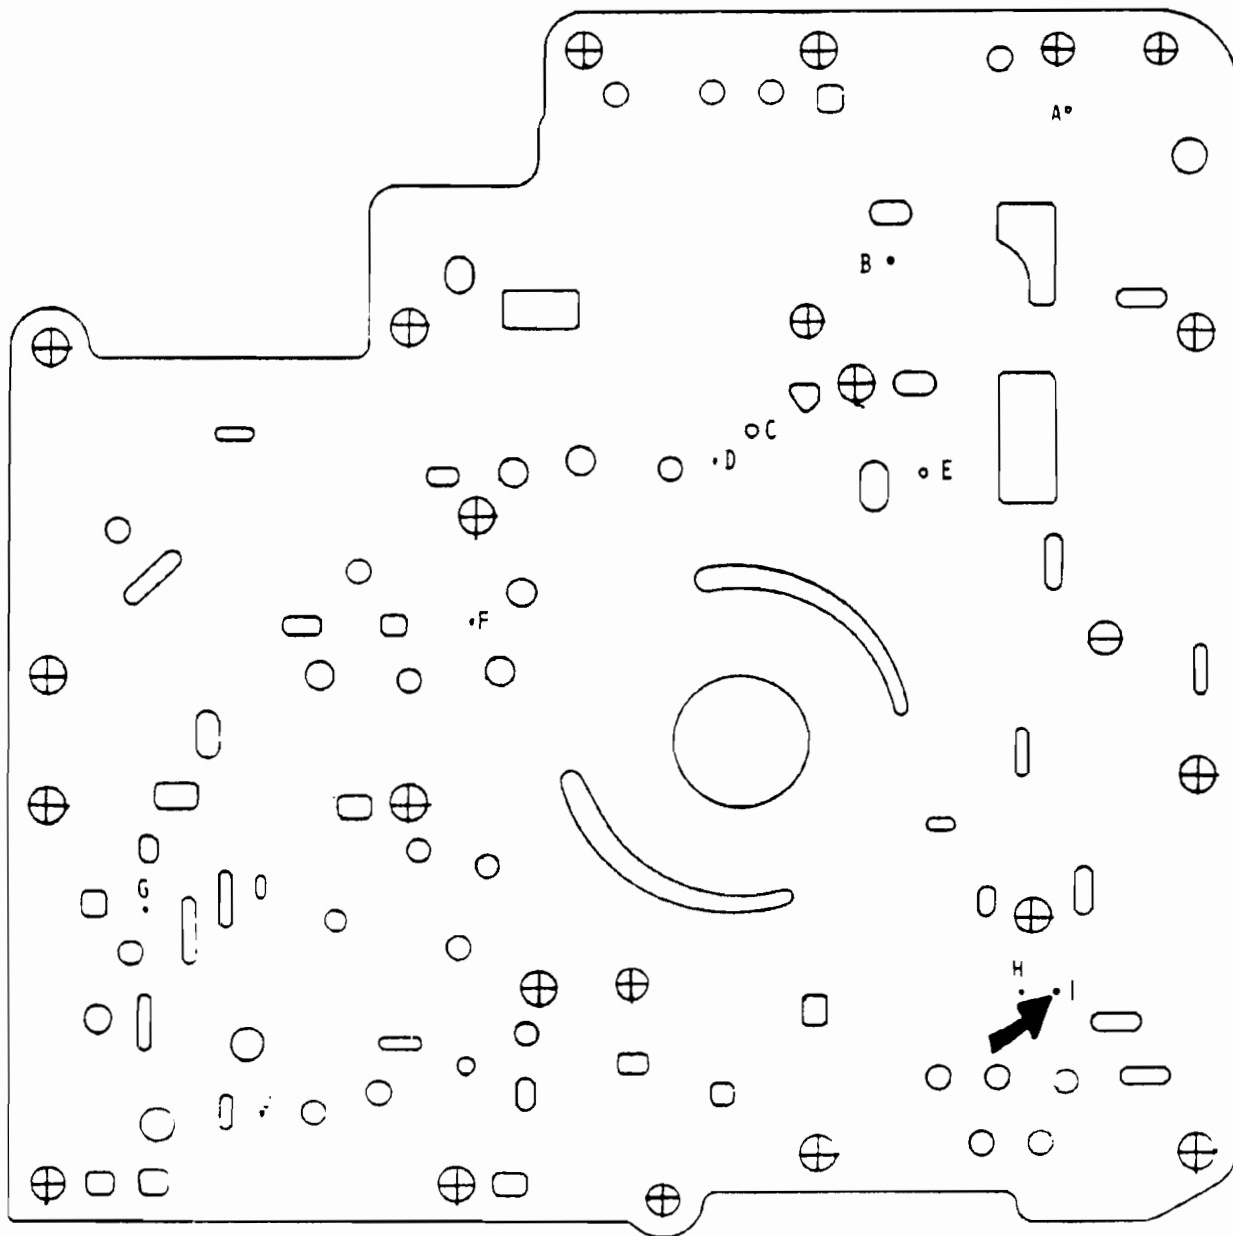
Figure 2

ENLARGE HOLE INDICATED BY ARROW TO .093" FOR FIRMER 2-3 SHIFT.

FOR SOFT 2-3 SHIFT:  
Drill the direct clutch feed passage in the oil pump spacer plate, hole marked "I", out to .093" as shown in Figure 2.

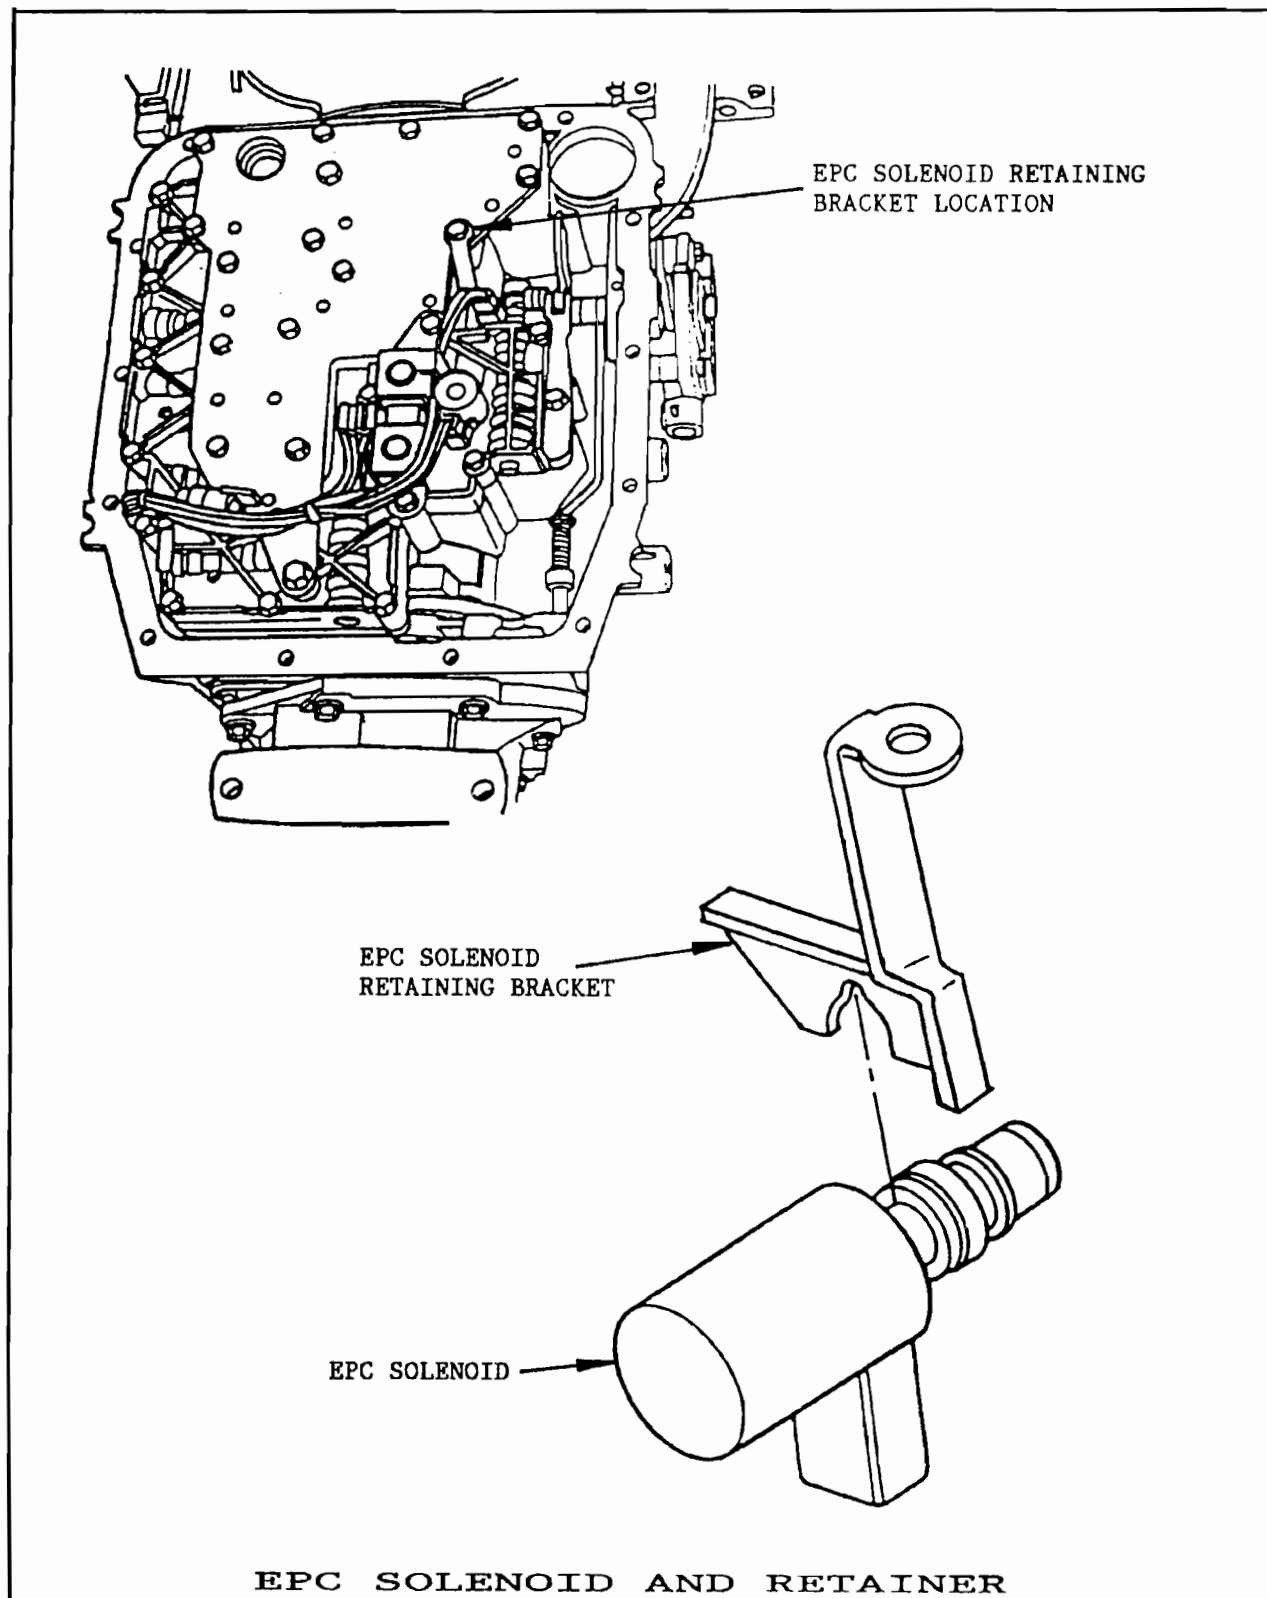
Figure 1

COMPLAINT: Line pressure instability created by lack of EPC Solenoid function and can create a variety of different concerns including soft shifts, soft engagements and repeated transmission clutch and band failures.

CAUSE NO. 1: Solvent or other cleaning solutions, which are used to clean the transmission case are being used while the EPC Solenoid is still mounted in the case. Contamination from the case is being washed into the case and EPC Solenoid assembly.

CAUSE NO. 2: The EPC Solenoid Retaining Bracket not installed back in the proper position to retain the EPC Solenoid into the case.

CAUSE NO. 3: Moisture or water contamination that has gathered in the vehicle wiring harness connector at the case connector on the passenger side of the vehicle.

CAUSE NO. 4: Defective and/or contaminated EPC Solenoid.

Replace the EPC Solenoid with OEM part number F2VY-7G383-A, and insure retaining bracket is secured in proper position as shown in Figure 1. Manual shift linkage must be removed from case to replace the solenoid.

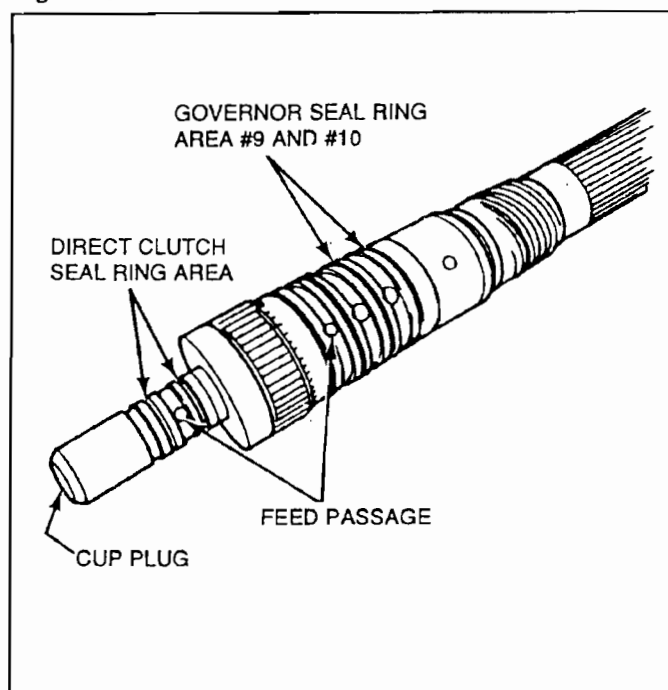
Figure 2

5. Inspect the output shaft feed passages and the cup plug for leakage.
  - a. Apply 5-10 psi (34-69 kPa) air to the output shaft feed passages, Figure 2.

5. Check the last two large seal rings on the output shaft (#9, #10), Figure 2.
  - a. The seal rings should move freely on the output shaft.
  - b. Check for metal or other contamination or burrs between the seal and the output shaft; replace the seals and/or output shaft as required.

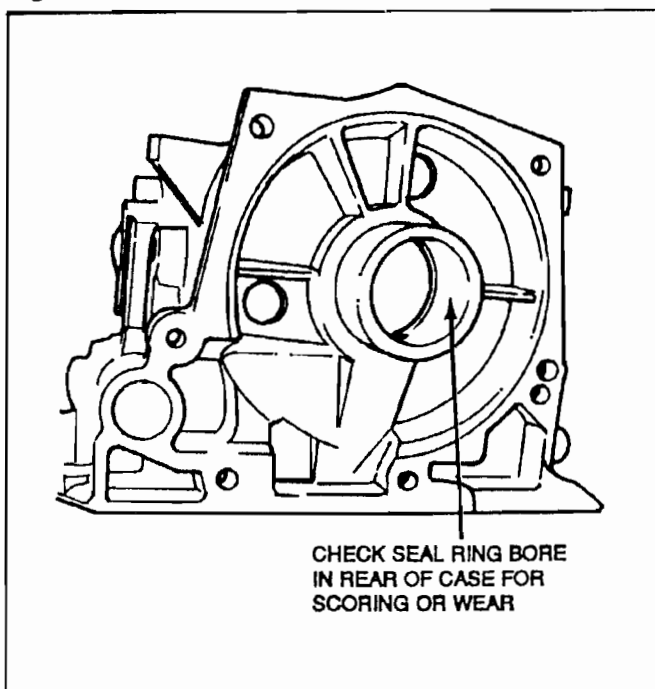
Figure 4

6. Check the seal ring bore at the rear of the case for scoring. Light scoring is permissible, but deep grooving indicates case wear. Replace the case if deep grooving is found, Figure 4.

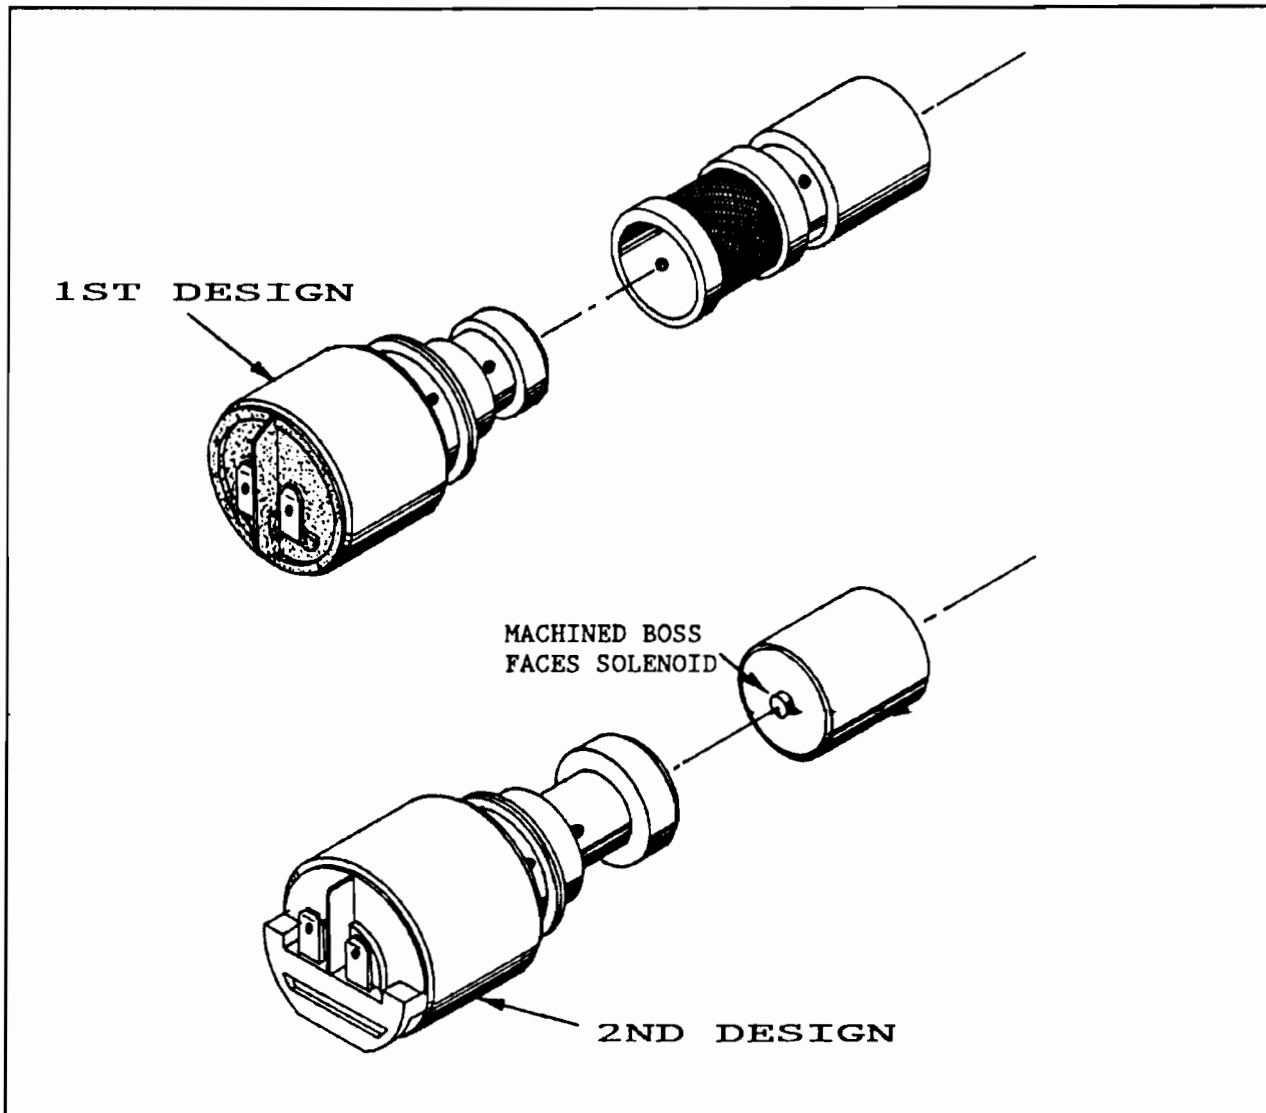
FIGURE 1

The 2nd design eliminates the screen, has dimensional changes on the solenoid itself, and includes a new plug with a boss machined on one end. The plug must be installed with the machined boss facing the solenoid as shown in Figure 1.

The 2nd design 3-4 shift solenoid WILL retro-fit back to all previous models, if it is required.

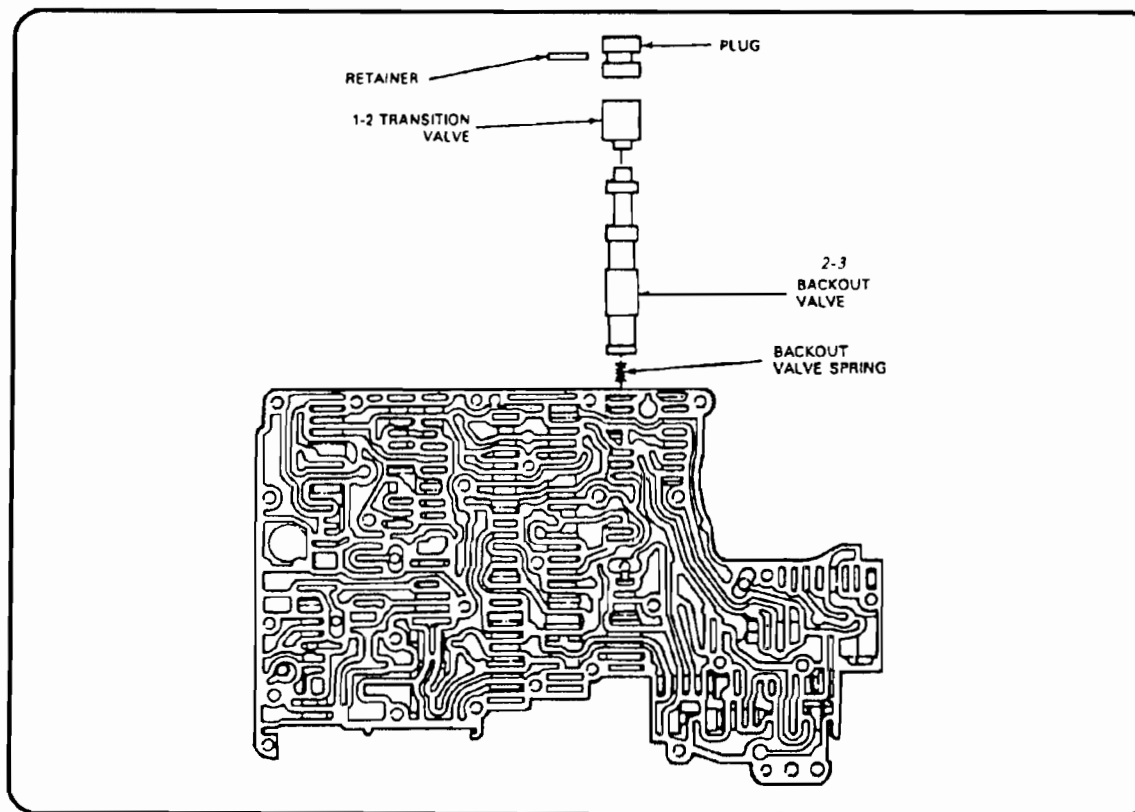
Figure 1.

**CAUSE:** This is caused by the incorrect calibration of the 2-3 backout valve spring in the valve body.

**CORRECTION:** A new 2-3 backout valve spring is available from Ford that has a revised calibration. It is light blue in color. The part # is **F3TZ-7D230-B**. See figure 1 for the proper bore identification and spring location.

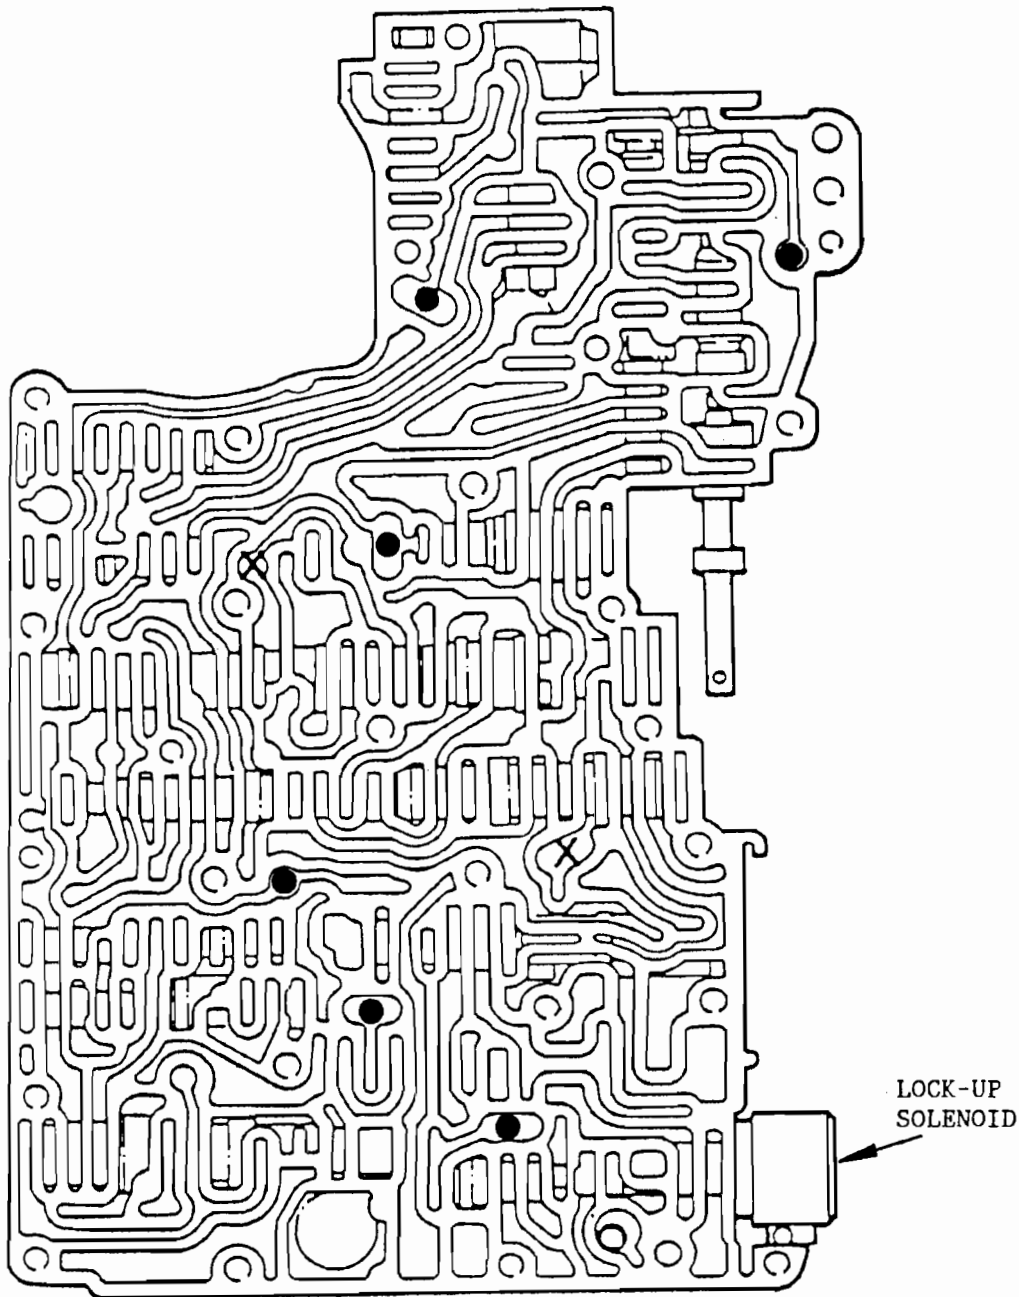
Figure 1

# A4LD VALVE BODY SINGLE SOLENOID CHECKBALL LOCATIONS

THESE VALVE BODIES REQUIRE SIX (6) CHECKBALLS PLACED IN THE LOCATIONS SHOWN BELOW. DO NOT INSTALL CHECKBALL IN LOCATION MARKED WITH AN "X".

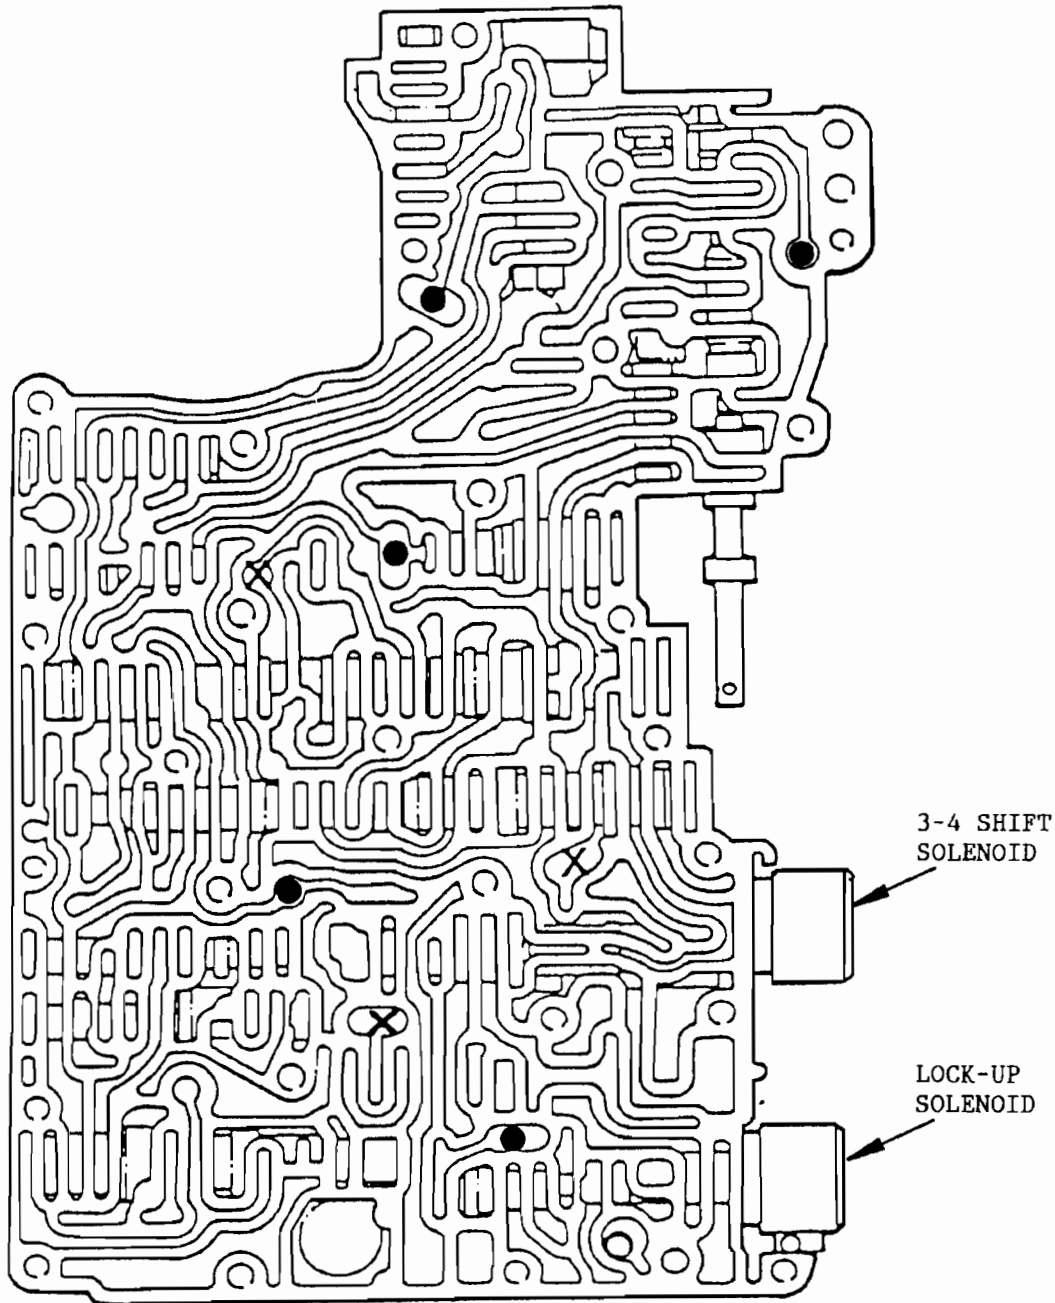
Figure 2

# A4LD VALVE BODY DOUBLE SOLENOID CHECKBALL LOCATIONS (WITHOUT REVERSE ENGAGEMENT VALVE)

THESE VALVE BODIES REQUIRE FIVE (5) CHECKBALLS PLACED IN THE LOCATIONS SHOWN BELOW. DO NOT INSTALL CHECKBALL IN LOCATIONS MARKED WITH AN "X".

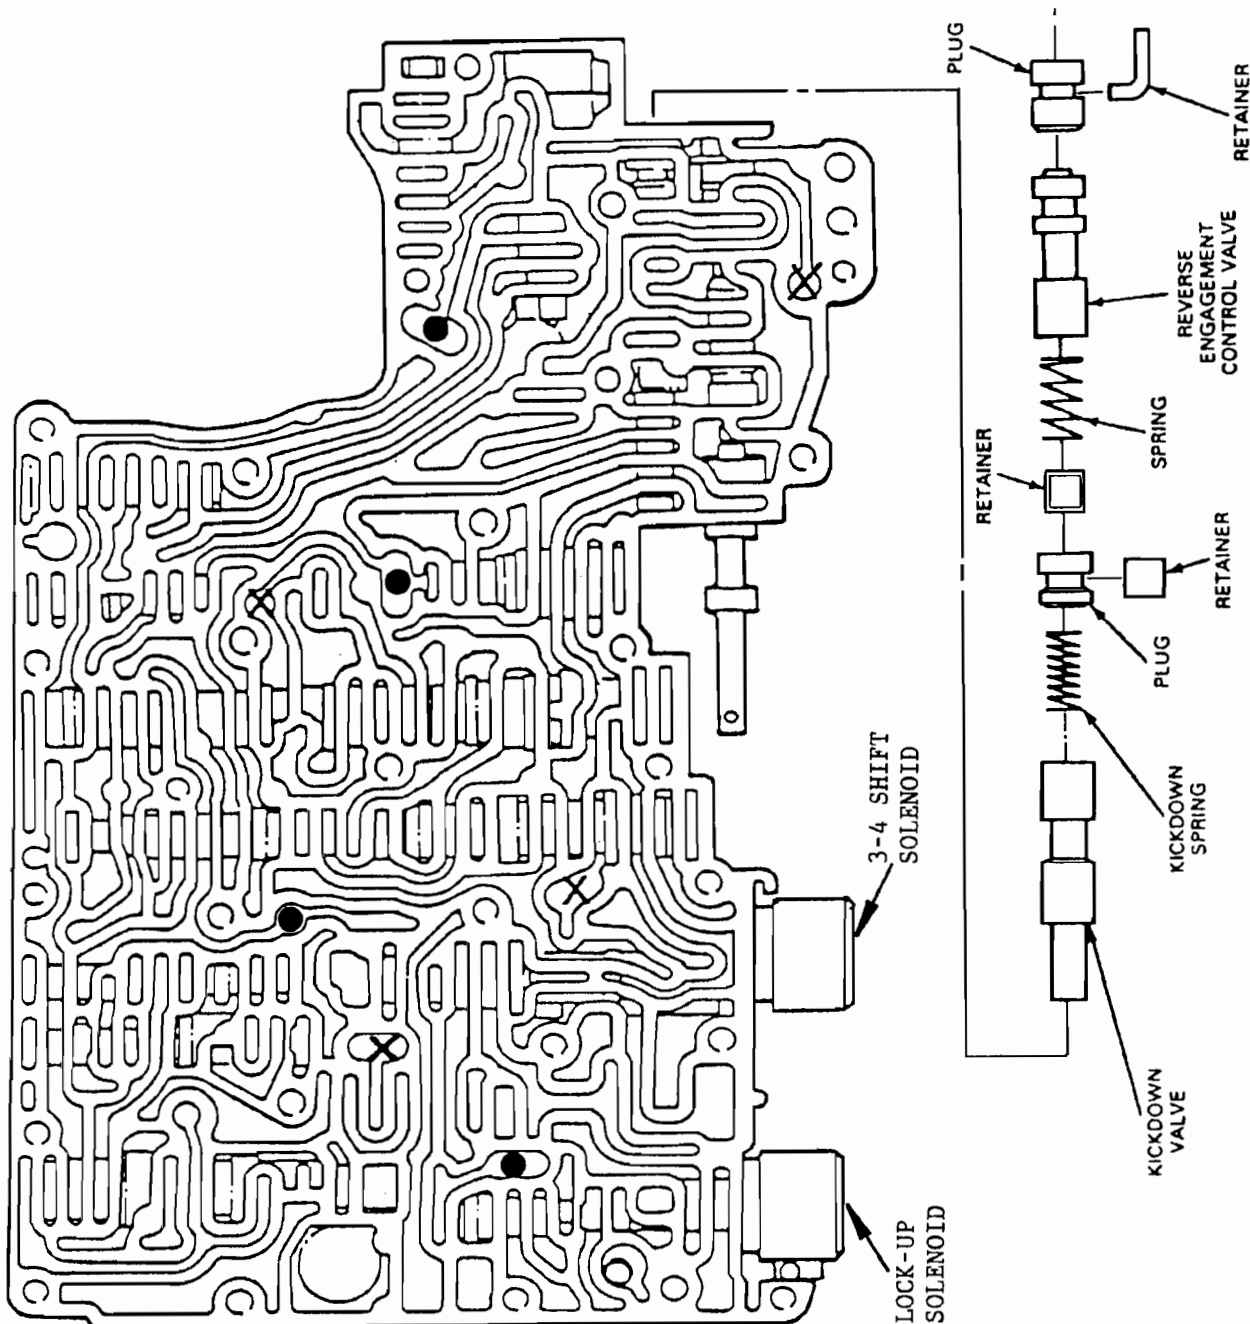
Figure 3

# A4LD VALVE BODY DOUBLE SOLENOID CHECKBALL LOCATIONS (WITH REVERSE ENGAGEMENT VALVE)

THESE VALVE BODIES REQUIRE FOUR (4) CHECKBALLS PLACED IN THE LOCATIONS SHOWN BELOW. DO NOT INSTALL CHECKBALL IN LOCATIONS MARKED WITH AN "X".

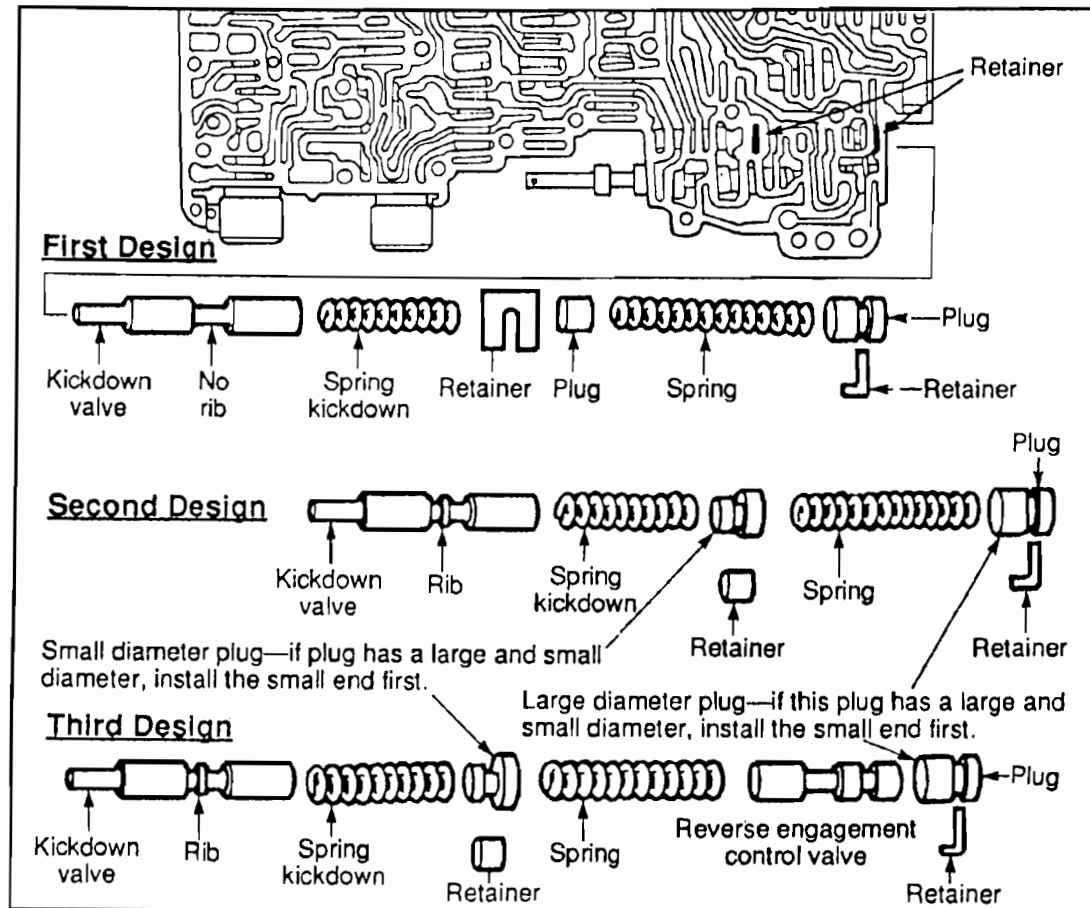
NOTE: Figure 4 shows all three design levels of the order in which the reverse engagement valve bore is loaded. The first two design levels do not use reverse engagement valve, but placement of retainers is critical.  
(SEE FIGURE 4).
