"2000" SEMINAR INFORMATION "FIXES TODAY FOR Y2K"

INDEX FORD & CHRYSLER

AUTOMATIC TRANSMISSION SERVICE GROUP

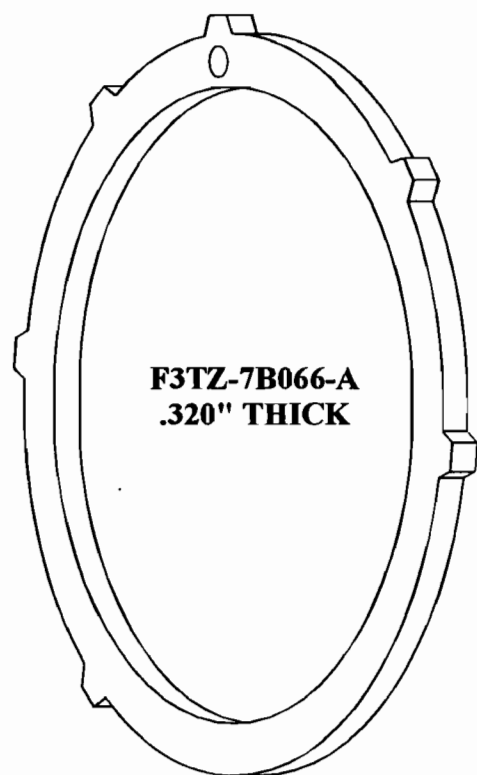
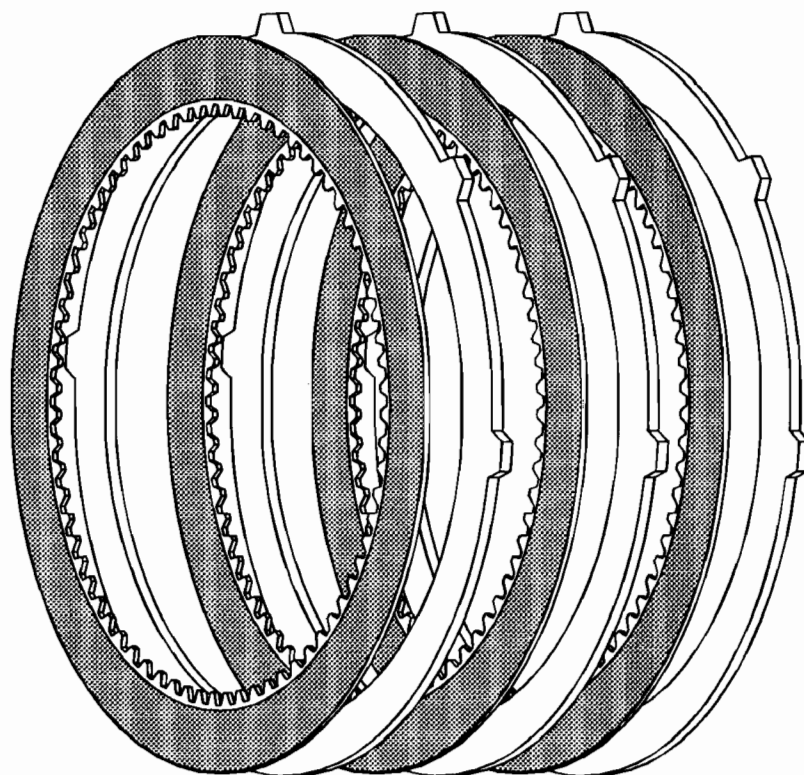
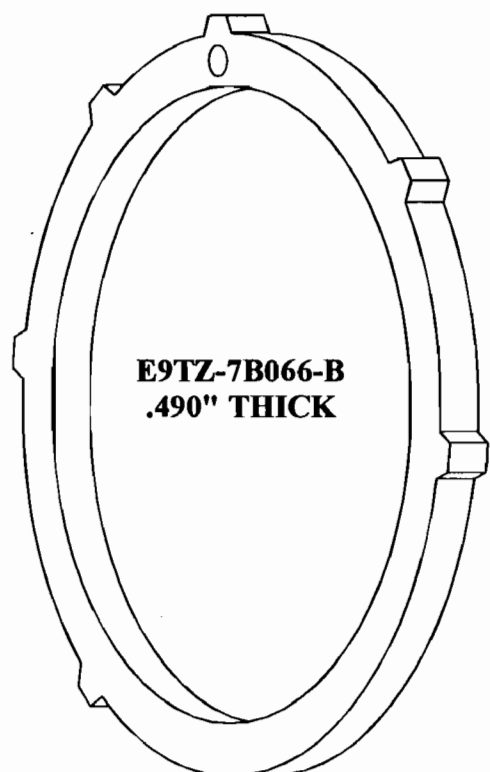
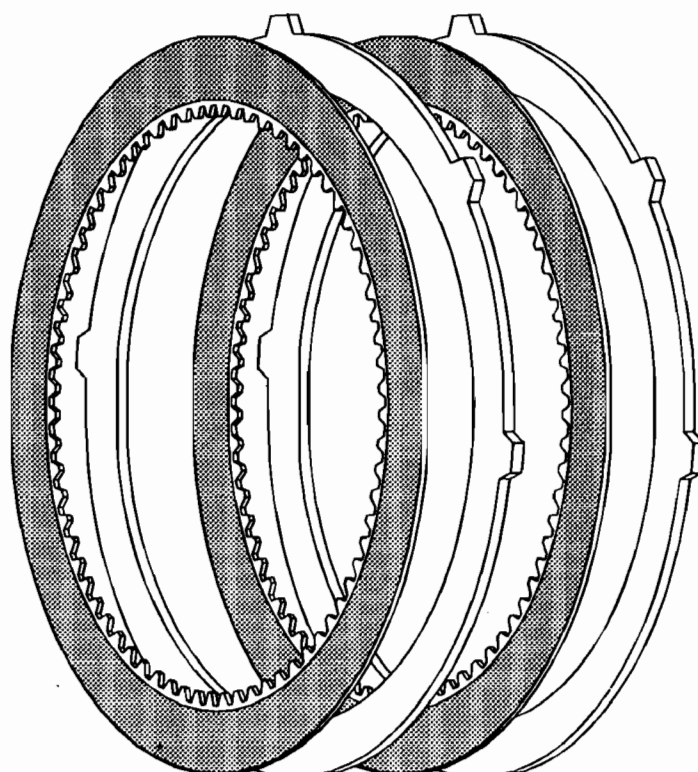
FORD E4OD
PREMATURE OVERDRIVE CLUTCH FAILURE
(INCREASED CAPACITY)

COMPLAINT: Some vehicles equipped with the E4OD transmission may exhibit premature failure of the overdrive clutches, especially heavier loaded vehicles.

CAUSE: The cause may be, not enough clutch capacity for the overdrive clutch.

CORRECTION: Install 3 clutches in the overdrive clutch pack by purchasing a thinner, .320" thick backing plate, to replace the previous .490" thick backing plate. The 3 clutch backing plate is available under OEM part number F3TZ-7B066-A. Refer to Figure 1 for both 2 clutch and 3 clutch stack-ups.

Overdrive Clutch Backing Plate (3 Clutch)	F3TZ-7B066-A
Overdrive Clutch Backing Plate (2 Clutch)	E9TZ-7B066-B

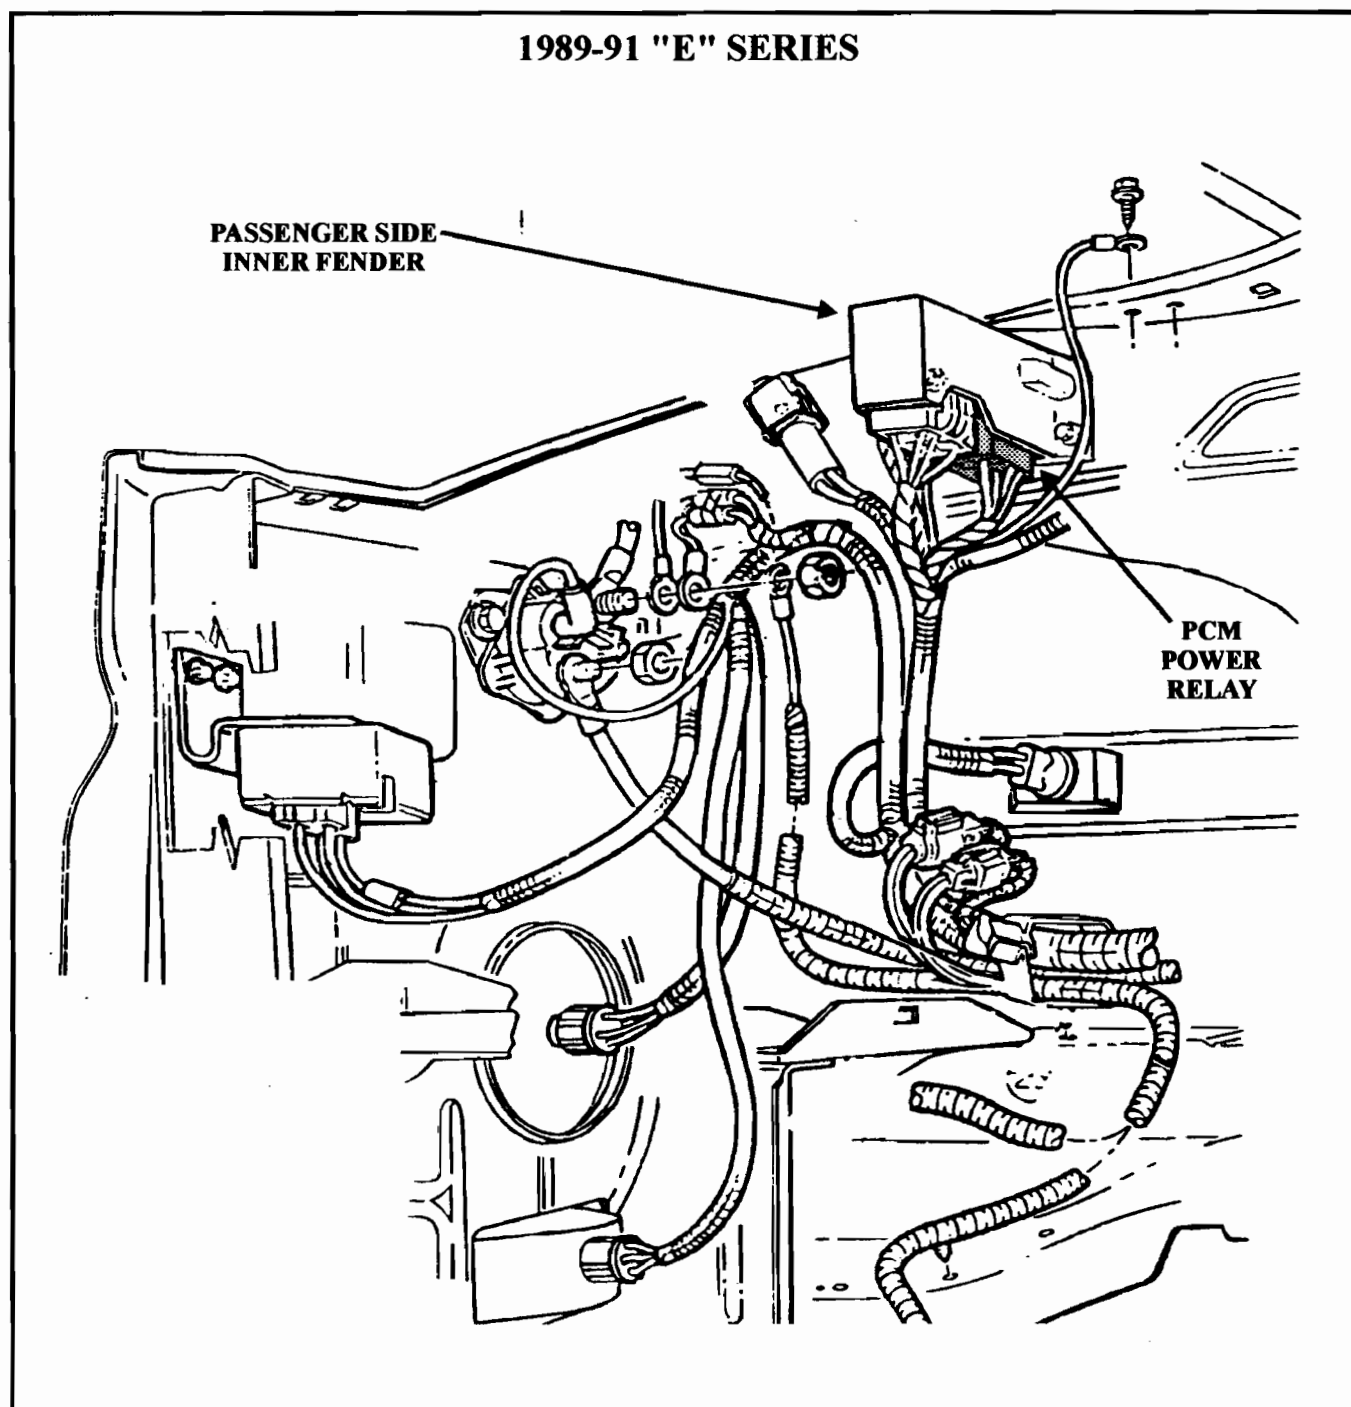
Figure 2

**STUCK IN FOURTH GEAR, HIGH LINE PRESSURE, NO CODES STORED,
SELF-TESTS CANNOT RUN AND BATTERY(S) MAY RUN DOWN**

1989-91 "E" SERIES

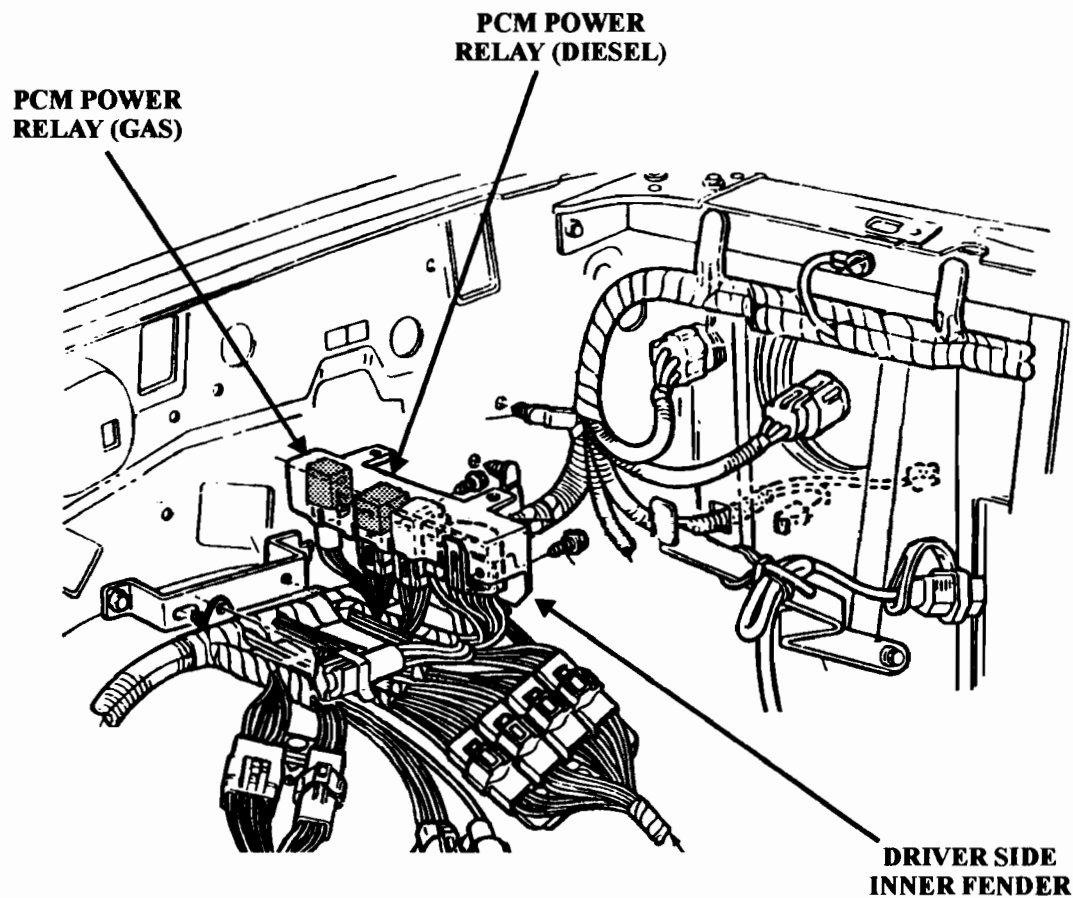
Figure 3

**STUCK IN FOURTH GEAR, HIGH LINE PRESSURE, NO CODES STORED,
SELF-TESTS CANNOT RUN AND BATTERY(S) MAY RUN DOWN**

1989-91 "F" SERIES

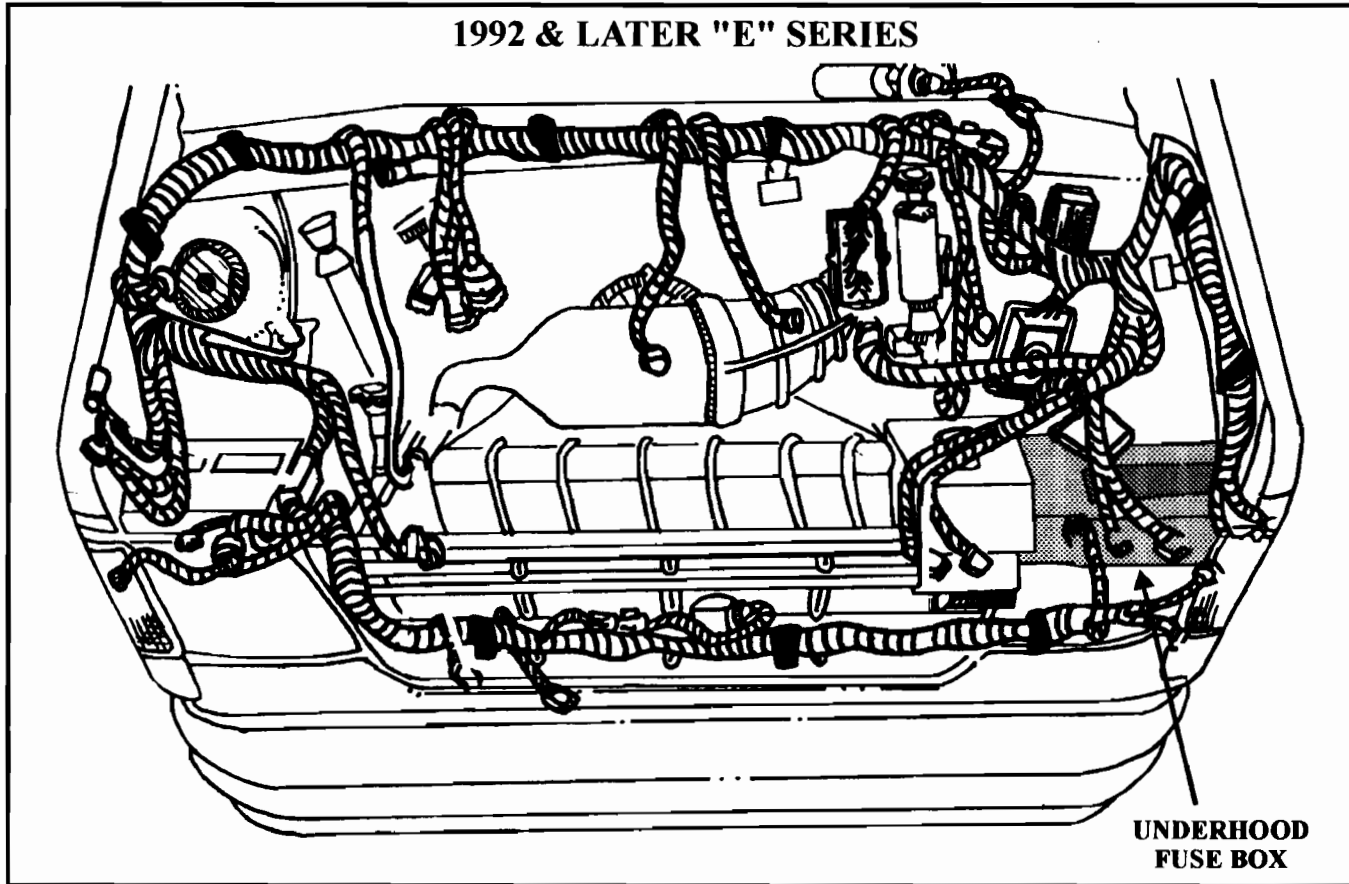
Figure 4

**STUCK IN FOURTH GEAR, HIGH LINE PRESSURE, NO CODES STORED,
SELF-TESTS CANNOT RUN AND BATTERY(S) MAY RUN DOWN**

1992 & LATER "E" SERIES

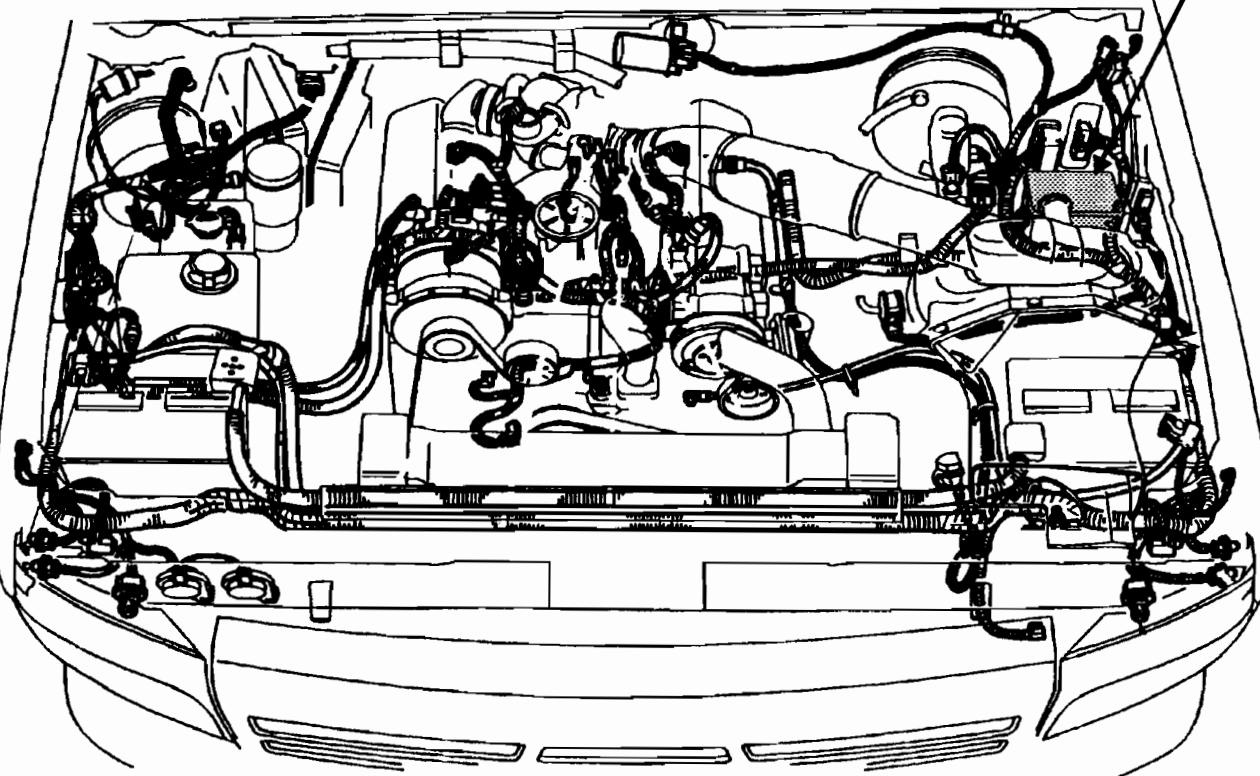
Figure 6

1992 & LATER "F" SERIES

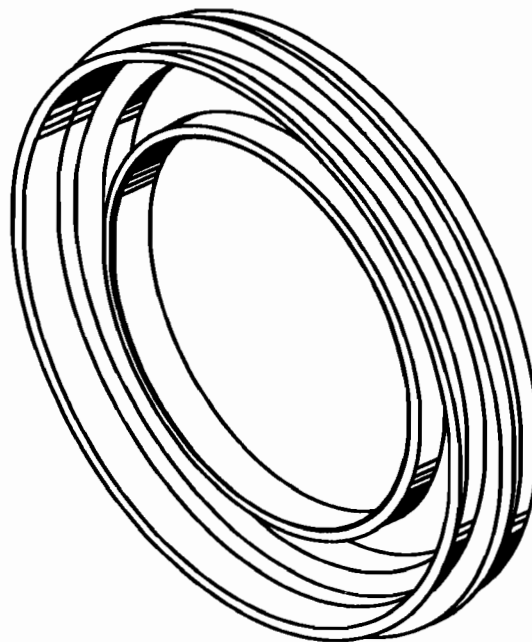
Ford Part Number F4DZ-7A262-A

FORD AX4S TRANSAXLE
SECOND GEAR STARTS

Steel Forward Clutch Piston.....F4DZ-7A262-A

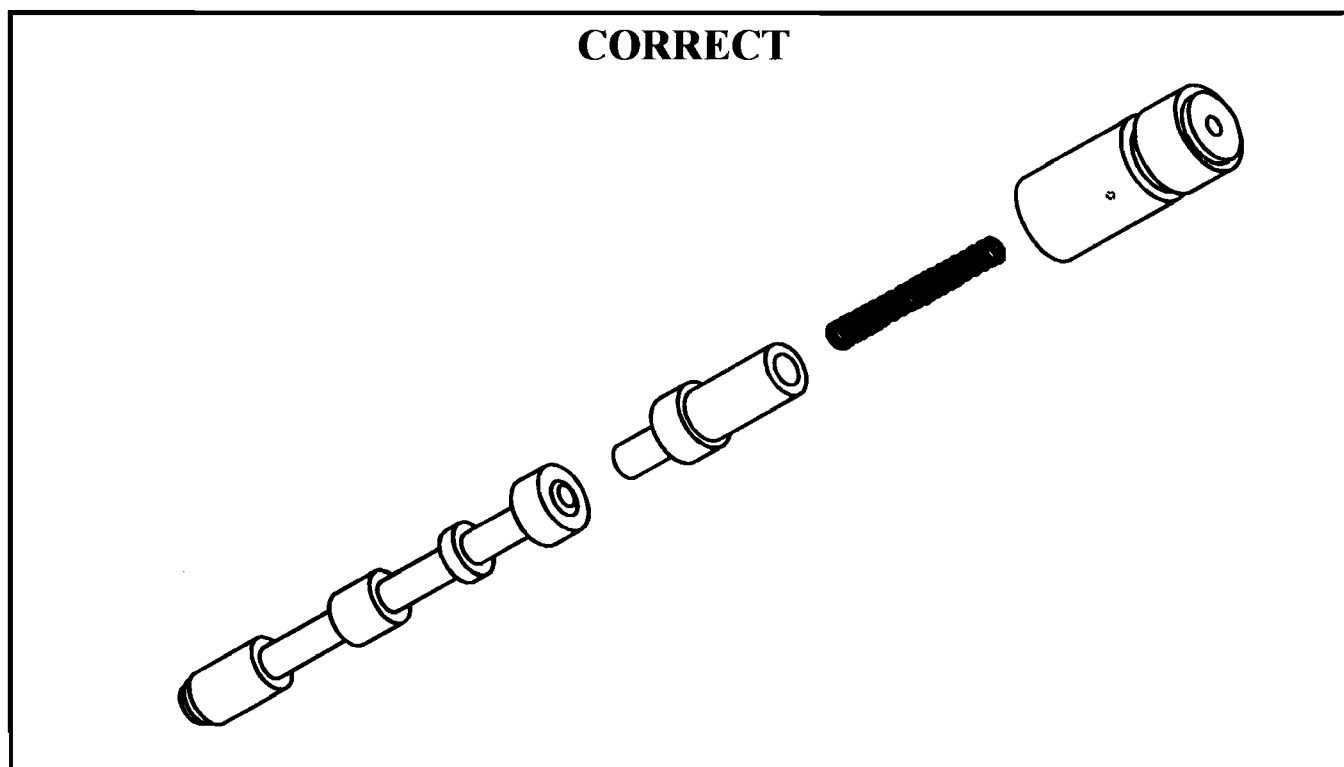
Figure 3

COMPLAINT: After overhaul, the engine stalls as soon as the manual shift lever is pulled into any position except park and neutral.

CAUSE: The *Bypass Clutch Control Plunger*, located in the bypass clutch control valve line up shown in figure 1, is shown backwards in most service manuals. When the spring and plunger are installed backwards, the plunger blocks the feed hole in the plunger sleeve, which now causes the balance of the valve to be lost. This causes the bypass clutch control valve to stroke to a position that will allow all converter clutch release oil to be exhausted, allowing the converter clutch to apply. This in turn will cause the engine to stall as soon as the manual shift lever is moved out of park or neutral as seen in figure 2.

NOTE: The Bypass Clutch Control Sleeve should *always* be checked for wear during overhaul, as it is a high wear item, and can cause TCC apply and lube circuit problems.

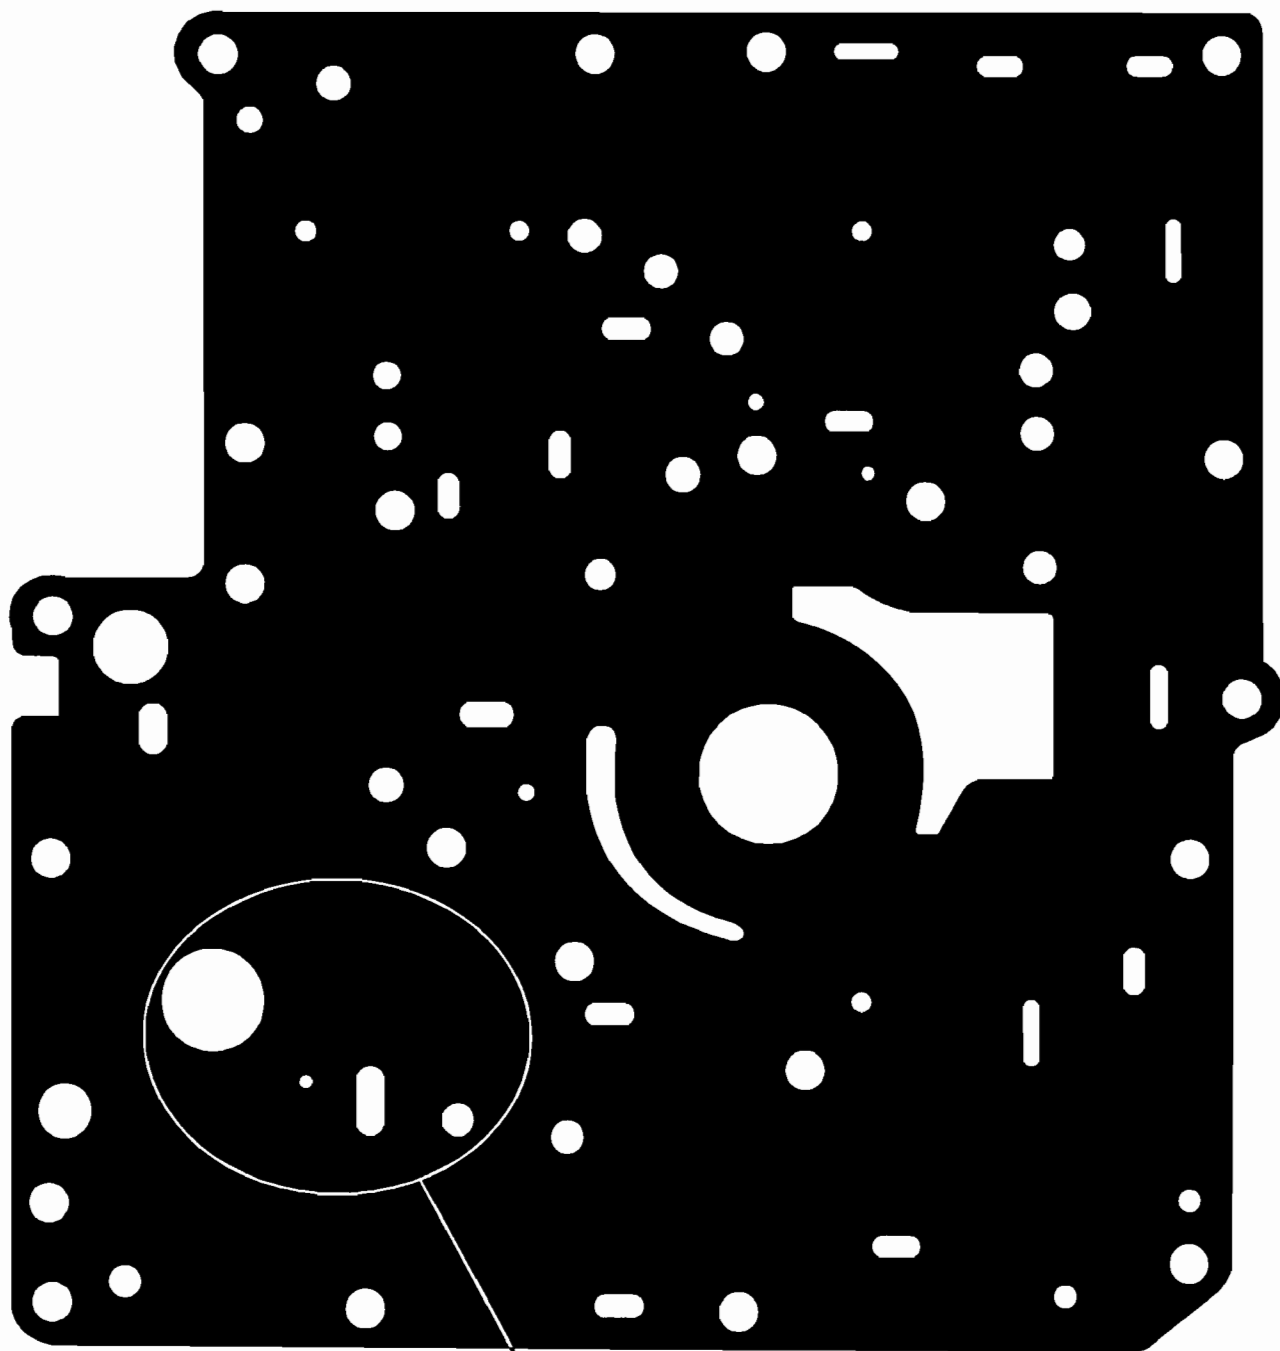
**PREVIOUS DESIGN LEVEL PUMP SPACER
PLATE TO VALVE BODY GASKET**

AFFECTED AREA

Pump Spacer Plate To Valve Body Gasket (New Design) F8DZ-7A136-AB

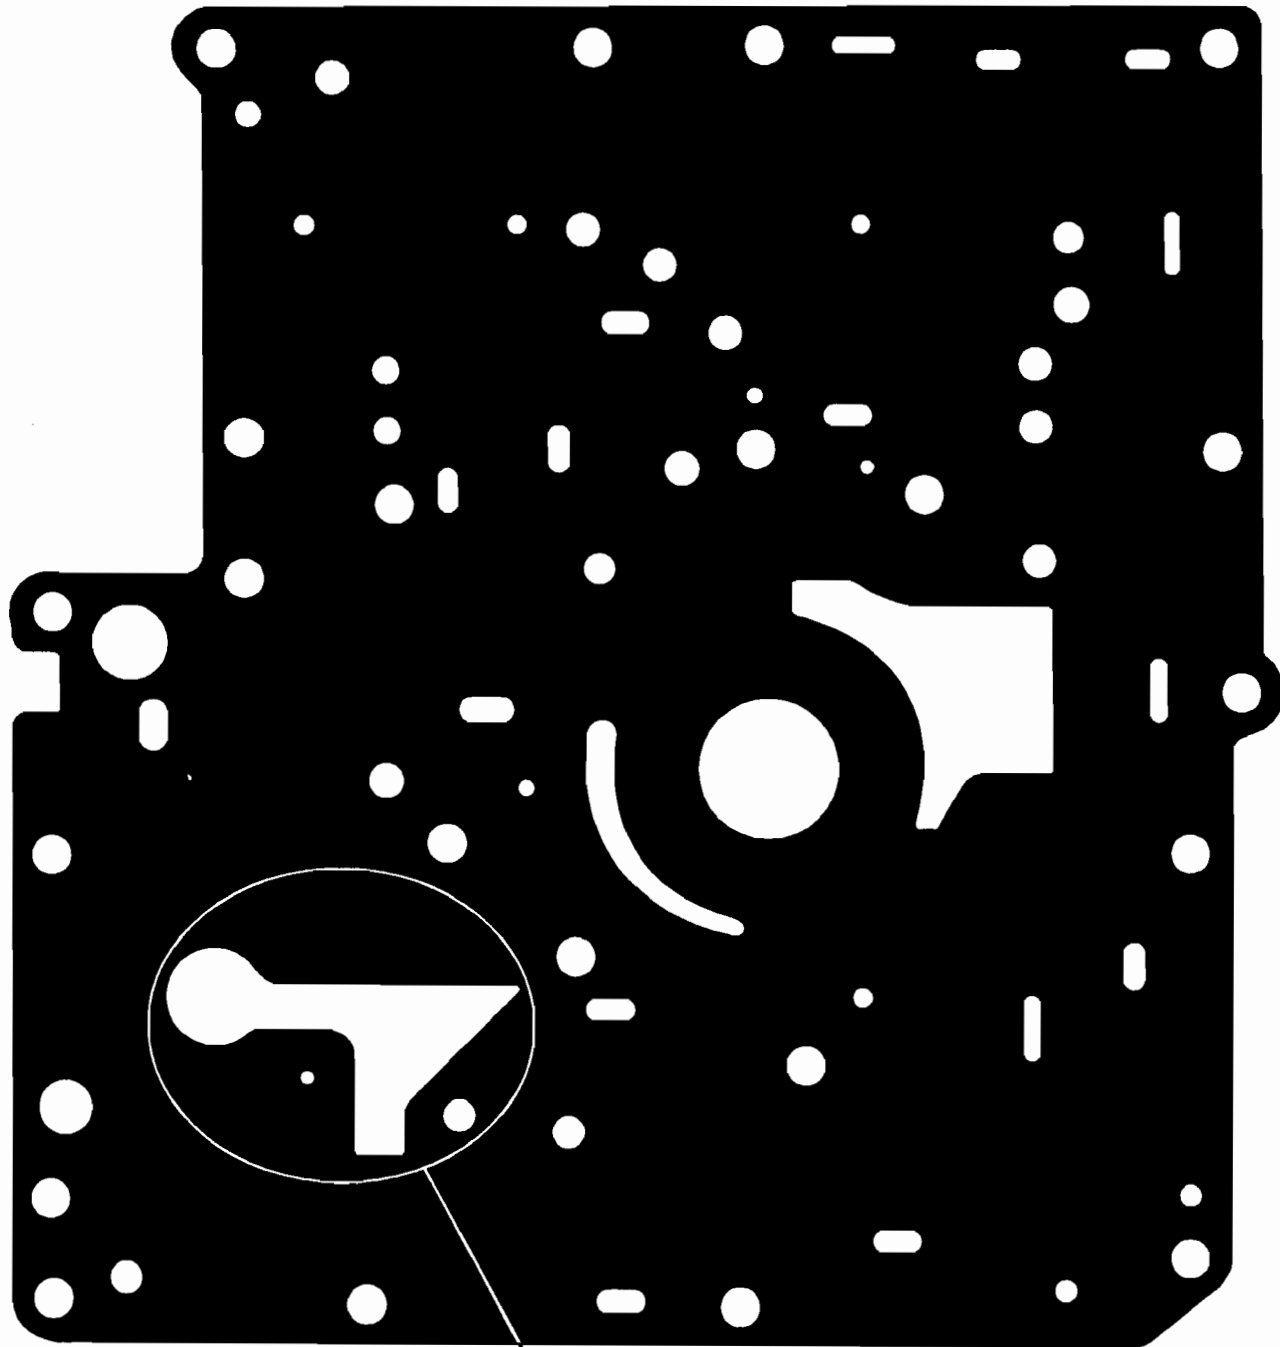
**NEW DESIGN LEVEL PUMP SPACER
PLATE TO VALVE BODY GASKET
PART NUMBER F8DZ-7A136-AB**

AFFECTED AREA

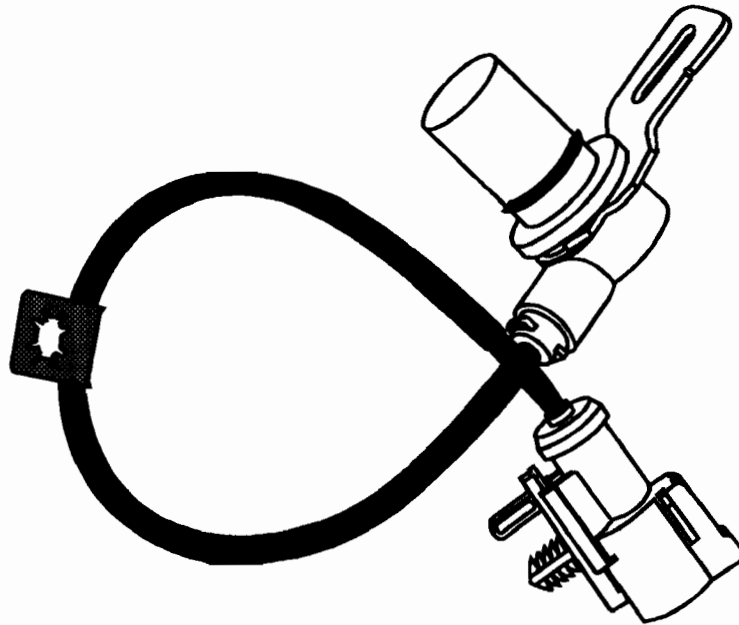
Figure 2

CHANGE: The gear driven vehicle speed sensor that has been in use in the AX4S and the AX4N since their inception will be replaced, as a running change during the 1999 model year beginning with the AX4S and at the start of production for the 2000 model year for the AX4N, with a permanent magnet speed sensor. The PM Generator will be mounted in the barrel of the case and will be using the park gear teeth as an exciter wheel.

REASON: The possibility of the VSS drive or driven gear "apple coring" will be eliminated as well as the intermittent loss of vehicle speed signal due to the speed sensor sub harness damage that would occur as a result of exhaust system heat transferral.

XF2Z-7H103-AA

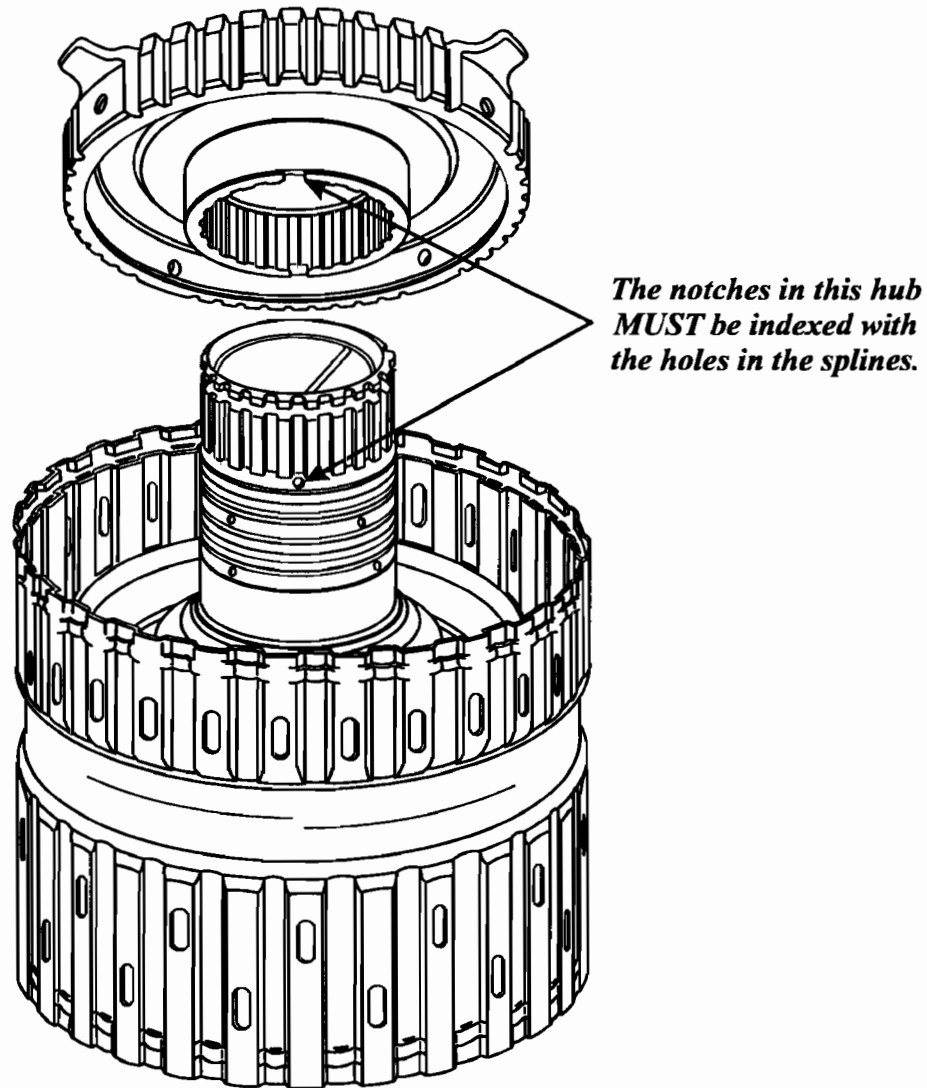
Figure 2

COMPLAINT: After overhaul, a vehicle equipped with a CD4E transaxle exhibits premature failure of the top bushing in the reverse input housing (See Figure 1), and apparently due to lack of lubrication. Because of the bushing failure, the ring area in the reverse input housing may be grooved, and the sealing rings on the forward/coast/direct housing may be worn.

CAUSE: The cause may be, mis-assembly of the reverse input clutch hub onto the splines of the forward/coast/direct clutch housing. The reverse input clutch hub has 2 slots machined 180 degrees apart on the bottom of the hub, as shown in Figure 2. These slots *must* be indexed over the two lubrication holes 180 degrees apart in the splines of the forward clutch housing, as shown in Figure 2. If the slots are not lined up with the lube holes in the splines, premature failure of the reverse input housing bushing will be the result.

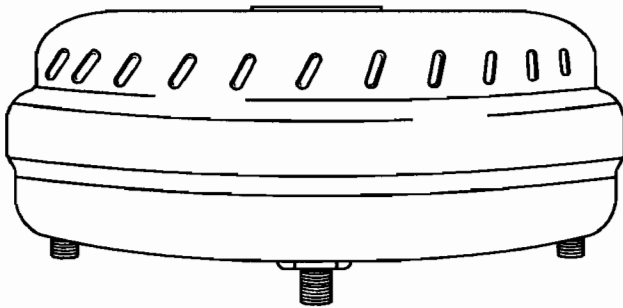
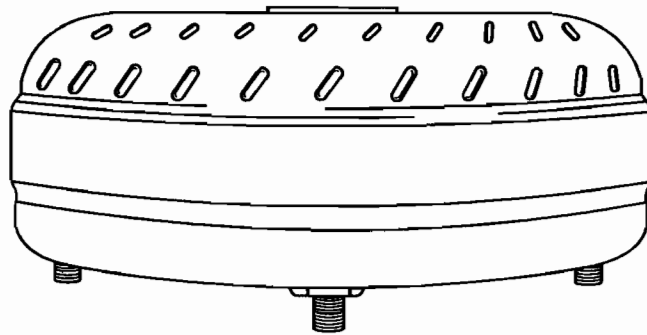
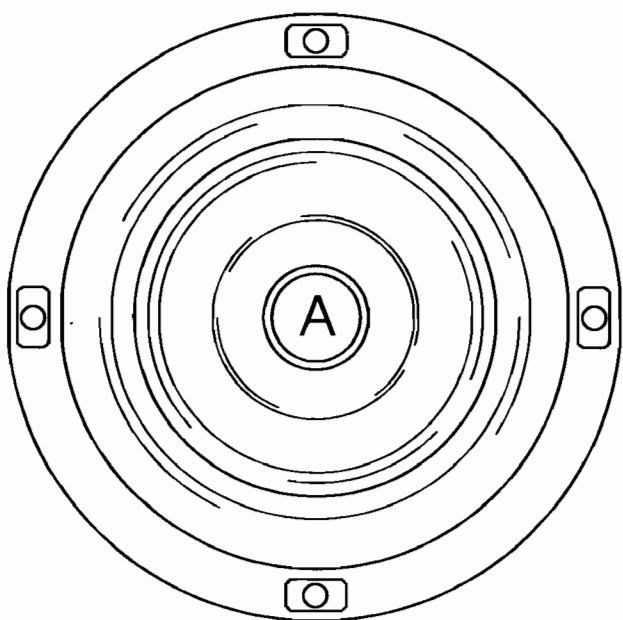
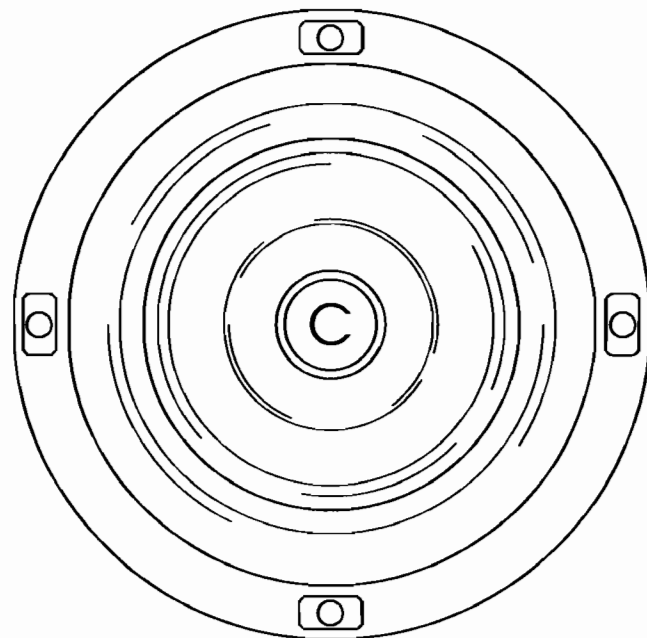
Figure 2

COMPLAINT: Some vehicles equipped with the CD4E transaxle may exhibit a front seal leak after overhaul.

CAUSE: One cause may be, the incorrect converter was installed in the vehicle.

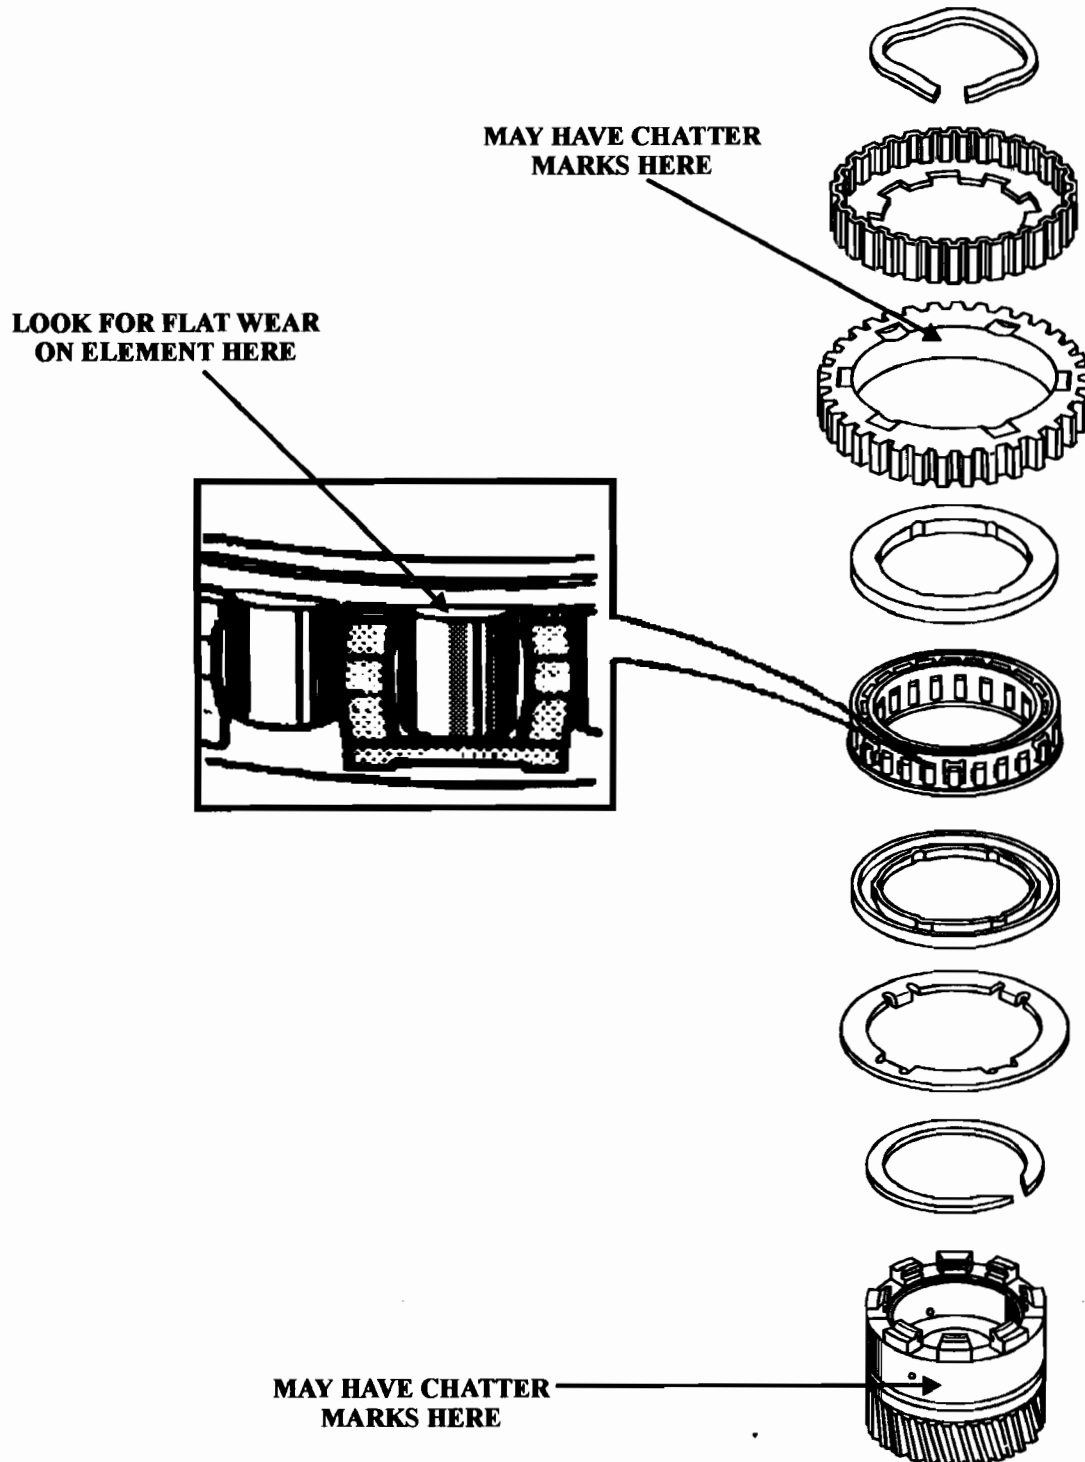
Figure 2

CAUSE: When the forward one-way clutch or forward clutch slips and the computer sees this slip take place, the computer will go to **Failure Mode Effects Management (FMEM)**. Even though a gear ratio code has not been stored, line pressure will be high. *The reason for this is, the computer has to see a slip three (3) times in order to store a slip code, but it only needs to see the slip occur once to go to FMEM. This is why you may have high line pressure and no gear ratio error codes.* When the engine RPMs rise as a result of the slip, the computer does not see vehicle speed also rise and will therefore think the vehicle speed sensor has failed and will store a false VSS code.

FORD CD4E/MAZDA LA4A-EL
HIGH LINE PRESSURE

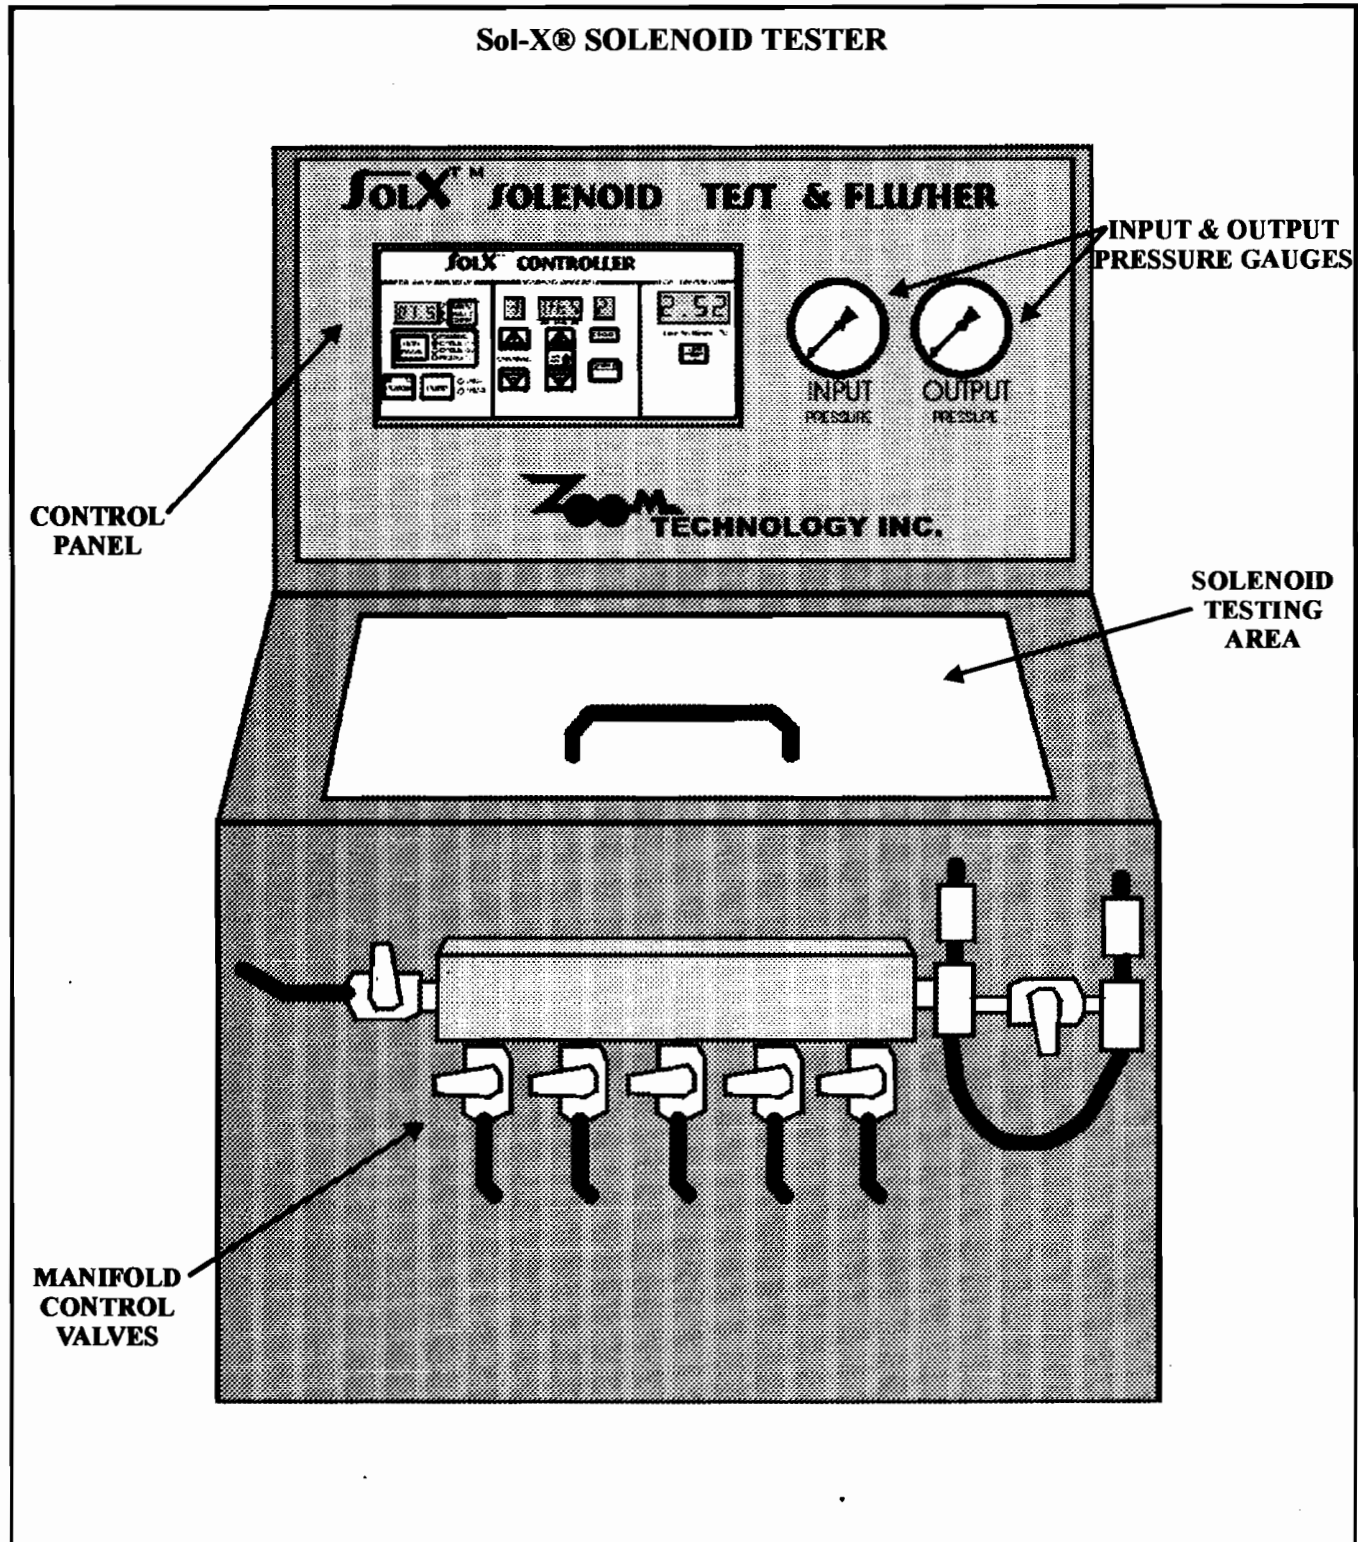
Figure 1

SOLENOID FAILURE WHEN HOT

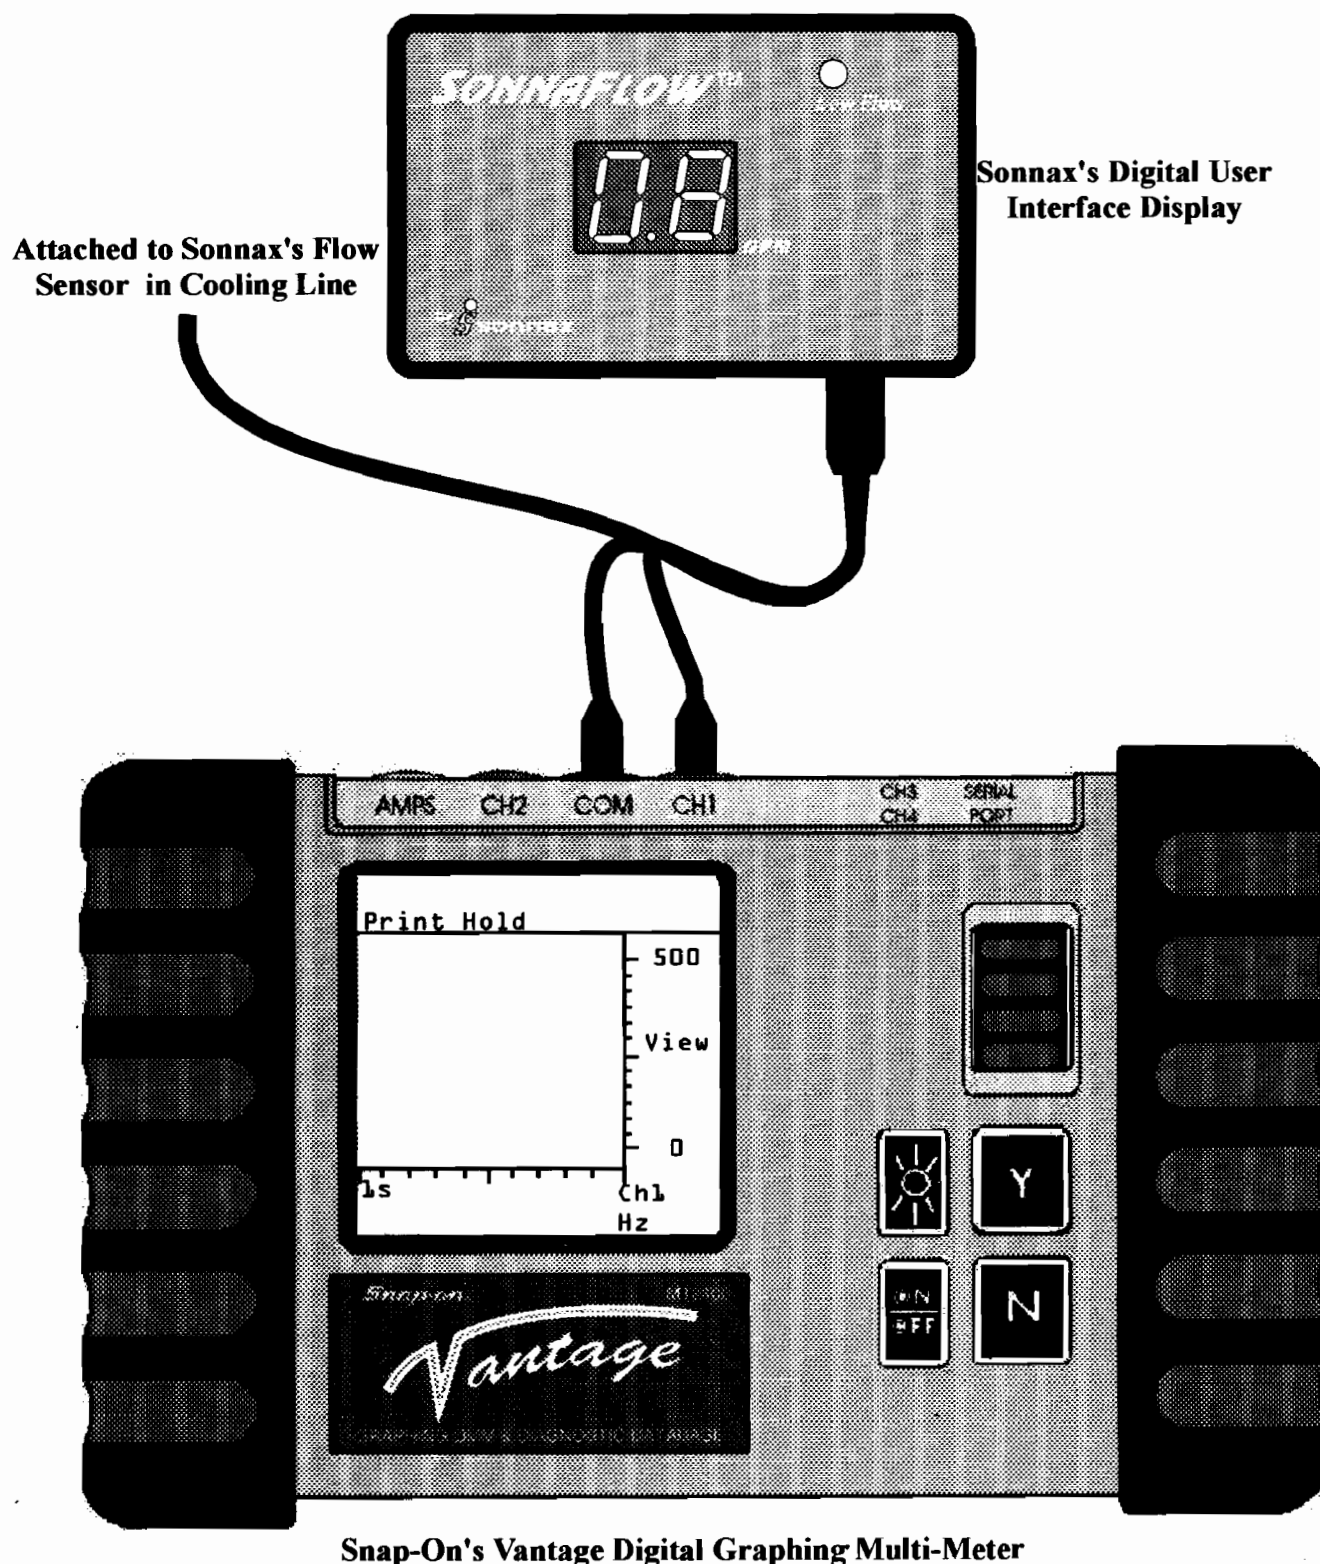
Figure 2

The traditional flow check of 1 quart in 20 seconds corresponds to a flow rate of 0.7 to 0.8 GPM.
