"2000" SEMINAR INFORMATION "FIXES TODAY FOR Y2K"

INDEX FORD & CHRYSLER

AUTOMATIC TRANSMISSION SERVICE GROUP

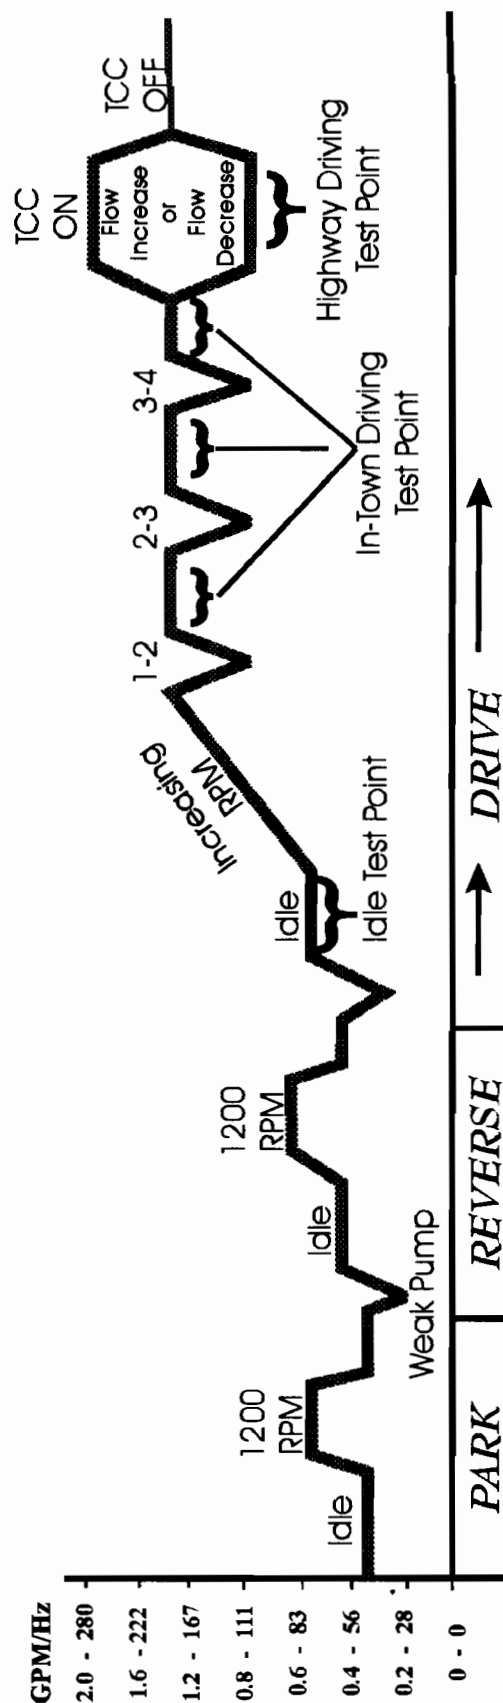
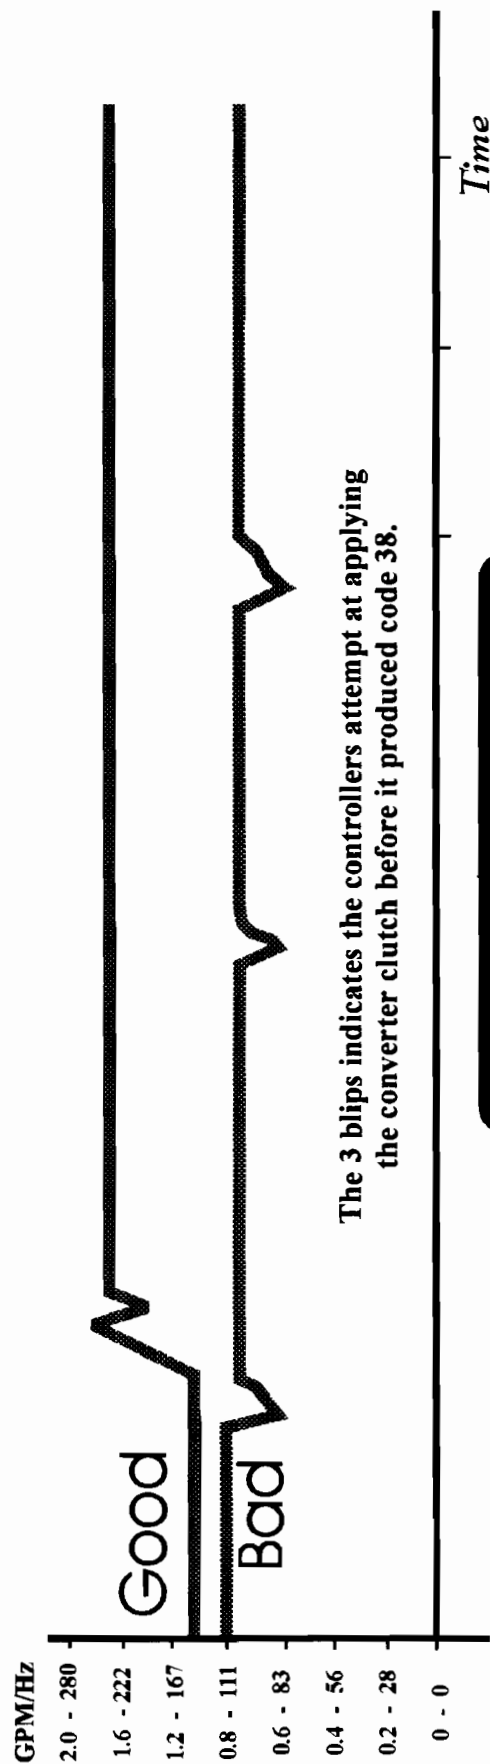
Figure 3

A604 TCC vs No TCC Code 38

A sticking or stuck TCC Control valve produces code 38.

The 3 blips indicates the controllers attempt at applying the converter clutch before it produced code 38.

Replaced TCC control valve with
Sonnax Switch Valve Regulating Assembly
92835-01K

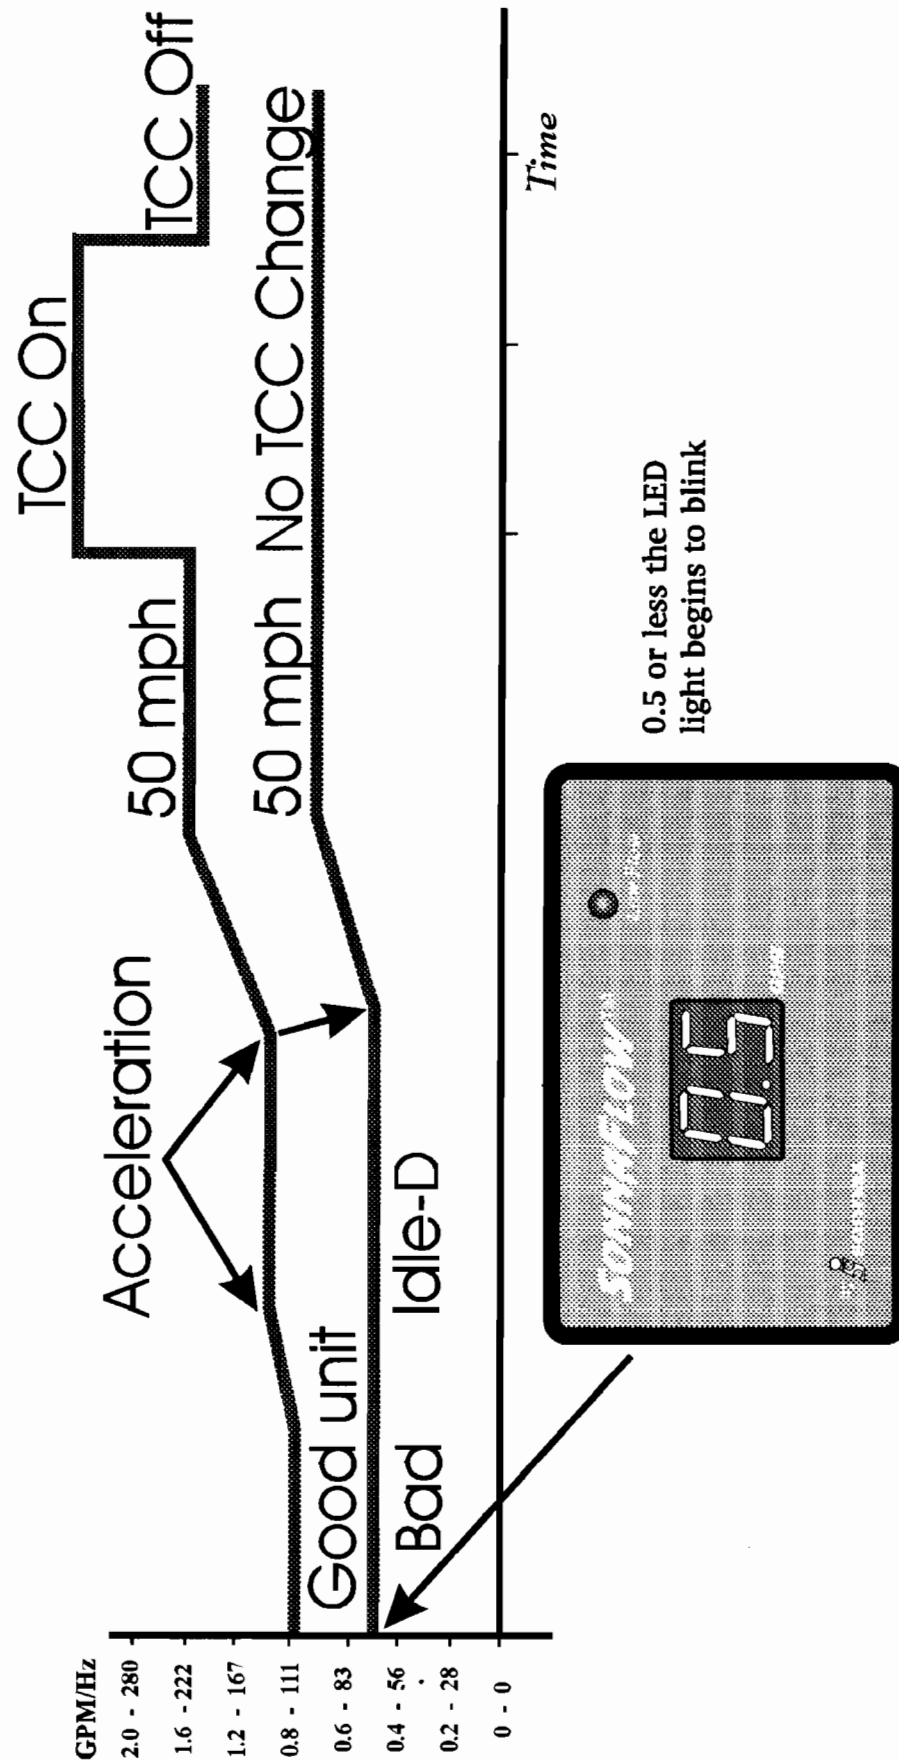
Figure 5 - A defective cooler

The lower graph has been taken from a Dodge Pickup with a 47RE transmission experiencing repeated planetary failure. Notice that the cooler flow never achieves a flow rate much higher than 0.6 gpm. Also noticed that the converter clutch never applied. This low cooler flow had effected the operation of the 4 spool switch valve which this particular valve body had, not allowing the correct hydraulic move of the valve to occur. The above graph is what occurred after the cooler was replaced.

47RE Good vs Bad

Flushed Cooler Line w/machine
Repeated planet failure
Original - Converter Failure

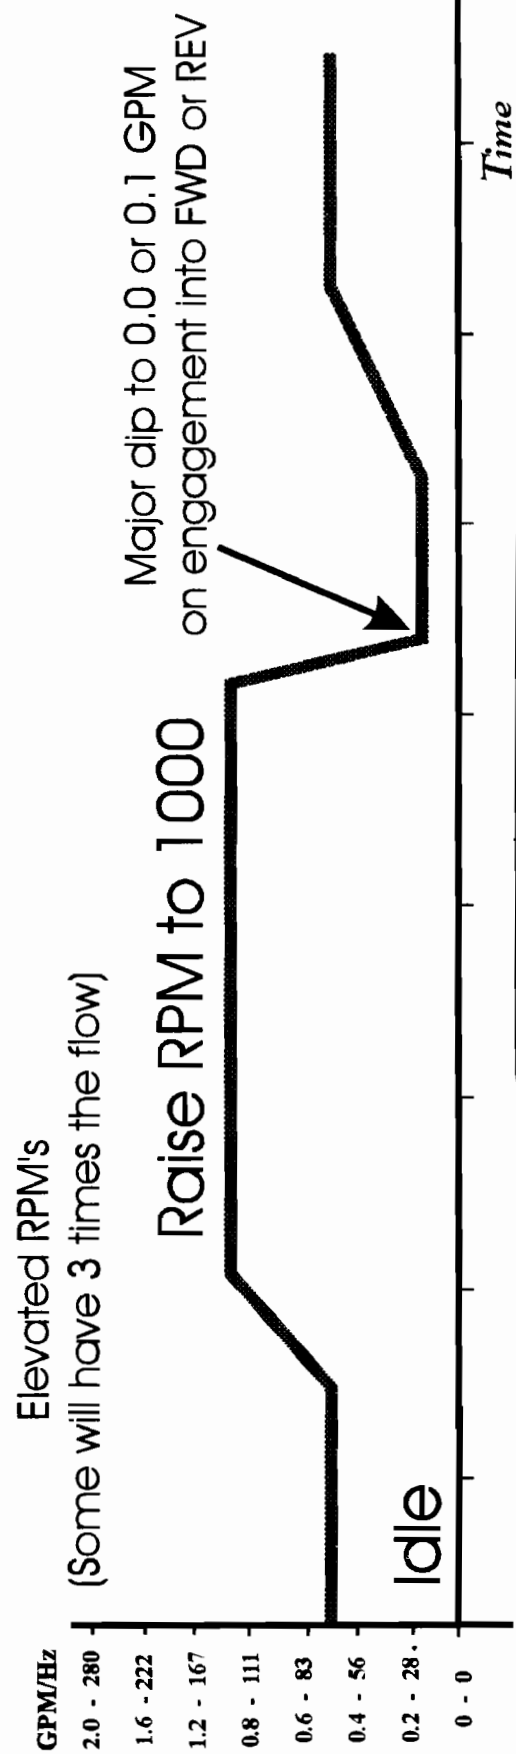
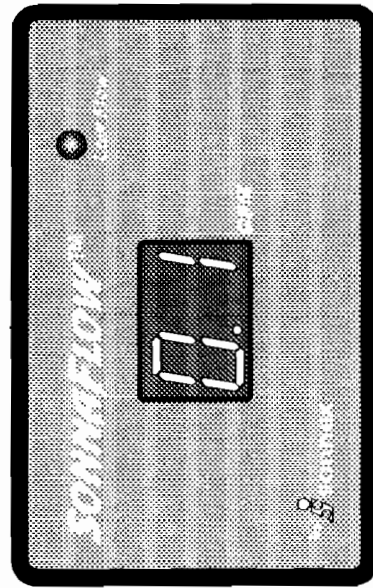
Figure 6 - A weak pump

Figure 6 is a graph of a transmission with a weak pump. In the past, different methods were employed to determine weak pumps. A flow meter is the single most easiest method which can be employed for all automatic transmissions.

Weak Pump in Drive Range Often Worse in Reverse

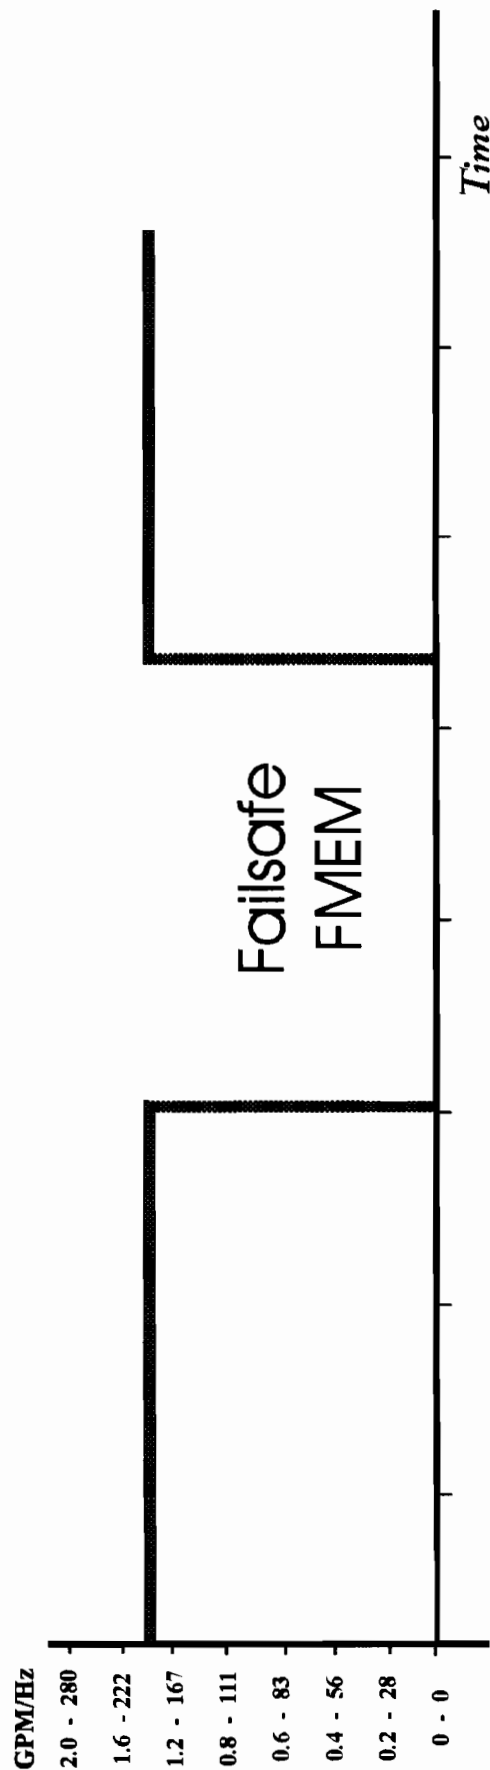
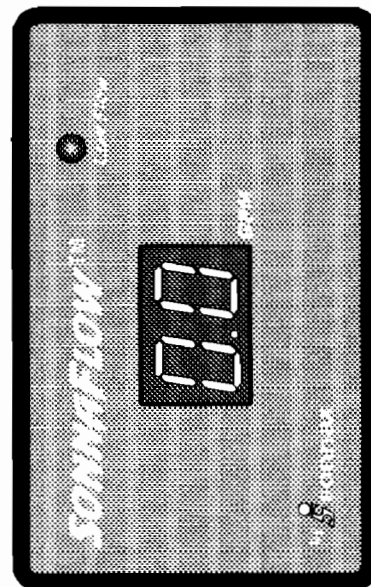
Figure 7 - High line low or no cooler flow

Some technicians may have had the unfortunate experience of placing a C3 modulator into a C4 transmission only to find themselves with a vehicle that has a no move condition. This scenario caused the pressure regulator valve to be in such a high line pressure condition, converter fill and lube flow was cut off. When the correct modulator is installed, converter fill and cooler flow is restored and the no move condition is cured. This situation serves as an example as to what could happen to converter fill and lube flow for most transmissions should high line pressure occur. Drilling from a line pressure circuit into a lube circuit has become common place in most shops as an insurance method of providing constant lube should high line pressure take place. The example in Figure 7 is from a Ford Taurus with an AXODE transmission. This transmission did not have the updated cross over pipes nor was line to lube drilled. As soon as a code was stored whereby the processor went into "Failure Mode Effect Management" (FMEM), line pressure went up and cooler flow dropped to 0.

AXODE/AX4S

Intermittent Failsafe & Solenoid Rattle
In town speed 30-45 mph

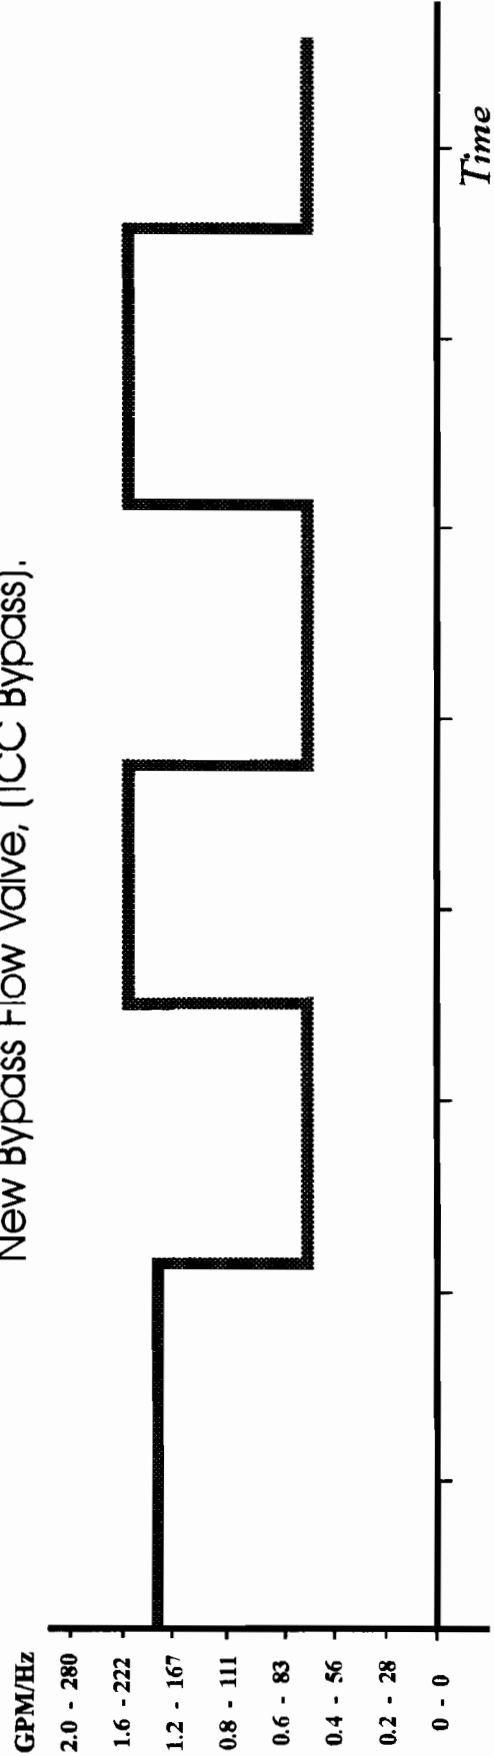
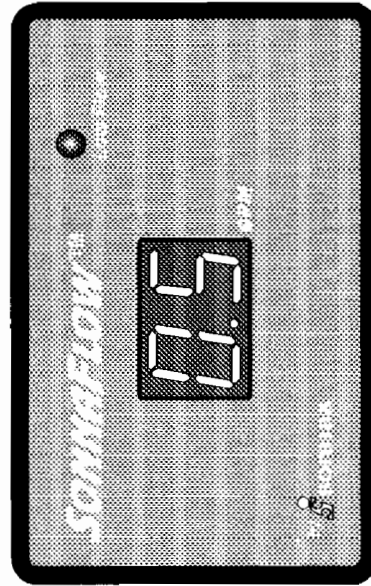
Figure 8 - Will the real cause please stand up

The cause of a sudden flare into Neutral while driving 60 mph in a Ford Taurus is usually found to be a defective Manual Lever Position Sensors (MLPS). In this case all electronics have been replaced, i.e. solenoids and sensors. The graph indicates that cooler flow was dropping simultaneously with the neutralizing. Line pressure was not spiking during this condition either. The evidence provided by the flow meter via the graph indicated a loss of hydraulic stability placing the transmission into neutral. With this information the next step is to go into the valve body to check the pump shaft, sealing rings etc.. Only a worn TCC bypass valve and sticking lube relief valves were found and repaired to correct this condition.

AXODE @ 60 mph drops out of Gear

All Electronics Replaced.....

Slow hydraulic Surge: problem = loss of
line control. Fix = New Boost, Lube reliefs fixed,

New Bypass Flow Valve, (TCC Bypass).

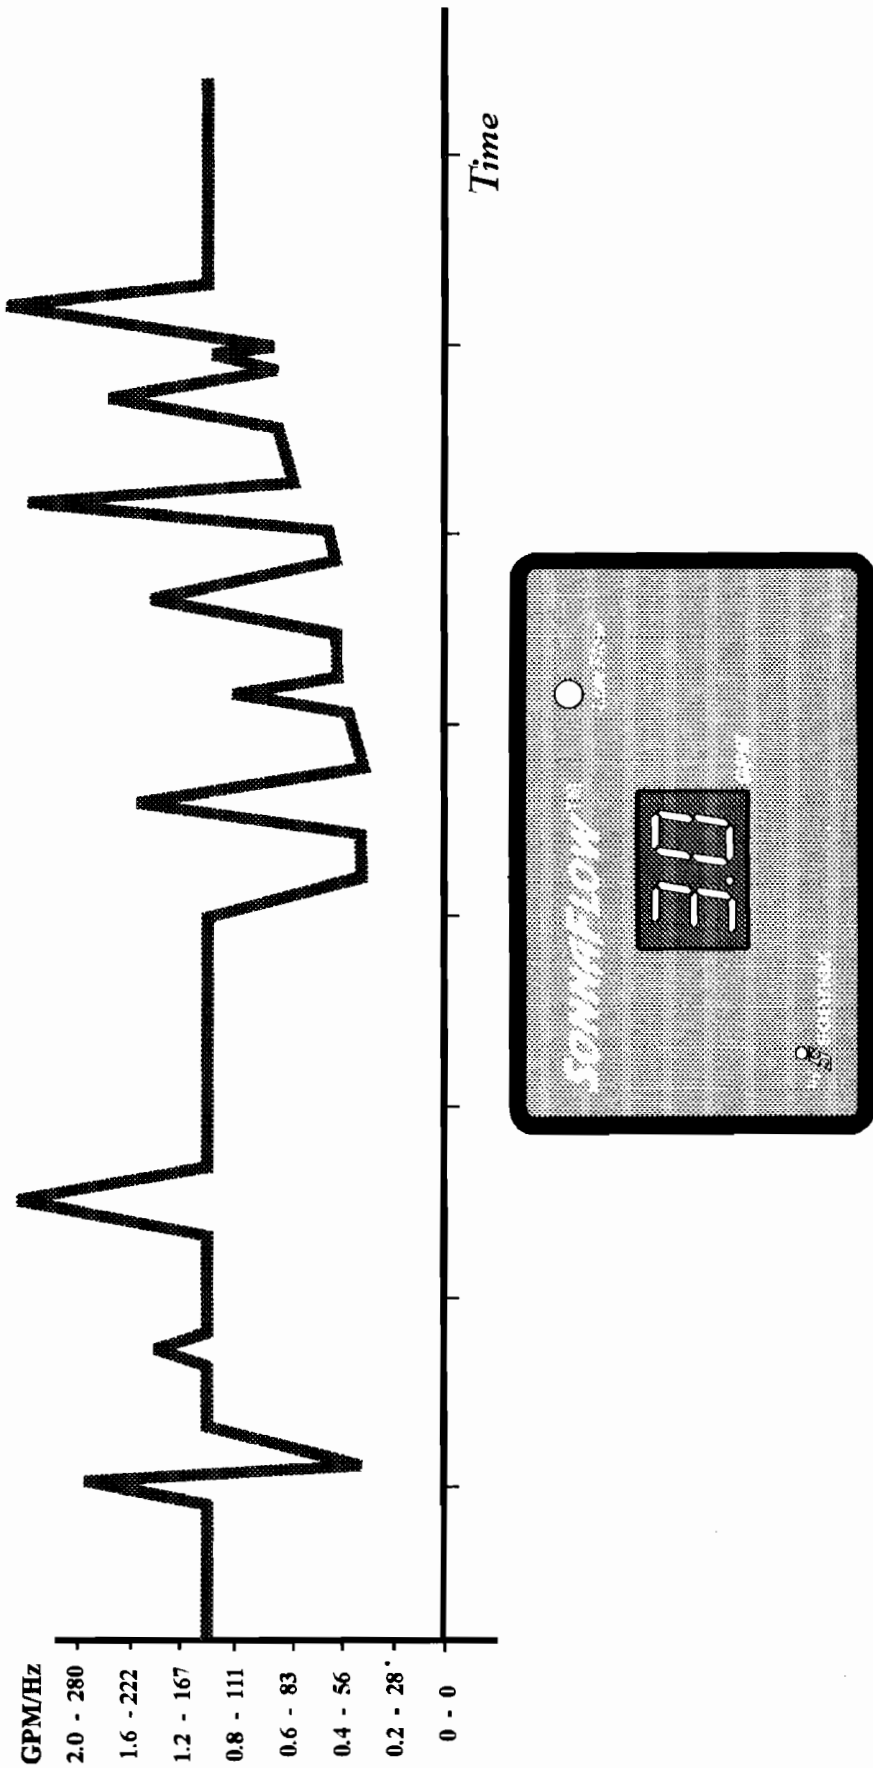
Figure 9 - Pump cavitation

The *Sonnaflow*™ sensor uses a little paddled wheel to sense flow. When a pump sucks to much air into the system it is said to have cavitation. spurts of air rushing past the wheel spins the wheel faster making the readings spike. The graph in figure 9 displays this as an irregular wave form reaching heights as high as 3.0 gpm and better.

Aerated Fluid, Low Fluid levels, Pump Cavitation

45-55 mph Acceleration from Stop

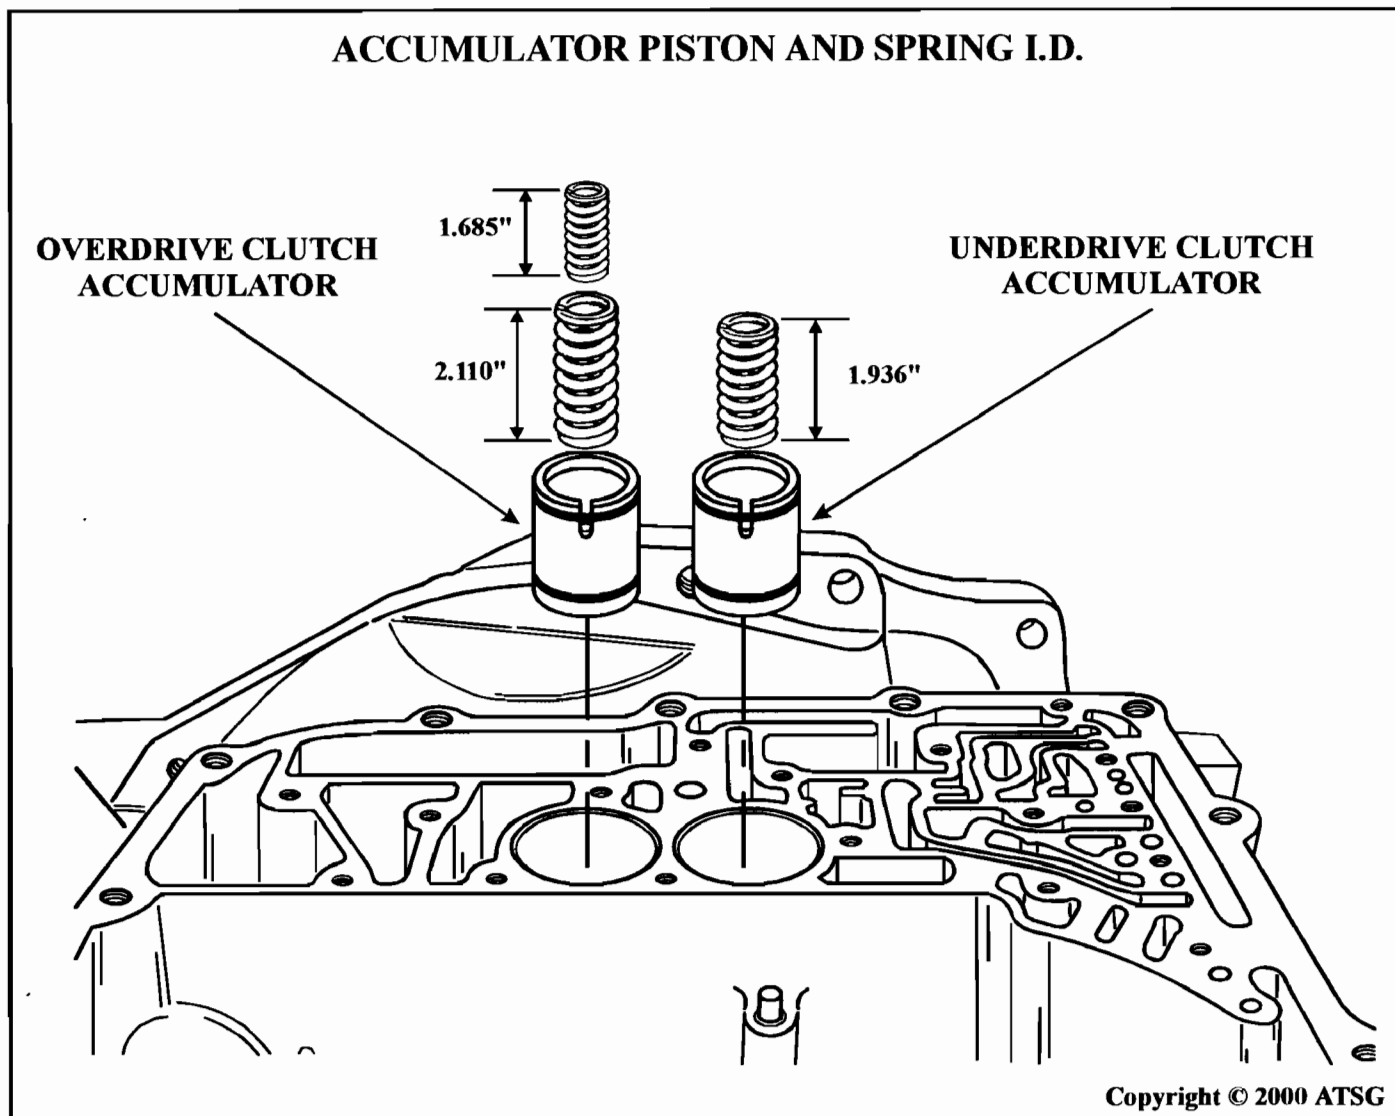
CHRYSLER 41TE
HARSH ENGAGEMENT IN DRIVE RANGES
AND / OR HARSH 4-3 DOWNSHIFT

CAUSE: The cause may be, the Overdrive Clutch Accumulator springs were placed into the Underdrive Clutch Accumulator piston.

CORRECTION: Refer to Figure 1 for the correct Accumulator Piston and Spring I.D.

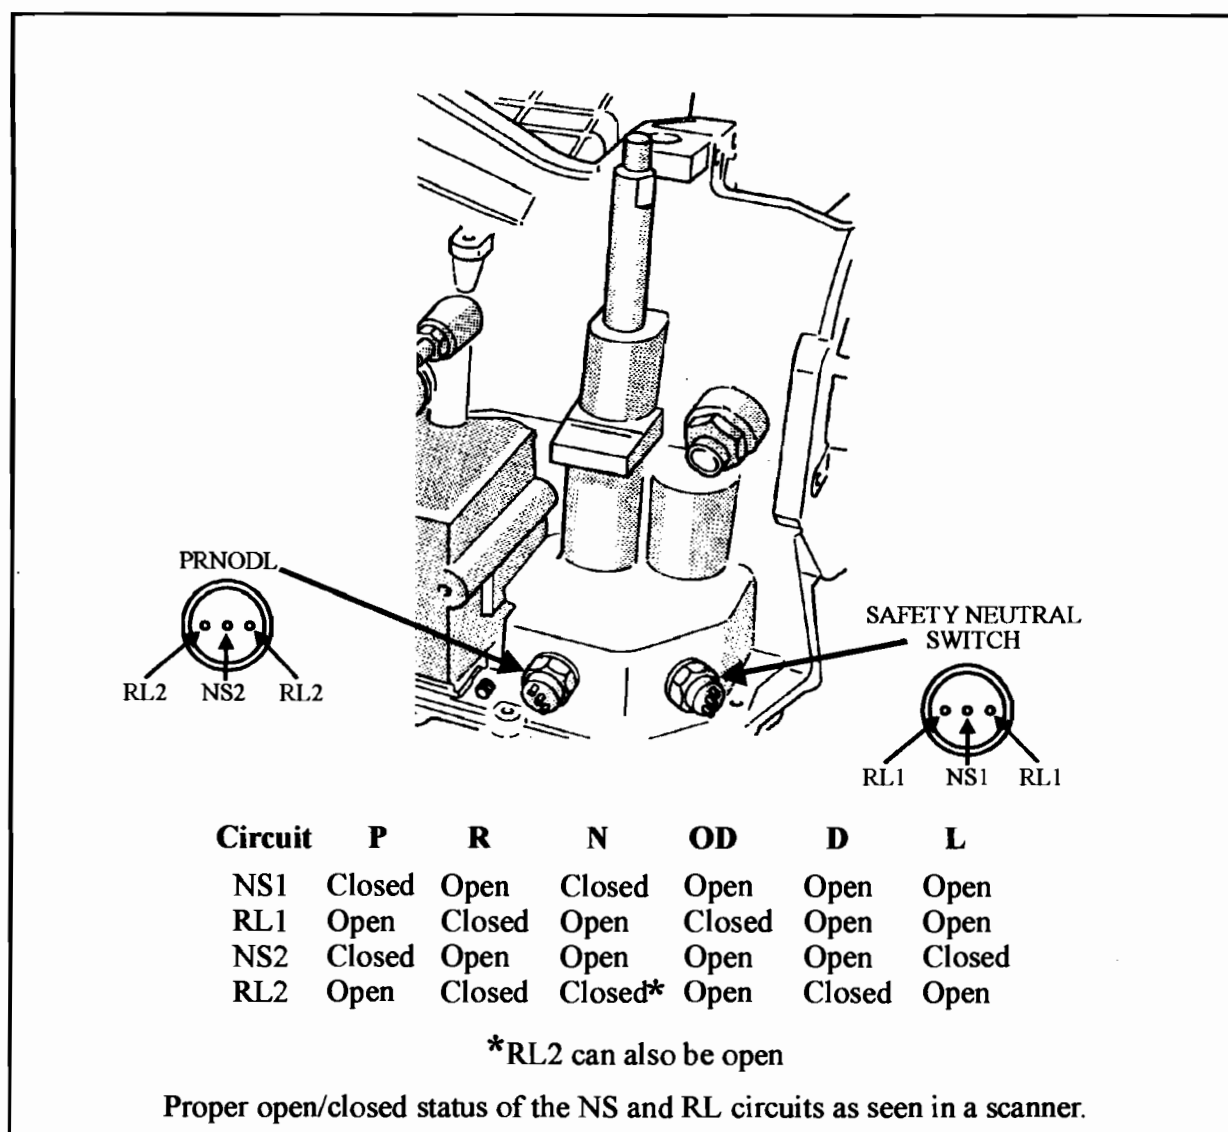
Figure 1

COMPLAINT: Only 41TE transaxels that have PRNODL and NEUTRAL switches may exhibit a shift in manual low, a 3-4 upshift in D3, works fine in D4, starts in Park but not in Neutral after rebuild. When the open, closed status of the NS and RL circuits are viewed through a scanner, it is noticed that the sequence is incorrect. The switches are replaced and the problem remains (See Figure 1).

CAUSE: The switches have been cross connected.

CORRECTION: Unplug and swap switch connectors.

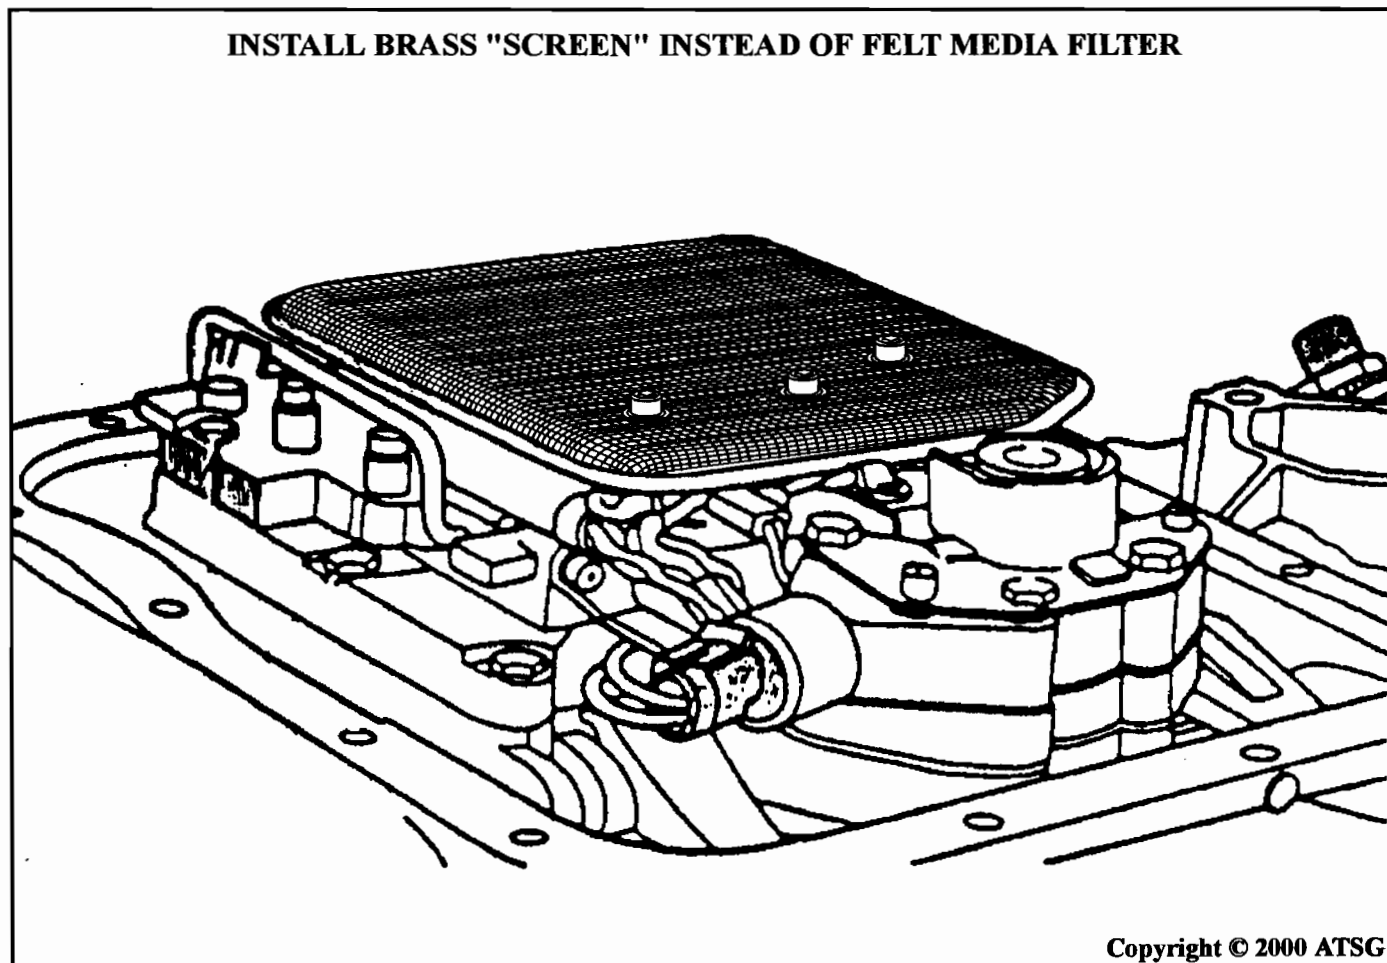
Figure 1

CHRYSLER 42RE
"BUZZING" NOISE IN REVERSE

CAUSE: The cause may be, the Pressure Regulator Valve buzzing because of a partially clogged main filter, or may be the PR valve itself.

CORRECTION: First install a brass "Screen" in place of the felt media filter in the bottom pan, as shown in Figure 1. If this does not cure the condition, replace the aluminum PR valve in the valve body with the previous design steel PR valve (See Figure 2), available under OEM part number 4130169

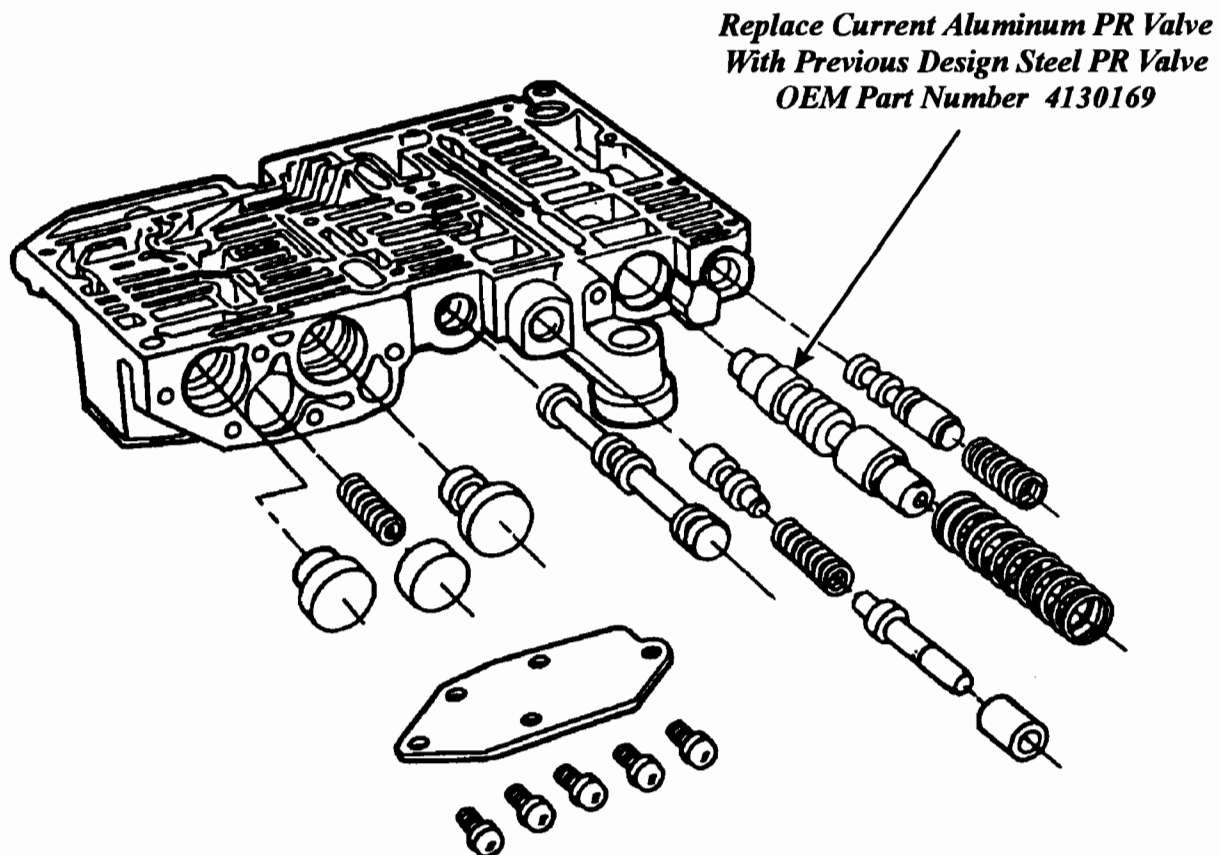
**PREVIOUS DESIGN STEEL
PRESSURE REGULATOR VALVE
PART NUMBER 4130169**

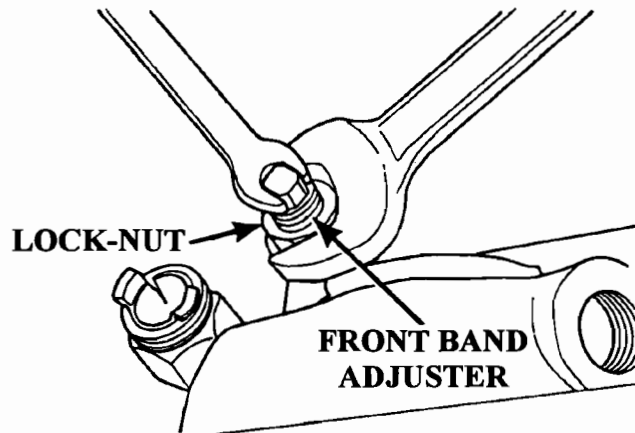
Figure 1

COMPLAINT: After rebuild, some vehicles may exhibit a 1-2 upshift shuttle condition that may lead you into thinking it is governor pressure or valve body related.

CAUSE: The cause may be, that you have adjusted the intermediate band incorrectly, or the seal rings on the 1-2 accumulator piston are leaking.

CORRECTION: We have gotten into the habit of adjusting the intermediate band with a visual adjustment during the rebuild process, before we install the bottom pan. This is a grave mistake on the 42RE transmission. You *must* tighten the adjusting screw to 72 inch pounds, and then back the adjusting screw off *exactly* 3-5/8 turns, as shown in Figure 1. In some cases we have also had to install the previous design 1-2 accumulator piston with steel seal rings as shown in Figure 2.

*Tighten band adjuster to 72 inch pounds,
and back off "Excatly" 3-5/8 turns.*

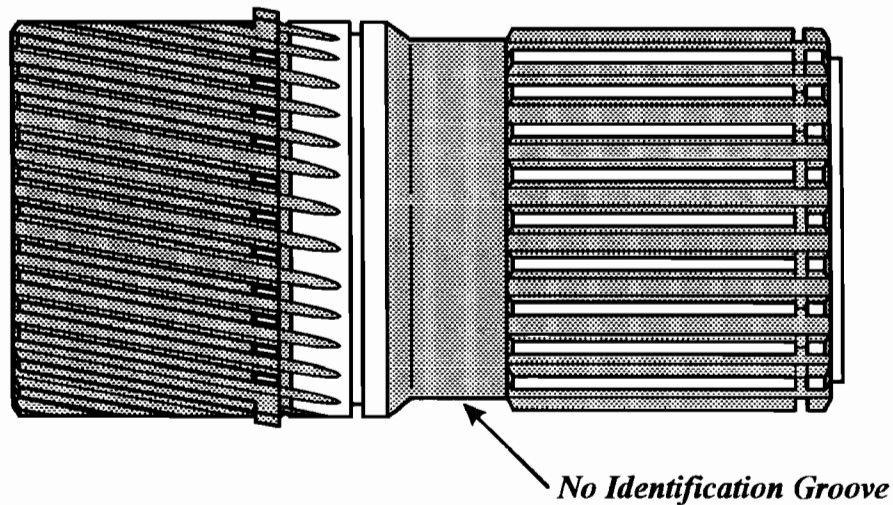
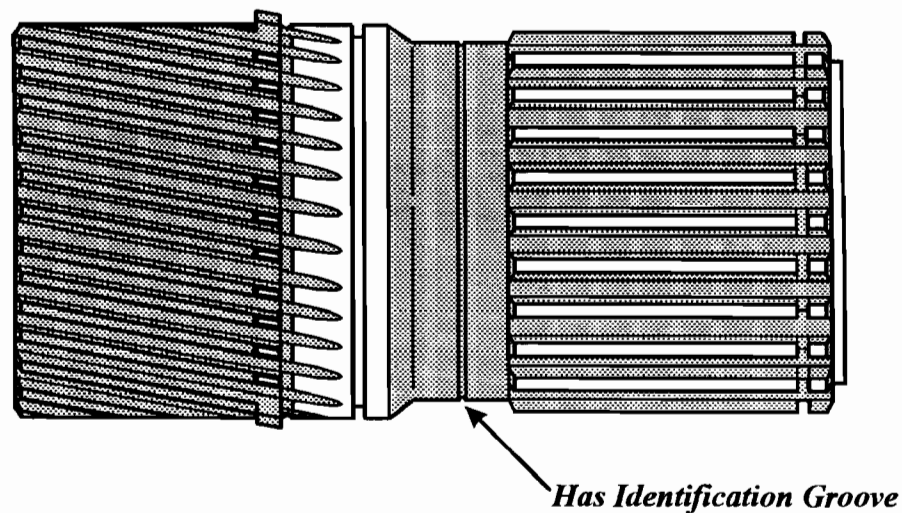
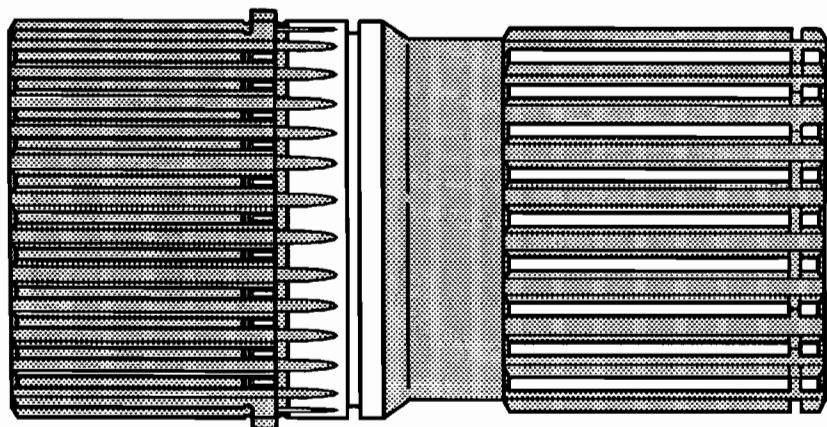
Figure 1

CHANGE: Beginning in model year 1995 Chrysler introduced a new design Overdrive Planetary Gear Set with 15 degree helical cut gears, to replace the previous design straight cut (spur) gears. The straight cut gears were found in the Turbo Diesel engine models equipped with the 47RH. The 46RH used a 4 pinion 22 1/2 degree helical cut overdrive gear set. This change has created a service concern for transmission technicians, as you now have two different angles of helical cut overdrive gear sets for the A518 transmission.

22 1/2 DEGREE OVERDRIVE SUN GEAR

15 DEGREE OVERDRIVE SUN GEAR

STRAIGHT CUT (SPUR) OVERDRIVE SUN GEAR

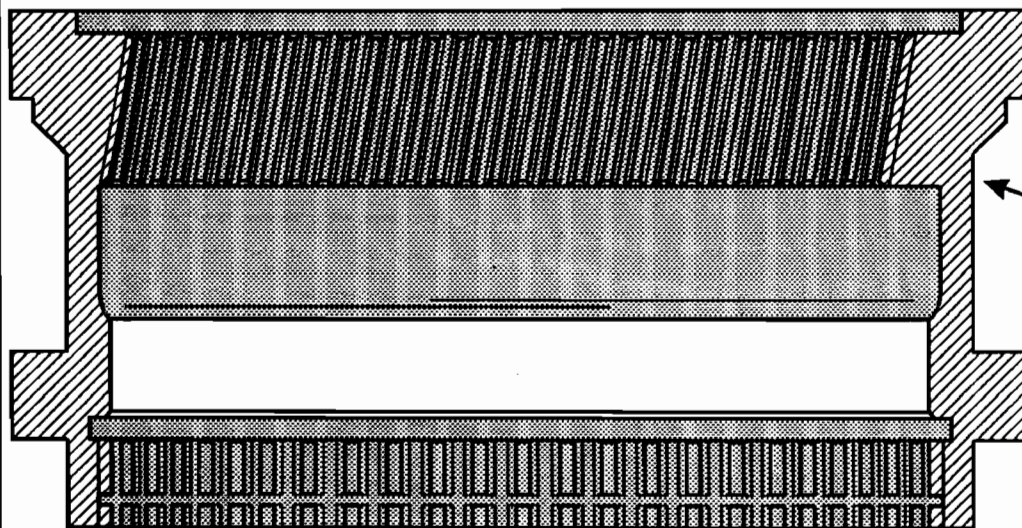
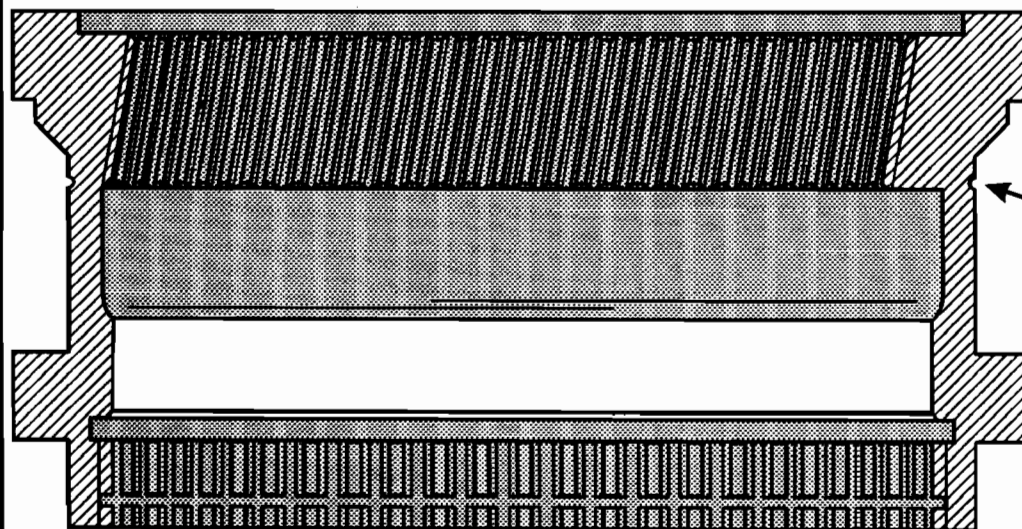
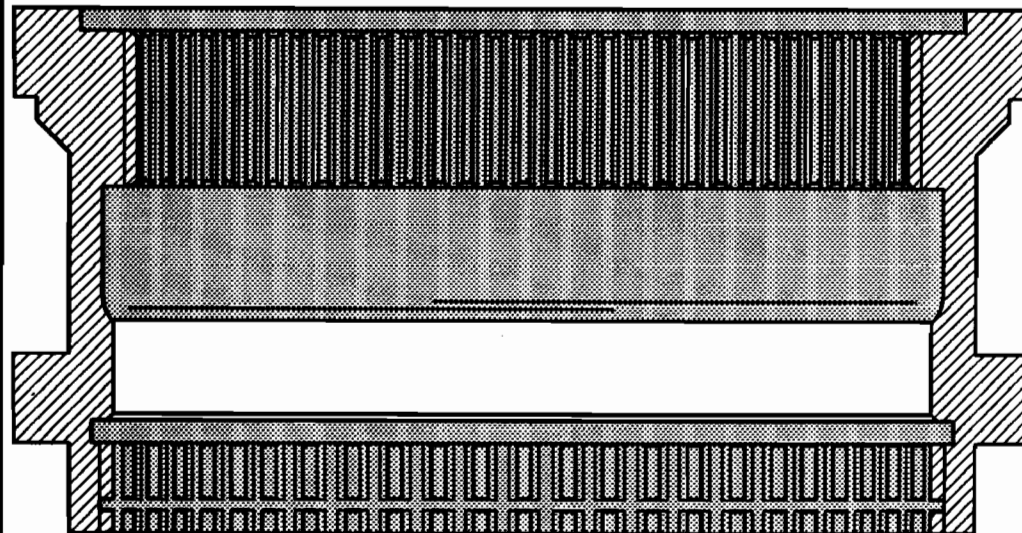
Figure 2

22 1/2 DEGREE OVERDRIVE RING GEAR

*No Identification Groove
Cut In Outside Diameter*

15 DEGREE OVERDRIVE RING GEAR

*Has Identification Groove
Cut In Outside Diameter*

STRAIGHT CUT (SPUR) OVERDRIVE RING GEAR

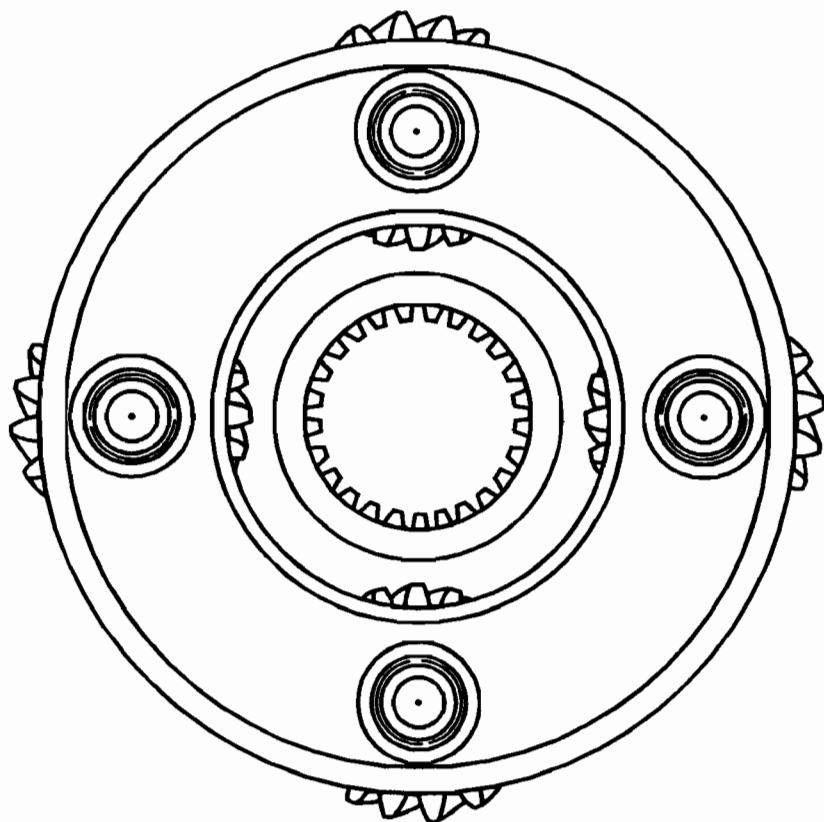
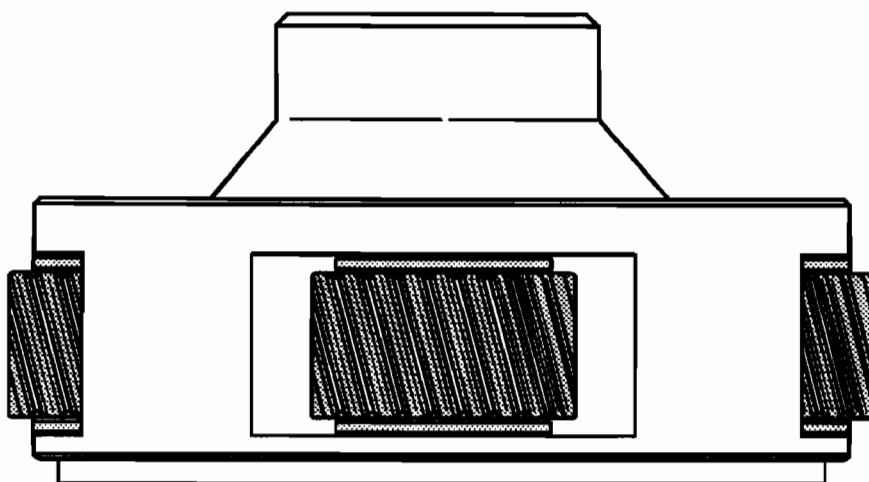
- (3) **OVERDRIVE PLANETARY CARRIER** - Now has 15 degree helical cut pinion gears and the 22 1/2 degree helical cut gears are also still used. There are not any identification marks on the carriers to distinguish between the two, but they will not assemble if the wrong components are used. Refer to Figure 3 for illustration of the 4 pinion carriers.
Refer to Figure 4 for illustration of the 5 pinion straight cut (spur) gear and is easy to identify because of the straight cut gears.
Refer to Figure 5 for illustration of the 5 pinion, 15 degree helical cut pinion gears, that was used to replace the straight cut design to reduce noise in the unit. The 5 pinion, 15 degree helical cut planetary must be used in the Turbo Diesel and the V-10 models.

4 PINION OVERDRIVE PLANETARY CARRIER
MANUFACTURED IN BOTH 15 DEGREE AND 22 1/2 DEGREE HELICAL CUT GEARS

***NO POSITIVE IDENTIFICATION BUT
WILL NOT ASSEMBLE WITH WRONG COMPONENTS***

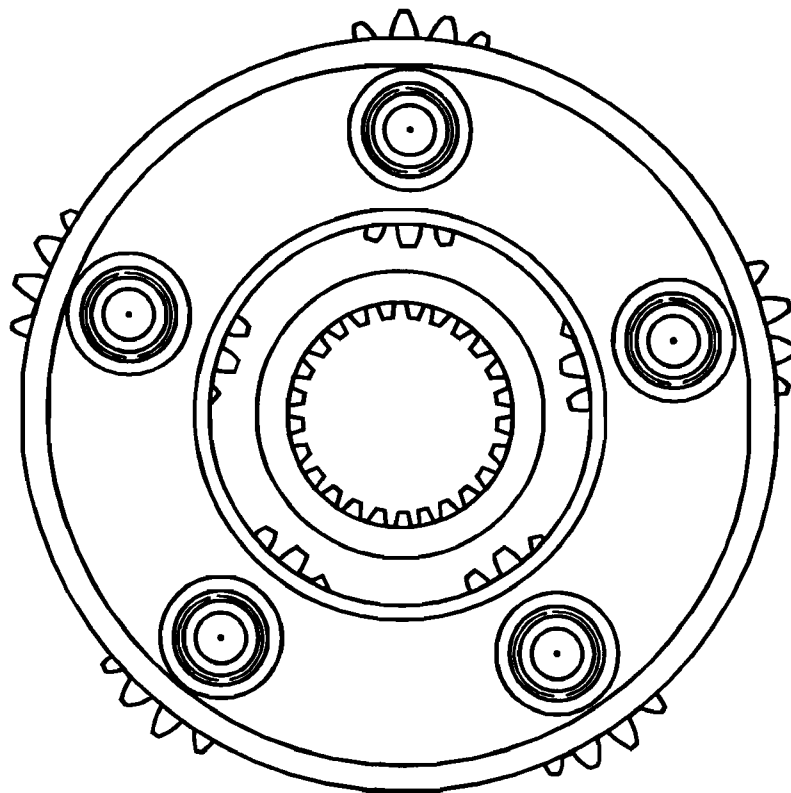
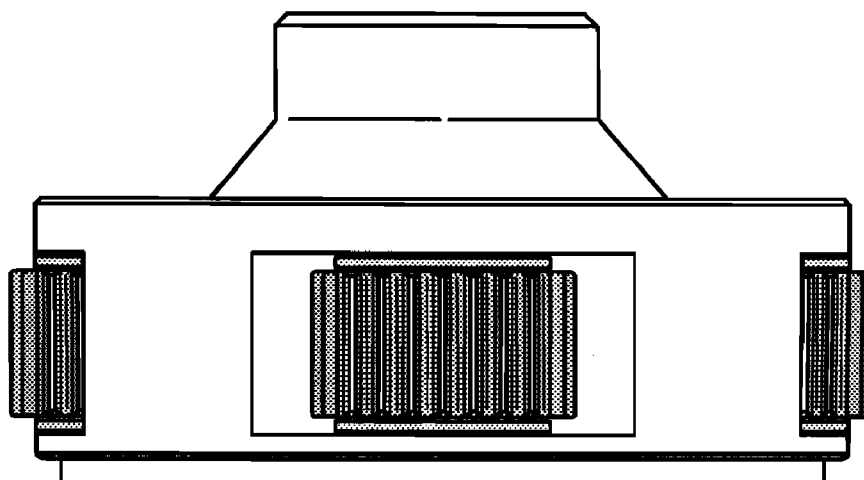
Figure 4

5 PINION STRAIGHT CUT OVERDRIVE PLANETARY CARRIER
FIRST INTRODUCED INTO THE TURBO DIESEL MODELS FOR STRENGTH

*REPLACED WITH 15 DEGREE HELICAL CUT
GEARS IN 1995 TO REDUCE NOISE*

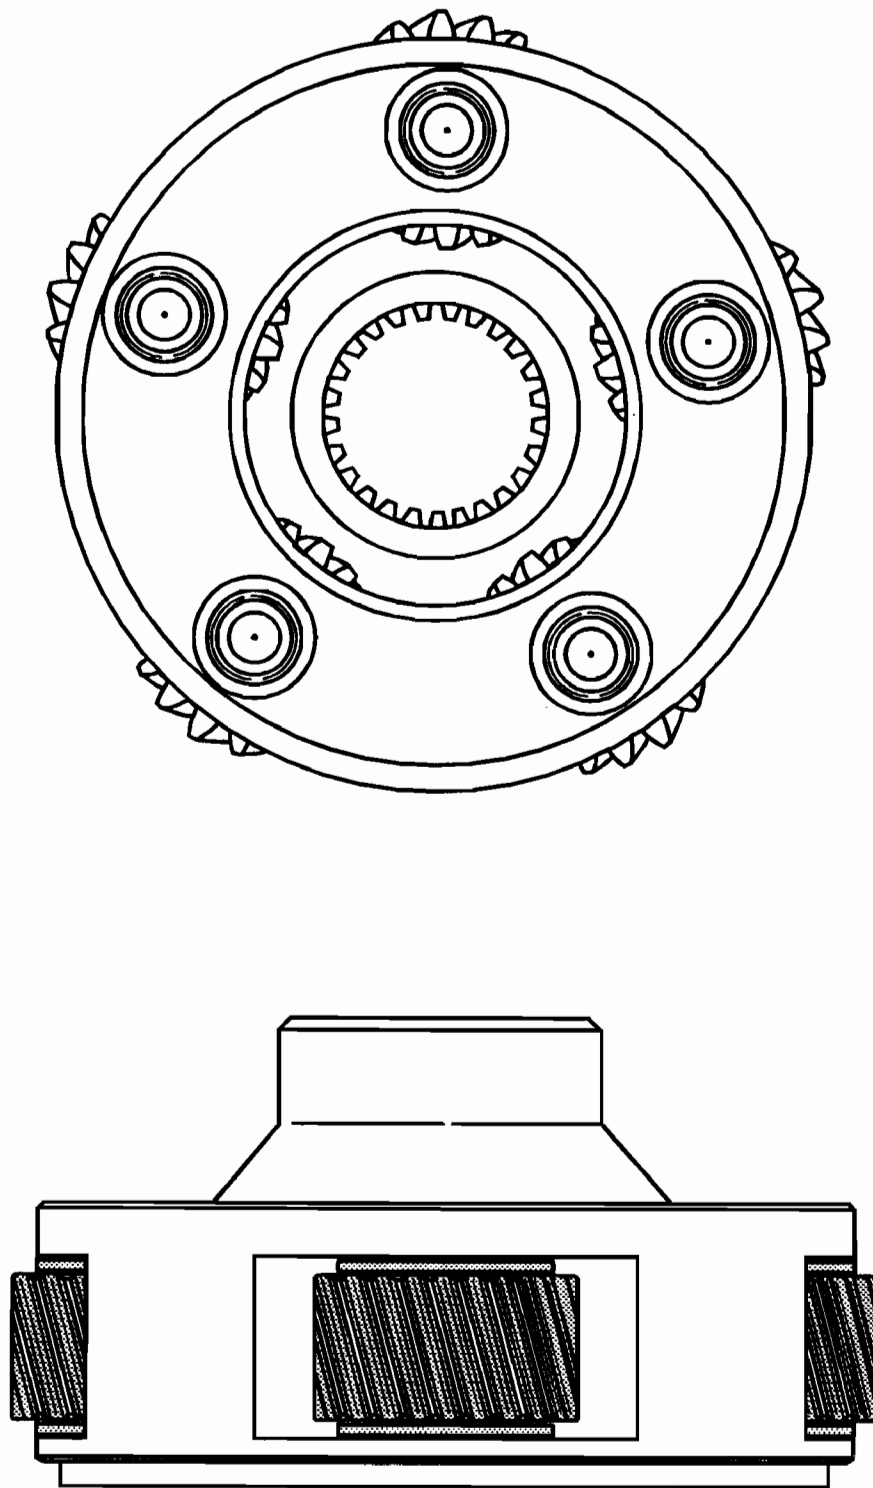
Figure 5

5 PINION 15 DEGREE HELICAL CUT OVERDRIVE PLANETARY CARRIER
INTRODUCED IN 1995 FOR TURBO DIESEL AND V-10 MODELS TO REDUCE NOISE

The new design 5 pinion, 15 degree helical cut overdrive carrier will replace the straight cut design when used with the 15 degree sun gear and the 15 degree internal ring gear, and is highly recommended. The 5 pinion design *must* be used in the Turbo Diesel and the V-10 models, and is recommended for any heavy duty application.

The 4 pinion, 22 1/2 degree helical cut set-up is used in the 46RH models, but could be upgraded to the 5 pinion, 15 degree set-up, for heavy duty applications as necessary.
